title
South West Elevation Proposed

drawing number
1706-123

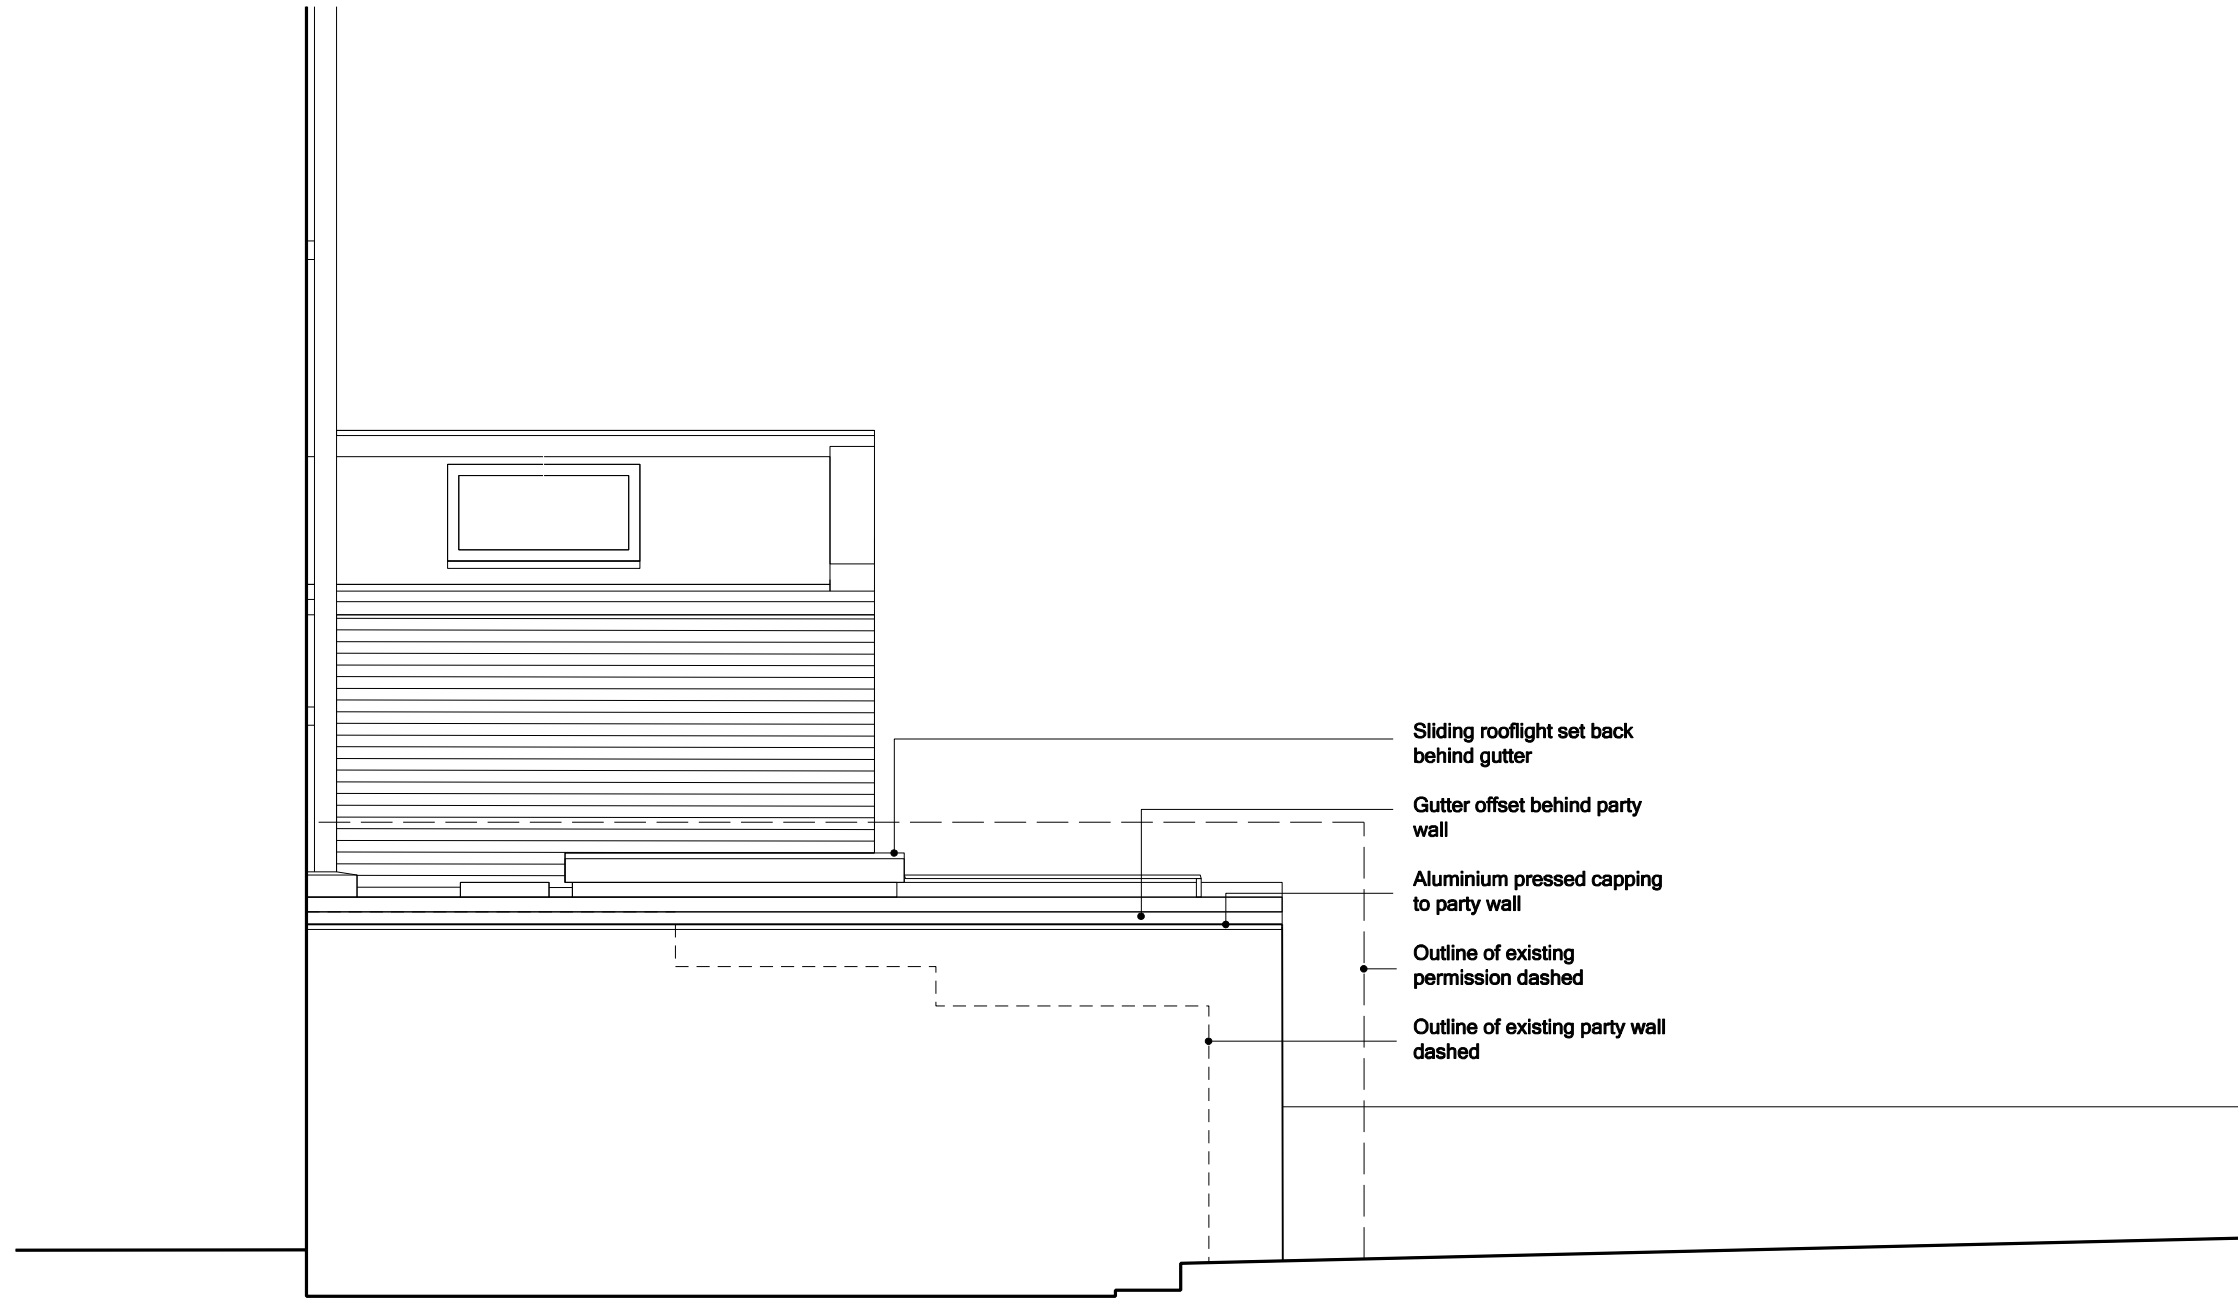
Sliding rooflight set back behind gutter

Gutter offset behind party wall

Aluminium pressed capping to party wall

Outline of existing permission dashed

Outline of existing party wall dashed
