# 24 Heath Drive Ecology Report

Eight Associates has been commissioned by The Estates Office to carry out a Phase 1 Habitat survey and bat building assessment in connection with a proposed new development at 24 Heath Drive in the London Borough of Camden

Development Name	24 Heath Drive
Development Address	24 Heath Drive, London, NW3 7SB
Development Description	The project consists of the refurbishment and extension of a listed residential building in the London Borough of Camden.

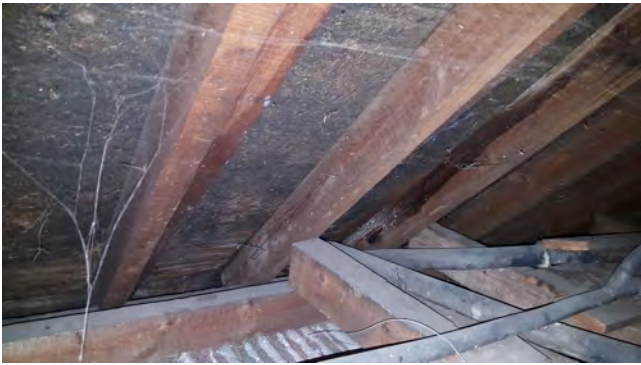
Northwestern eaves space

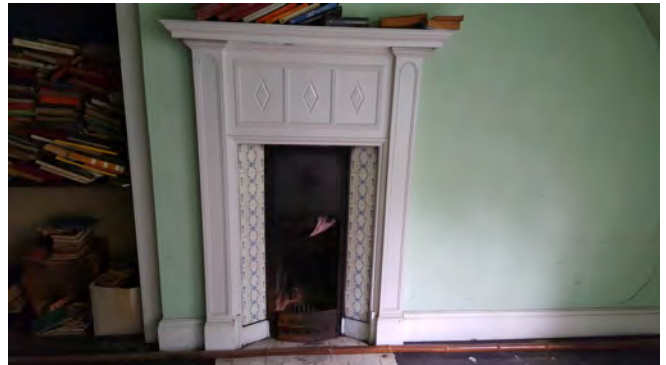
The top floor bedrooms and bathroom have no features that bats could have accessed or used to roost – although there are number of cracks in the walls due to subsidence damage, there are no points at which bats could access the internal space. Therefore these gaps could not be used by roosting bats. The fireplace located in one of the bedrooms is also blocked.

Blocked up fireplace

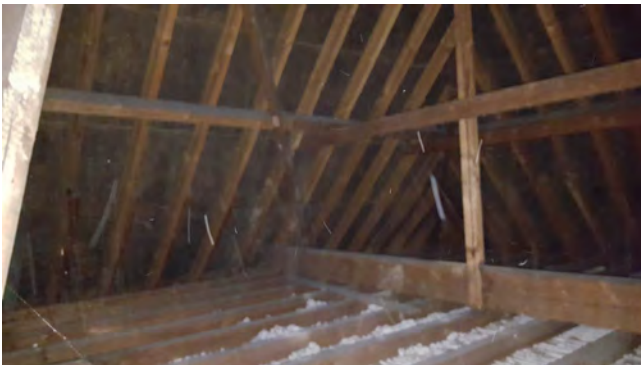
The eaves space facing north-east, accessed by a panel in the boiler room, was inspected. The eaves were of timber construction, and were lined with black waterproofing material that prevent bat access across the roof. The space was dark and heavily cobwebbed. There were two access points where light could be seen shining from the outside. One was located in the middle of the length of the void, which looked to have no evidence of bats using the space, and another at the northern corner of the space which could not be safely closely examined. No droppings were seen in the space.

Northeastern eaves space

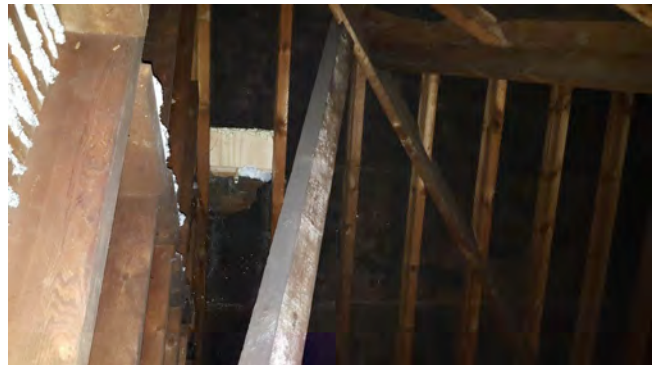
Opening in northeastern eaves space

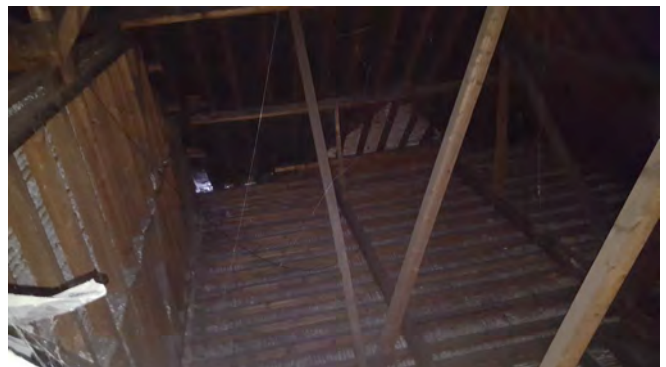
The loft space was also inspected. This is a dark, large space of timber construction with a black waterproof lining. Only one access point could be seen in the loft space, which corresponded to the gap under the north-western soffit that has been blocked by a tree. No droppings or other bat use indicators were seen in the space.

Opening in the loft space

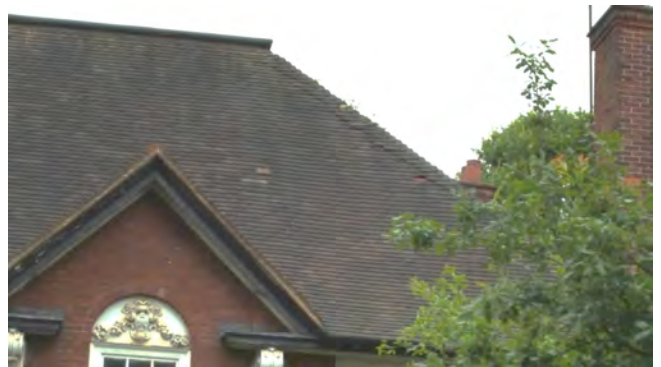
The slate roof is in a reasonable state of repair, with evidence of tiles being replaced over time. Two broken tiles that could act as ingress points, located on the front and rear of the building were observed. Tiles were also damaged along the ridge of the eastern extension, however these did not provide access into the internal space.

Front facing roof with broken tile

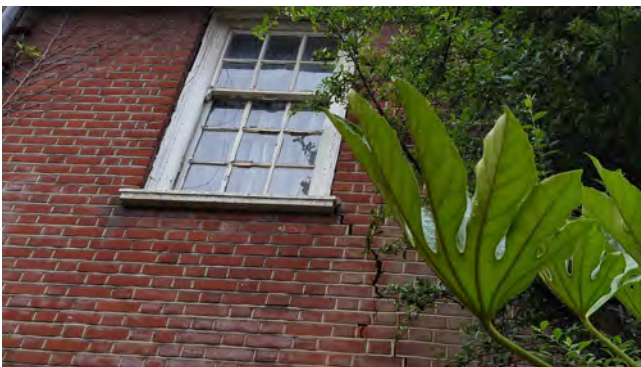
The building's brickwork is generally in a good state of repair, with no gaps in the mortar that could act as roosts. There is a large crack in the brickwork on the front of the house, on the garage extension – this was inspected using binoculars and no signs of bat use were seen. There is also a crack in the south-east facing wall of the garage, which has opened up enough to give enough space for bats to access the gap. However, the small courtyard area it looks out onto is relatively enclosed due to the surrounding trees and buildings, and it would be difficult for a bat to navigate to the feature. In addition there were no signs of bat use when the crack was inspected.

Crack in the wall on the front façade

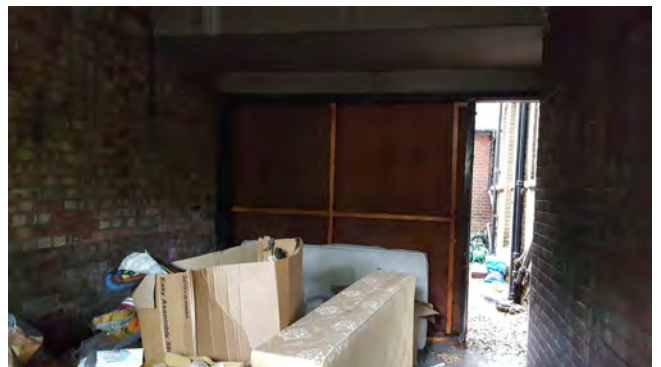
The garage was inspected internally for access points. Both entrances to the garage are blocked by doors, and there were no suitable bat roosting features inside.

Internal garage space

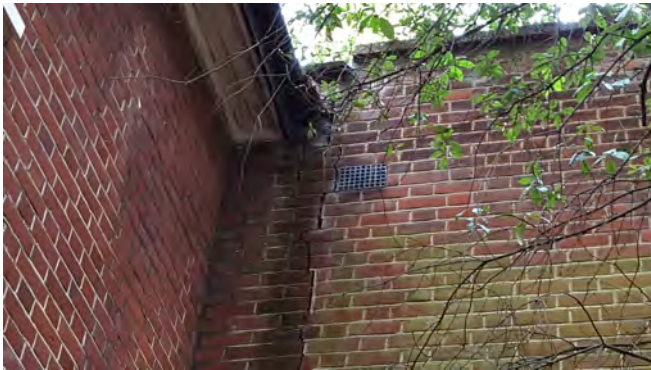
Crack in garage wall

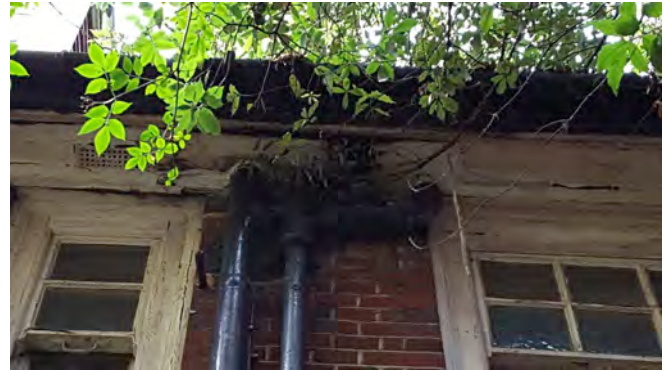
Original timber frame windows are present on all sides of the building; none of the windows frames had appropriate crevices for bats. The timber soffit has a gap on the north-western façade overlooking the small courtyard area, however this was blocked by a tree branch and the courtyard area is too enclosed for bat flight, so this feature is unlikely to be used by bats. A similar hole was seen on the south-eastern façade, but, again, due to the proximity of the neighbouring house it would be difficult for a bat to maneuver into this access point.

Gap in soffit covered by tree branches

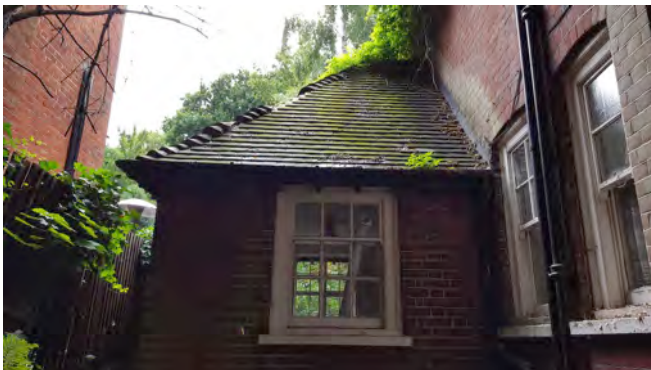
Extension with missing tiles on roof ridge

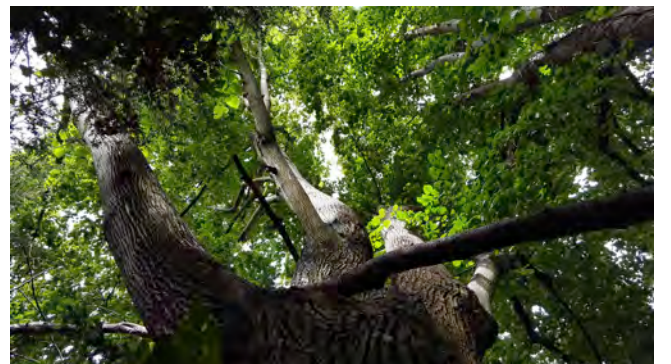
The mature trees on the site were inspected with binoculars for features that could accommodate roosting bats, e.g., loose bark, cavities in the trunk and branches, woodpecker holes. No such features were seen on any of the trees on the site.

Mature tree with no bat roosting potential

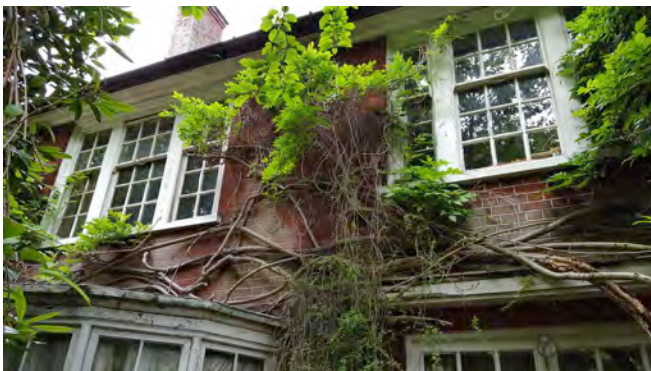
Although the rear façade of the building is partially covered in stem and leaf vegetation from a wisteria, it does not have a tight structure that would act as bat roost habitat.

The rear façade of the house was covered with a wisteria *Wisteria sp.* climber. This plant had some foliage but large sections were dead, with major decay in the stems. A small raised flowerbed is present in the courtyard, containing scattered male ferns and ivy *Hedera helix*. A goat willow *Salix caprea* and elder tree *Sambucus nigra* are also present in the courtyard.

Wisteria covering rear façade of the house

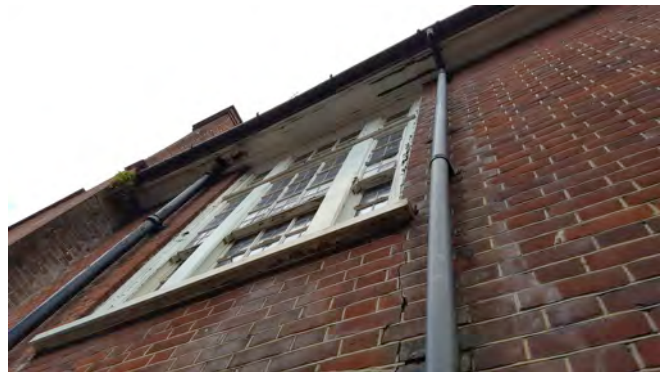
Hole in the south-west facing soffit
