Gilling Court, Belsize Grove 1735 WINDOW REPLACEMENTS -SV 01

**EXISTING ELEVATIONS** checked 1:100@A1 <sup>28.11.17</sup> RE

drawing
WINDOW REPLACEMENTS - SV 02
EXISTING ELEVATIONS
scale date drawn checked
1:100@A1 28.11.17 RE

GA 01

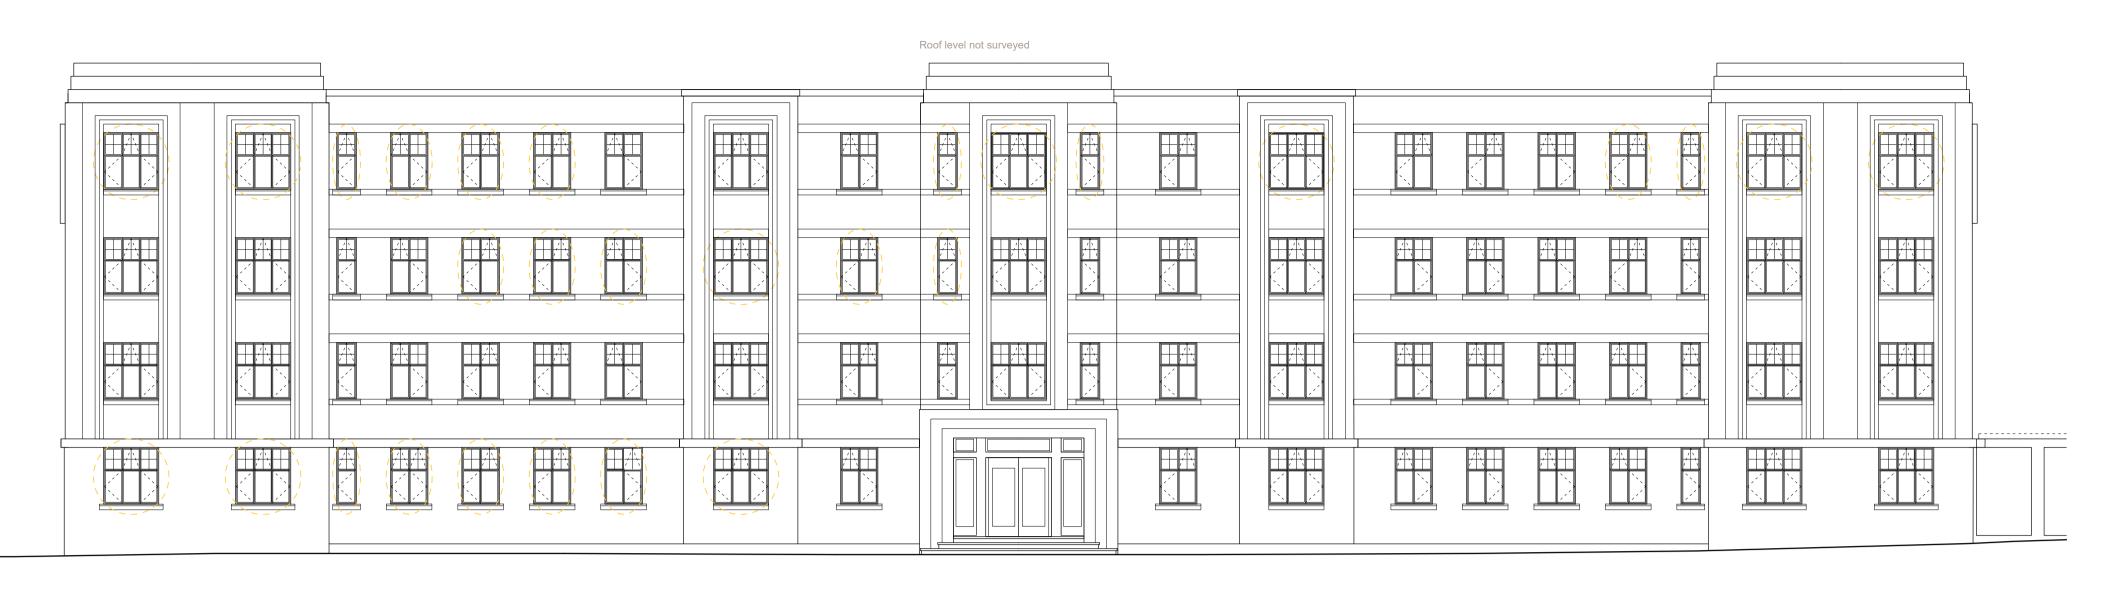
## Front elevation - 1

The window survey was an external inspection only - some assumptions regarding openings and window replacements have been made

Some windows are fitted with internal security bars

Original windows replaced - generally in

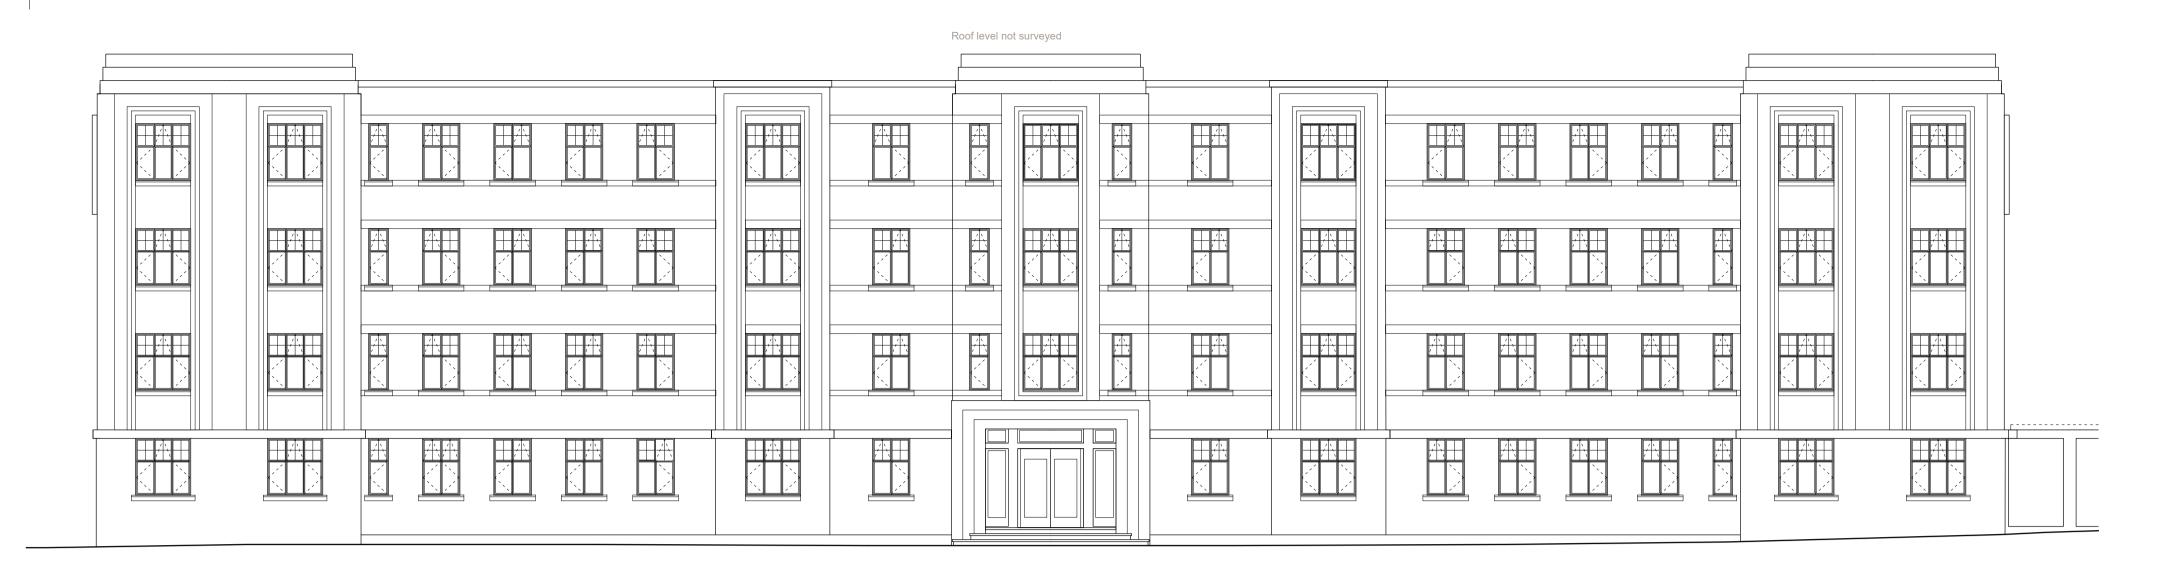
## Front elevation - 1

All windows to be replaced with the Alitherm Heritage aluminium system and are to closely match the original window design.

The replacement windows are to be Alitherm Heritage design with fixed light and open-out windows, internally and externally

All opening vents are hung on concealed stainless steel variable angle friction stays and fitted with cockspur/espagnolette locking mechanisms.

Thermal breaks are formed with polyamide strips PA 6.6 25 reinforced with glass fibre, fitted between aluminium extrusions. All profiles are extruded from aluminium alloy 6060/6063 T5/T6 and comply with the recommendations of BS EN 12020-2; 2001/BS 755-9: 2001.
