ARLINGTON STUDIOS, CAMDEN, NW1 – GROUND INVESTIGATION AND INTERNAL AIR SPACE MONITORING

FIGURE 1 – INSPECTION PIT LOCATION PLAN

APPENDIX 2 – INSPECTION PIT RECORDS AND PHOTOGRAPHS

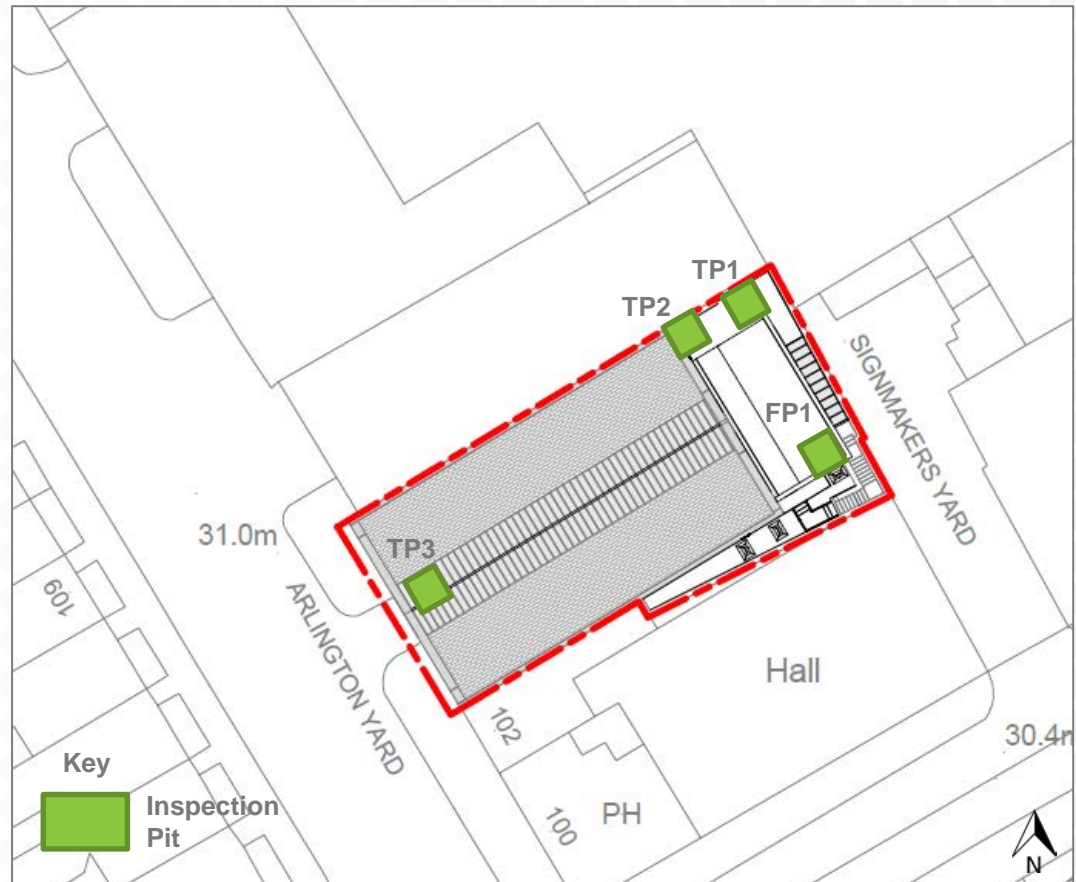
Figure 1 Inspection Pit Location Plan

Two phases of investigation were undertaken at the site in accordance with the principles of BS 5930:1999 and BS 10175:2011. The first phase was undertaken on 20 September 2017 and involved soil sampling from inspection pits at locations shown on Figure 1. A Paragon representative logged the ground conditions and took representative soil samples for chemical laboratory analysis. The soil samples were collected into dedicated containers (clean glass amber jars and plastic tubs). The samples were stored under cooled conditions for submission to i2 Analytical, an MCERTS and UKAS-accredited facility, for chemical laboratory testing including:

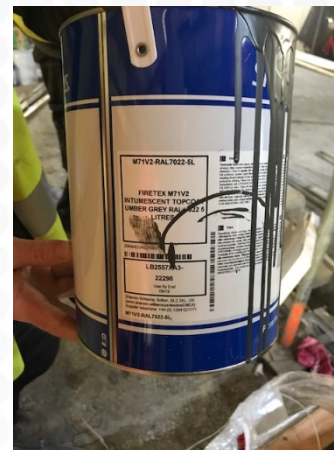
Low level TVOC concentrations (0.7 ppmv) were detected in the ground floor area. However, given the absence of TVOCs in the basement area (<0.1 ppmv) and the ongoing refurbishment being undertaken during the survey, it is likely these low level concentrations are simply residual vapours emitted from drying paints and adhesives, rather than ingress from an external ground contamination source. Photographs showing the adhesives etc. being used in the ground floor refurbishment are shown in Appendix 2.

Paints and adhesives in use for the ground level refurbishment
