Arboricultural Opinion

The Water House, Millfield Lane, N6 6HQ.

Draft report of: Matthew Searle BSc (Hons), MICFor, MRTPI

Dated: 23rd February 2018

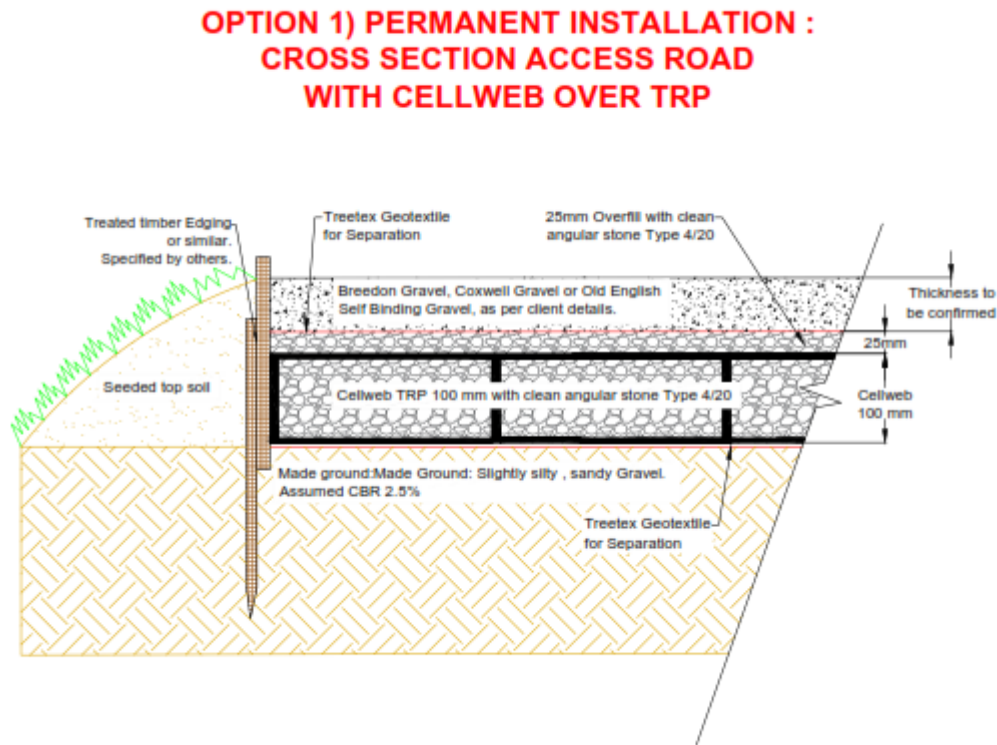
Figure 1 The Permanent Solution

4.1.5. Having reviewed the submissions (set out in Appendix F) most notably the two consultant structural engineers reports and the Tree Root Radar survey, I am of the opinion that the permanent 'no dig' cellular confinement system specification in proximity to the three veteran trees, submitted by Geosynthetics Limited (and shown in Figure 1 below) would reduce any detrimental impact on existing tree roots, albeit that these impacts are likely to be minimal. The biggest gain when looking at the objectives (paragraph 1.3.2) would be the opportunity to also improve the rooting environment as part of the system.

4.1.7 In order to reduce further rutting and damage to the verges from construction traffic, I would therefore recommend a permanent cellular confinement system be installed in proximity to the three veteran trees, across the entire area of the Root Protection Areas (59.5 metres in length), the extent of which is delineated on the Tree Plan (Appendix C) and that the specification shown in figure 1 above is generally fit for purpose, but I would suggest the following amendments:

- Unless it can be demonstrated that the suggested surface finish of Breedon Gravel, Coxwell Gravel or Old English Self Binding Gravel are fully permeable over a number of years, an alternative surface layer solution should be found. Anecdotal evidence suggests such surfaces can silt up with fines, making them less and less porous over time. One of the key performance criteria required is a truly permeable construction that allows the roots and rooting environment to receive sufficient access to water, nutrients and oxygen.

- Only up to a maximum of 100mm be stripped off the current surface to enable the required leveling, although it is my understanding that the

Geosynthetics Limited solution does not require a completely level surface, having some flexibility to deal with undulations. This is recommended to protect existing tree roots.

- Any potholes, ruts or depressions to be filled BY HAND with inert materials including where possible, mulches and also soil and builders sand. Soft sand MUST NOT be used as it tends to contain salt, which is toxic to tree roots. This is recommended to protect existing tree roots and the rooting environment in which new tree roots can exploit.

- The seeded top soil edge to be graded so as not to exceed 200mm above existing ground levels. This is recommended to protect existing tree roots.
- The existing ground layer to be carefully forked BY HAND and have a mulch layer (supplied by The City Of London) and applied across the Root Protection Area.

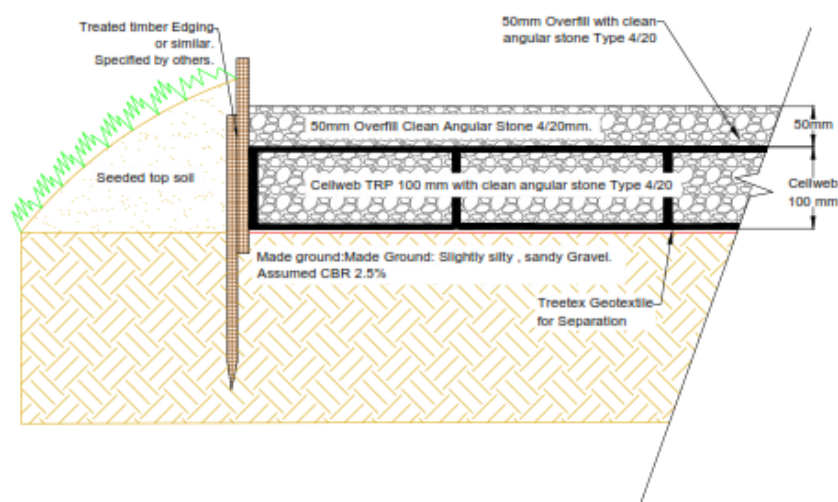
Figure 2 the Temporary Solution

**OPTION 2) TEMPORARY INSTALLATION :
CROSS SECTION ACCESS ROAD
WITH CELLWEB OVER TRP**

4.1.8 For the other mature trees along Millfield Lane, the majority of which are at least 4 metres from the track and at levels below 1 metres from the existing track ground level, I am of the opinion that whilst the proposed temporary solution (Figure 2 below) with my recommended additions set out in paragraphs 4.1.6 above would, in theory, be more than sufficient to protect any tree roots and their associated rooting environment, the installation process, including surface removal and leveling has the potential to cause more harm to tree roots and the rooting environment than is mitigated by the temporary system.

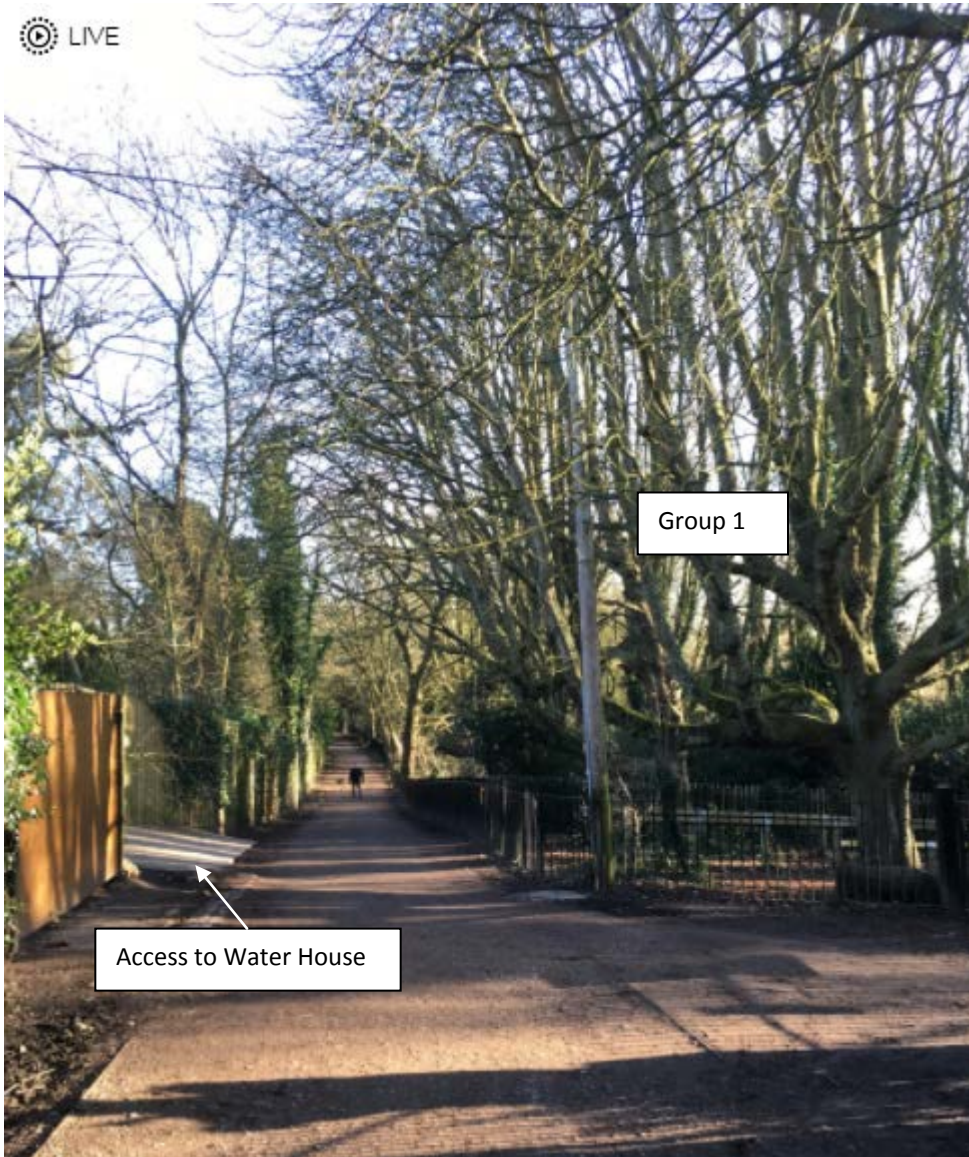
Image 5: Group 1 (part of) looking south east

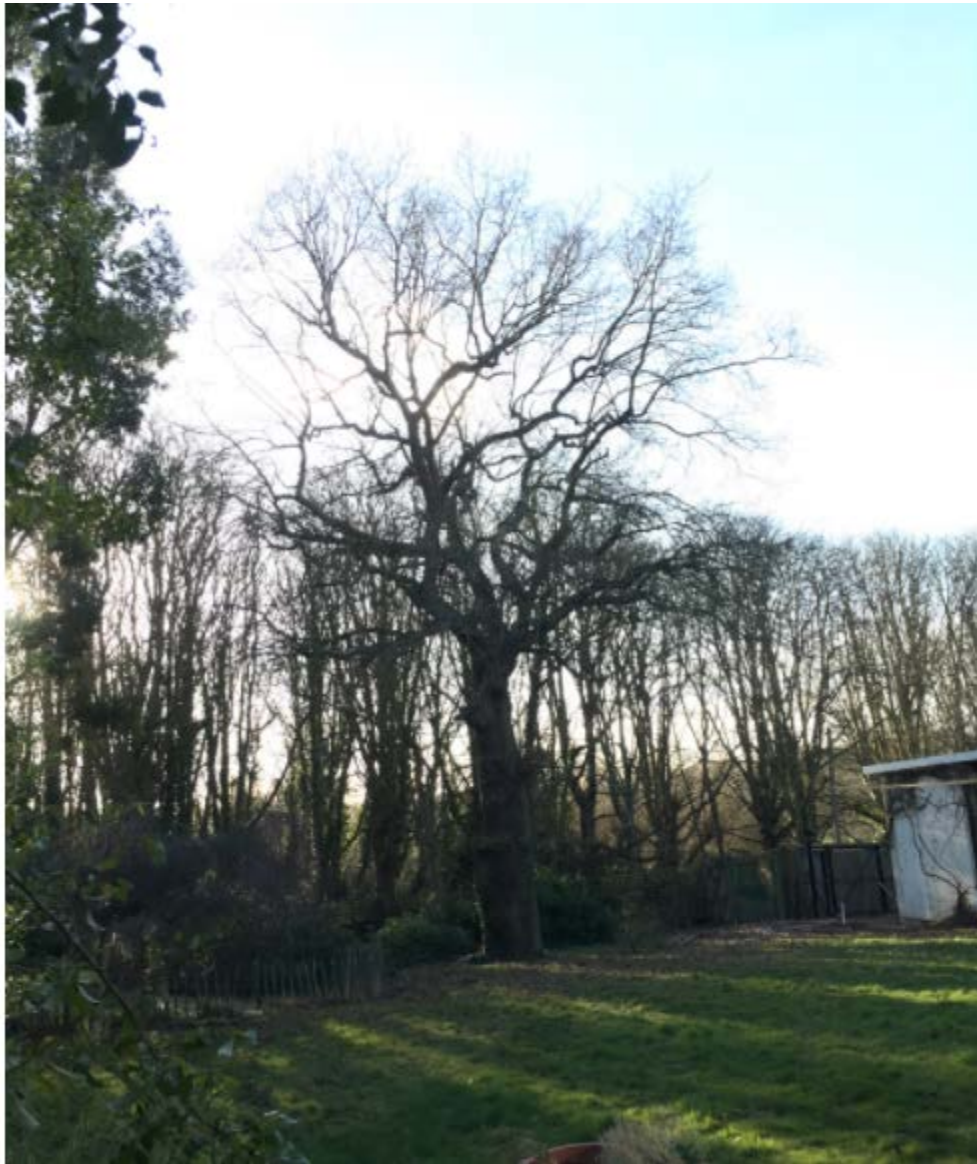
Image 6: Tree T5 looking south west

4.1.11 The AIA identifies a 'low' impact on tree T17 from the proposed demolition and rebuilding of the outbuilding, with careful demolition and low-invasive foundations proposed in mitigation and for T5, new hard surfaces to be constructed within the RPA of T5, the most significant tree on site, which will be mitigated through the use of a no-dig construction methodology and porous finished surface (not unlike the cellular confinement system proposed by Geosynthetics for Trees T1 –T3). I note the incursion into the RPA represents only 4.36% of the total RPA, which can be described as minimal, with a consequently very low impact.

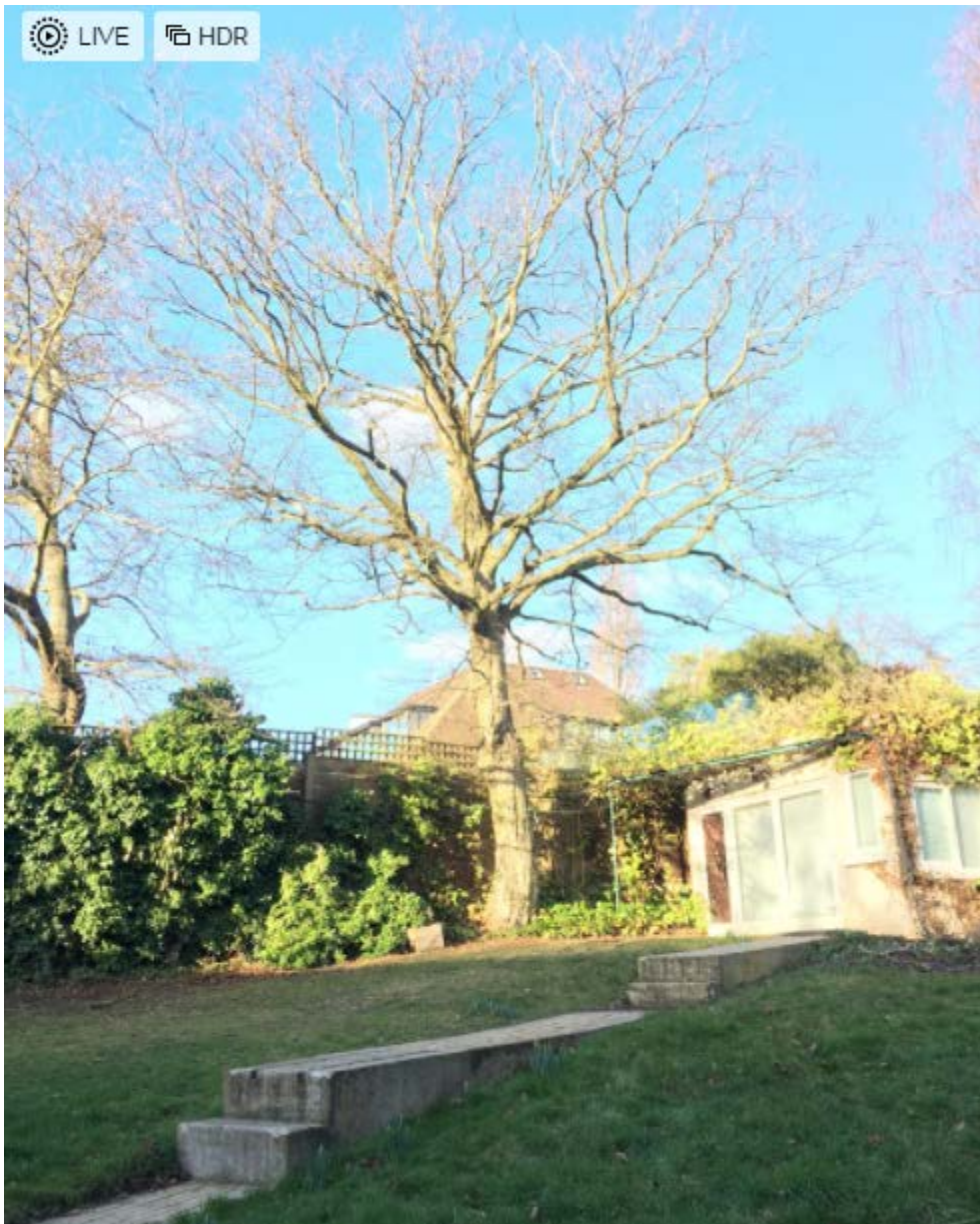
Image 7: Tree T17 looking north

- 3.2.6 Tree T17, the Hornbeam on the site itself has also been assessed as having only a low physiological condition during my inspection. Landmark Trees noted the early loss of foliage in 2017 and the presence of the pathogen honey fungus (*armillaria* species) at its base. It is important to note that this tree may decline irrespective of the development.

4.1.17 I note from Landmark Trees findings and my own observations, that tree T17, the Hornbeam is in only a 'fair to low' physiological condition. I note too that Landmark Trees noted the presence of the pathogen honey fungus (*armillaria* species), which is often associated with trees already under stress and which could hasten its decline irrespective of the proposed development.

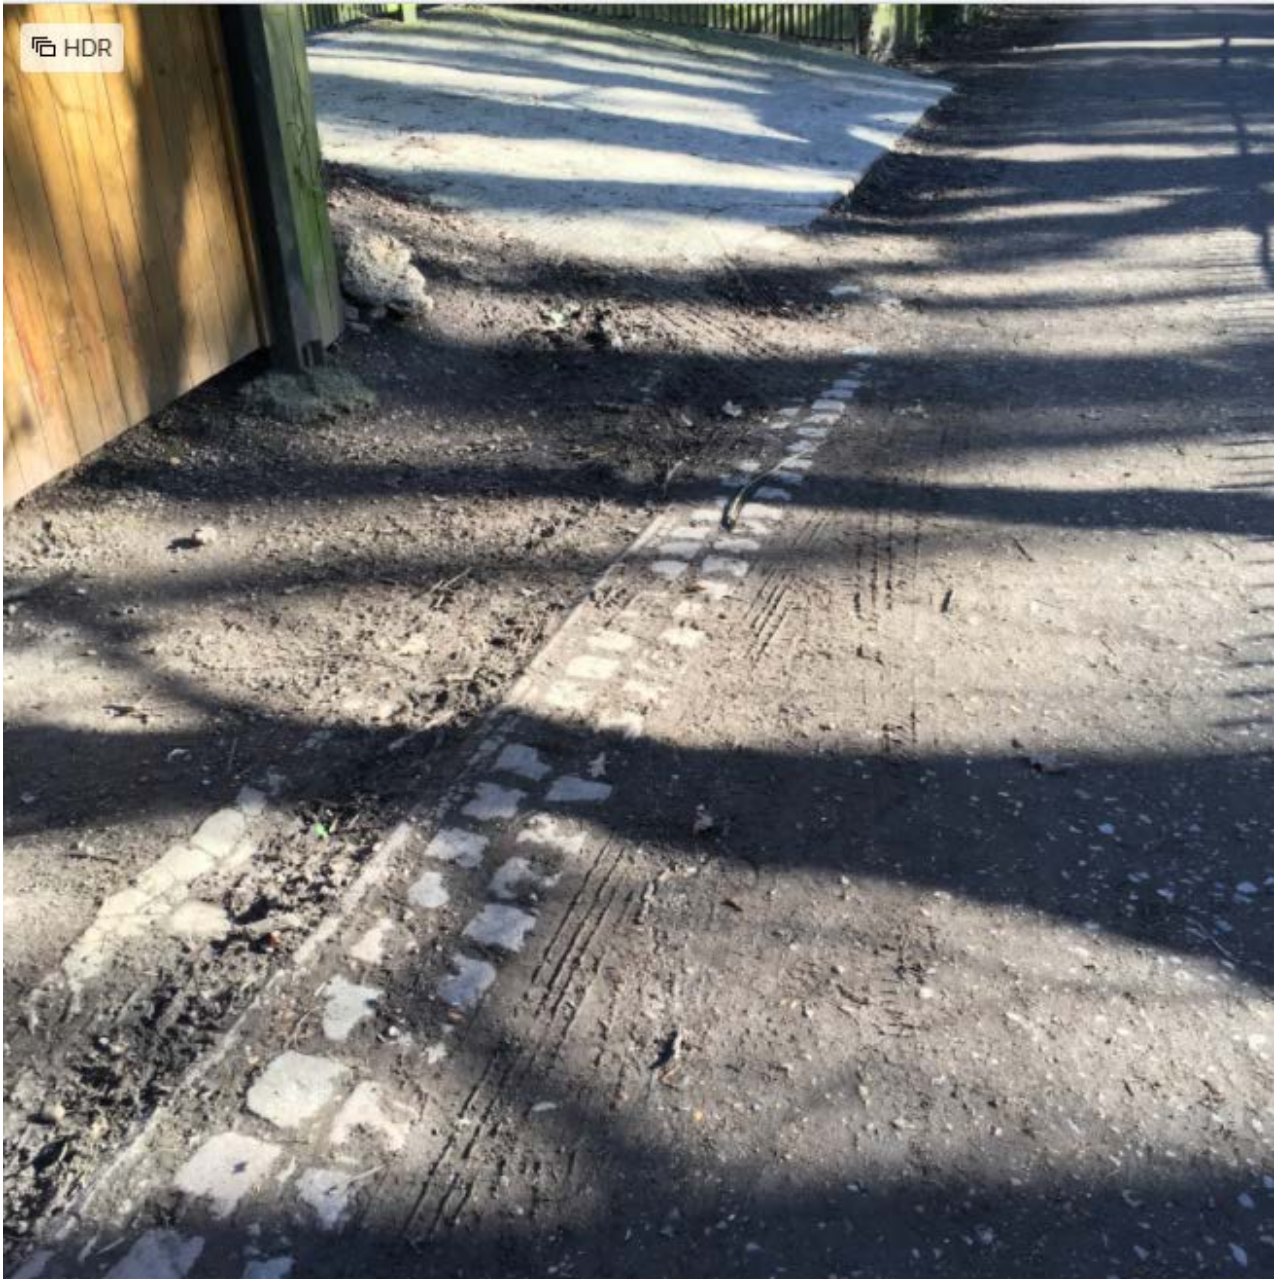
3.16 Millifield Lane's contours vary across its length with a general cross fall towards the heath. The lane also contains small hollows, potholes and is rutted at its soft edges.

Image 8: Typical vehicle tyre rutting

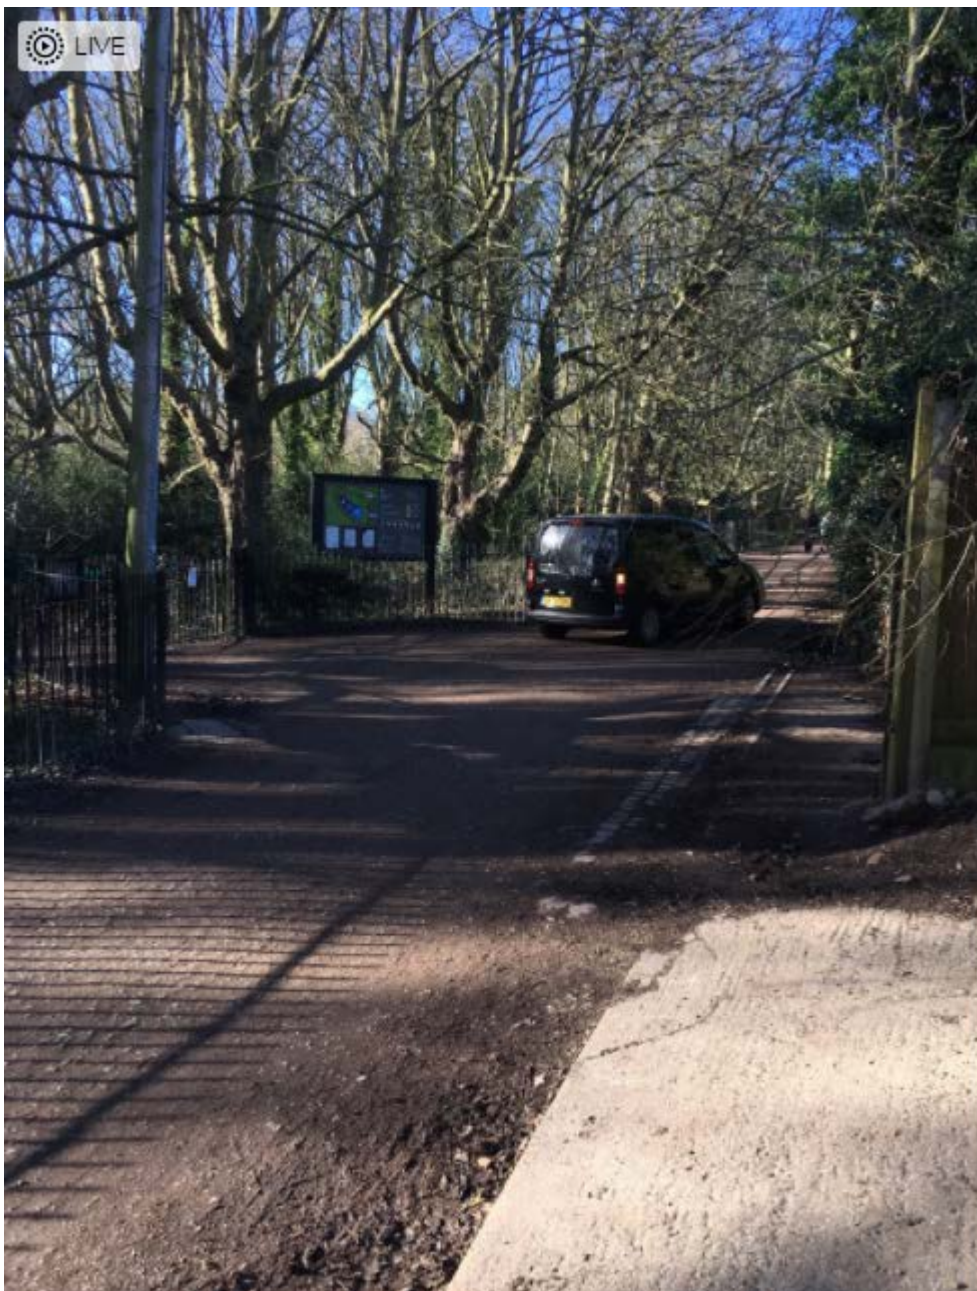
Image 9: Vehicle using the lane
