# WINDOW SCHEDULE

## PLANNING ISSUE

MAREK WOJCIECHOWSKI ARCHITECTS  
LONDON

Project No. 17103  
Client GFZ Investments Ltd.  
Date December 2017  
Project 34 Great James Street  
Revision -

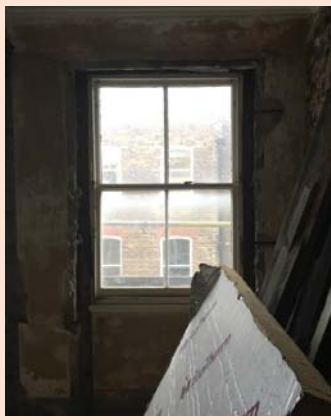
Front Elevation			
Window Ref	Existing Window Description	Existing Window	Proposed Window Description
FW 01	2 over 2 pane timber sash window with horns, thin profiled glazing bars (late Georgian or Victorian style but could be later reproduction), timber architraves, modern plate glass, no shutters internall.

Structural opening retained, window to be replaced. 6 over 6 pane timber sash windows without horns, exposed sash boxes externally, fat profiled glazing bars (reproduction of early Georgian style), single-glazed, frame & glass of top sash to follow curved shape of reveal, to be set almost flush with the wall, sills to be repaired where required.  <b>Refer to drawing 400_301 Proposed Window Type A for details of the new window.</b>
FW 02	2 over 2 pane timber sash window with horns, thin profiled glazing bars (late Georgian or Victorian style but could be later reproduction), timber architraves, modern plate glass, no shutters internall.

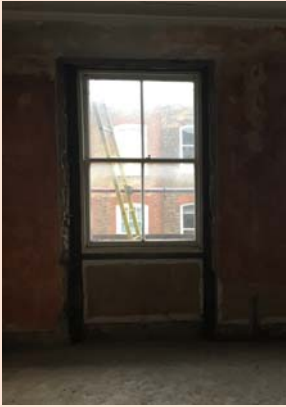
FW 03	2 over 2 pane timber sash window with horns, thin profiled glazing bars (late Georgian or Victorian style but could be later reproduction), timber architraves, modern plate glass, no shutters internall.

Structural opening retained, window to be replaced. 6 over 6 pane timber sash windows without horns, exposed sash boxes externally, fat profiled glazing bars (reproduction of early Georgian style), single-glazed, frame & glass of top sash to follow curved shape of reveal, to be set almost flush with the wall, sills to be repaired where required.  <b>Refer to drawing 400_301 Proposed Window Type A for details of the new window.</b>
FW 04	1 over 1 pane timber sash window with horns (later replacement), no shutters internally

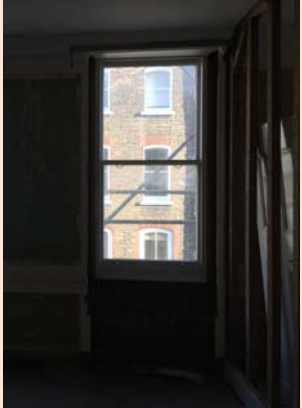
FW 05	1 over 1 pane timber sash window with horns (later replacement), no shutters internally

<p>Structural opening retained, window to be replaced. 6 over 6 pane timber sash windows without horns, exposed sash boxes externally, fat profiled glazing bars (reproduction of early Georgian style), single-glazed, frame &amp; glass of top sash to follow curved shape of reveal, to be set almost flush with the wall, sills to be repaired where required.</p> <p><b>Refer to drawing 400_301 Proposed Window Type B for details of the new window.</b></p>
FW 06	1 over 1 pane timber sash window with horns (later replacement), no shutters internally

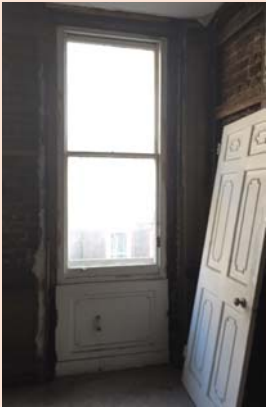
FW 07	1 over 1 pane timber sash window with horns, modern plate glass, no shutters internally, windows rotting in places externally

<p>Structural opening retained, window to be replaced. 6 over 6 pane timber sash windows without horns, exposed sash boxes externally, fat profiled glazing bars (reproduction of early Georgian style), single-glazed, frame &amp; glass of top sash to follow curved shape of reveal, to be set almost flush with the wall, internal shutters to be reinstated, sills to be repaired where required.</p> <p><b>Refer to drawing 400_301 Proposed Window Type C for details of the new window.</b></p>
FW 08	1 over 1 pane timber sash window with horns, modern plate glass, no shutters internally, windows rotting in places externally

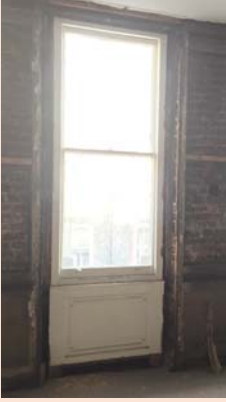
FW 09	1 over 1 pane timber sash window with horns, modern plate glass, no shutters internally, windows rotting in places externally

<p>Structural opening retained, window to be replaced. 6 over 6 pane timber sash windows without horns, exposed sash boxes externally, fat profiled glazing bars (reproduction of early Georgian style), single-glazed, frame &amp; glass of top sash to follow curved shape of reveal, to be set almost flush with the wall, internal shutters to be reinstated, sills to be repaired where required.</p> <p><b>Refer to drawing 400_301 Proposed Window Type C for details of the new window.</b></p>
FW 10	1 over 1 pane timber sash window with horns (later replacement), shutters removed internally, architraves may be later

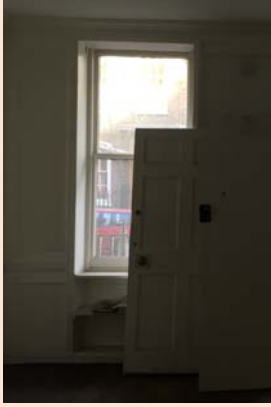
FW 11	1 over 1 pane timber sash window with horns (later replacement), shutters removed internally, architraves may be later

Structural opening retained, window to be replaced. 6 over 6 pane timber sash windows without horns, exposed sash boxes externally, fat profiled glazing bars (reproduction of early Georgian style), single-glazed, frame & glass of top sash to follow curved shape of reveal, to be set almost flush with the wall, internal shutters to be reinstated ,sills to be repaired where required.  <b>Refer to drawing 400_302 Proposed Window Type D for details of the new window.</b>
FW 12	C20th timber casement window

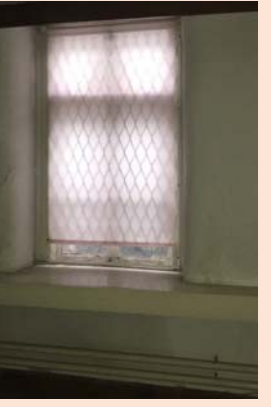
FW 13	C20th timber casement window

Structural opening retained, window to be replaced. 6 over 6 pane timber sash windows without horns, exposed sash boxes externally, fat profiled glazing bars (reproduction of early Georgian style), single-glazed, frame & glass of top sash to follow curved shape of reveal, to be set almost flush with the wall, internal shutters to be reinstated,sills to be repaired where required.  <b>Refer to drawing 400_302 Proposed Window Type E for details of the new window.</b>
<b>Rear Elevation</b>			
RW 01	6 over 6 pane timber sash window with horns, fat early Georgian style glazing bars (later reproduction), external sill rotting badly in places, no shutters internally

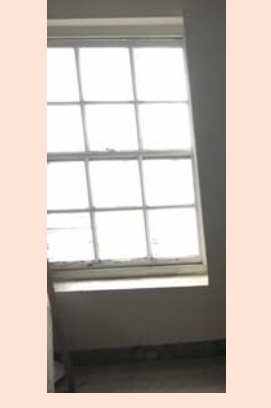
RW 02	6 over 6 pane timber sash window with horns, fat Georgian style profiled glazing bars (later reproduction), modern plate glass, no shutters internally

6 over 6 pane timber sash windows without horns, exposed sash boxes externally, fat profiled glazing bars (reproduction of early Georgian style), single-glazed, rectangular headed top sash, to be set almost flush with the wall, sills to be repaired where required.  <b>Refer to drawing 400_303 Proposed Window Type F for details of the new window.</b>
RW 03	6 over 6 pane timber sash window with horns, fat early Georgian style glazing bars (later reproduction), modern plate glass, external sill rotting badly, no shutters internally

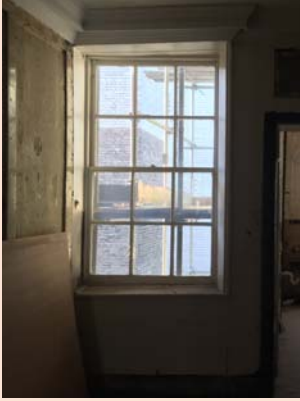
<p>6 over 6 pane timber sash windows without horns, exposed sash boxes externally, fat profiled glazing bars (reproduction of early Georgian style), single-glazed, rectangular headed top sash, to be set almost flush with the wall, sills to be repaired where required.</p> <p><b>Refer to drawing 400_303 Proposed Window Type F for details of the new window.</b></p>
RW 05	6 over 6 pane timber sash window with horns, fat early Georgian style glazing bars but probably modern reproduction, no historic glass, external sill badly rotten

<p>6 over 6 pane timber sash windows without horns, exposed sash boxes externally, fat profiled glazing bars (reproduction of early Georgian style), single-glazed, rectangular headed top sash, to be set almost flush with the wall, sills to be repaired where required.</p> <p><b>Refer to drawing 400_303 Proposed Window Type F for details of the new window.</b></p>

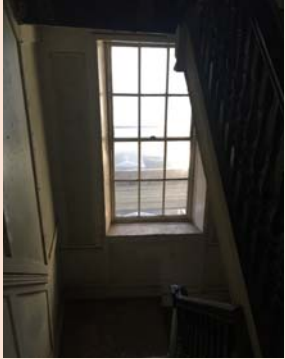
RW 06	6 over 6 pane timber sash window with horns, fat early Georgian style glazing bars but probably modern reproduction, modern plate glass with one pane cracked, external sill rotten, no shutters internally

<p>6 over 6 pane timber sash windows without horns, exposed sash boxes externally, fat profiled glazing bars (reproduction of early Georgian style), single-glazed, rectangular headed top sash, to be set almost flush with the wall, sills to be repaired where required.</p> <p><b>Refer to drawing 400_303 Proposed Window Type F for details of the new window.</b></p>
RW 07	6 over 6 pane timber sash window with horns, historic panelling to window reveals possibly original shutters

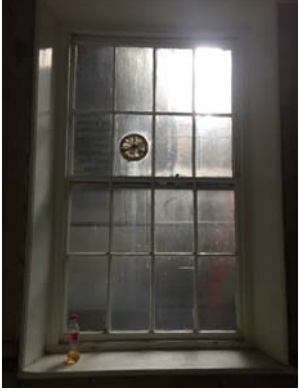
RW 10		Not Accessible	To be removed
RW 11	8 over 8 pane timber sash window, fine profile glazing bars more consistent with late Georgian or Victorian period (may be later), sill badly rotting

Structural opening & window retained & refurbished,
RW 12	6 over 6 pane timber sash window with external horns, have early C18th profile glazing bars but window frame is a modern replacement, modern plate glass, possibly concrete sill

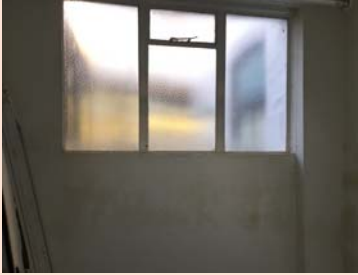
To be removed
RW 15	modern plastic casement window obscure glazing

Structural opening to be amended, window to be replaced.  Refer to drawing 400_303 Proposed Window Type J for details of the new window.

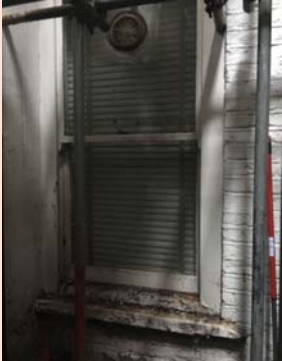
To be removed
RW 17	1 over 1 pane modern timber sash window

<p>6 over 6 pane timber sash windows without horns, exposed sash boxes externally, fat profiled glazing bars (reproduction of early Georgian style), single-glazed, rectangular headed top sash, to be set almost flush with the wall, sills to be repaired where required.</p> <p>Refer to drawing 400_303 Proposed Window Type G for details of the new window.</p>
RW 18

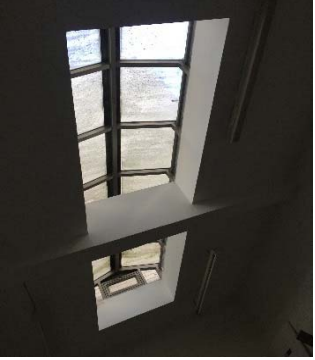
<p>New Window.</p> <p>Refer to drawing 400_304 Proposed Window Type I for details of the new window.</p>
<b>Roof Lights</b>			
RL 01	Modern Roof light

To be removed
RL 02	Modern Roof light

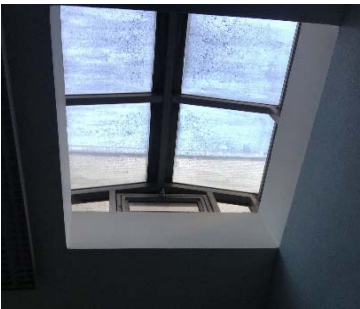
To be removed
RL 04	Modern Roof light

To be removed
RL 05	Modern Roof light
