**1 Triton Square**

St Anne's  
Contamination Desk Study and  
Programme of Investigation

Issue | 16 February 2018

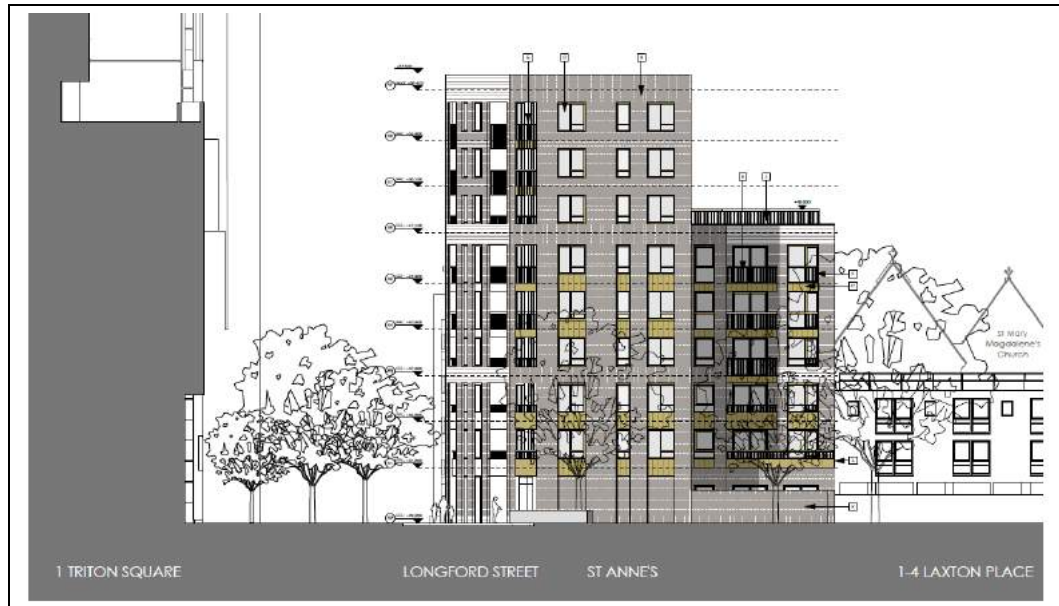
Table 1 Architectural drawing of the proposed development at St Anne's

The wider development approved under application ref 2016/6069/P also includes 1 Triton Square and Longford Place (shown on Figure 2). Table 1 shows the proposed development at St Anne's.

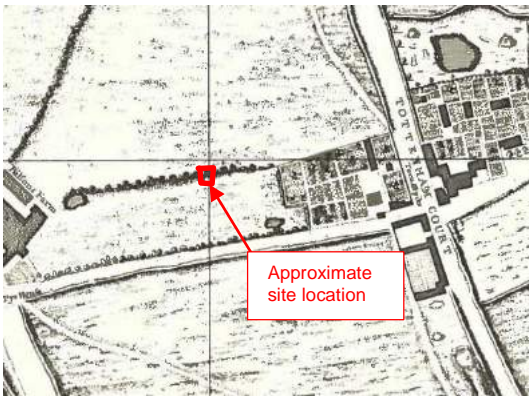
Year	Description	Map Extract
1746	<p><b>Onsite</b></p> <p>Rocque's map shows the site to be undeveloped with a possible ditch or brook running across the site. From east to west</p> <p><b>Offsite</b></p> <p>Possible pits, ponds and drainage ditches exist in the vicinity. Buildings are present to the east towards Tottenham Court.</p>

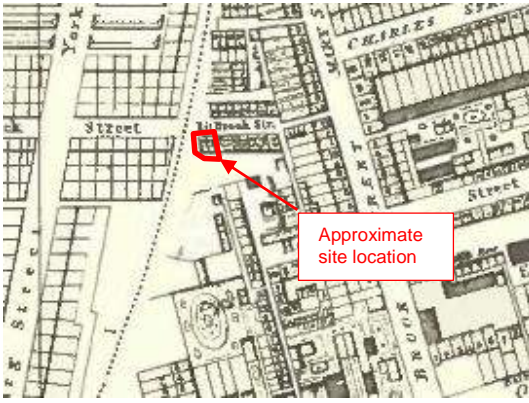
1813	<p><b>Onsite</b></p> <p>Horwood's map shows the site has been developed before this date. The site is occupied by terraced buildings, likely residential use.</p> <p><b>Offsite</b></p> <p>Little Brook Street is adjacent to the north and further terraced buildings and Brook Street lie to the east of the site.</p>

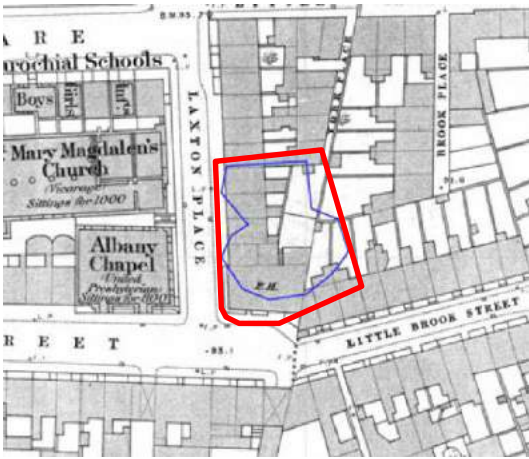
1873	<p><b>Onsite</b></p> <p>The site is occupied by residential buildings with gardens. The main building onsite is a public house.</p> <p><b>Offsite</b></p> <p>The surrounding area is predominantly residential with several schools and a chapel to the west.</p>

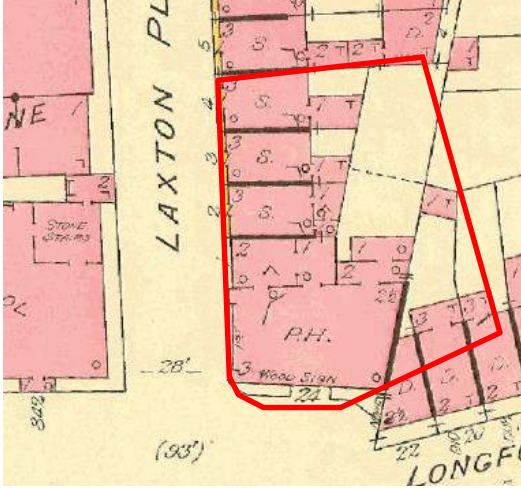
Year	Description	Map Extract
1889	<p><b>Onsite</b> The buildings in the north of the site are identified as shops and dwellings are identified in the south east.</p> <p><b>Offsite</b> No significant changes in the immediate surrounding area.</p>

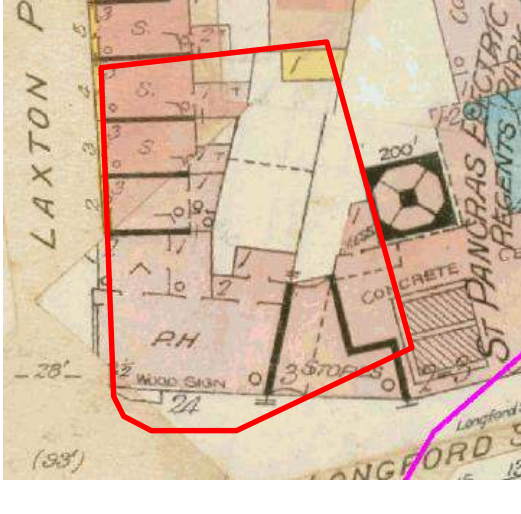
1916	<p><b>On site</b> dwellings in the south east of the site are no longer identified on the map.</p> <p><b>Offsite</b> there is no significant change in the surrounding area.</p>	
1927	<p><b>Onsite</b> The public house and shops are still present. New buildings have been built in the south east including a store room which is part of the St Pancras Electric Power Station.</p> <p><b>Offsite</b> The St Pancras Electric Power Station extends offsite to the east. It has a factory chimney, steam boilers, a coal store, an underground tank (north east), engines and dynamos. A planing and saw mill is also present to the east.</p>

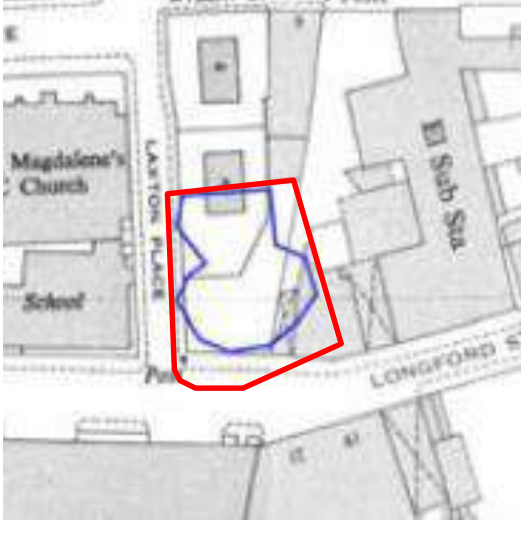
1952	<p><b>Onsite</b> The public house and shops are no longer shown. A building is shown in the north of the site extending offsite to the north.</p> <p><b>Offsite</b> The areas to the south and east have undergone significant redevelopment and are now in primarily commercial and industrial use. The power station is now identified as a substation. An engineering works (sheet metal &amp; galvanizing) is located to the south as is an optical instrument works. A furniture works is to the north east.</p>

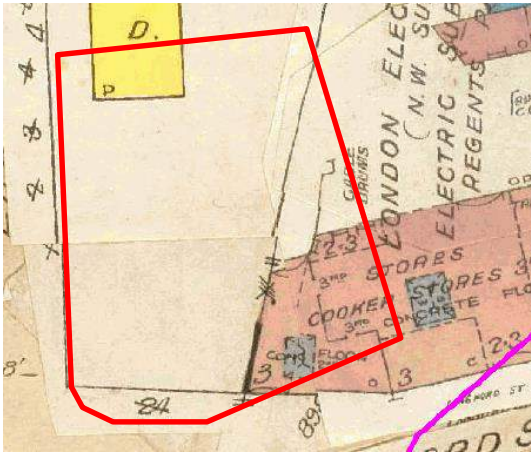
Year	Description	Map Extract
1957	<p><b>Onsite</b> The building in the north of the site is identified as wooden with asbestos cladding on the Goad plan.</p> <p><b>Offsite</b> The substation is identified as a London Electricity Board substation. This includes associated switch rooms, stores, transformers and rotary converters.</p>

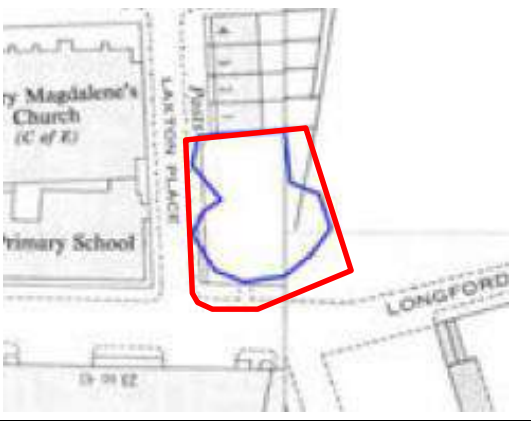
1965	<p><b>Onsite</b> No buildings are shown onsite.</p> <p><b>Offsite</b> Large areas to the east have been cleared. Four buildings, possibly residential, are present to the north. The substation to the east is no longer shown. To the south the works is no longer identified and Triton Square is identified as a road with an adjacent electricity board depot.</p>

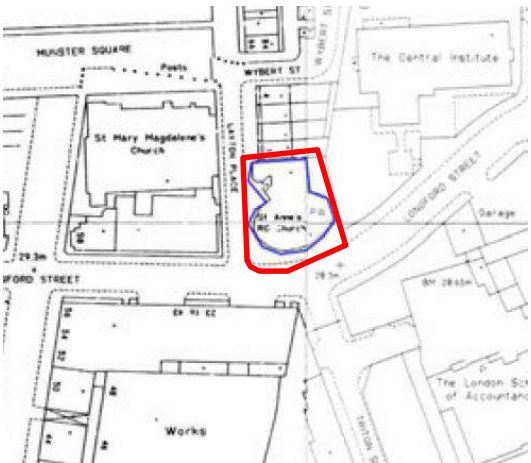
1970	<p><b>Onsite</b> no significant changes are shown.</p> <p><b>Offsite</b> a road has been developed to the south of the site.</p>	
1982	<p><b>Onsite</b> St Anne's Church is now present and in its current configuration.</p> <p><b>Offsite</b> no significant changes are shown.</p>

1985	<p><b>Onsite</b> no significant changes are shown.</p> <p><b>Offsite</b> a garage is identified to the east and the London School of Accountancy is present to the south.</p>	
1993 to present day	<p><b>Onsite</b> There are no significant changes and the site remains in the same configuration today.</p> <p><b>Offsite</b> No significant changes are shown. The area to the south was subsequently demolished and developed as 1 Triton Square.</p>
