# Arboricultural Impact Assessment

13A Crossfield Road  
London  
NW3 4NS

PJC ref: 4815/18-02 Rev -

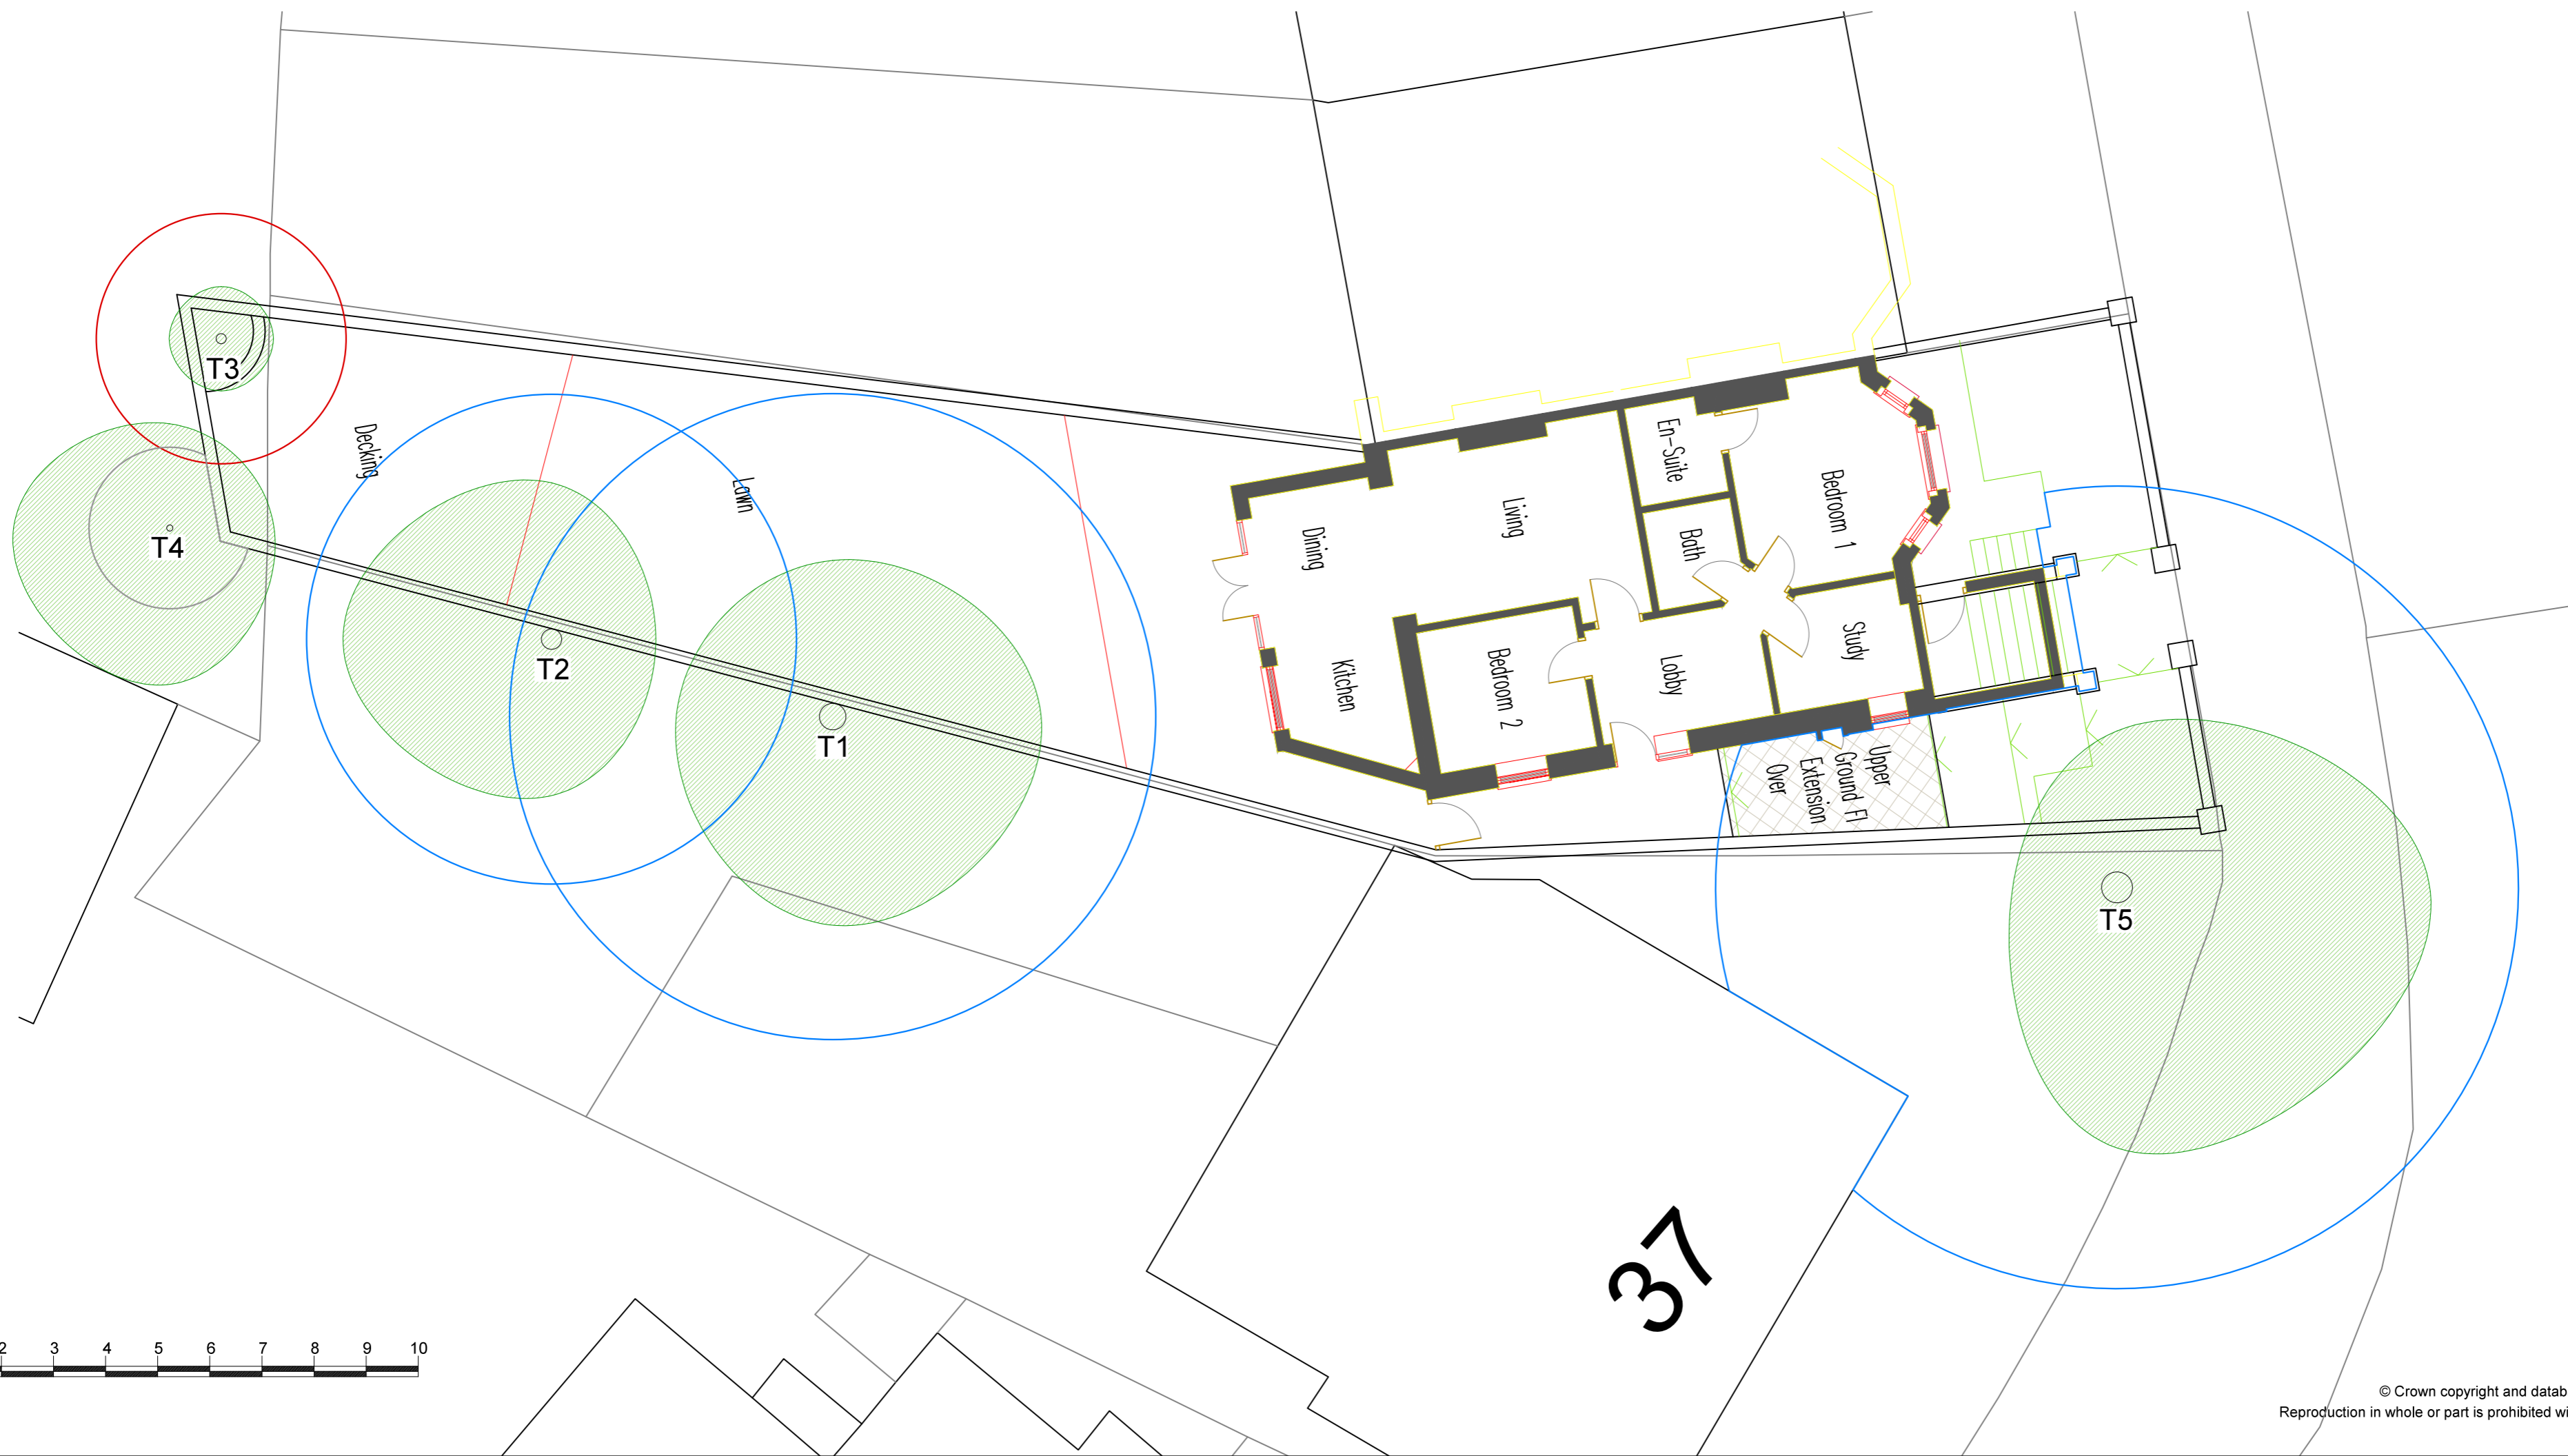
**Drawing title:** Tree Constraints Plan

- Key:**
- RPA for CAT B\* tree
  - RPA for CAT C\* tree
  - RPA for CAT U\* tree
  - Tree canopy
