Taylor Wimpey Central London

Mount Pleasant – Phoenix Place Site

Desk Based Review and Supplementary Investigation

Project no. 29518-01 (00)

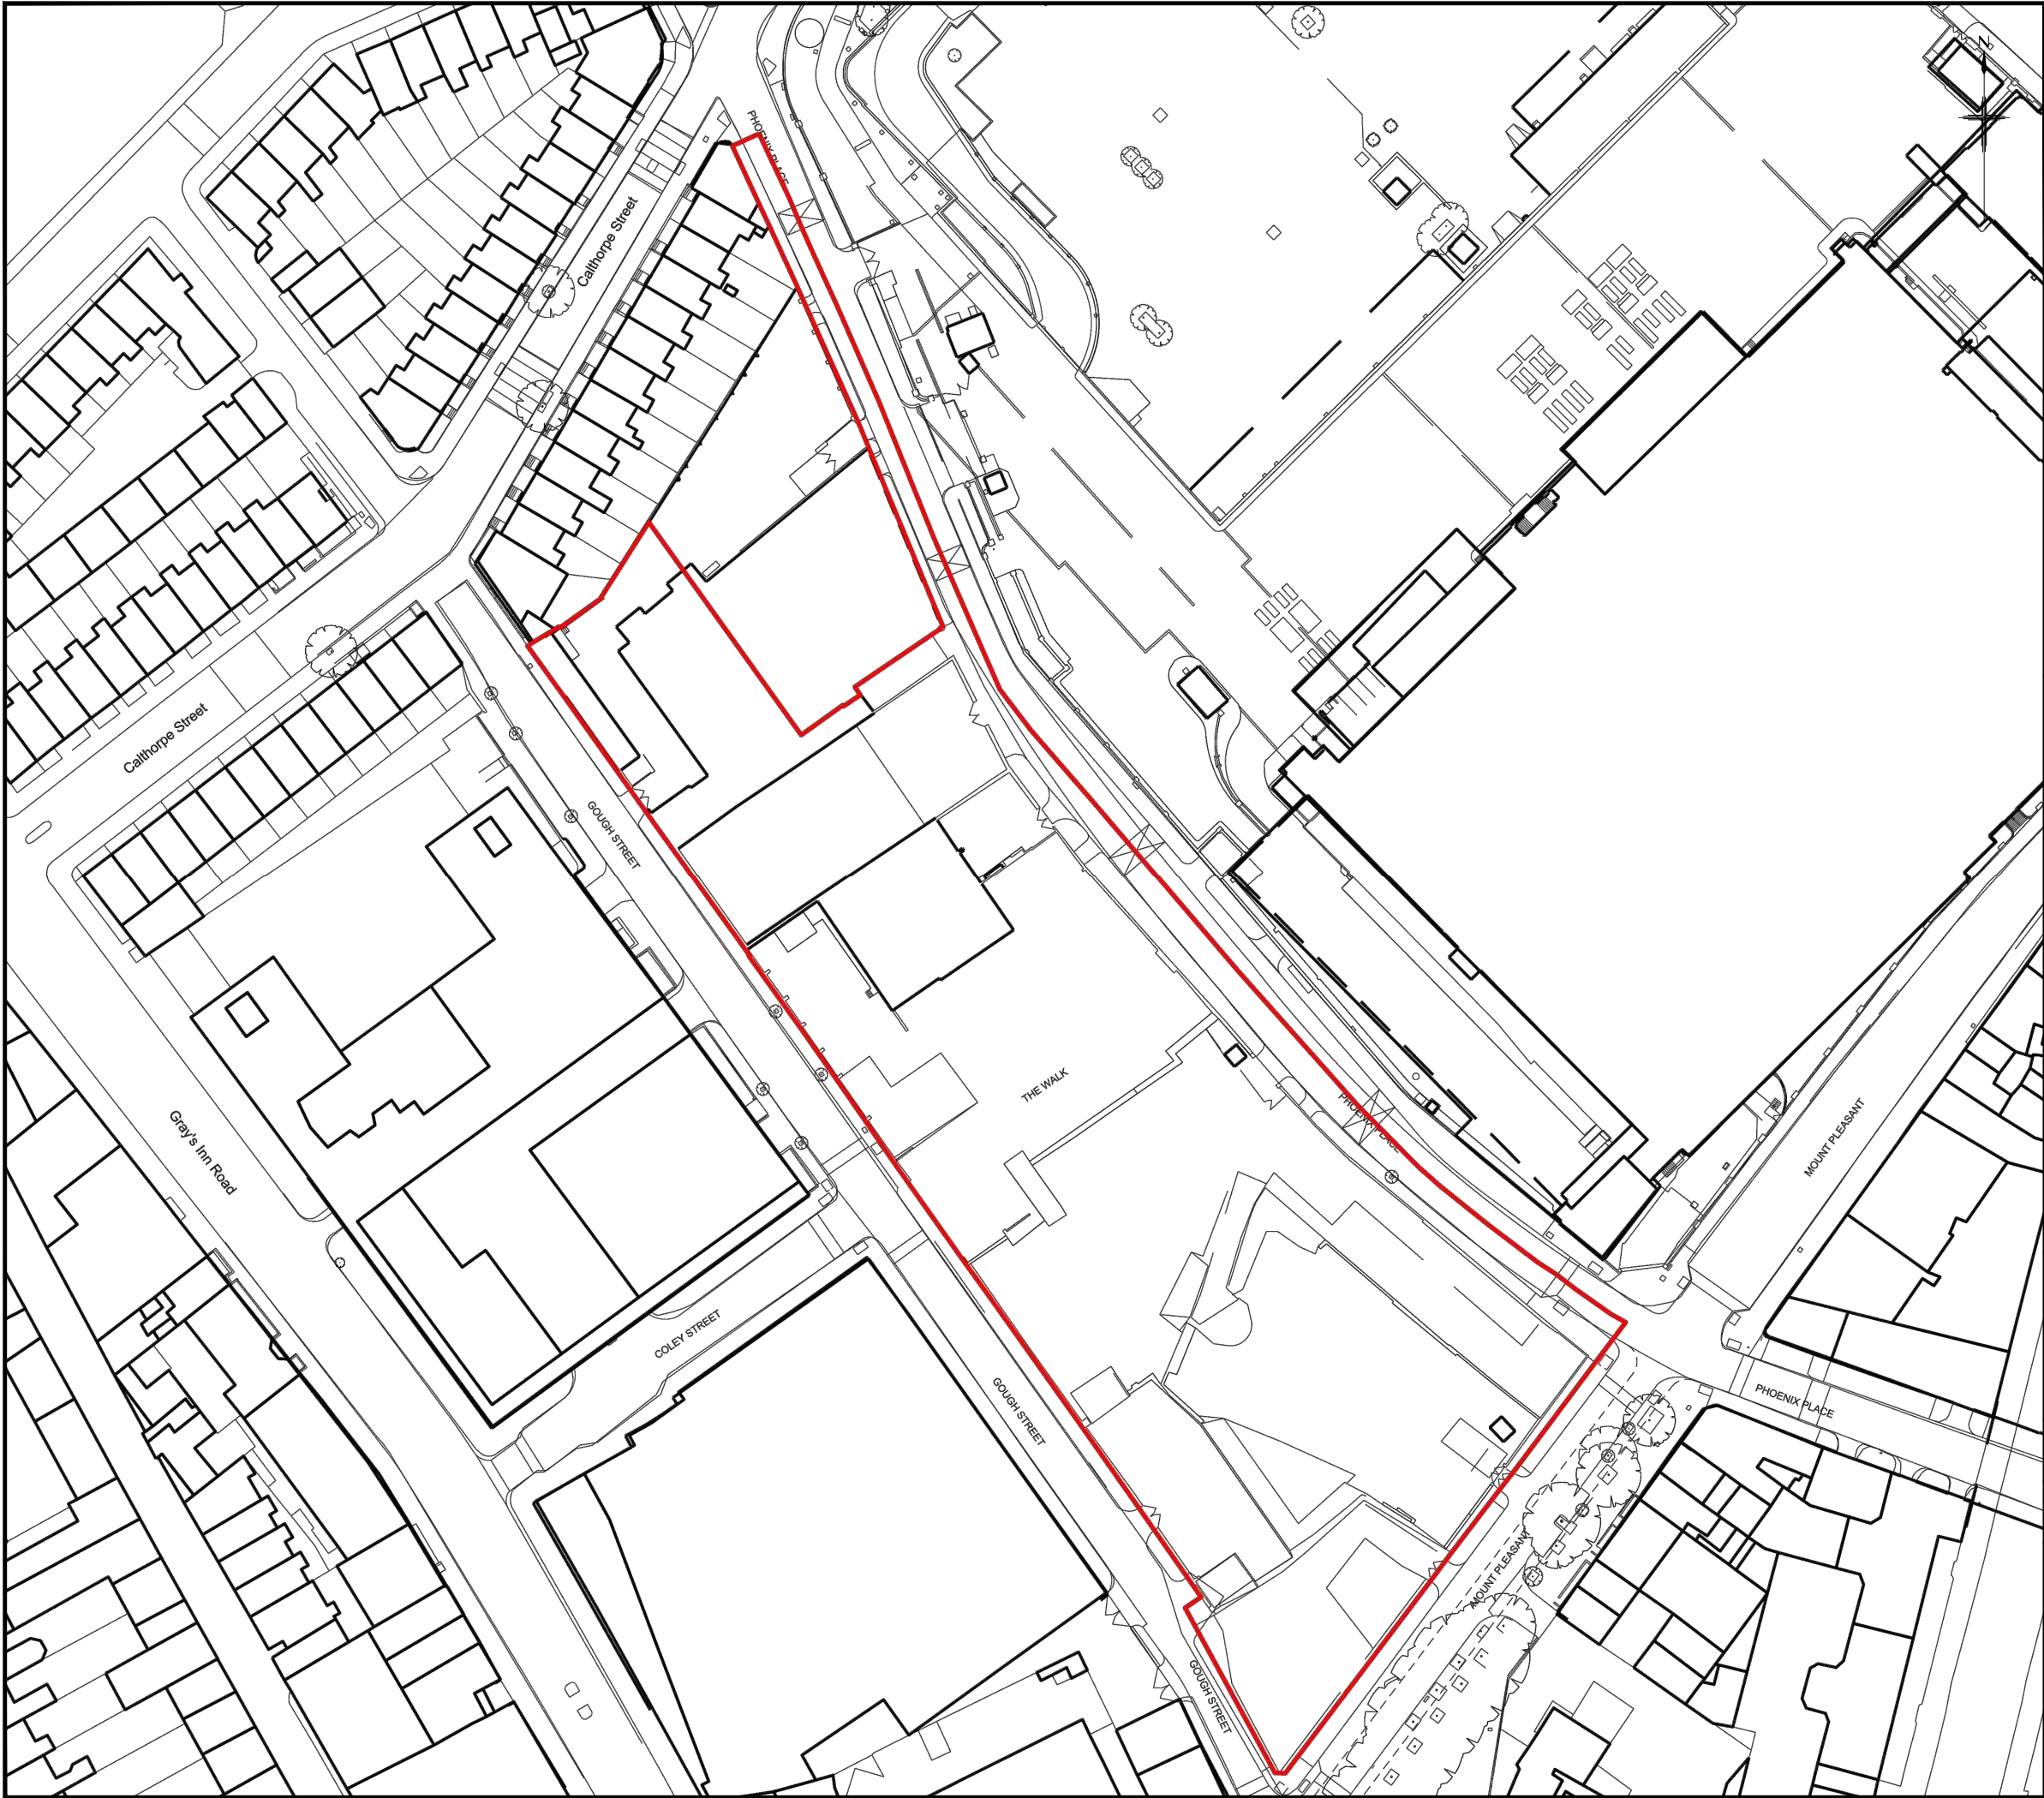
A retaining structure is present at the western boundary along Gough Street, its height varying between 1 m and 3 m. The majority of the site is covered by compacted fill material and concrete, which is in poor condition (**Figure 2**).

The site covers an area of approximately 1.1 hectares, and comprises open land formerly used as a car-park for the Royal Mail staff, with vehicular access from Phoenix Place (street) from the east. The site slopes down from the north-west to the south-east, with four distinct platforms, at levels of between 19 mAOD to 14 mAOD (**Figure 2**).
