79, Redington Road, Hampstead, LONDON, NW3 7RR

Envirocheck[®] Report:

Mining and Ground Stability Datasheet

Unexploded Ordnance Preliminary Risk Review
79 Redington Road, Hampstead, London NW3 7RR

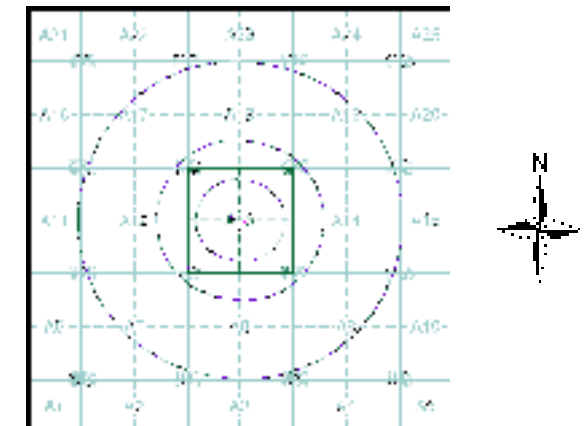
Historical Map - Slice A

VectorMap Local (Raster) is Ordnance Survey's highest detailed 'backdrop' mapping product. These maps are produced from OS's VectorMap Local, a simple vector dataset at a nominal scale of 1:10,000, covering the whole of Great Britain, that has been designed for creating graphical mapping. OS VectorMap Local is derived from large-scale information surveyed at 1:1250 scale (covering major towns and cities), 1:2500 scale (smaller towns, villages and developed rural areas), and 1:10 000 scale (mountain, moorland and river estuary areas).

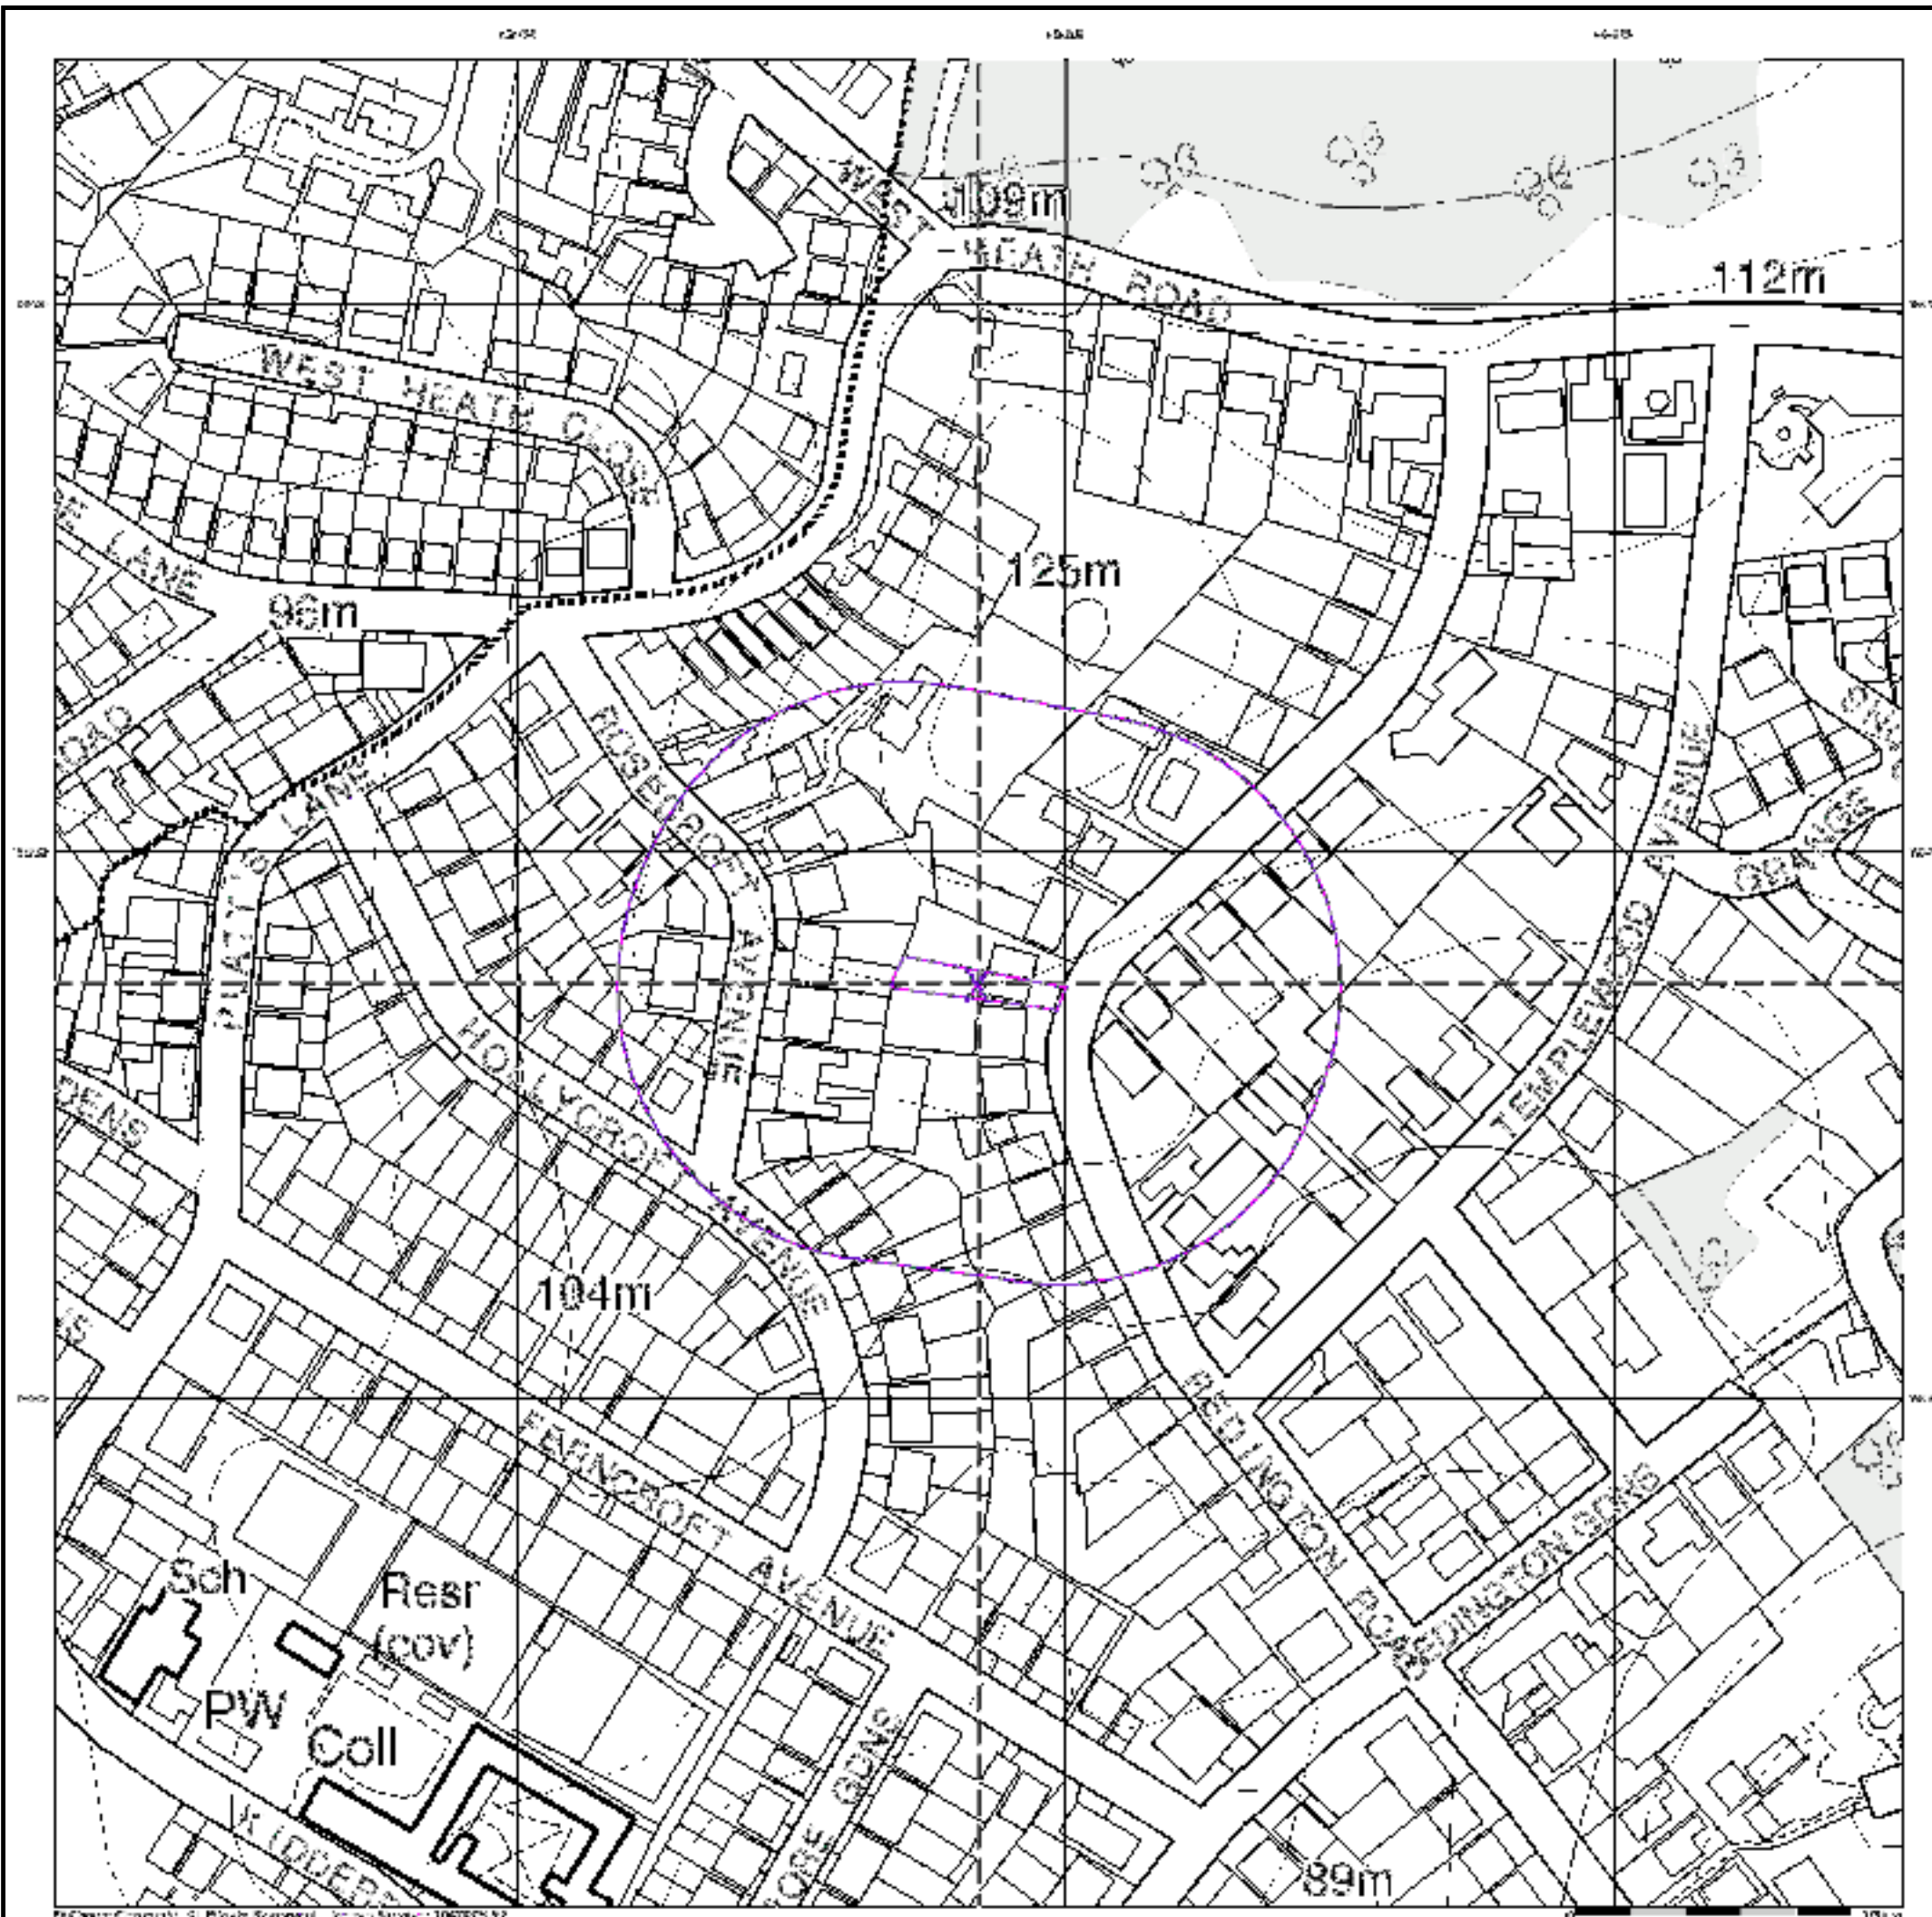
Motion Map Data (1:2,500)

General

● Station A13
 ● Station B100
 ● Station B101
 ● Station B102
 ● Station B103

Average Velocity Gradient

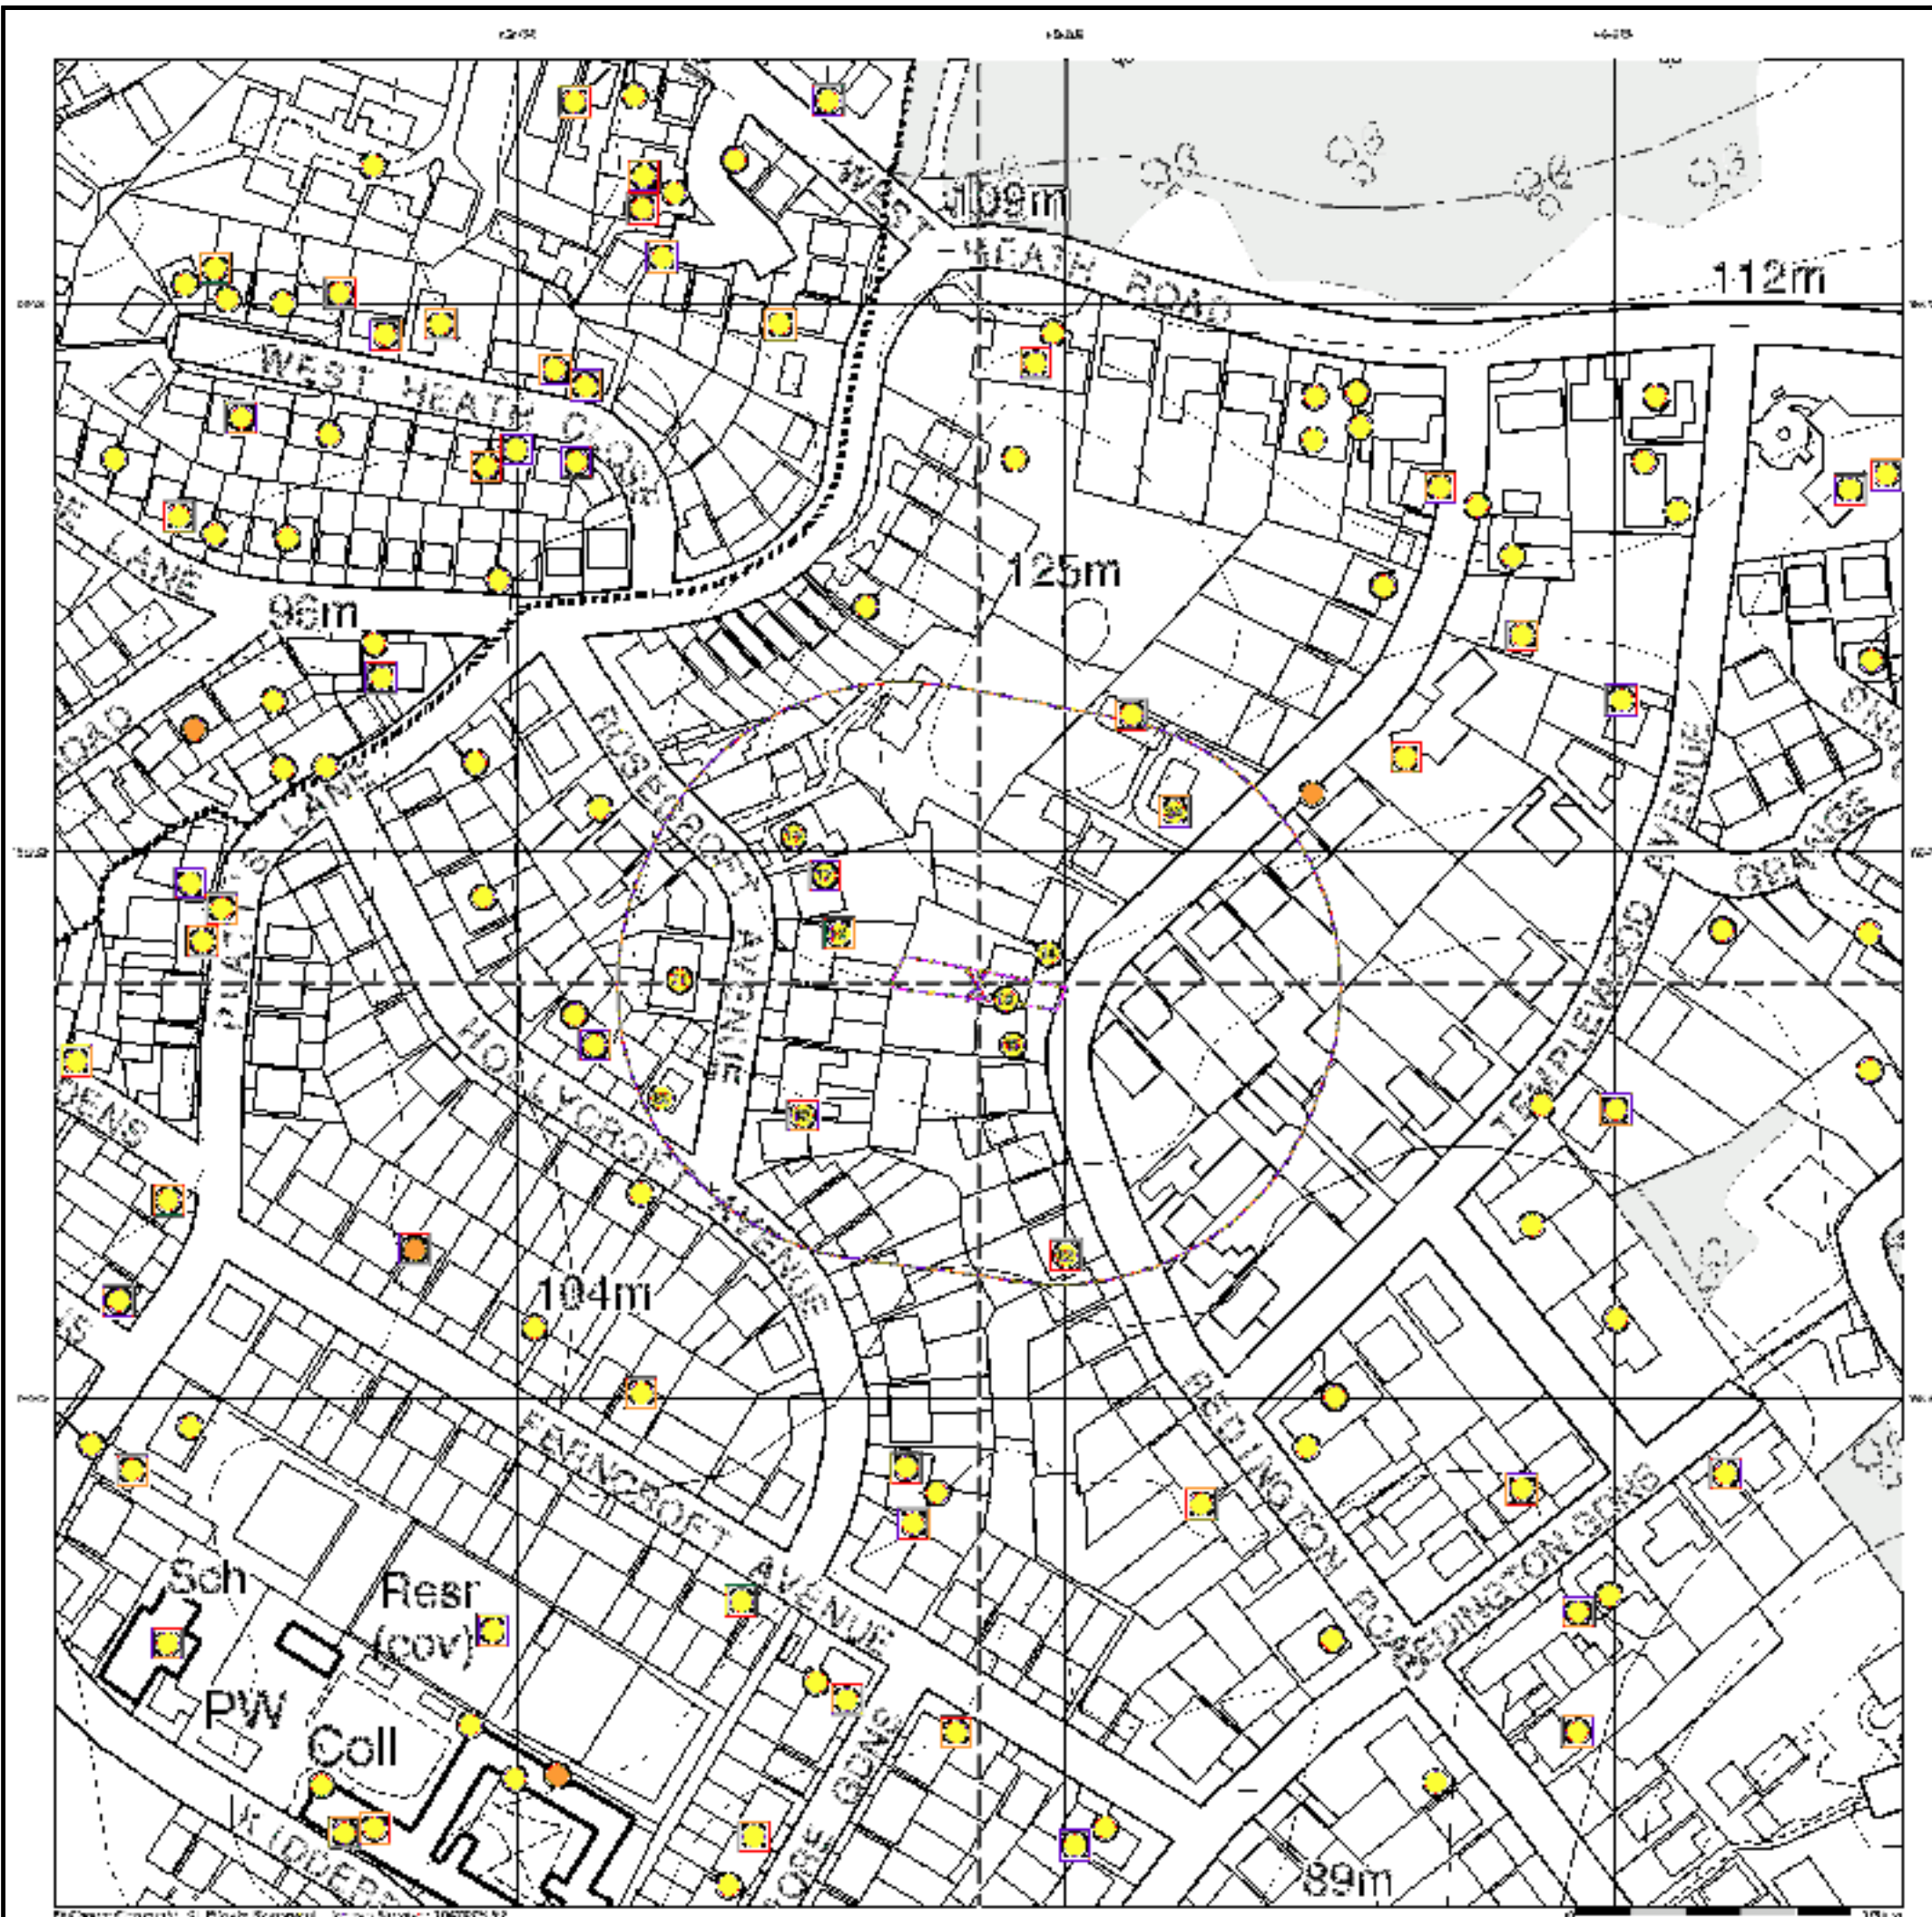
Historical Land Use Information (1:10,000)

General

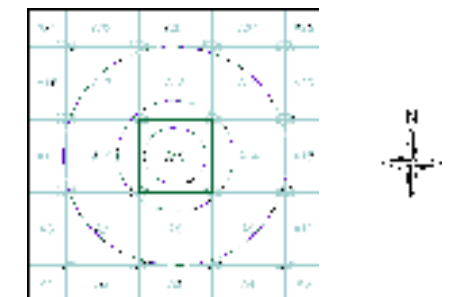
Mining and Ground Stability - Slice A

Potential for Compressible Ground Stability Hazards

Potential for Collapsible Ground Stability Hazards

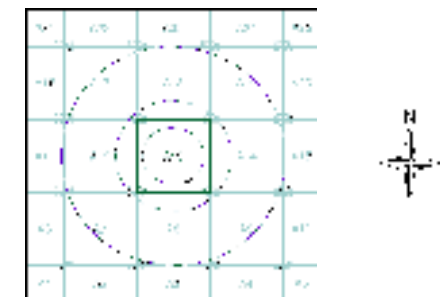
Mining and Ground Stability - Slice A

Potential for Landslide Ground Stability Hazards

Potential for Ground Dissolution Stability Hazards

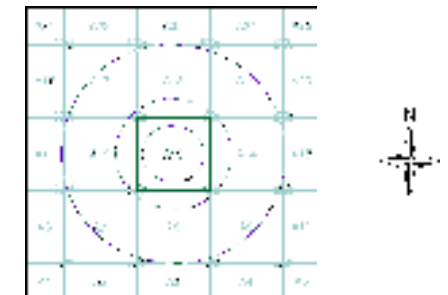
Mining and Ground Stability - Slice A

Potential for Running Sand Ground Stability Hazards

Potential for Shrinking or Swelling Clay Ground Stability Hazards

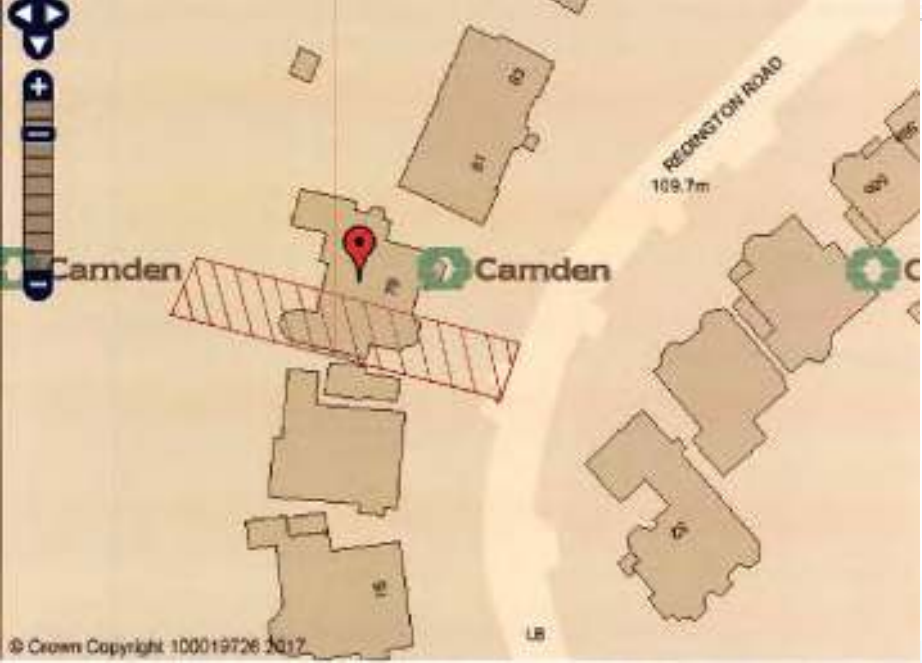
<p>Site location</p>	<p>Site Address: 79 Redington Road, Hampstead, London NW3 7RR</p> <p>Grid Reference: 525579, 186148</p>

<p>Scope of Intended works</p>	<p>Preliminary review of the risk that may be posed by UXO to geotechnical investigations.</p>
<p>History</p>	<p>HAA gun sites were located to the north, east and west of the site to defend against air attack and combat engagements with enemy aircraft did take place.</p>
<p>Wartime History</p>	<p>No records were found to confirm a bomb strike within the site footprint and LCC Bomb Damage Map 27 indicates that property within the site footprint did not suffer damage from enemy bombing. The nearest recorded bomb fell c.a.300m east of the site at Grange Gardens. Consequently, this source of UXO contamination is considered unlikely, but cannot be ruled out entirely.</p>
<p>Unexploded Ordnance (UXO) Finds</p>	<p>No reports were found to indicate that items of UXO have been found within or recovered from the site footprint.</p>

<p>Post War Development</p>	<p>The majority of the site has undergone a limited level of post-war development.</p>

Although the area suffered significant bombing during WWII, no records were found to confirm a bomb strike within the site footprint. Whilst considering the history of the site and the level of post-war development, the following conclusions have been reached:

- It is considered that there is not a credible likelihood of encountering UXO on the site. Consequently, the UXO risk is considered to be LOW within the site boundary.
- Nevertheless, it is recommended that:
 - All site personnel are provided with a UXO Safety Awareness Talk before intrusive works are commenced.
