JOB
130A AGAR GROVE NW1

DRAWING DESCRIPTION
EXG. AND PROP. FRONT

DRAWING NUMBER P130AG 07	REV B
-----------------------------	----------

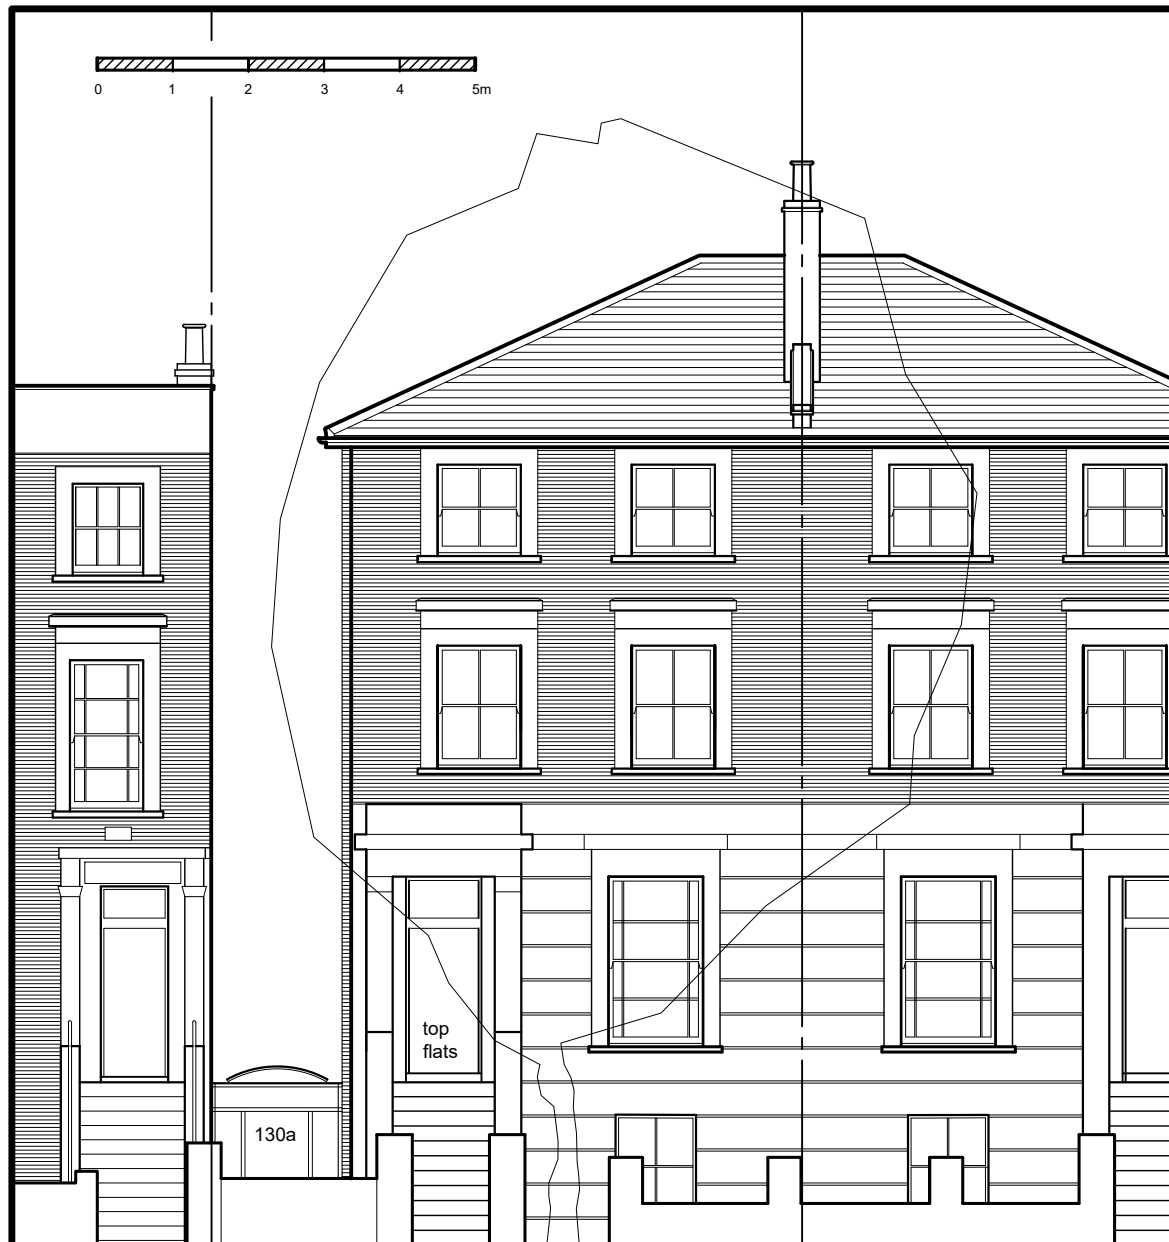
EXISTING FRONT ELEVATION

no.132 no.130 no.128

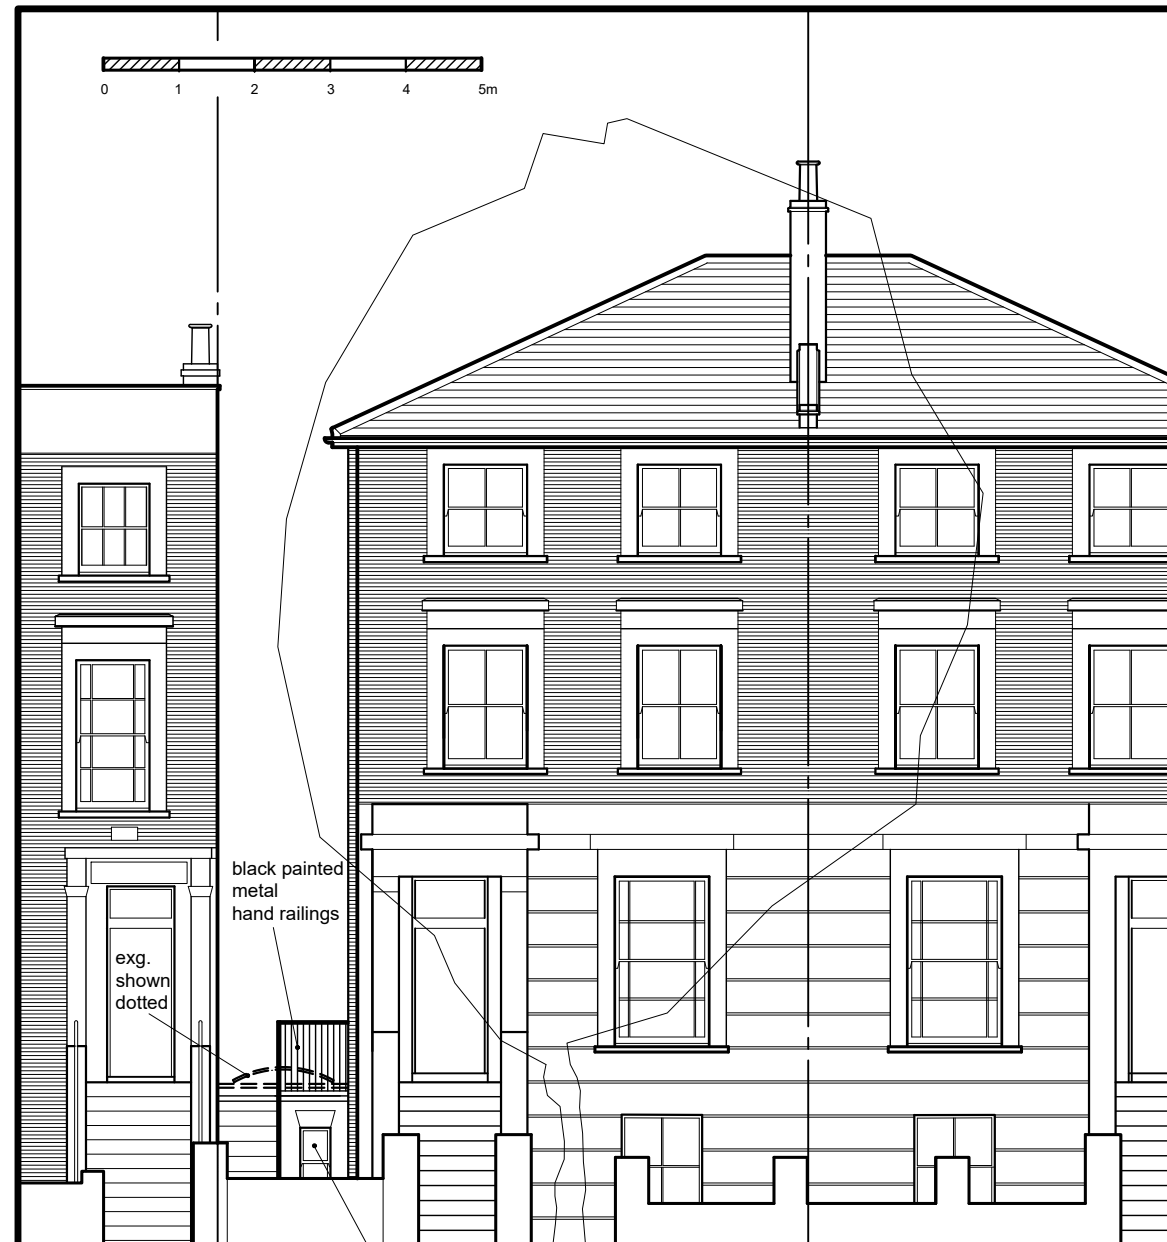
PROPOSED FRONT ELEVATION

no.132 timber sash window no.130 no.128

materials:
timber window
reconstituted
stone copings
steel stair
second hand
yellow stock
brickwork

note:
existing entrance gate
panel shown dotted
this may be retained,
demolished or rebuilt
under permitted
development

note:
brick extensions
are not visible

Rev A. 26.2.18 rear railings
shown on front elevation

Rev B. 2.4.18 wrap around
rear railings removed
