Athlone House,  
Hampstead Lane, London N6:

Restoration of historic landscape:  
Conservation of the Pulhamite  
artificial rockwork and other  
associated historic garden  
landscape structures

Discharge of planning condition  
9b (ref: 2017/4156/P)

April 2018

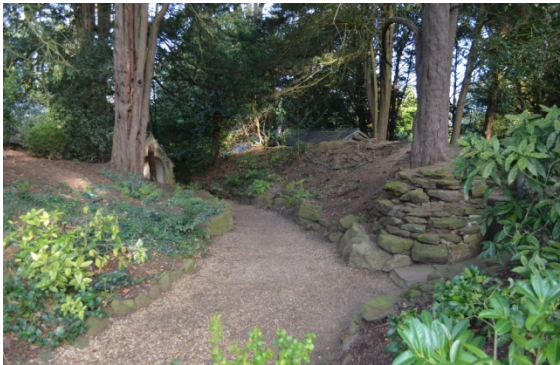
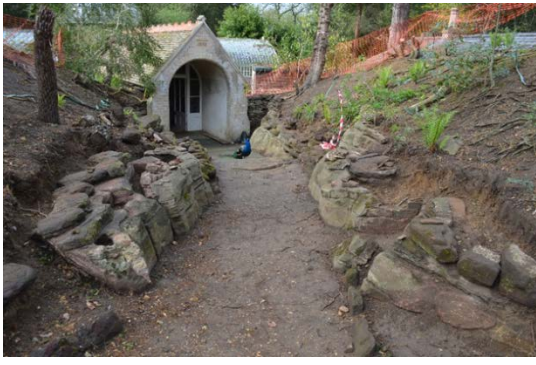
<p>1.View of southern approach to the Grotto at Swiss Garden, Biggleswade which illustrates the potential for Pulhamite to be lost in the earth over time.</p>	<p>2.View of southern approach to the Grotto at Swiss Garden, Biggleswade The right side shows rockwork carefully defined by digging the soil away by hand around it largely undertaken by garden volunteers.</p>

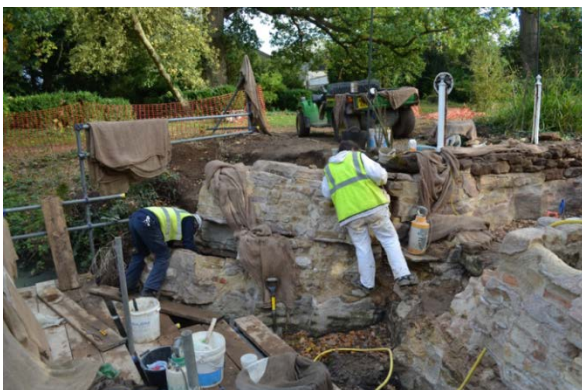
<p>3.Use of scaffold erected in the lower pond of the cascade at Swiss Garden illustrating the use of scaffold erected in the drained and dredged pond. Consolidation and stabilisation work in progress before the lost areas of coating were re-established. Note also the bridge abutments in the background.</p>

- 4.5 A condition re-assessment may be necessary once excavations and dredging have taken place, so that further defects can be identified.
- 4.6 Most of the restoration work will be on the pond faces of the Pulhamite therefore it will be necessary to erect suitable scaffold platforms in the dredged and drained pond to allow for access to undertake such works (Photo 3). Protection from mortar falling into the pond will be built into the scaffold design.
