# Basement Impact Assessment

3A Mornington Crescent, London  
NW1 7RH

Geotechnical Factual Report

21 November 2017

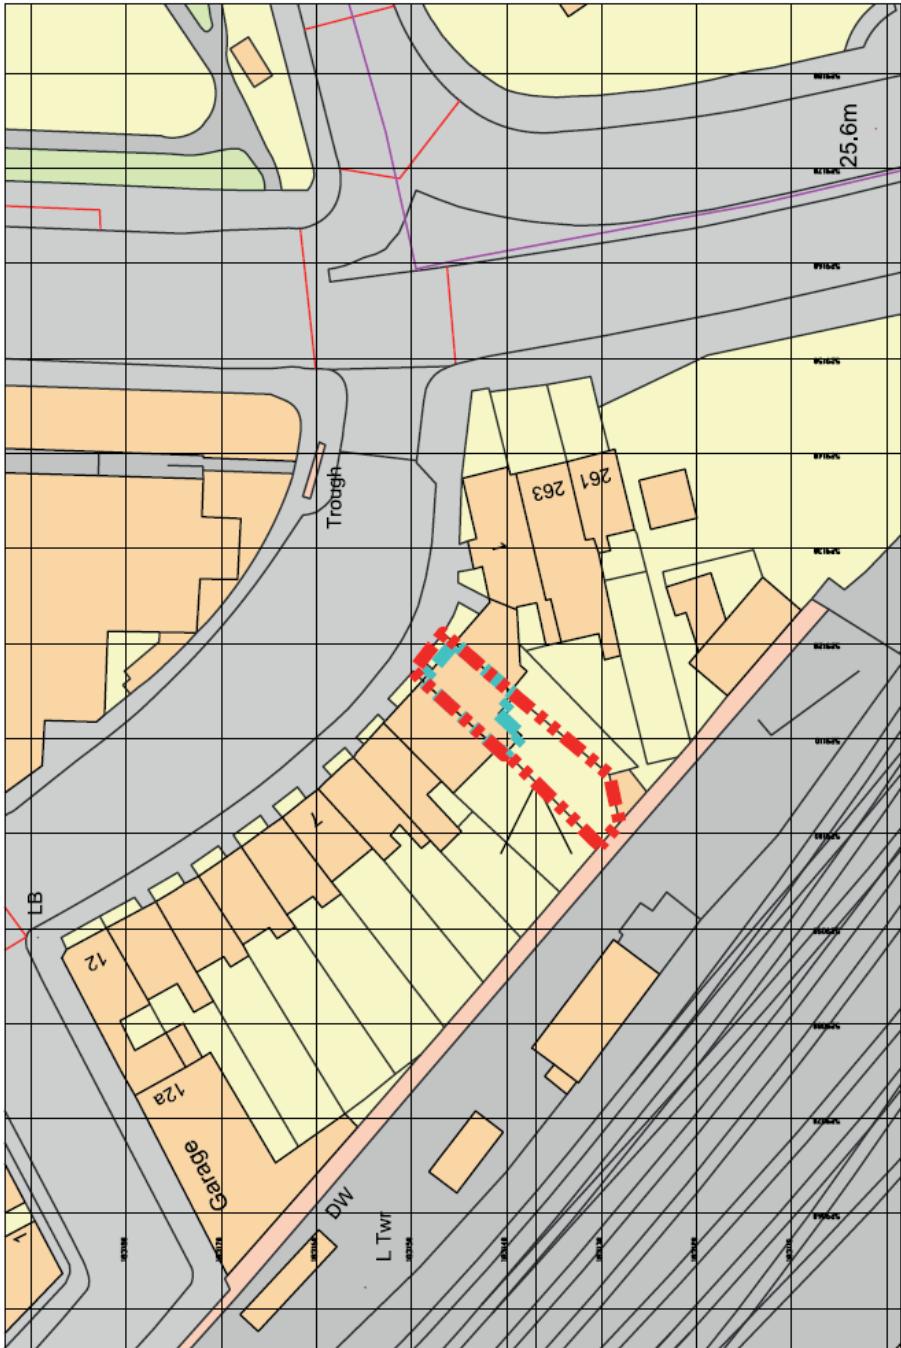
Site Location Plan

The property is located on Mornington Crescent which is within the London Borough of Camden, shown on Figure 1 in Appendix A.

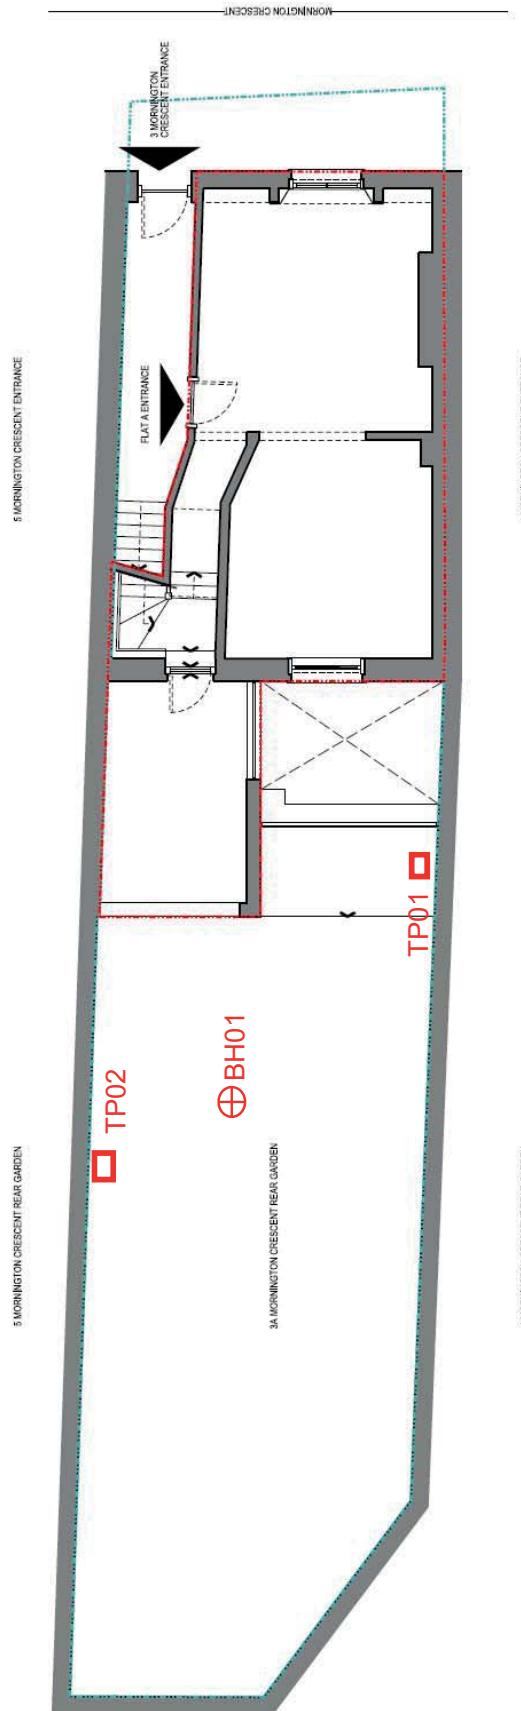
Figure	2
--------	---

Client	Dilhan Sebastian	Project	3A Mornington Crescent
Job No.	MGC/17/26	Title	Exploratory Location Plan

A ground investigation was undertaken on 2<sup>nd</sup> November 2017. The investigation was carried out by Topdrill Ltd which comprised 1 No. cable percussive borehole and two No. hand dug trial pits to expose party wall footings. The borehole was undertaken using a specialist LLAMR rig which was carried through the house in sections and assembled at the borehole location. The location of the exploratory holes is shown in Figure 2 in Appendix A.

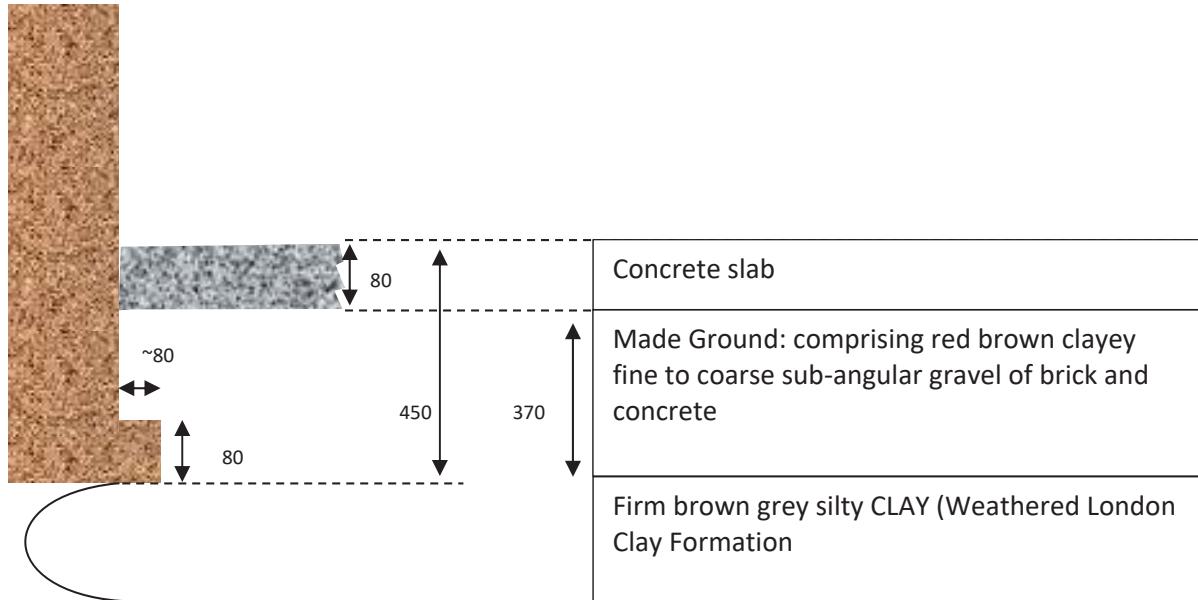
Concrete

Brick wall (with concrete render)

Client: <b>Dilhan Sebastian</b>	Date: <b>November 2017</b>	Project: <b>3A Mornington Crescent NW1 7RH</b>
Section Drawing: <b>Foundation Exposure TP01</b>	<b>MAUND GEO- CONSULTING</b>	Ref: <b>MGC 17-26</b>

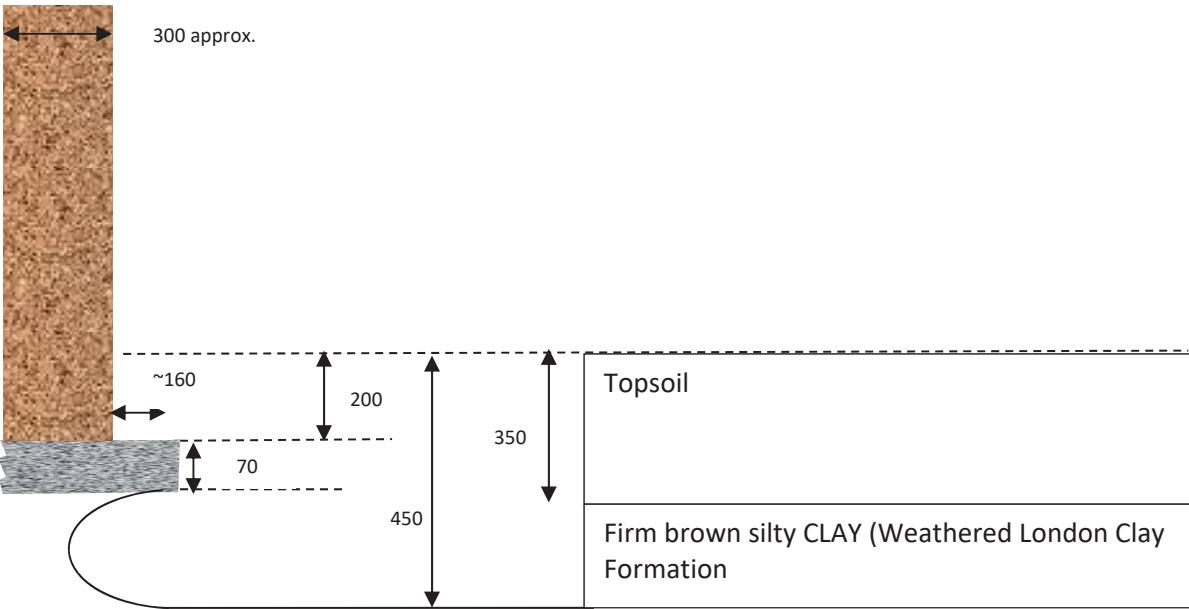
Concrete footing (extent not proven on neighbour's side)

Brick wall

Client: <b>Dilhan Sebastian</b>	Date: <b>November 2017</b>	Project: <b>3A Mornington Crescent NW1 7RH</b>
Section Drawing: <b>Foundation Exposure TP02</b>	<b>MAUND GEO- CONSULTING</b>	Ref: <b>MGC 17-26</b>

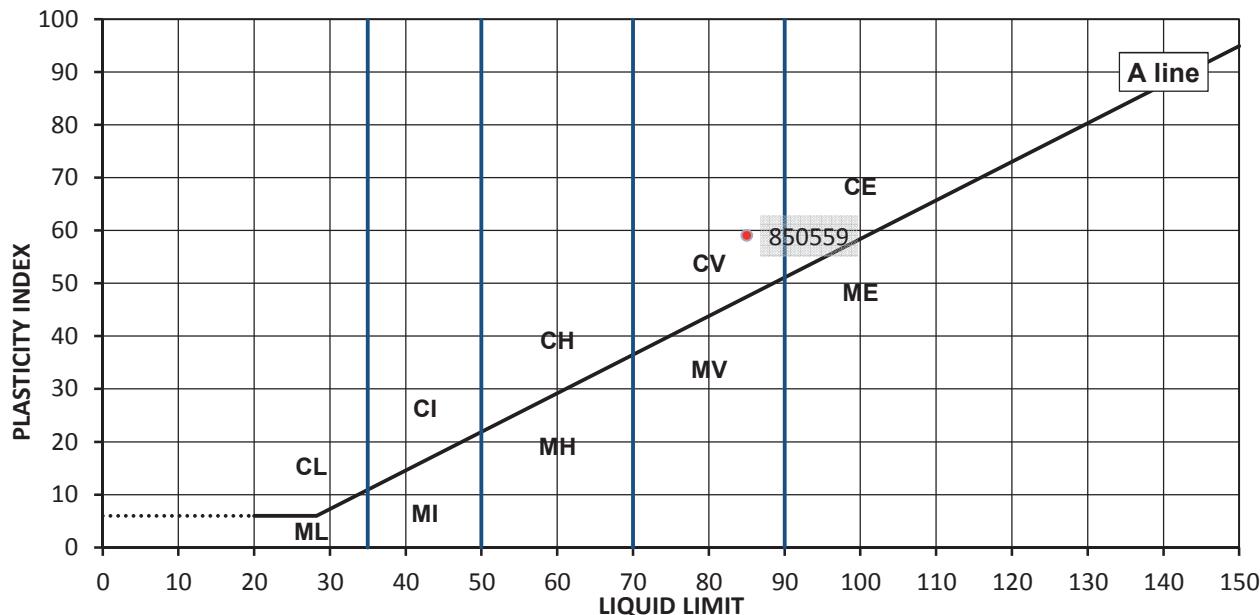
Description: Brown CLAY  
Location: BH01  
Sample Preparation: Tested in natural condition

As Received Moisture Content [%]	Liquid Limit [%]	Plastic Limit [%]	Plasticity Index [%]	% Passing 425µm BS Test Sieve
19	85	26	59	100

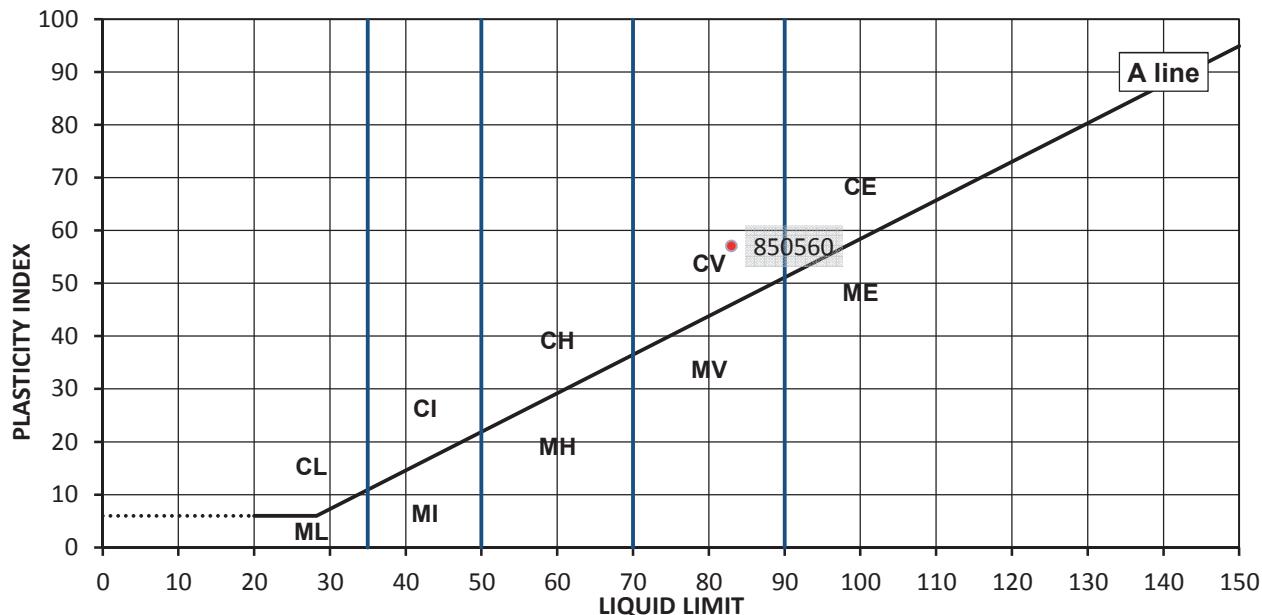
Description: Brown CLAY  
Location: BH02  
Sample Preparation: Tested in natural condition

As Received Moisture Content [%]	Liquid Limit [%]	Plastic Limit [%]	Plasticity Index [%]	% Passing 425µm BS Test Sieve
21	83	26	57	100

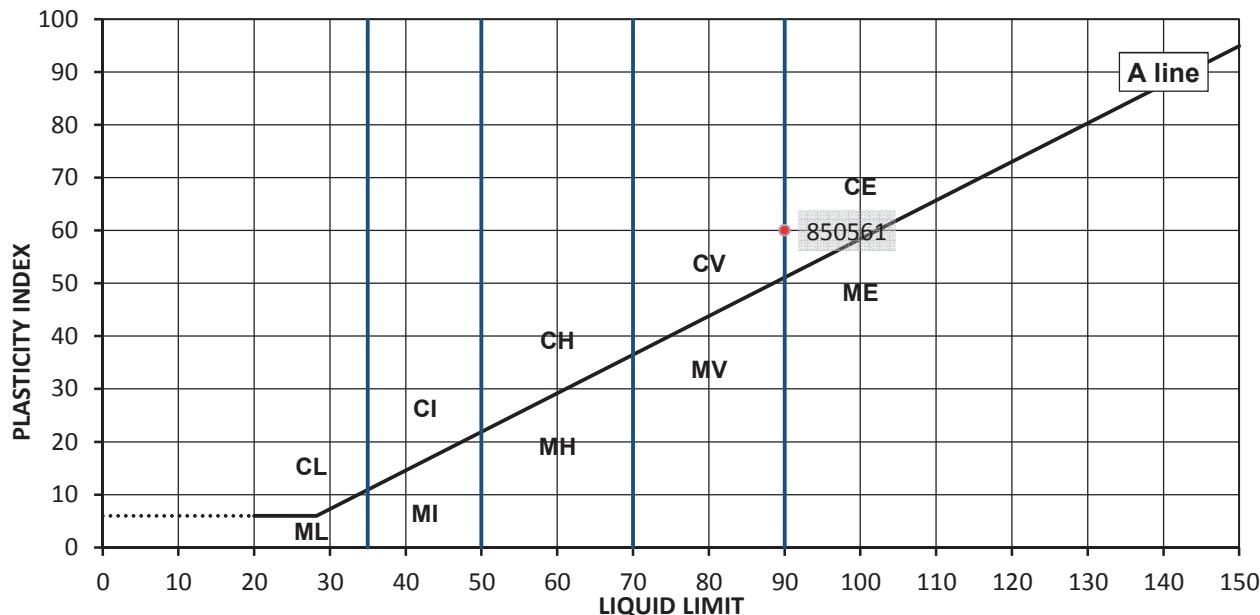
Description: Brown CLAY  
Location: BH03  
Sample Preparation: Tested in natural condition  
Sample Type: B  
Depth Top [m]: 3.00  
Depth Base [m]: Not Given

As Received Moisture Content [%]	Liquid Limit [%]	Plastic Limit [%]	Plasticity Index [%]	% Passing 425µm BS Test Sieve
28	90	30	60	100

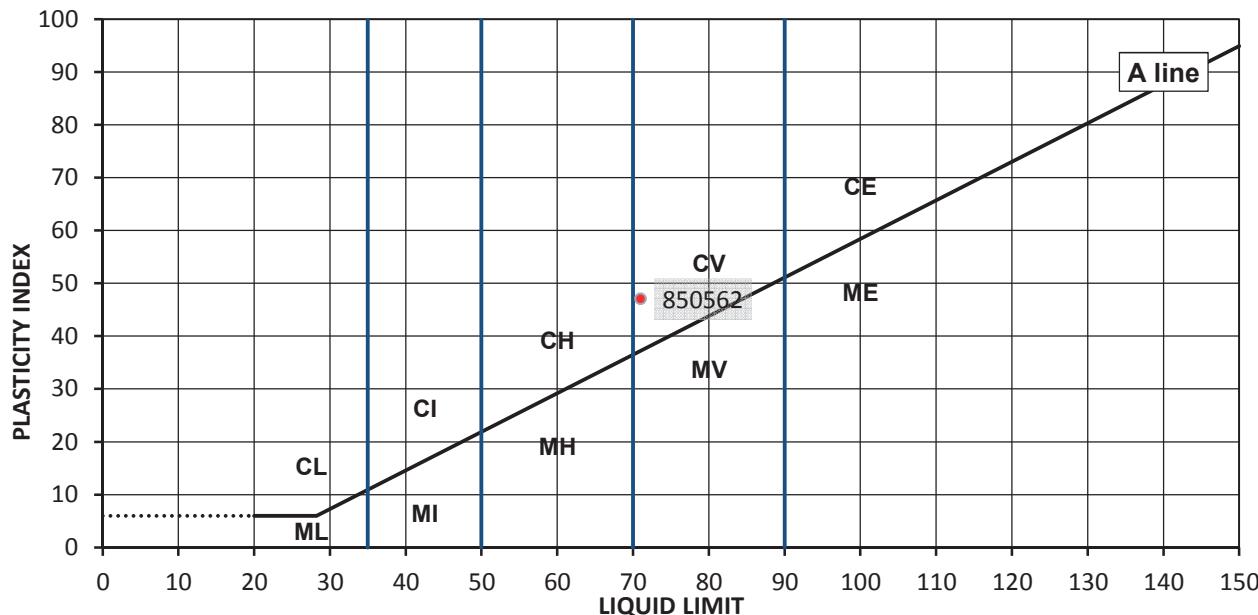
Description: Brown CLAY  
Location: BH01  
Sample Preparation: Tested in natural condition  
Sample Type: B  
Depth Top [m]: 6.00  
Depth Base [m]: Not Given

As Received Moisture Content [%]	Liquid Limit [%]	Plastic Limit [%]	Plasticity Index [%]	% Passing 425µm BS Test Sieve
27	71	24	47	100

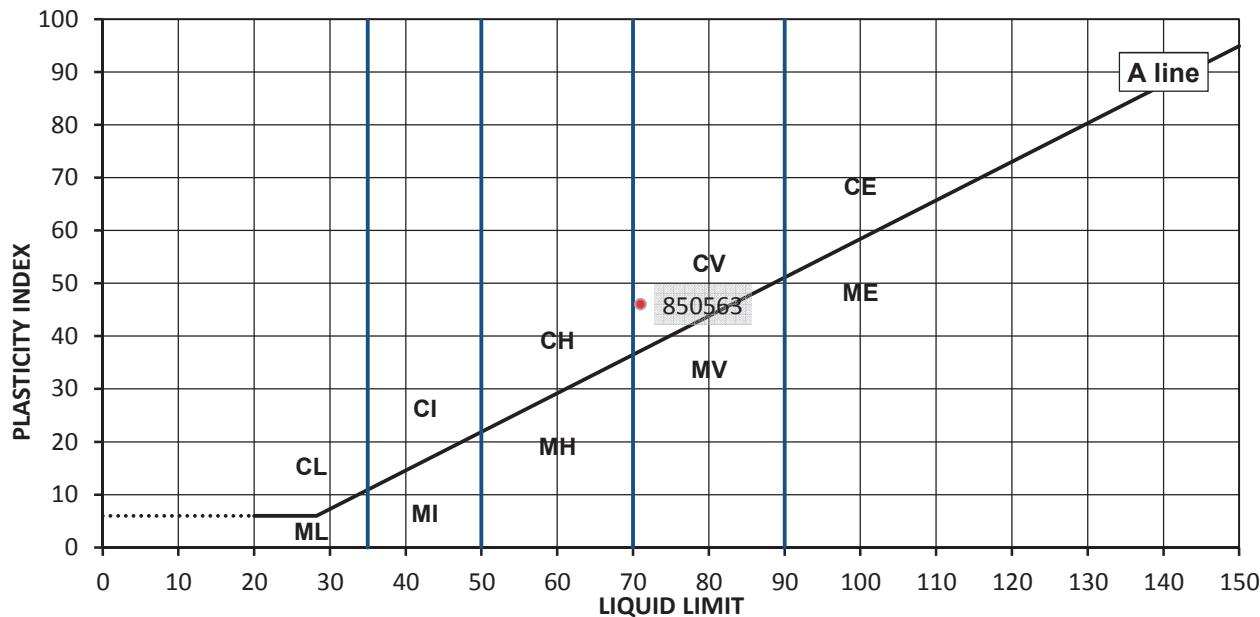
Description: Brown CLAY with gypsum crystals  
 Location: BH02  
 Sample Preparation: Tested in natural condition  
 Sample Type: B  
 Depth Top [m]: 8.00  
 Depth Base [m]: Not Given

As Received Moisture Content [%]	Liquid Limit [%]	Plastic Limit [%]	Plasticity Index [%]	% Passing 425µm BS Test Sieve
30	71	25	46	100

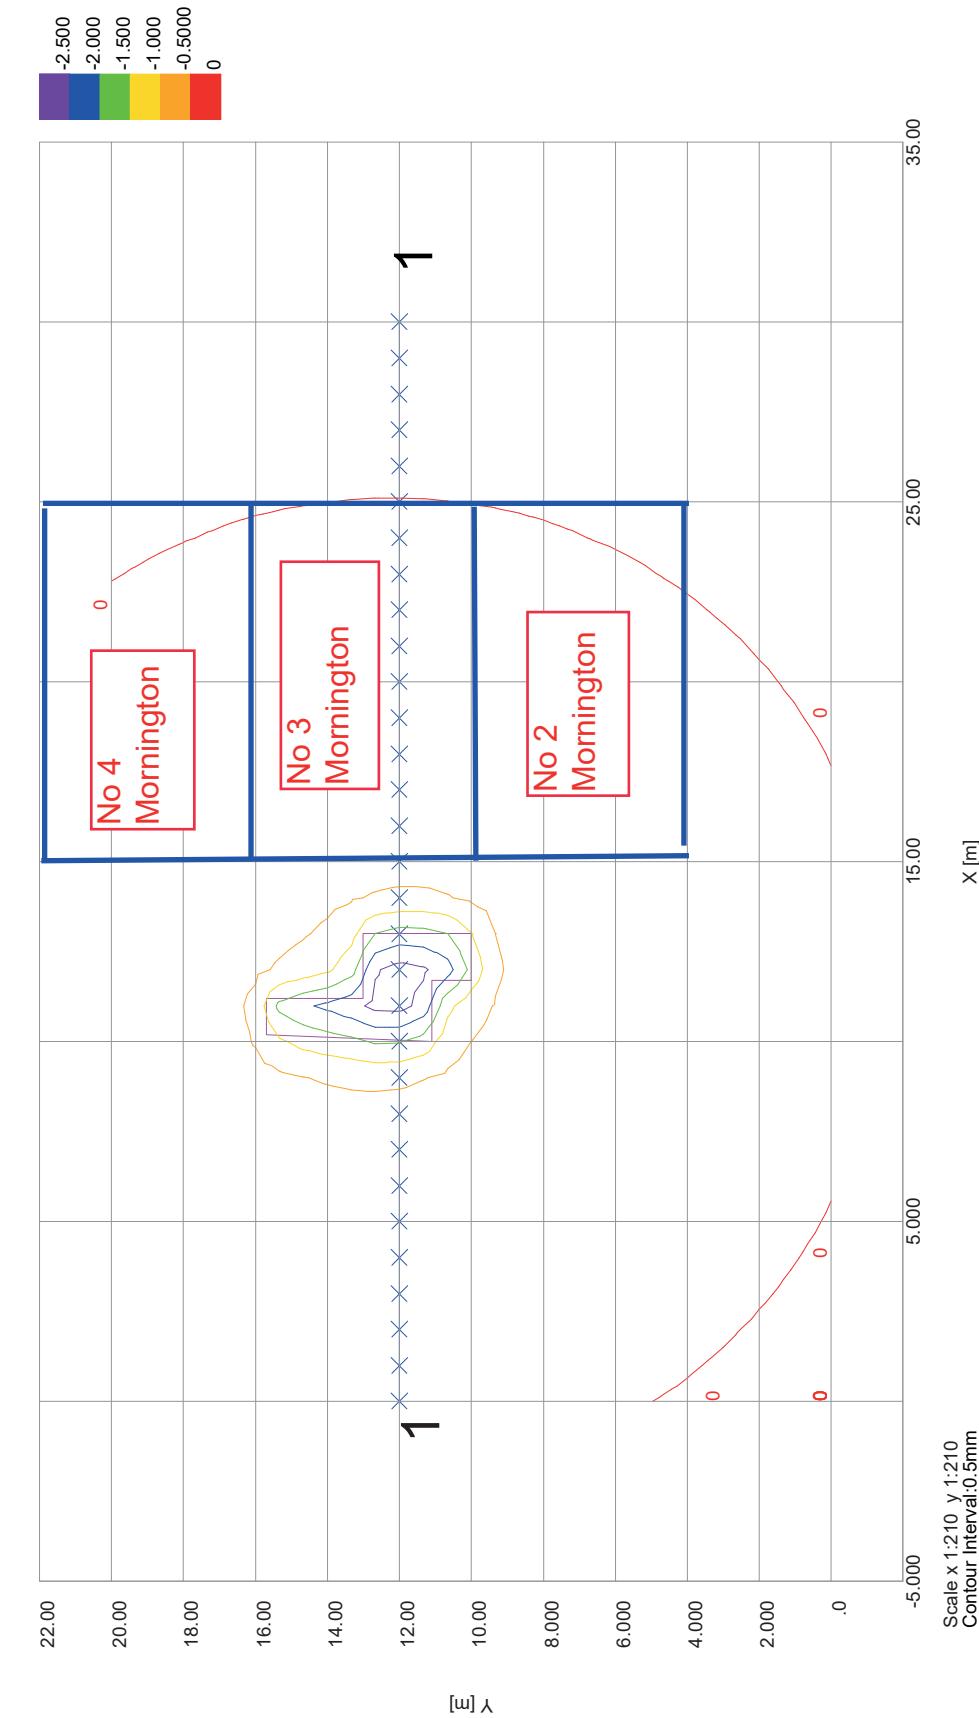
MAUND  
GEO-CONSULTING LTD  
3A Mornington Crescent  
B1A  
Undrained short term movement from excavation

Scale x 1:210 y 1:210  
Contour Interval: 0.5mm

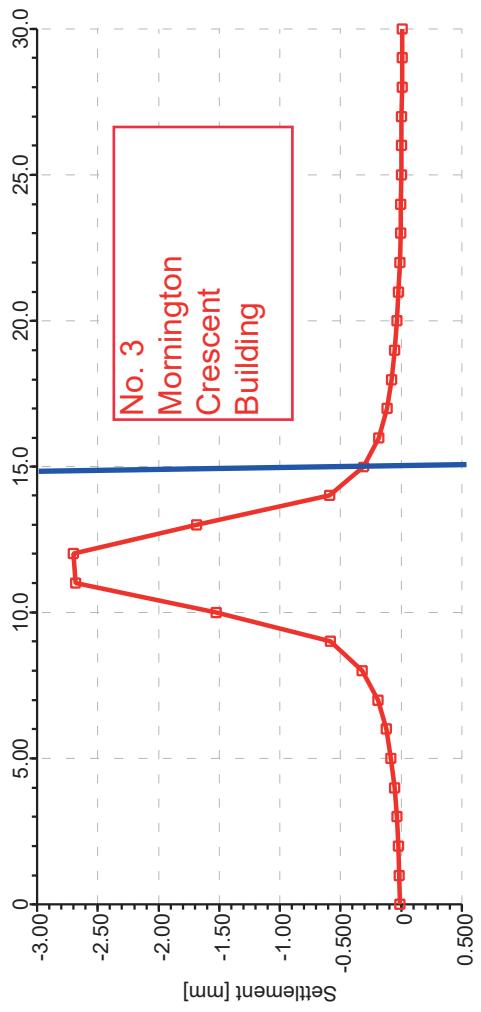
## Displacement for SW-NE 2

Distance from (0,12) in m

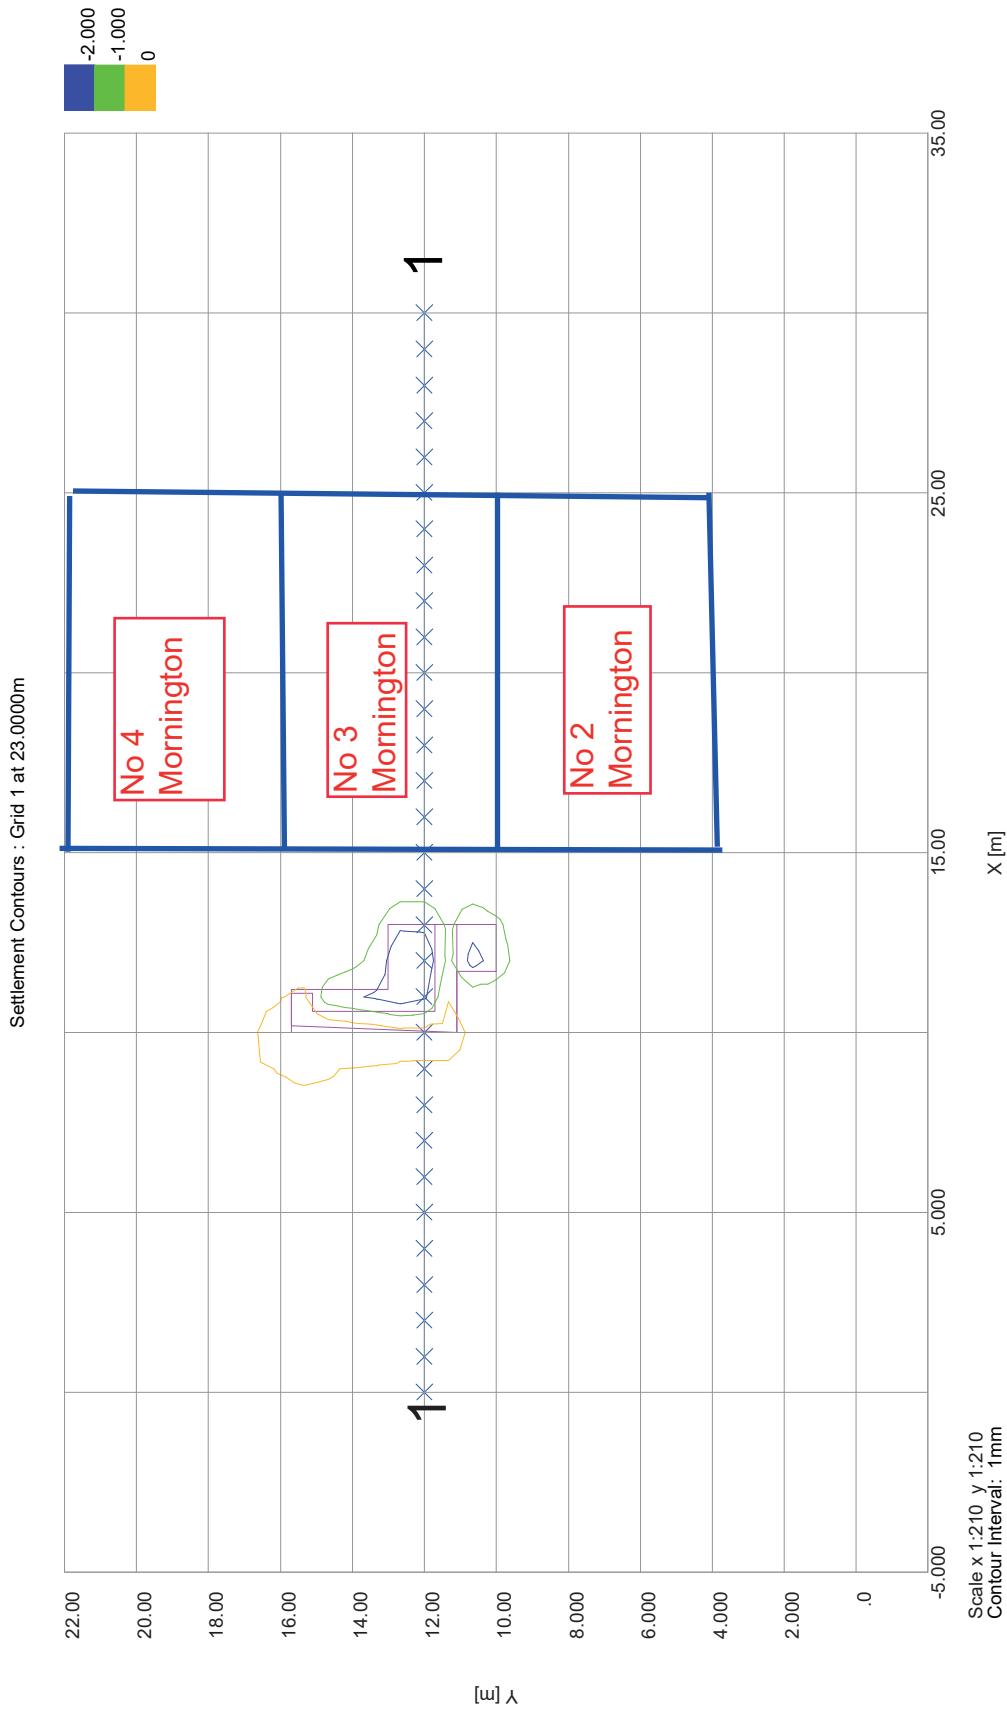
Drained long term movements. Including basement loads

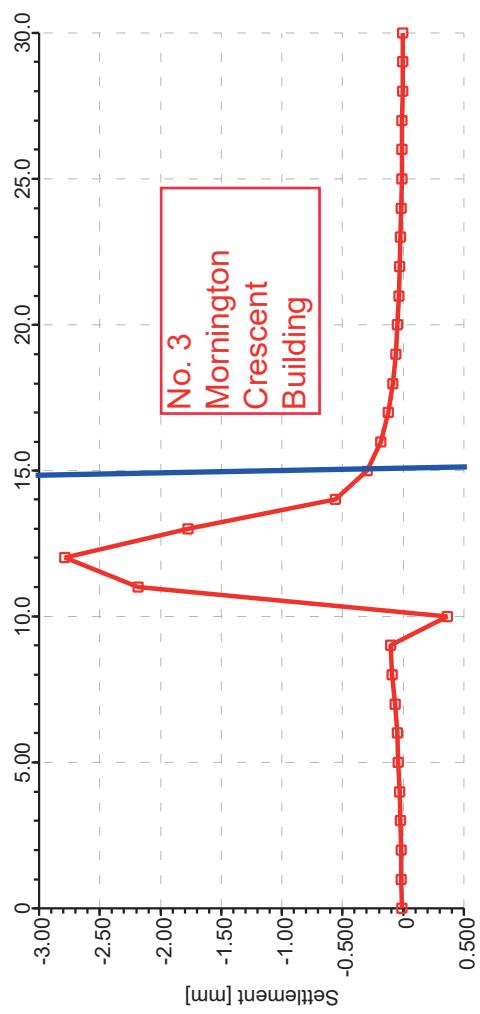
## Displacement for SW-NE 2

Distance from (0,12) in m
