Title: Product wind, water and impact resistance testing of a LineAL

aluminium rainscreen system supplied by Ash & Lacy

Report No: N950-18-17539

Customer: Ash & Lacy

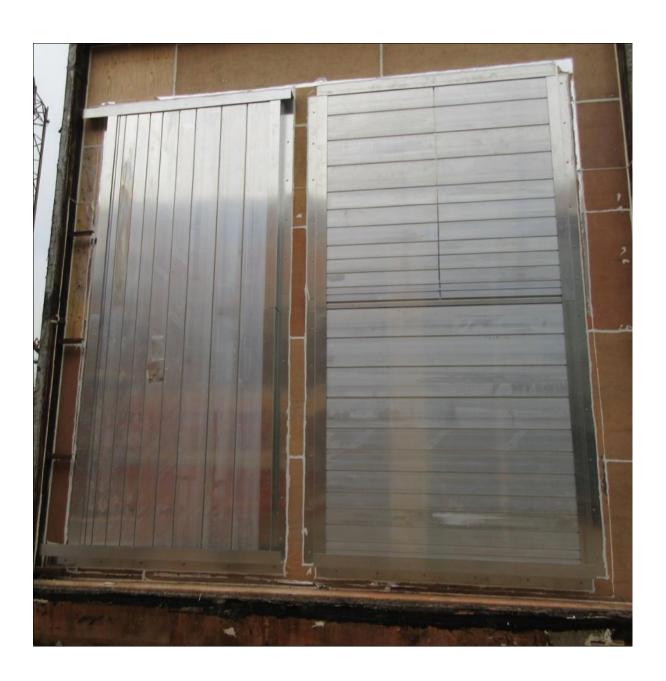
PHOTO 6734

The test samples measured 5 m high and comprised LineAL rainscreen systems.

TEST SAMPLE ELEVATION

The sample was as shown in the photo below and the drawings included as an appendix to this report.

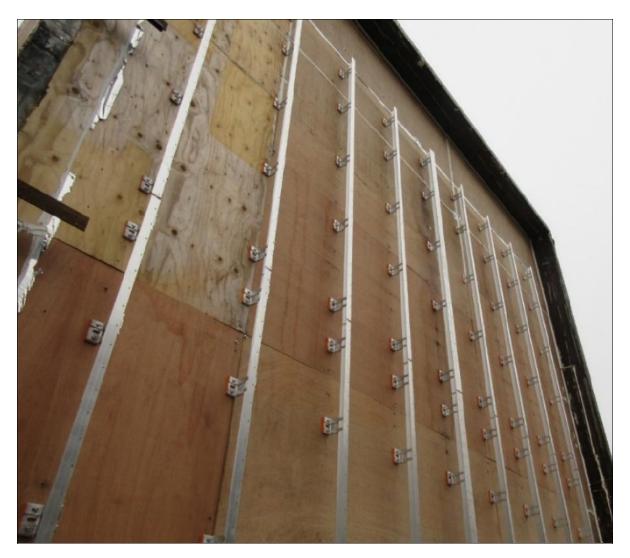
PHOTO 6670

During the dismantling of the sample no water penetration or discrepancies from the drawings were found.

SUPPORT RAILS

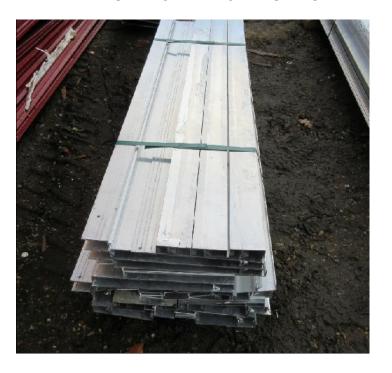
PHOTO 6795

PLANKS REMOVED FROM TEST RIG

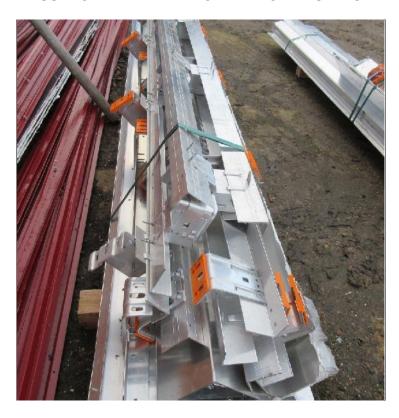
PHOTO 6797

SUPPORT FRAME REMOVED FROM TEST RIG

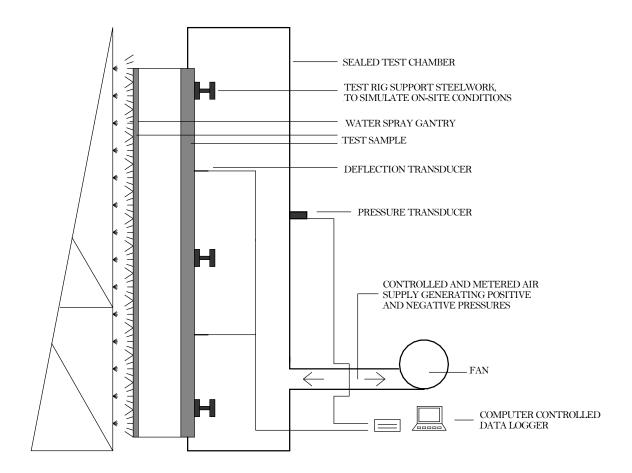
FIGURE 1

The test sample was mounted on a rigid test rig with support steelwork designed to simulate the on-site/project conditions. The test rig comprised a well sealed chamber, fabricated from steel and plywood. A door was provided to allow access to the chamber. Representatives of Ash & Lacy installed the sample on the test rig. See Figure 1.

TEST RIG SCHEMATIC ARRANGEMENT

SECTION THROUGH TEST RIG

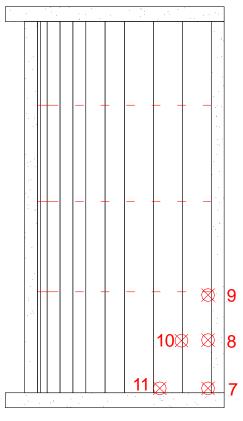
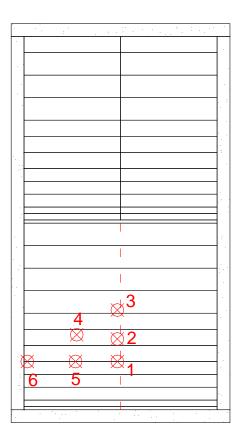
FIGURE 2

Displacement transducers were used to measure the deflection of principle framing members to an accuracy of 0.1 mm. The gauges were set normal to the sample framework at mid-span and as near to the supports of the members as possible and installed in such a way that the measurements were not influenced by the application of pressure or other loading to the sample. The gauges were located at the positions shown in Figure 2.

DEFLECTION GAUGE LOCATIONS

The deflections measured during the wind resistance test, at the positions shown in Figure 2, are shown in Tables 3 and 4.

The deflections measured during the structural safety test, at the positions shown in Figure 2, are shown in Table 5.

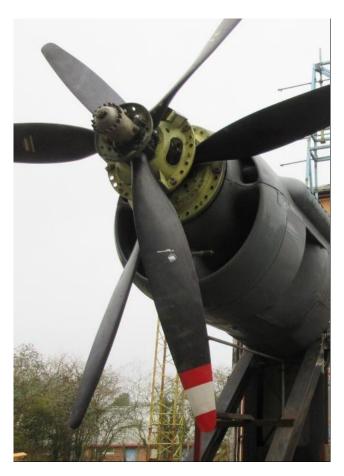
PHOTO 6549

A wind generator was mounted adjacent to the external face of the sample and used to create positive pressure differentials during dynamic testing. The wind generator comprised a piston type aero-engine fitted with 4 m diameter contra-rotating propellers.

DYNAMIC WIND GENERATOR

The aero-engine was used to subject the sample to wind of sufficient velocity to produce average deflections in the principle framing members equal to those produced by a static pressure differential of 600 pascals. These conditions were maintained for 15 minutes. Throughout the test the inside of the sample was examined for water penetration.

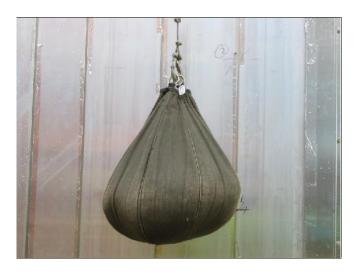
PHOTO 6755

The soft body impactor comprised a canvas spherical/conical bag 400 mm in diameter filled with 3 mm diameter glass spheres with a total mass of 50 kg suspended from a cord at least 3 m long.

The impactor almost touched the face of the sample when at rest. It was swung in a pendular movement to hit the sample normal to its face. The test was performed at the locations shown in Figure 3. The impact energies were 120 Nm for serviceability and 350 Nm and 500 Nm for safety at each location.

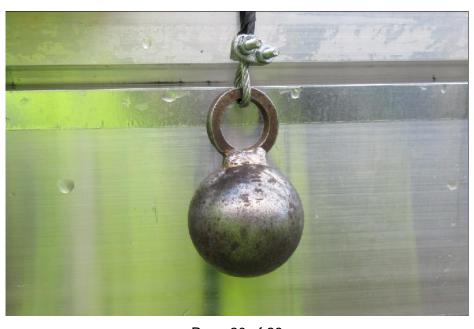
PHOTO 6763

The hard body impactor was a solid steel ball of 50 mm or 62.5 mm diameter and approximate mass of 0.5 kg or 1.0 kg.

The impactor almost touched the face of the sample when at rest. It was swung in a pendular movement to hit the sample normal to its face. The test was performed at the locations shown in Figure 4. The impact energies were 3 Nm, 6 Nm and 10 Nm at each location.

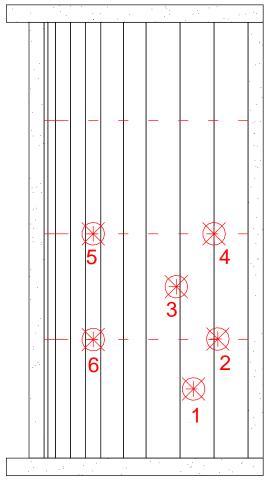
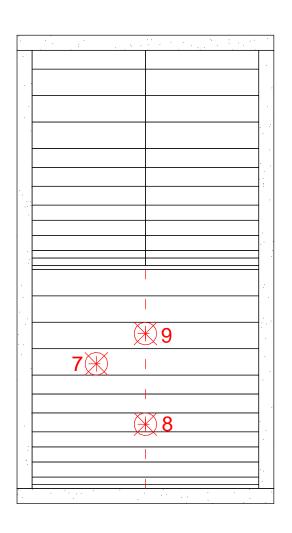
FIGURE 3

SOFT BODY IMPACT TEST LOCATIONS

Impact location	Impactor	Impact energy (Nm)	Observations	Class
1	Soft body	120 x3 350 500	No damage No damage 3 mm indentation	1 Negligible risk Negligible risk
2	Soft body	120 x3 350 500	No damage No damage No damage	1 Negligible risk Negligible risk
3	Soft body	120 x3 350 500	No damage No damage 2 mm indentation	1 Negligible risk Negligible risk
4	Soft body	120 x3 350 500	No damage No damage No damage	1 Negligible risk Negligible risk
5	Soft body	120 x3 350 500	No damage No damage No damage	1 Negligible risk Negligible risk
6	Soft body	120 x3 350 500	No damage No damage No damage	1 Negligible risk Negligible risk
7	Soft body	120 x3 350 500	No damage No damage 3 mm indentation	1 Negligible risk Negligible risk
8	Soft body	120 x3 350 500	No damage No damage No damage	1 Negligible risk Negligible risk
9	Soft body	120 x3 350 500	No damage No damage No damage	1 Negligible risk Negligible risk
10	Hard body	3 6 10	Minor indentation Minor indentation 1 mm indentation	1 2 3 Negligible risk

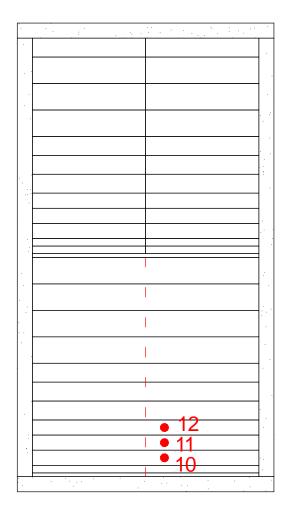
FIGURE 4

HARD BODY IMPACT TEST LOCATIONS

11	Hard body	3 6 10	Minor indentation Minor indentation 1 mm indentation	1 2 3 Negligible risk
12	Hard body	3 6 10	Minor indentation Minor indentation 1 mm indentation	1 2 3 Negligible risk

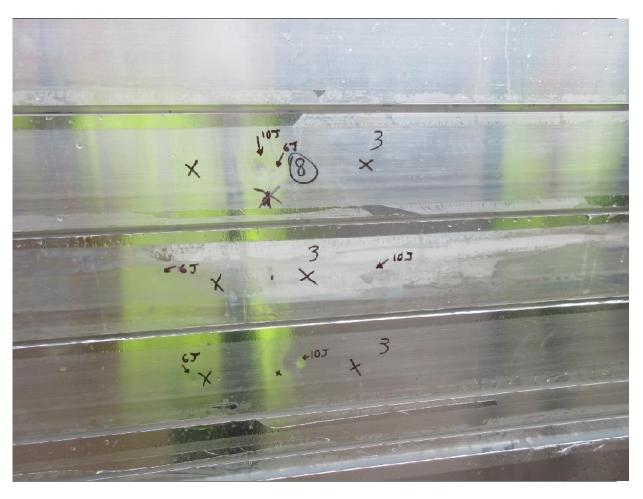
PHOTO 6764

HARD BODY IMPACTS

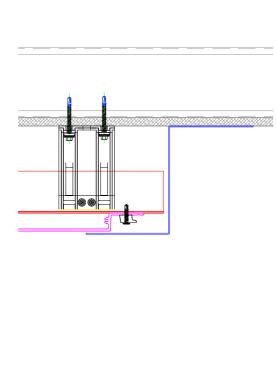
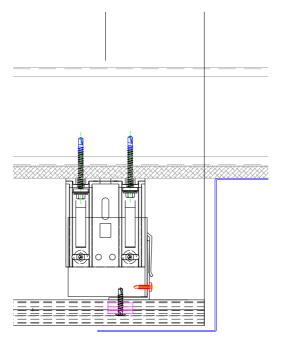
Head Detail of LineAL H Section

movement between two floors

accommodate the Use Flash to

Bottom Detail of LineAL H Section

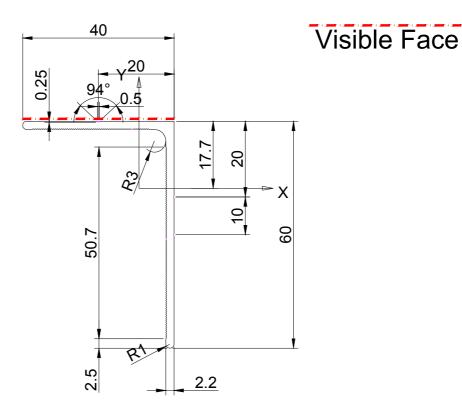
Drawing No: ED-Facade-1707.03-04

Z49X27X26X2 FlashIng

Area: 205.8 mm²
 Weight: 0.556 kg/m

Moment of Inertia X: 78271.5 mm⁴
 Moment of Inertia Y: 28704.5 mm⁴

- 1. Material: Alum 6063T6 with mechanical properties applied to BS EN755-2:1997
- 2. Profile dimension tolerance applied to BS EN 755-9:2008 unless stated on the drawing
- 3. Standard extrusion length 3000 mm 4850 mm 6000 mm
- 4. Remove sharp corner with 0.5 mm R

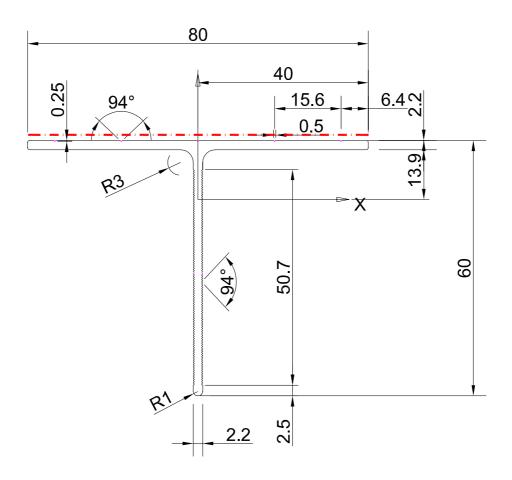
1. Area: 293.4 mm²

2. Weight: 0.792 kg/m

Moment of Inertia X: 94038.2 mm⁴
 Moment of Inertia Y: 93382.7 mm⁴

- 1. Material: Alum 6063T6 with mechanical properties applied to BS EN755-2:1997
- 2. Profile dimension tolerance applied to BS EN 755-9:2008 unless stated on the drawing
- 3. Standard extrusion length 3000 mm 6000 mm
- 4. Remove sharp corner with 0.5 mm R

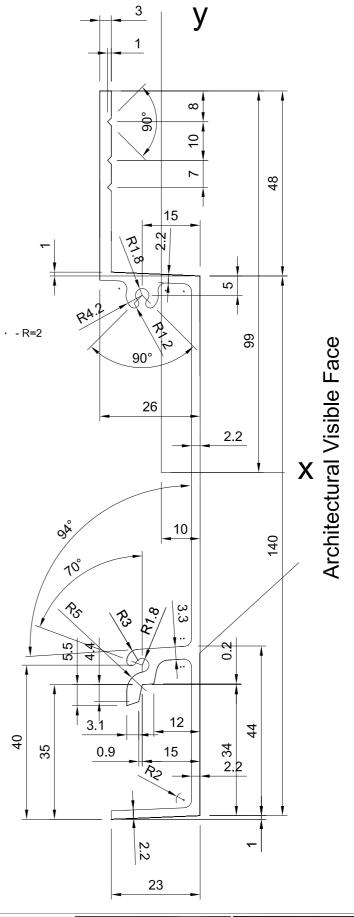
Construction	
Cllent: Internal	
Project: ED-Tech-1607-02.02	
Drawlng No: SD.LX.01	Rev:

Area: 686.1 mm²
 Weight: 1.85 kg/m

3. Moment of inertia X: 2266565 mm⁴
4. Moment of inertia Y: 63226 mm⁴

- 1. Material: Alum 6063T6 with mechanical properties applied to BS EN 755-2:1997
- 2. Profile dimension tolerance applied to BS EN 755-9:2008
- 3. Radius for all sharp corners are 0.4 mm
- 4. Overall dimension tolerance ±0.6 mm except stated on the drawing
- 5. Standard length: 6 m
- 6. The test criteria for architectural visible face needs to be agreed with the supplier prior to supply

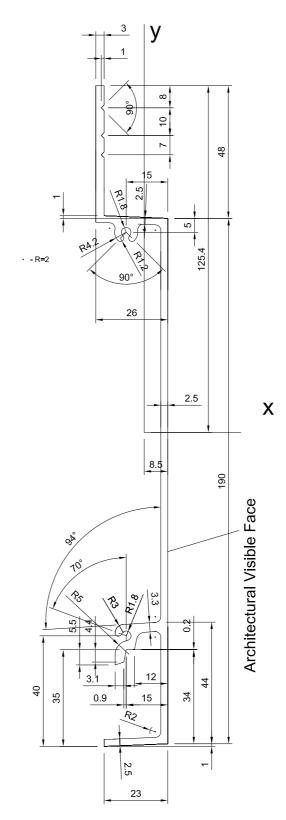
Area: 861.9 mm²
 Weight: 2.33 kg/m

3. Moment of inertia X: 4780806.6 mm⁴ 4. Moment of inertia Y: 73764.6 mm⁴

- 3. Radius for all sharp corners are 0.4 mm
- 4. Overall dimension tolerance ±0.6 mm except stated on the drawing
- 5. Standard length: 6 m
- 6. The test criteria for architectural visible face needs to be agreed with the supplier prior to supply

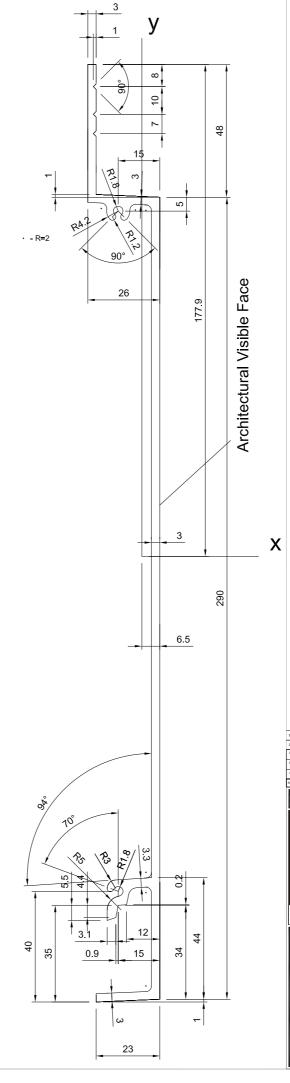
1. Area: 1270.5 mm² 2. Weight: 3.43 kg/m

3. Moment of inertia X: 14290299.0 mm⁴ 4. Moment of inertia Y: 87753.9 mm⁴

4. Overall dimension tolerance ±0.6 mm except stated on the drawing
