Planning and Heritage Statement

1 and 1a Montague
Street, Bloomsbury

April 2018

1 & 1a MONTAGUE STREET – HERITAGE REPORT

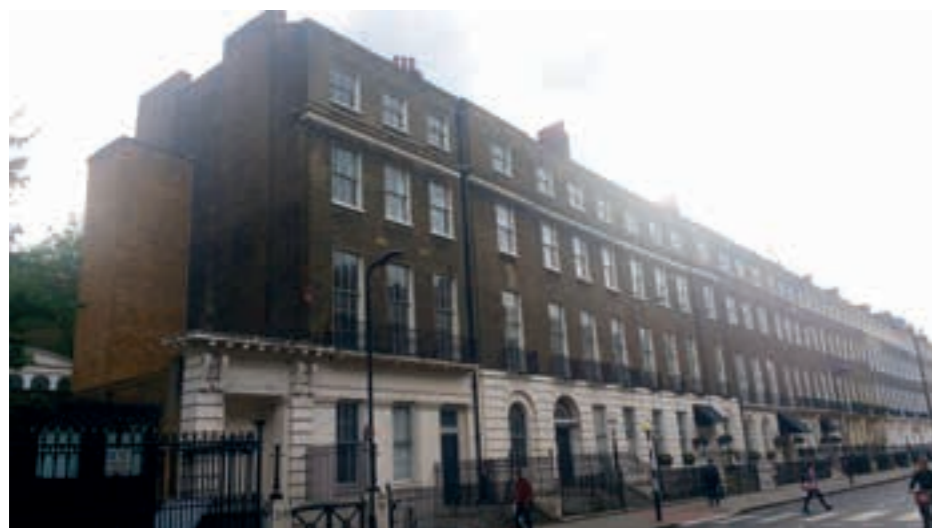
Figure 4.1 Front elevations to Montague Street

- 4.8 The front elevations to Russell Square retain the original brickwork, the fenestration arrangement, entrances at the ground floor, and cast iron railings at the ground level with balconies at upper floors. Some of the windows are modern timber sash replacements, though their style as traditional sashes are sympathetic to the historic building (**Figure 4.1**).

- 6.47 The original features to the front elevation, including railings and other ironwork, are to be retained, with repair and redecoration where needed to improve the appearance of the building. Access to the balconies once the offices are in operation are to be restricted to ensure their conservation.
- 6.48 The stucco to the ground floor is to be redecorated, and minor repairs undertaken where required, to improve the appearance of the building to Montague Street and to ensure the long term preservation of the historic materials.
- 6.49 Taken as a whole, the works to the exterior of the building will enhance the appearance of the historic building, and preserve its contribution to the conservation area, in keeping with part ‘e’ of Policy D2 of Camden’s Local Plan.

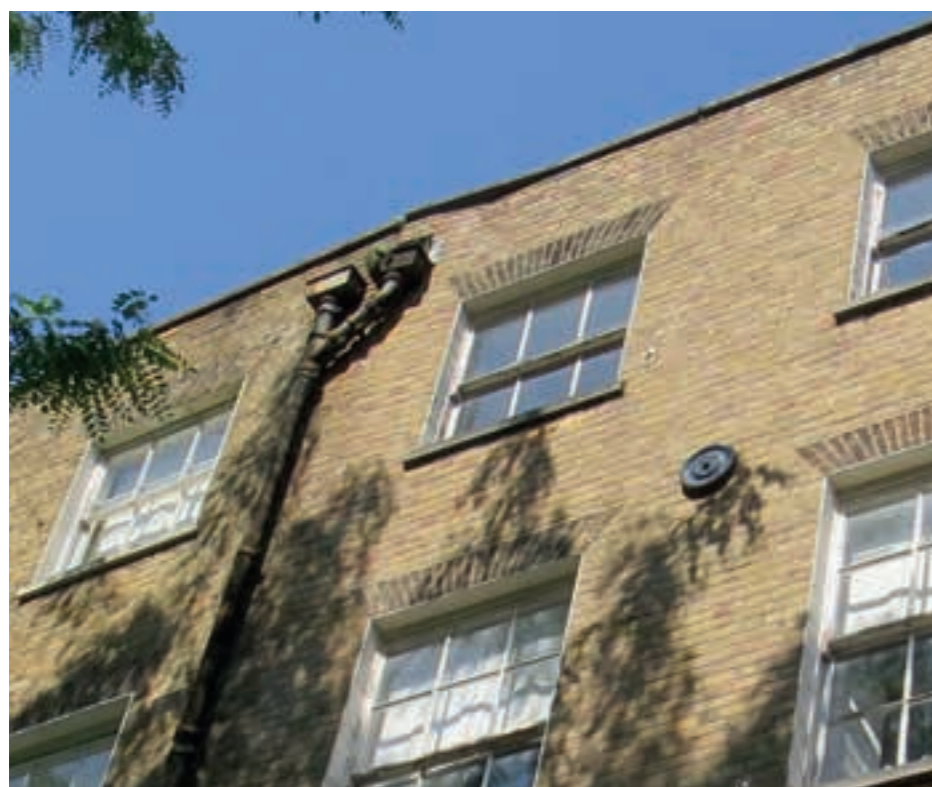
Figure 4.2 Rear brickwork to no. 1a Montague Street, showing evidence of damage

- 4.9 At the ground floor, the elevation is treated with channelled stucco and has a uniform appearance with the remainder of the terrace at 2-11.
- 4.10 The rear elevation of the property is also in brickwork. Some of this brickwork shows evidence of structural damage caused by movement of the building, where it is visibly uneven (**Figure 4.2**). The Structural Report by Curtins, which forms part of this Application, states that the movement is believed to be "longstanding and non-progressive, or at least not significantly progressive and as such to have reached a stable equilibrium". The rear part of the property has been reinforced internally by a large scaffolding structure since the 1990s, to support the building and prevent any further movement.

- 4.11 This movement is visible internally in the extensive cracks and floor movement throughout the rear parts of no.1.
- 4.12 The rear elevation shows contrasting brickwork at the upper two storeys. The date of this change is unclear, and it appears that the rebuild adhered to the original line of the building. The fenestration has also been altered, with some 20th century metal framed windows and an area of render to the rear of 1a, which suggests that a previous window opening has been blocked in, possibly during the 1980s (**Figure 4.4**).

- Replacement of displaced brick to rear of 1a to align with remainder of wall, repair and structural works to existing balcony;
 - Addition of a new service riser from the basement to the third floor level; and

- 6.43 To the rear of Montague Street, the brickwork below the first floor balcony is to be removed and reinstated, and balcony fixings consolidated to ensure the stability of the structure.
- 6.44 These areas have previously been affected by movement in the building, and require rectifying works to address the resultant damage.
- 6.45 The works will ensure the structural integrity of the building, and its continued use.
- 6.46 Localised repairs, including the removal of organic growth and loose debris, will be undertaken at roof level, to ensure the preservation of the historic building.

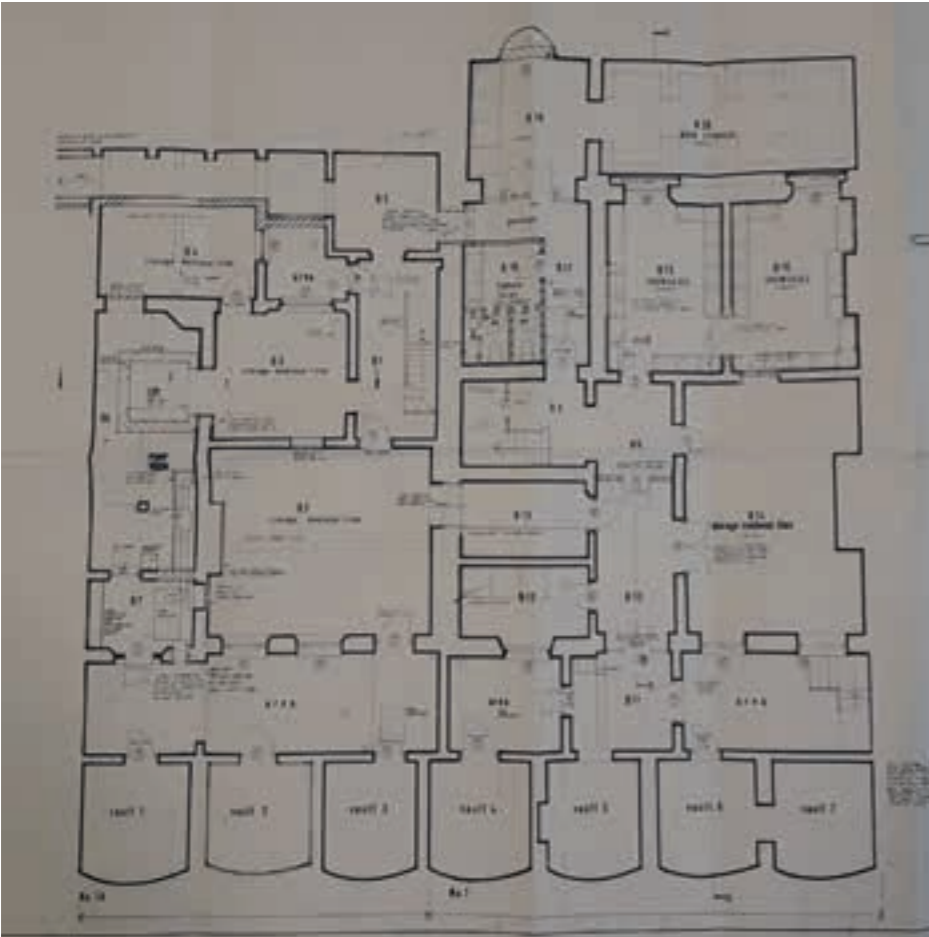
Figure 4.5 Basement plan of the properties in 1984 showing access corridor to the British Museum and assorted storage uses

- 4.22 The plan at **Figure 4.5** shows that the basements to both properties had a complex plan form consisting of a series of subdivided storage spaces, and a total of seven vaults. To the rear of no.1, the basement spaces are shown adapted to accommodate showcases and book storage (B15 and B20).
- 4.23 The properties are combined internally at this floor level via two openings in the party wall, and some internal partitions at 1a have been removed to open up the space to the front of the property. The lift is shown in the pump room space.
- 4.24 To the rear of 1a, an opening links to the 'White Wing Corridor', which provides internal access directly to the museum (**Figure 4.6**). This was added during the museum's use of the property as office space.

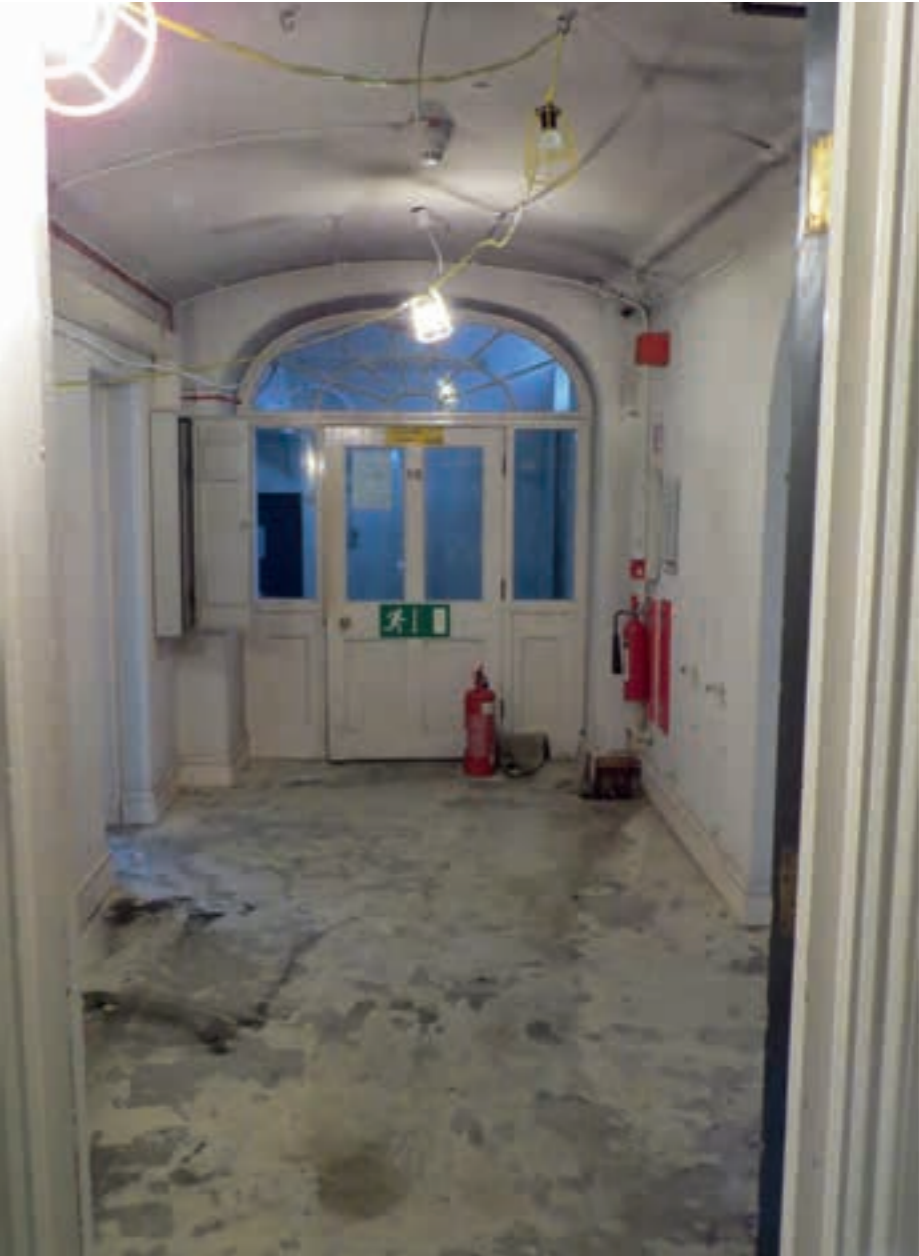
Figure 4.7 Fanlight at basement level

- 4.25 A full account of features of interest is provided by the HOK Report at Appendix 2, however we provide a brief summary of some of these here. To the rear of 1a, an internal double door in the lobby space is surmounted by a decorated fanlight (**Figure 4.7**), which reflects the former bank entrance.

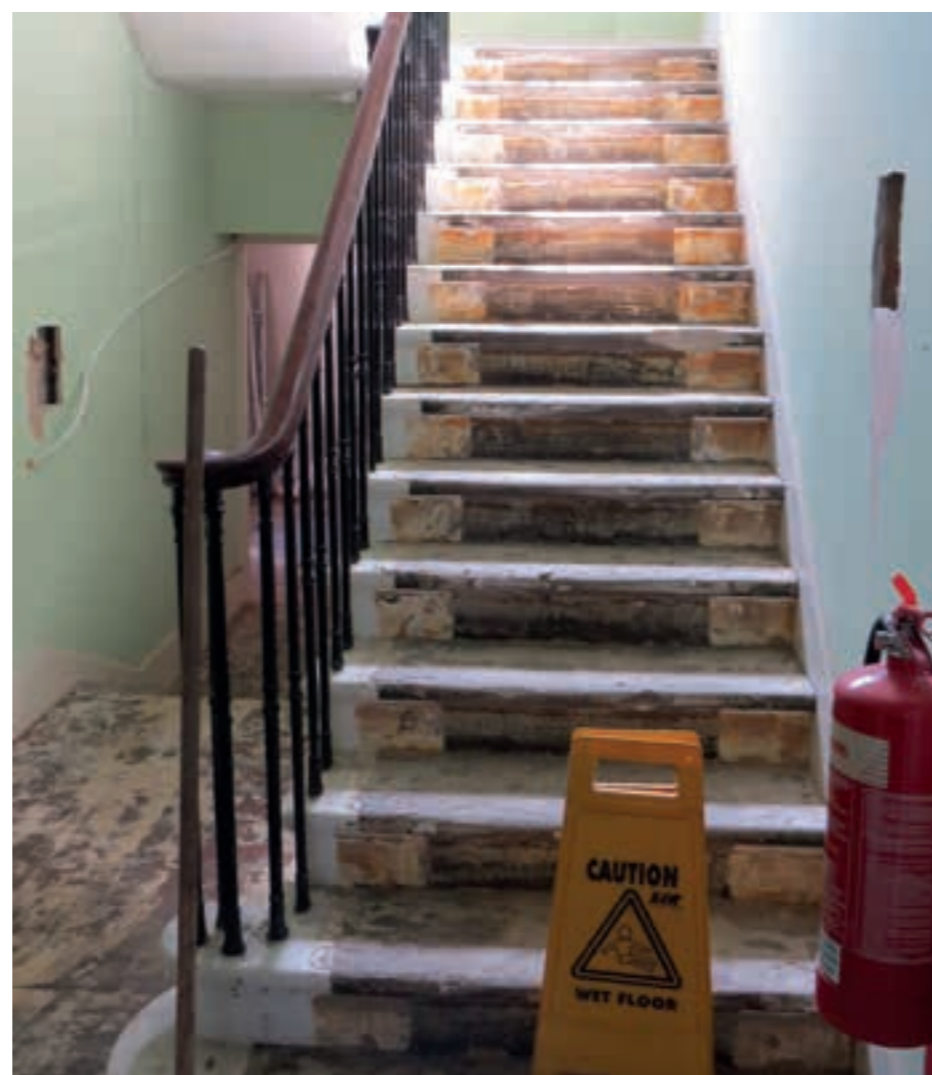
Figure 4.9 The main stair to no.1a at ground level

- 4.30 The staircase and iron balustrade from basement to ground floor in no.1 appear original. These are undecorated, reflecting the hierarchy of spaces within the interior, and contribute to an understanding of the historic circulation pattern.
- 4.31 The wrought iron balustrade to the main cantilevered staircase is original with some of the handrail and balusters altered later (**Figure 4.9**). The staircase forms an integral part of the original layout, and a key internal feature of significant interest.

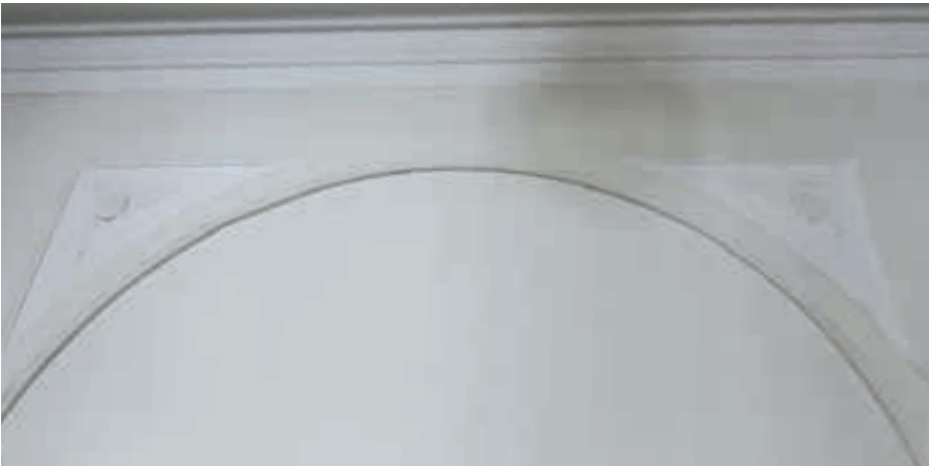
Figure 4.12 Original opening between reception rooms

- 4.33 The original blocked opening between reception rooms at no.1 is visible in the wall as a decorated arch shape (**Figure 4.12**). The detail in the decorative wall friezes is clearly visible and well preserved within the infilled wall.
- 4.34 The cornices to the ground floor hallway in no.1 and the left hand reception room both survive in good condition. The hallway has detailed, pulvinated ornamentation (**Figure 4.13**).
- 4.35 The ground floor to no.1 retains original architraves and doorways to the reception rooms at the front of the property. The doors have carved decoration, and are painted white.

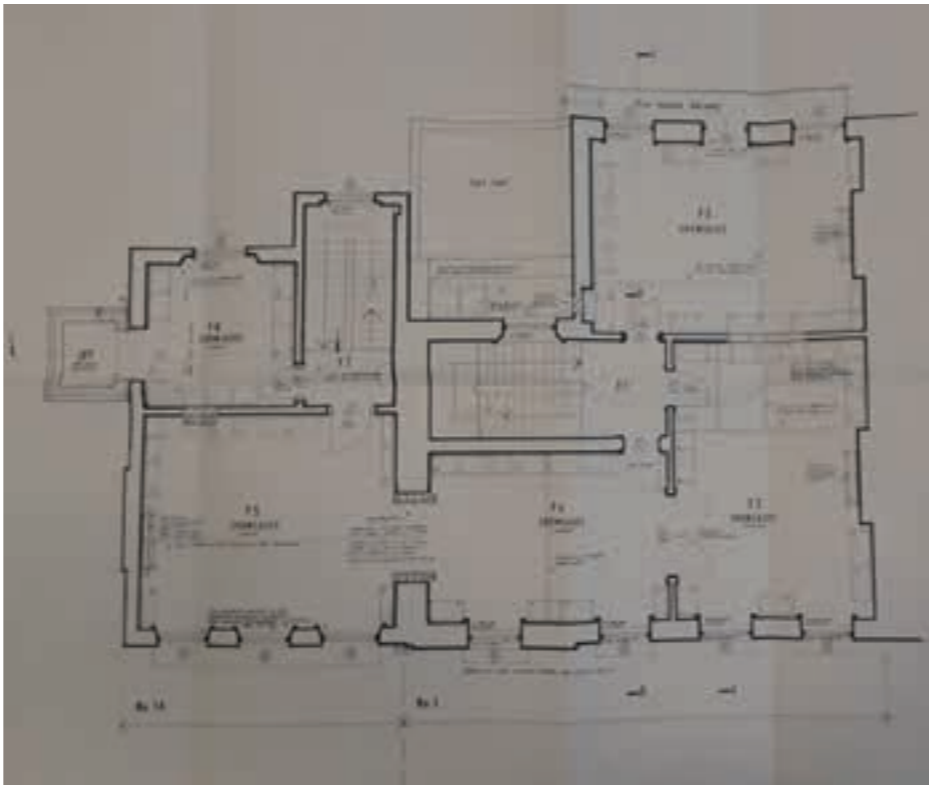
Figure 4.14 First floor plan of the properties in 1984, showing proposed internal alterations

- 4.36 At first floor level, the 1984 plans show that a chimney breast was removed to create an opening through the party wall. The first floor was adapted to house museum artefacts, and fitted with internal showcases which were bolted into the walls.
- 4.37 The plan form at this level appears to have undergone earlier change with the subdivision of internal rooms, and as part of the proposals, internal partitions in no. 1 were removed (**Figure 4.14**).

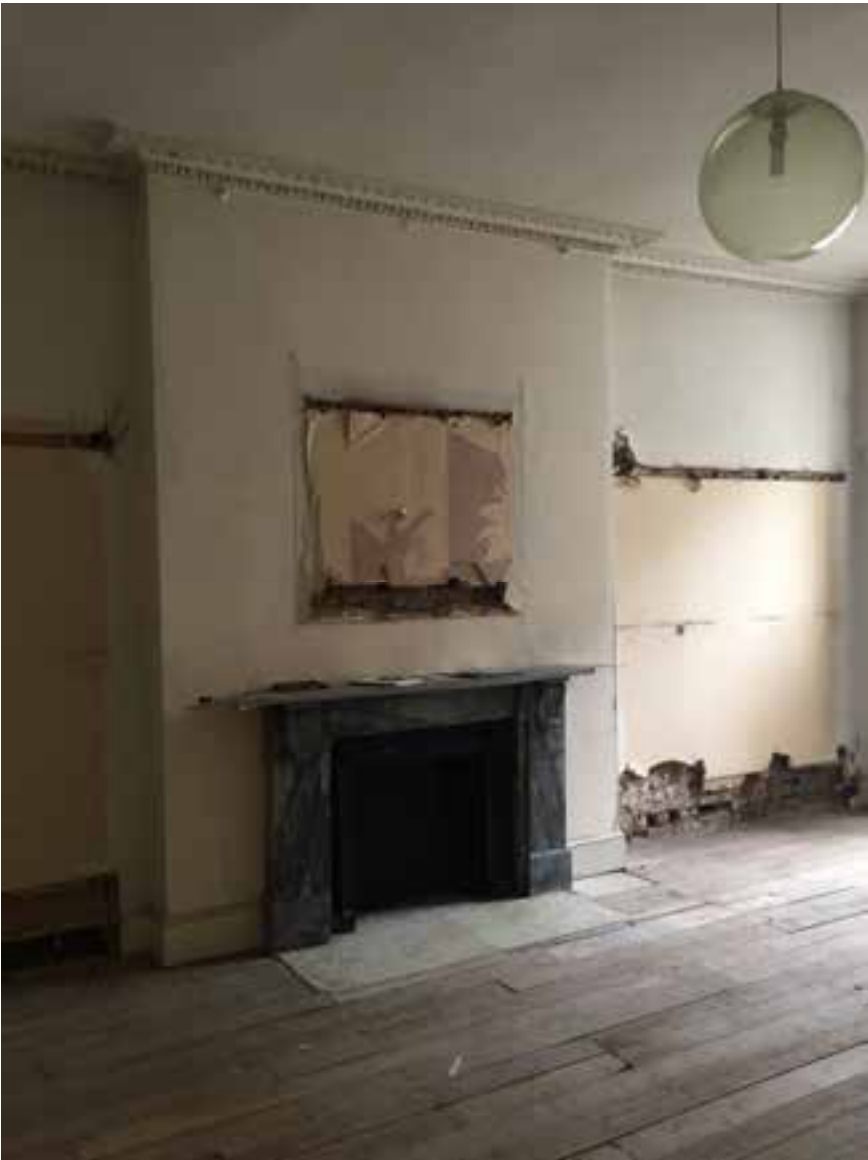
- A good marble surround with a cast iron inset to the fireplace. This is of high significance.

General View of the Fireplace and cornice

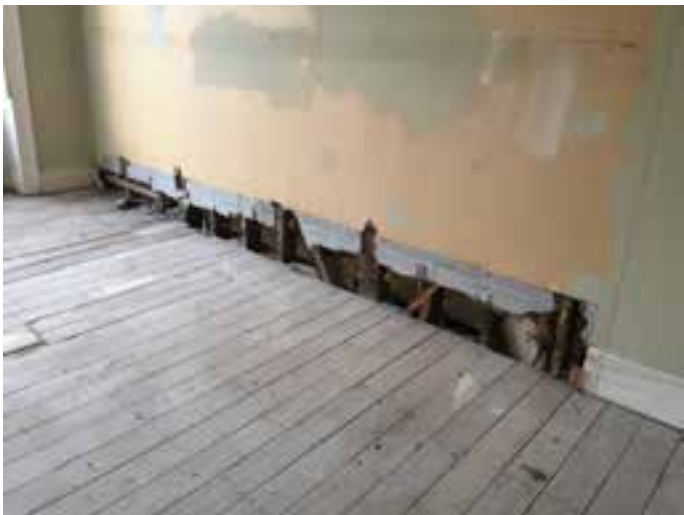
View of timber studs visible following removal of display cases

- 6.27 Internal plasterwork and partition walls require works to rectify damage caused by the construction of display used to house museum artefacts. This includes the repair of original lath and plaster partitions where possible and internal plasterwork. The approach to decorative plasterwork is described in the Method Statement as following;
*"Surfaces to be dusted down and any loose debris removed.
 New thin paint coating to be applied using water soluble soft distemper or water thinned alkyd resin paints to ensure decorative detail is not lost. Water thinned contract grade emulsion may be acceptable. Suggested trial area for inspection.
 Applies to full extent of cornices in principal spaces at ground and first floor levels. Where small areas of decorative cornice have been identified as damaged, a cast detail is to be undertaken using traditional techniques and materials compatible with the historic fabric."*

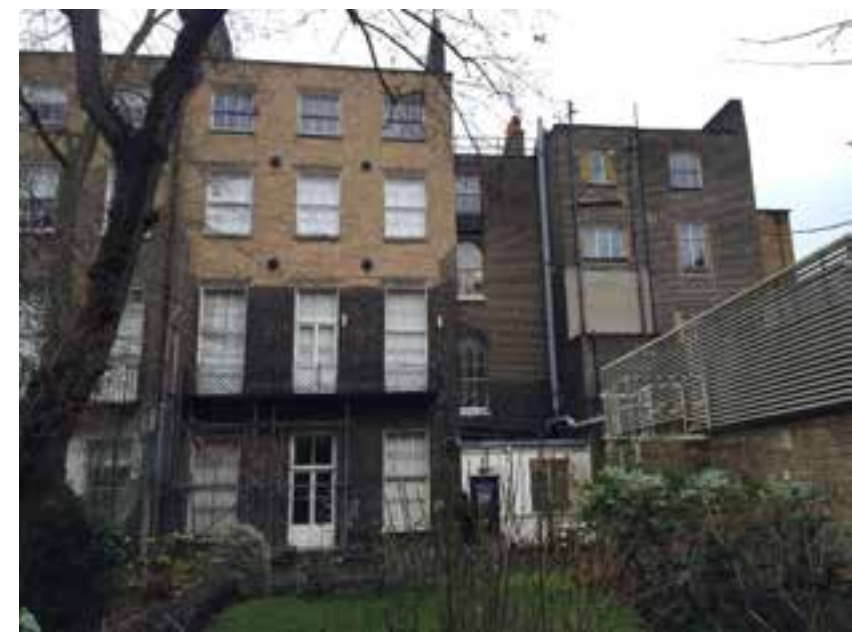
As already stated the rear elevations has been more extensively altered / repaired. There are areas of re-pointing and rebuilding associated with the fitting of Critall windows. The dates for these works is unclear. A new external lift shaft has also been added circa 1984 to the side elevation – this is viewed as intrusive in significance terms as are the Critall windows.

General view of the rear elevation

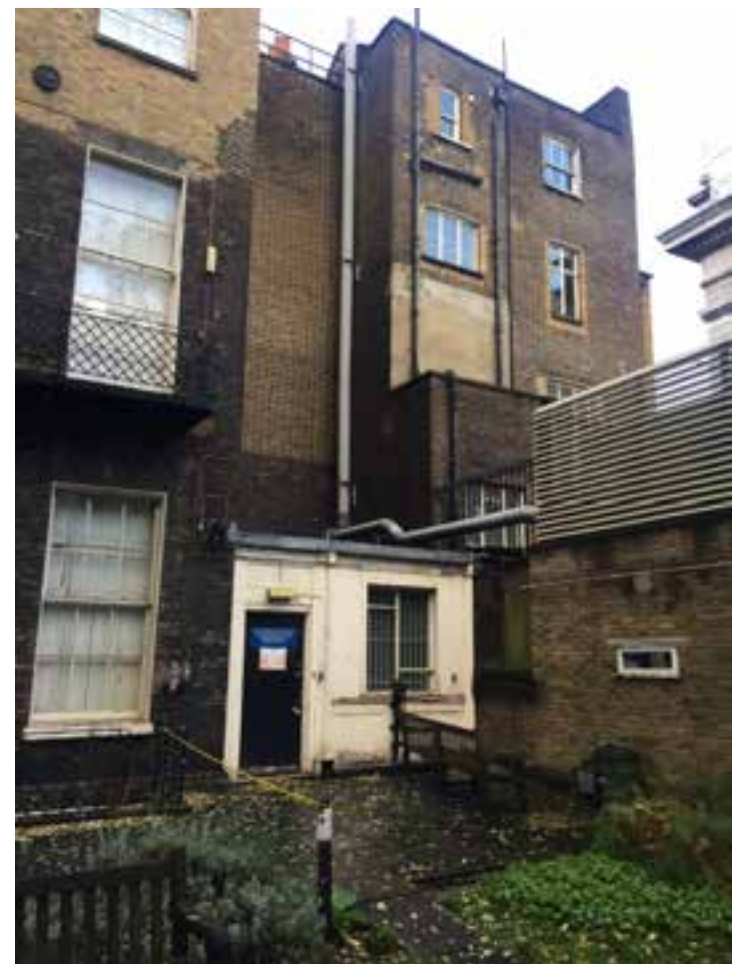
Detail view of the rear elevation showing repairs and Critall windows

- 6.32 It is proposed to replace the two rear windows of 1a Montague Street, which are metal framed and date to the late 20th century. Their replacement with sympathetic, timber framed sashes will contribute to the historic character of the building, and enhance the appearance of its rear elevation.
- 6.33 Elsewhere, the restoration of windows will preserve the external and internal appearance of the building. A window schedule has been produced by BDP which outlines the works to be undertaken to refurbish windows at the property. These include cleaning, renewal of putty, minor fabric and timber repairs and redecoration.
- 6.34 The upgrading of fenestration will enhance the appearance of the building in the conservation area, in keeping with part 'e' of Policy D2 of the local plan.
