Appendix C: Site Photographs

Hoxton Hotel, Holborn
 Client: Ennismore Capital

Dunelm Geotechnical & Environmental Ltd Factual Ground Investigation Report Hoxton Hotel, Holborn,
Rev. no. 3 dated 3/11/2017 (M516 The Hoxton v3.pdf).

HOXTON HOTEL, HOLBORN

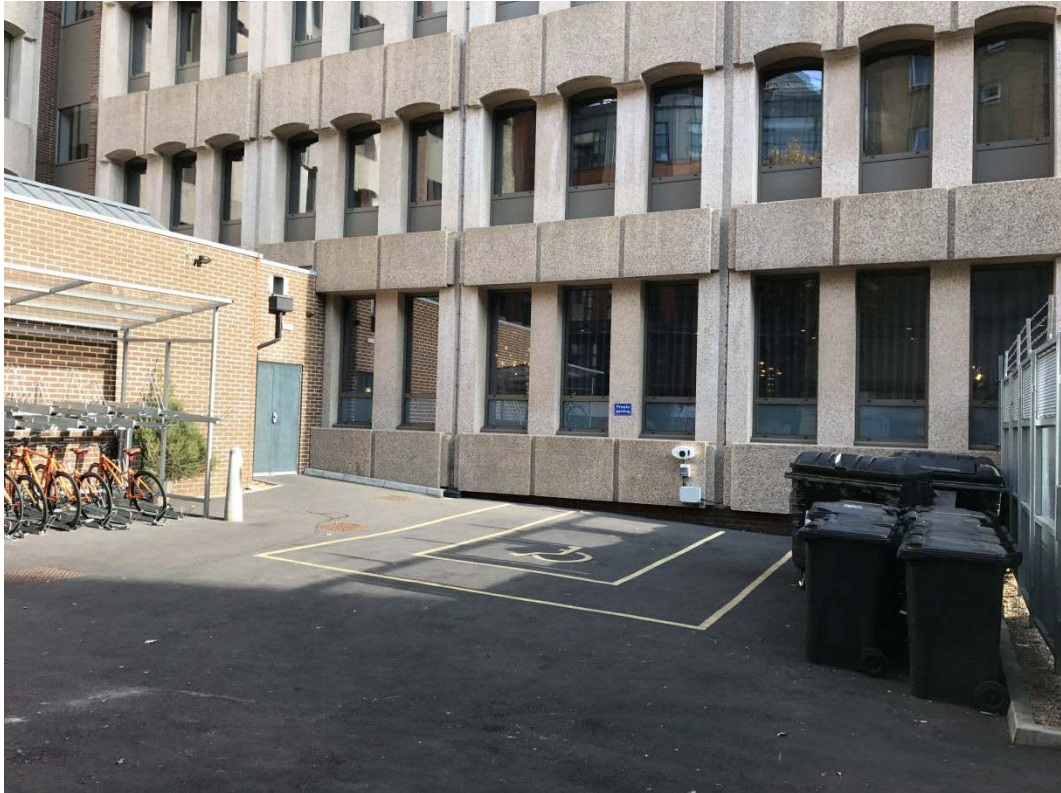
Photograph 1: Hoxton Hotel service yard looking east

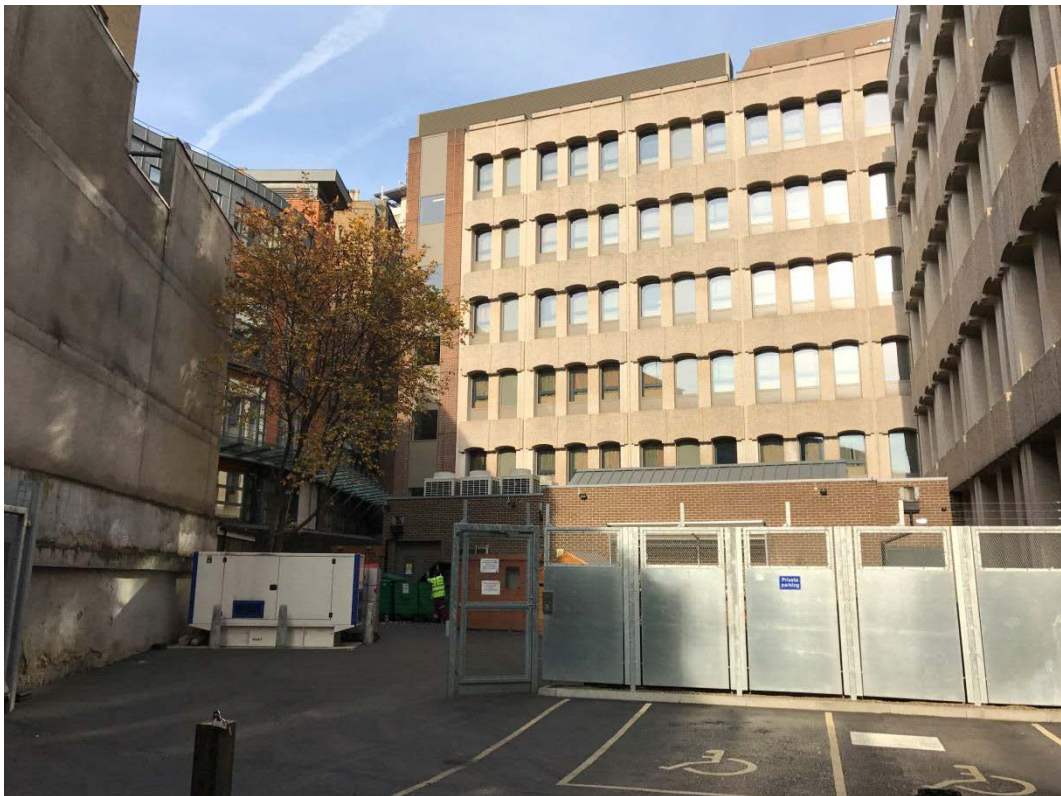
Photograph 2: Hoxton Hotel service yard looking north

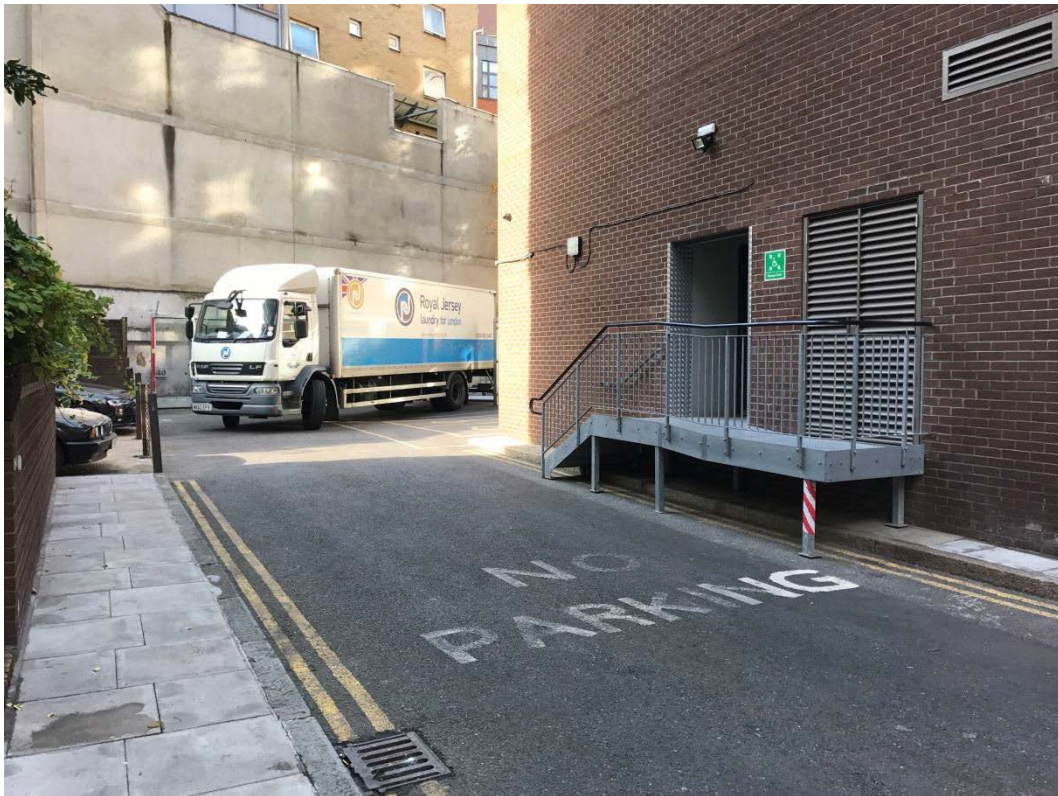
Photograph 5: Service yard access road

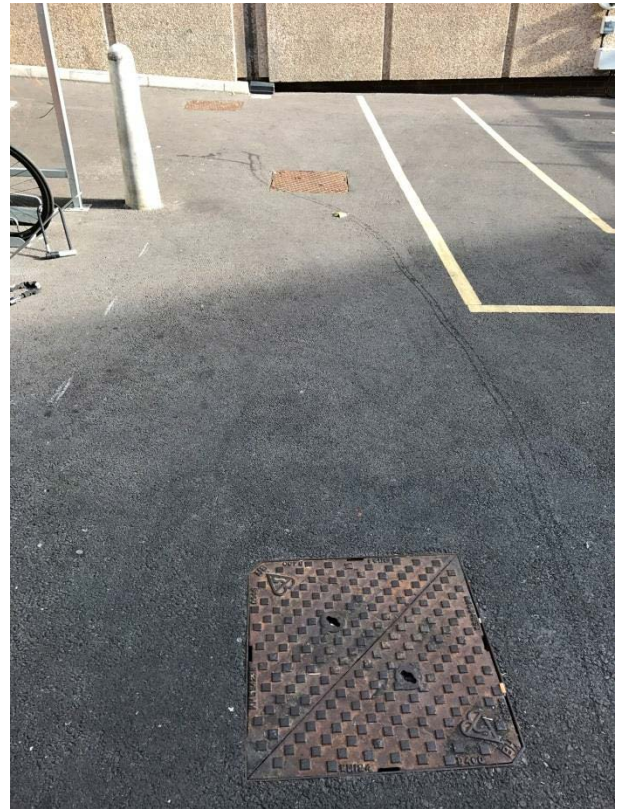
Photograph 7: Manholes within service yard

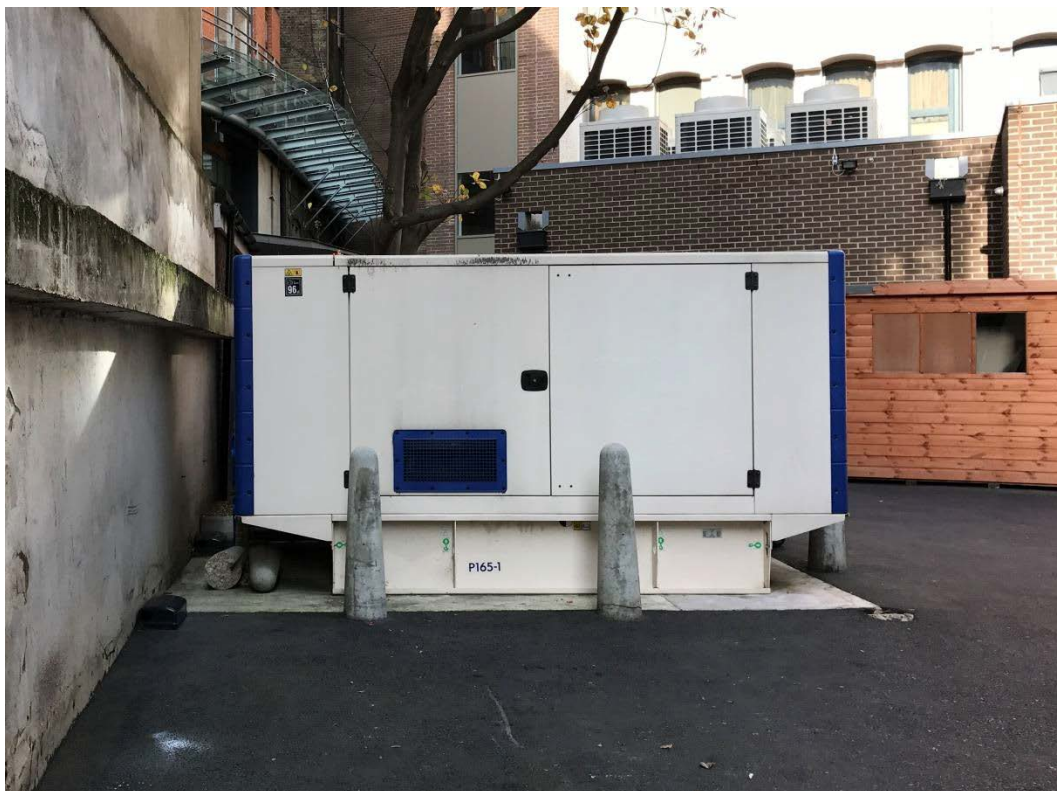
Photograph 8: Generator in service yard likely to remain in service yard post development

The site is currently used by the hotel as a service yard which houses with a large diesel power generator, two wooden storage sheds, a fixed bicycle rack, waste and laundry bins. Crossrail 1 lies directly beneath the area to be investigated and The London Underground Central line passes beneath the existing hotel.
