Detailed Unexploded Ordnance (UXO) Threat & Risk Assessment

Meeting the requirements of CIRIA C681 'Unexploded Ordnance (UXO) A guide for the Construction Industry' Risk Management Framework

PROJECT NUMBER	P6399	ORIGINATOR	S. Barratt
VERSION NUMBER	1.0	REVIEWED BY	B. Wilkinson (31 st January 2018)
CLIENT	Ennismore Capital	RELEASED BY	L. Askham (31 st January 2018)
SITE	The Hoxton Holborn, 199-206 High Holborn, WC1V 7BD		
RATING	VERY HIGH - This Site requires further action to reduce risk to ALARP during intrusive activities.

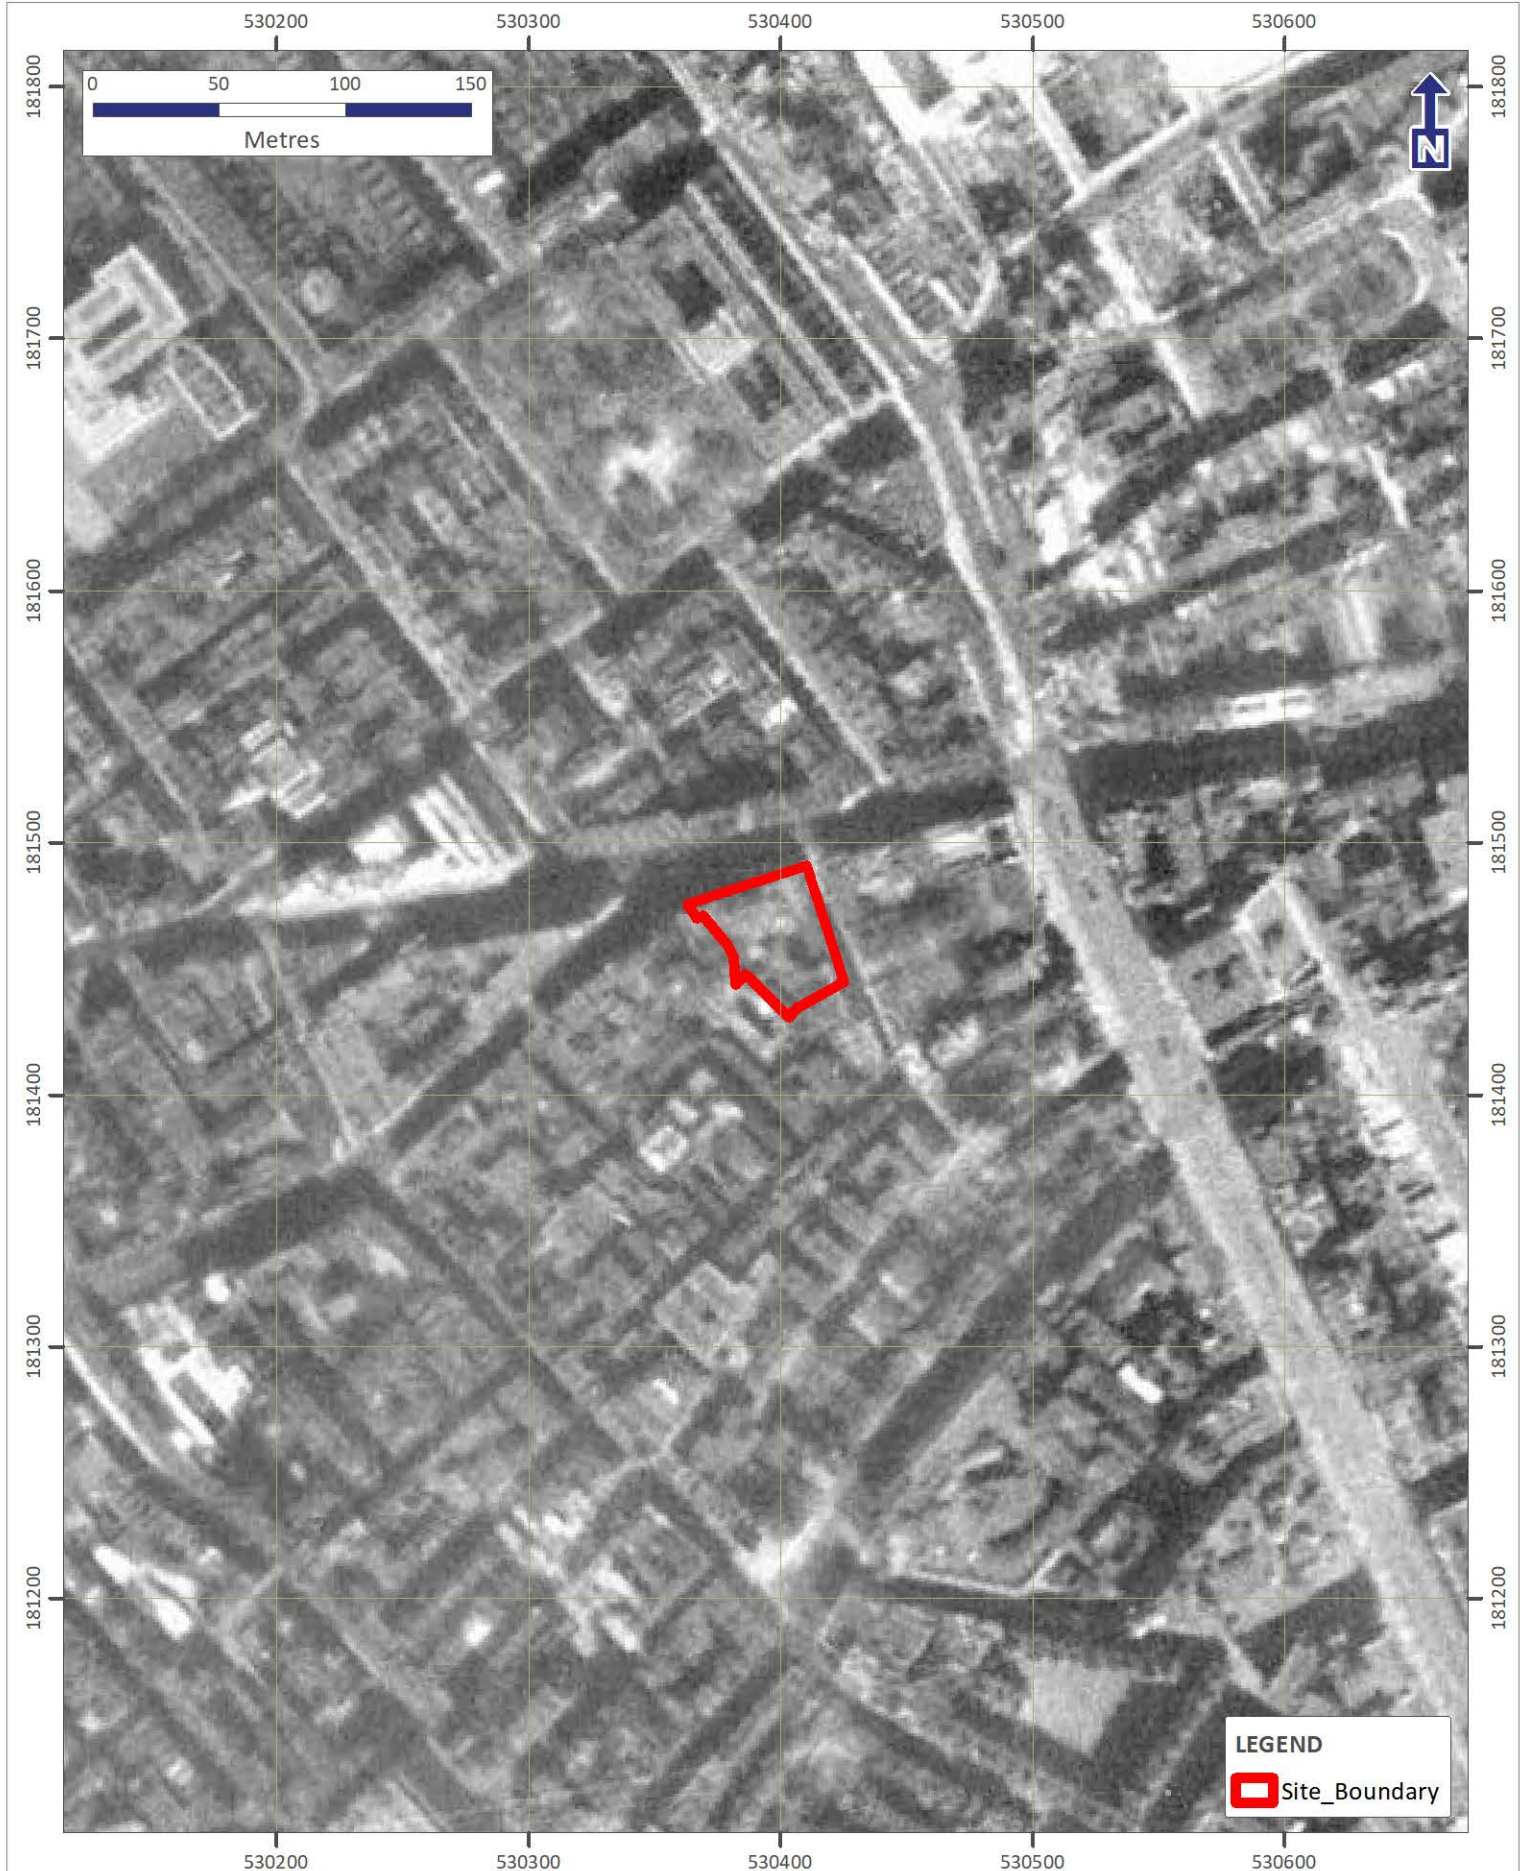
The aerial photography (1945) identified that structures occupied the entire Site. Nonetheless, the resolution of the photograph is insufficient to be able to identify accurately, the precise local features and/or type of structures, then within the curtilage of the Site.

Aerial Photography (1945) (Figure 4)

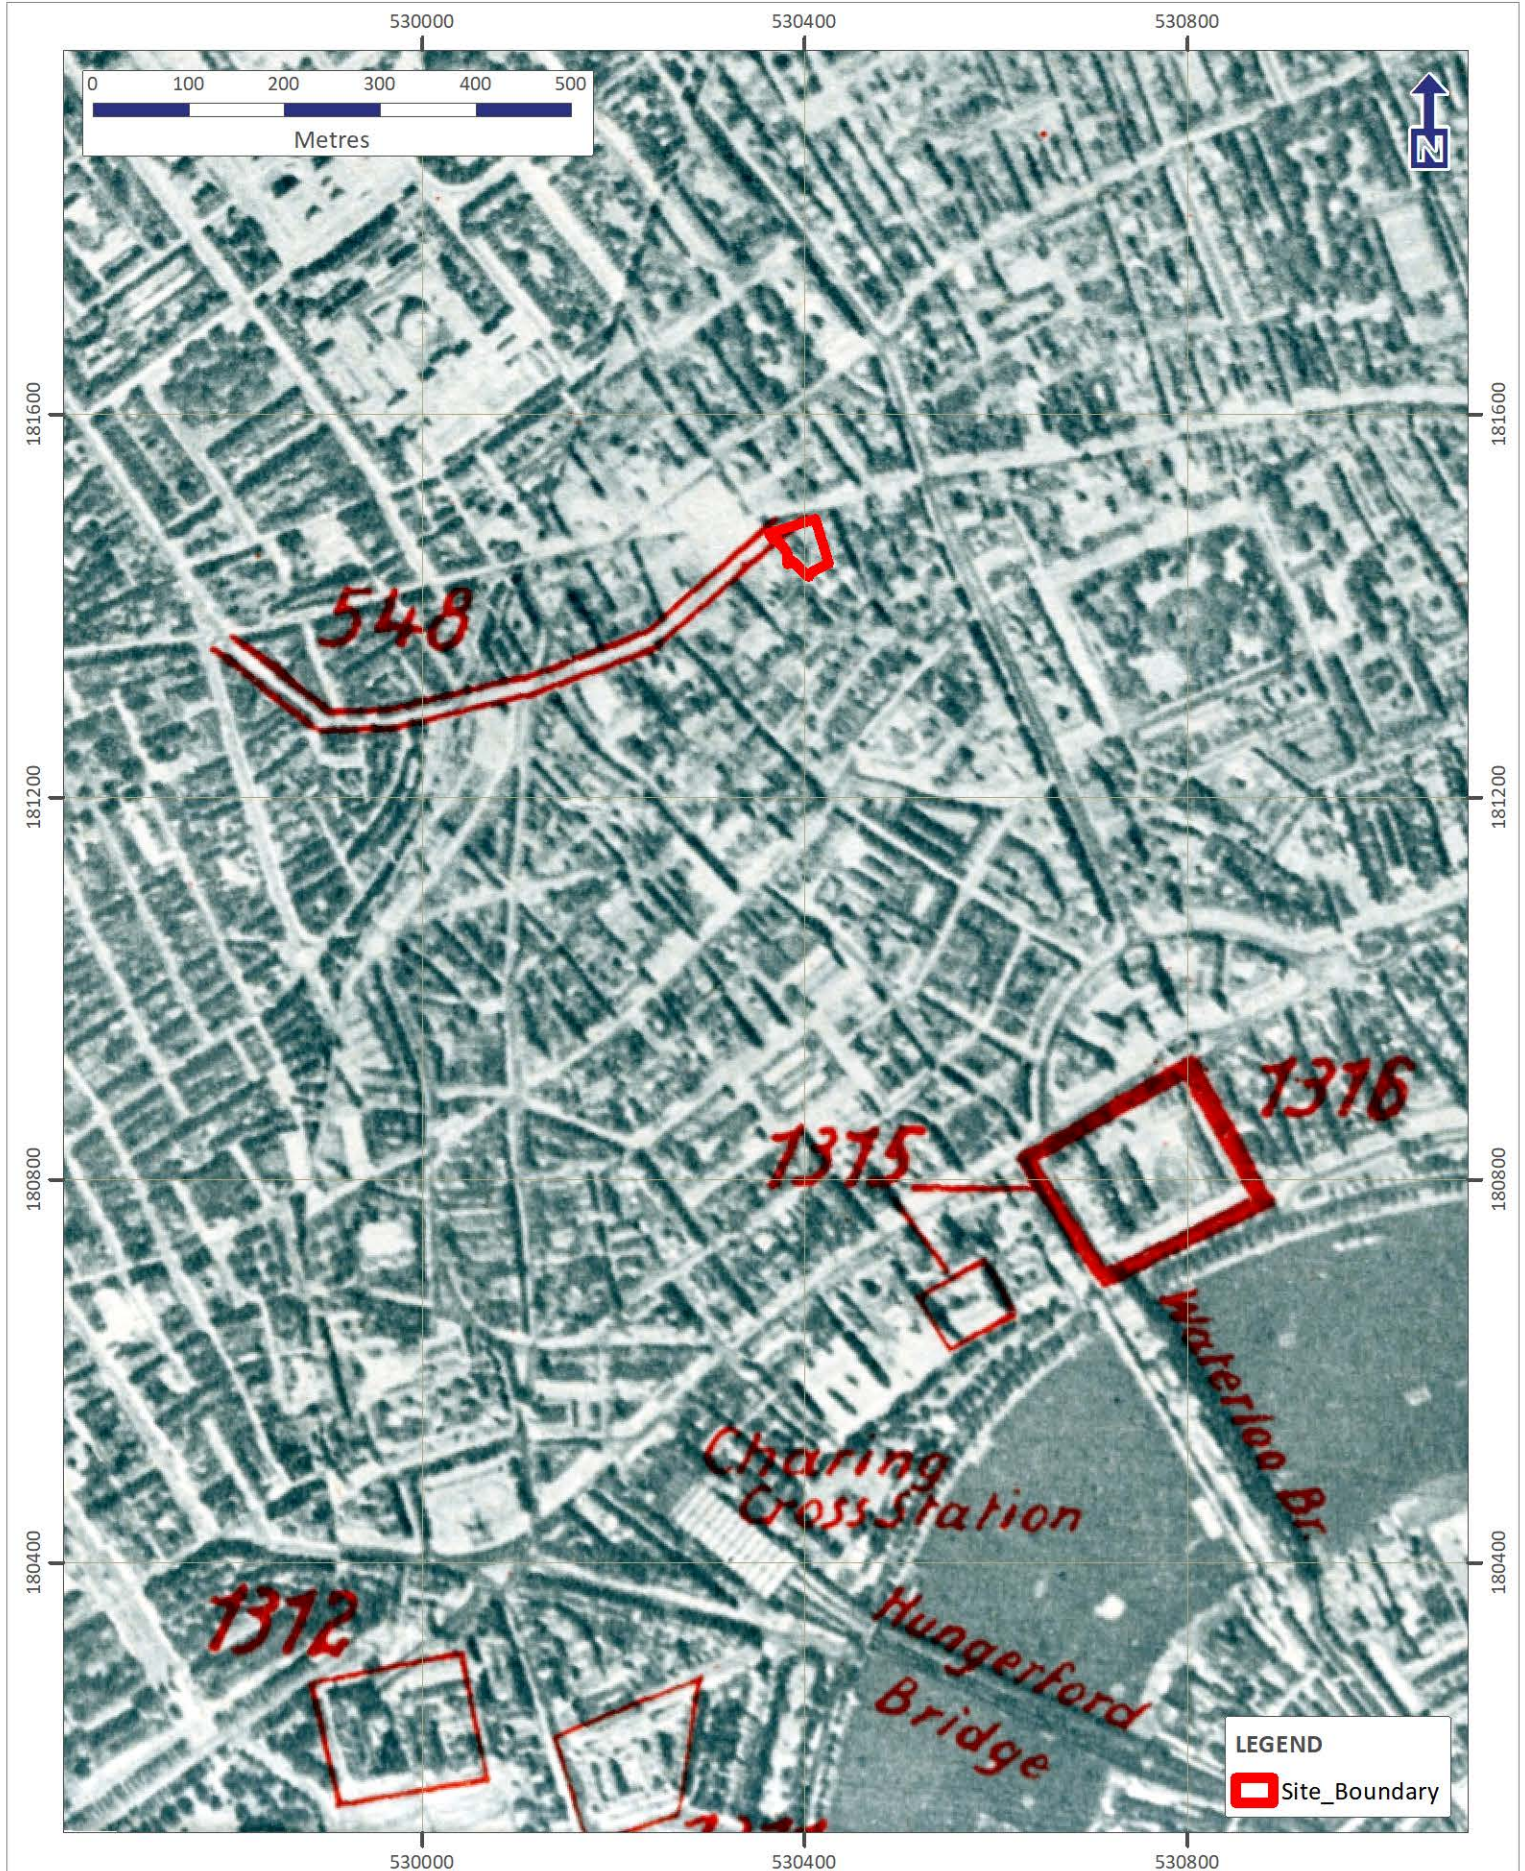
WWII Luftwaffe Aerial Photography

Luftwaffe aerial reconnaissance photography associated with the Site identified a drainage system (located immediately west) and command posts (located 630m to the south-south-east and 735m to the south) as primary bombing targets. In addition, railway stations (located 815m to the south-east and 960m to the south) may have been considered secondary bombing targets. Furthermore, research also identified numerous pillboxes (five located within 900m; the closest being 460m to the south east) and gun emplacements (located 665m to the south-south-east and 720m to the south-south-east), which are likely to have been targeted in an attempt to reduce *Luftwaffe* aircraft losses.

WWII Luftwaffe Bombing Targets (Figure 5A & 5B)

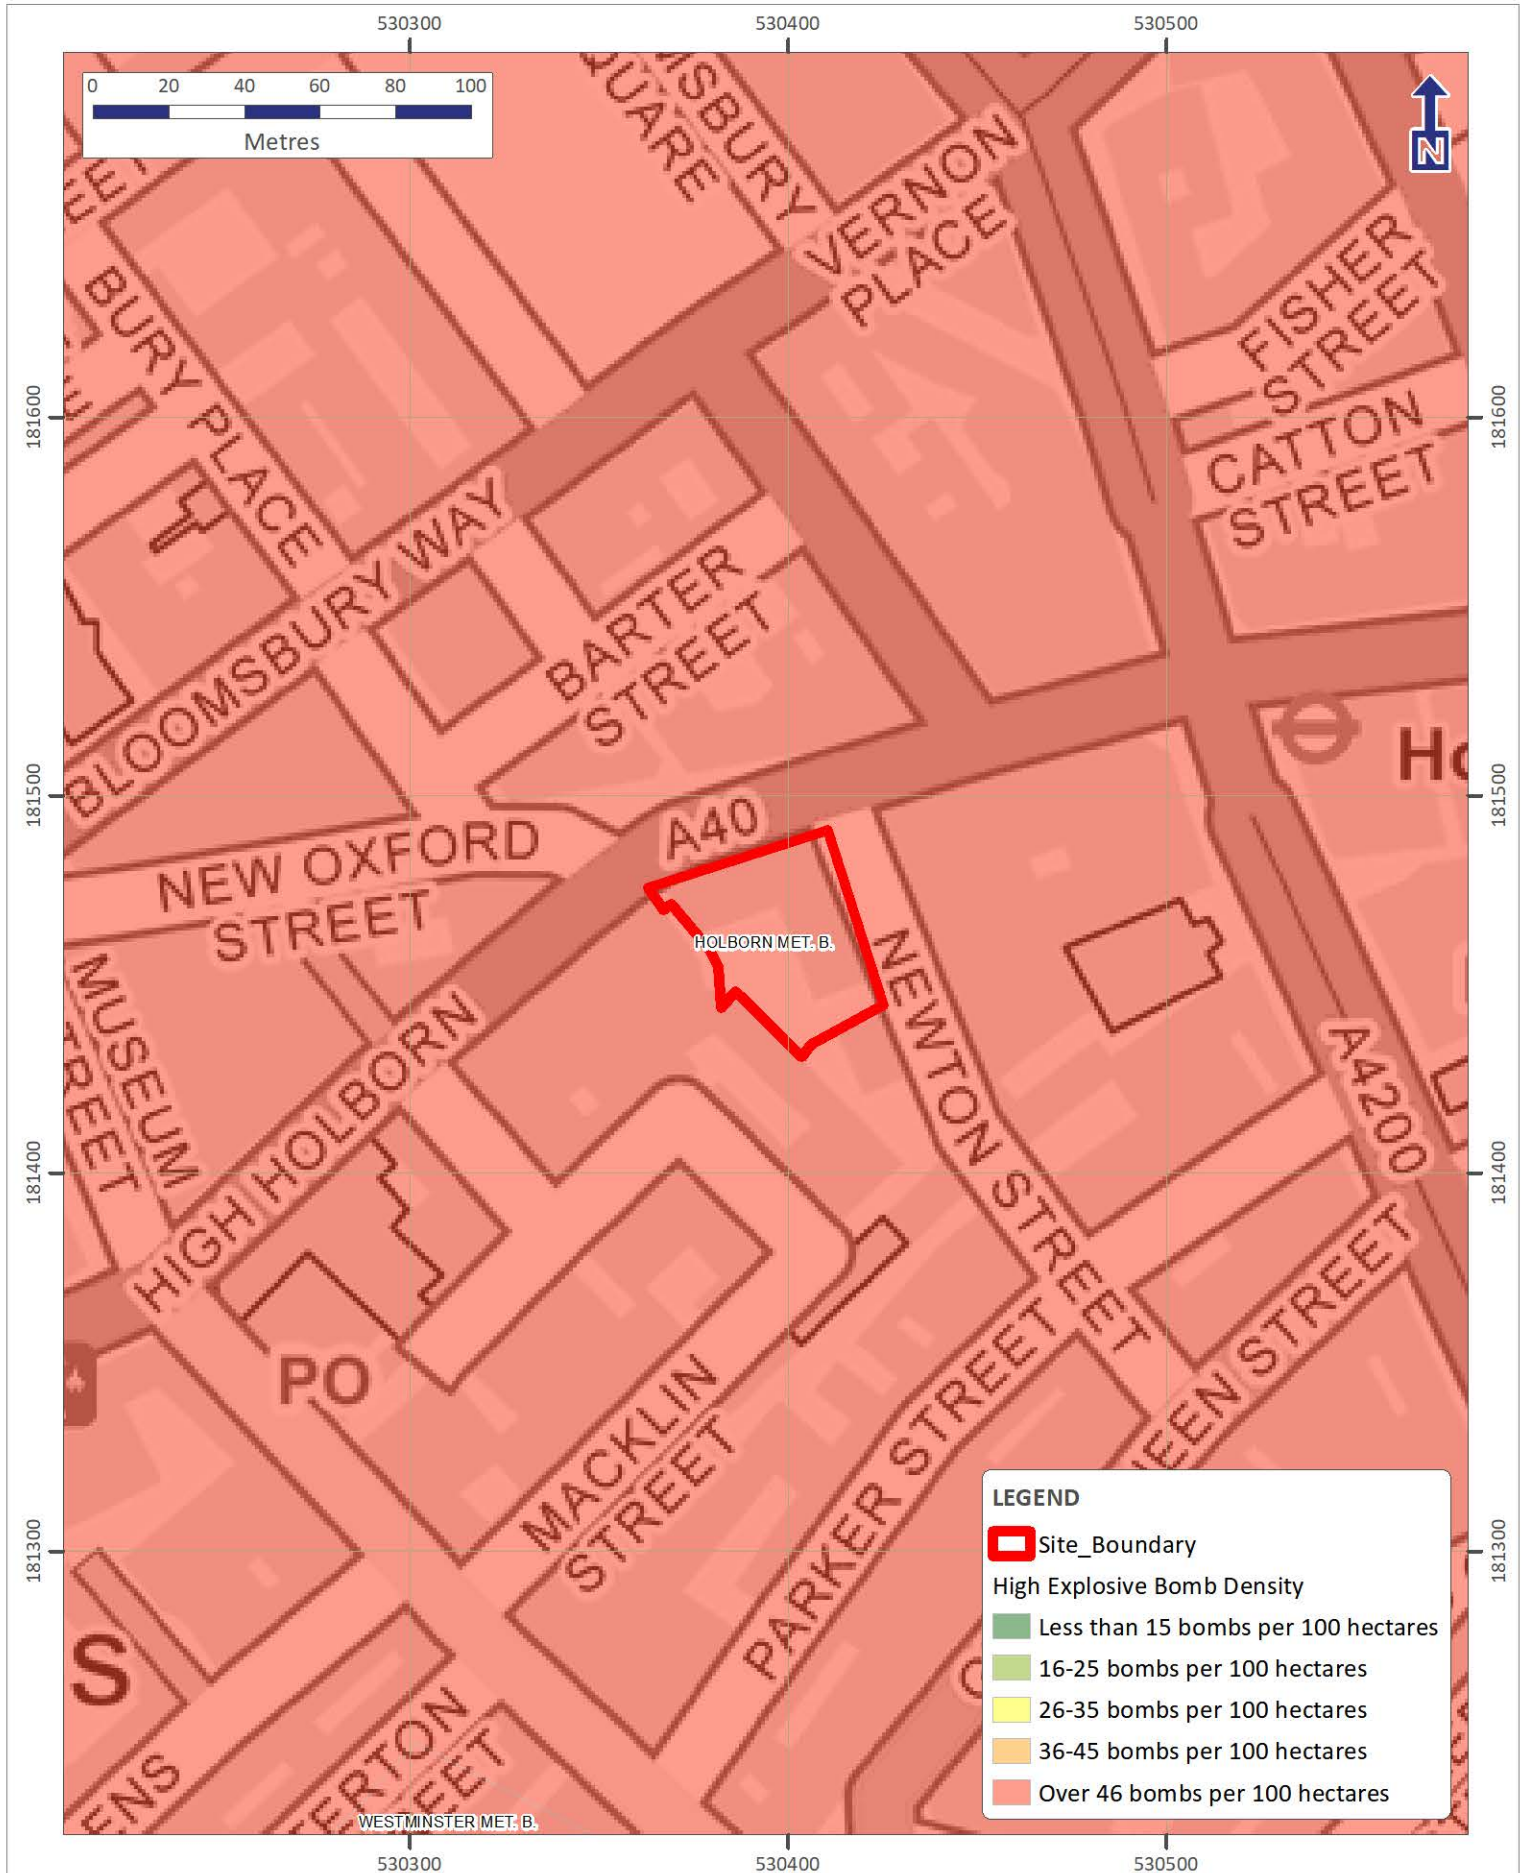
WWII High Explosive Bomb Density

The Study Site was located within the *Holborn Metropolitan Borough*, which recorded 216 HE bombs per 100 hectares, a very high level of bombing.

WWII HE Bomb Density (*Figure 8*)
