The Hoxton Holborn, Holborn  
199 – 206 High Holborn  
London  
WC1V 7BD

Interpretative Geotechnical Report

Ennismore Capital

January 2018

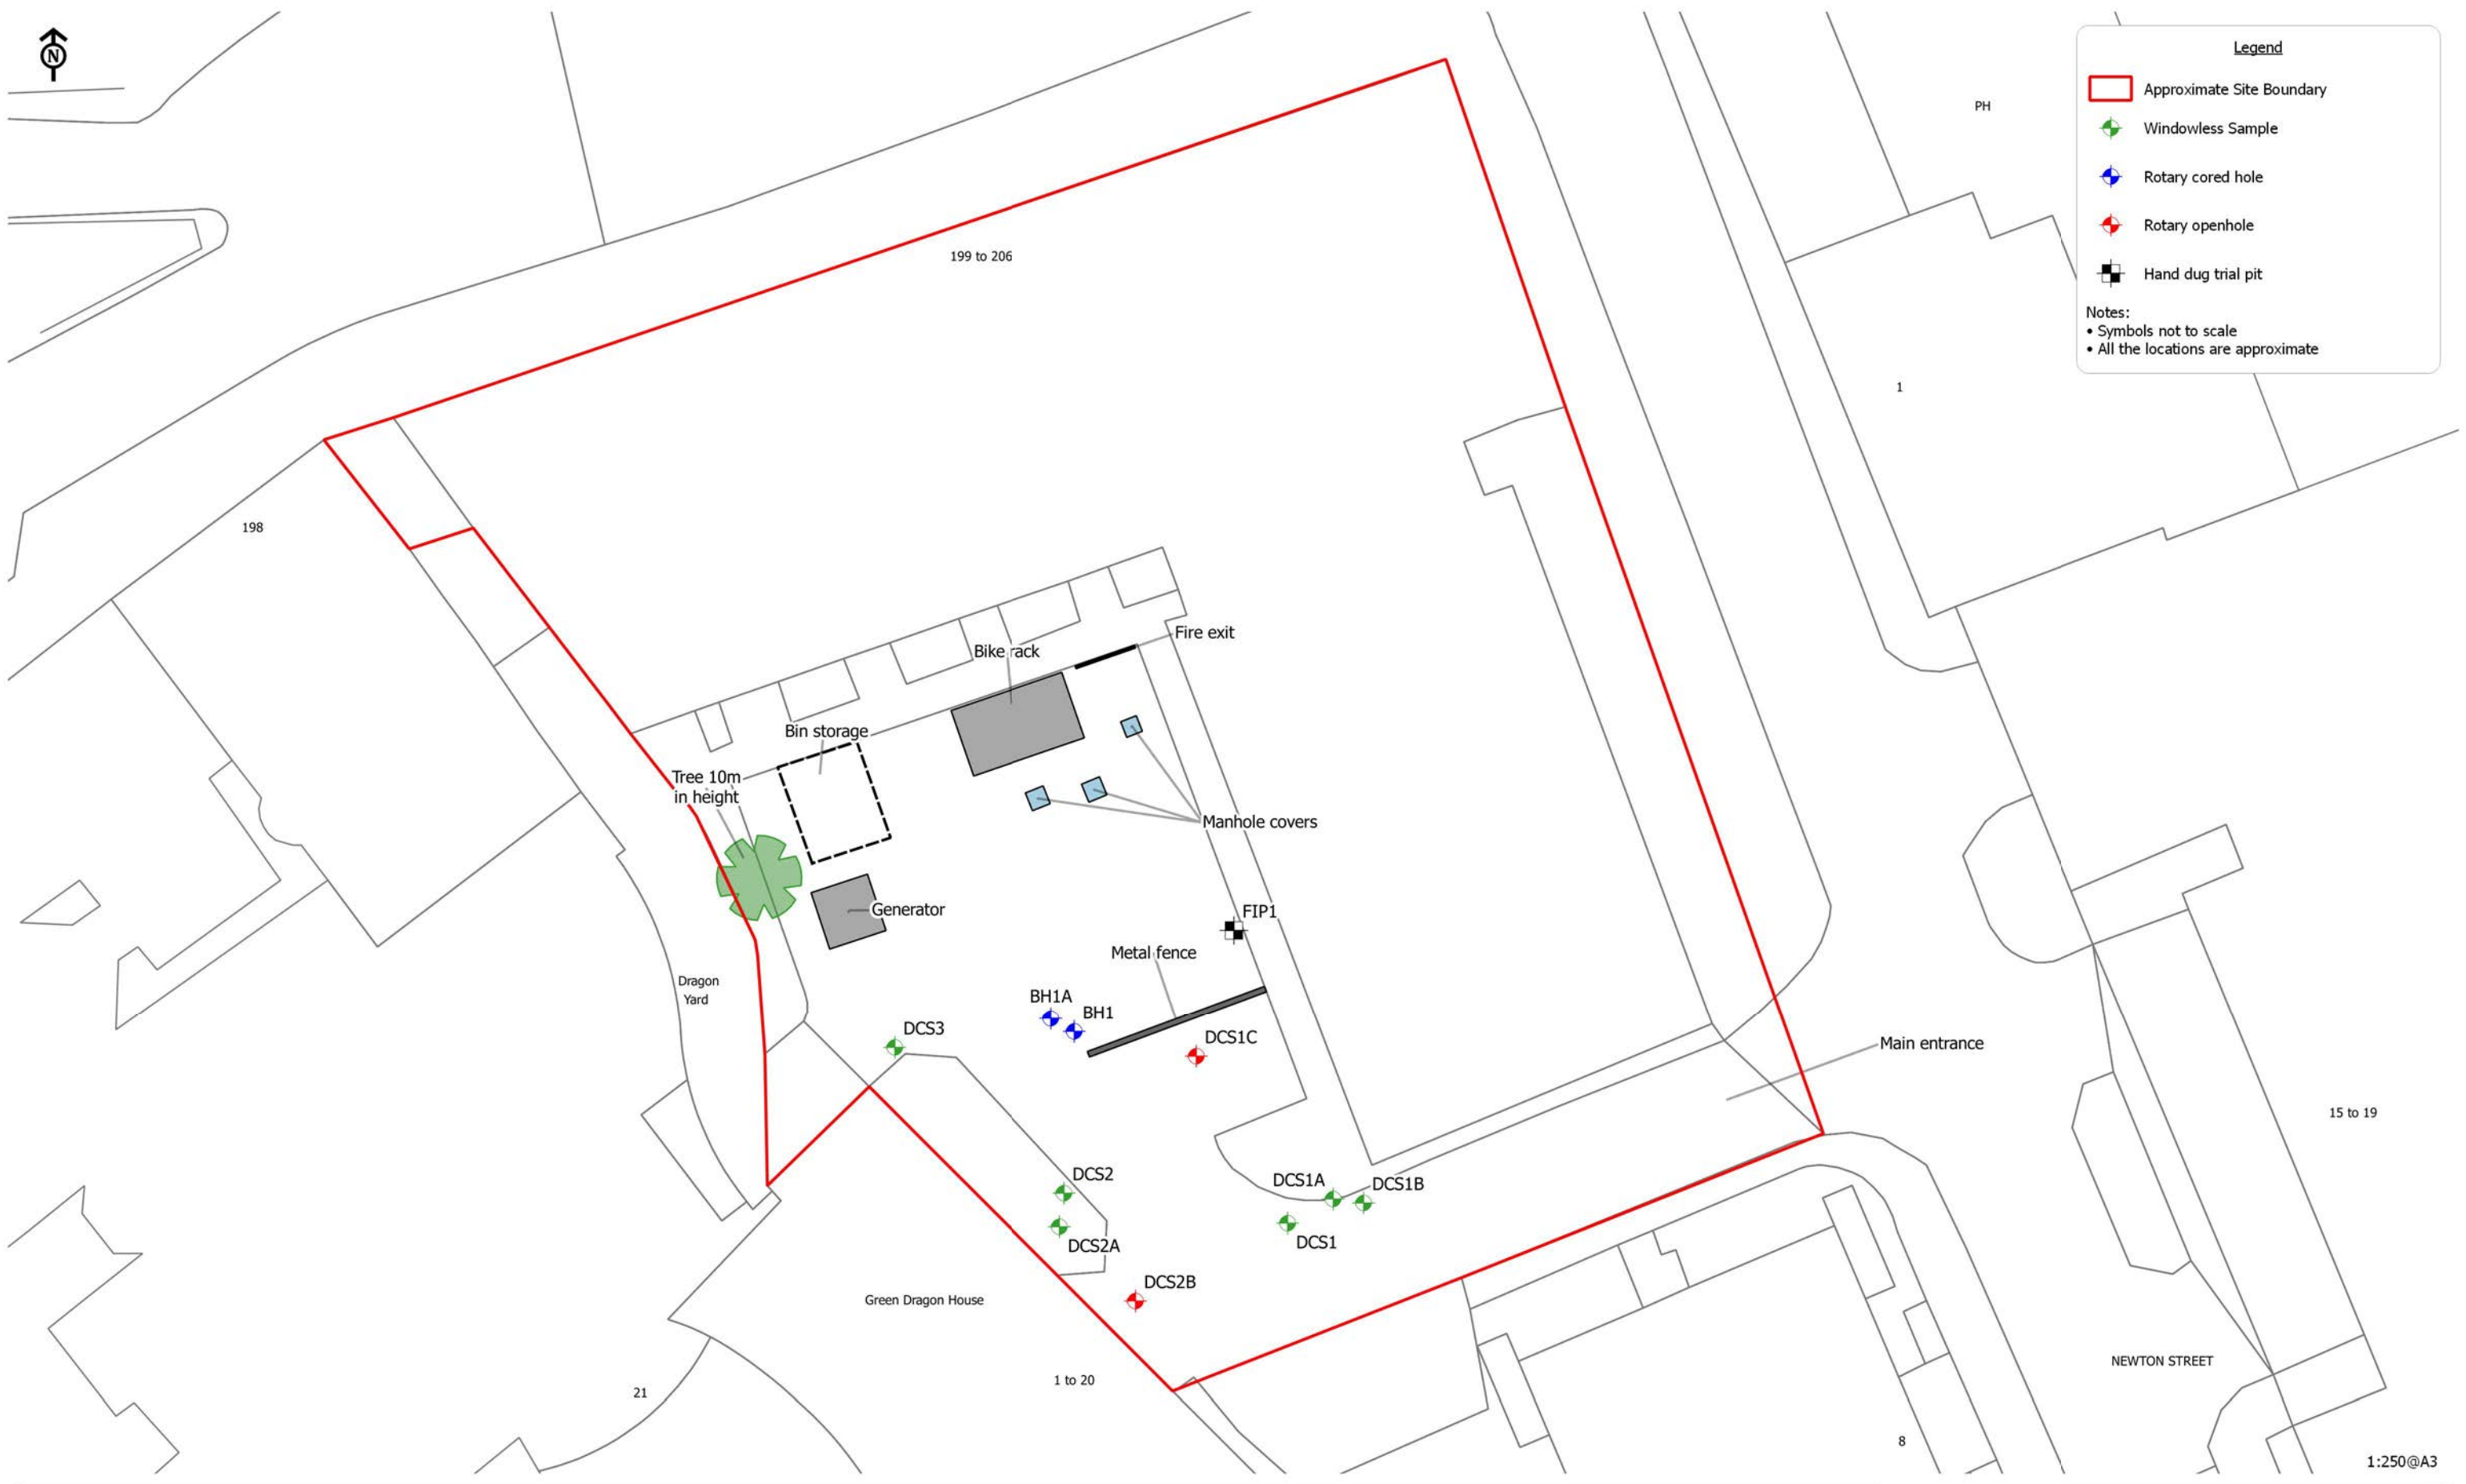
**Legend**

- Approximate Site Boundary
- ◆ Windowless Sample
- ◆ Rotary cored hole
- ◆ Rotary openhole
- Hand dug trial pit

- 1 no. rotary cored boreholes to a maximum depth of 40m bgl (BH1);
- 3 no. windowless sampling boreholes (DCS1 – DCS3);
- 1 no. foundation inspection pit.
