**GREAT ORMOND STREET HOSPITAL
P22 IMRI SUITE, LONDON**

**FACTUAL AND INTERPRETATIVE
REPORT ON GROUND INVESTIGATION**

Report No E8013-18-2

Carried out for:
Kier Construction Ltd
2 Langston Road,
Loughton,
Essex,
IG10 3SD

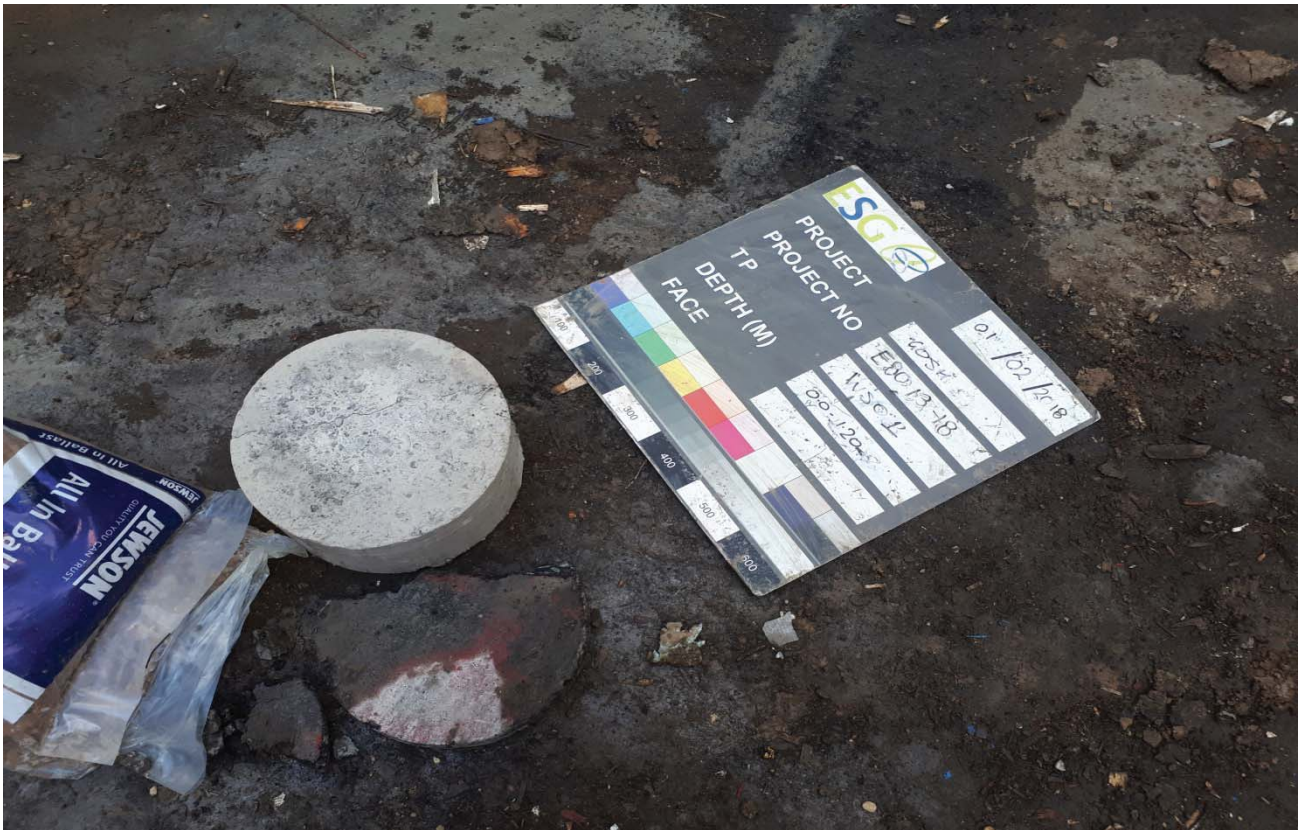
WS01 Concrete core

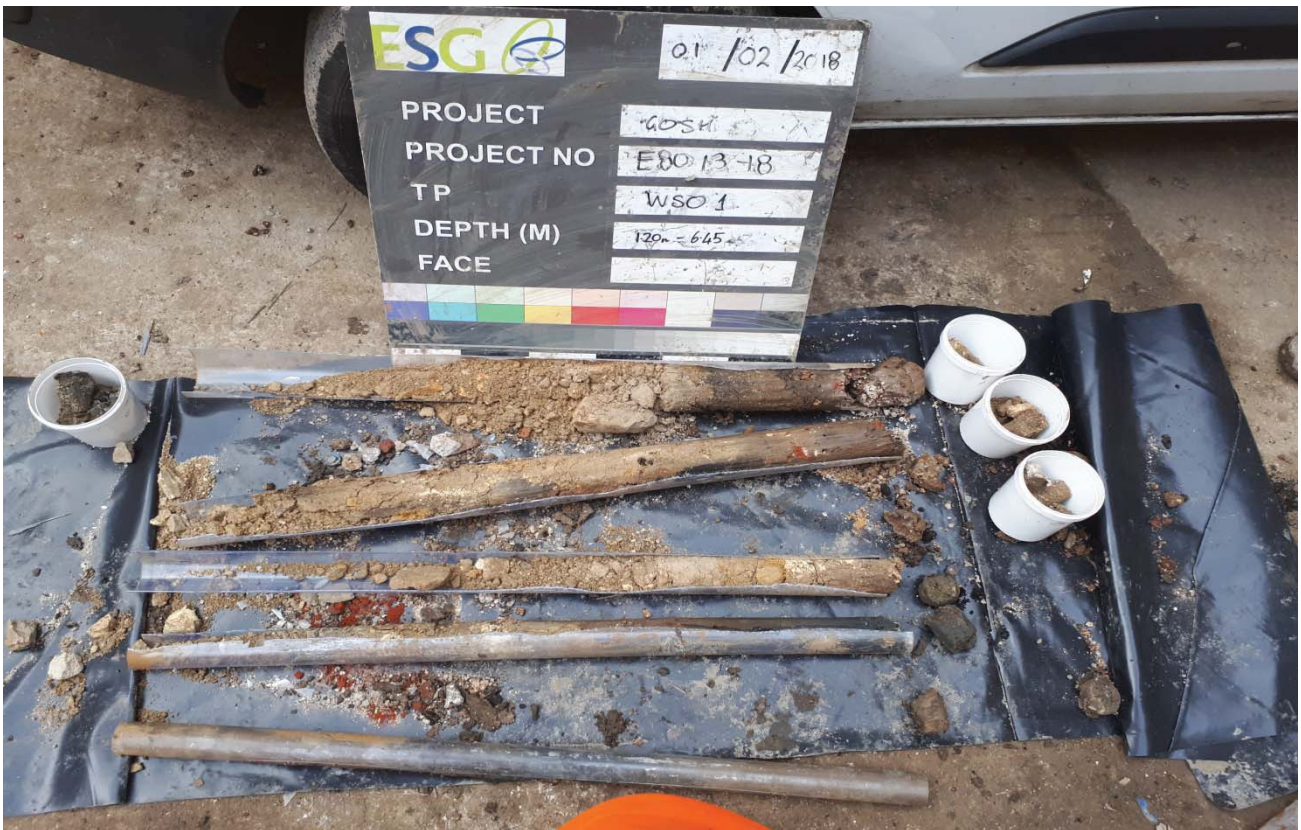
WS01 Dynamic Sample liners

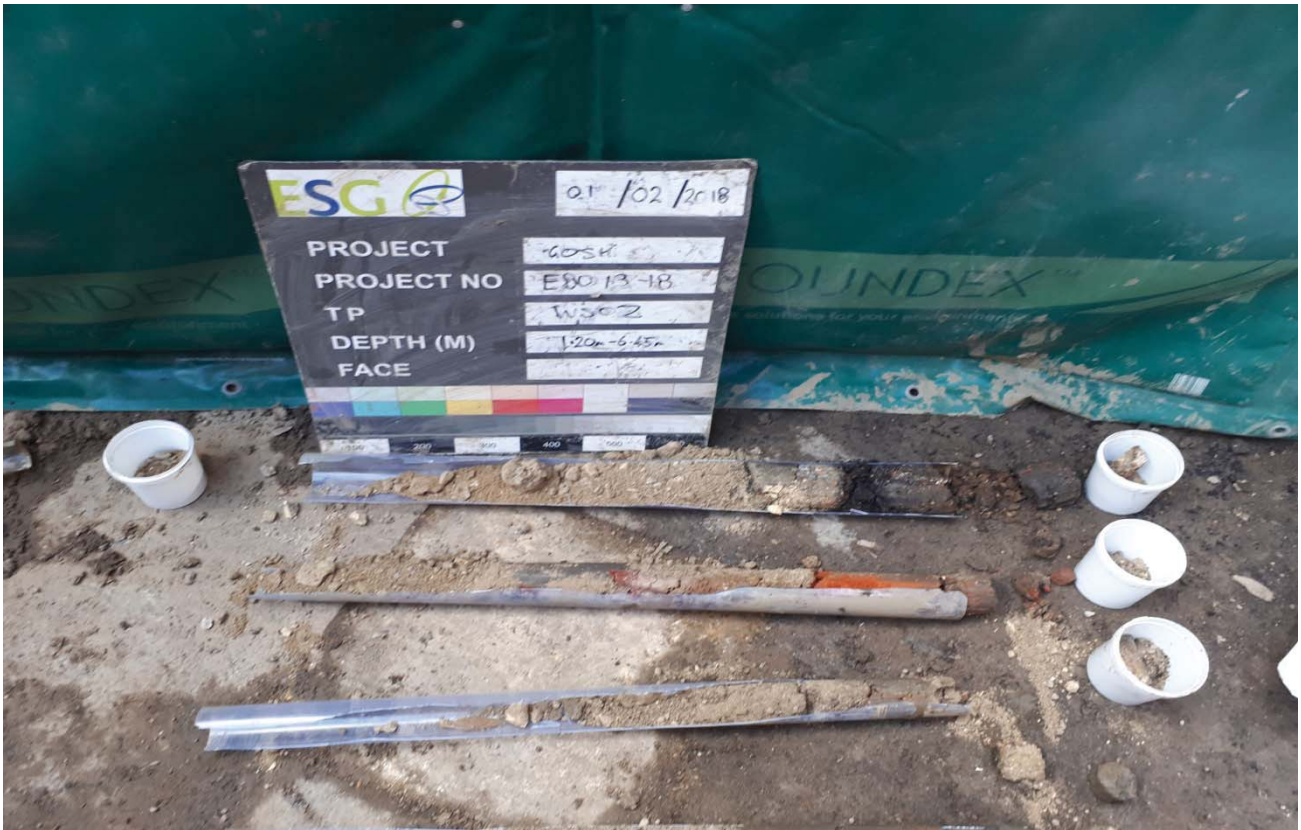
WS02 Dynamic Sample liners

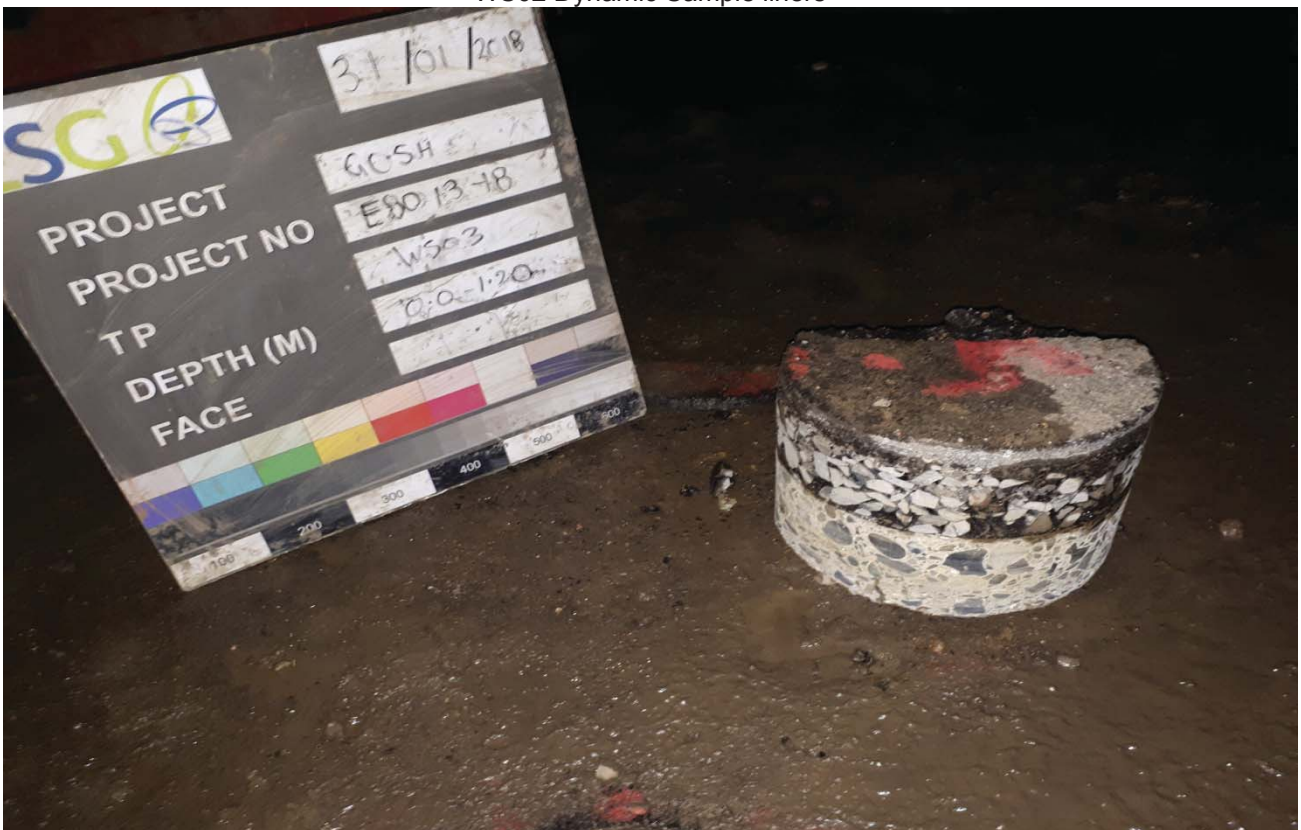
WS03 Concrete Core

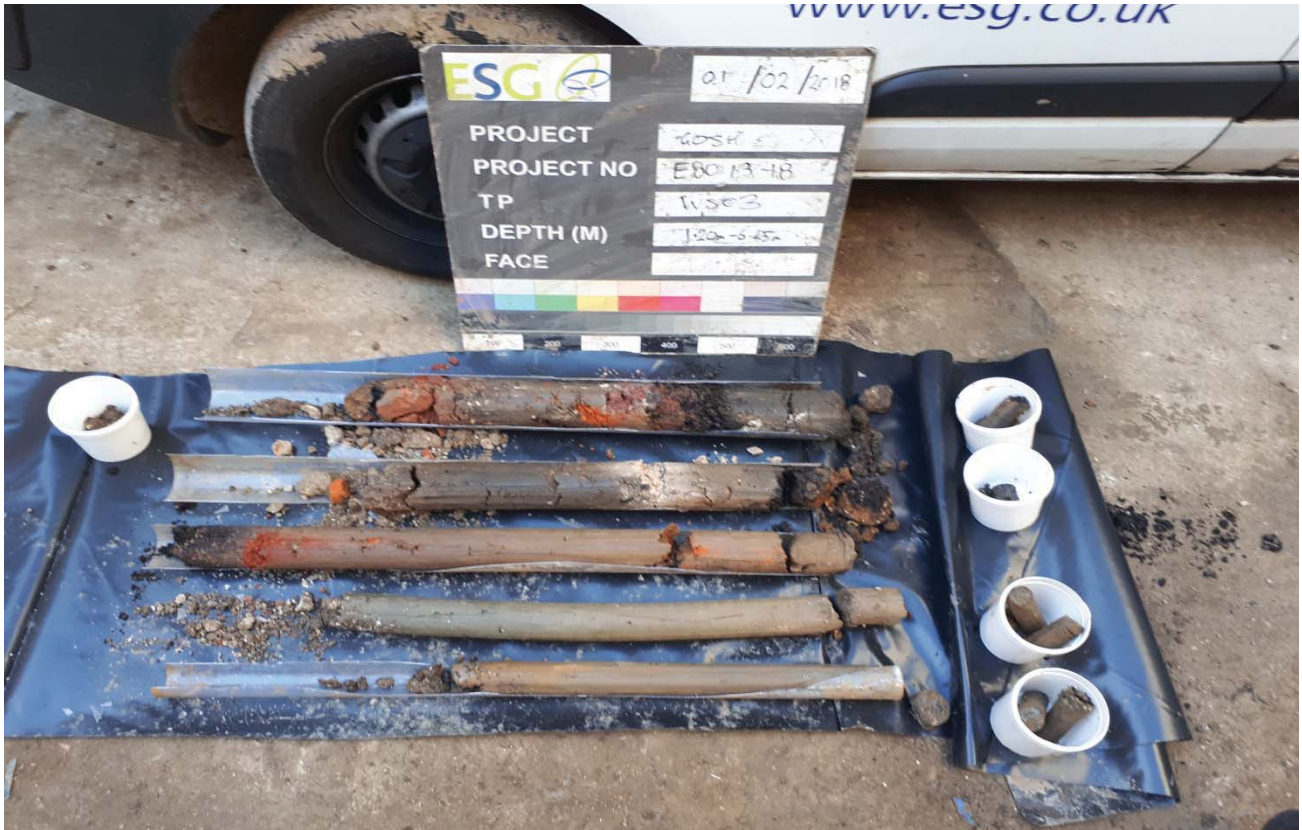
WS03 Dynamic Sample liners

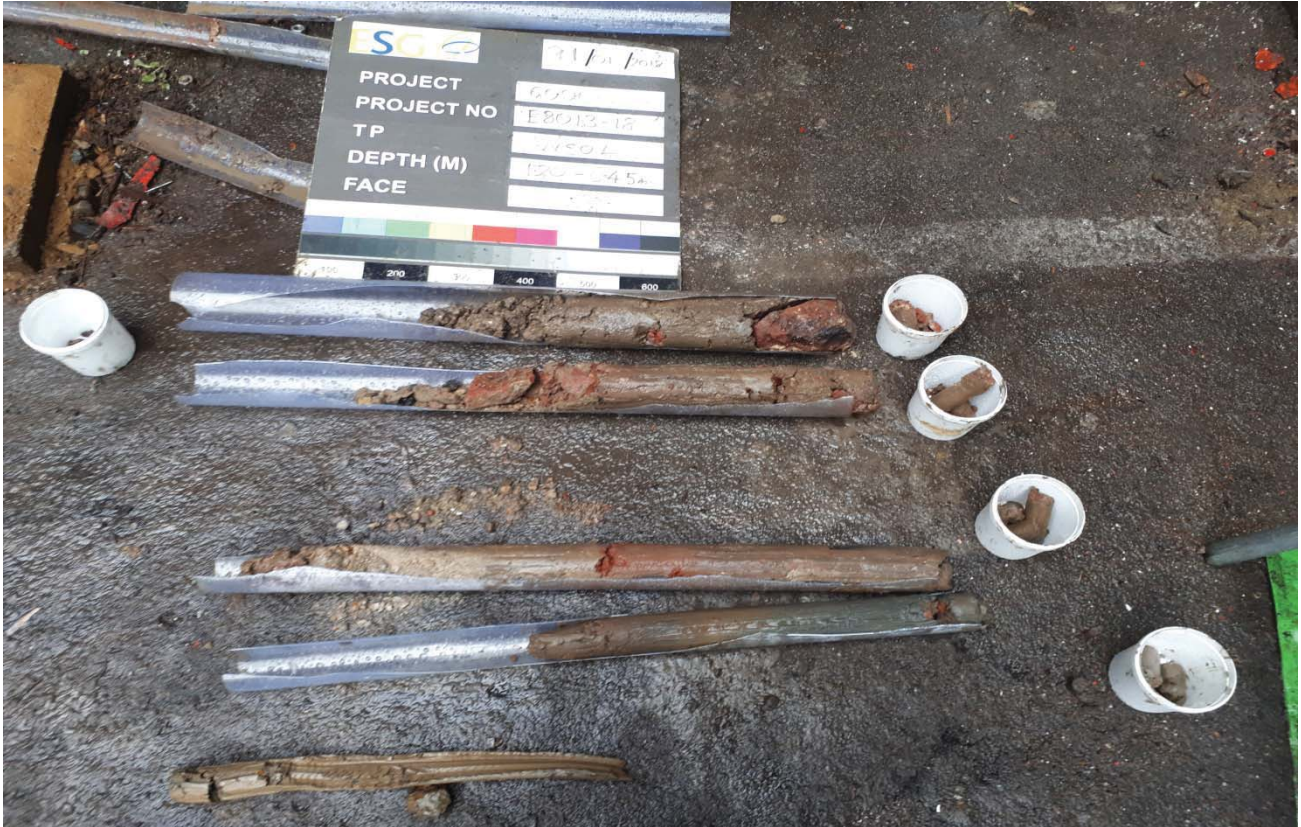
WS04 Dynamic Sample liners

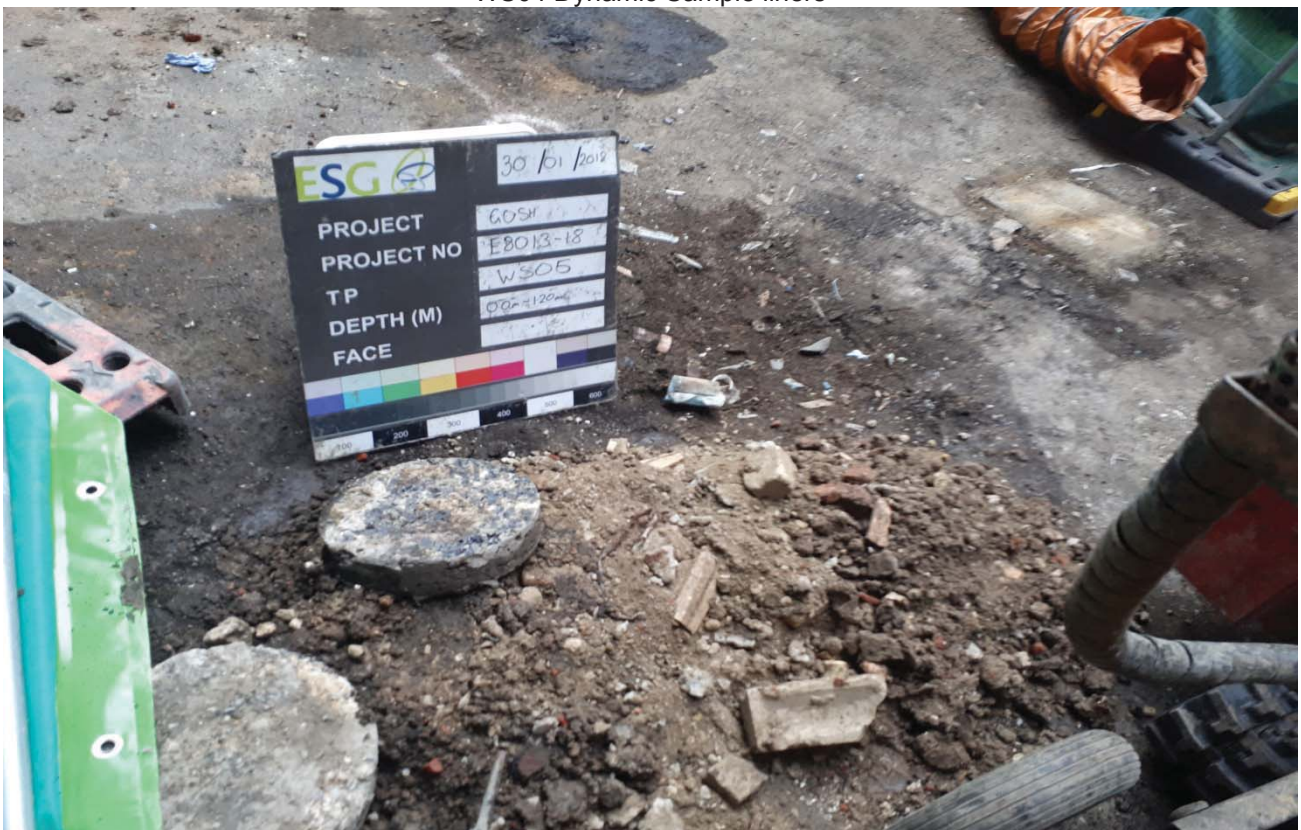
WS05 Concrete Core

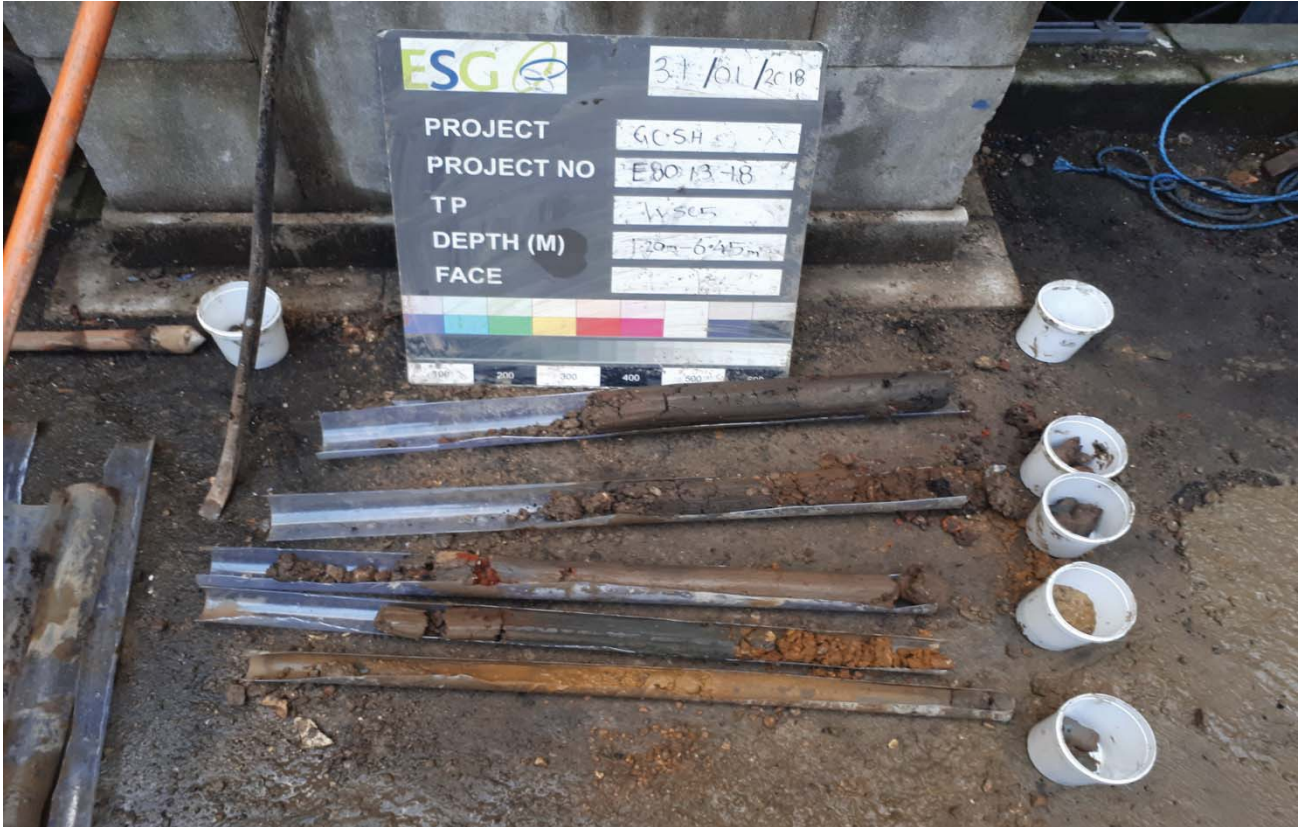
WS05 Dynamic Sample liners

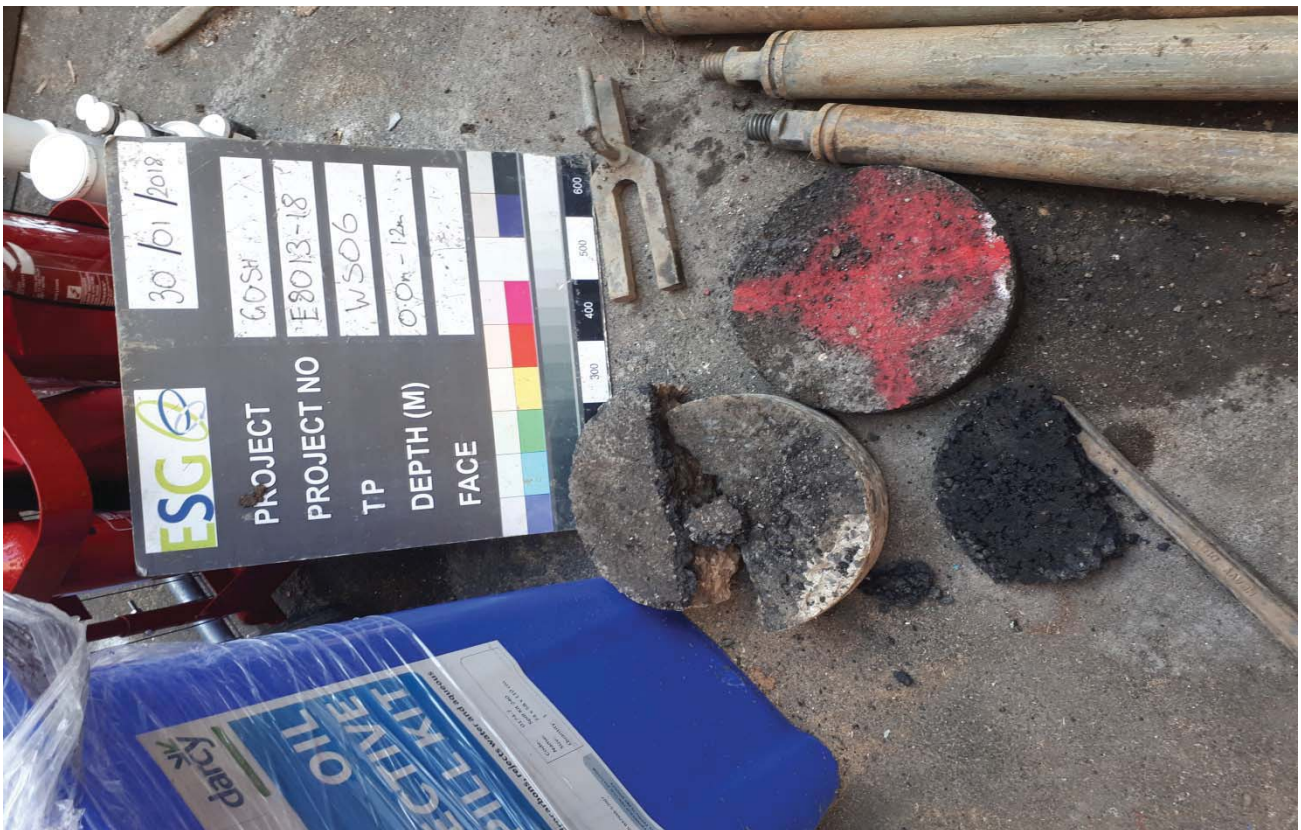
WS06 Concrete core

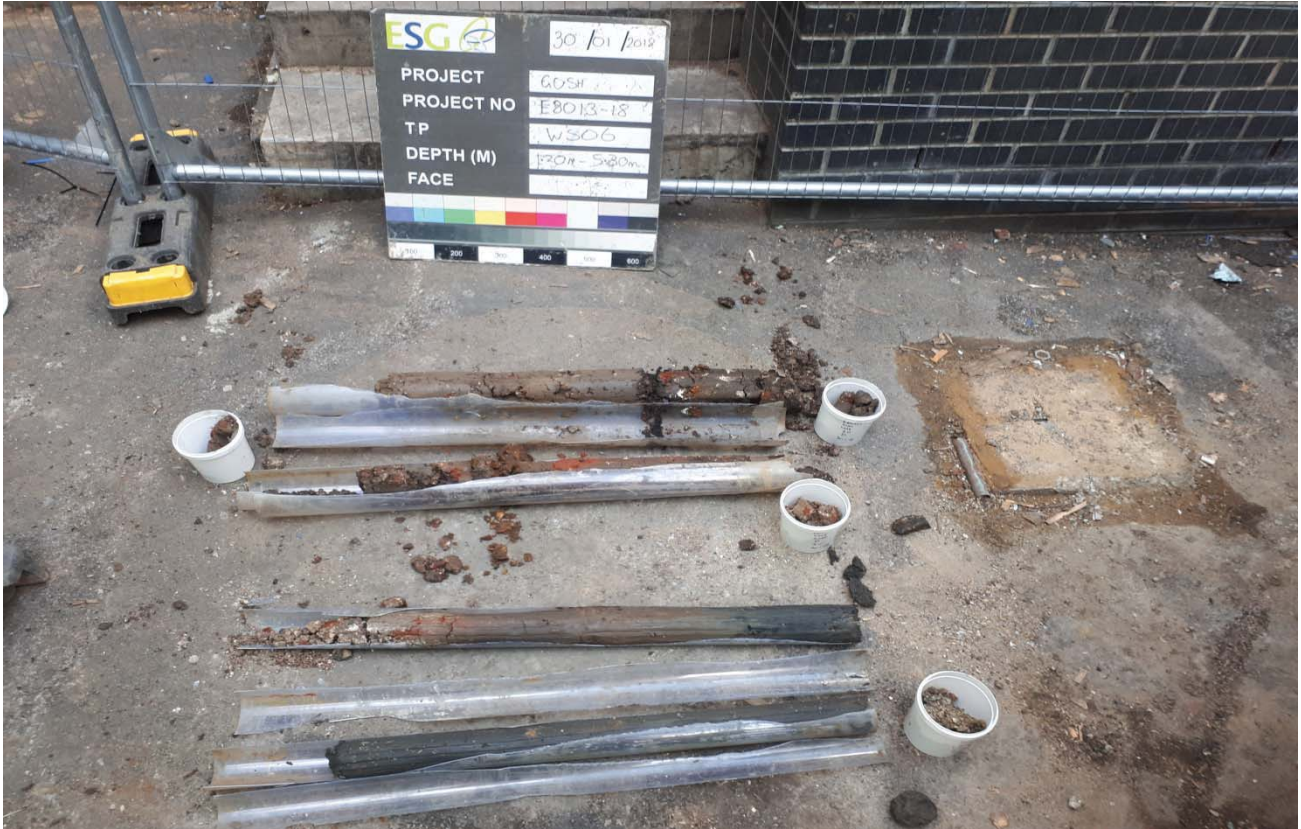
WS06 Dynamic Sample liners
