Special Features - Ornamental Roof Trusses

Demolition

The Vicarage Basement

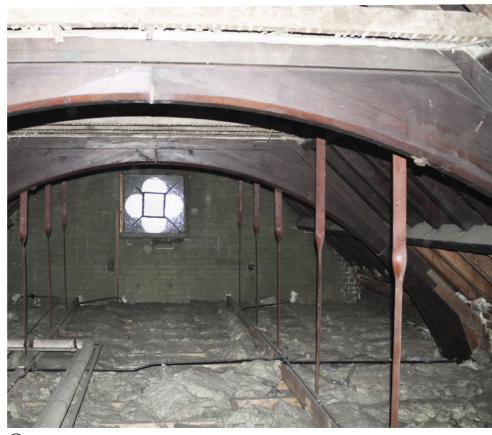
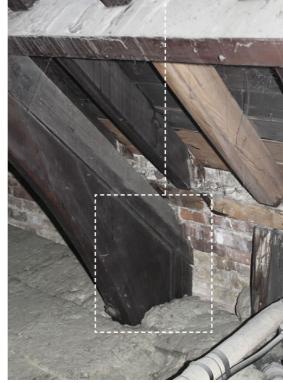
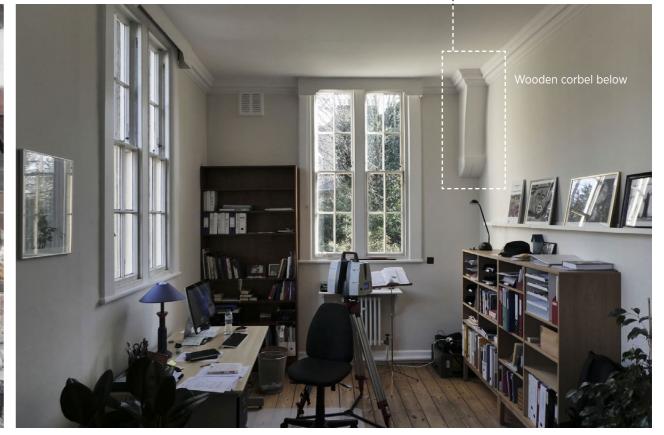
4 Existing wooden roof trusses and rose window in roof attic

Truss connection to brick wall

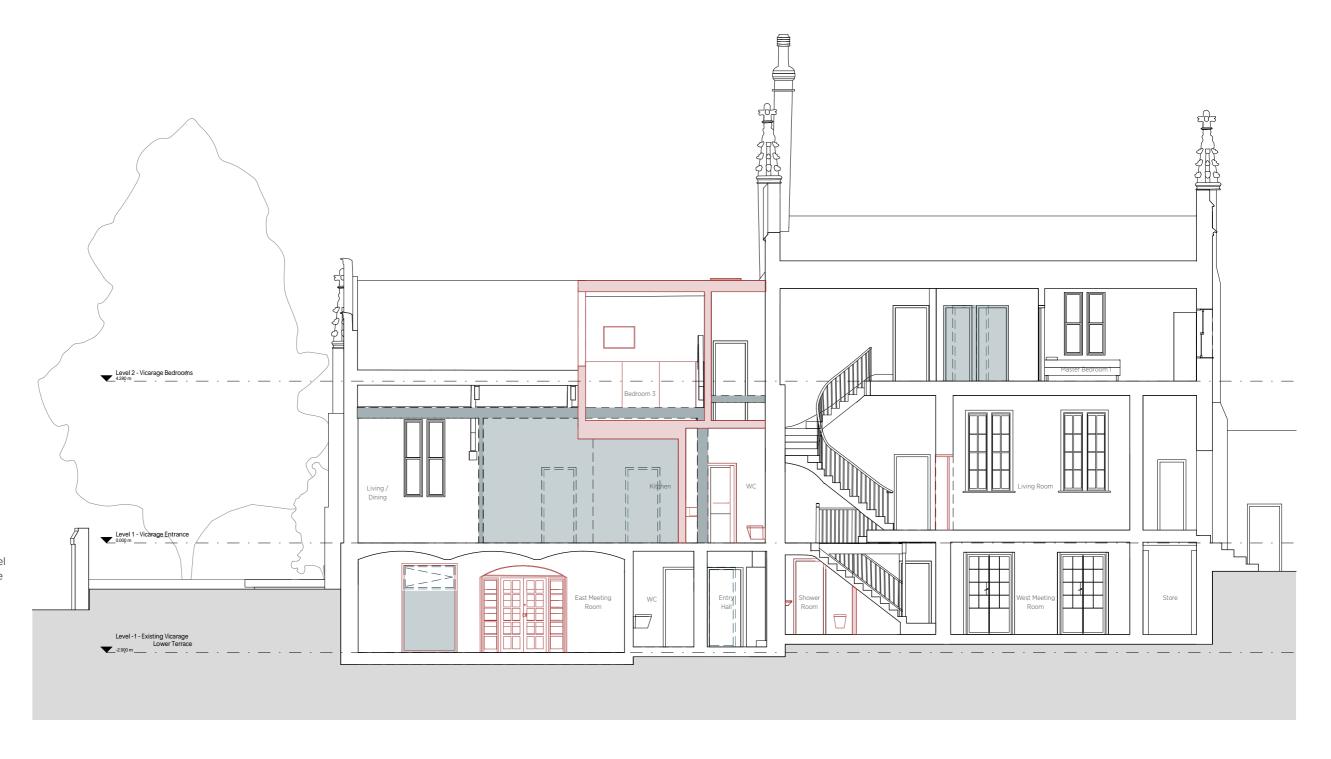
The Vicarage Section C-C

Remove suspended ceiling to reinstate and reveal ornamental wooden trusses in the kitchen and dining space;

Lower window at basement level to create greater connection the terrace and garden.

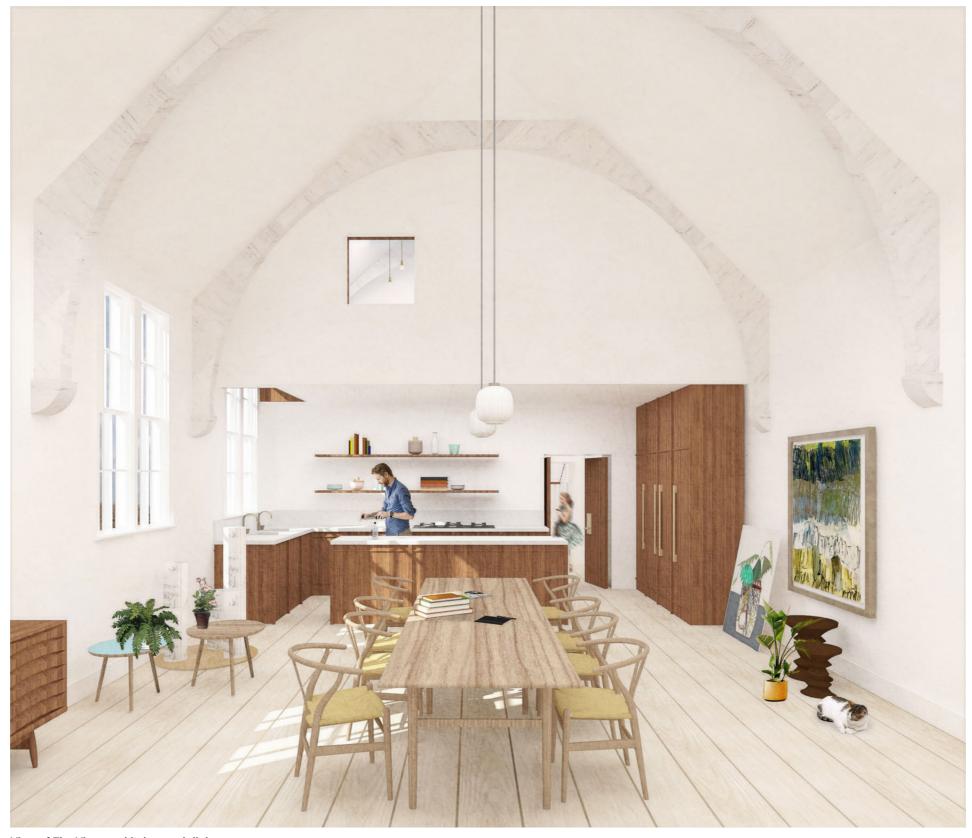
The Vicarage Indicative View

View of The Vicarage kitchen and dining area

Double-height space and wooden trusses reinstated

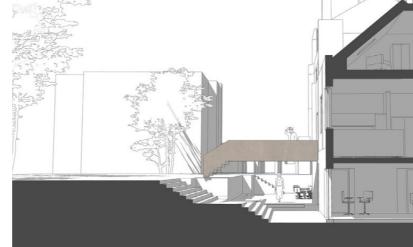
Option 2

- As previously, creates an exhaustive journey to the sunken terraces;
- The bridge entrance to the Vicarage spans a great distance would need extra structural support

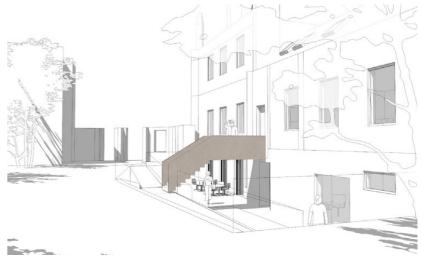
Option 3

- Ramps are overpowering and take up majority of the terrace space;
- You must walk down the ramp or steps before going up the Vicarage steps
- Much of the terrace space is not useable space;
