**FAO Camden Borough Council Planning Department**

**Representations regarding planning application 2018/1696/P**

**Flat 5  
61 Leighton Road  
NW5 2QH**

**2018/1696/P Representations – Annex**

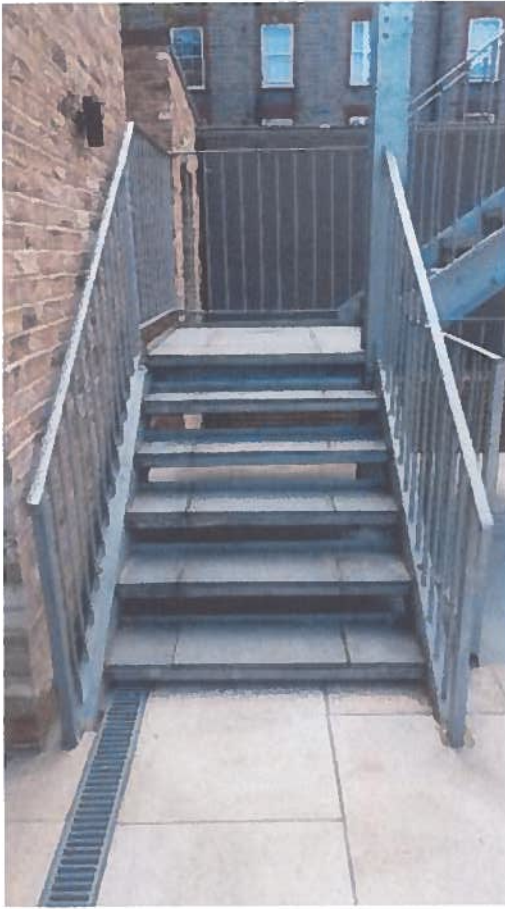
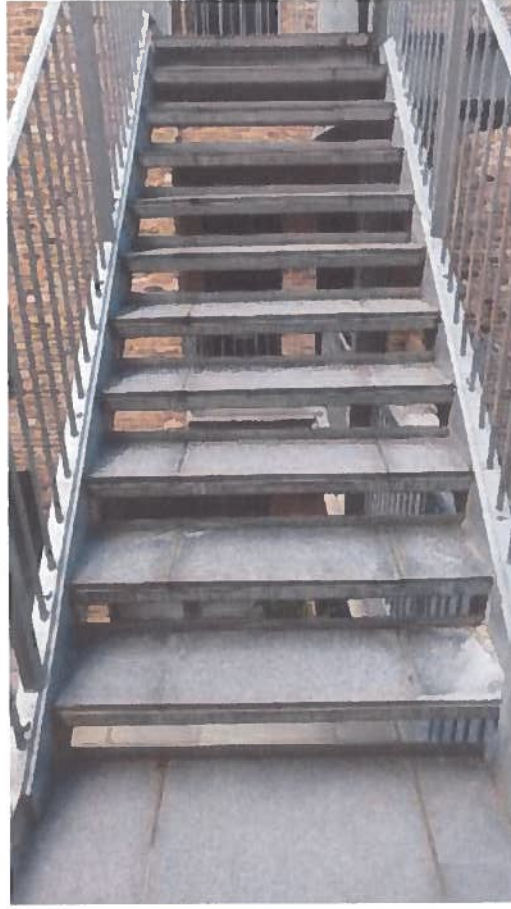
The built staircase.

The two flights are 6 and 11 steps instead of 9 and 9. The finish is uncoated galvanised steel. Safety rods not in evidence.

What has actually been built is 6 steps west + 11 steps north.

What has actually been built is uncoated galvanised steel. Obviously this is a much less attractive finish than is described in the plans, is inconsistent with the finish used on other metal surfaces in the development, and creates an unfinished “industrial” feel.

Drawing P-14-1 (top right) shows the presence of 20mm safety rods, which have not been included in the built staircase.

- Correct the finish of the existing staircase to meet that specified in the drawings, namely PPC RAL9011;
- Submit for approval drawings of the subsequent extension of the staircase to provide evidence that the extended staircase will be built in such a way as to minimise the impact on the view from existing dwellings in the back block;
- Take up and re-lay the paving in such a way that it is properly waterproofed and doesn't present a future safety issue;
- Properly box in and protect the electrical cables.

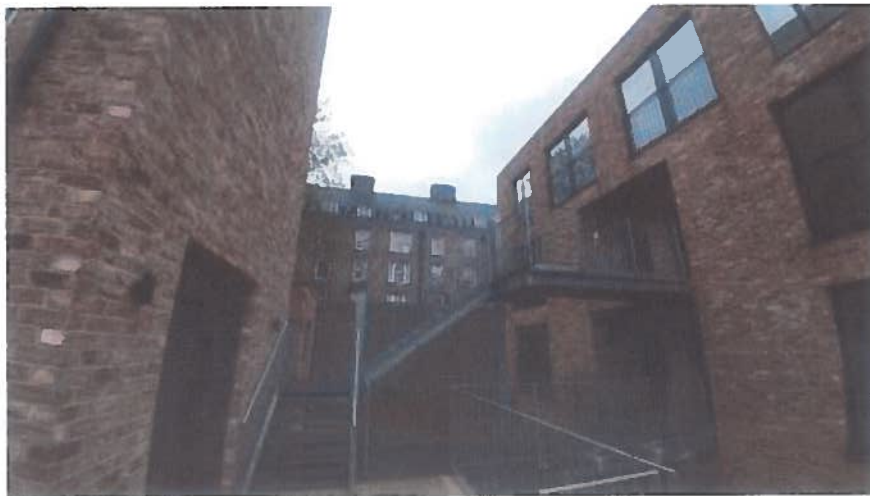
Illustrating the degree to which the staircase, when extended, will dominate the view from the maisonettes.

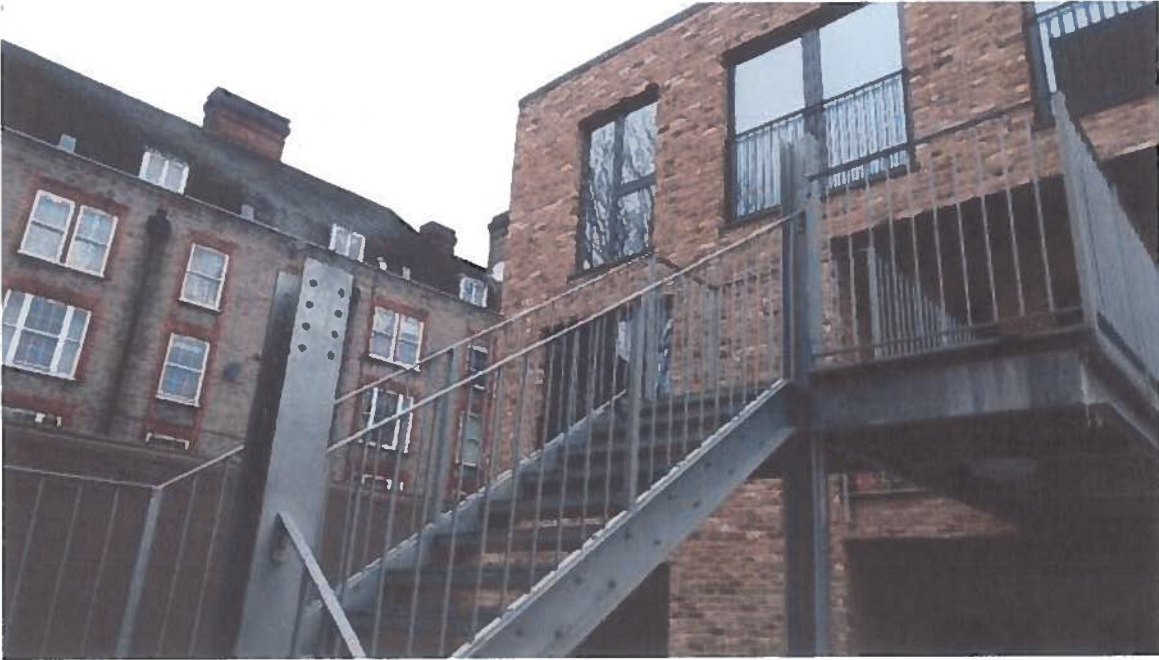
**“Industrial” finish (or unfinished?)**

**Does anyone really want another four flights plus a landing that looks like this??**

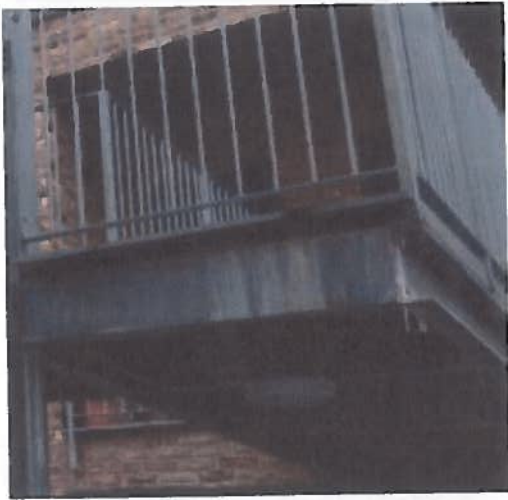
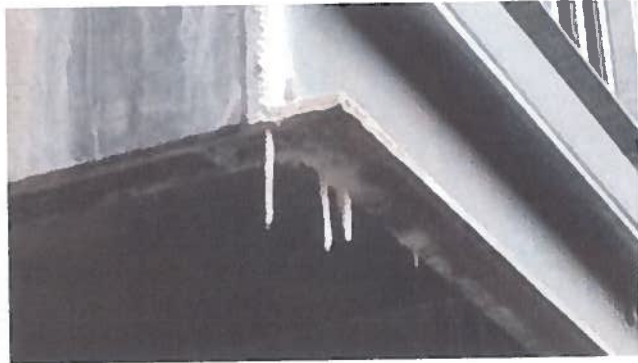
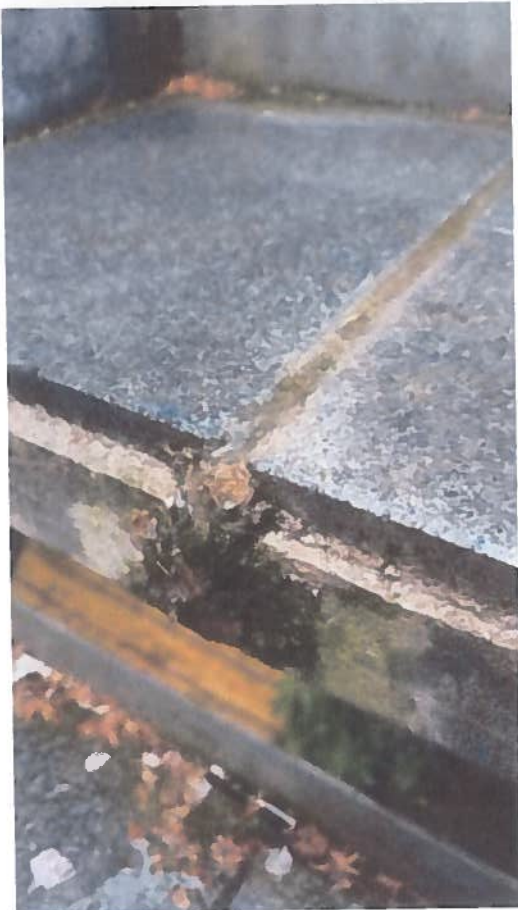
There are issues of quality and safety with the current state of the staircase. It appears to have been constructed with the paving bedded into sand and cement rather than a waterproof epoxy. The additional failure to use any kind of waterproof grouting has resulted in the cement leaching out of

the render. This can clearly be seen in the formation of streaking and “stalactites” and has already resulted (after less than two years) in some of the paving becoming loose. As this situation continues to deteriorate, the staircase will become increasingly hazardous.

Streaking and stalactites caused by leaching.

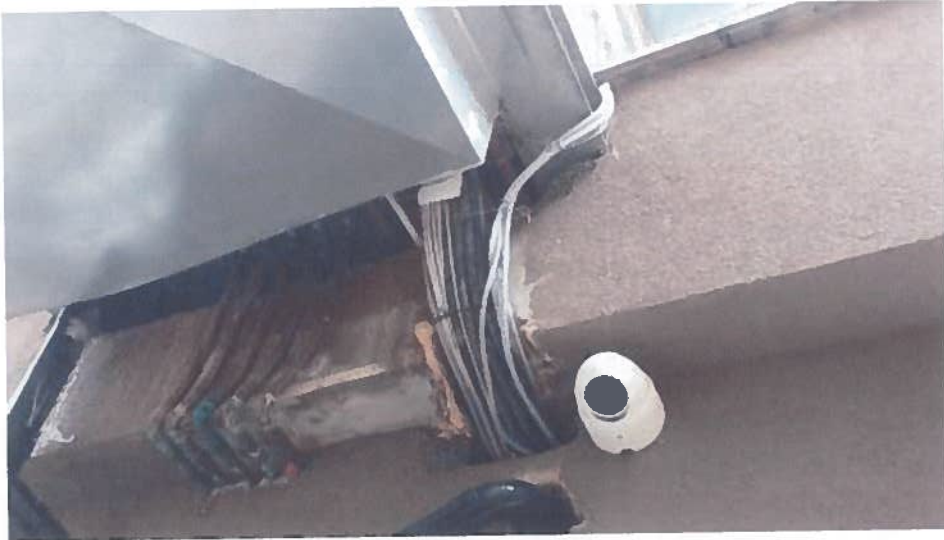
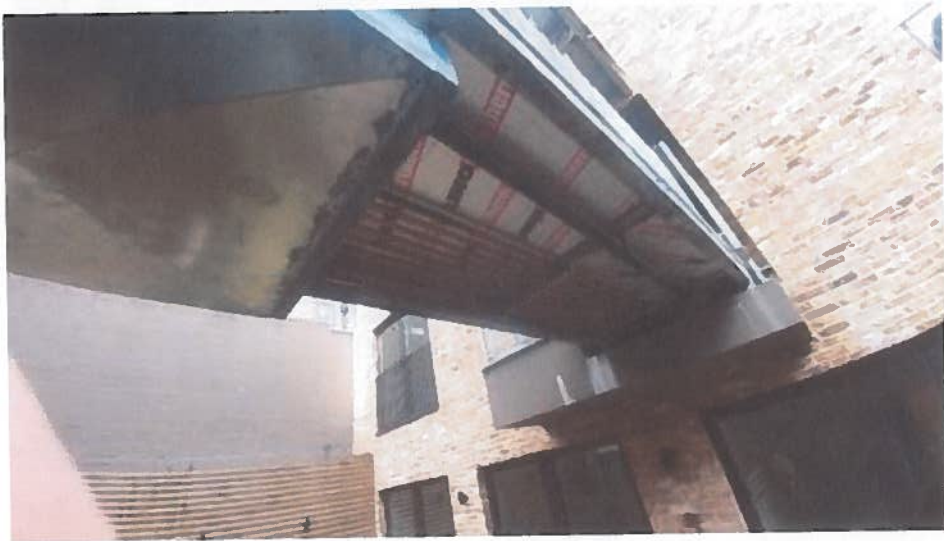
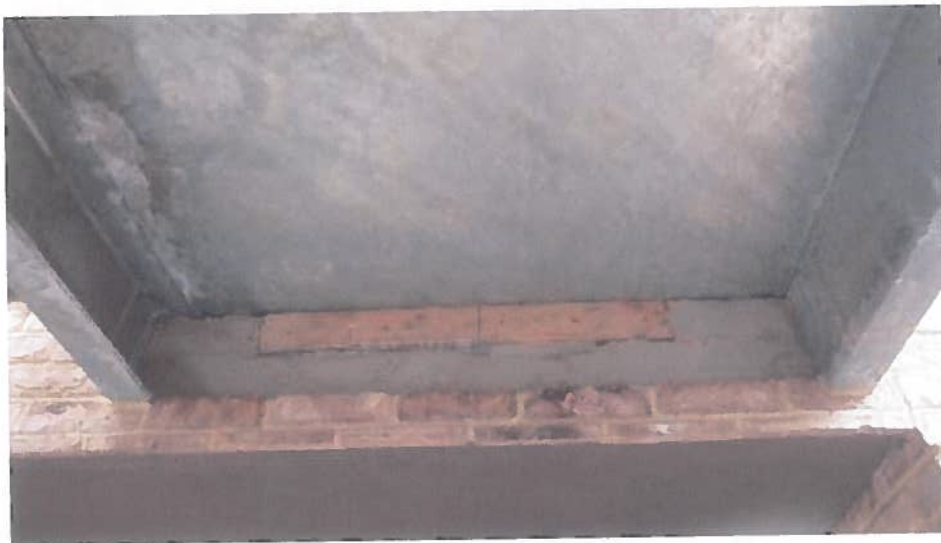
Another failure of quality and potential safety issue is the electric lighting cable which in some places has just been taped onto the staircase (which of course is made of metal!) and left exposed to the elements.

Unboxed cables, unlagged pipes, unprotected wood.

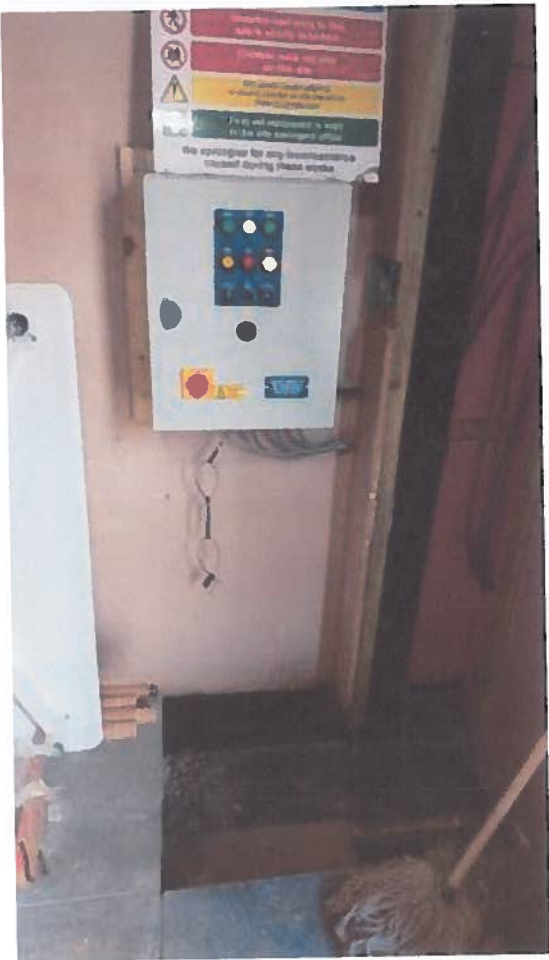
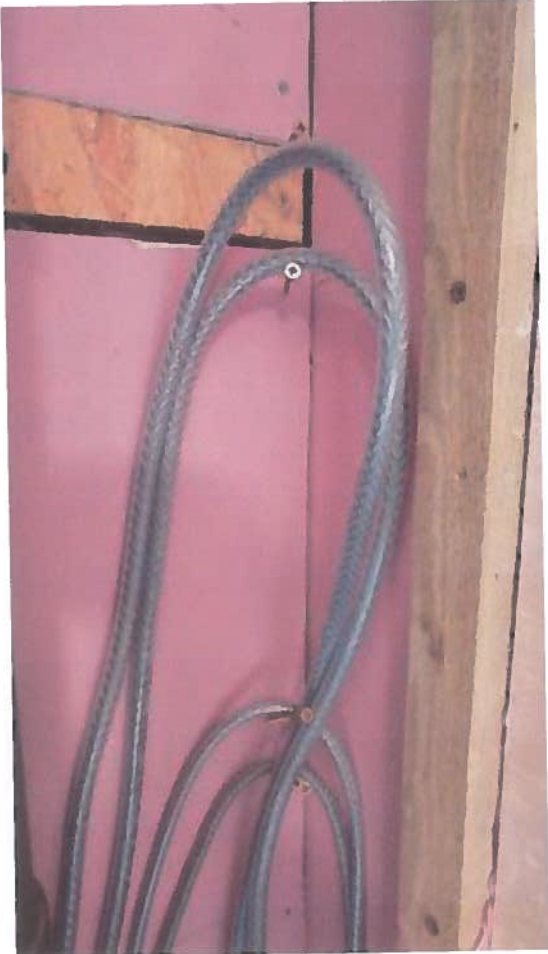
- 2013/1614/P condition 7 (Cycle store to be operational before residential occupancy). Thanks largely to the efforts of the council, racking has recently been installed in the cycle store. However, it remains unpainted, with a hole in the floor and unboxed high voltage cables hanging off screws. It therefore cannot be described as “completed”, and the developer should be required to rectify this breach before being granted permission.

Hole in the floor, unboxed high voltage cables hanging on screws.

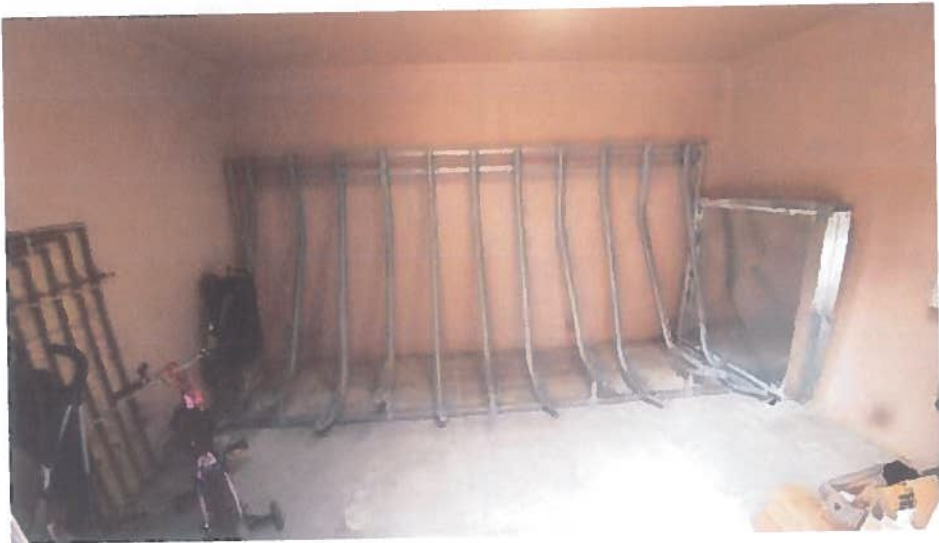
Unpainted, racking not screwed to wall.

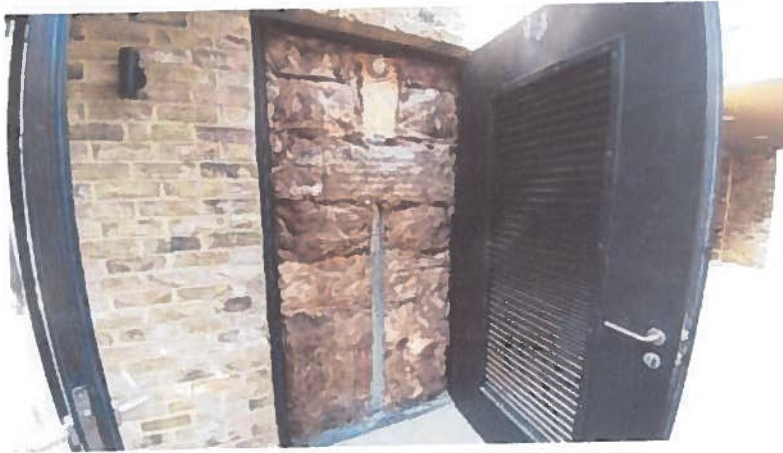
- 2013/1614/P condition 6 (Details of waste storage). The plans submitted by the developer with this application – specifically *T 1 482 101 J proposed ground floor plan* – show an enclosure designated as the “office refuse store”. This was in fact converted – by the developer himself – into a toilet. The commercial unit has since been sharing the residential refuse store, having no replacement facility of its own, and doesn't even seem to have its own refuse bins (for which there is barely space in any case). In parallel with this reduction in overall refuse capacity, the developer has been making his application for permission to increase the number of residential units and the consequent residential refuse requirements. With the development at only 50% of potential occupancy, it is not at all clear that sufficient refuse capacity exists. The developer should be required to rectify this breach, or at least submit new calculations demonstrating that sufficient capacity exists, before being granted permission.

Where the office's refuse store should be, according to the plans.

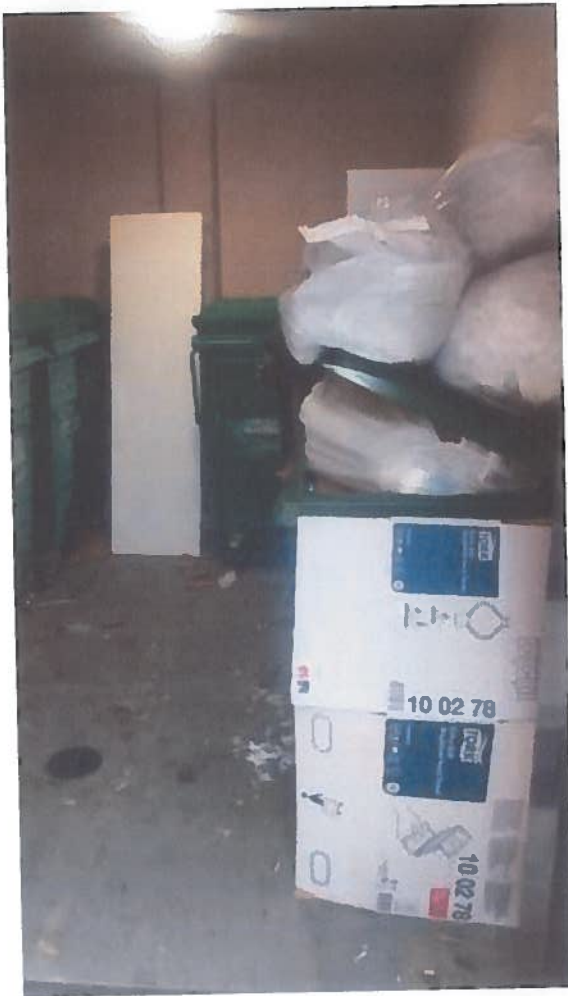
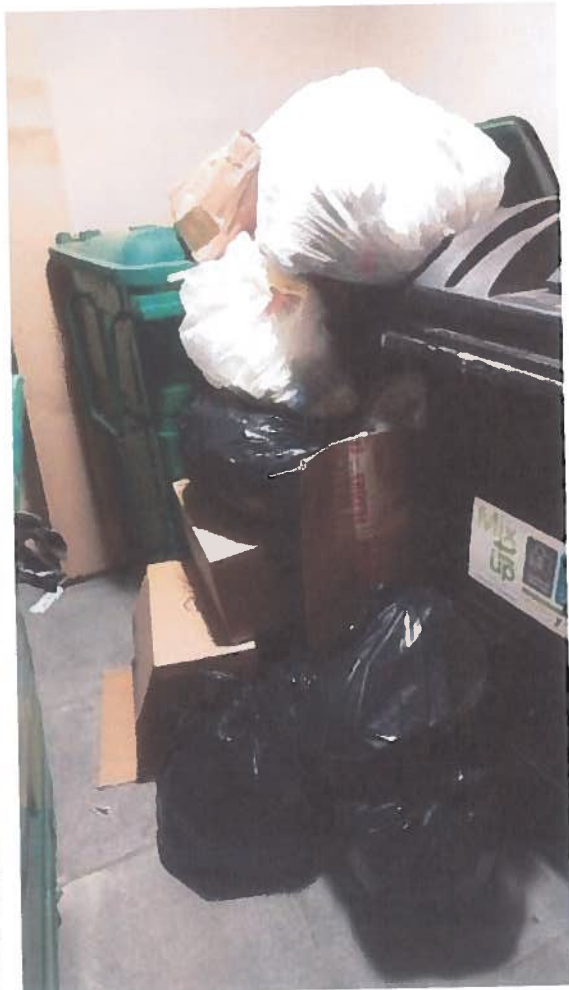
Commercial waste sometimes requires significant space. Black sacks on floor because office doesn't have a refuse bin of its own.

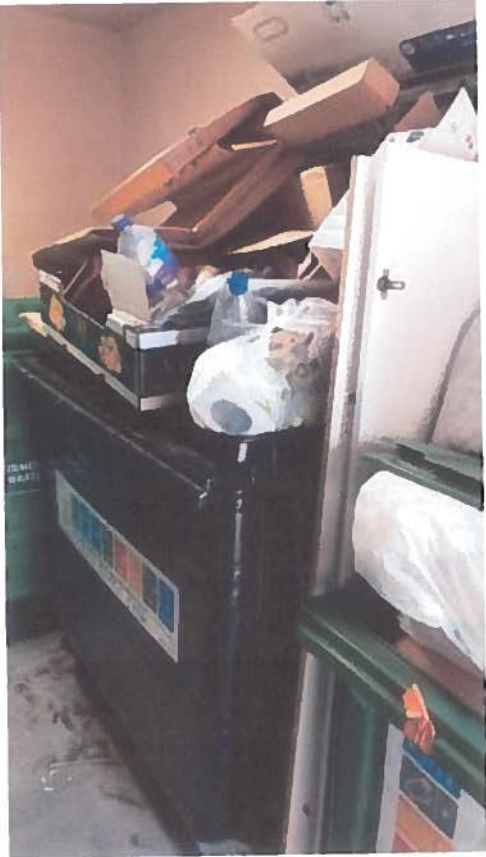
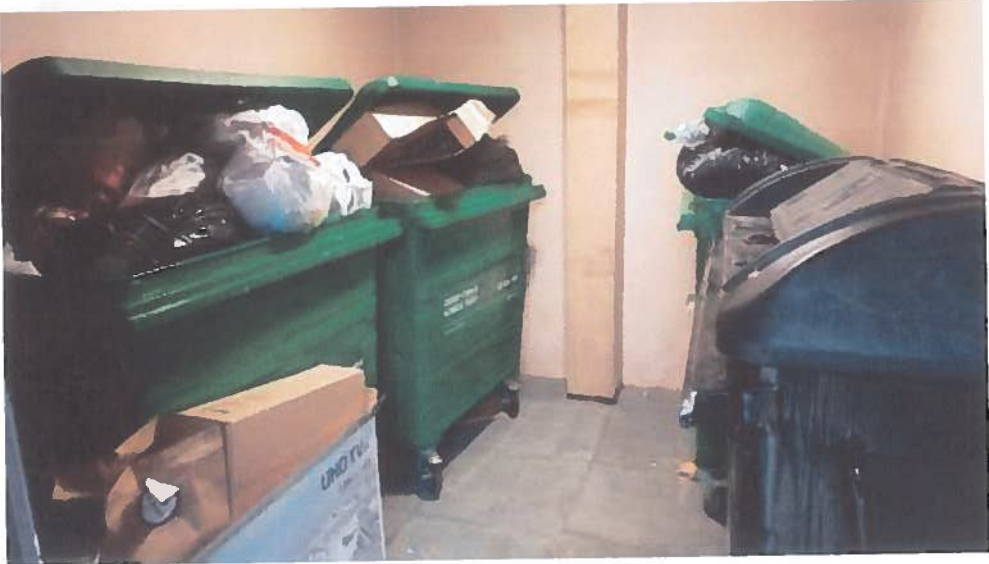
Residential waste already seems close to capacity on occasion.
