University College London

Langton Close House

Installation of Photovoltaics on the roof

Report on the Loadings applied to the roof structure.

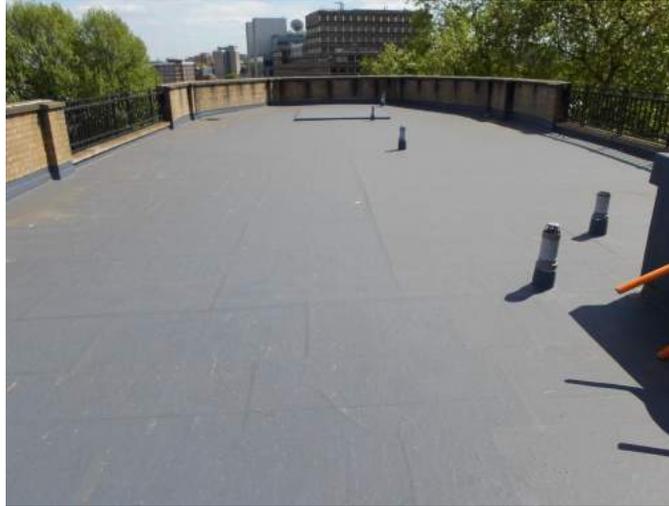
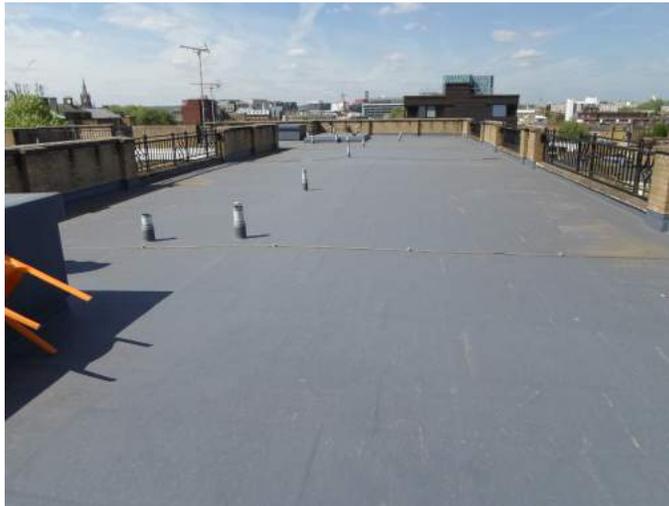
7. Photographs of roof area.

The area is divided into 2 sections and all at one level where it is proposed to locate the PV's. There are several raised areas which are lift over-runs and possible rooflights.

There are numerous soil vent pipes which extend above the roof.

The roof has been fairly recently been re-covered

Clearly the PV's will need to be securely fixed to the roof but it is important that the existing roof waterproofing is not damaged.

Soil vent pipes which penetrate the roof will need to be avoided or reduced in height.

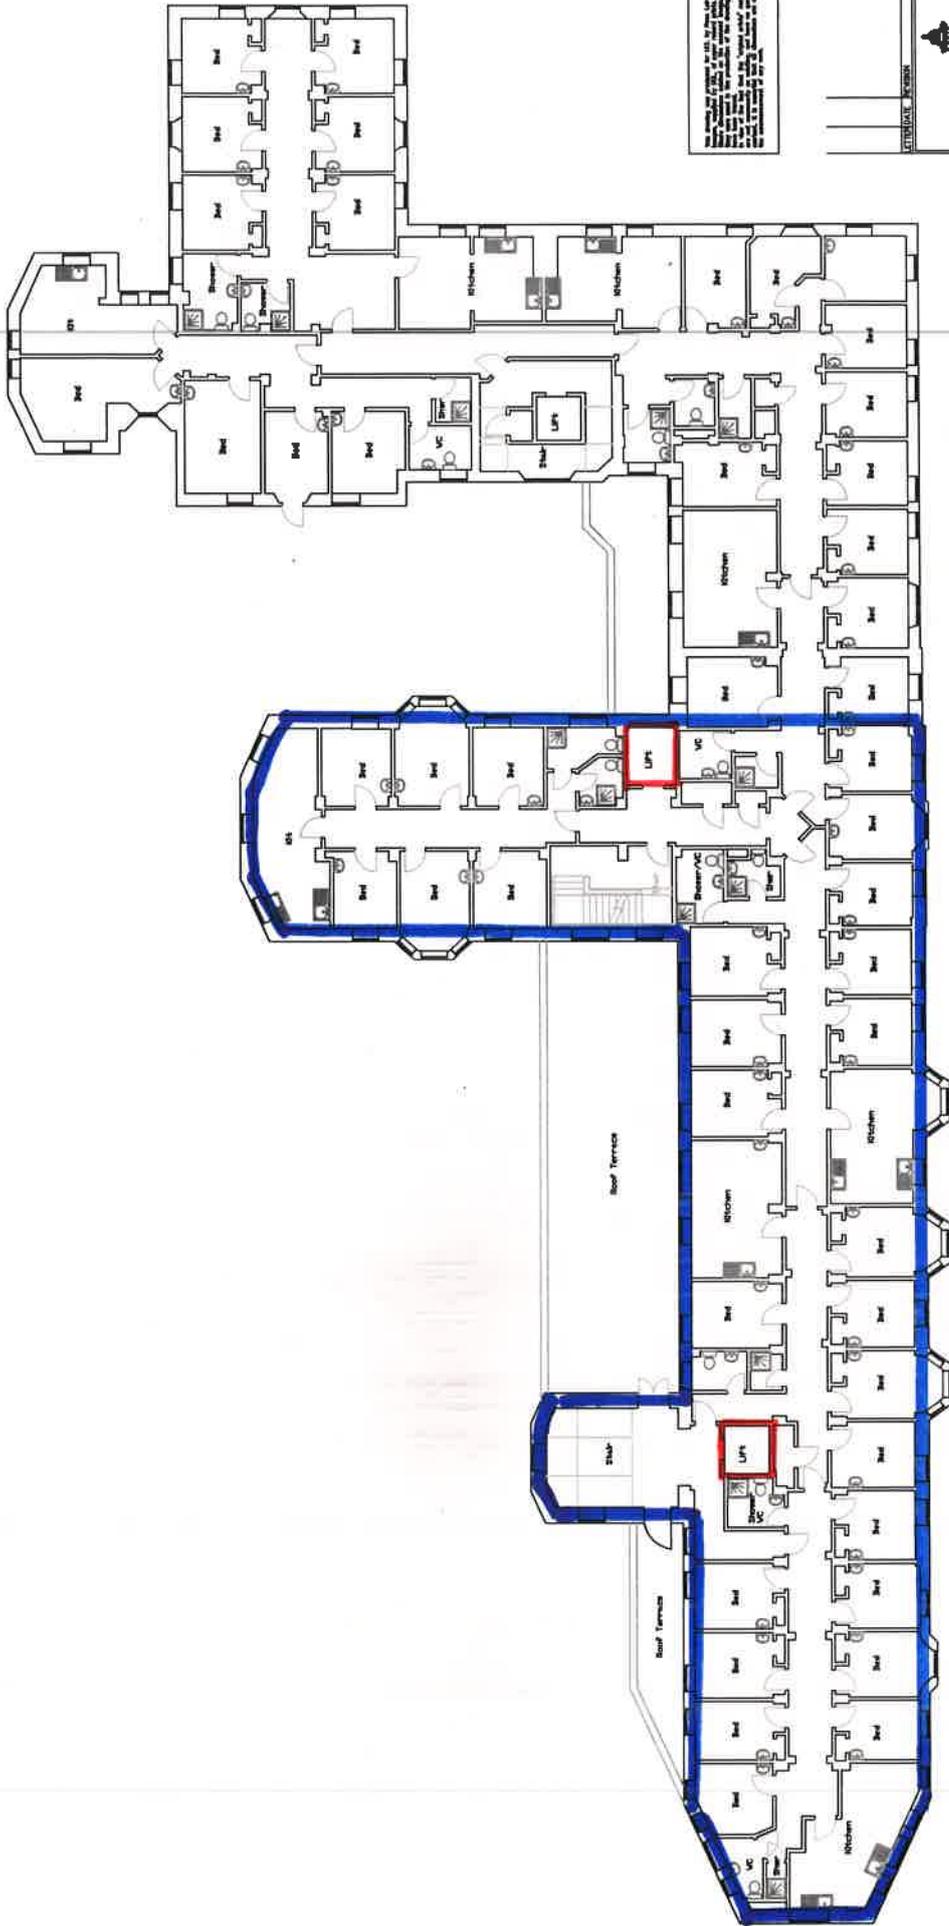
ESTATES AND FACILITIES DIVISION 1000 PARK STREET, LONDON, W1C 7BT	
DATE: September 2003	SCALE: 1:100
DRAWN:	PROJECT:
Langton Close Wren St London WC1X 0ND	
First Floor Plan	
DRG. NO.	103 0634 73

Only a basic layout drawing of the building's First floor was available. The flat roof area is indicated in blue on the plan.
