SENATE HOUSE
London WC1

A Report on the Decorative Schemes
following an Examination of the
Malet Street Railings

Patrick Baty

7th October 2016

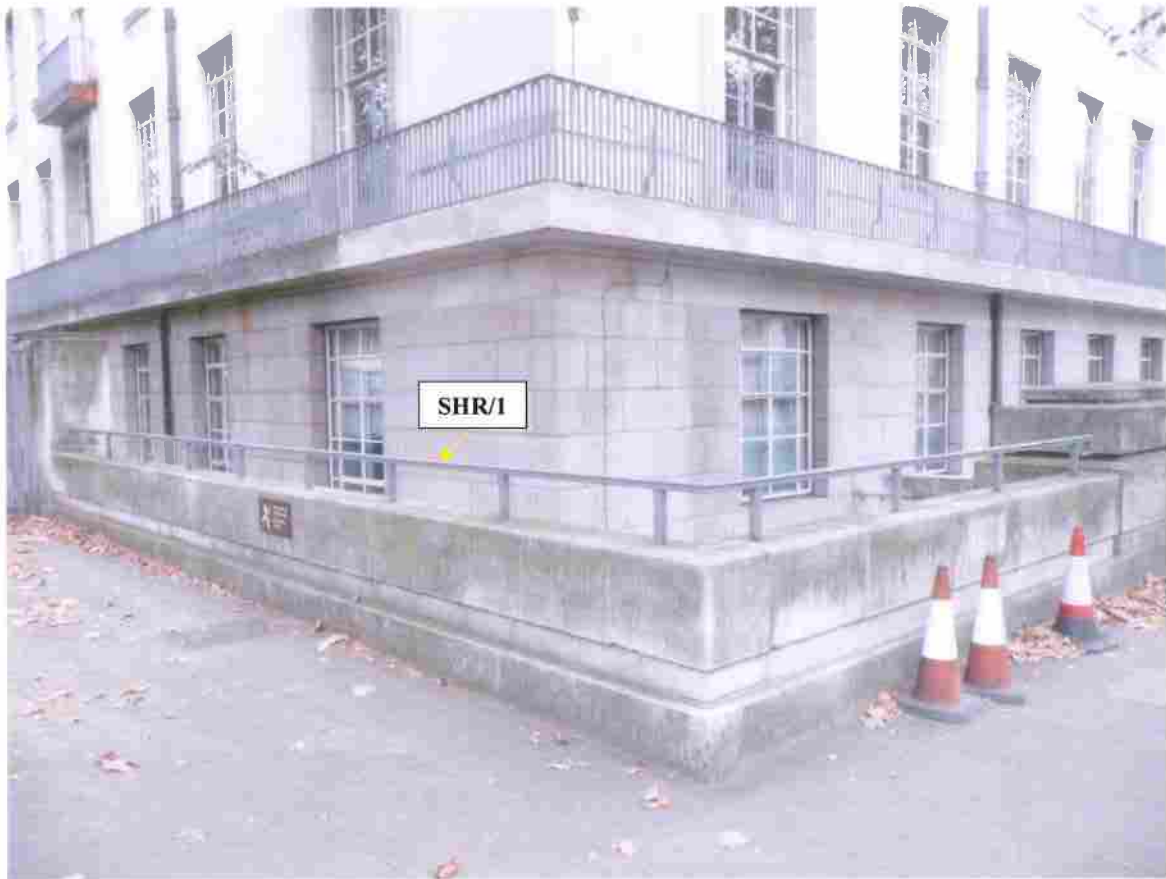
Low Guard Rail on SW corner of the building (Malet Street and Montague Place)
(see sample SHR/1 in Appendix Two)

A sample taken from the low guard rail set into the top of the wall around the SW corner of the building (Malet Street and Montague Place)⁷ displays just one decorative scheme. The fixings and paint suggest that this is a fairly recent introduction (see photomicrograph of SHR/1).

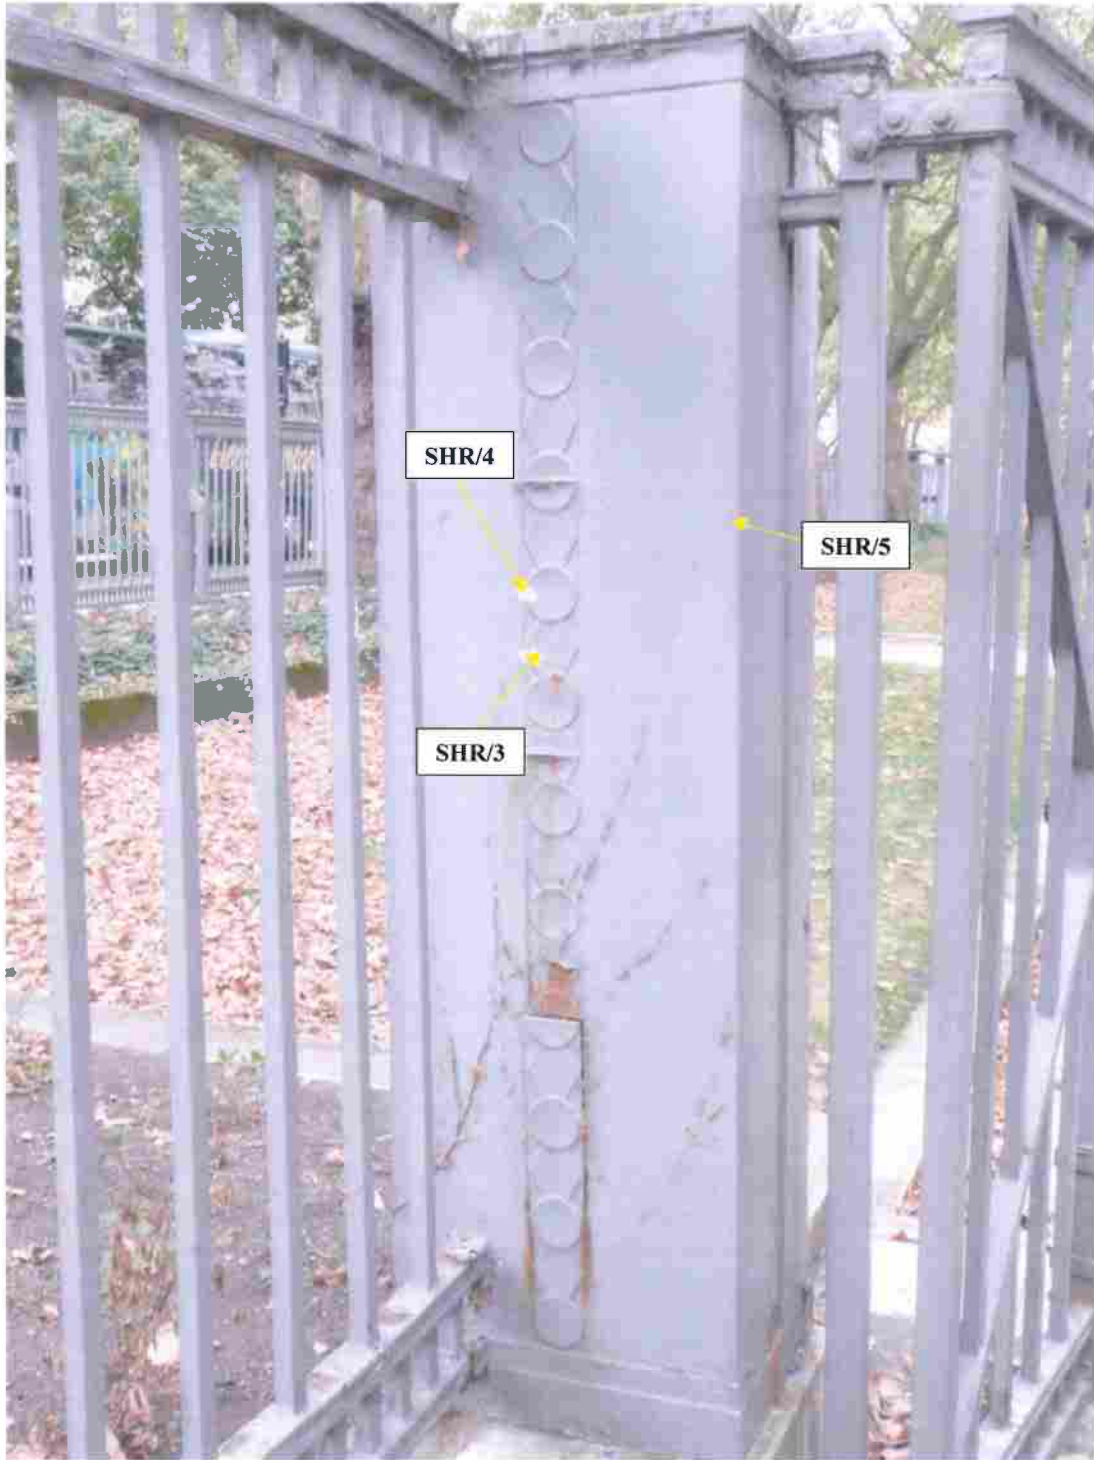
Gate Pier SW Corner. Note the Decorative Detail
(see samples SHR/3; SHR/4 and SHR/5 in Appendix Two)

The decorative nature of the piers with the circle and diamond detail might be an indication that the latter had been picked out in a different colour to the body of the piers. As a consequence, samples were taken from each element on several of the piers – both from those framing gates and those supporting panels. When one compares the samples from the gate at the south end, for example – SHR/5 from the pier; SHR/3 from a diamond and SHR/4 from a circle – it can be seen that there was no colour difference at either the beginning or at any later stage. It can also be seen that there are fifteen schemes on each of these surfaces.

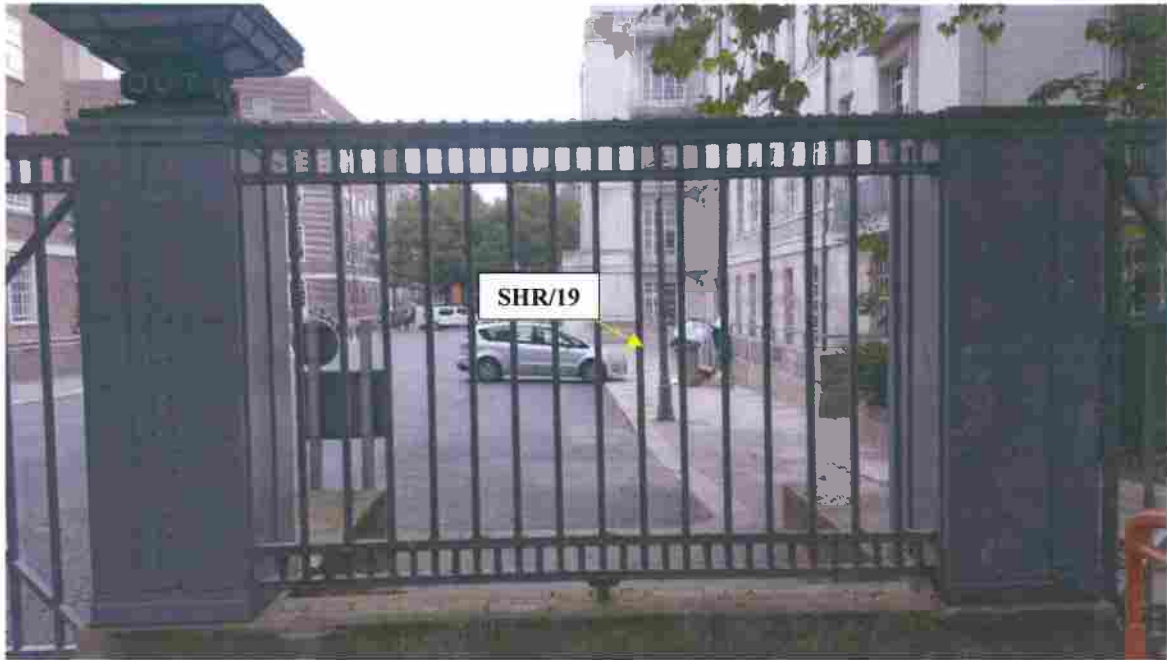
N end. Main gates. Upright of panel between R/H main gates & R/H pedestrian gate
(See sample SHR/19 in Appendix Two)

However, when one compares SHR/6, from an upright close to the south end, with SHR/19 from an upright from the north end (between the main gates and the pedestrian gate) it can be seen that there is one less scheme at the north end.⁸ Furthermore, the second scheme at the south end is the same as the first at the north end and each starts with a very distinctive coat of red lead paint. This suggests that the first of the fifteen schemes at the south end dates from 1932 and that the second dates from 1934.⁹

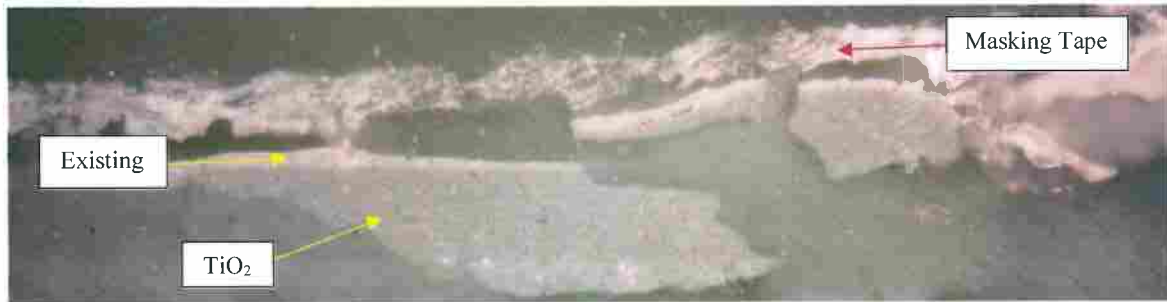
Photomicrograph of SHR/1 (x200)
S end. SW corner. Low rail on wall

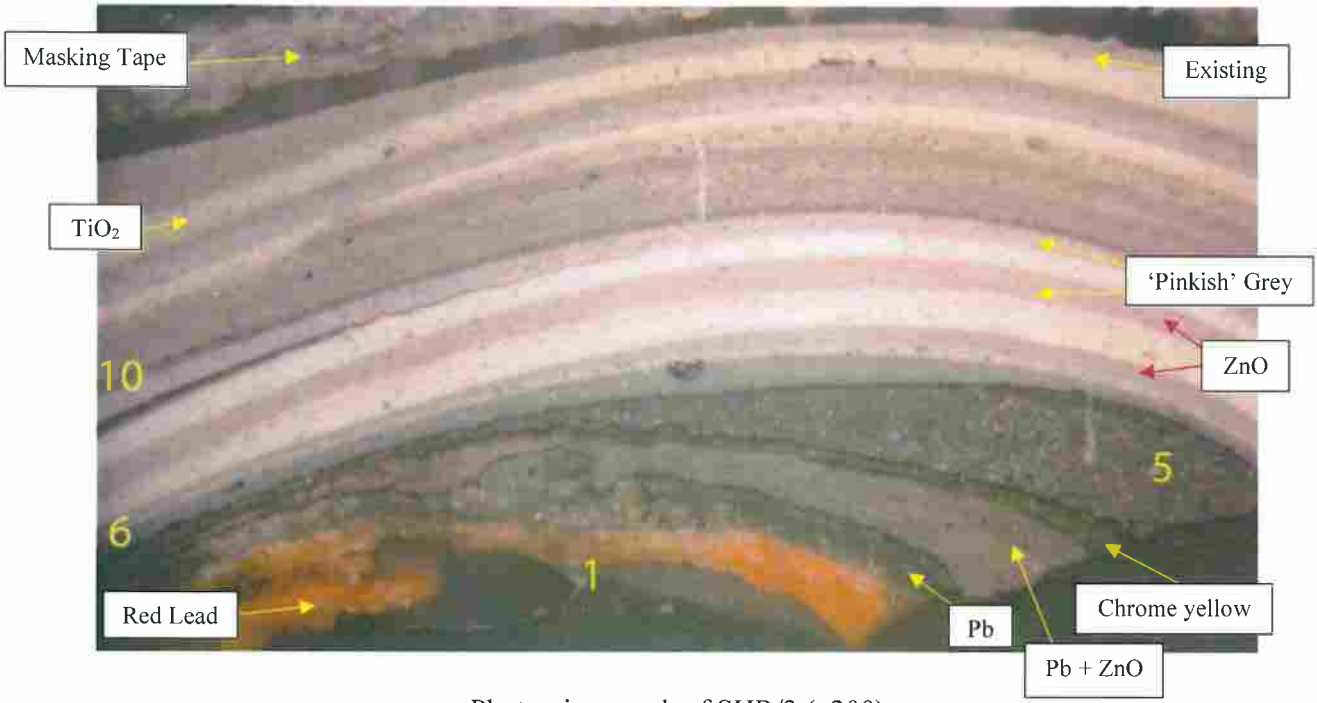
A primer consisting of red and white lead was applied as the first of the coats that formed the second scheme.¹⁴ This can be seen in most of the samples as a bright orange layer (see SHR/3 and SHR/6 for example). A mid grey undercoat and a slightly darker and greener top coat followed. A red lead primer can be seen at the bottom of the sequence of coatings on an upright from the north end (see SHR/19) which, as has been explained, was applied when the second scheme was applied at the south end. Underneath this are particles of rust and, presumably applied directly to the metalwork, the remains of what appears to be a coat of oil.¹⁵

The top coats of the third and fifth schemes were very similar to the first two, but the fourth one has a distinctly greyish green appearance.¹⁶ In some of the cross sections this fourth scheme displays small amounts of the pigment chrome yellow (see SHR/3 for example).¹⁷ It is just

Photomicrograph of SHR/3 (x200)
S end. L/H gate pier. Decorative panel. Diamond
