<b>Provider Details</b>		<b>Client Details</b>		<b>Risk Address</b>	
Name:	MHN Ltd	Insurance Co.:		Occupier:	Mr David Blagbrough
Date of Issue:	7/1/13	Client Name:	[REDACTED]	Address:	160 Camden Road
<b>Monitoring Details</b>		Contact:		Address:	
Instruction Date:	14/12/12	Email:		Town:	London
First Reading Date:	02/01/2013	Client Ref:	[REDACTED]	County:	
Duration:	TBC	Address:	[REDACTED]	Post Code:	NW1 9HJ
Anticipated Expiry Date:	UFN	Address:	[REDACTED]	Tel Home:	0207 267 7701
Monitoring Int (Wks):	4 weekly	Town:		Tel Work:	
		County:		Mobile:	[REDACTED]
		Post Code:		Other:	
		Other Email:		Other:

Client: Marishal Thompson

Client Ref: M384

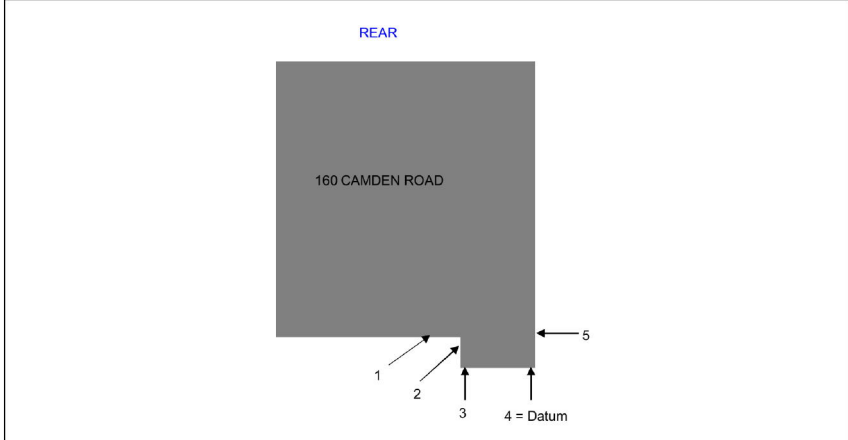
- The Occupier raised no new conce
- Due to the render surface of the pr was not possible to install all statio the same brick course. There fore i readings can not be interpreted as Data
- Readings are relative to level statio requested. It has an assumed valu 10.0000m

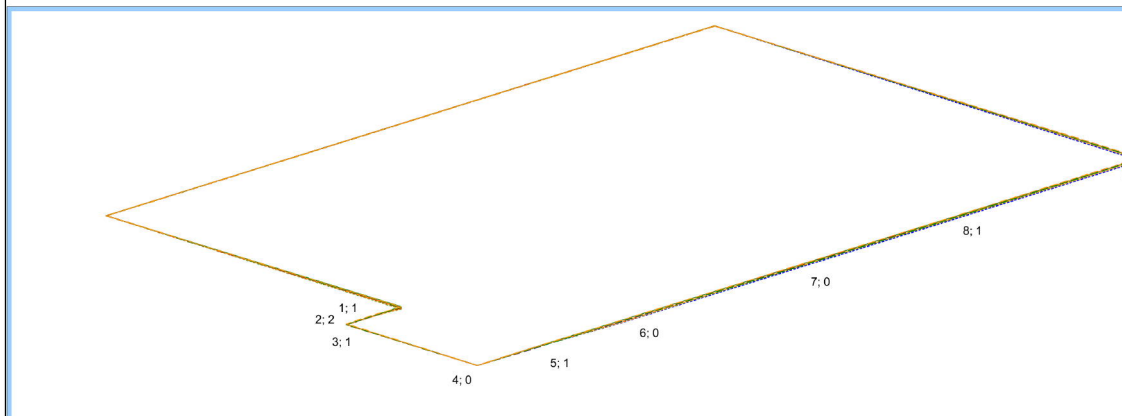
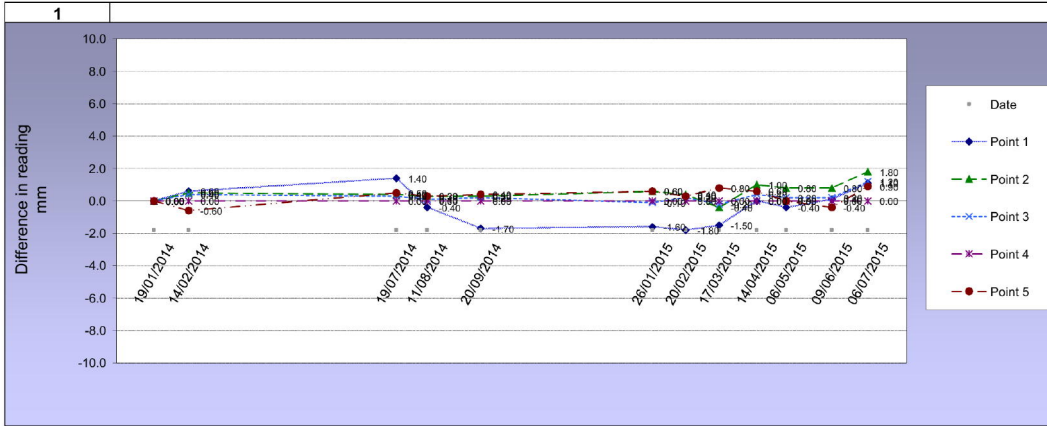
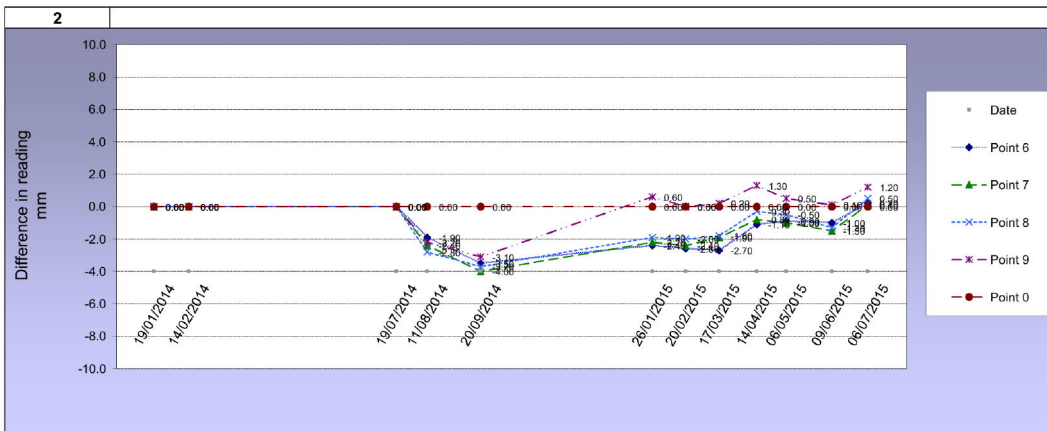
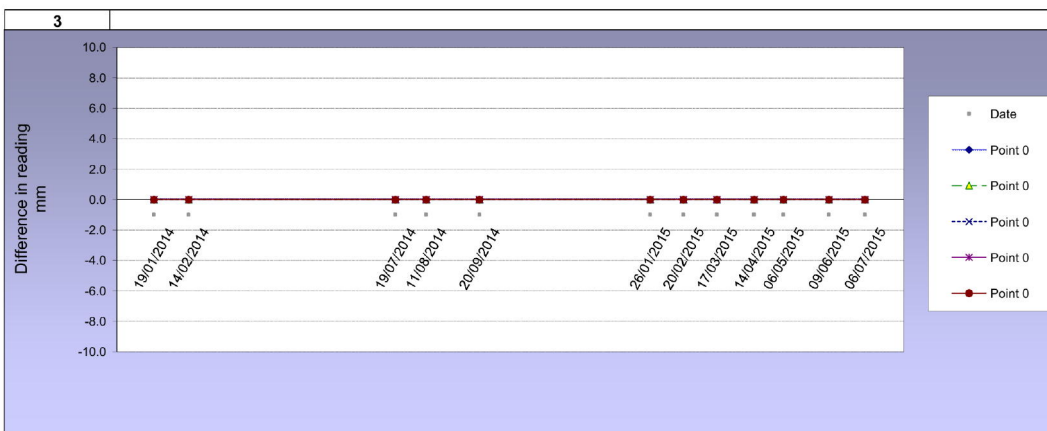
Reading 13 (19/1/14)	Reading 14 (14/2/14)	Reading 15 (19/7/14)	Reading 16 (11/8/14)	Reading 17 (20/9/14)	Reading 18 (26/1/15)
Reading 19 (20/2/15)	Reading 20 (17/3/15)	Reading 21 (14/4/15)	Reading 22 (6/5/15)	Reading 23 (9/6/15)	Reading 24 (6/7/15)

Notes:  
Vertical distorted scale 1: 20

Point labels give level difference of last reading from original datum in mm.
