<b>Provider Details</b>		<b>Client Details</b>		<b>Risk Address</b>	
Name:	MHN Ltd	Insurance Co.:		Occupier:	Mr David Blagbrough
Date of Issue:	7/1/13	Client Name:	[REDACTED]	Address:	160 Camden Road
<b>Monitoring Details</b>		Contact:	[REDACTED]	Address:	London
Instruction Date:	14/12/12	Email:	[REDACTED]	Town:	
First Reading Date:	02/01/2013	Client Ref:	[REDACTED]	County:	
Duration:	TBC	Address:	[REDACTED]	Post Code:	NW1 9HJ
Anticipated Expiry Date:	UFN	Address:	[REDACTED]	Tel Home:	0207 267 7701
Monitoring Int (Wks):	4 weekly	Town:	[REDACTED]	Tel Work:	[REDACTED]
		County:	[REDACTED]	Mobile:	[REDACTED]
		Post Code:	[REDACTED]	Other:	
		Other Email:	[REDACTED]	Other:

Client: Marishal Thompson

Client Ref: M384

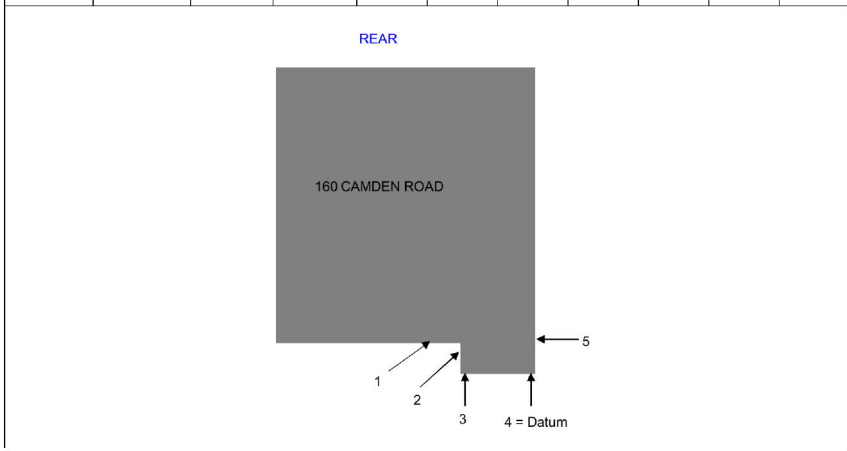
Target Date:				29/7/15	1/9/15	23/12/15	22/1/16	15/4/16	9/5/16	3/6/16	28/6/16	4/8/16	22/9/16	20/10/16
Reading Date:														
Issue Date:														
Row No.	Point Name	X Co-ordinate	Y Co-ordinate	25	26	27	28	29	30	31	32	33	34	35
1		0.00	0.00											
2	1	5.40	0.00	9.7346	9.7354	9.7354	9.7356	9.7366	9.7364	9.7360	9.7360	9.7373	9.7381	9.7343
3	2	5.40	-0.50	9.5762	9.5765	9.5779	9.5758	9.5770	9.5767	9.5760	9.5751	9.5765	9.5788	9.5767
4	3	5.40	-1.00	10.0235	10.0234	10.0232	10.0235	10.0237	10.0238	10.0238	10.0237	10.0237	10.0241	10.0237
5	4	7.80	-1.00	10.0000	10.0000	10.0000	10.0000	10.0000	10.0000	10.0000	10.0000	10.0000	10.0000	10.0000
6	5	7.80	0.00	9.8158	9.8164	9.8167	9.8157	9.8164	9.8160	9.8150	9.8154	9.8156	9.8150	9.8158
7	6	7.80	1.60	9.7986	9.7994	9.7998	9.7996	9.8001	9.8001	9.7997	9.8000	9.8004	9.8018	9.7975
8	7	7.80	4.60	9.7278	9.7288	9.7288	9.7288	9.7290	9.7290	9.7287	9.7294	9.7289	9.7290	9.7255

9	8	7.80	7.50	9.5633	9.5644	9.5642	9.5634	9.5645	9.5642	9.5638	9.5641	9.5648	9.5655	9.5597
10	9	7.80	11.15	9.4813	9.4814	9.4815	9.4811	9.4812	9.4810	9.4804	9.4817	9.4807	9.4821	9.4749
11		0.00	11.15											
12														
13														
14														
15														
16														
17														
18														
19														
20														
21														
22														
23														
24														
25														
26														
27														
28														
29														
30														
31														
32

- The Occupier raised no new conce
- Due to the render surface of the pr was not possible to install all stati the same brick course. There fore i readings can not be interpreted as Data
- Readings are relative to level stati requested. It has an assumed valu 10.0000m

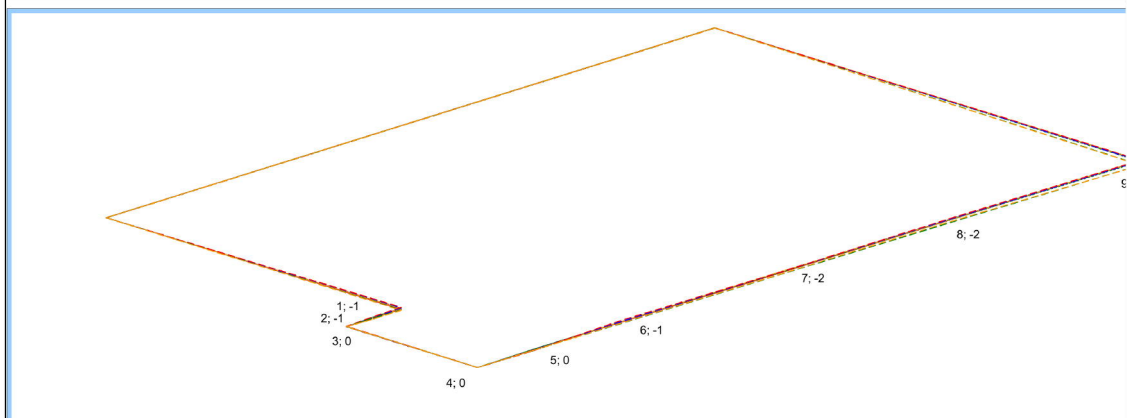
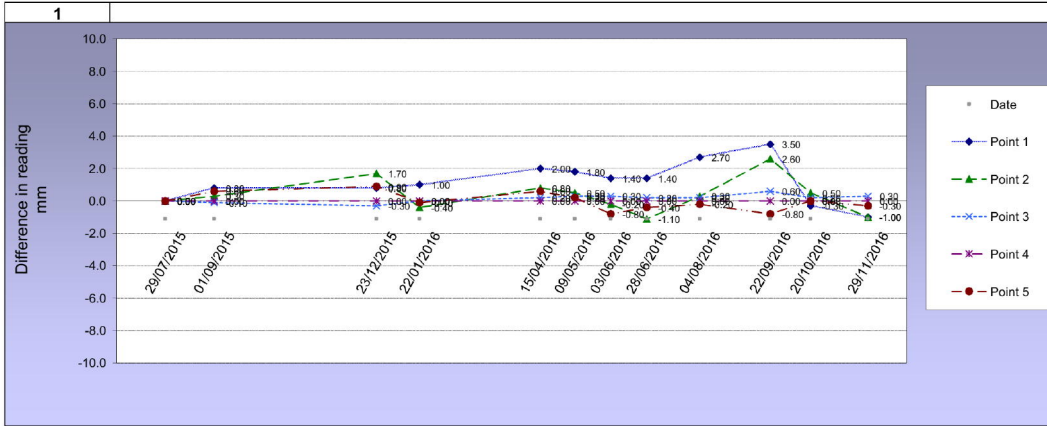
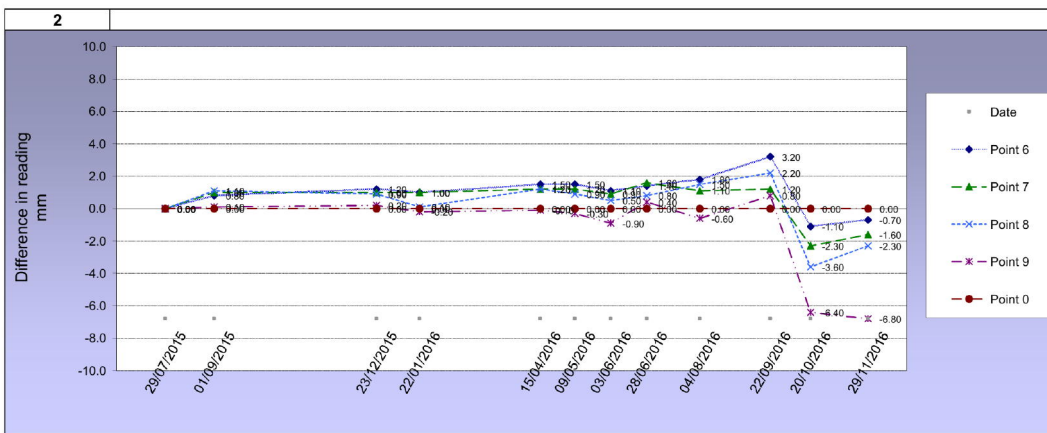
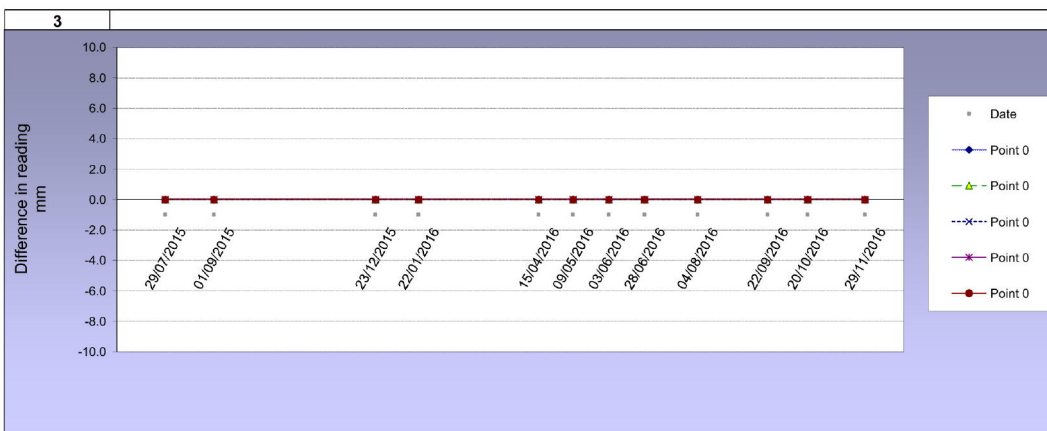
Reading 25 (29/7/15)	Reading 26 (1/9/15)	Reading 27 (23/12/15)	Reading 28 (22/1/16)	Reading 29 (15/4/16)	Reading 30 (9/5/16)
Reading 31 (3/6/16)	Reading 32 (28/6/16)	Reading 33 (4/8/16)	Reading 34 (22/9/16)	Reading 35 (20/10/16)	Reading 36 (29/11/16)

Notes:  
Vertical distorted scale 1: 20

Point labels give level difference of last reading from original datum in mm.
