1EW02 Enabling Works – Area South

Heritage Agreement Method Statement Building Recording of 14 and 15 Melton Street

Document number: 1EW02-CSJ-EV-PRO-S003-000003

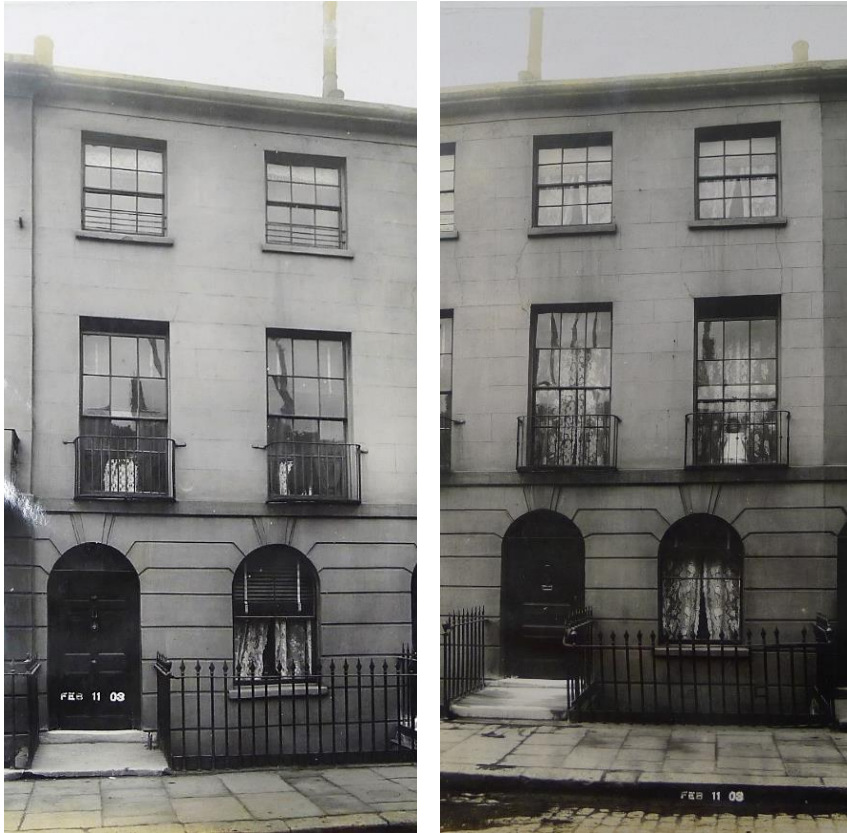
Figure 1 Nos. 14 (left) and 15 (right) Melton Street in 1903 (Source: Camden Council Local Studies and Archives Centre)

- 2.2.4 The terraced houses are constructed of brick, finished with painted render and displaying a rusticated ground floor. Vertical fractures through the render are visible between the first and second floor windows in the 1903 photograph (Figure 2 below).

- 2.2.13 The photographs of 1903 (Figure 1) suggest that their facades were finished with stucco from the outset. The stucco at ground floor imitated rusticated masonry, on the upper floors it was lined (incised) to imitate ashlar stonework. Fractures are visible in the stucco, extending between first and second floor windows at this stage, some 80 years after construction. The stucco has since been repaired and overpainted to the extent that the incised 'ashlar' joint lines are no longer visible, apart from in very small isolated areas on the rear elevation.

- 2.2.15 When first built, the ground floor was at a slightly higher level than the Melton Street pavement and set back from the pavement behind iron spearhead railings, as shown in Figure 1 below. This provided for a lightwell at the front to illuminate the basement service areas of the properties. The walkway level in front of the doors has since been raised by repair work which has concealed the iron boot scraper in front of No.14, apart from its rounded ends which protrude through the surface adjacent to the entrance.

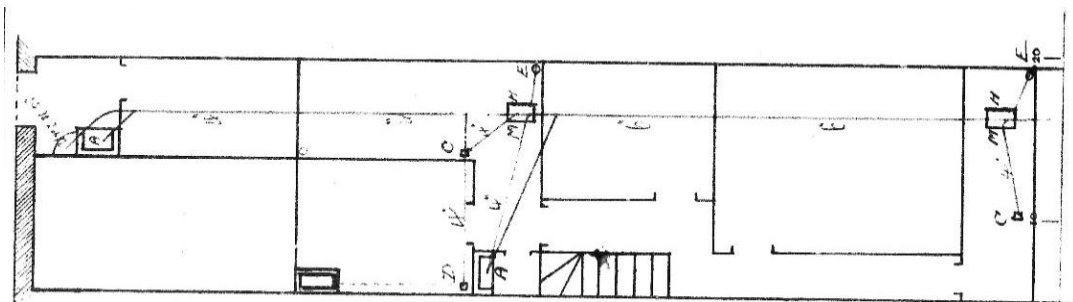
Figure 2 Drainage plan of 1893 for No. 14 Melton Street at basement level; Melton Street is to the right. The rear yard with building is on the left. (Source: Camden Council Local Studies and Archives Centre)

- 2.2.16 The drainage plan of 1893 for No. 14 (Figure 2) suggests that both houses were built to the traditional London plan established in the 18th century, one room wide, with an offset entrance and corridor leading through to a rear staircase. By 1893 at least there was another structure in the rear courtyard, apparently a separate building with a separate entrance positioned directly opposite the rear entrance to the house.

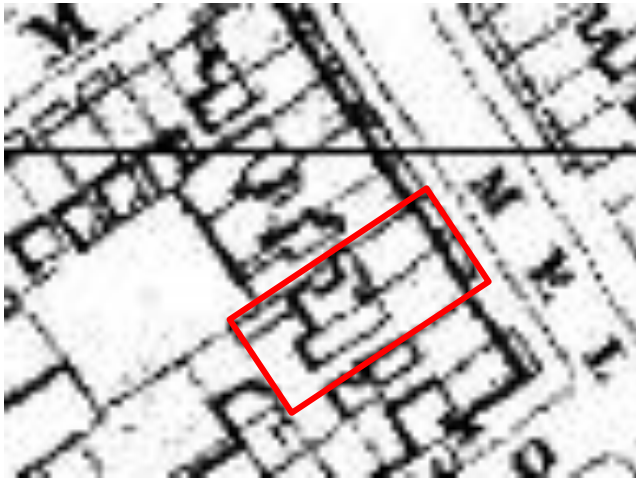
Figure 3 Ordnance Survey map at a scale of 1:2,500, from 1873-74, illustrating the rear extensions to the property

- 2.2.17 Figure 3).
- 2.2.18 The other houses on the western side of Melton Street were lost through piecemeal redevelopment in the 20th century (Figure 4). Nos. 16 and 17 to the north, along with part of the south side of Drummond Street, were demolished for the construction of the deep level tube station for the Charing Cross, Euston and Hampstead Railway in c.1907. To the south, the

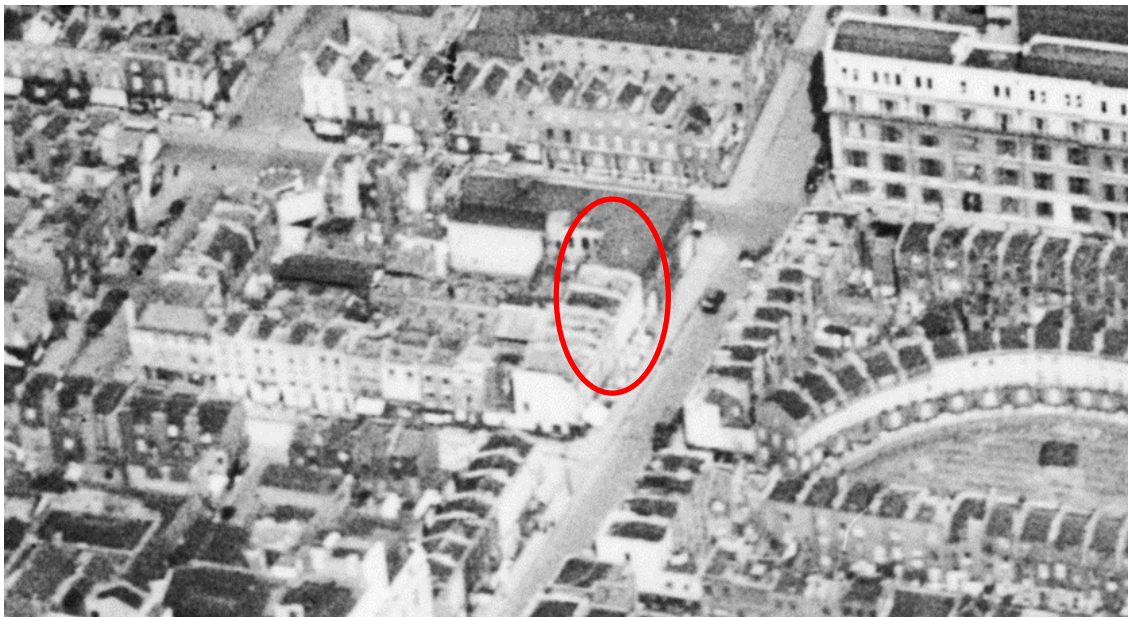
Figure 4 Aerial view of 1936 from the south-east, showing Nos. 14 and 15 Melton Street (circled) in their setting with the Euston Underground Station building which replaced the terraced houses to the north earlier in the twentieth century. (© Historic England. Licensor www.rcahms.gov.uk)

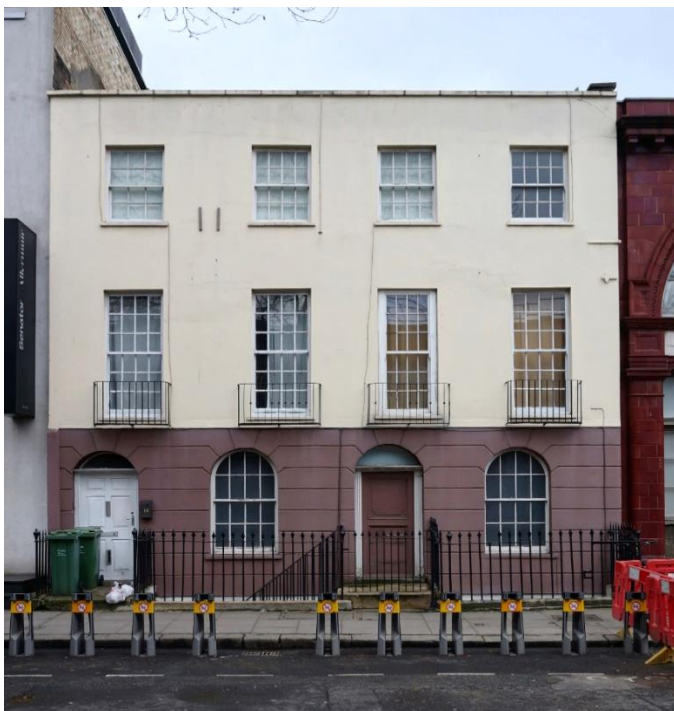
Figure 6 The street elevation of Nos. 14-15 Melton Street

- 2.2.7 The windows are timber sashes. None of the windows on the principal (Melton Street) elevation belong to the building as first constructed. Comparison of archival photographs of 1903 with the present arrangement (see Figure 6) shows that the fenestration has been substantially altered since 1903. The 6 over 6 sashes have been replaced with 12 over 12 sashes, apart from a single 6 over 6 replacement at second floor level on No.14 which is a relatively recent addition. The existing post-1903 first and second floor windows of No.15 have some typical historic features - horns and an ovolo fillet glazing bar profile – but they are without the frame and concealed opening mechanism (pulleys, cords and weights) which form part of a traditional timber sash window. Horns were introduced in the later nineteenth century to reinforce the sash rail and the stile, originally as a practical measure to support larger, heavier sheets of glass which were available by this stage.

- 2.2.20 Modifications were also carried out to the exterior of Nos. 14 and 15 in the latter part of the 20th century, though it has not been possible to establish the exact date (Figure 6). All the windows have been replaced and only the left-hand second-floor window of No. 14 still reflects the six-over-six arrangement that is recorded in the photograph of 1903 (Figure 1). The railings along the front elevation were altered: a fire escape was installed from the basement flat of No. 14 up to street level, and a gate was installed across the former entrance to No. 15, between the existing railings along the footway.
