**St Giles Circus site, WC1
No. 9 Denmark Street
Addendum: Record of historic wall
finishes, third-floor rear room**

**Prepared for
Consolidated Developments Ltd
June 2018**

St Giles Circus site, WC1: No. 9 Denmark Street**Addendum: Record of historic wall finishes, third-floor rear room****1.0 Introduction**

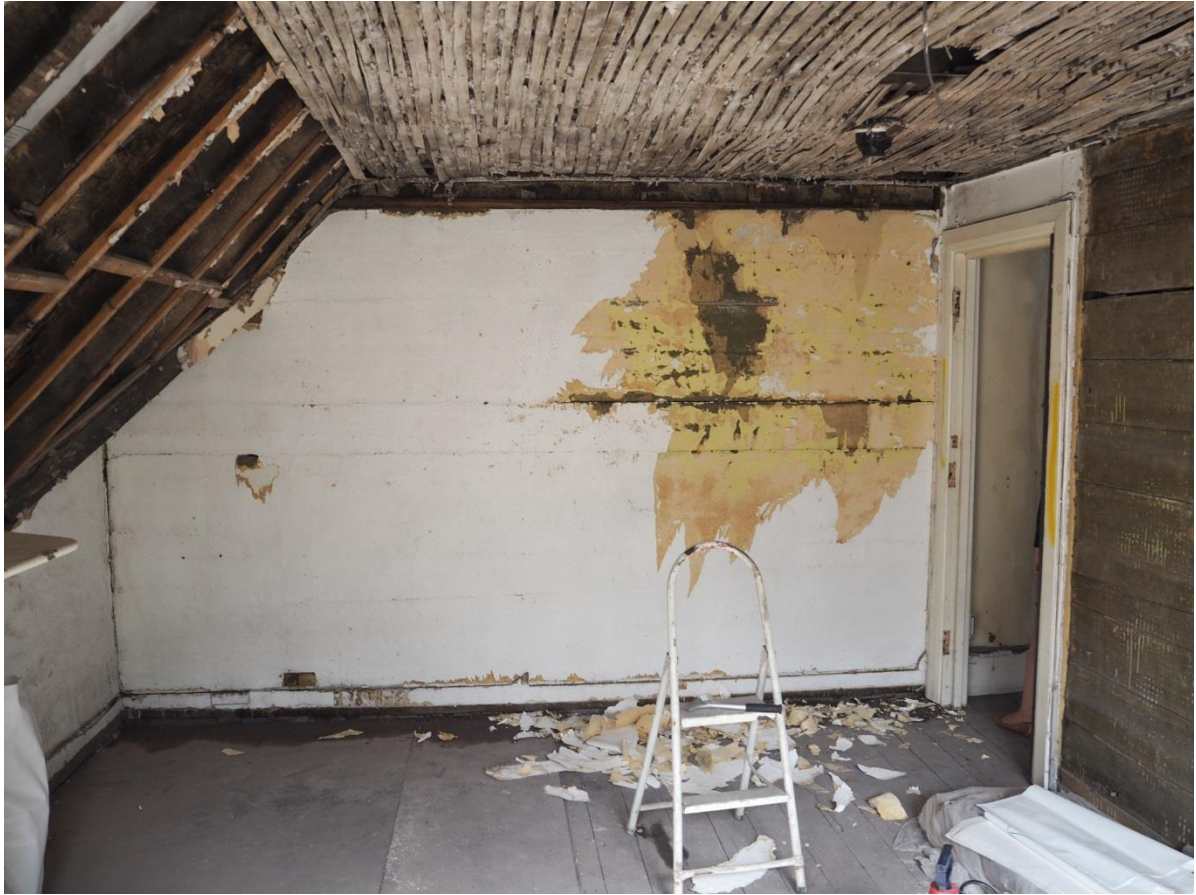
Figure 2: NW wall, Aug 2017

- 2.1** The tongue-and-groove boarding revealed following removal of modern plasterboard is shown in figures 2 and 4. The timber boards are laid horizontally, each one flush with the next. All the boards have a layer of ingrained green paint. In the case of the NW wall this is overpainted with later layers of yellow and white paint.

- 2.2** It was found that in most cases, the 'tongue' joint along the top edge of the board was no longer fitted into the groove on the underside of the board above, suggesting that the boards have contracted over time as the timber has dried out.

- 2.3** Robust tongue-and-groove boarding of this type was typically used during the nineteenth century in heavily used rooms where a robust treatment was required, e.g. in an industrial setting. This boarding contrasts with the smaller-scale, vertically laid, tongue-and-groove panelling that is sometimes found in domestic settings, e.g. in hallways or stair wells.

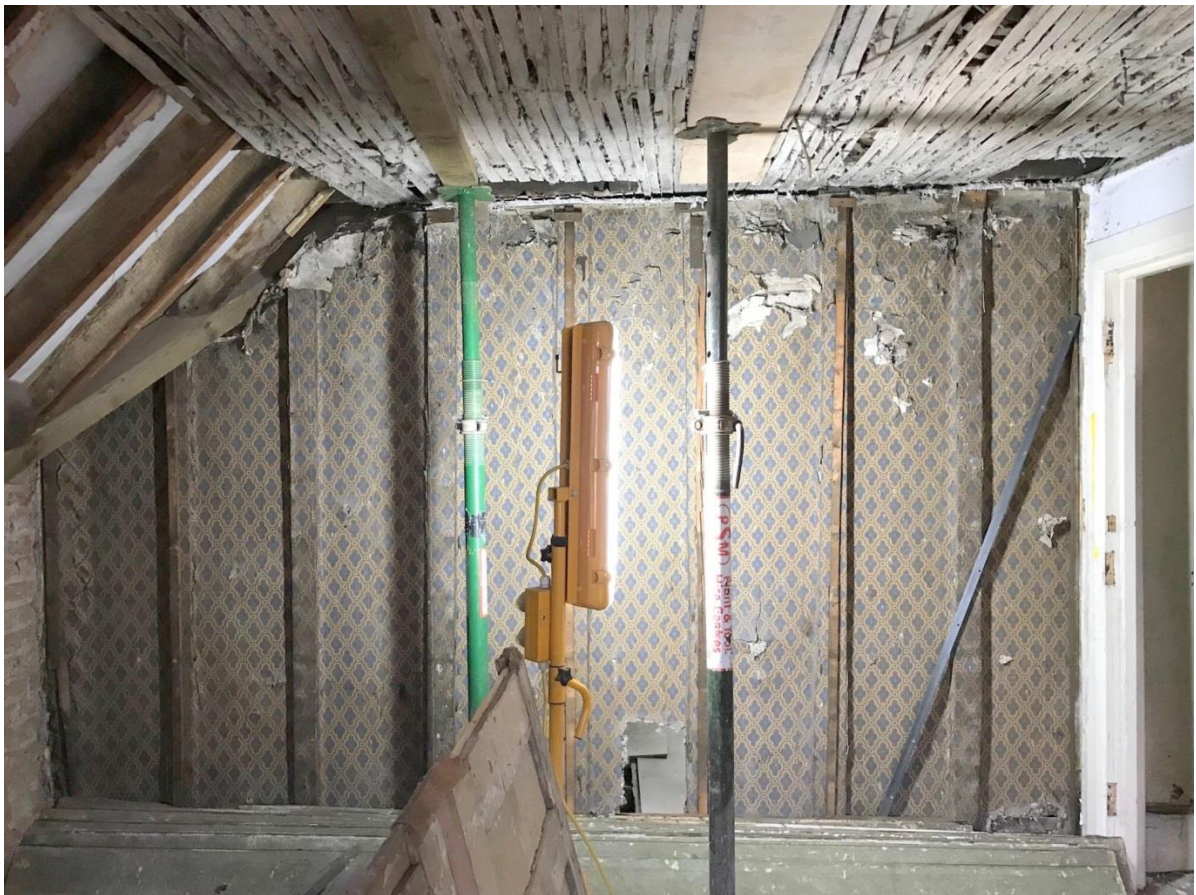
Figure 3: NW wall, Jan 2018

- 2.4** The wallpaper revealed following the removal of the tongue-and-groove boarding is shown in figures 3 and 5. The wallpaper is applied directly to the studwork partitions. The partitions are composed of traditional lath and plaster, fixed to vertical timber studs. The wallpaper is applied continuously across the studs, without a border treatment of any kind.

- 4.1** Following discussions with the Senior Conservation Officer Alfie Stroud, Ian Chalk Architects have been able to preserve the wallpaper *in situ*, with the exception of one area in the NW wall where a doorway is being inserted, as per the approved scheme (ref. 2012/6867/L). The tongue-and-groove boarding is being reinstated in the same manner. The wallpaper will then be covered up as it was prior to the investigation. Having taken into account the fragile nature of the historic wallpaper, this is considered to be the most effective way of ensuring its continued survival and preservation.

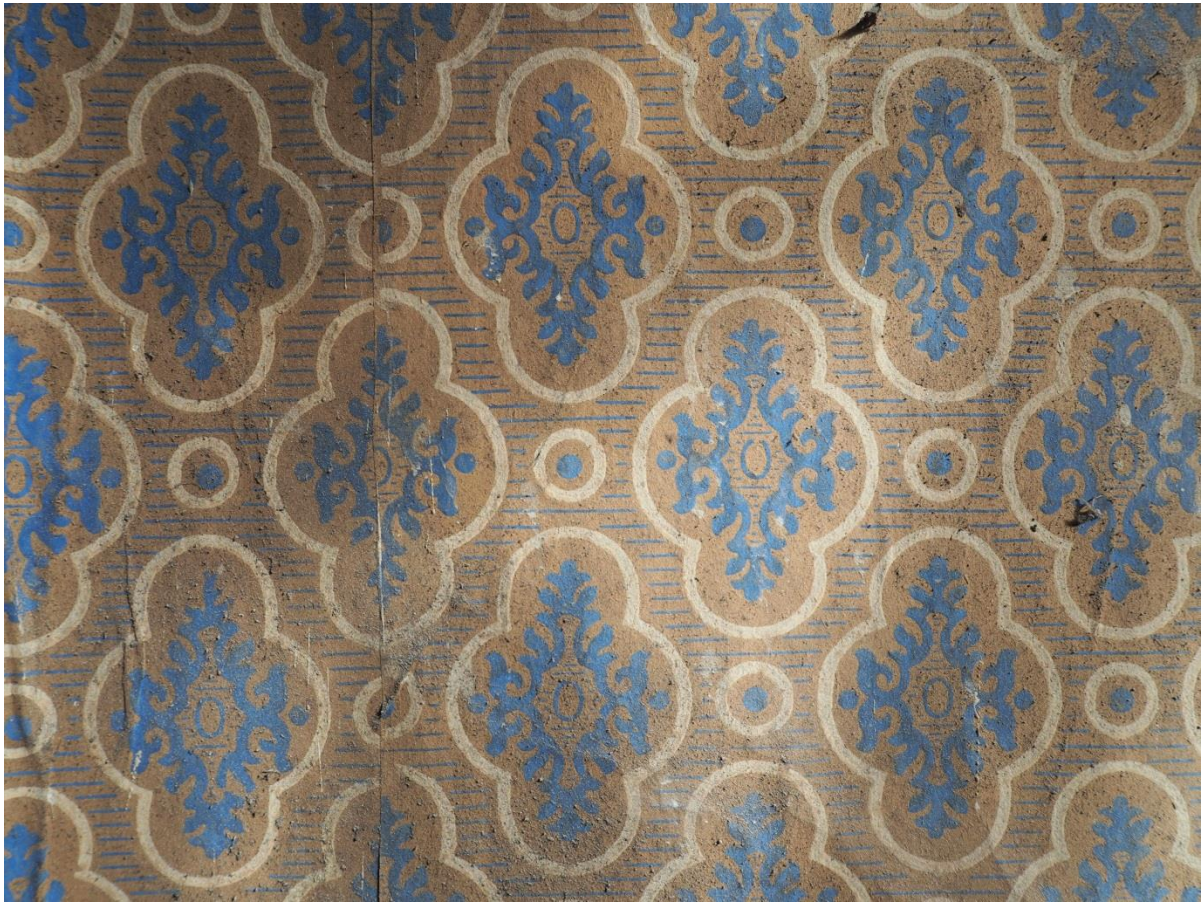
- 2.5** The wallpaper appears to be of the block-printed type, i.e. printed by hand using carved wooden blocks to transfer the paint. There are two colours, blue and cream, applied to a biscuit-coloured ground (see figures 6 and 7). Printing with two colours was more time consuming to produce and therefore usually more expensive than wallpaper printed with one colour.

- 2.6** No marks have been found to give an accurate date for the wallpaper. The overall pattern of circles, quatrefoils and stripes is of a type that can be found in eighteenth-century wallpaper, but would typically have incorporated flowers within the borders. Here, the quatrefoil borders incorporate stylised motifs that are only loosely based on plant forms. These curvilinear motifs are characteristic of early to mid nineteenth century design.

Figure 6: NW wall, detail of wallpaper

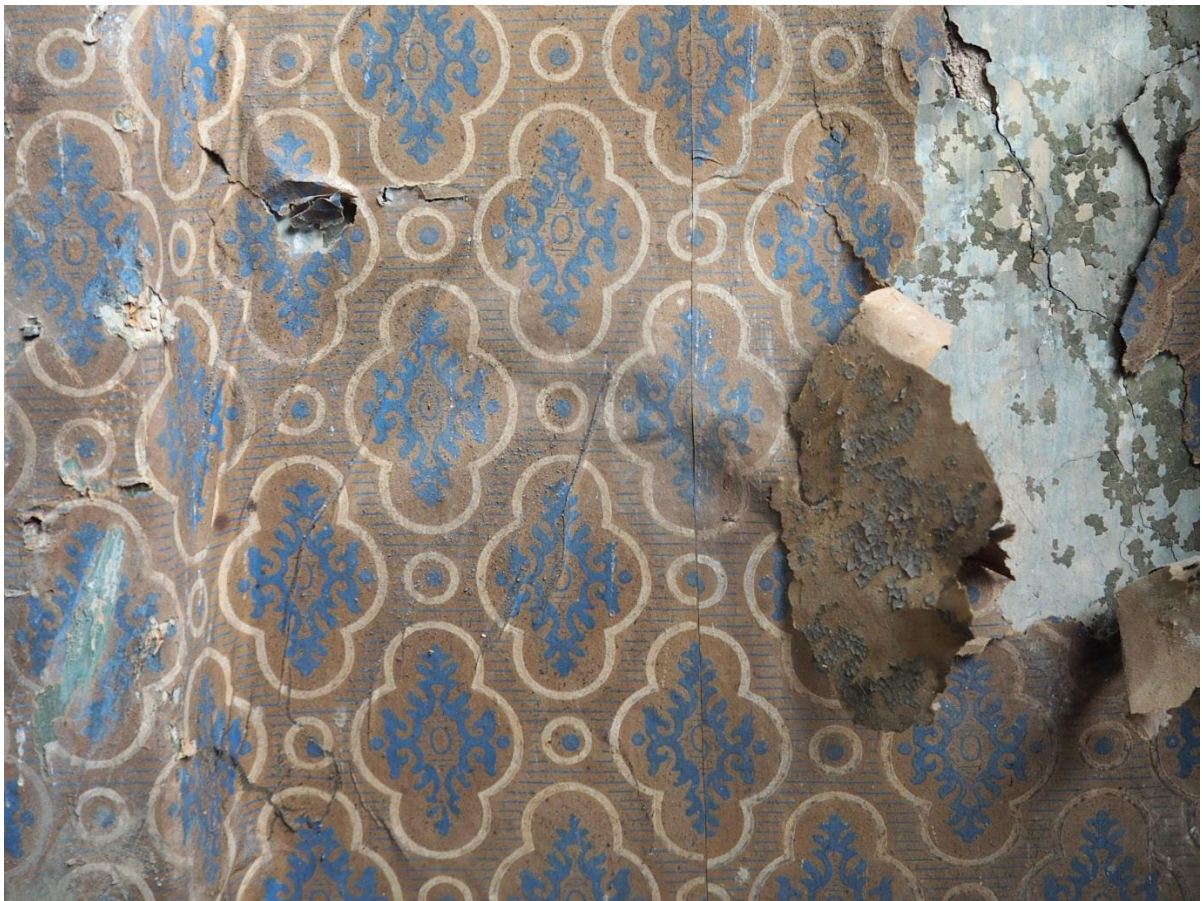
Figure 7: NE wall, detail of wallpaper
