ADDENDUM

Design & Access Statement

91 & 91a Regent's Park Road, London NW1 8UT

PLANNING APPLICATION

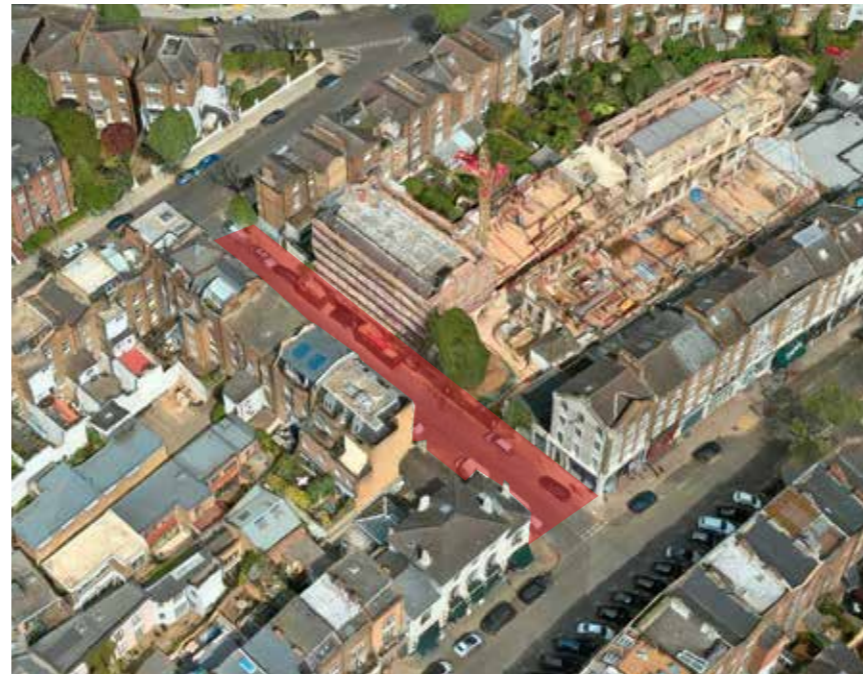
Aerial view towards the eastern side of Erskine Road

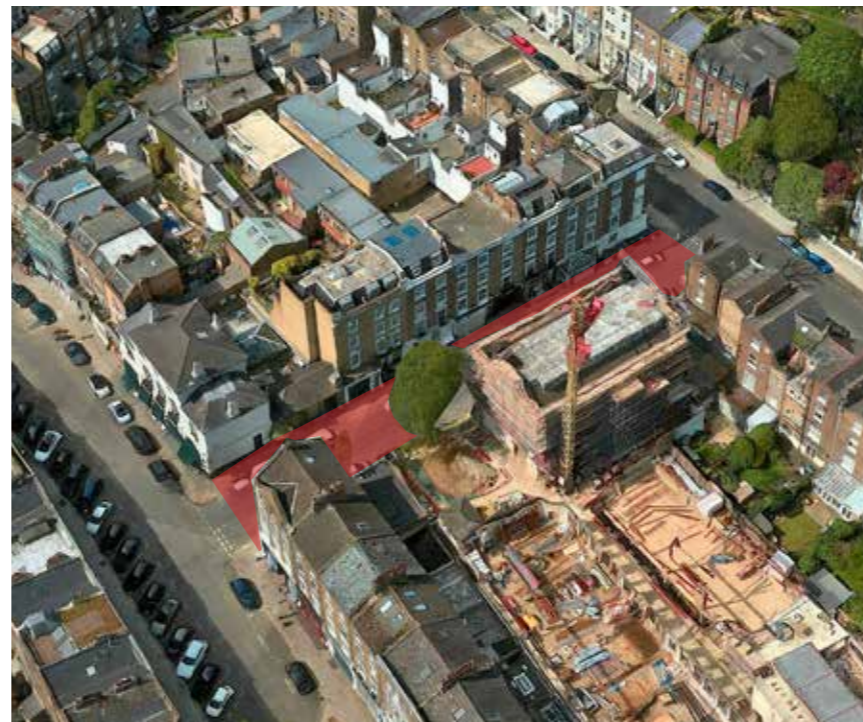
Aerial view towards the western side of Erskine Road

This *western* side of Erskine Road is very much residential in character with a terrace of mid 19th century buildings with rusticated ground floors. Some properties have been converted for commercial uses with the addition of shopfronts. There is only a small narrow gap between the corner 'Lemonia' restaurant (No.89 Regent's Park Road) and the residential terrace block. Importantly, there is no gap whatsoever at the corresponding corner with Ainger Road.

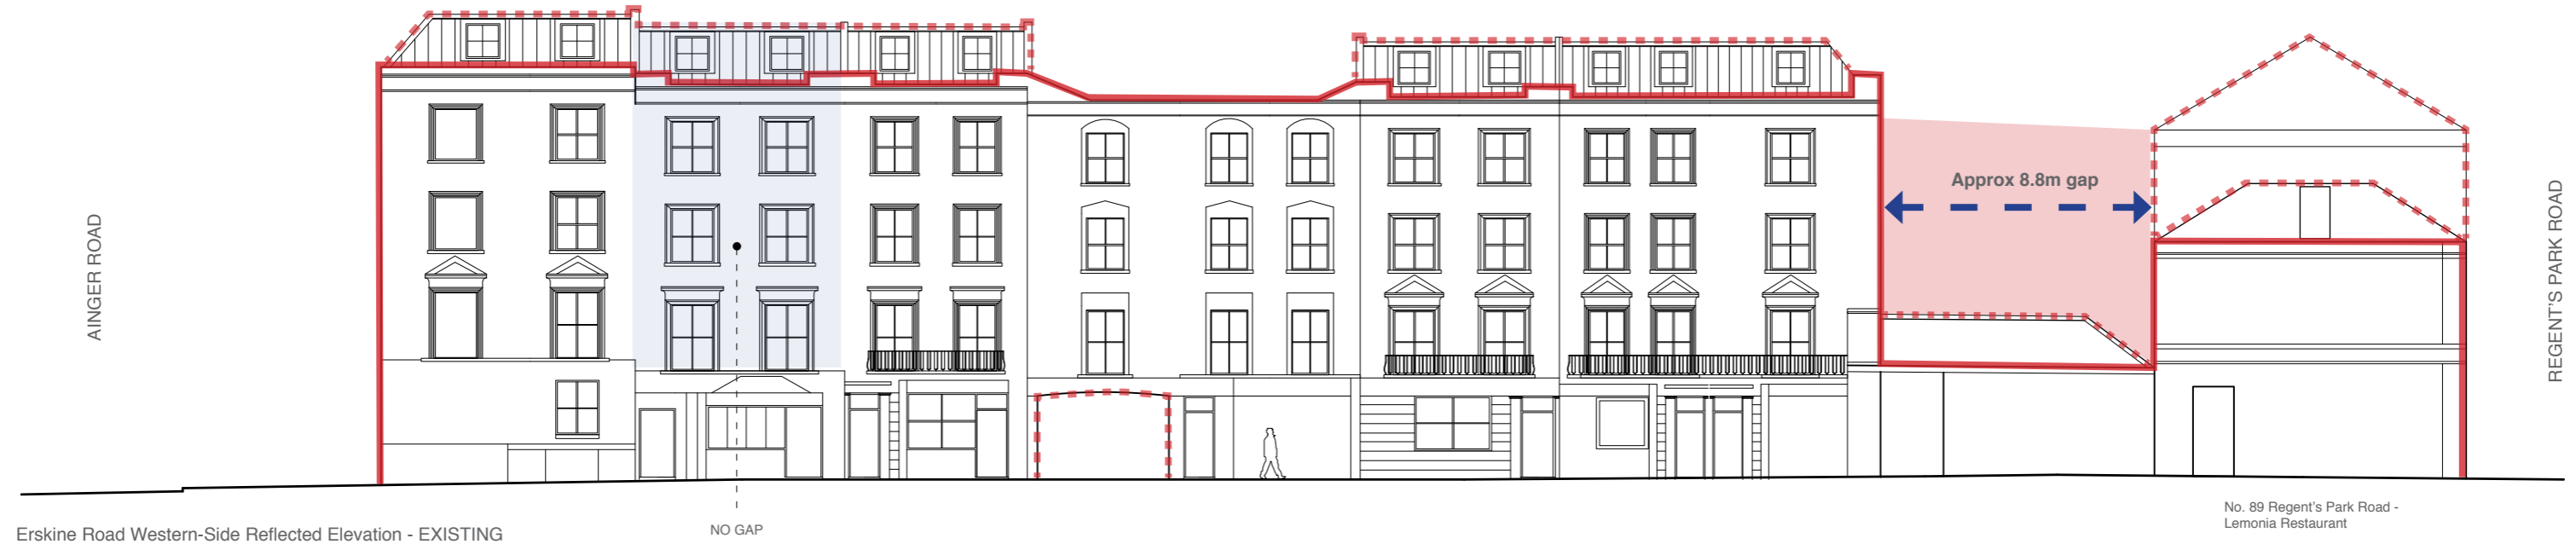
2.1 Erskine Road - Analysis of Existing Street Elevations

KEY:

- - - - - Silhouette
- Street Wall
- Gap

There is a much larger than usual gap in the townscape of approximately 23.4m between the three storey industrial Leeder House building and No. 91a.

This is unique to the area and important to consider in the context of any proposed development. The proposed extension above No. 91a would retain a substantial and meaningful gap of 16m that still allows views to the greater parts of the rear elevations of Nos.93-109. This would still be one of the largest and most generous in the area.

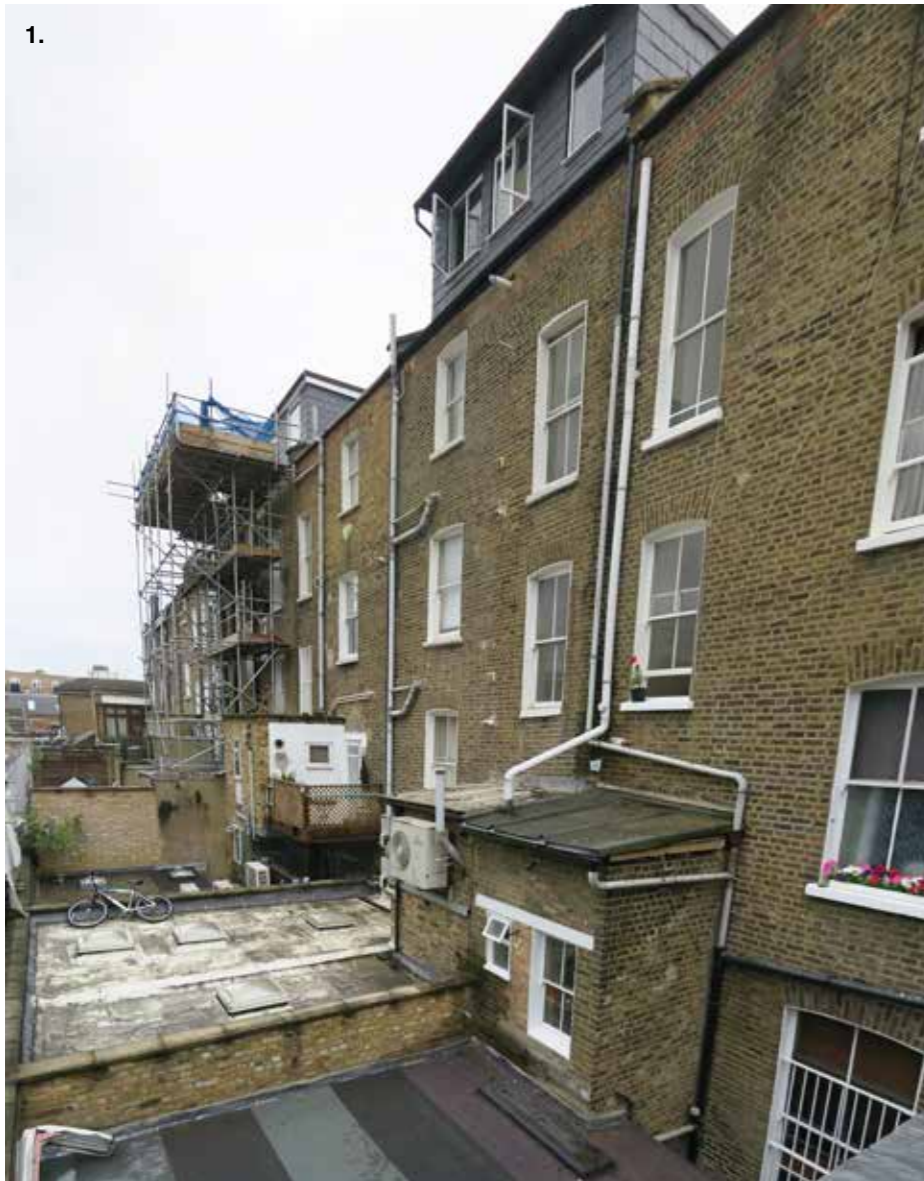
1. View of the rear elevations to Nos 93-109 Regent's Park Road

Fig. 1, taken from the roof of the Laundromat shows the rear elevations of Nos. 93-109. This shows the much altered rear facades, with plastic rainwater goods in various shades of white, grey and black, boiler flues, extraction vents, projecting air-conditioning units, and trailing telecoms cables. There are also various dormer extensions with casement windows and a number of patch brick repairs which detract. As such, this particular rear elevation is seen in Donald Insall's eyes to only make "...a modest positive contribution to the Conservation Area..", and the view can be enhanced by an extension of good design and quality.

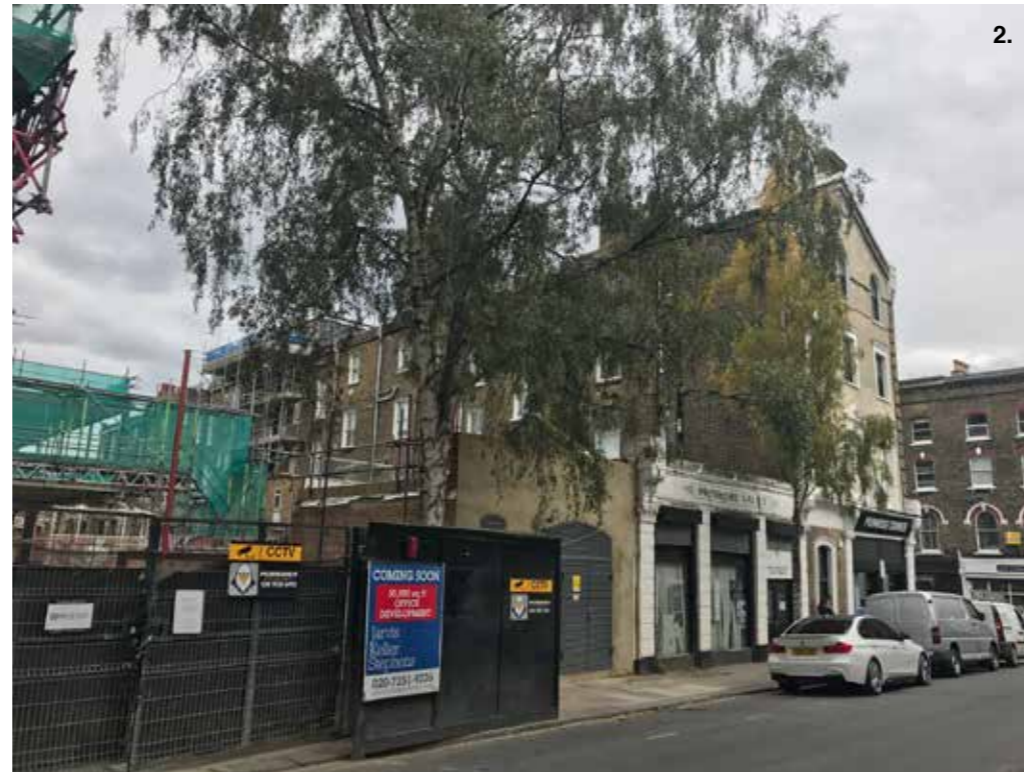
2. View through the gap to the rear of Nos.91-109.

Fig. 2 shows how the rear elevation of No.91 is barely visible through the trees.

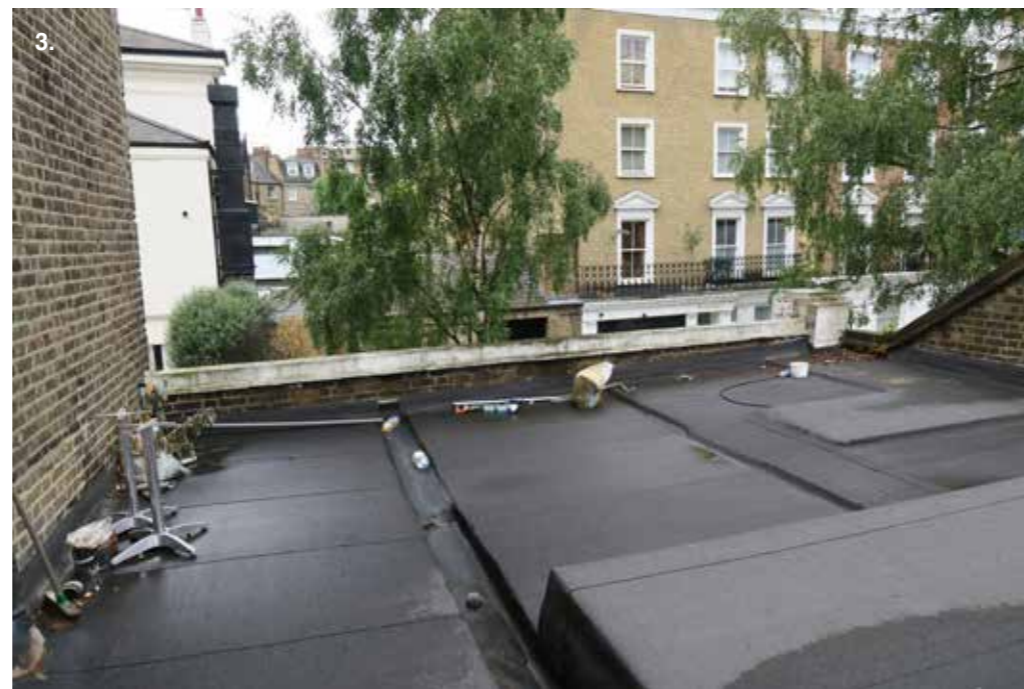
3. View from the roof of the No.91a Laundromat

Fig. 3 shows the reverse view from the roof of the Laundromat. This highlights the close proximity of the Birch tree in front that obscures the view to the opposite elevation and gap above No.89b.

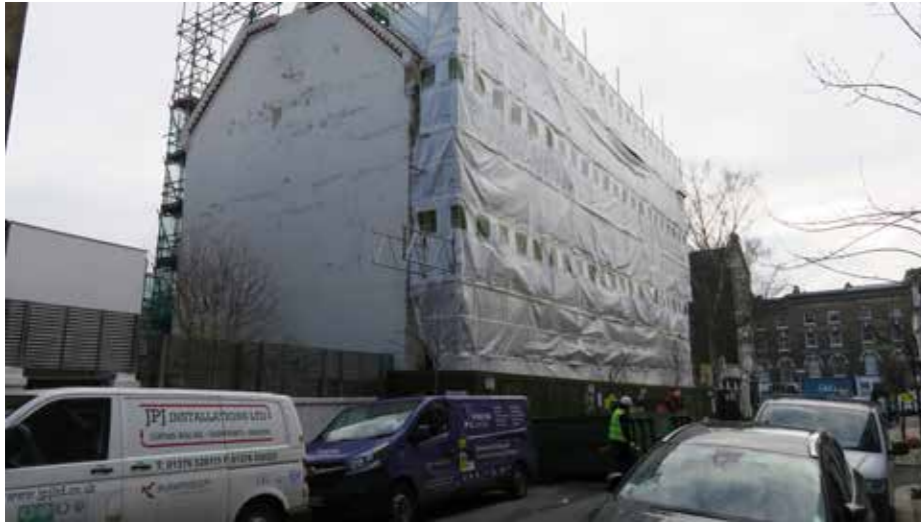
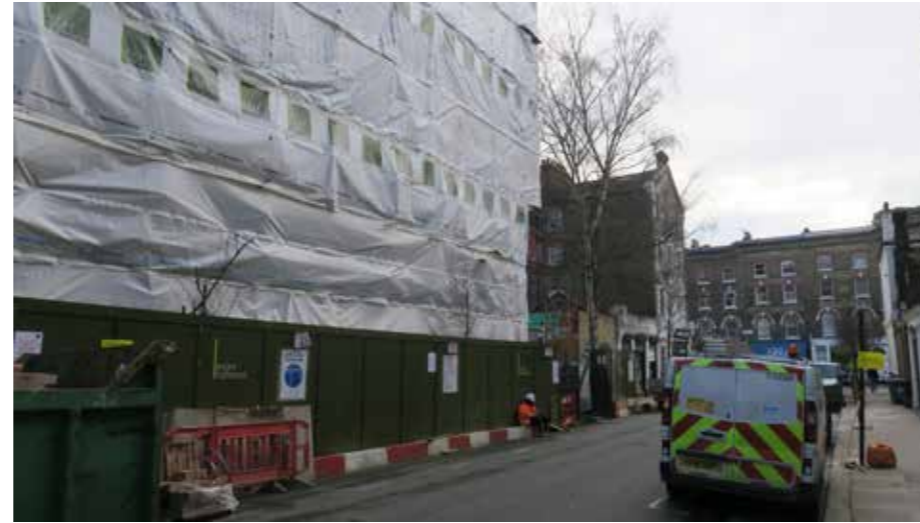
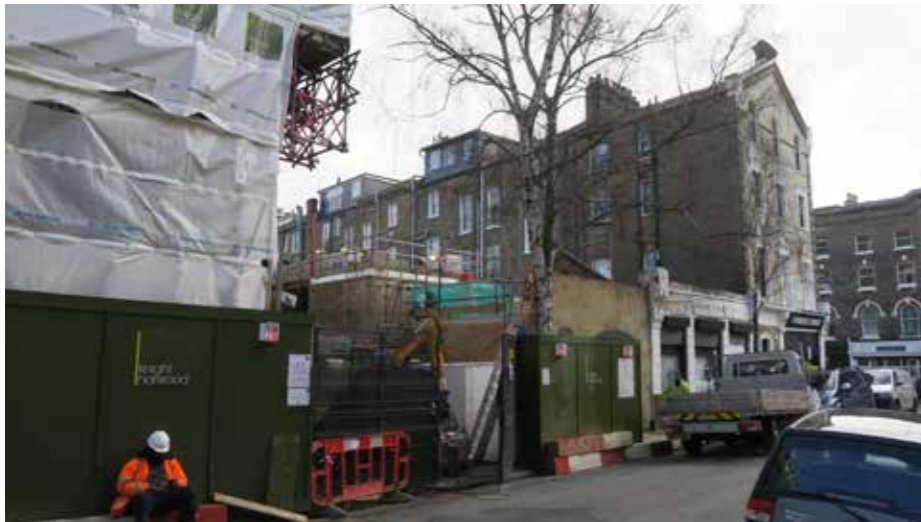
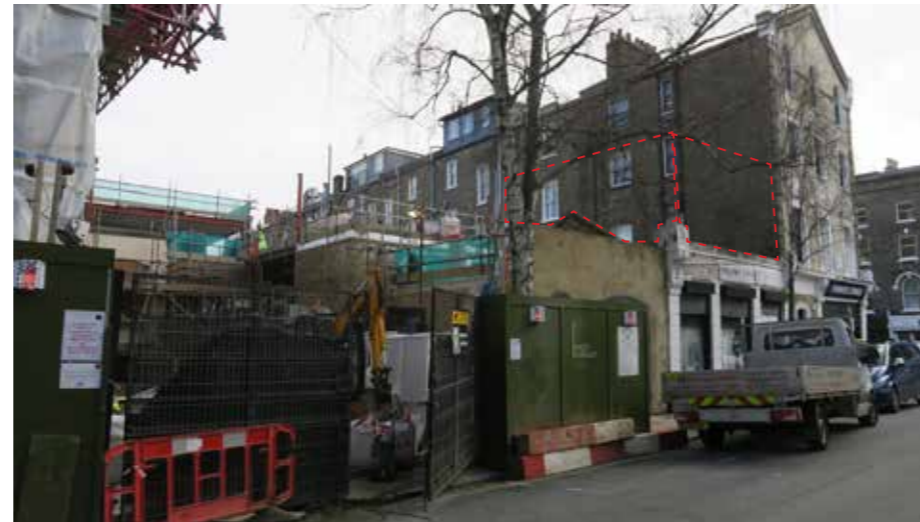
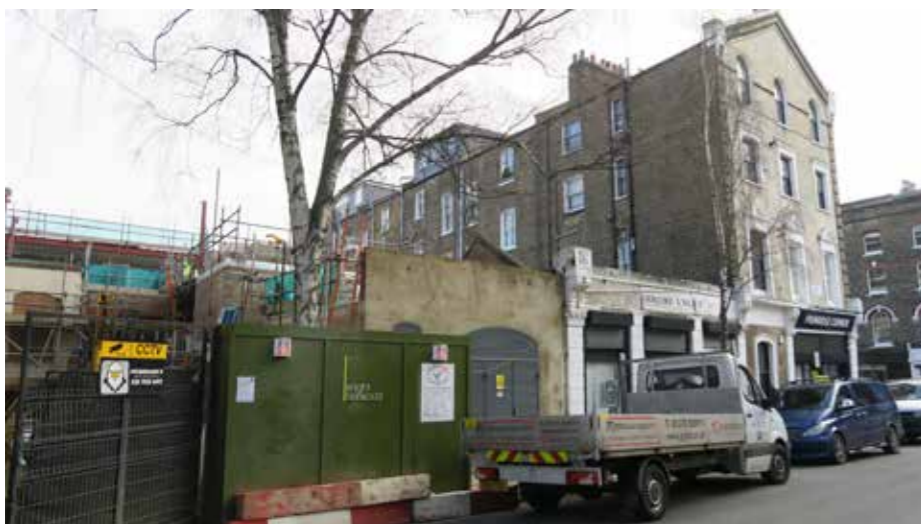
The following views of the north side of Erskine Road taken at various intervals clearly show both the current development works that are taking place as well as the considerable 23m gap that exists between Leeder House and No. 91 Regent's Park Road.

What is evident here is the extensive views across the rear elevations of Nos. 93-107 that can be seen at various points along Erskine Road through a wide vantage point.

The proposed revised lower and less bulky extension above the laundromat will only impinge upon this view to a minor extent. The greater part of the view of the rear elevations from Erskine Road will remain open.

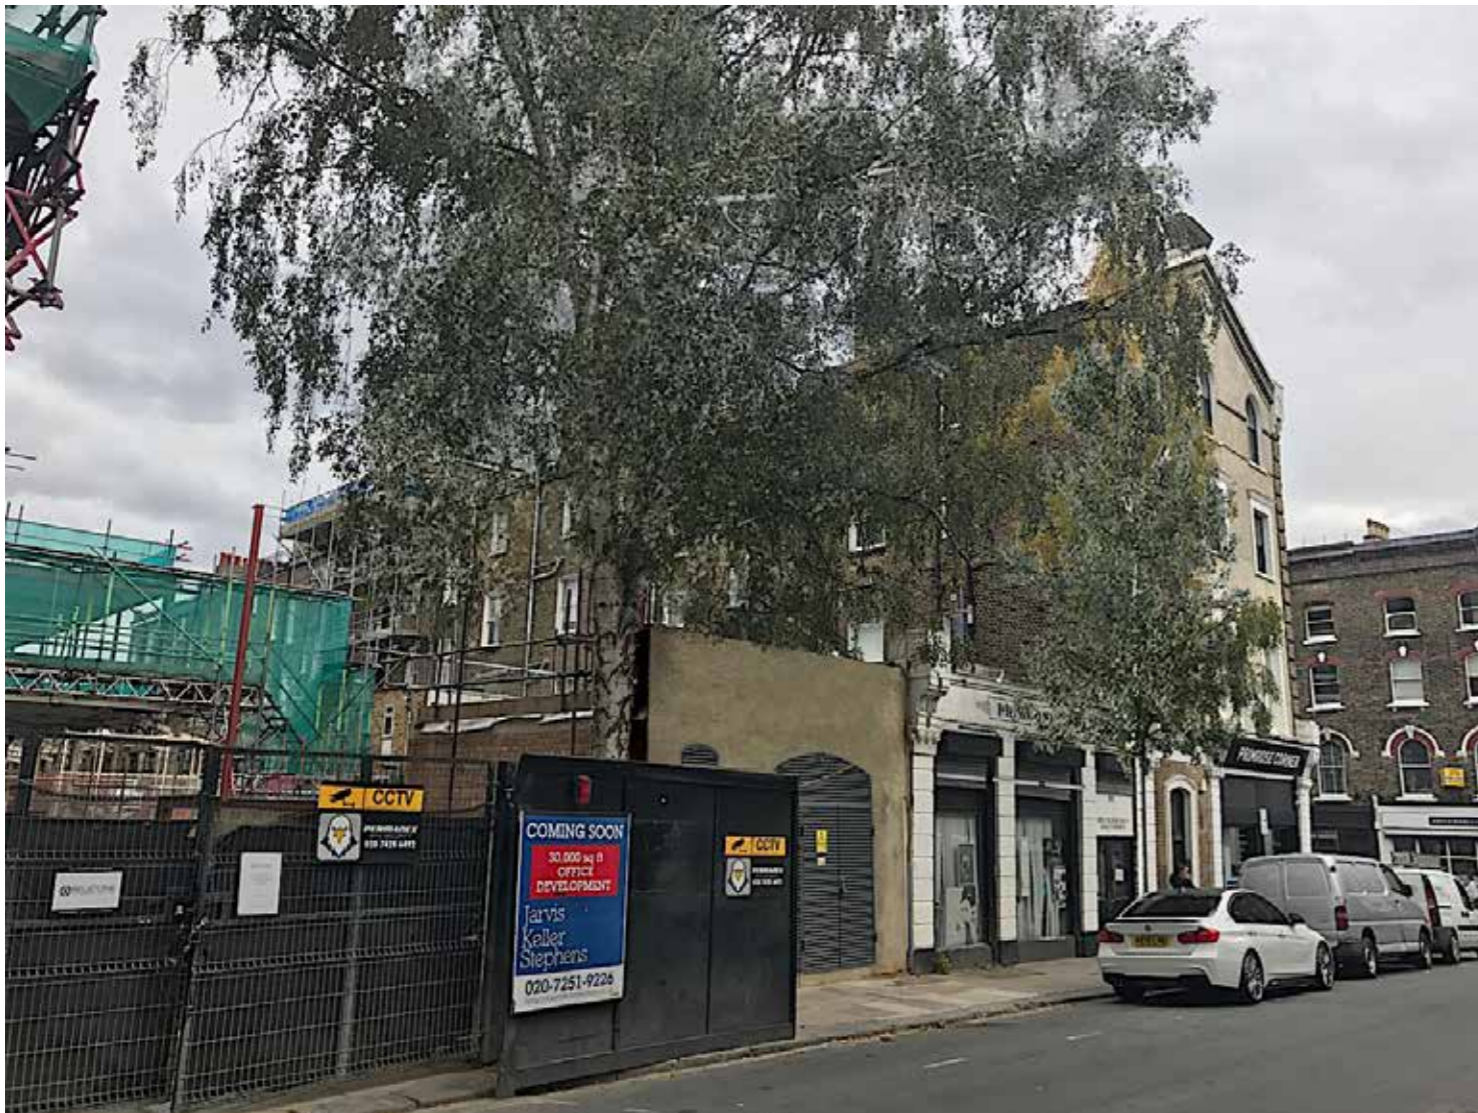
What is immediately noticeable is the extent by which the existing 2 Birch trees (in full leaf cover) already obscure the view of the rear elevations to Nos. 91-109.

Existing View

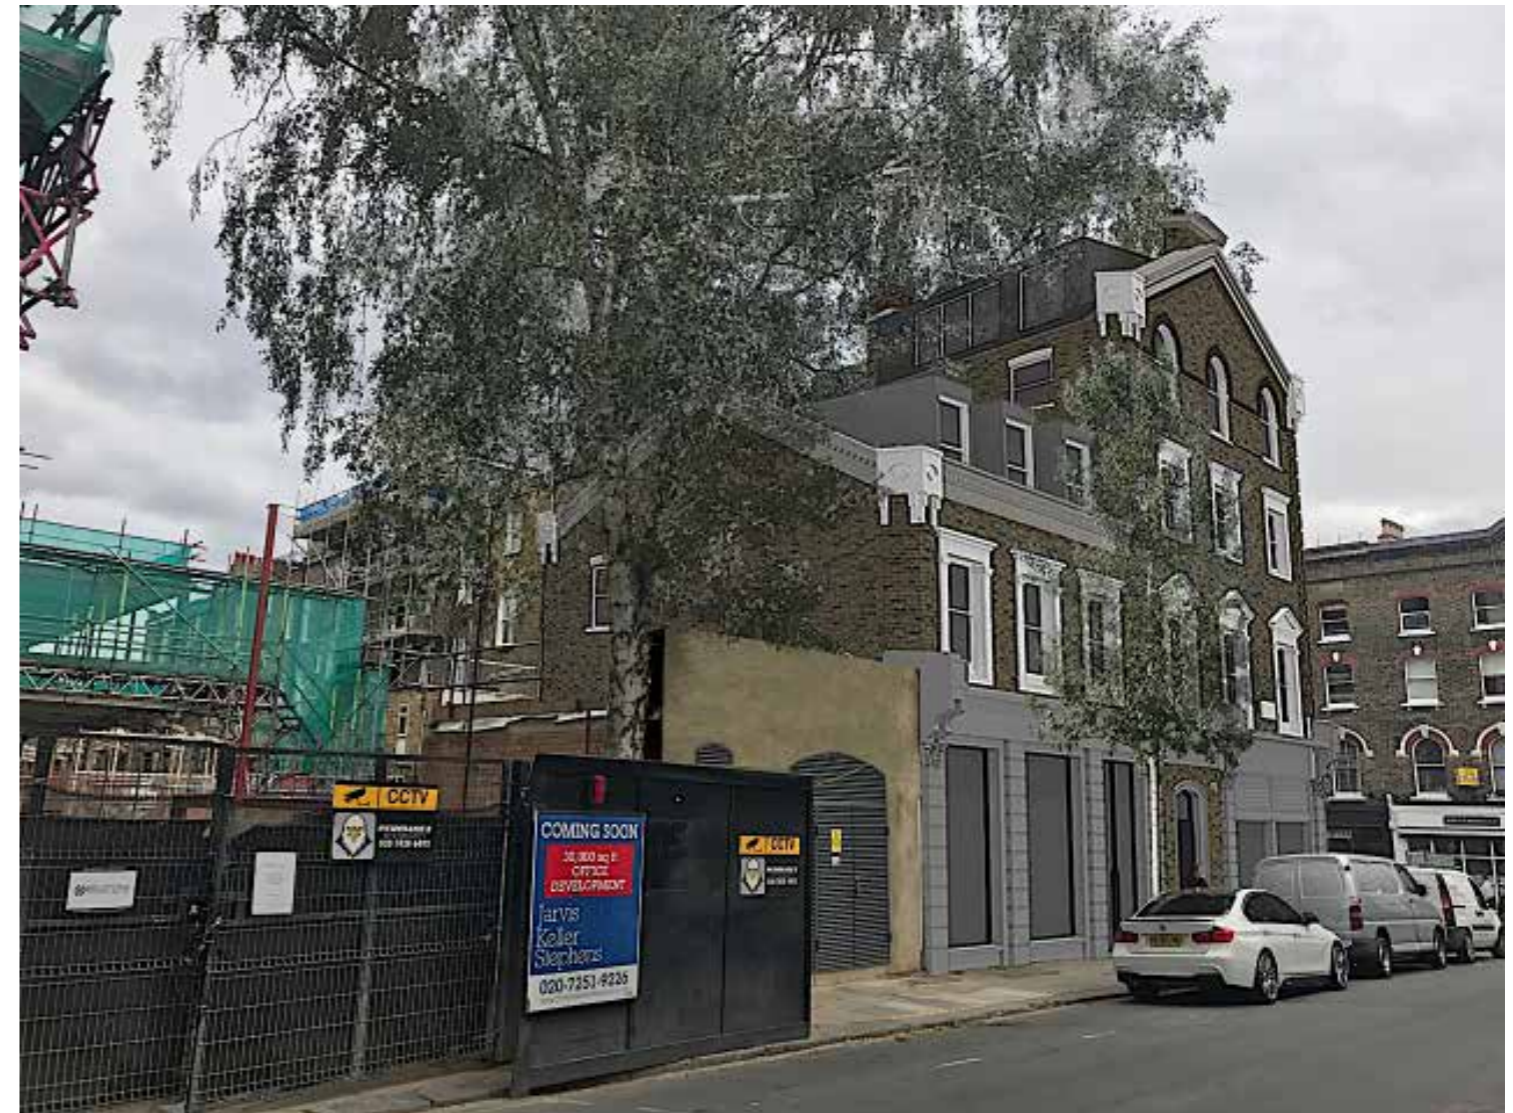
With this in mind, with the proposed extension, there is still a sense of openness and a generous sized gap that offers a reading and view of the rear facades to Nos. 91-109.

Proposed View

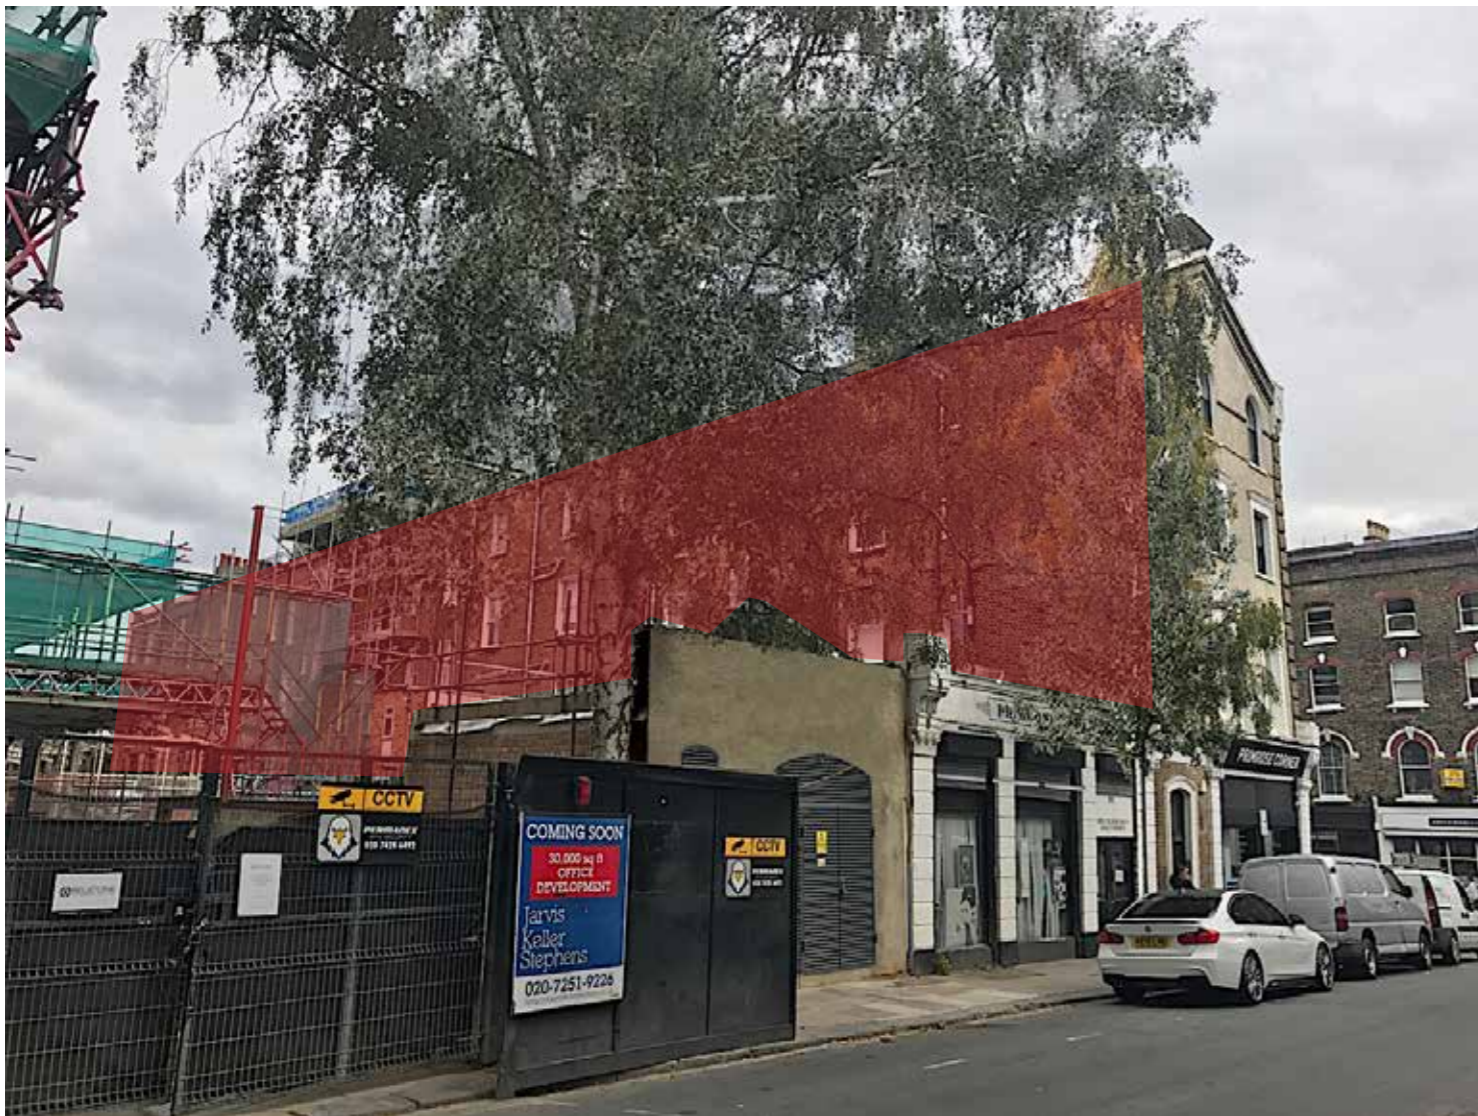
If we ignore the impact that the 2 trees have in already obscuring the view to the rear elevations of Nos. 91-107, the following images highlight the portion of rear elevational view lost as a result of the proposed extension.

Existing View

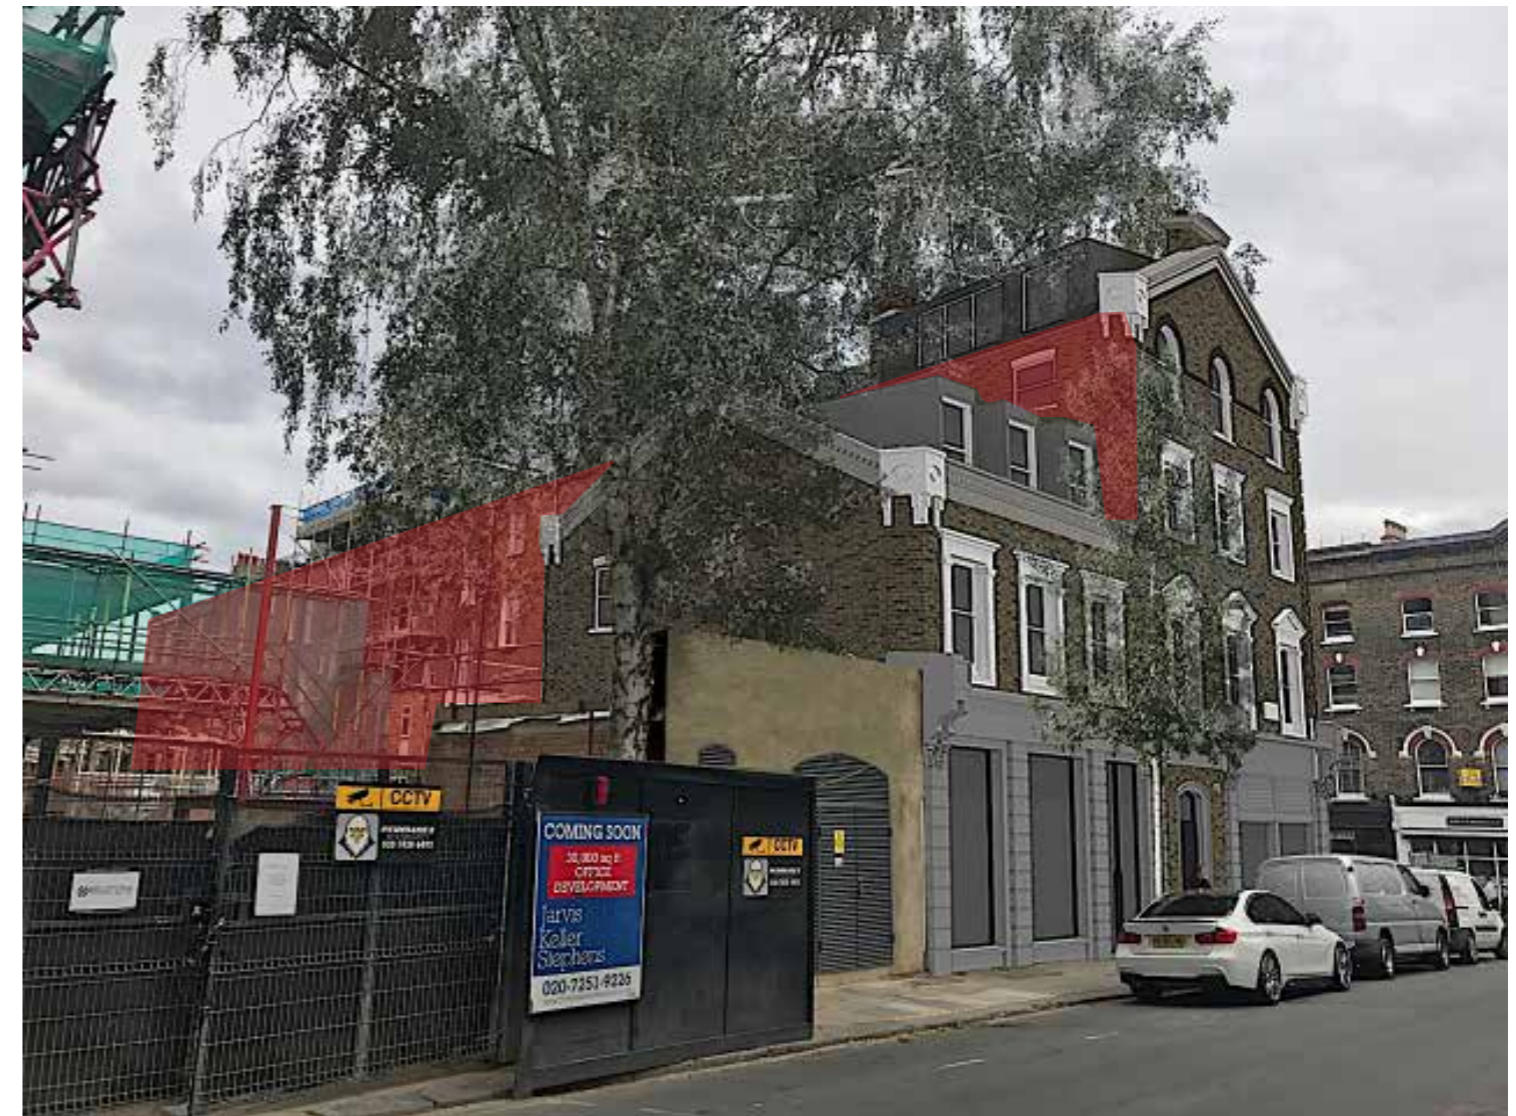
Proposed View

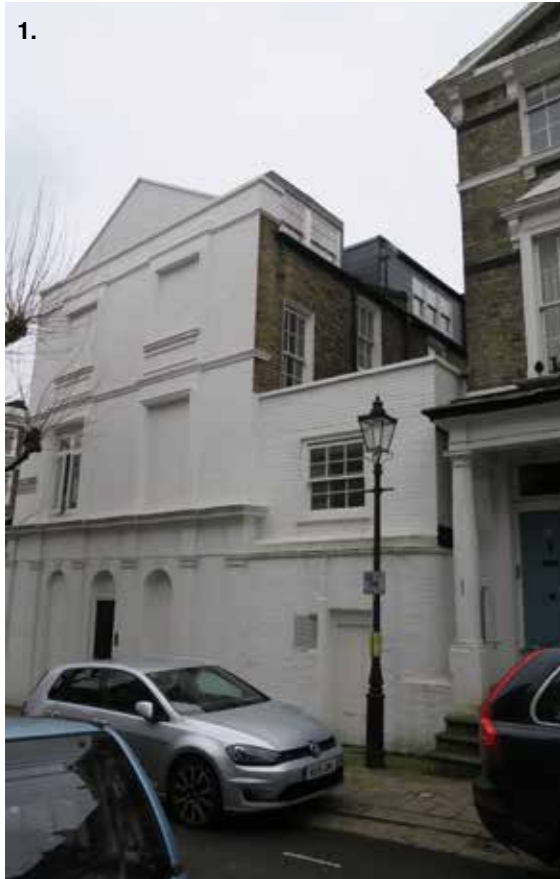
1. Two-storey infill side extension (possibly original) at the corner of Chamberlain Road & Regent's Park Road (North Side). The gap between the buildings is fully infilled.

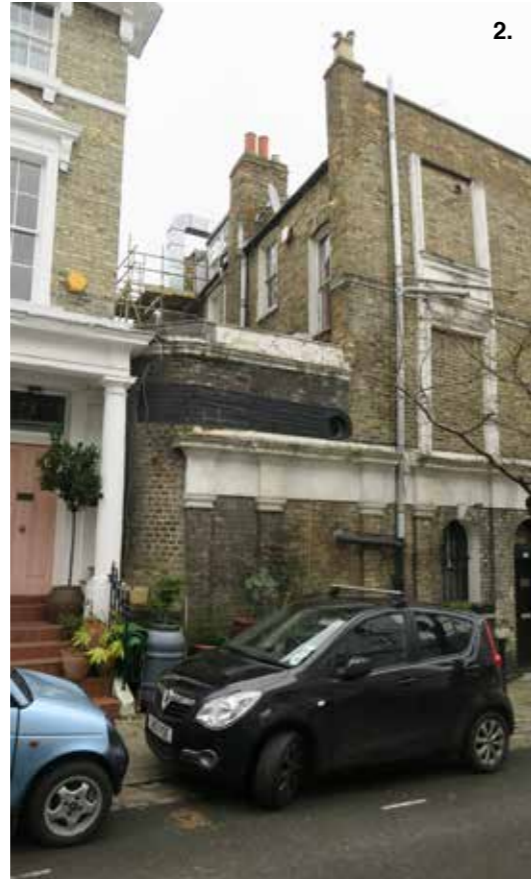
2. Original two-storey extension at the corner of Chamberlain Road & Regent's Park Road (South side). The gap between buildings is fully infilled.

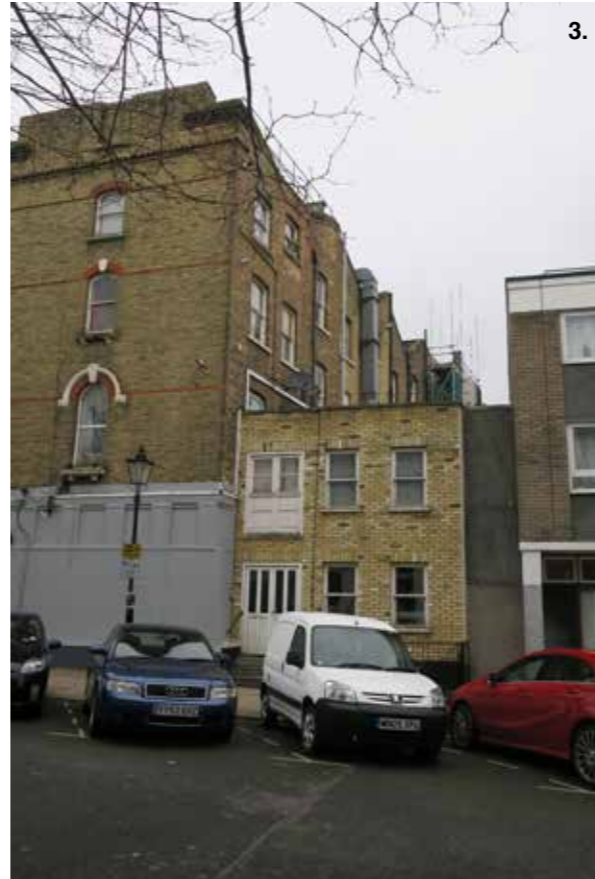
3. Recent two-storey side extension at the corner of Sharples Hall St. & Regent's Park Road (North Side). The gap between the main buildings is fully infilled.

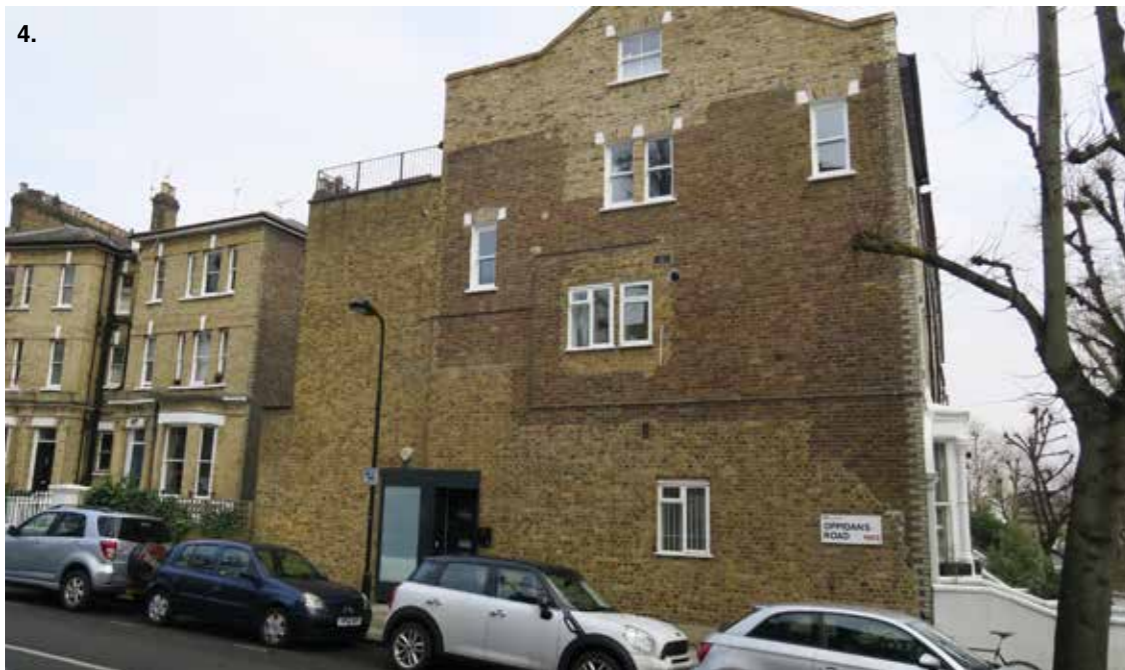
4. Three-storey side extension at the corner of Oppidans Road & Ainger Road (North Side). Approximately half the gap between the buildings has been infilled.

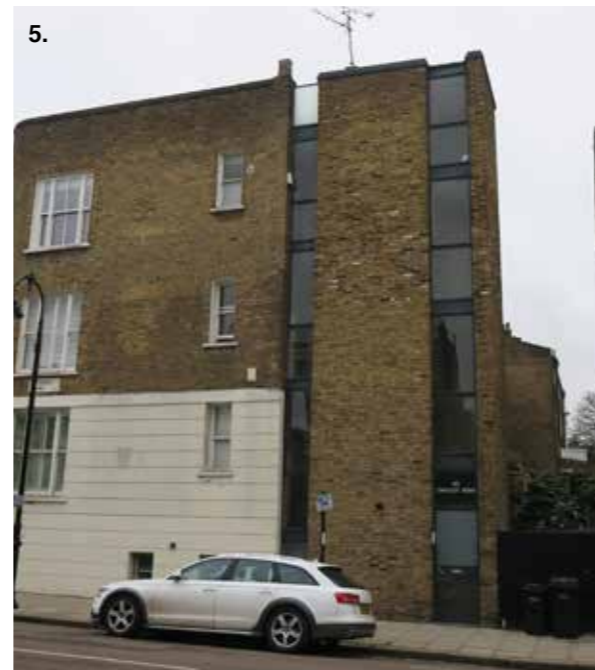
5. Three-storey side extension at the corner of Chalcot Road & Fitzroy Road (North Side). Approximately 66% of the gap between the main buildings has been infilled.

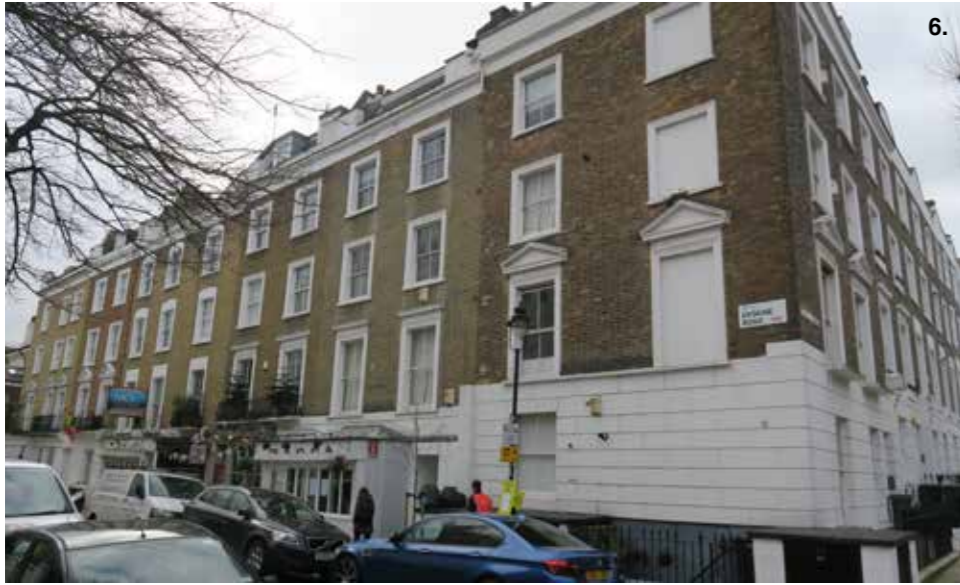
6. Corner of Erskine Road & Ainger Road (South Side).
No gap was created when the development was first completed.

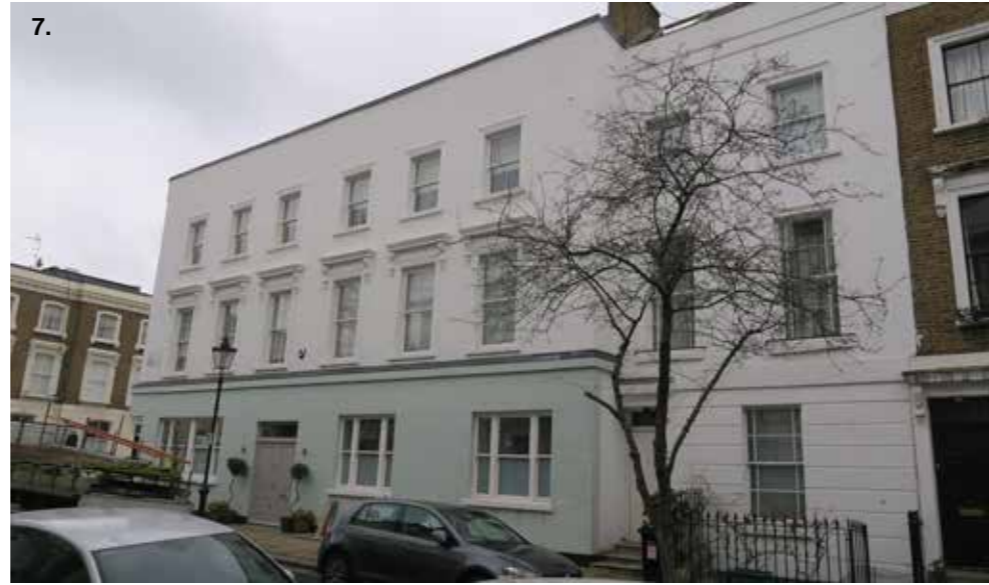
7. Three-storey side extension (possibly original) at the corner of Chalcot Road & Edis St. (North Side).
