Project 135-RVH

Rose Cottage, Vale of Health  
London, NW3 1AX

Drawing Title  
Existing Chimney at Ground Floor

Drawing No.  
CF-DR-135-1-2001-C

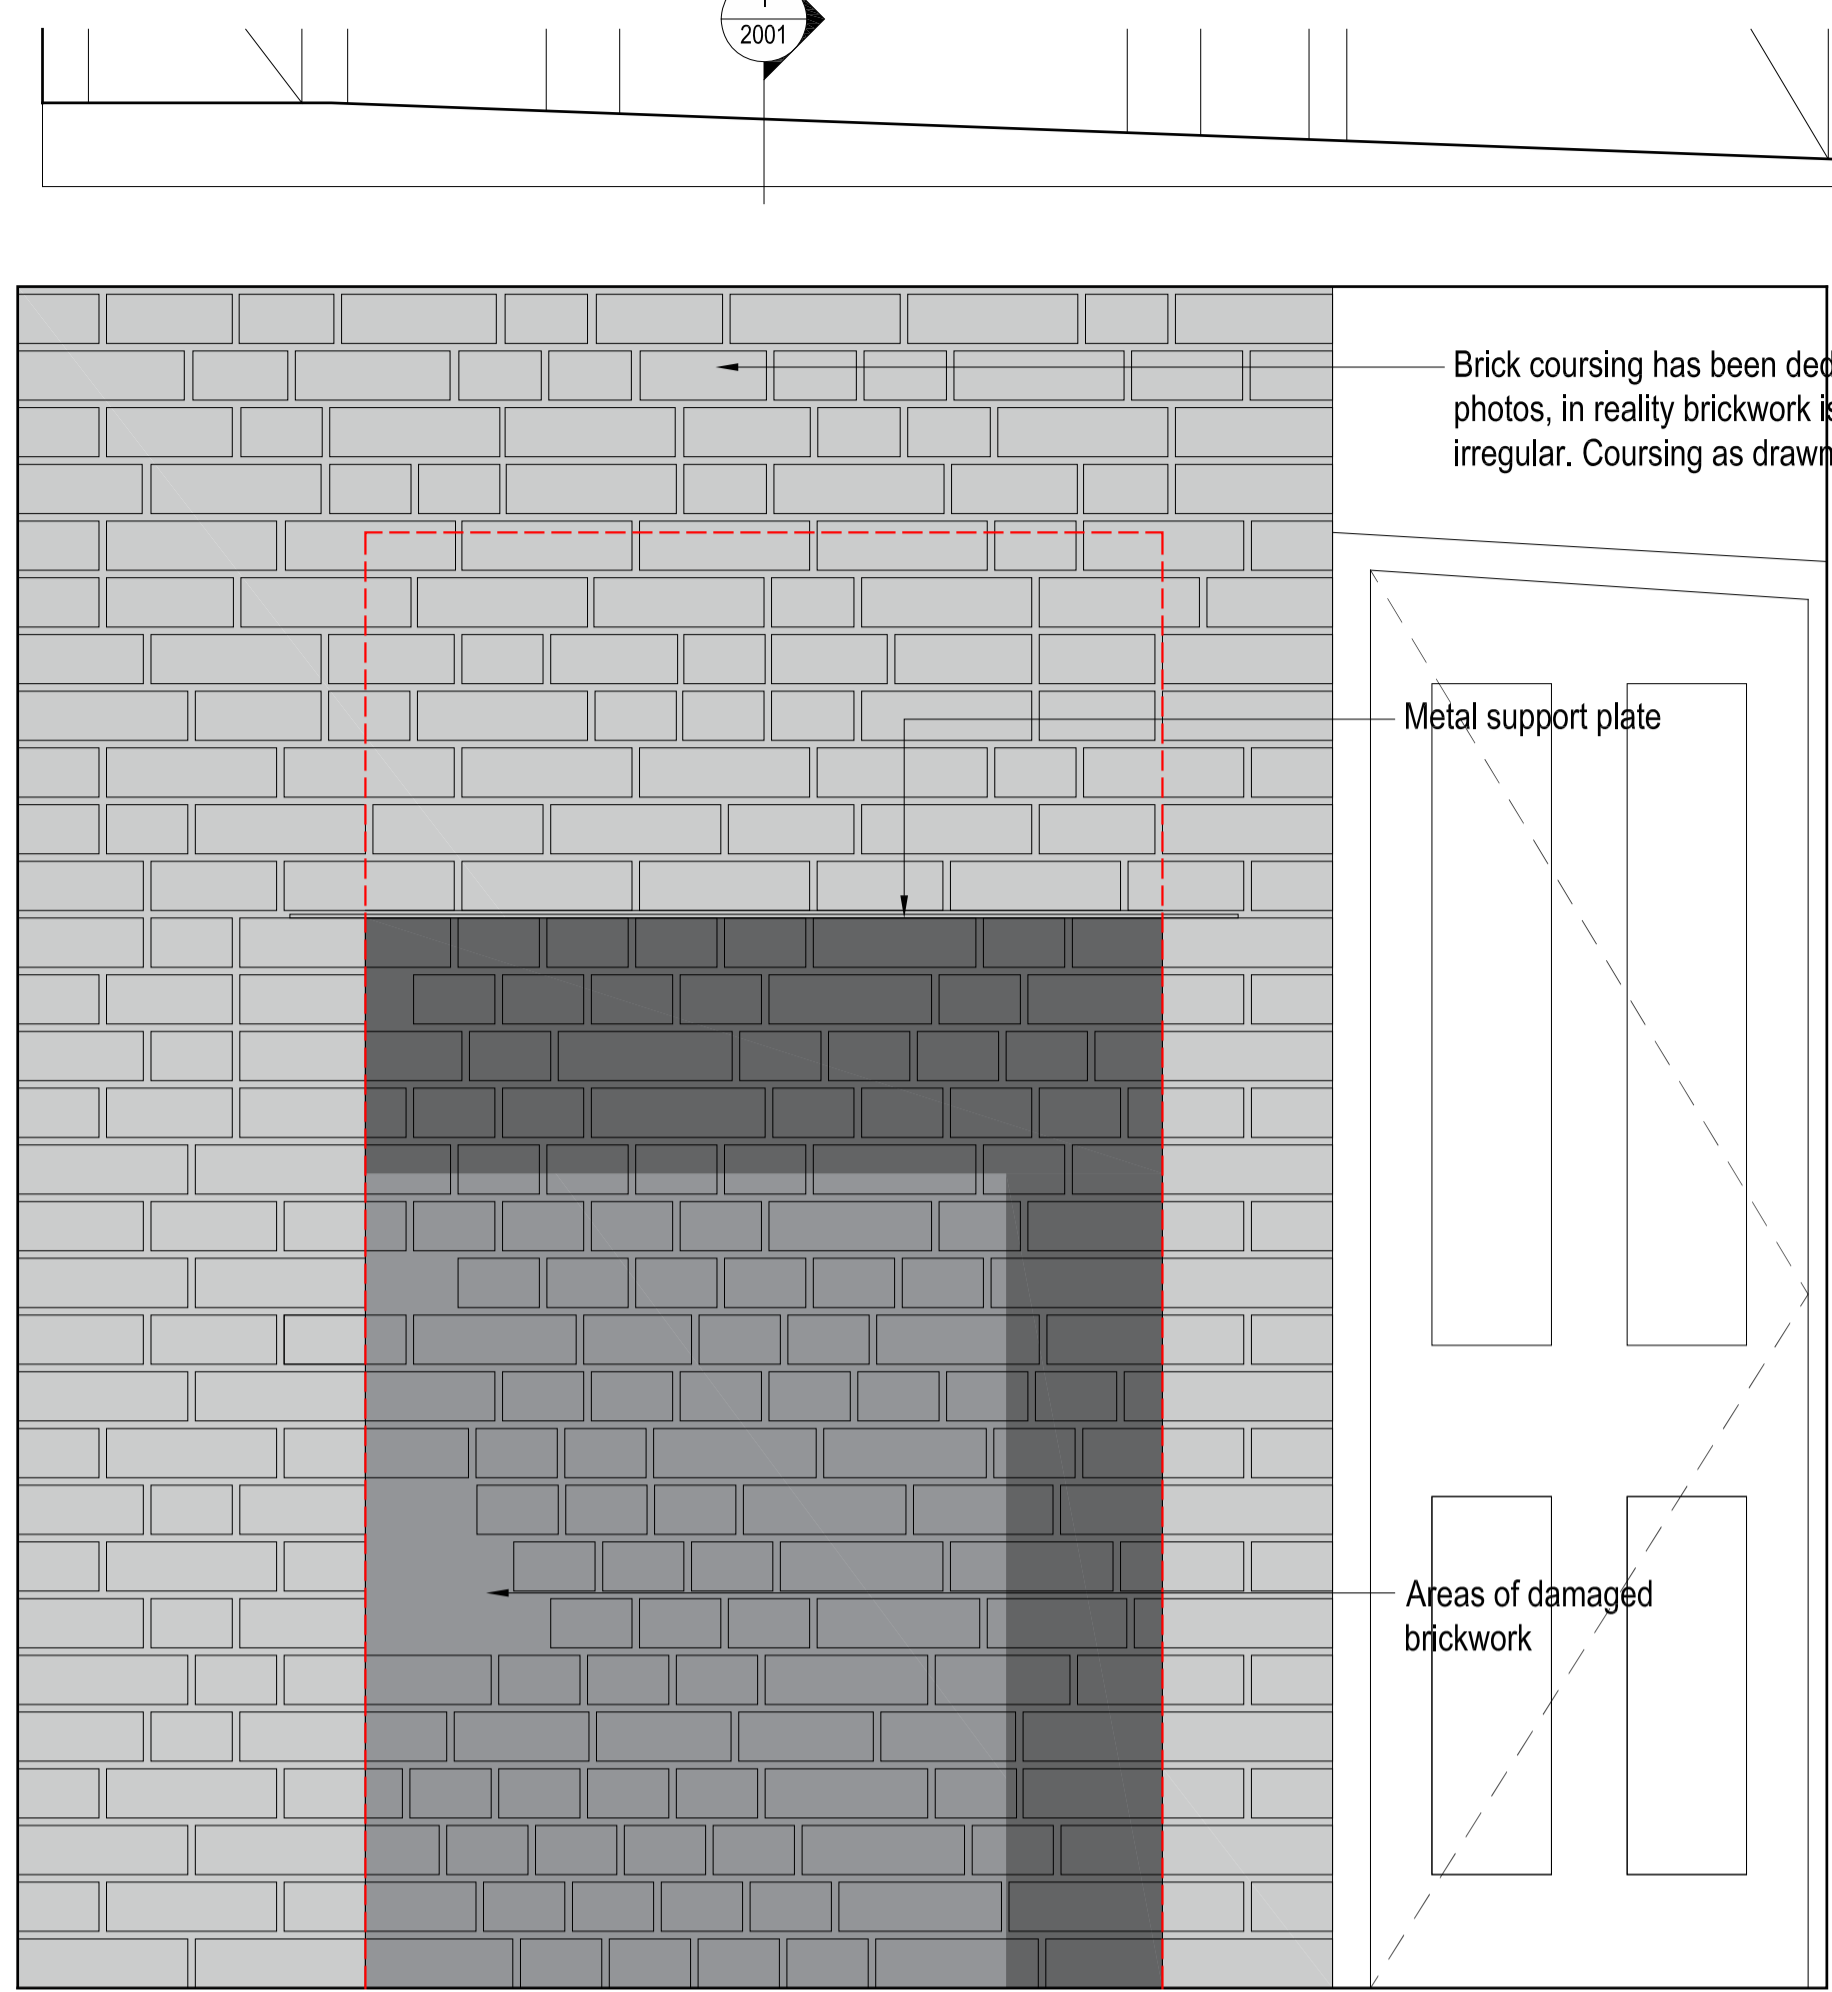
2 ELEVATION OF CHIMNEY  
1:10

Brick coursing has been deduced from photos, in reality brickwork is more irregular. Coursing as drawn is indicative

Metal support plate

Areas of damaged brickwork

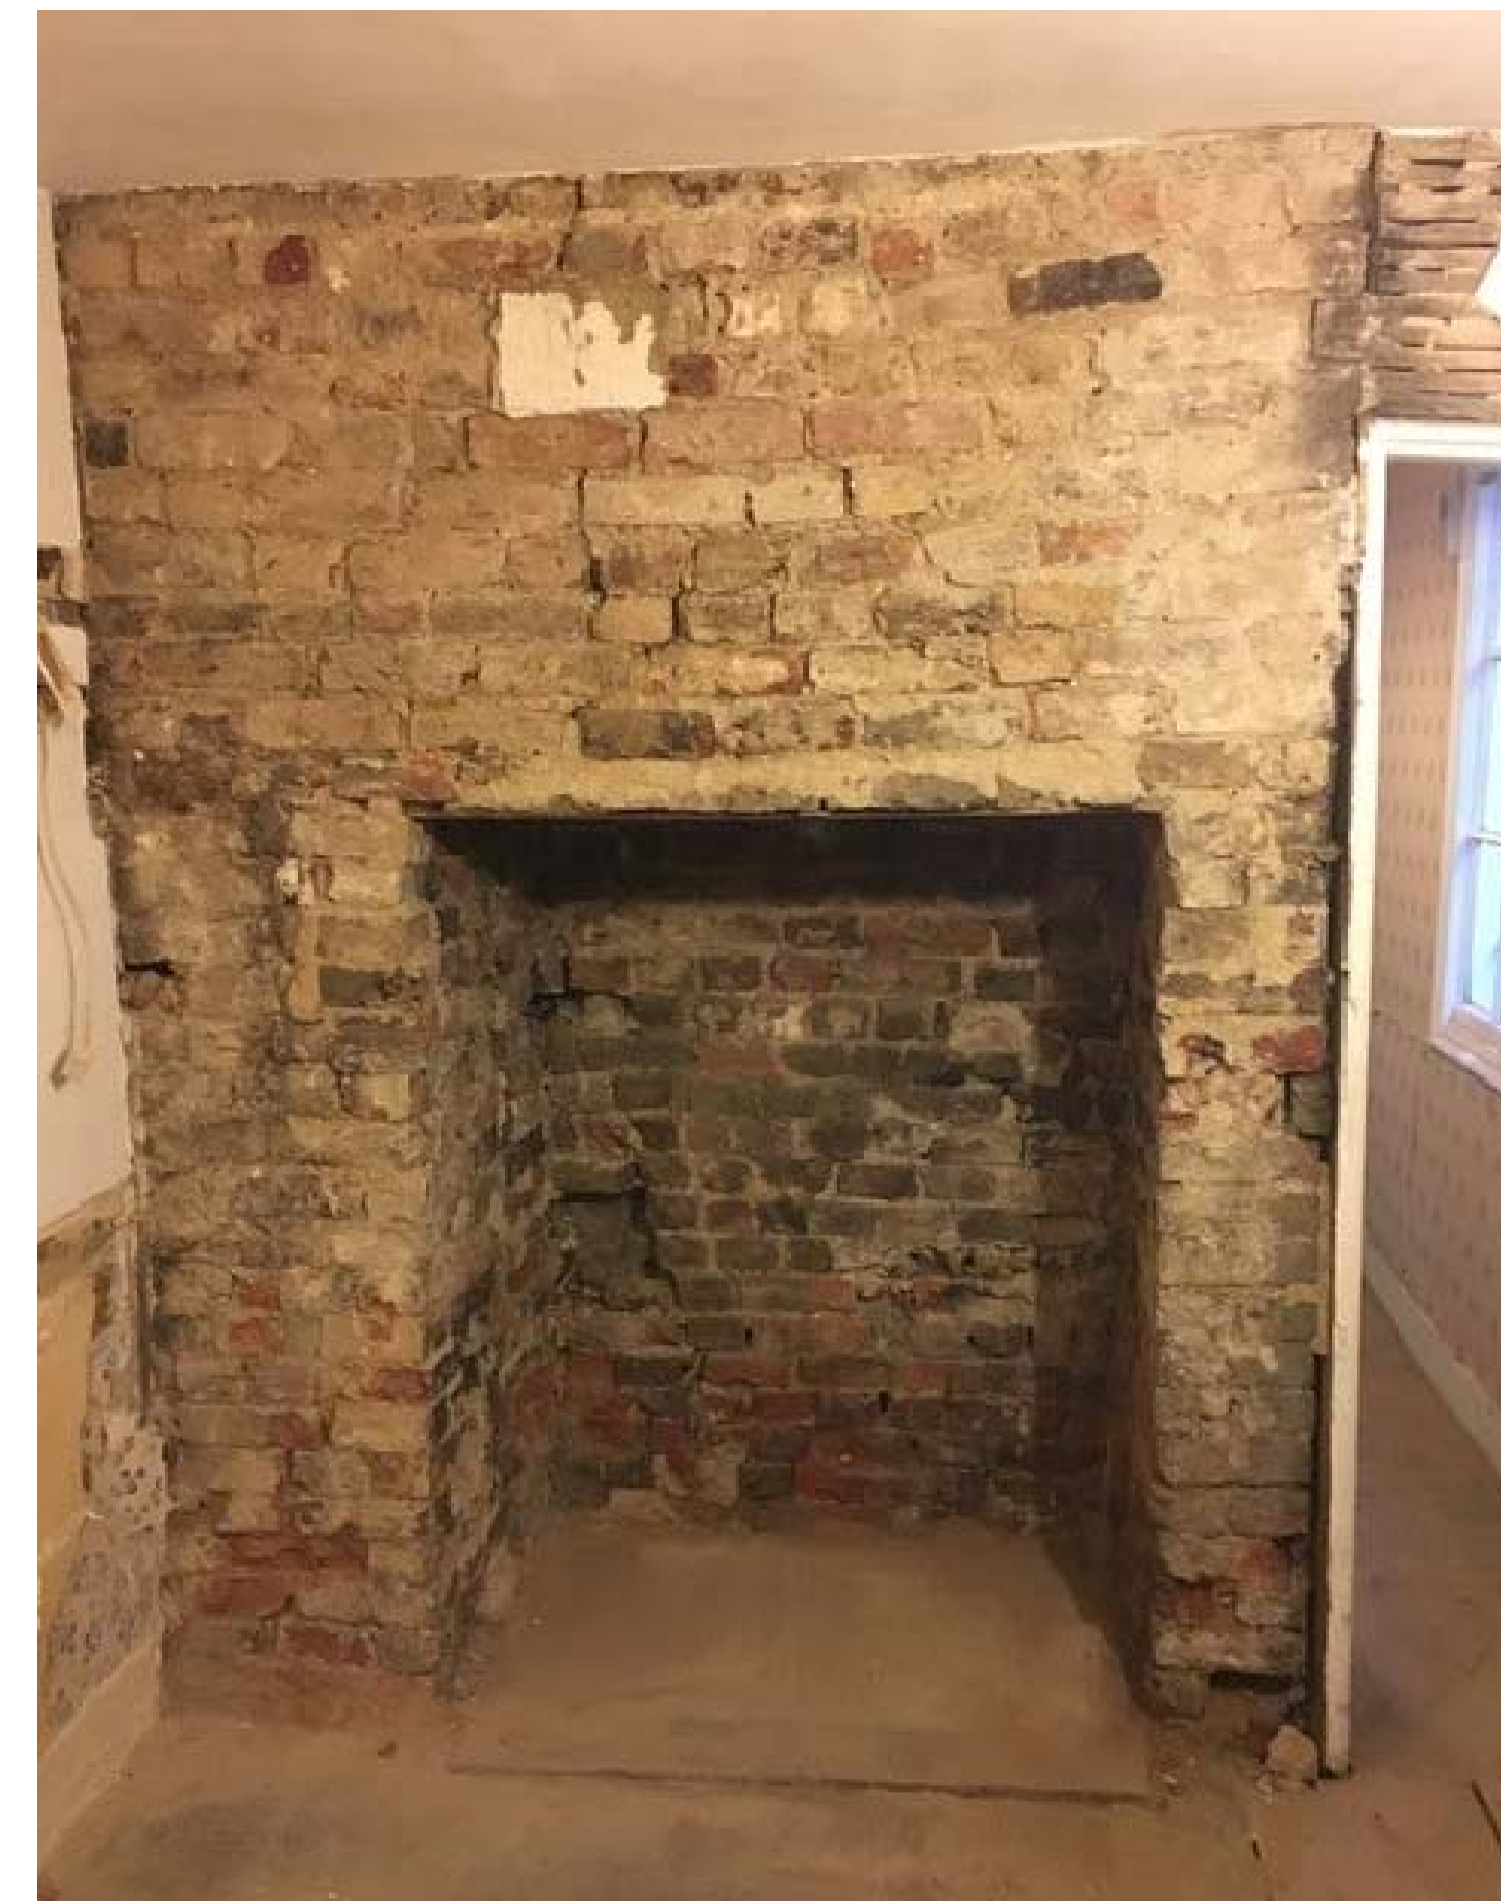
4 PHOTO OF EXISTING  
Elevation from kitchen

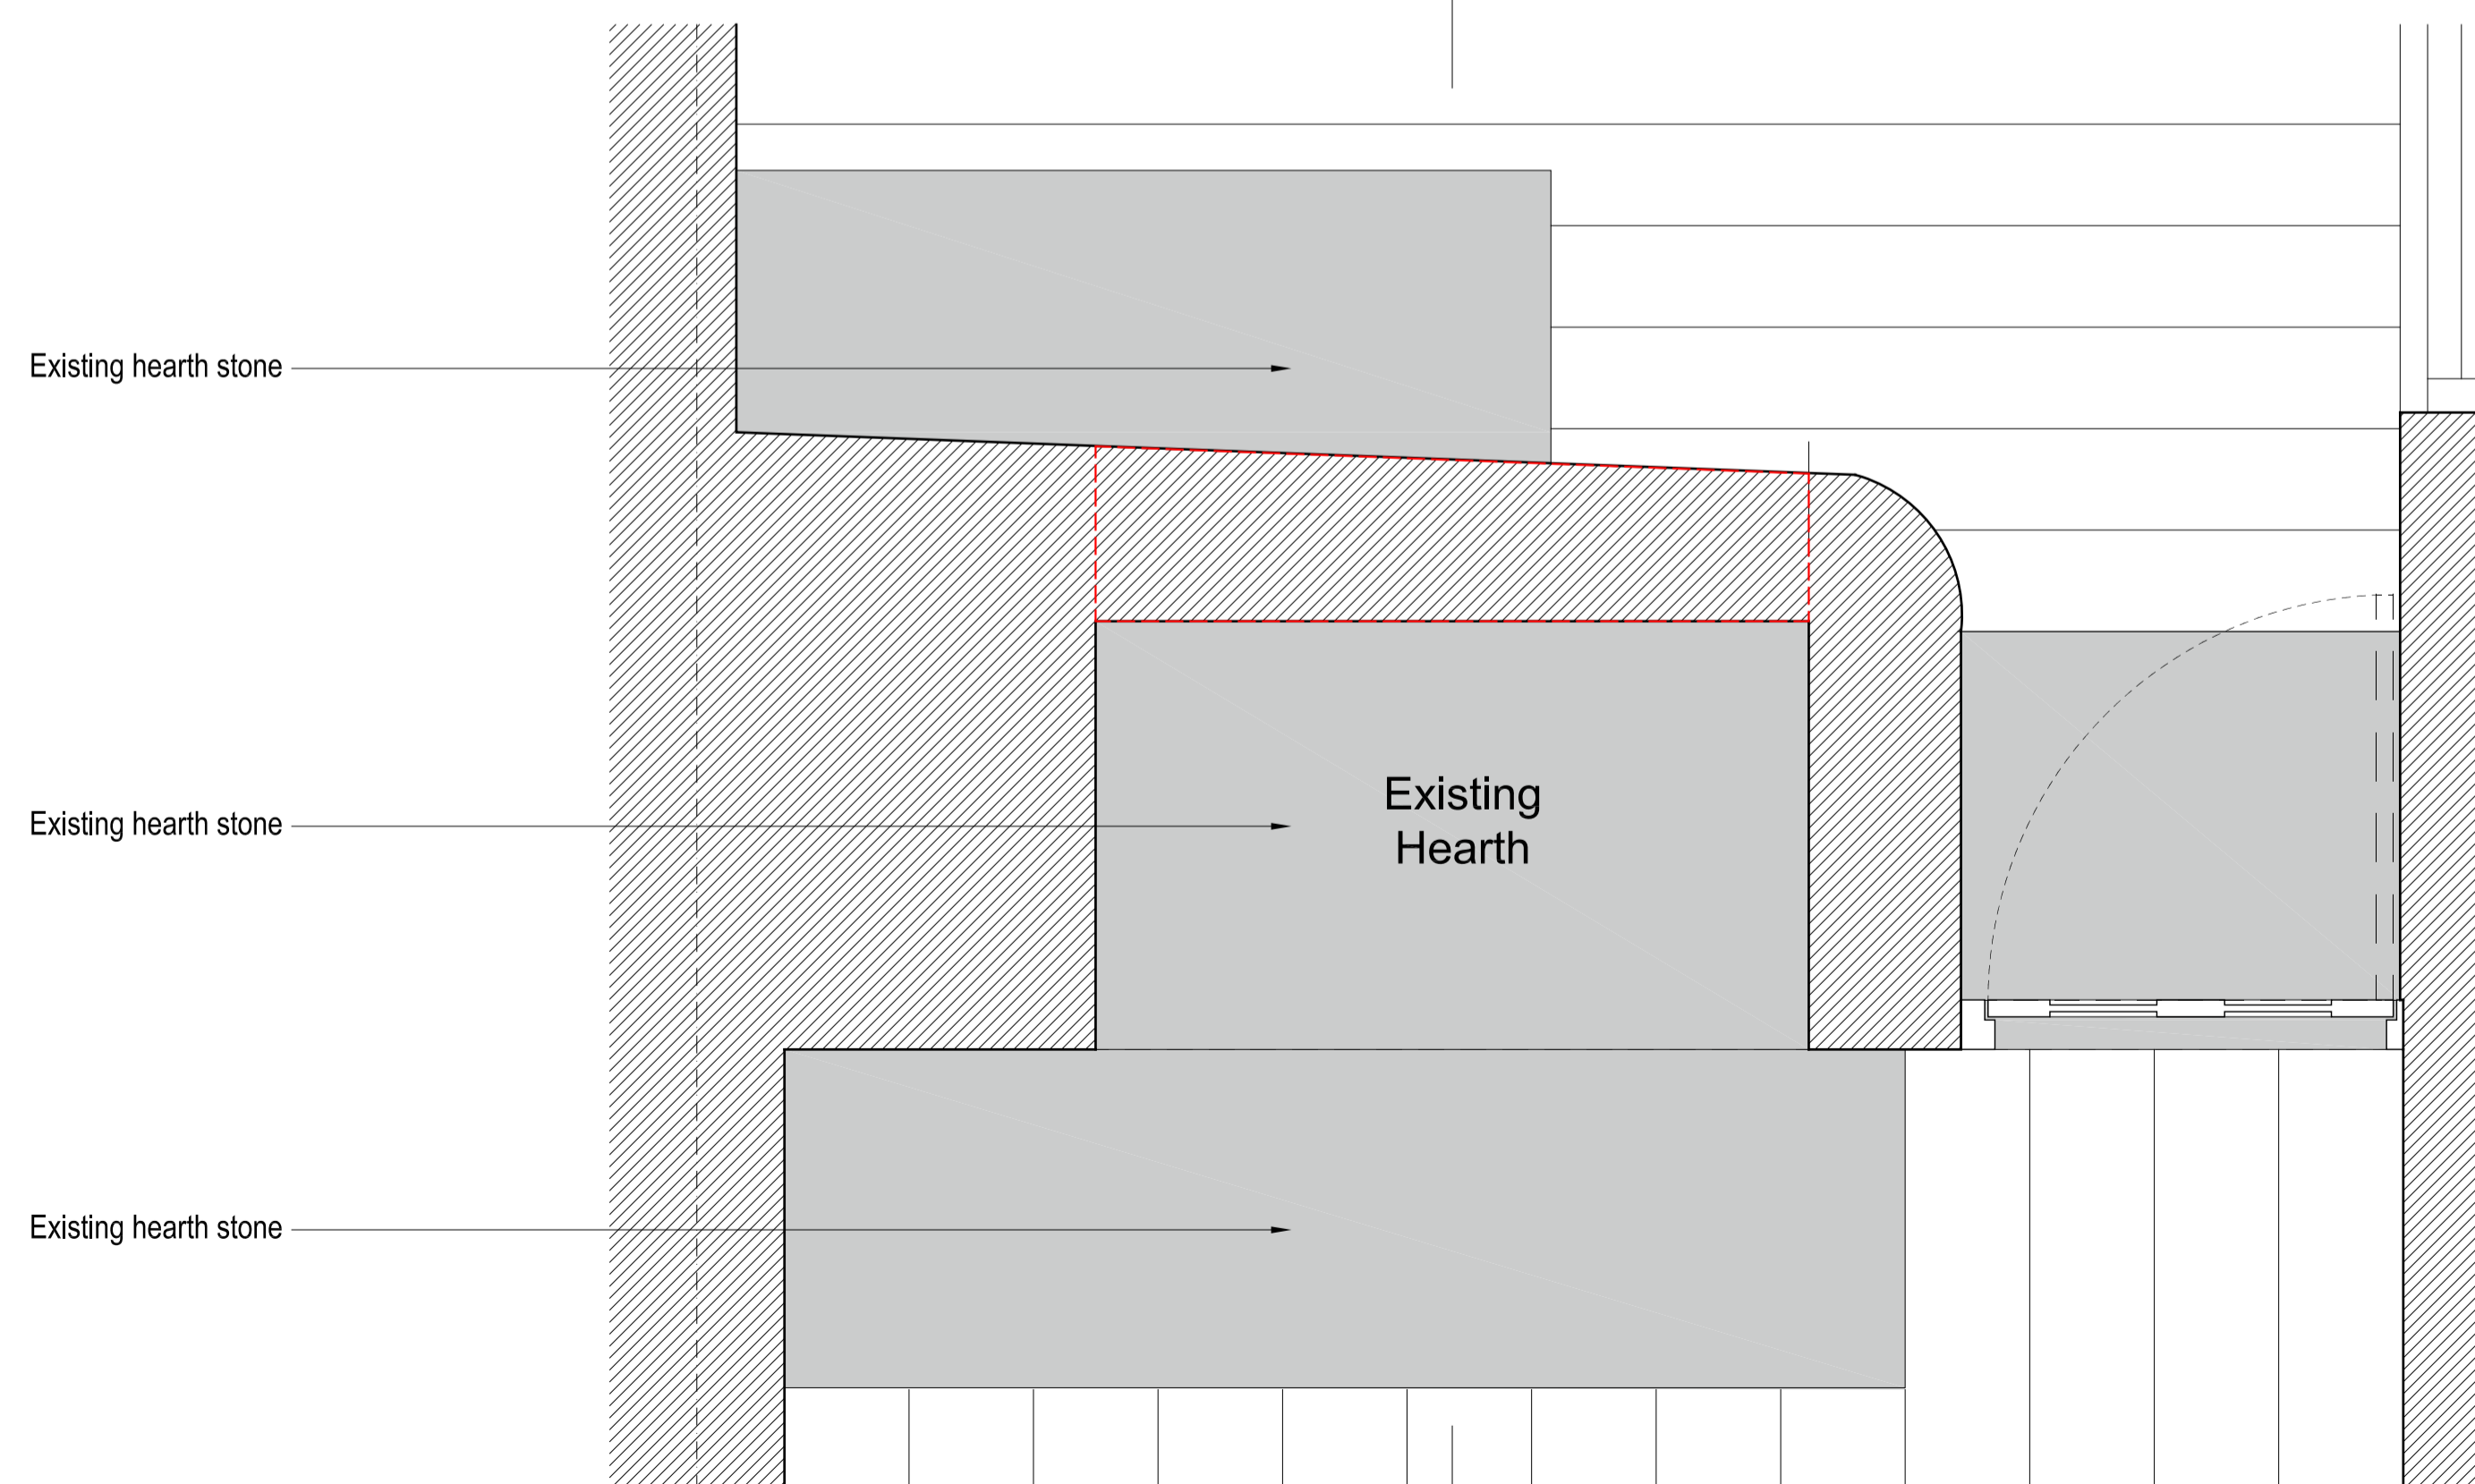
3 PLAN OF CHIMNEY  
1:10

Existing hearth stone

Existing  
Hearth

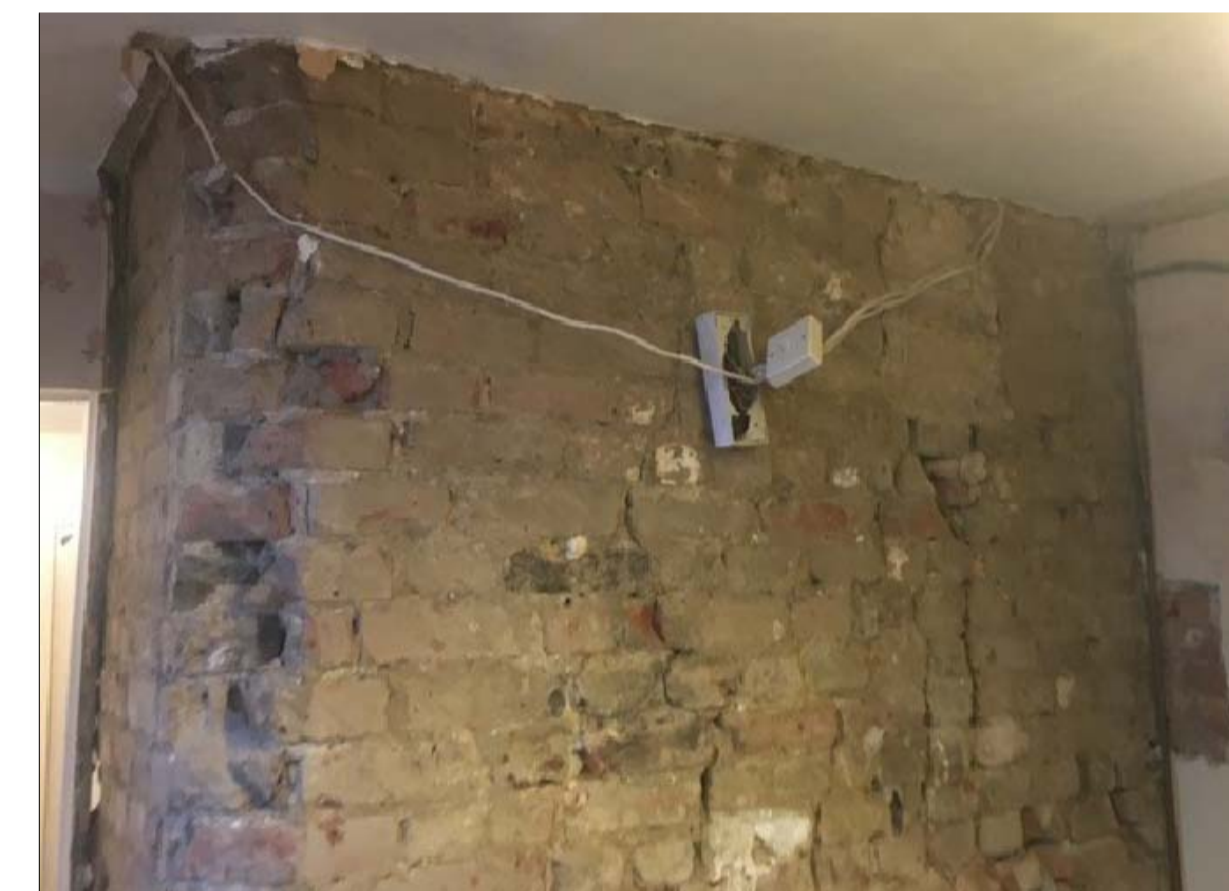
5 PHOTO OF EXISTING  
Elevation from sink room (upper portion)

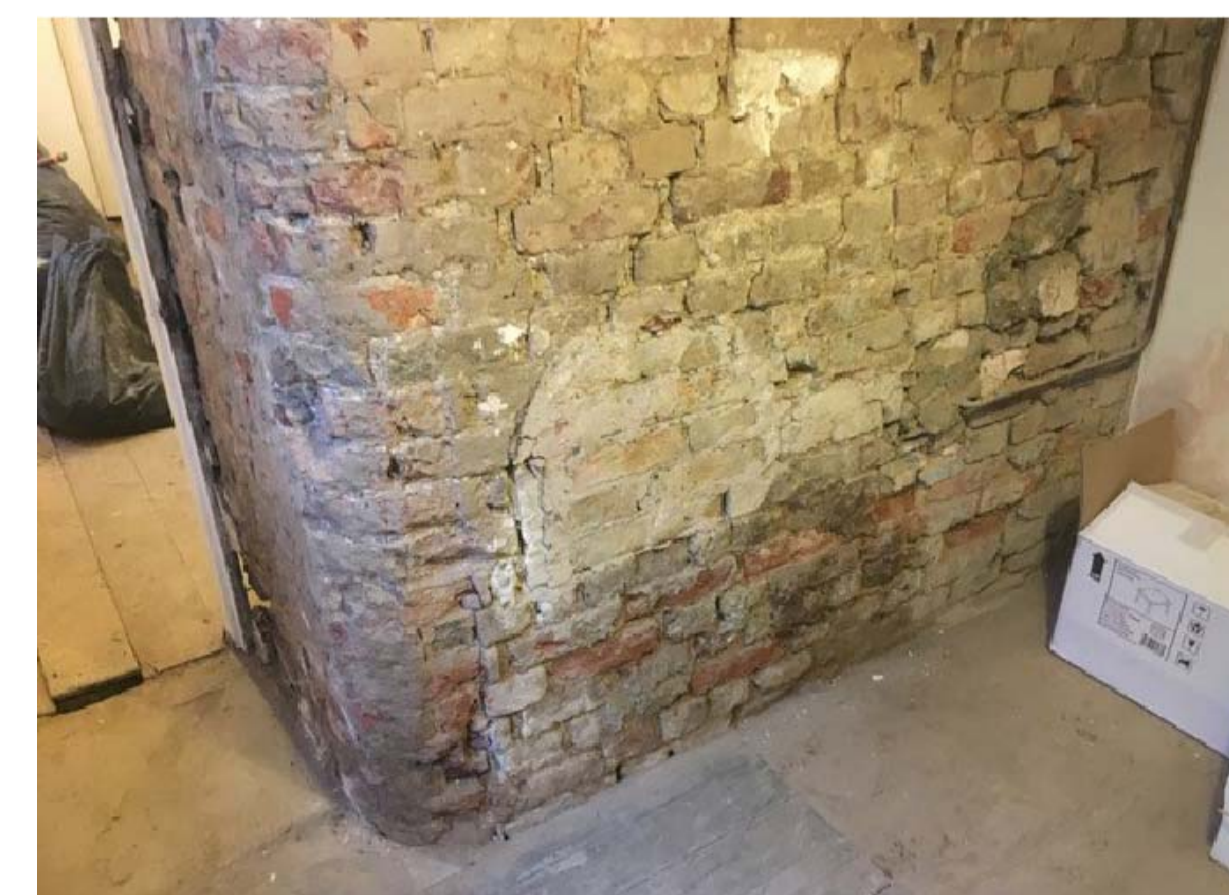
6 PHOTO OF EXISTING  
Elevation from sink room (lower portion)
