RE: 2017/4156/P – ATHLONE HOUSE, HAMPSTEAD LANE, LONDON, N6 4RU

APPLICATION FOR THE APPROVAL OF DETAILS RESERVED BY A CONDITION – CONDITION 4C SAMPLE PANELS (ROOF TILES)

Annex A Photos of Sample Panels

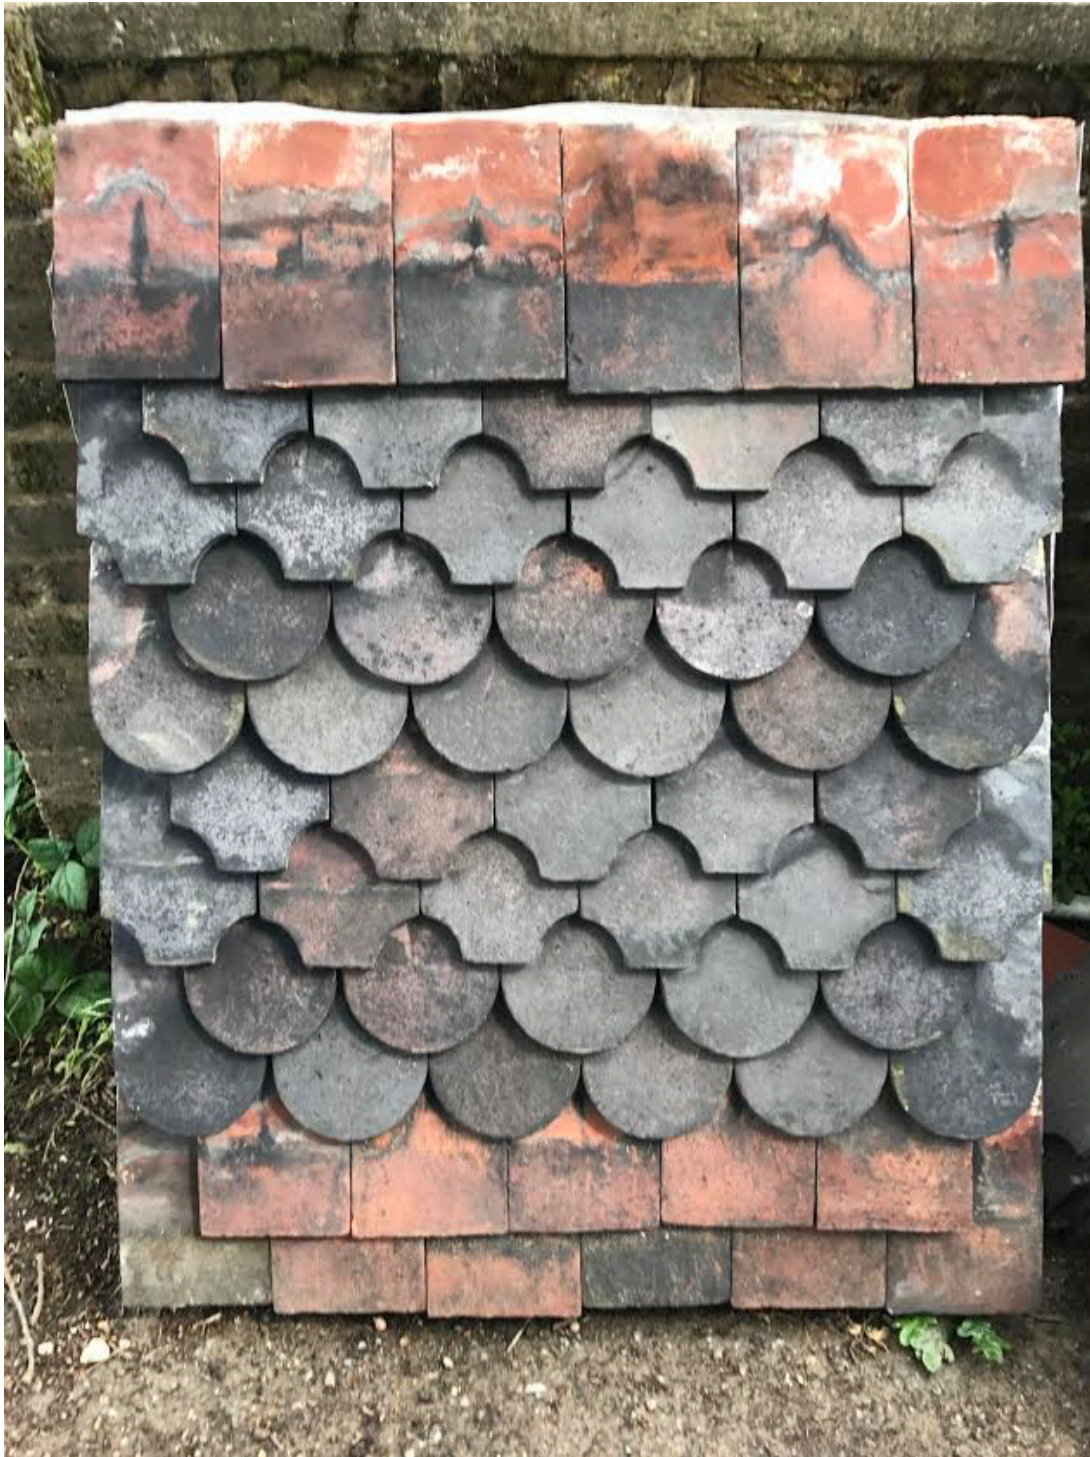
1. Cleaned Existing Tile Panel

The first photo at Annex A shows the panel of the existing roof tiles which have been cleaned using jet washing. Using abrasive methods to further clean, or to jet wash at close range, resulted in damage to the tiles, creating a friable surface. This can be seen in the second photo at Annex B.

As can be seen from the photos there is a considerable contrast between the cleaned tiles and the new tiles. Options to mix existing tiles with new (in order to secure fixing, end tiles and replace broken tiles) have also been explored. However, this will result in highly visible and unusual pattern which will not replicate the pattern of the original roof. Therefore, we propose that we will only use new tiles on the roof.

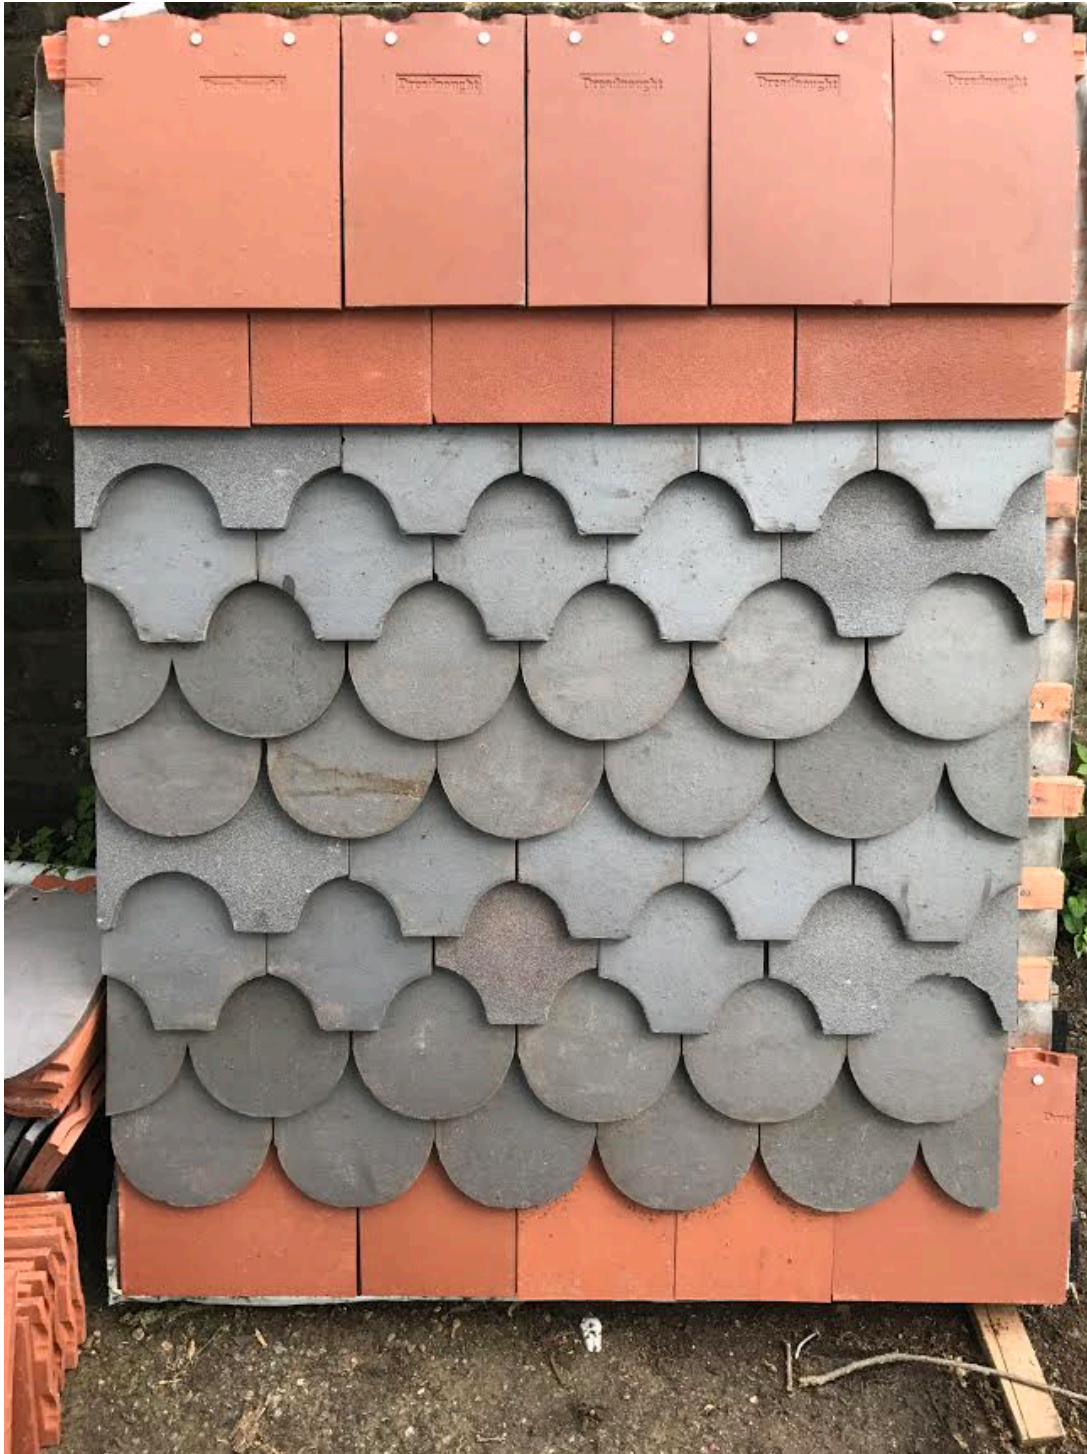
3. New Tile Panel

New tiles have been sourced to match the existing which are manufactured by Dreadnought, which are shown on the third photo at Annex A.
