169 West End Lane, NW6 2LH Basement Impact Assessment 35409.R.002.A.G.RJM May 2018

# Basement Impact Assessment

# 169 West End Lane NW6 2LH

Basement Impact Assessment
Planning reference (TBC)

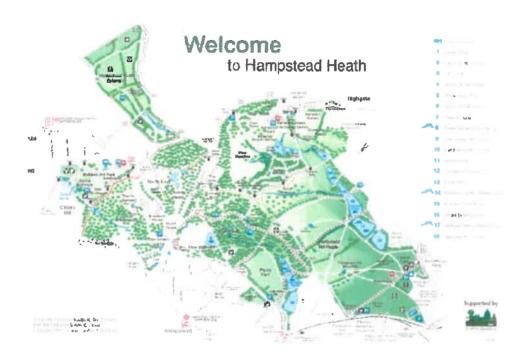
Hampstead Heath Map (LB Camden GHHS figure 13)

NOTE: The site lies more than 1km south

6. Is the lowest point of the proposed excavation (allowing for any drainage and foundation space under the basement floor) close to, or lower than, the mean water level in any local pond (not just the pond chains on Hampstead Heath) or spring line?	No	Site is located >1km south of the Hampstead Heath Pond Chains.

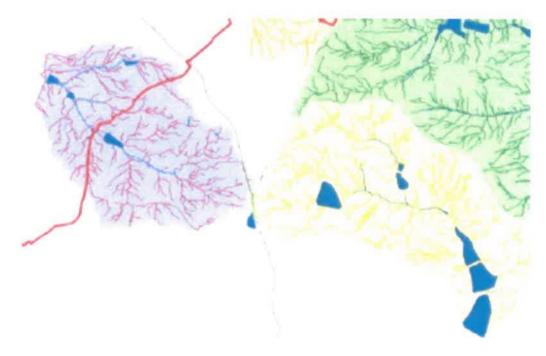
Hampstead Heath Surface Water Catchments & Drainage (LB Camden GHHS figure 14)

NOTE: The site lies more than 1km south

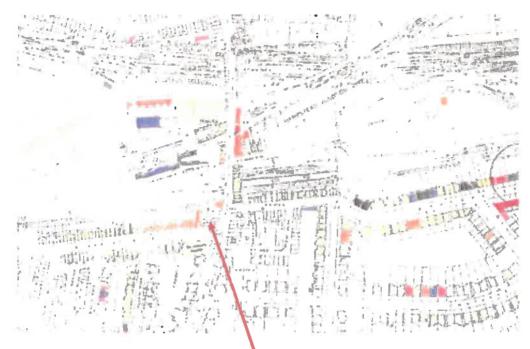
### WW2 Bomb Damage Map Extract

Site location (No damage indicated)

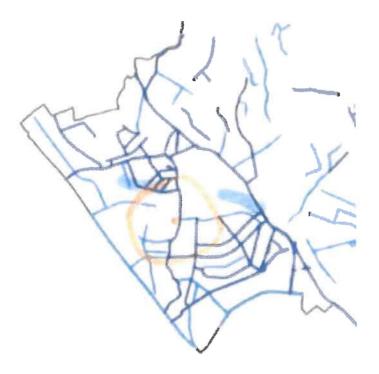
Flooded Streets Map (LB Camden GHHS Figure 15)

The highlighted streets are known to have flooded in 1975 and 2002 in West End Lane but it is understood that remedial actions described in `Flood in Camden` has reduced the risk of reoccurrence.

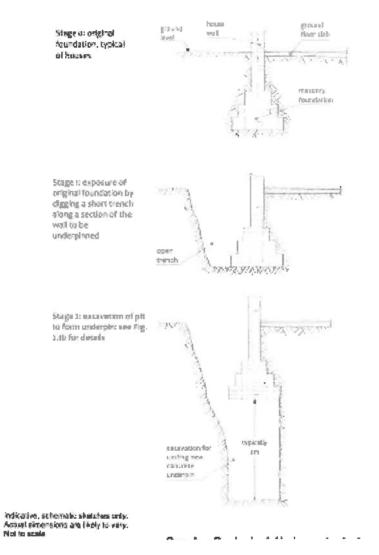
### • Typical underpinning construction sequence (LB Camden GHHS Figure 19)

- 2.3.10. The proposed development will utilise hit-and-miss underpinning methods to increase the foundation depths prior to excavation to form a new floor slab.
- 2.3.11. The outline construction programme will be developed in due course.
- 2.3.12. To conclude, the proposed improvements to the existing basement and lightwell are in full compliance with London Borough of Camden A5 Basement Requirements summarised below.

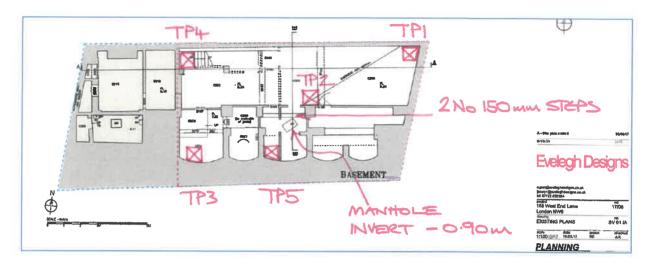
2.1 169 West End Lane Trial pit Location Plan.

5No hand dug pits were excavated to expose the existing foundation details around the footprint of the basement and lightwell.

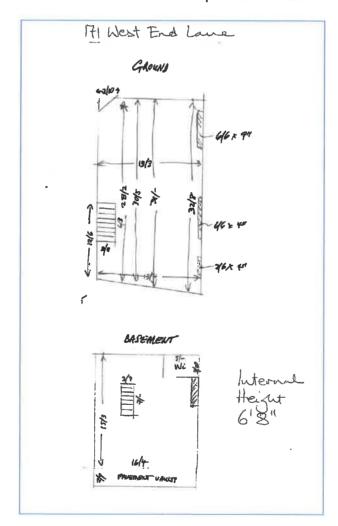
2.2 Sketches of 171 West End Lane.

13. Will the proposed basement significantly increase the differential depth of foundations relative to neighbouring properties?	No	Refer to Appendix 1. Sketch of basement of 171 West End Lane.

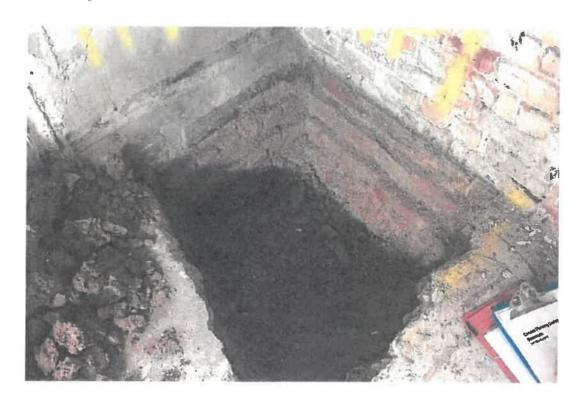
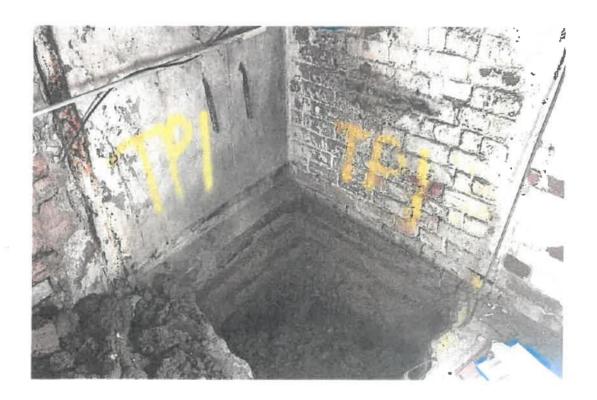
169 West End Lane – Trial Pit 1 (TP1)

Trial Pit TP1 in the north east corner of the existing basement confirmed a 2 brick corbel at 0.30m below existing basement slab level. In Section B-B under the West End Lane frontage, the corbel was founded on a 150mm layer of compacted brick fill over a 50mm layer of dry-packed crushed stone/lean mix concrete. In Section A-A, below the boundary with 171 West Lane, there was a 400mm thick layer of dry-packed gravel of brick and stone. Groundwater was struck in Trial Pit TP1 Section A-A but not in TP1 Section B-B. It is concluded that the water is perched within the gravel footing.

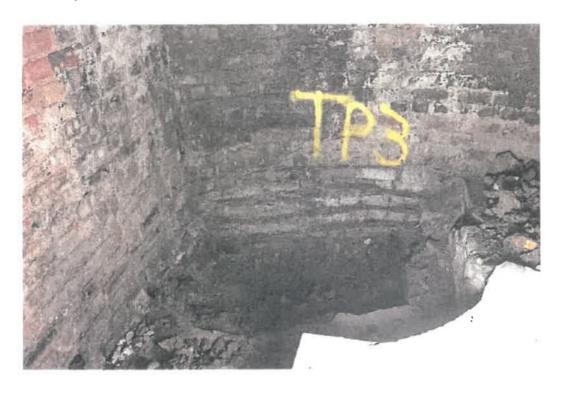
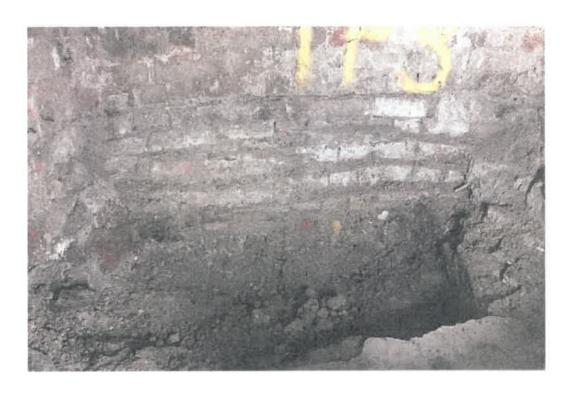
169 West End Lane – Trial Pit 1 (TP1)

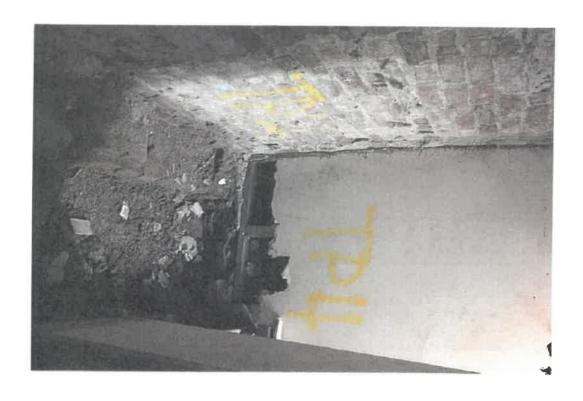
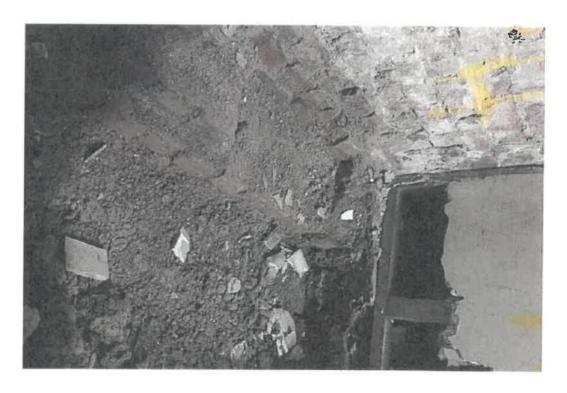
169 West End Lane – Trial Pit 3 (TP3)

TP3 was similar to TP1 and TP2 and consisted of a 3-brick corbel founded on a 400mm thick layer of lime cemented brick fill. A small amount of seepage occurred at the top of the London Clay and settled as 20mm of perched water on top of the *insitu* London Clay.

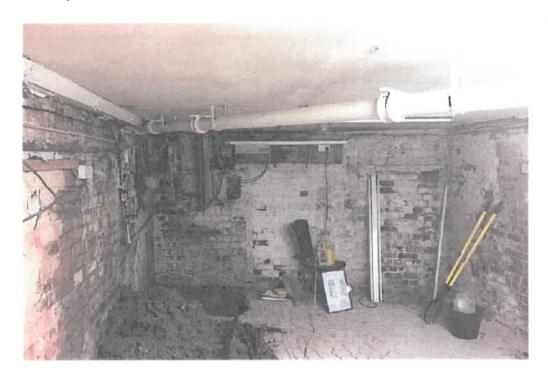
169 West End Lane – Trial Pit 4 (TP4)

TP4 is located in the north west corner of the basement, at the foot of the stairs from ground floor. TP4 encountered a 300mm wide brick footing at basement floor level which extended to a depth of 0.27m below floor level and was founded on a 180mm thick layer of lime cemented brick fill. No groundwater was encountered.

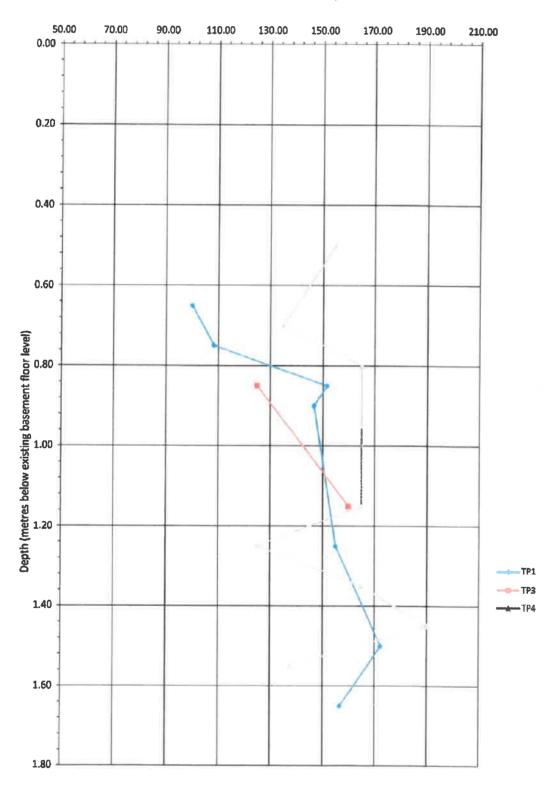
# 169 West End Lane, London, NW6 Undrained Shear Strength (Kn/m2) (Derived from PP)

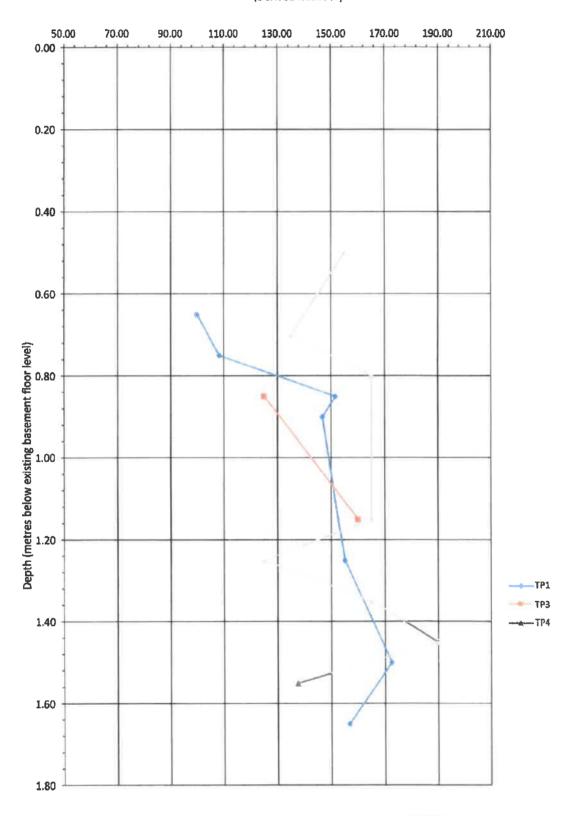
# 169 West End Lane, London, NW6 Undrained Shear Strength (Kn/m2) (Derived from PP)
