**78 Malden Road, London,  
NW5 4DA**

**Arboricultural Report, Tree Constraints Plan  
&  
Arboricultural Impact Assessment**

Survey Date: 4th July 2018

Report Date: 6th July 2018

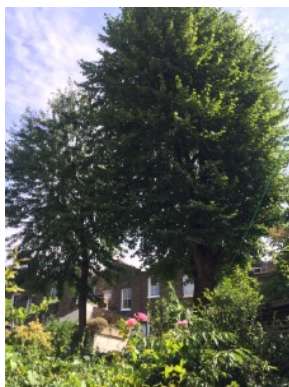
| ID | Species | H/T | Stems | Dia | | Canopy | | | | First Branch | Crown H/T | Age | Yrs | Cat | Observations | Recommendations | RPA (r) | RPA (a) |
|---|---|---|---|---|---|---|---|---|---|---|---|---|---|--|---|---|---|---|
| T1 | Lime | 15 | S | 550 | 4 | 4 | 4 | 4 | 6N | 5 | Early Mature | 40+ | A | Good overall condition, historic pollard, canopy in good condition, close to boundary wall. Within neighbouring property | Maintain management regime | 6.6 | 136.8 | |
| T2 | Cherry | 12 | S | 250 | 3 | 3 | 2 | 3 | 5E | 5 | Mature | 30 | B | Good overall condition, within neighbouring property | None | 3 | 28.3 | |

T's 1 & 2

T2 would be unaffected.

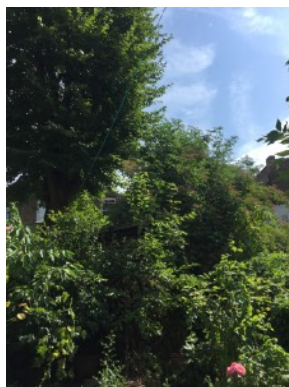
| ID | Species | H/T | Stems | Dia | | Canopy | | | | First Branch | Crown H/T | Age | Yrs | Cat | Observations | Recommendations | RPA (r) | RPA (a) |
|---|---|---|---|---|---|---|---|---|---|---|---|---|---|--|---|---|---|---|
| T3 | Elder | 4 | M | 150 | 2.5 | 2.5 | 3 | 3 | .5S | 0.5 | Early Mature | 40 | C | Low quality tree within property | None | 1.5 | 7.1 | |

T1 & T3 & undergrowth

T3 Cat C and other undergrowth would have to be removed to facilitate the new structure.

T3 is very close to the boundary and the new structure would be situated largely within the RPA. The existing structure is situated within the RPA and some excavation has obviously taken place to accommodate this. The garden containing T1 appears to be slightly lower than the proposed garden and it maybe that the roots from T1 are low in the soil structure as a result.

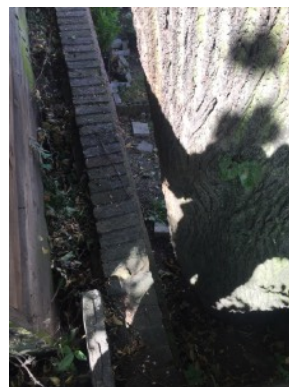
T1 main stem

T1 should have further investigation to establish root depth and possibility of shallow excavation for new footing.

At least 3 trial holes should be dug by hand within the location of the proposed structure to establish root depth and potential impact from excavation.

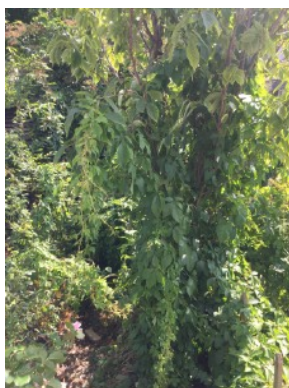
| ID | Species | H/T | Stems | Dia | | Canopy | | | | First Branch | Crown H/T | Age | Yrs | Cat | Observations | Recommendations | RPA (r) | RPA (a) |
|---|---|---|---|---|---|---|---|---|---|---|---|---|---|--|---|---|---|---|
| T4 | Cherry | 6 | M | 100 | 1 | 1 | 1 | 1 | 2S | 1 | Young | 10 | C | Poor quality specimen, included stems and very close to boundary wall | Monitor/possible removal | 1 | 3.1 | |

T4 Cherry with included stems

T4 Cat C could also be removed due to structural issues and facilitate soft landscaping/ improvements. Mitigation planting could be accommodated within the scheme.

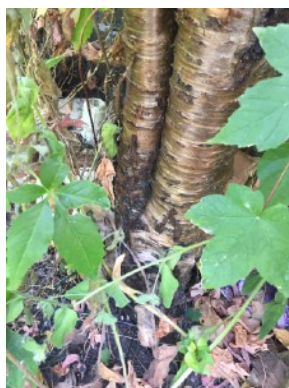
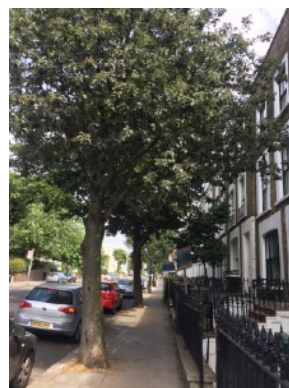
| ID | Species | H/T | Stems | Dia | | Canopy | | | | First Branch | Crown H/T | Age | Yrs | Cat | Observations | Recommendations | RPA (r) | RPA (a) |
|---|---|---|---|---|---|---|---|---|---|---|---|---|---|--|---|---|---|---|
| T5 | Norway Maple | 12 | S | 425 | 4 | 3 | 5 | 5 | 4S | 4 | Mature | 40+ | A | Good overall condition, Street tree | None | 5.1 | 81.7 | |
| T6 | Swedish Whitebeam | 10 | S | 400 | 2.5 | 3 | 2.5 | 2.5 | 3E | 3 | Mature | 40+ | B | Good overall condition, Street tree | None | 4.8 | 72.4 | |

T's 5 & 6 Street trees
