32-33 TORRINGTON SQUARE
MONITORING

Monitoring Report
SES-10215-MR03

Date of survey completion: 11th June 2018

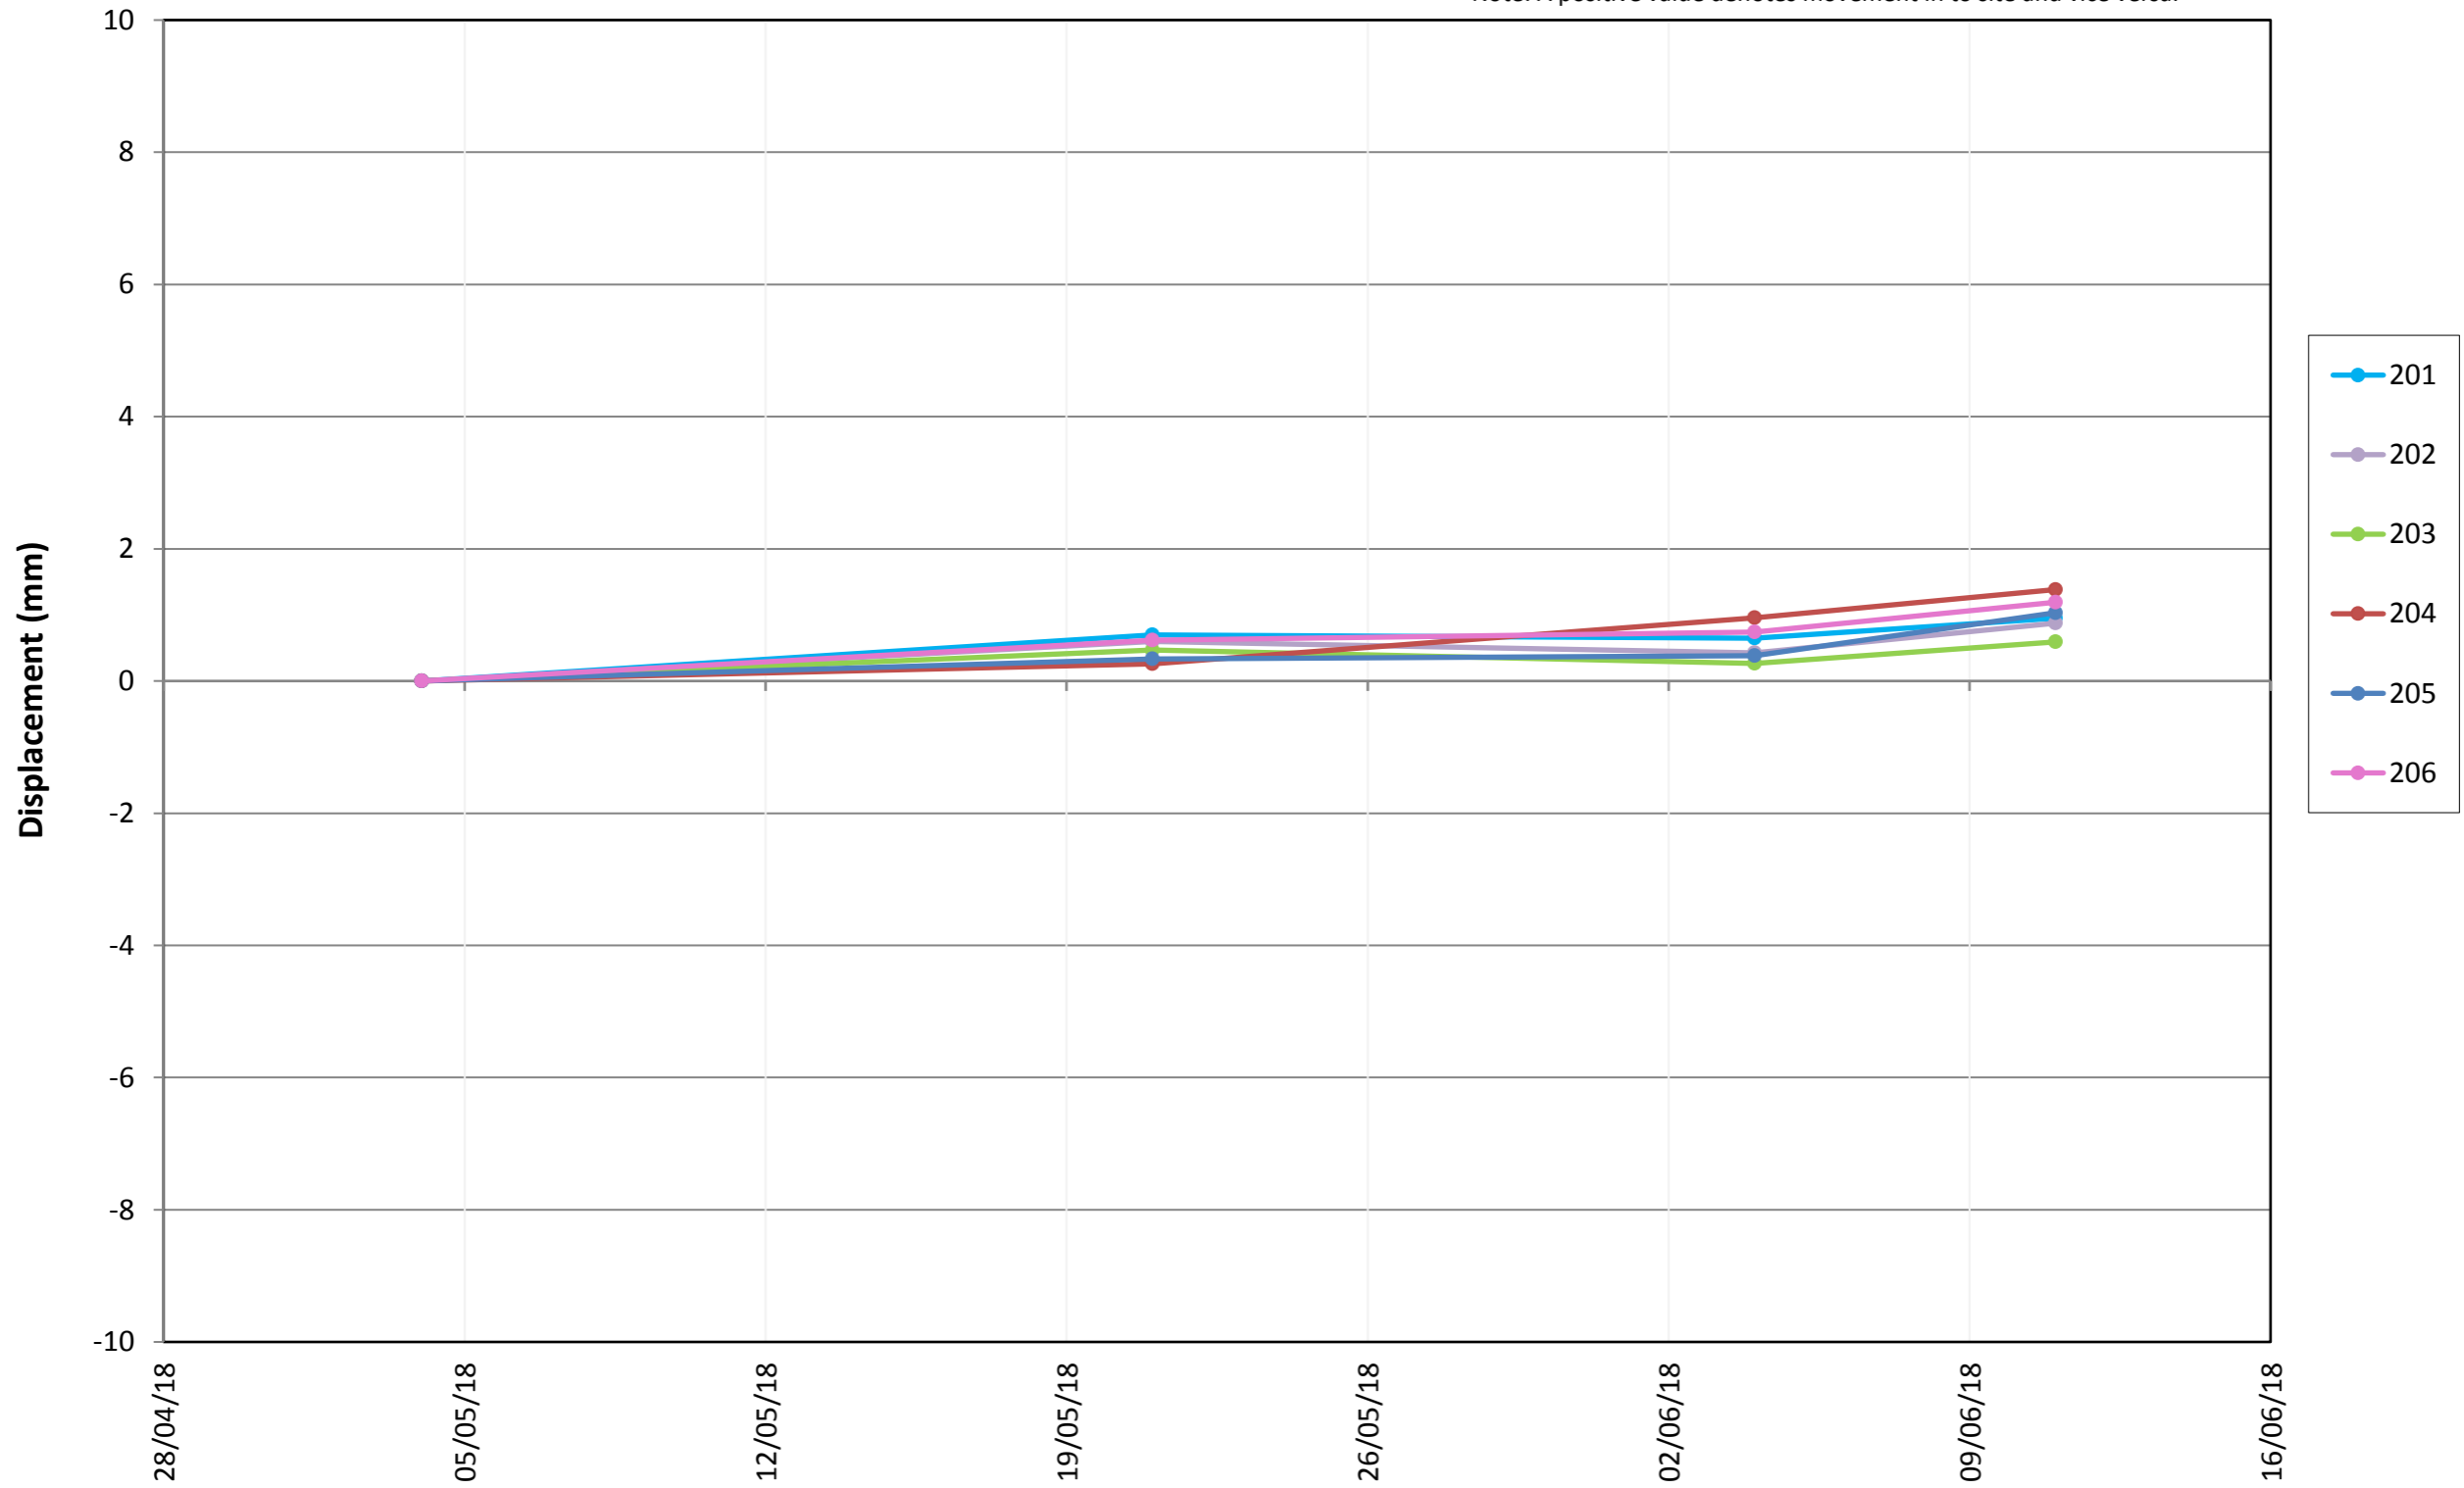
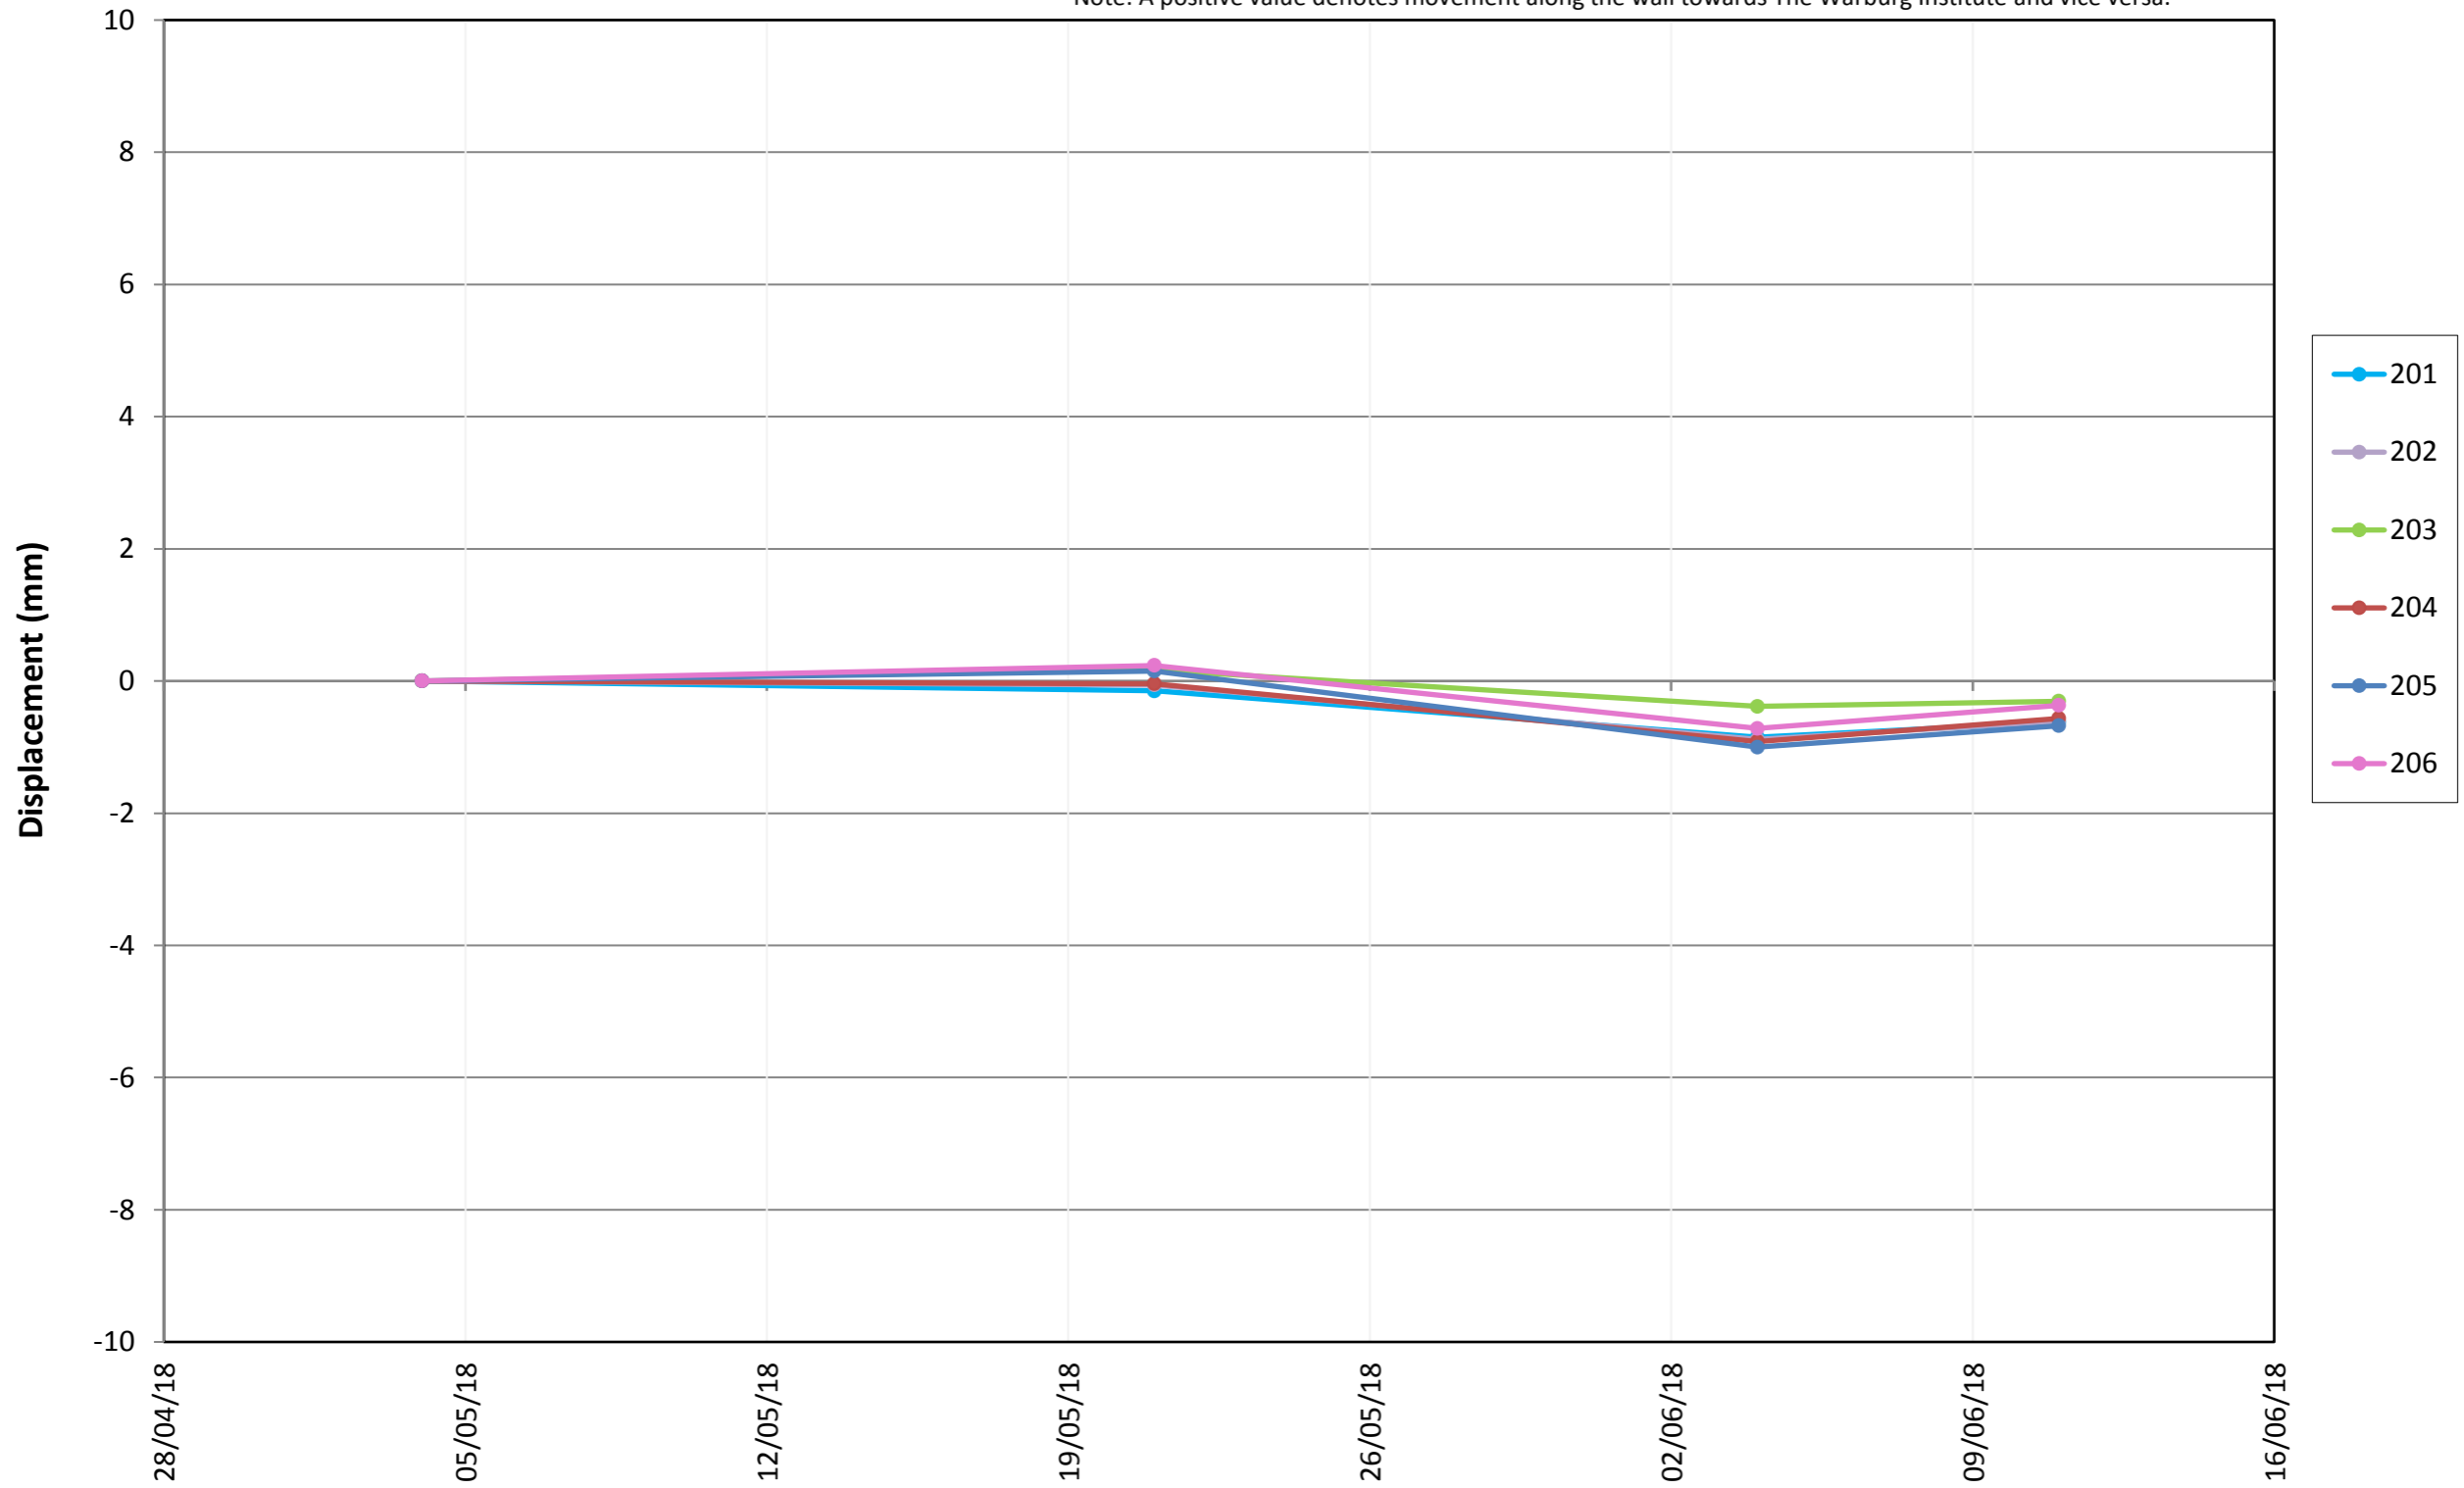
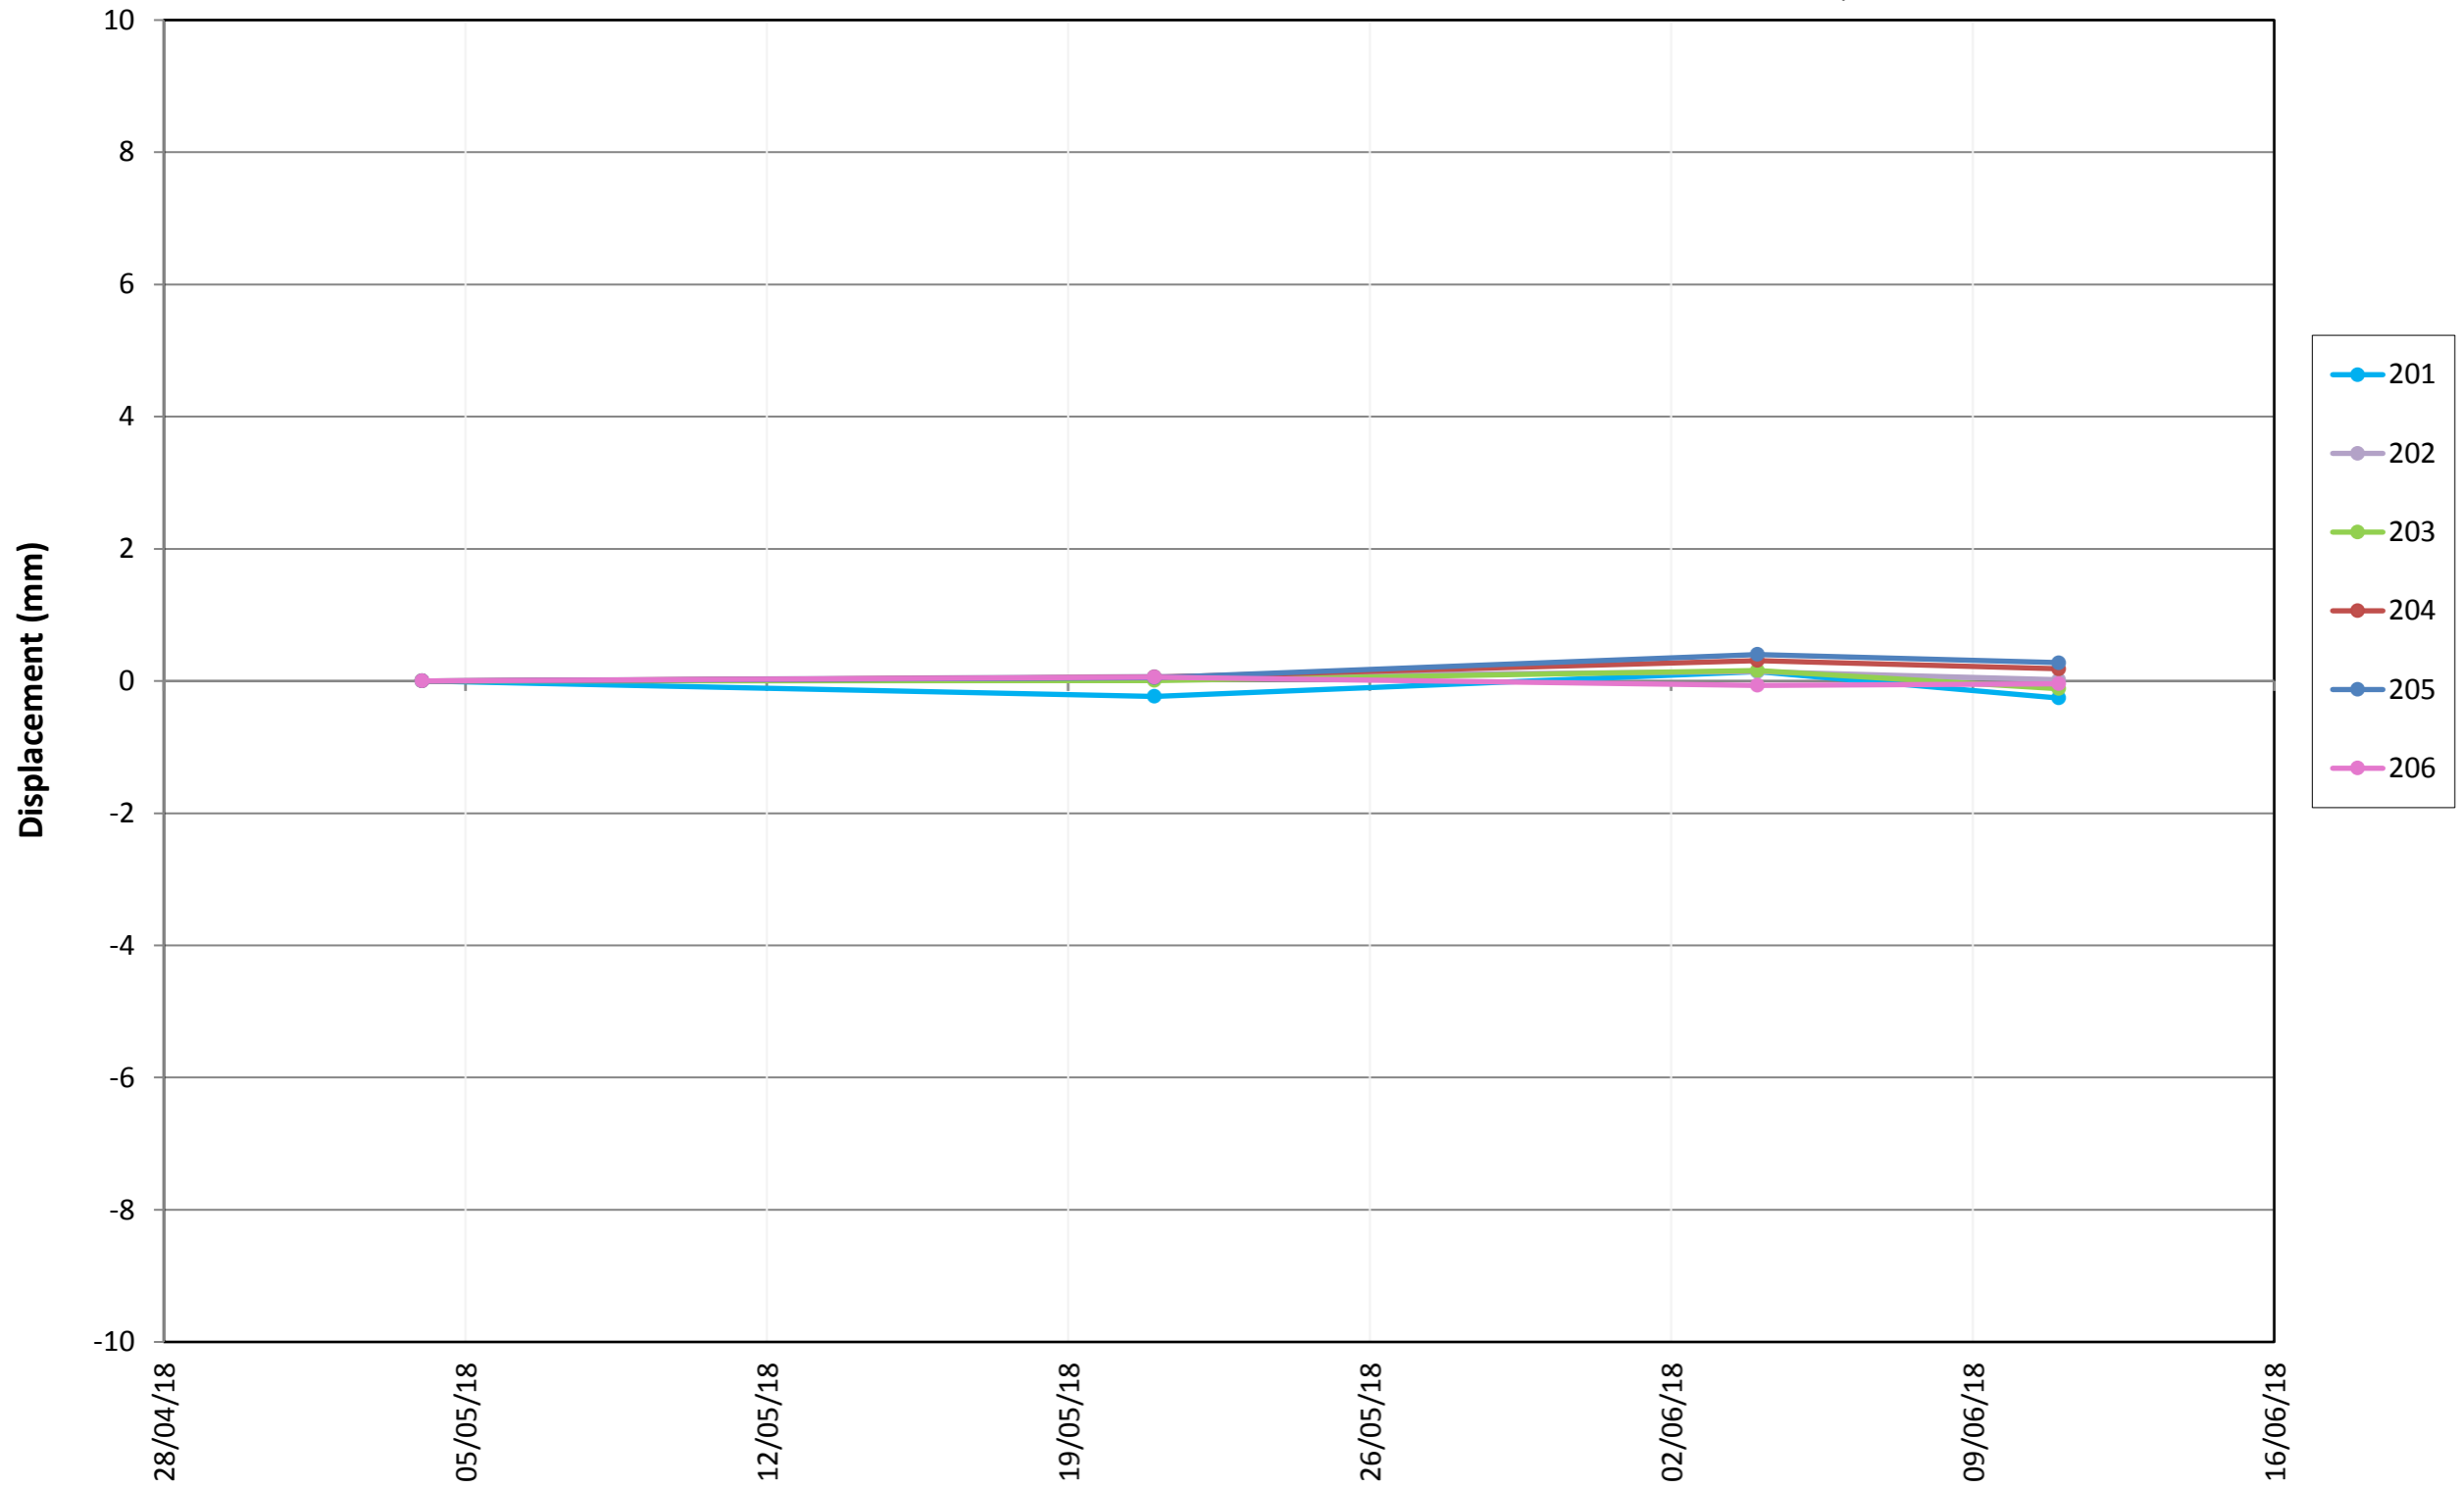
Graph 01T - Targets on Front Elevation of The Warburg Institute

Targets on Front Elevation of The Warburg Institute

Targets are showing negligible horizontal movement.
Targets are showing negligible vertical movement.

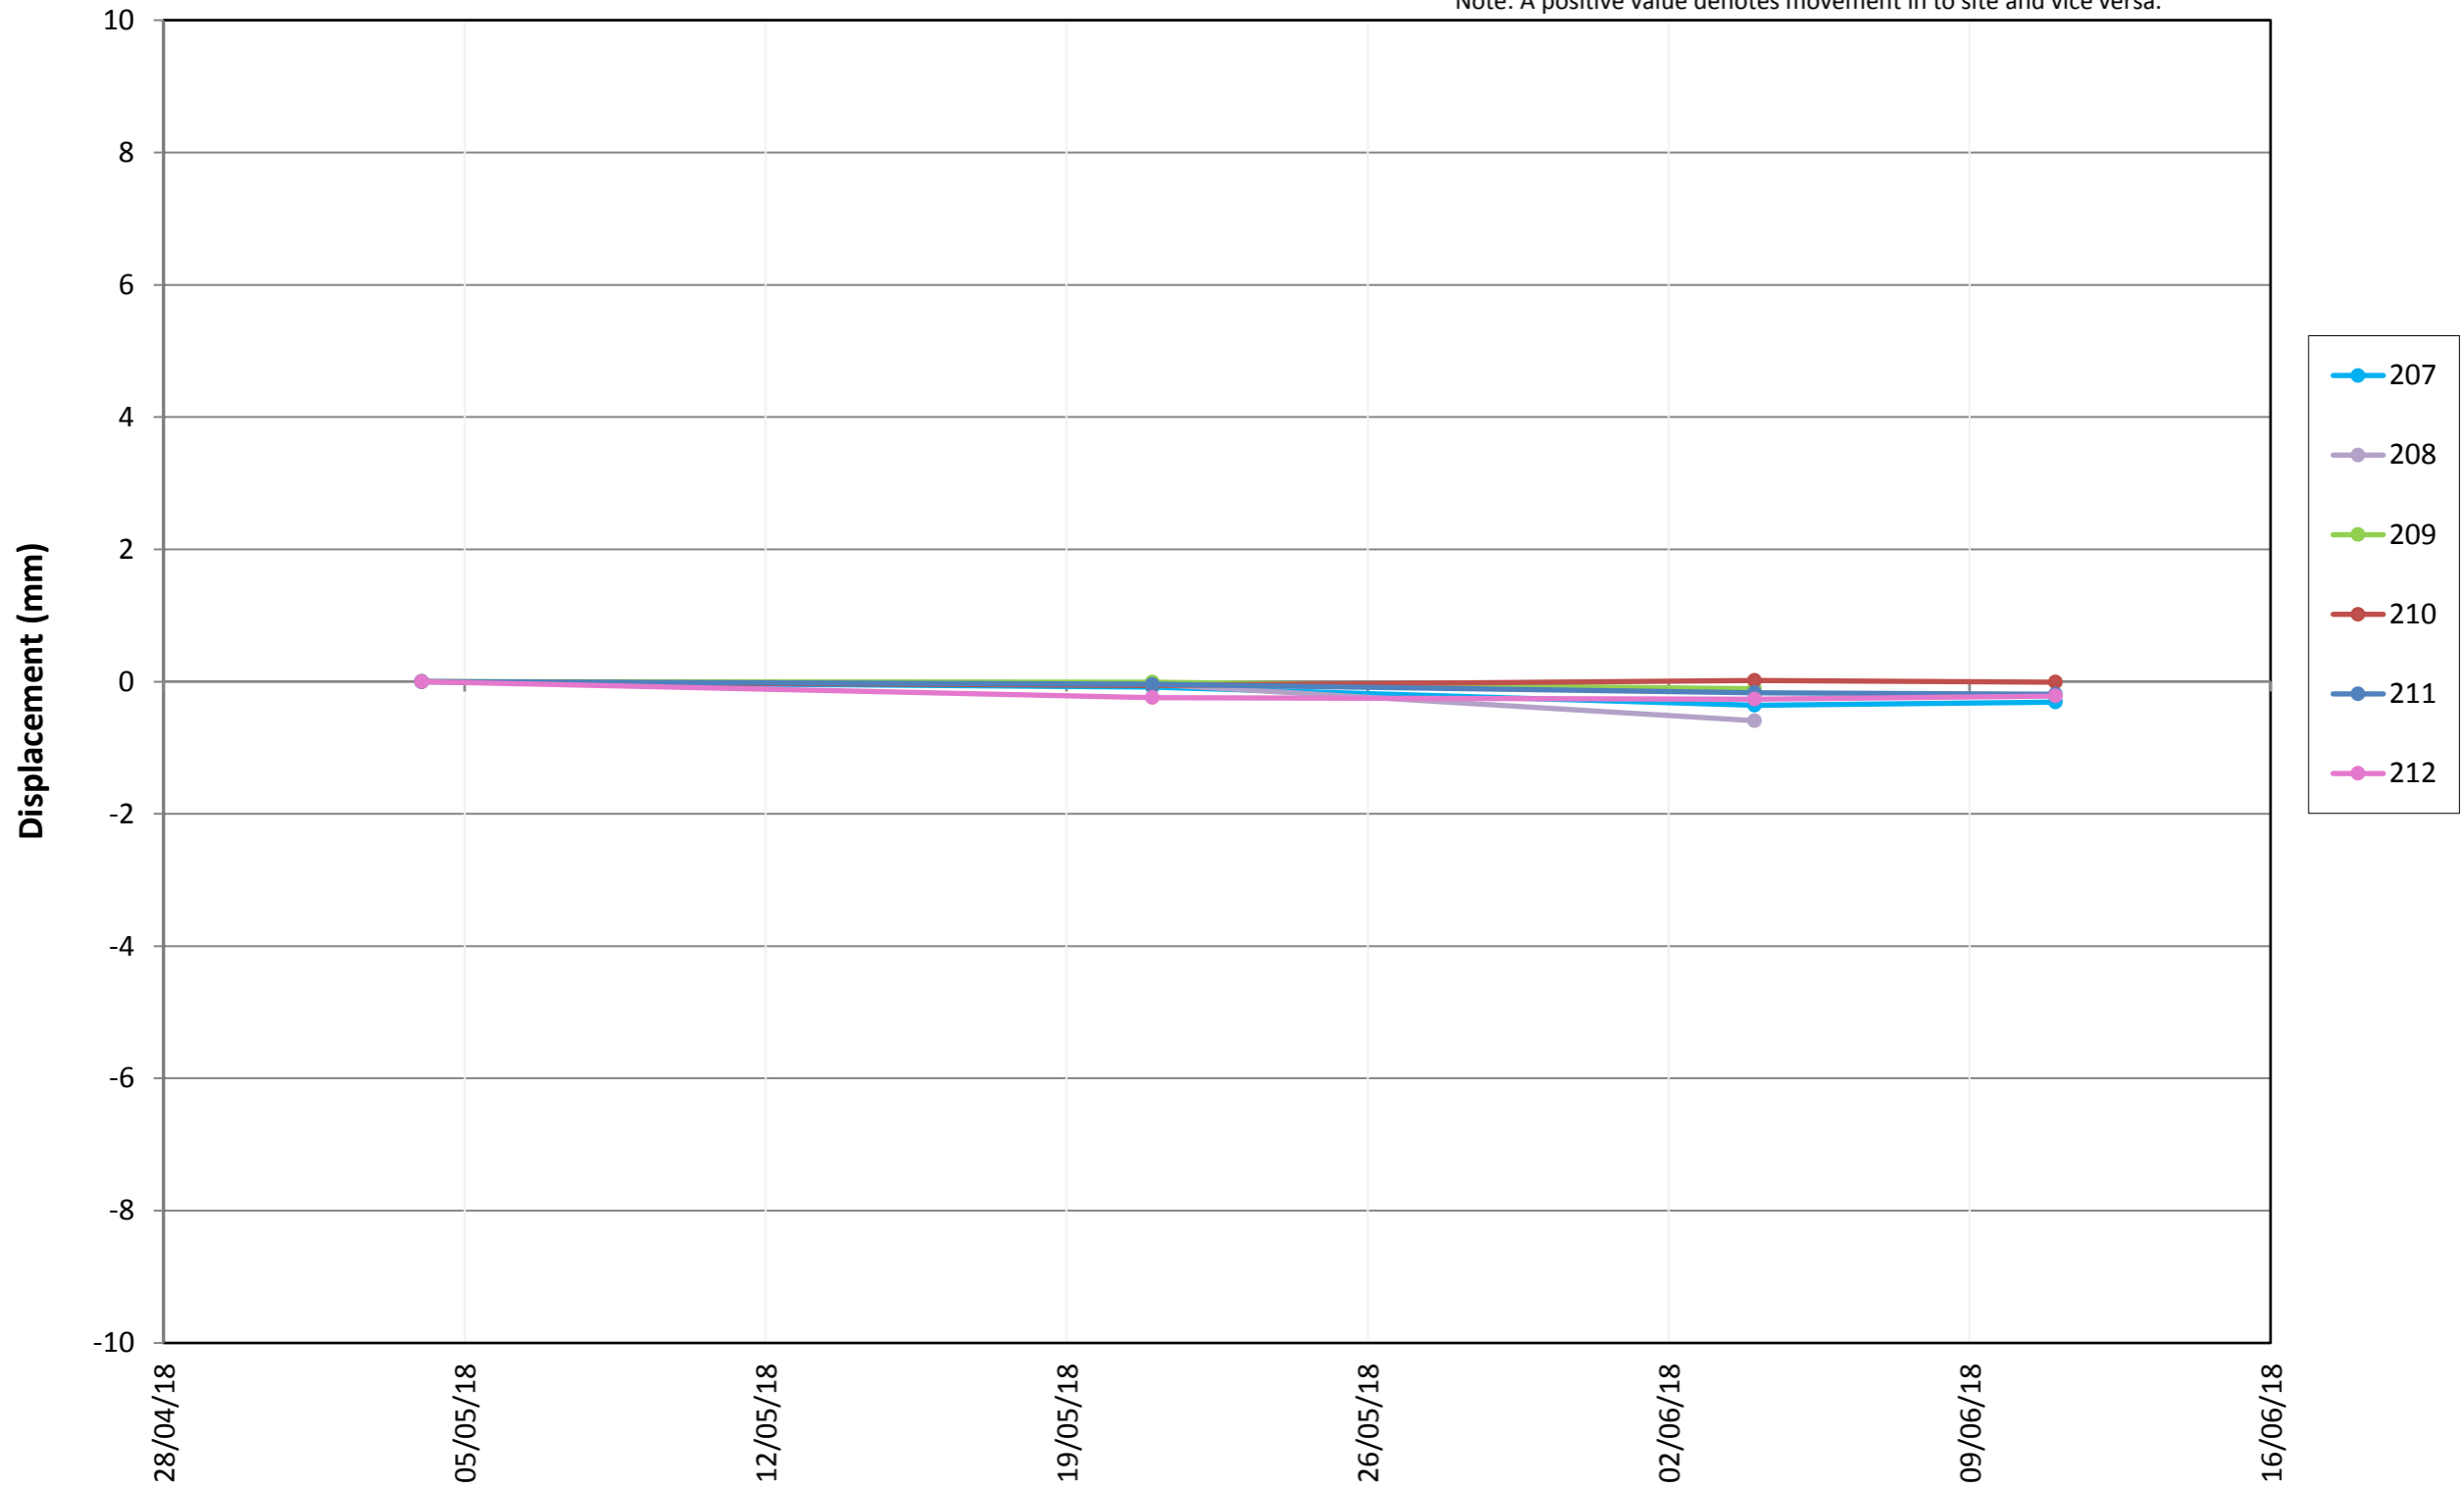
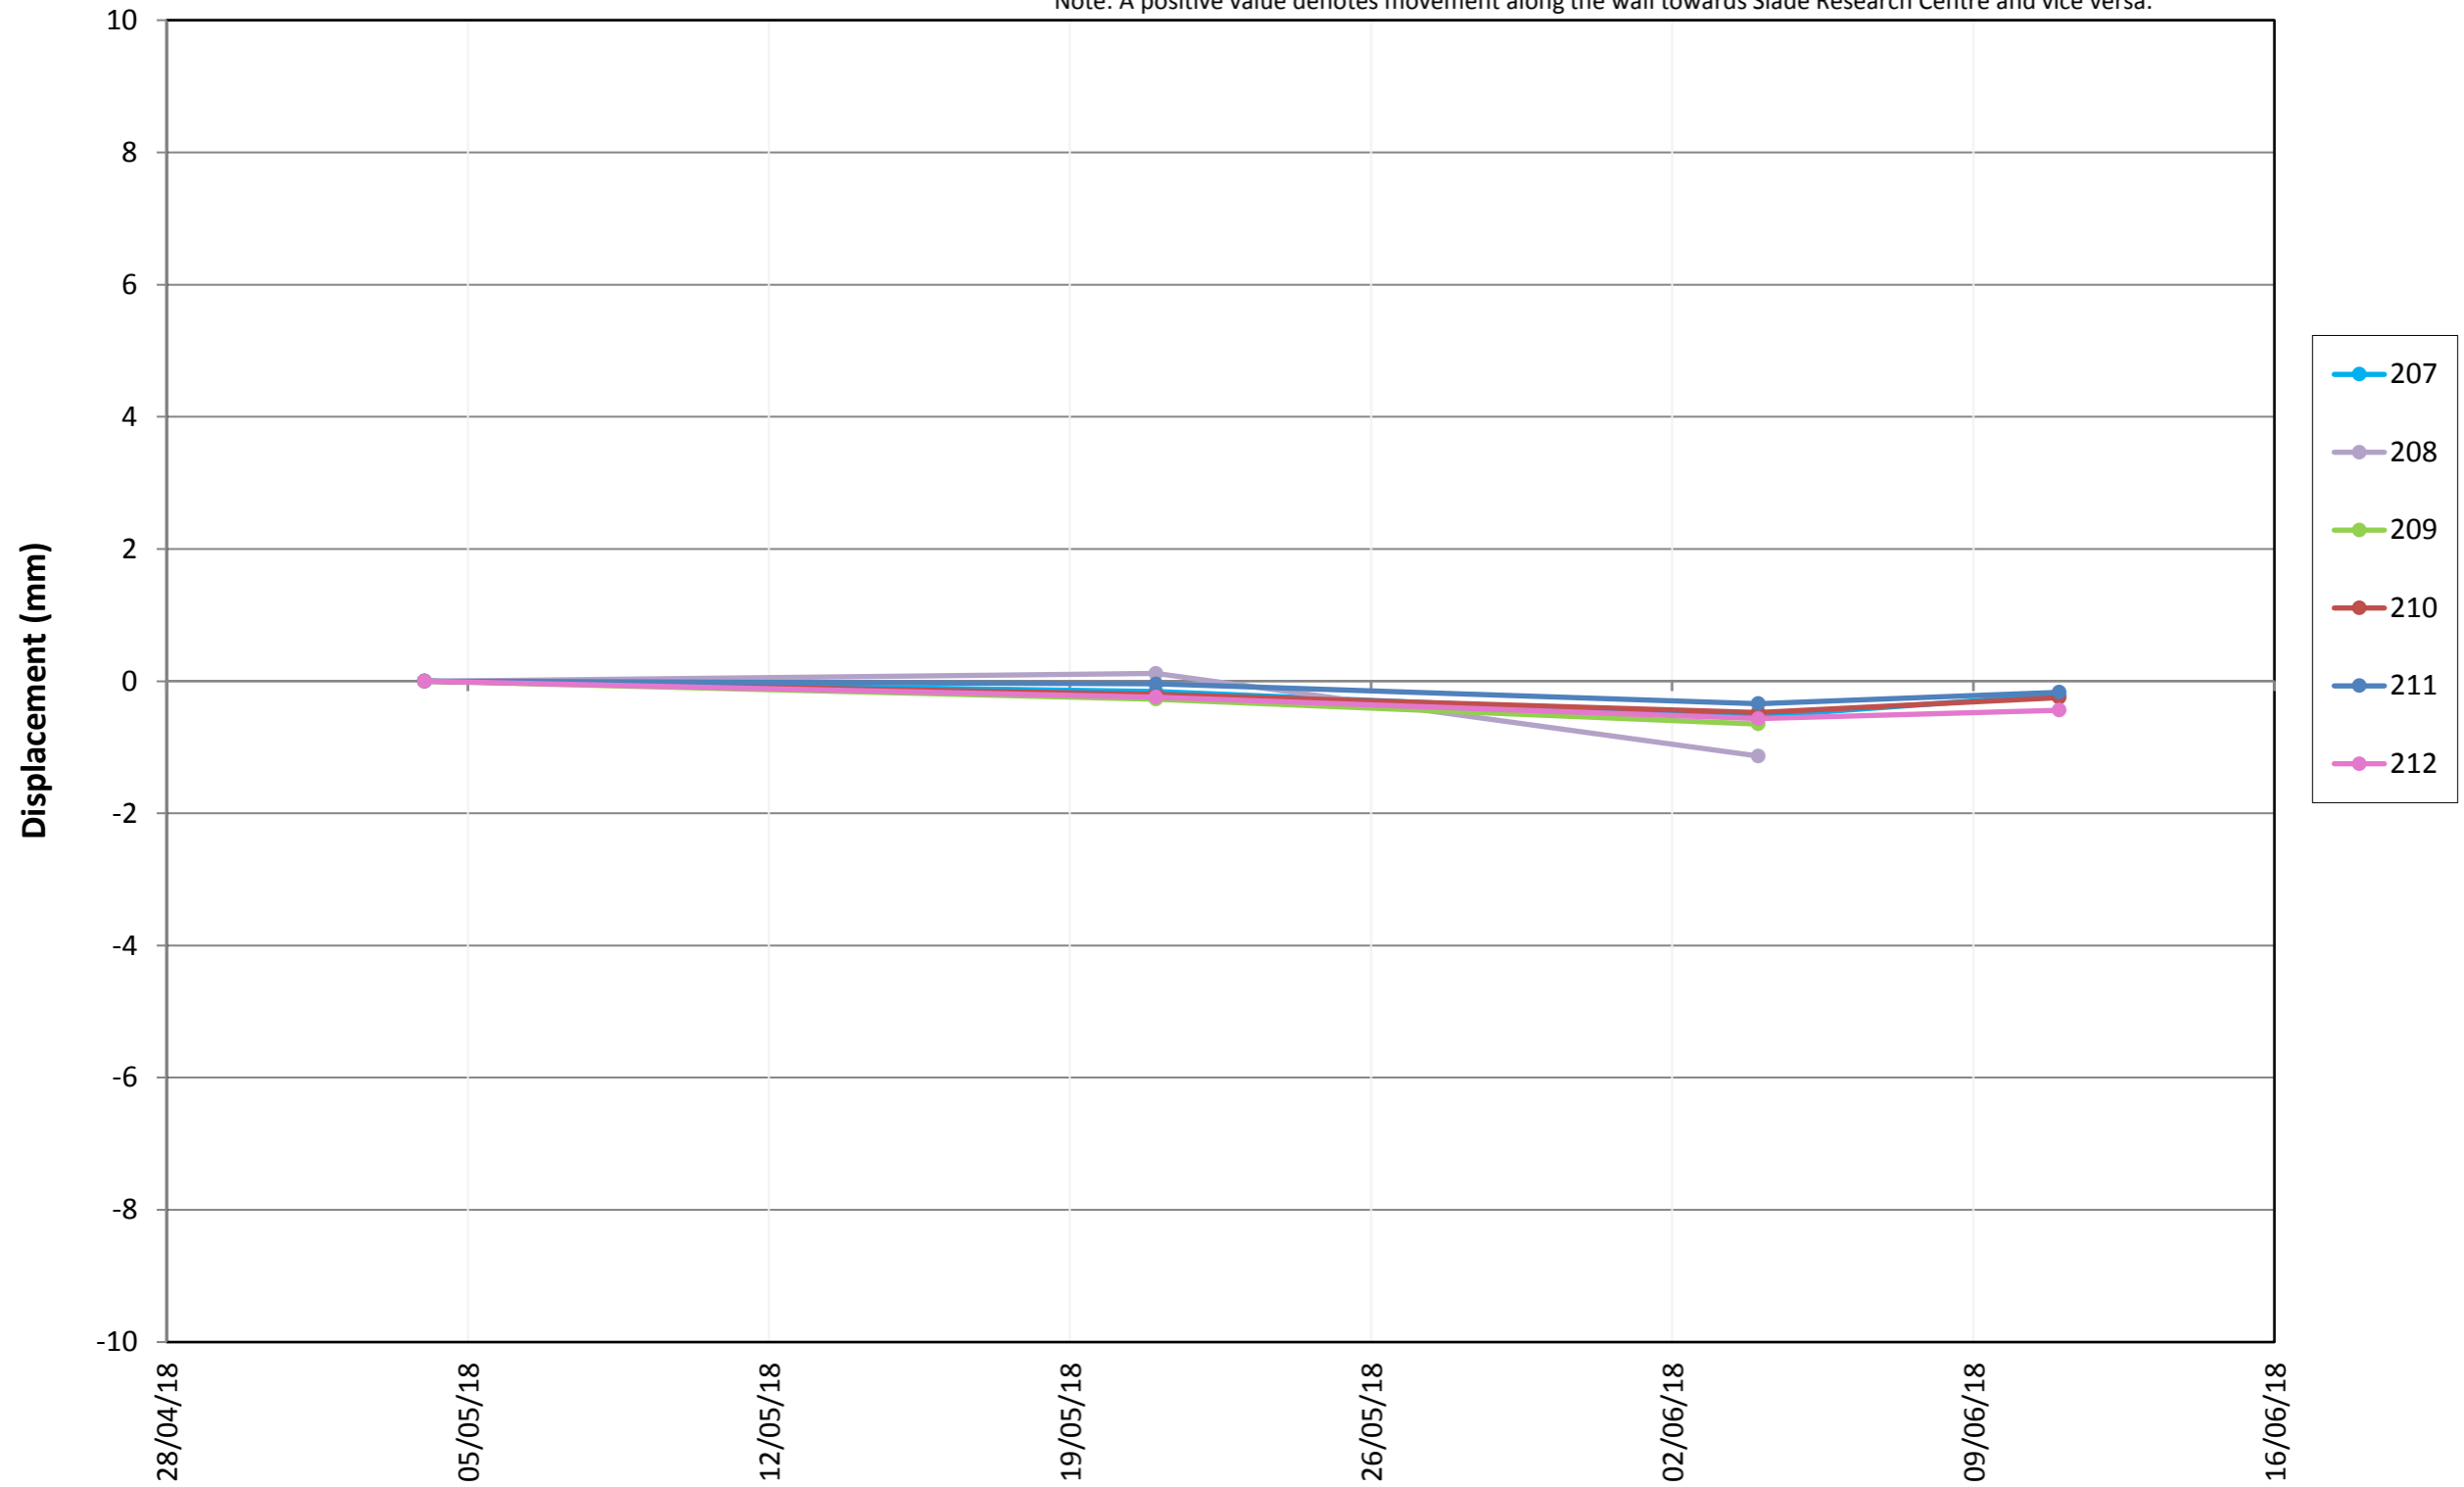
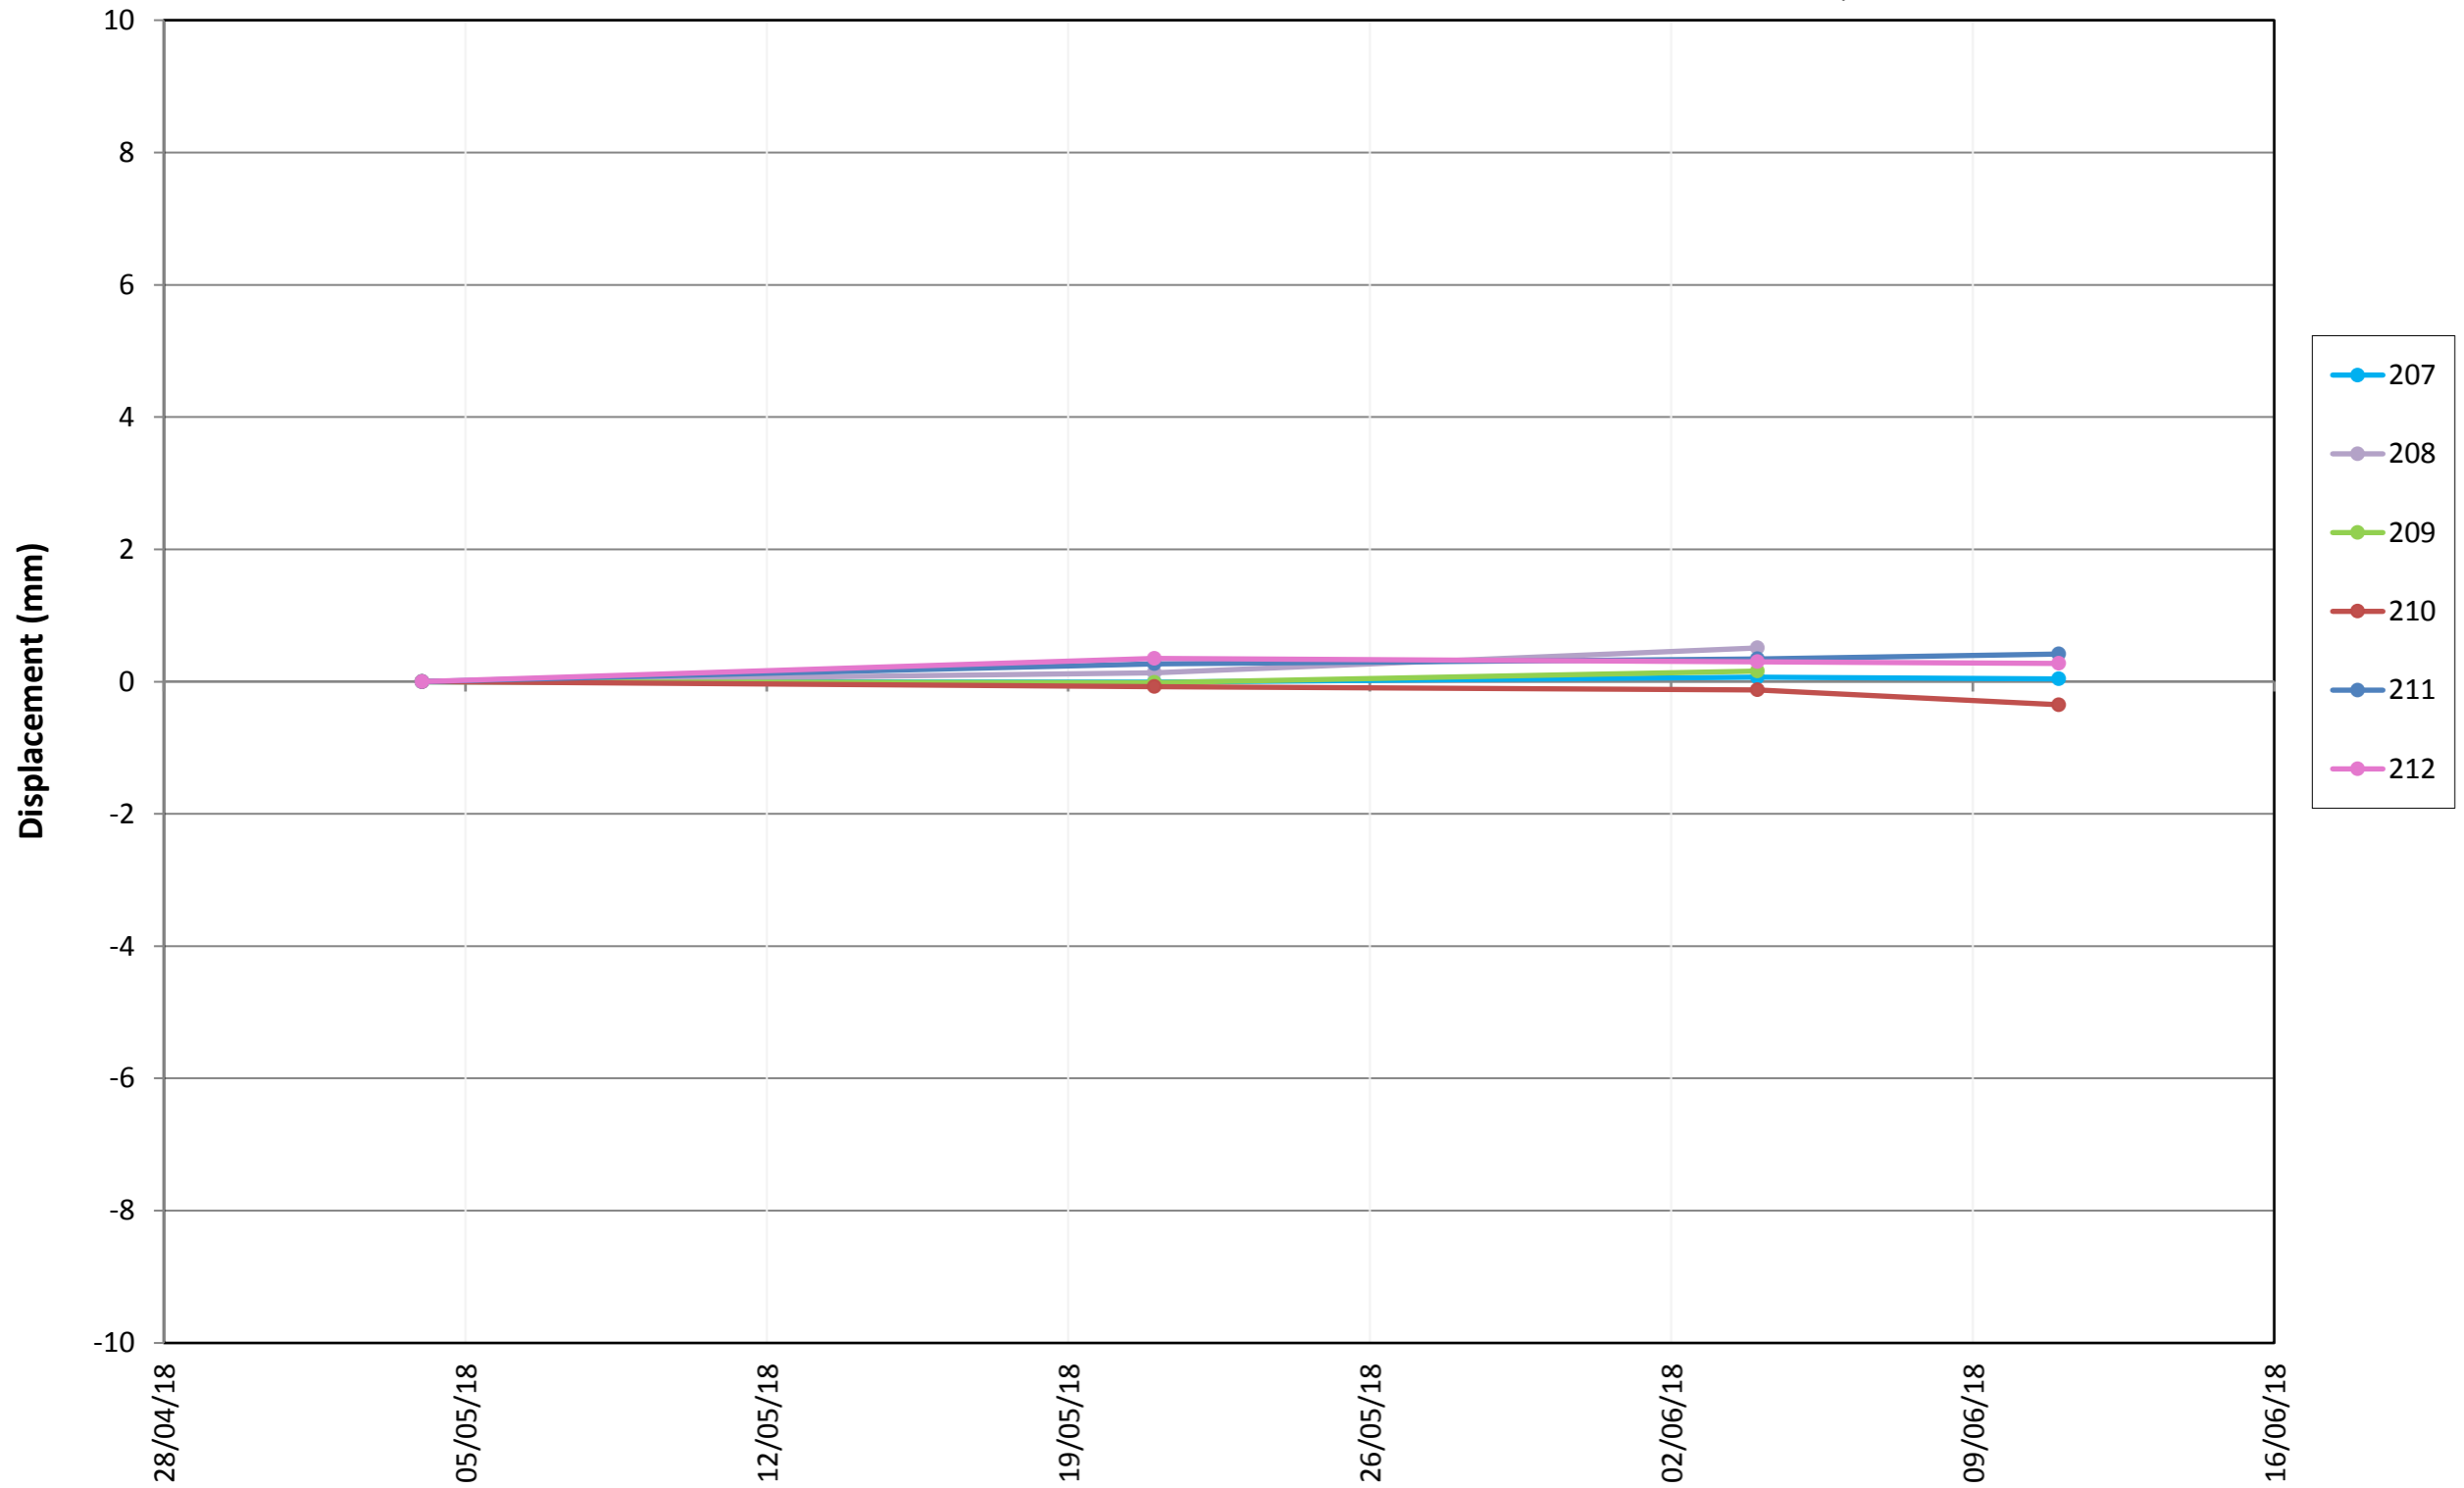
Graph 02T - Targets on Side Elevation of The Warburg Institute

Targets on Side Elevation of The Warburg Institute

Targets are showing negligible horizontal movement.
Targets are showing negligible vertical movement.
Target 208 is obstructed by scaffold.
Target 209 is destroyed
