32-33 TORRINGTON SQUARE
MONITORING

Monitoring Report
SES-10215-MR03

Date of survey completion: 11th June 2018

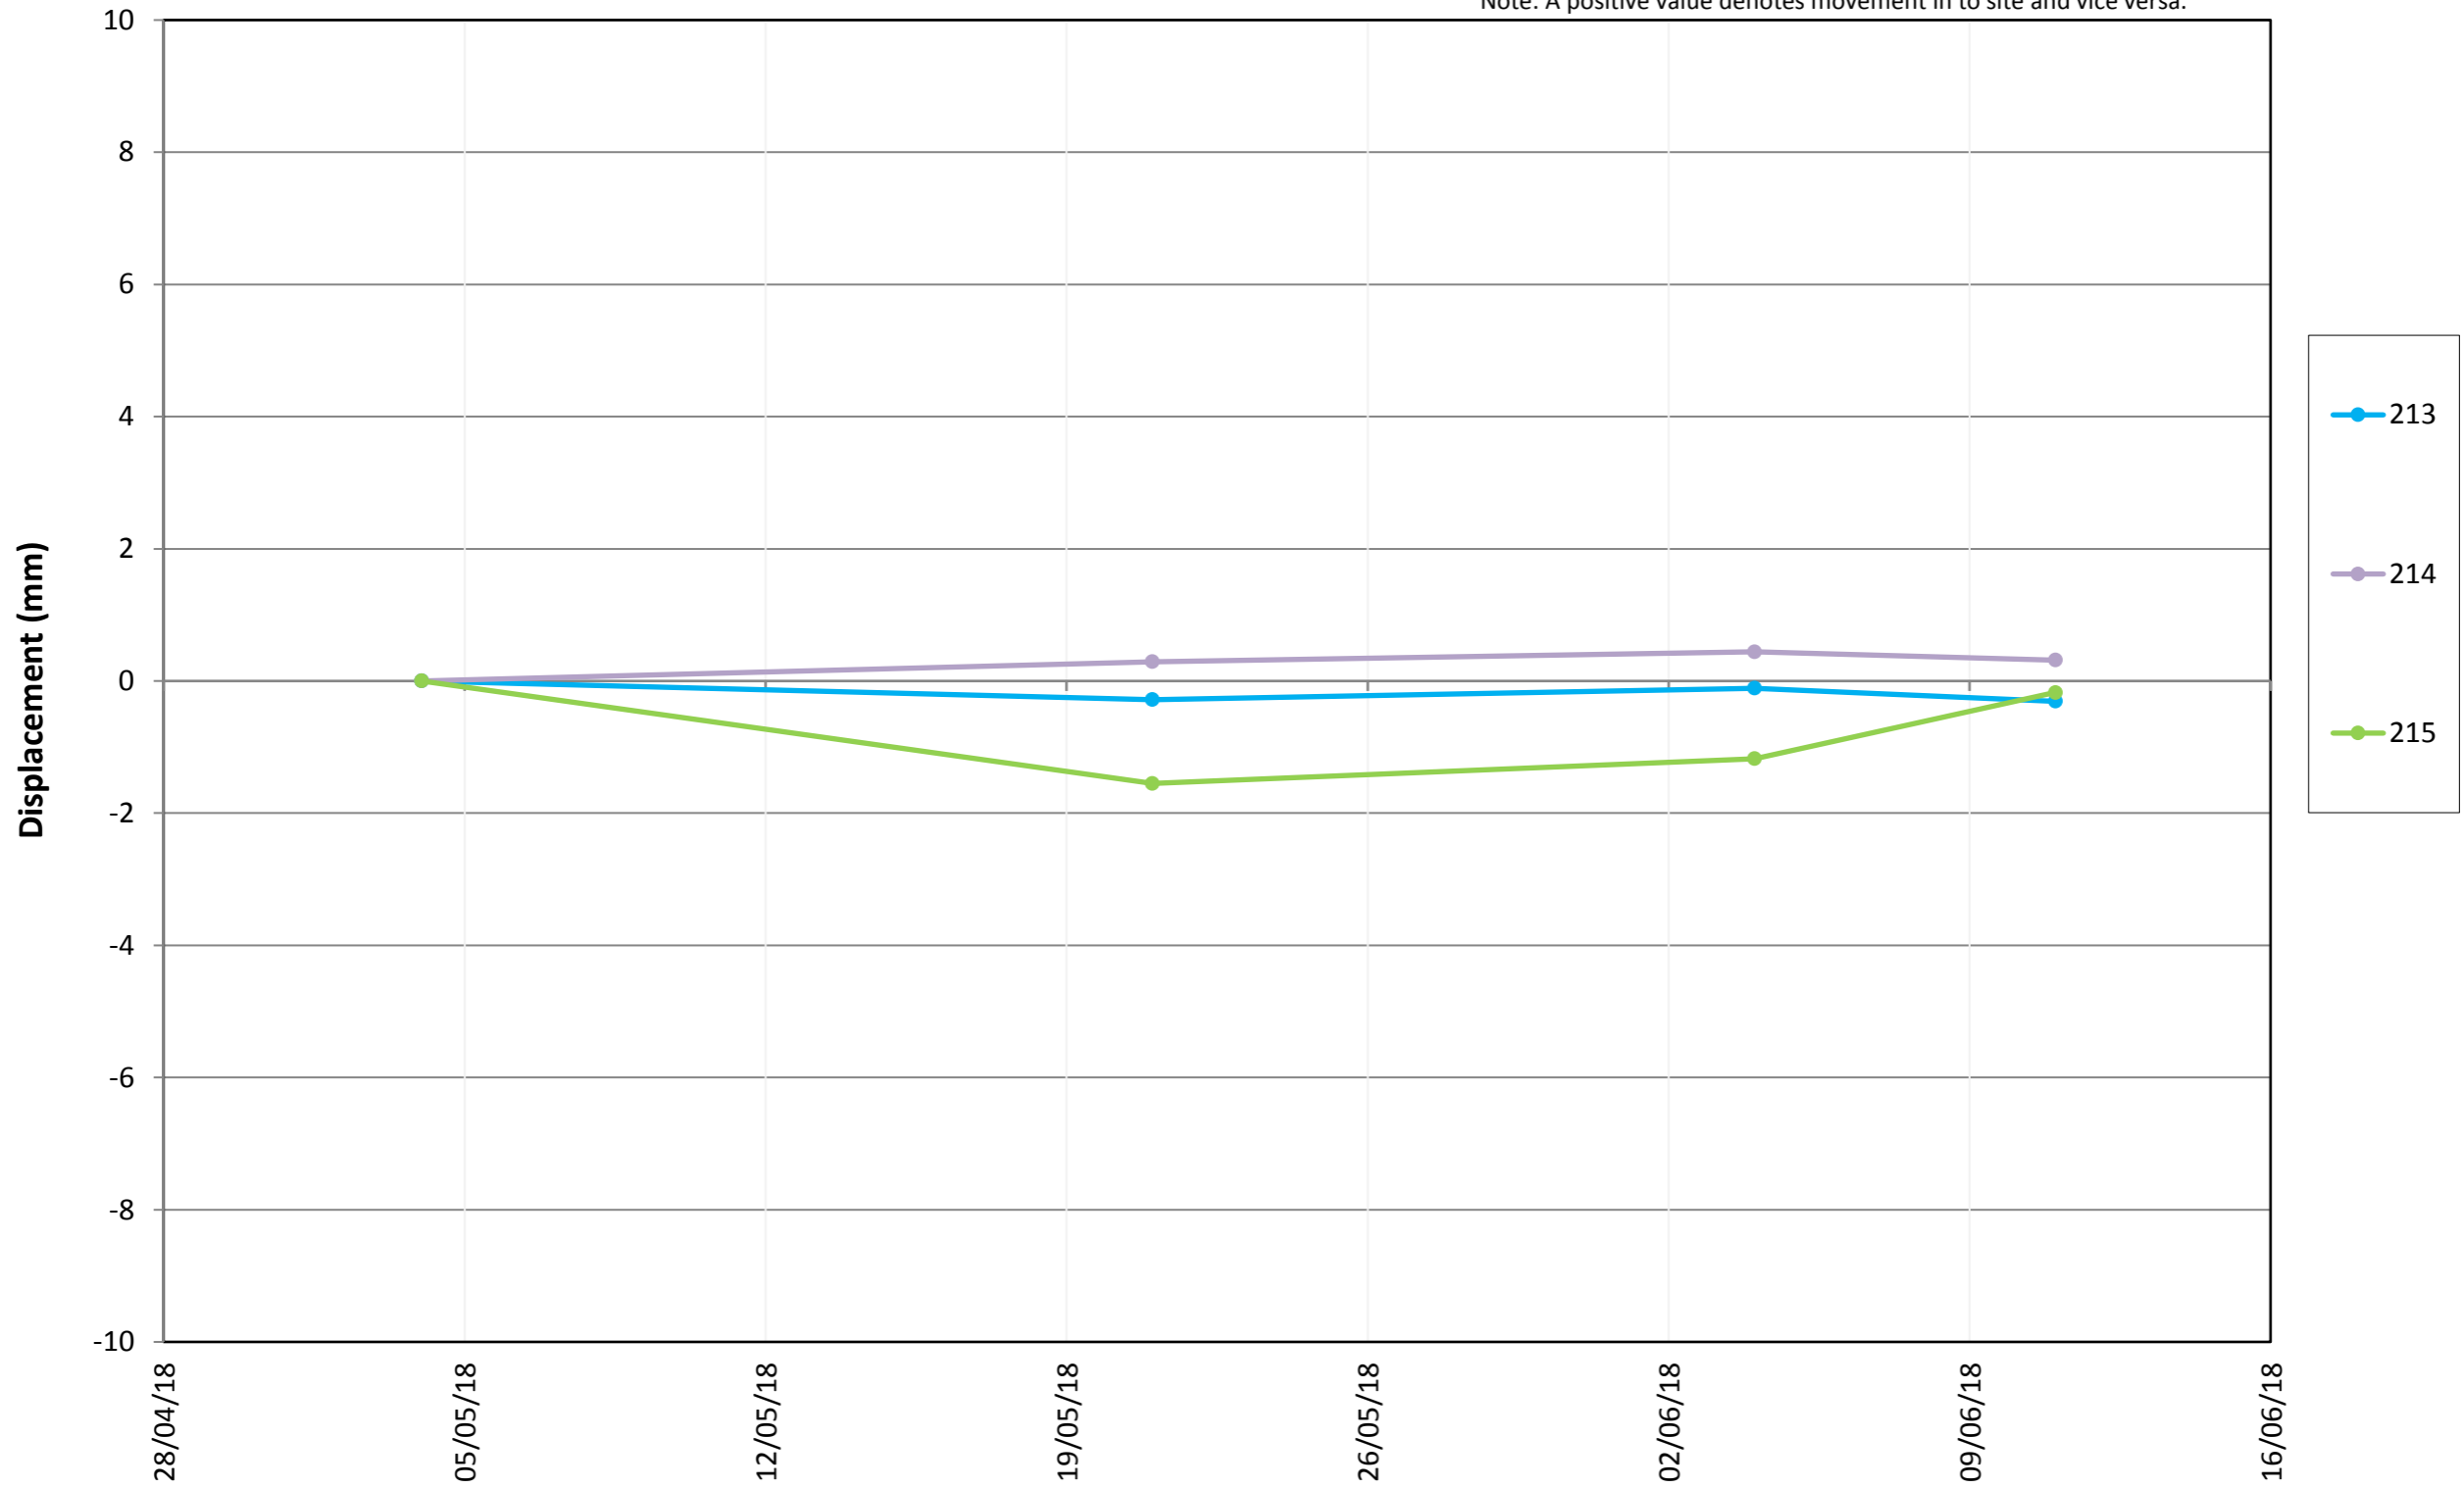
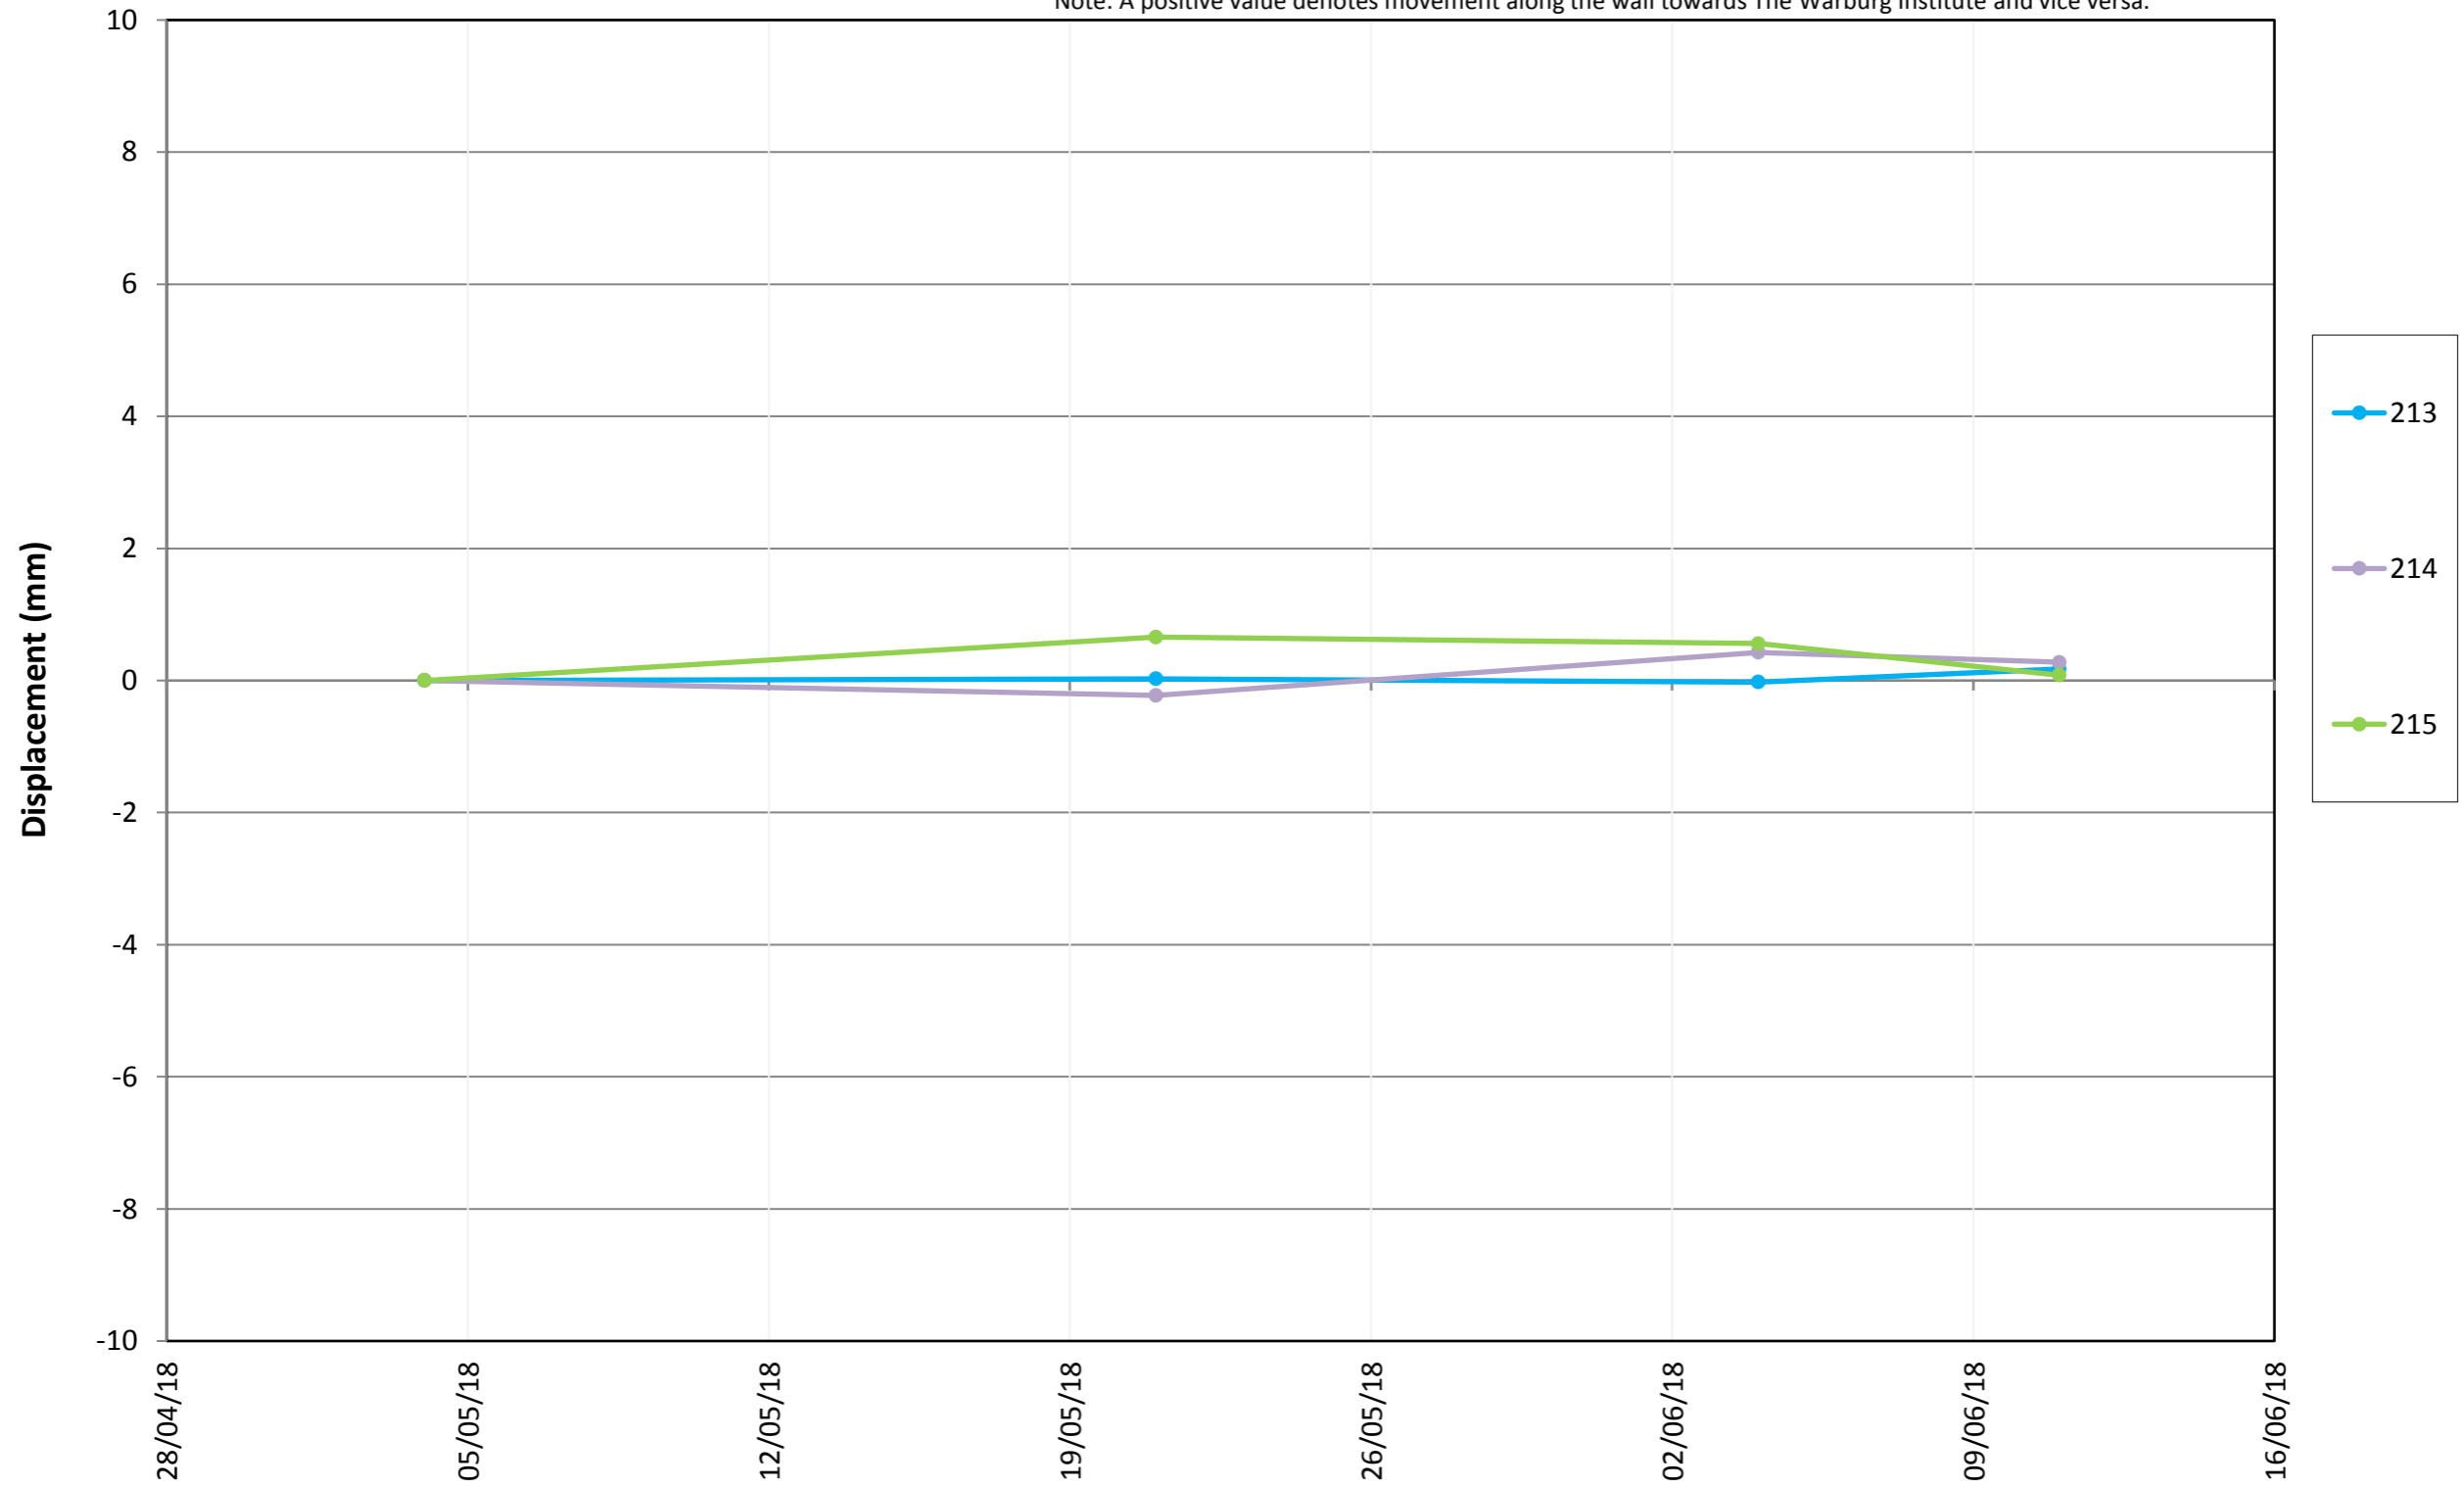
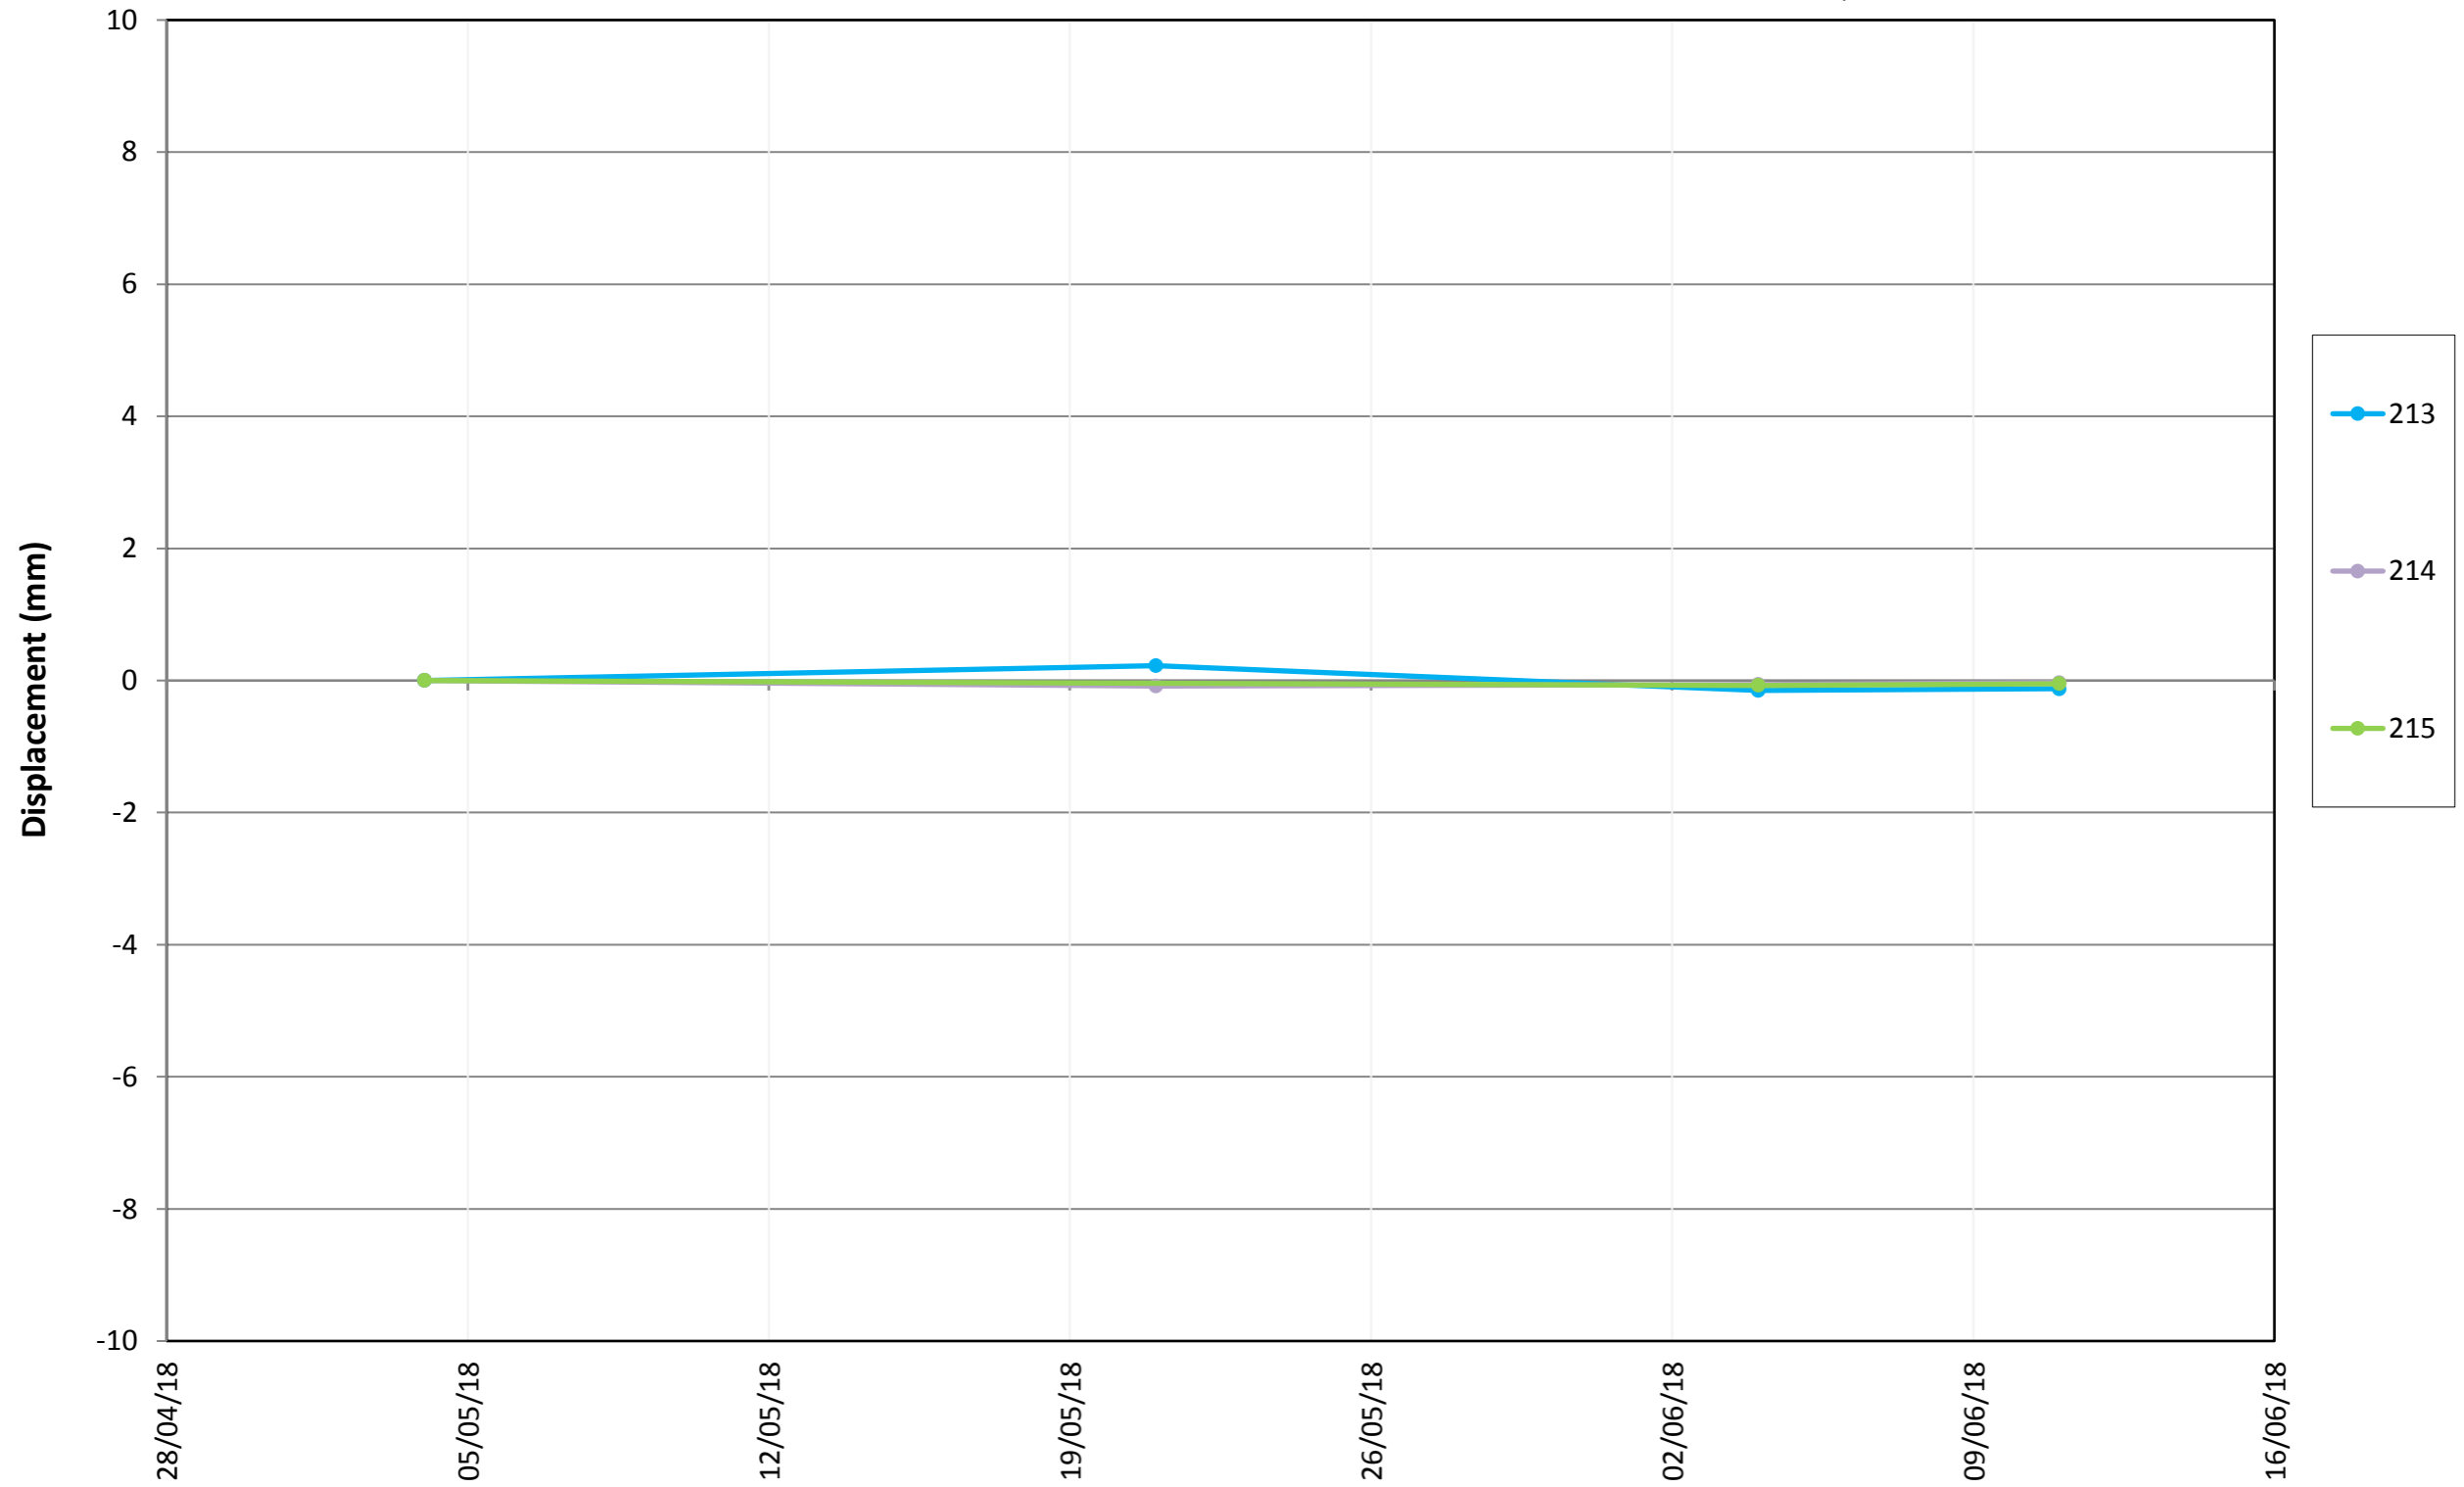
Graph 03T - Targets on Rear Elevation of The Warburg Institute

Targets on Rear Elevation of The Warburg Institute

Targets are showing negligible horizontal movement.
Targets are showing negligible vertical movement.
