32-33 TORRINGTON SQUARE
MONITORING

Monitoring Report
SES-10215-MR03

Date of survey completion: 11th June 2018

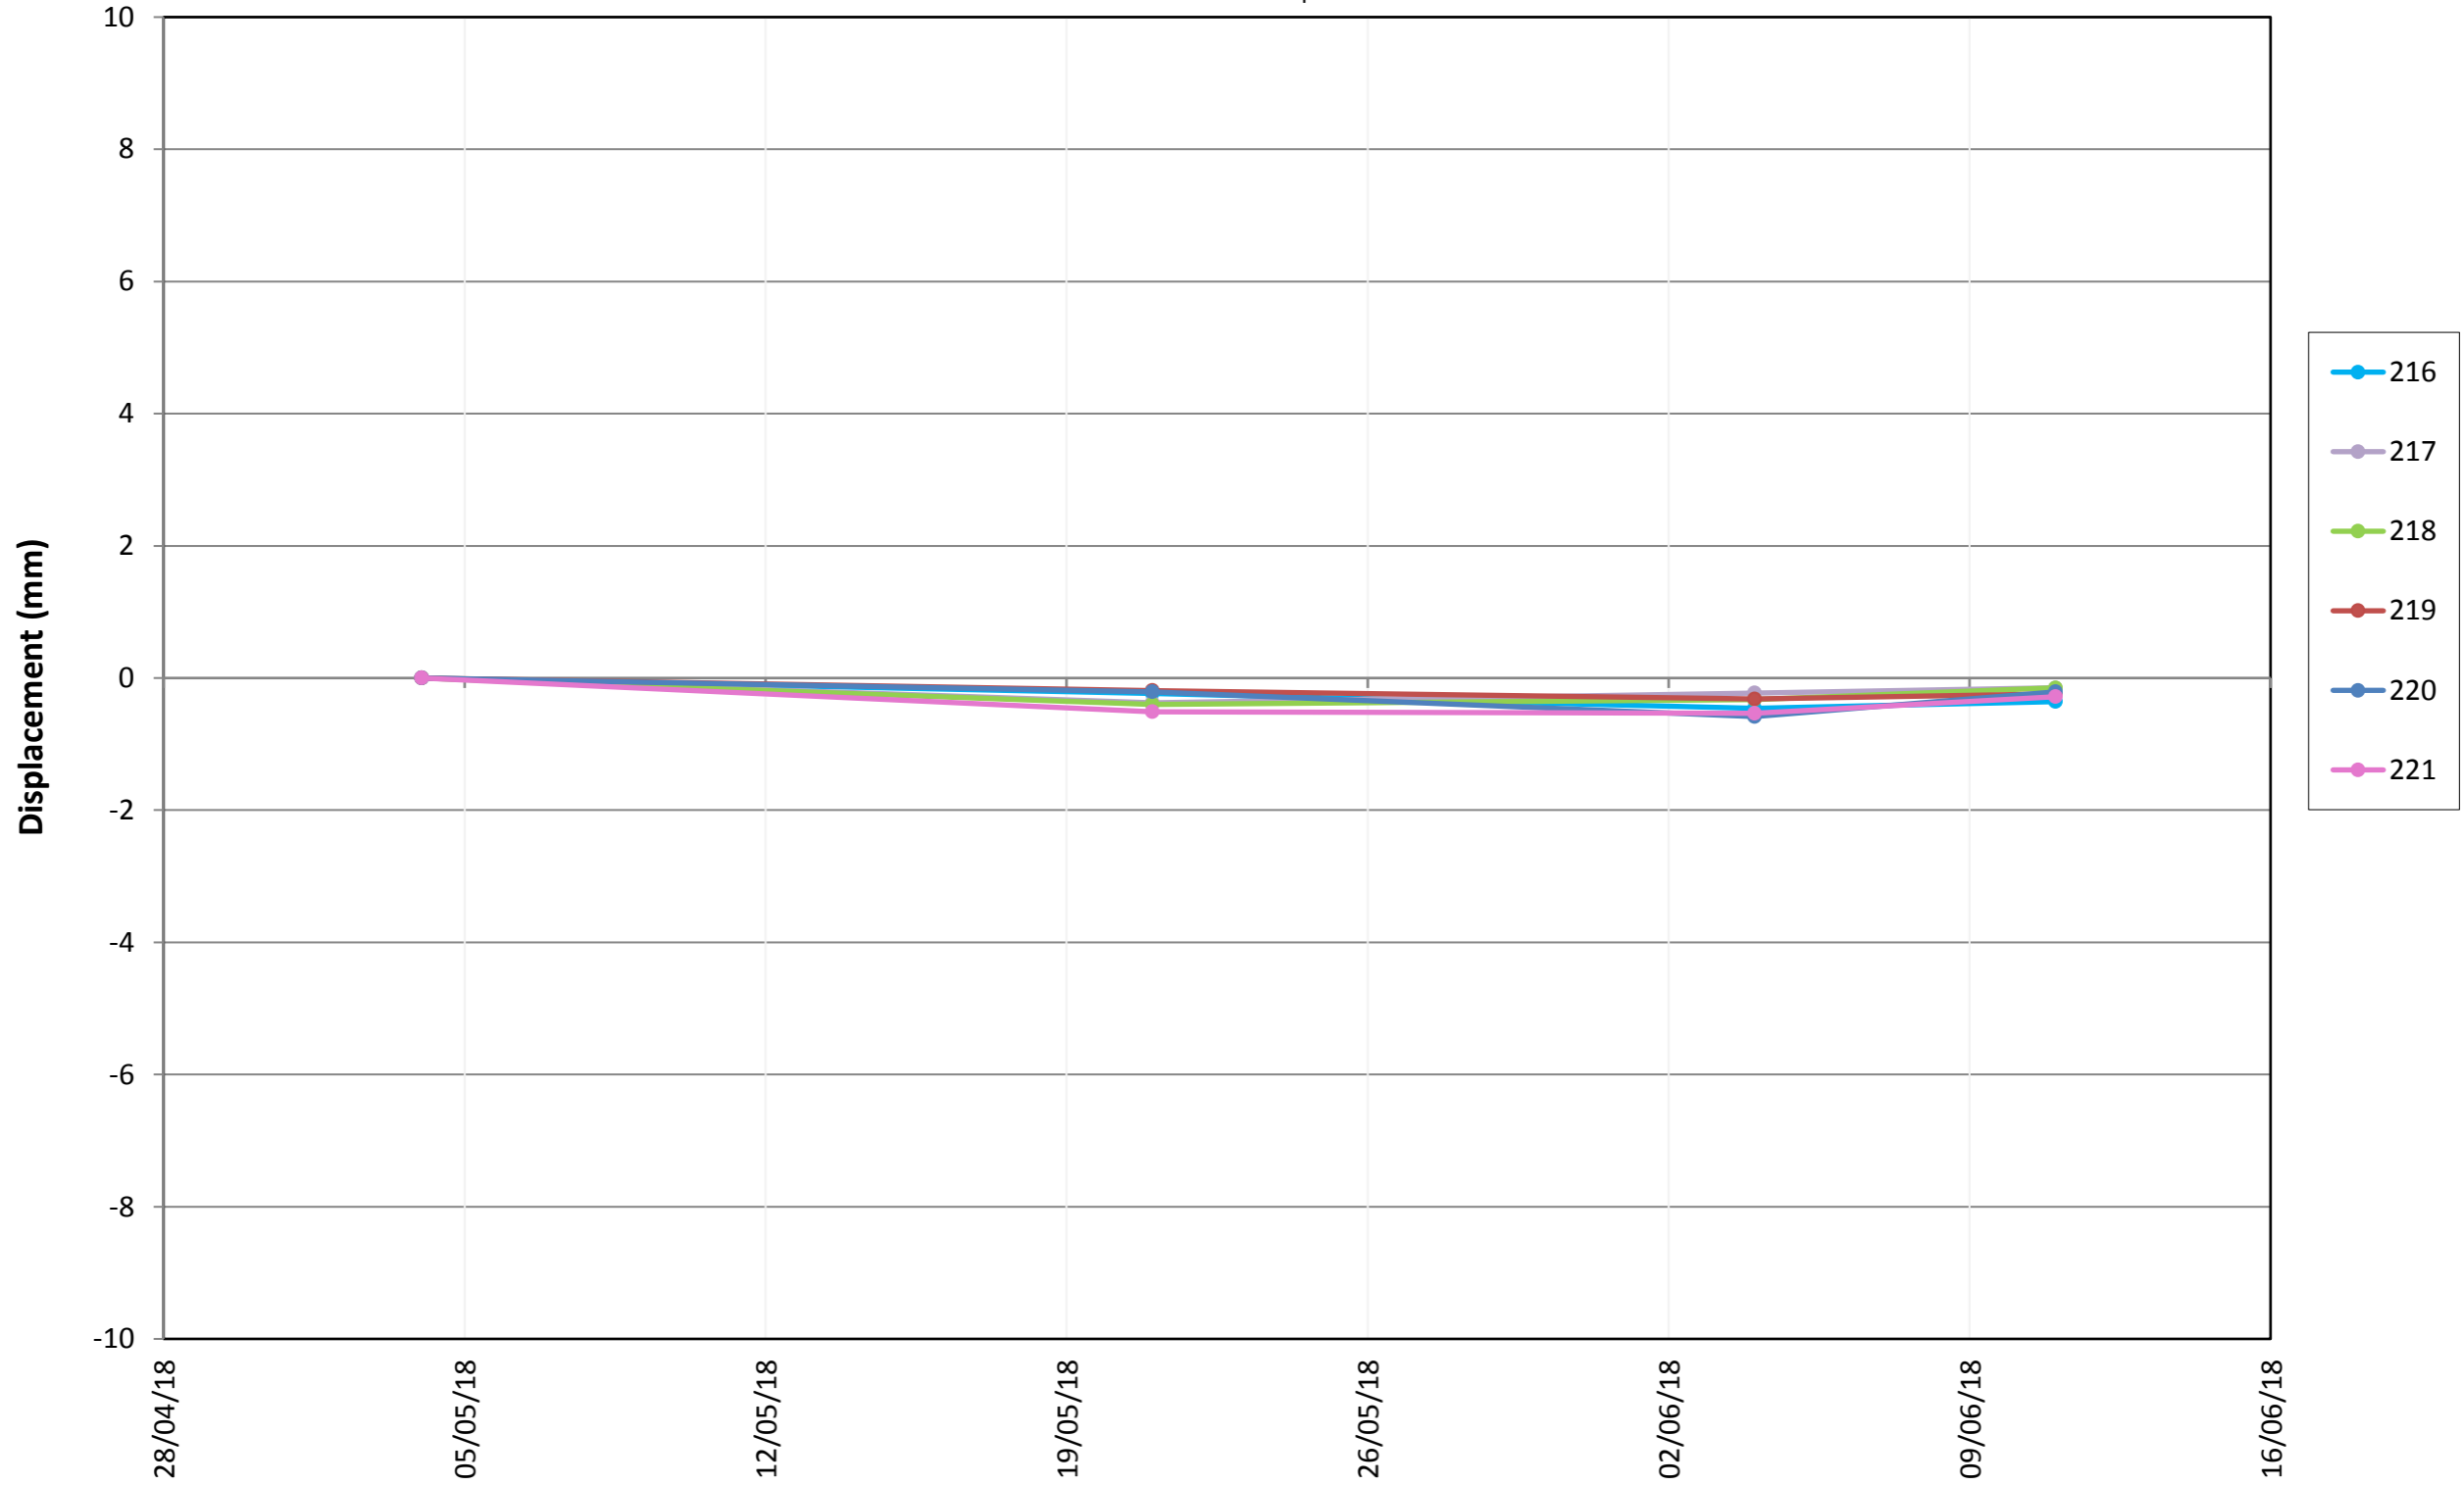
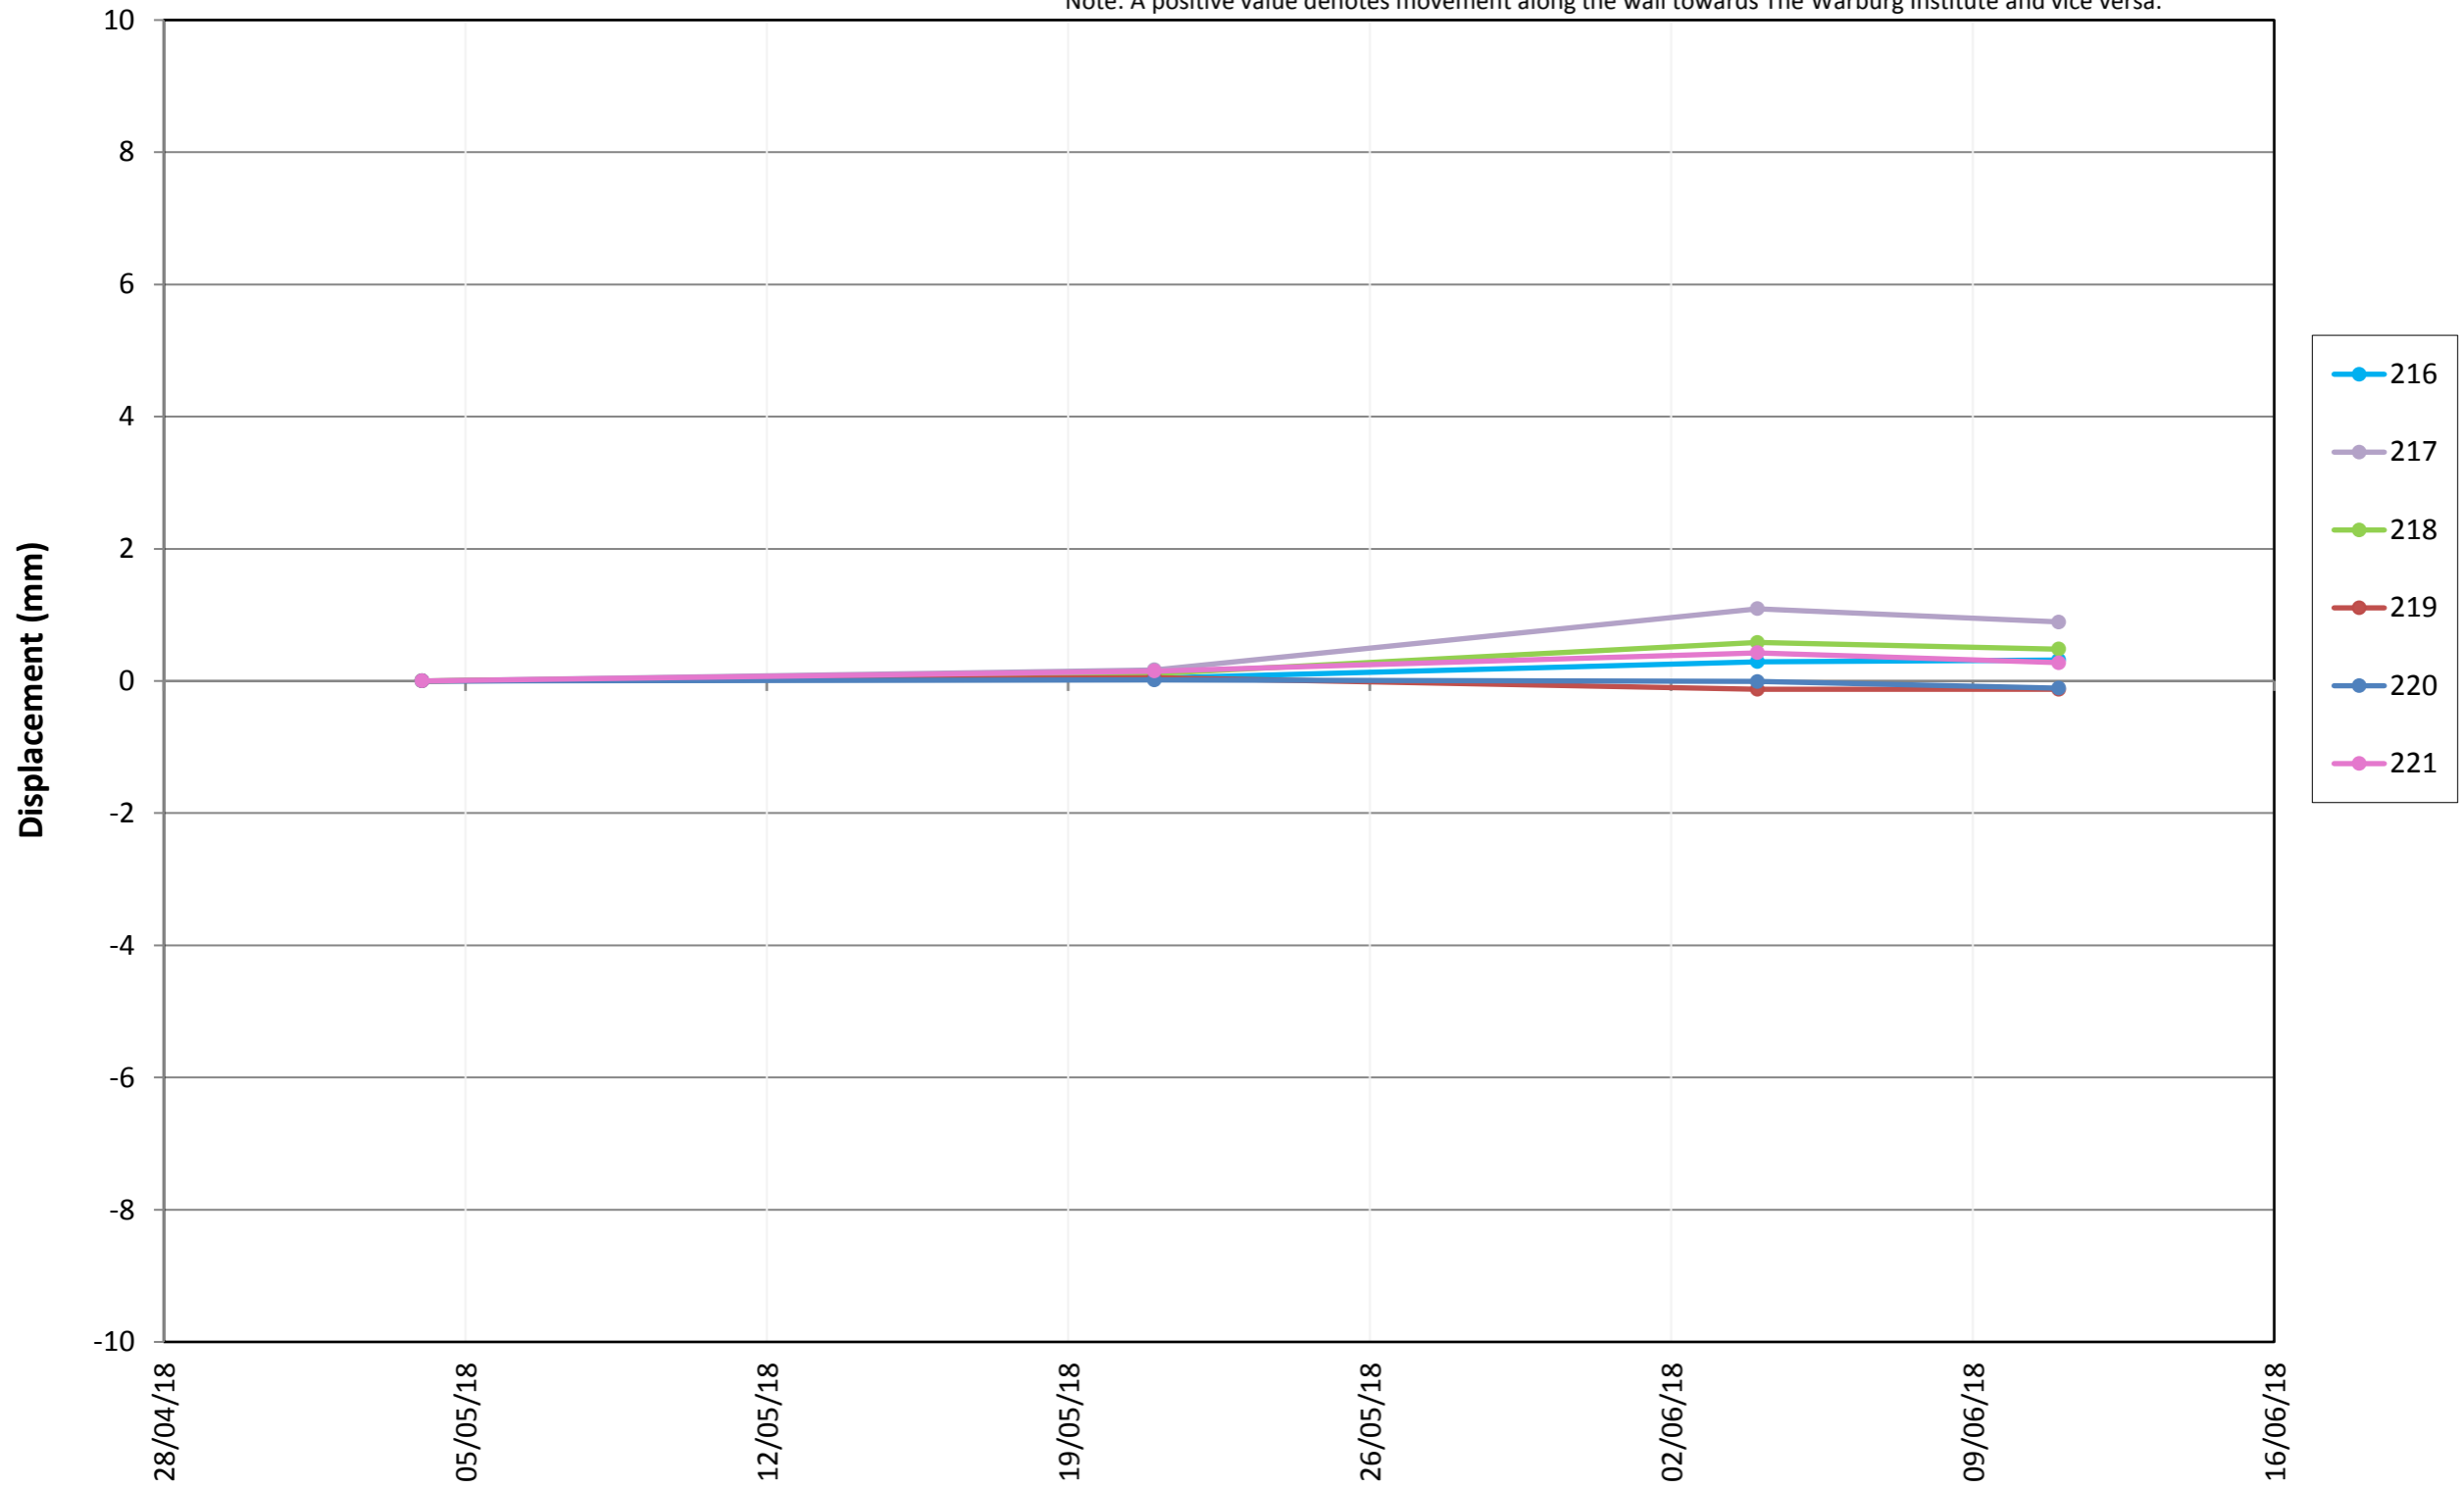
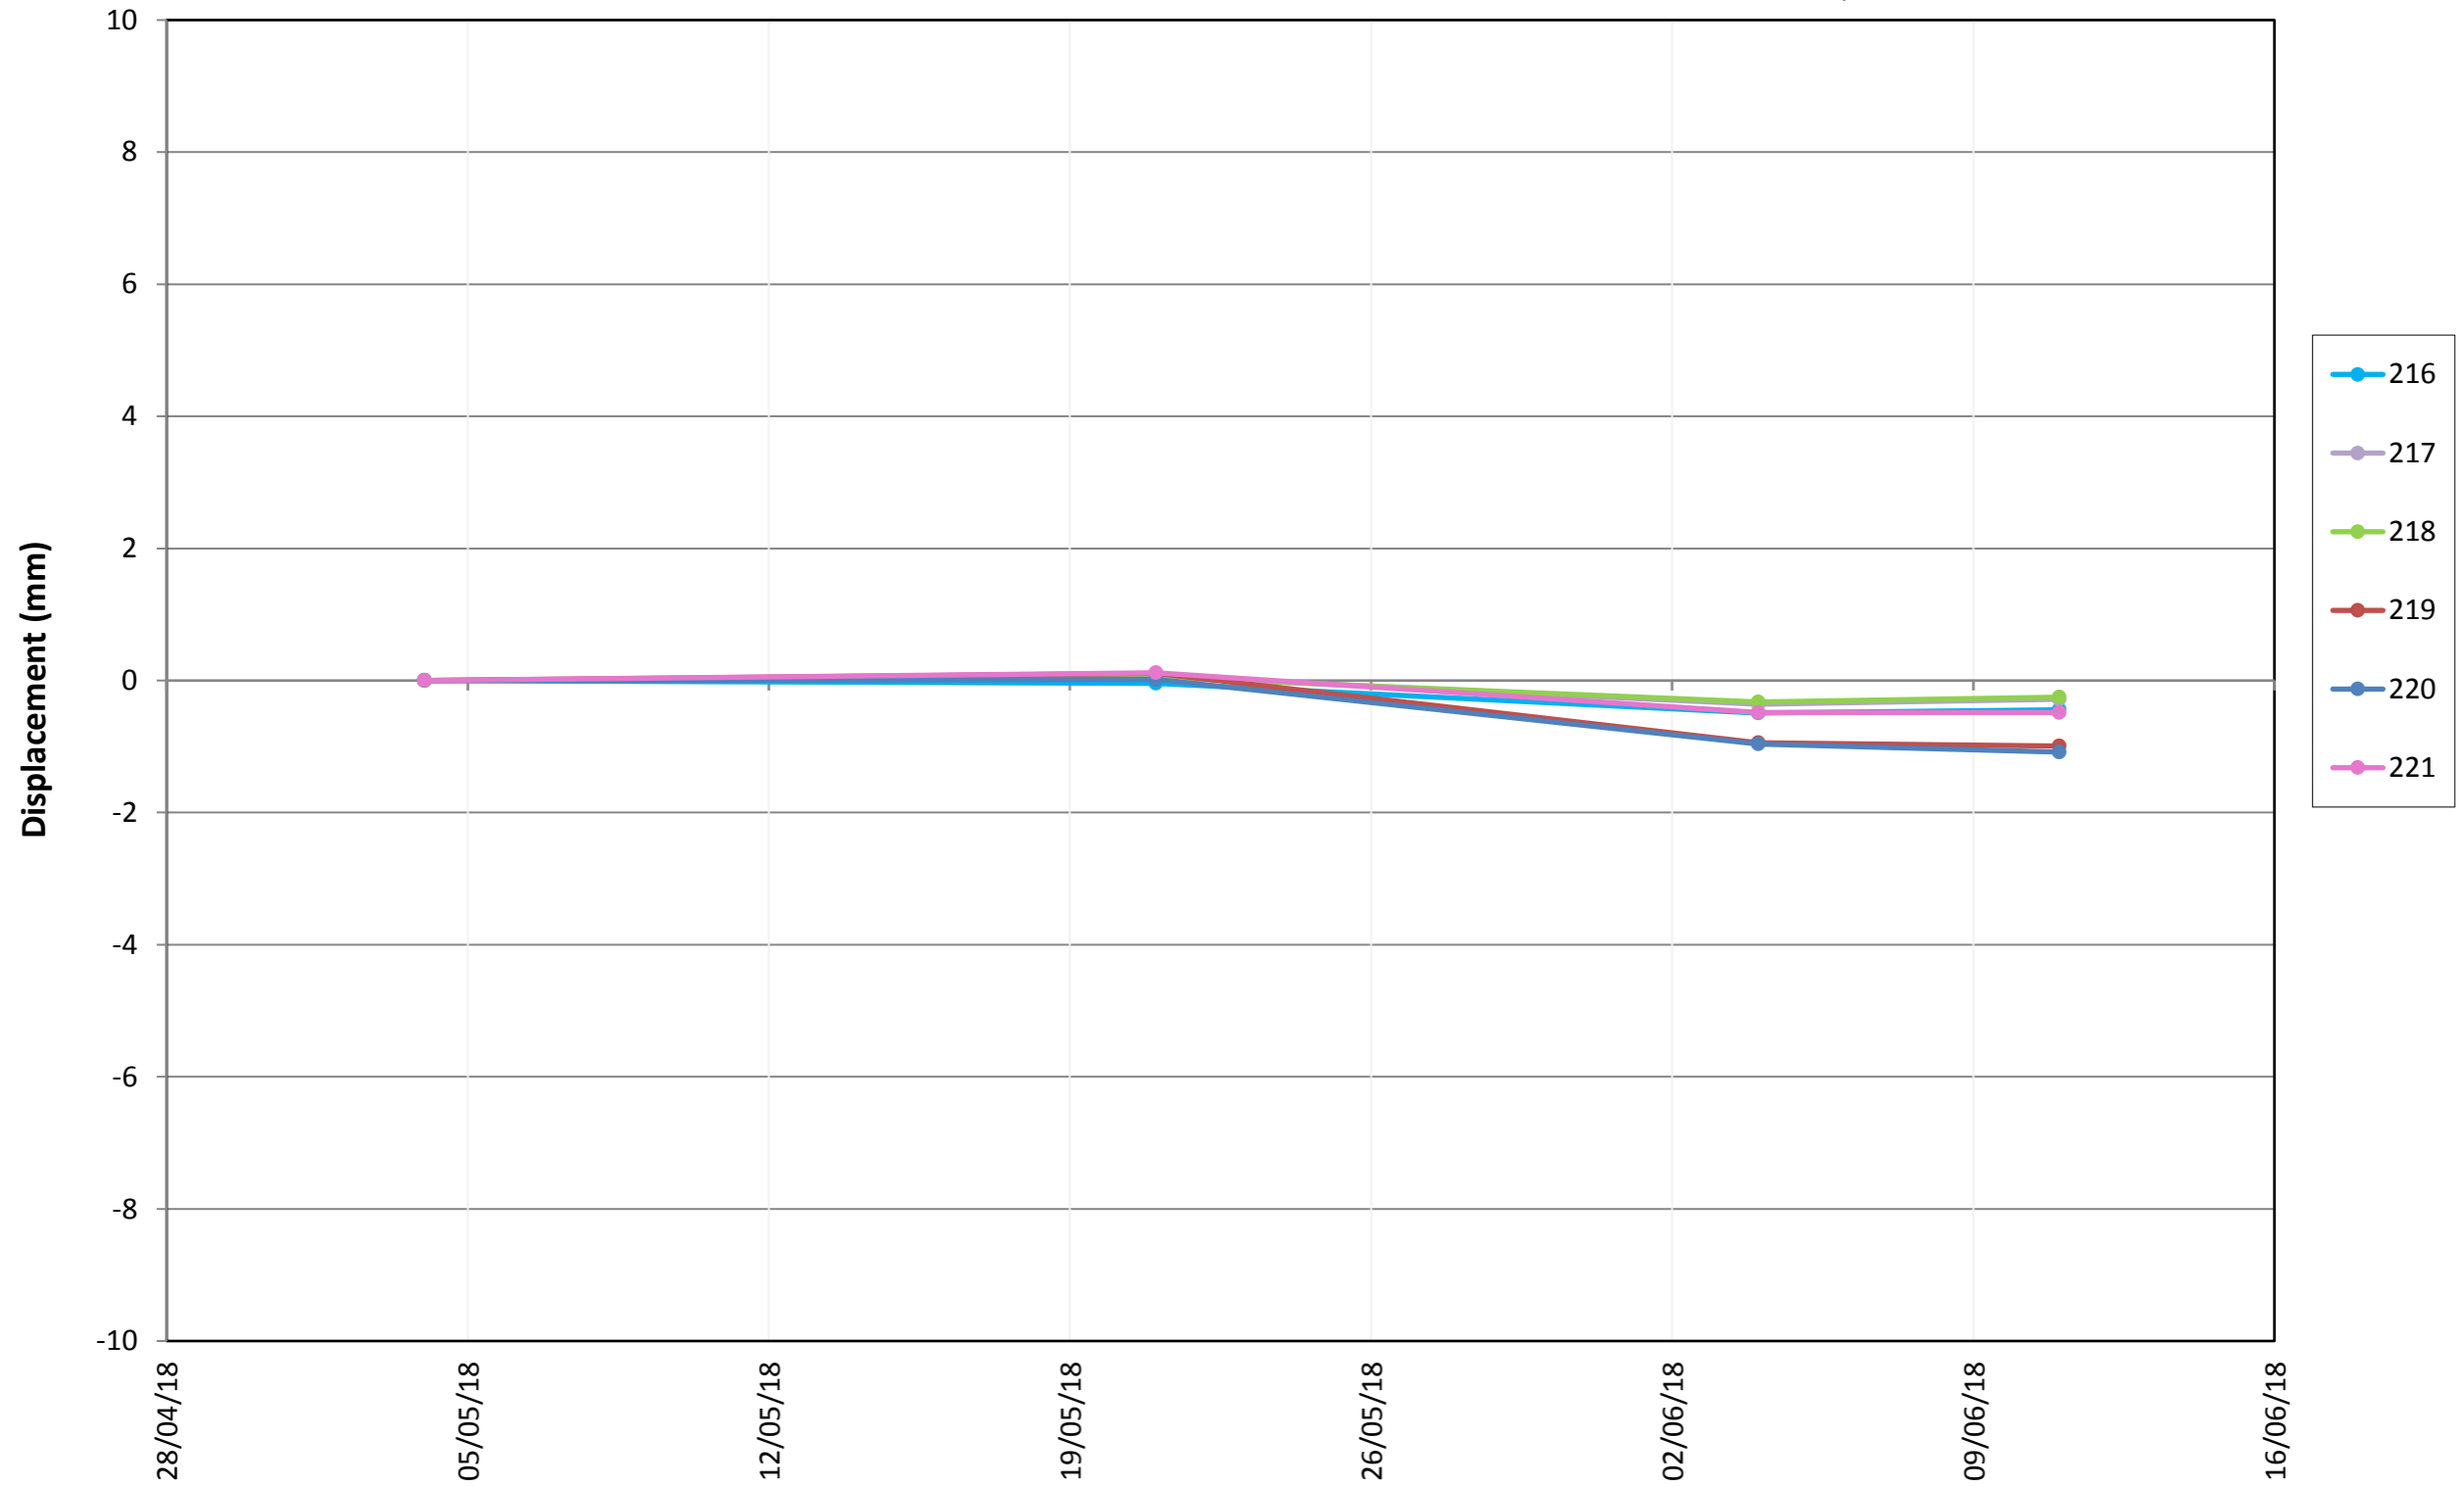
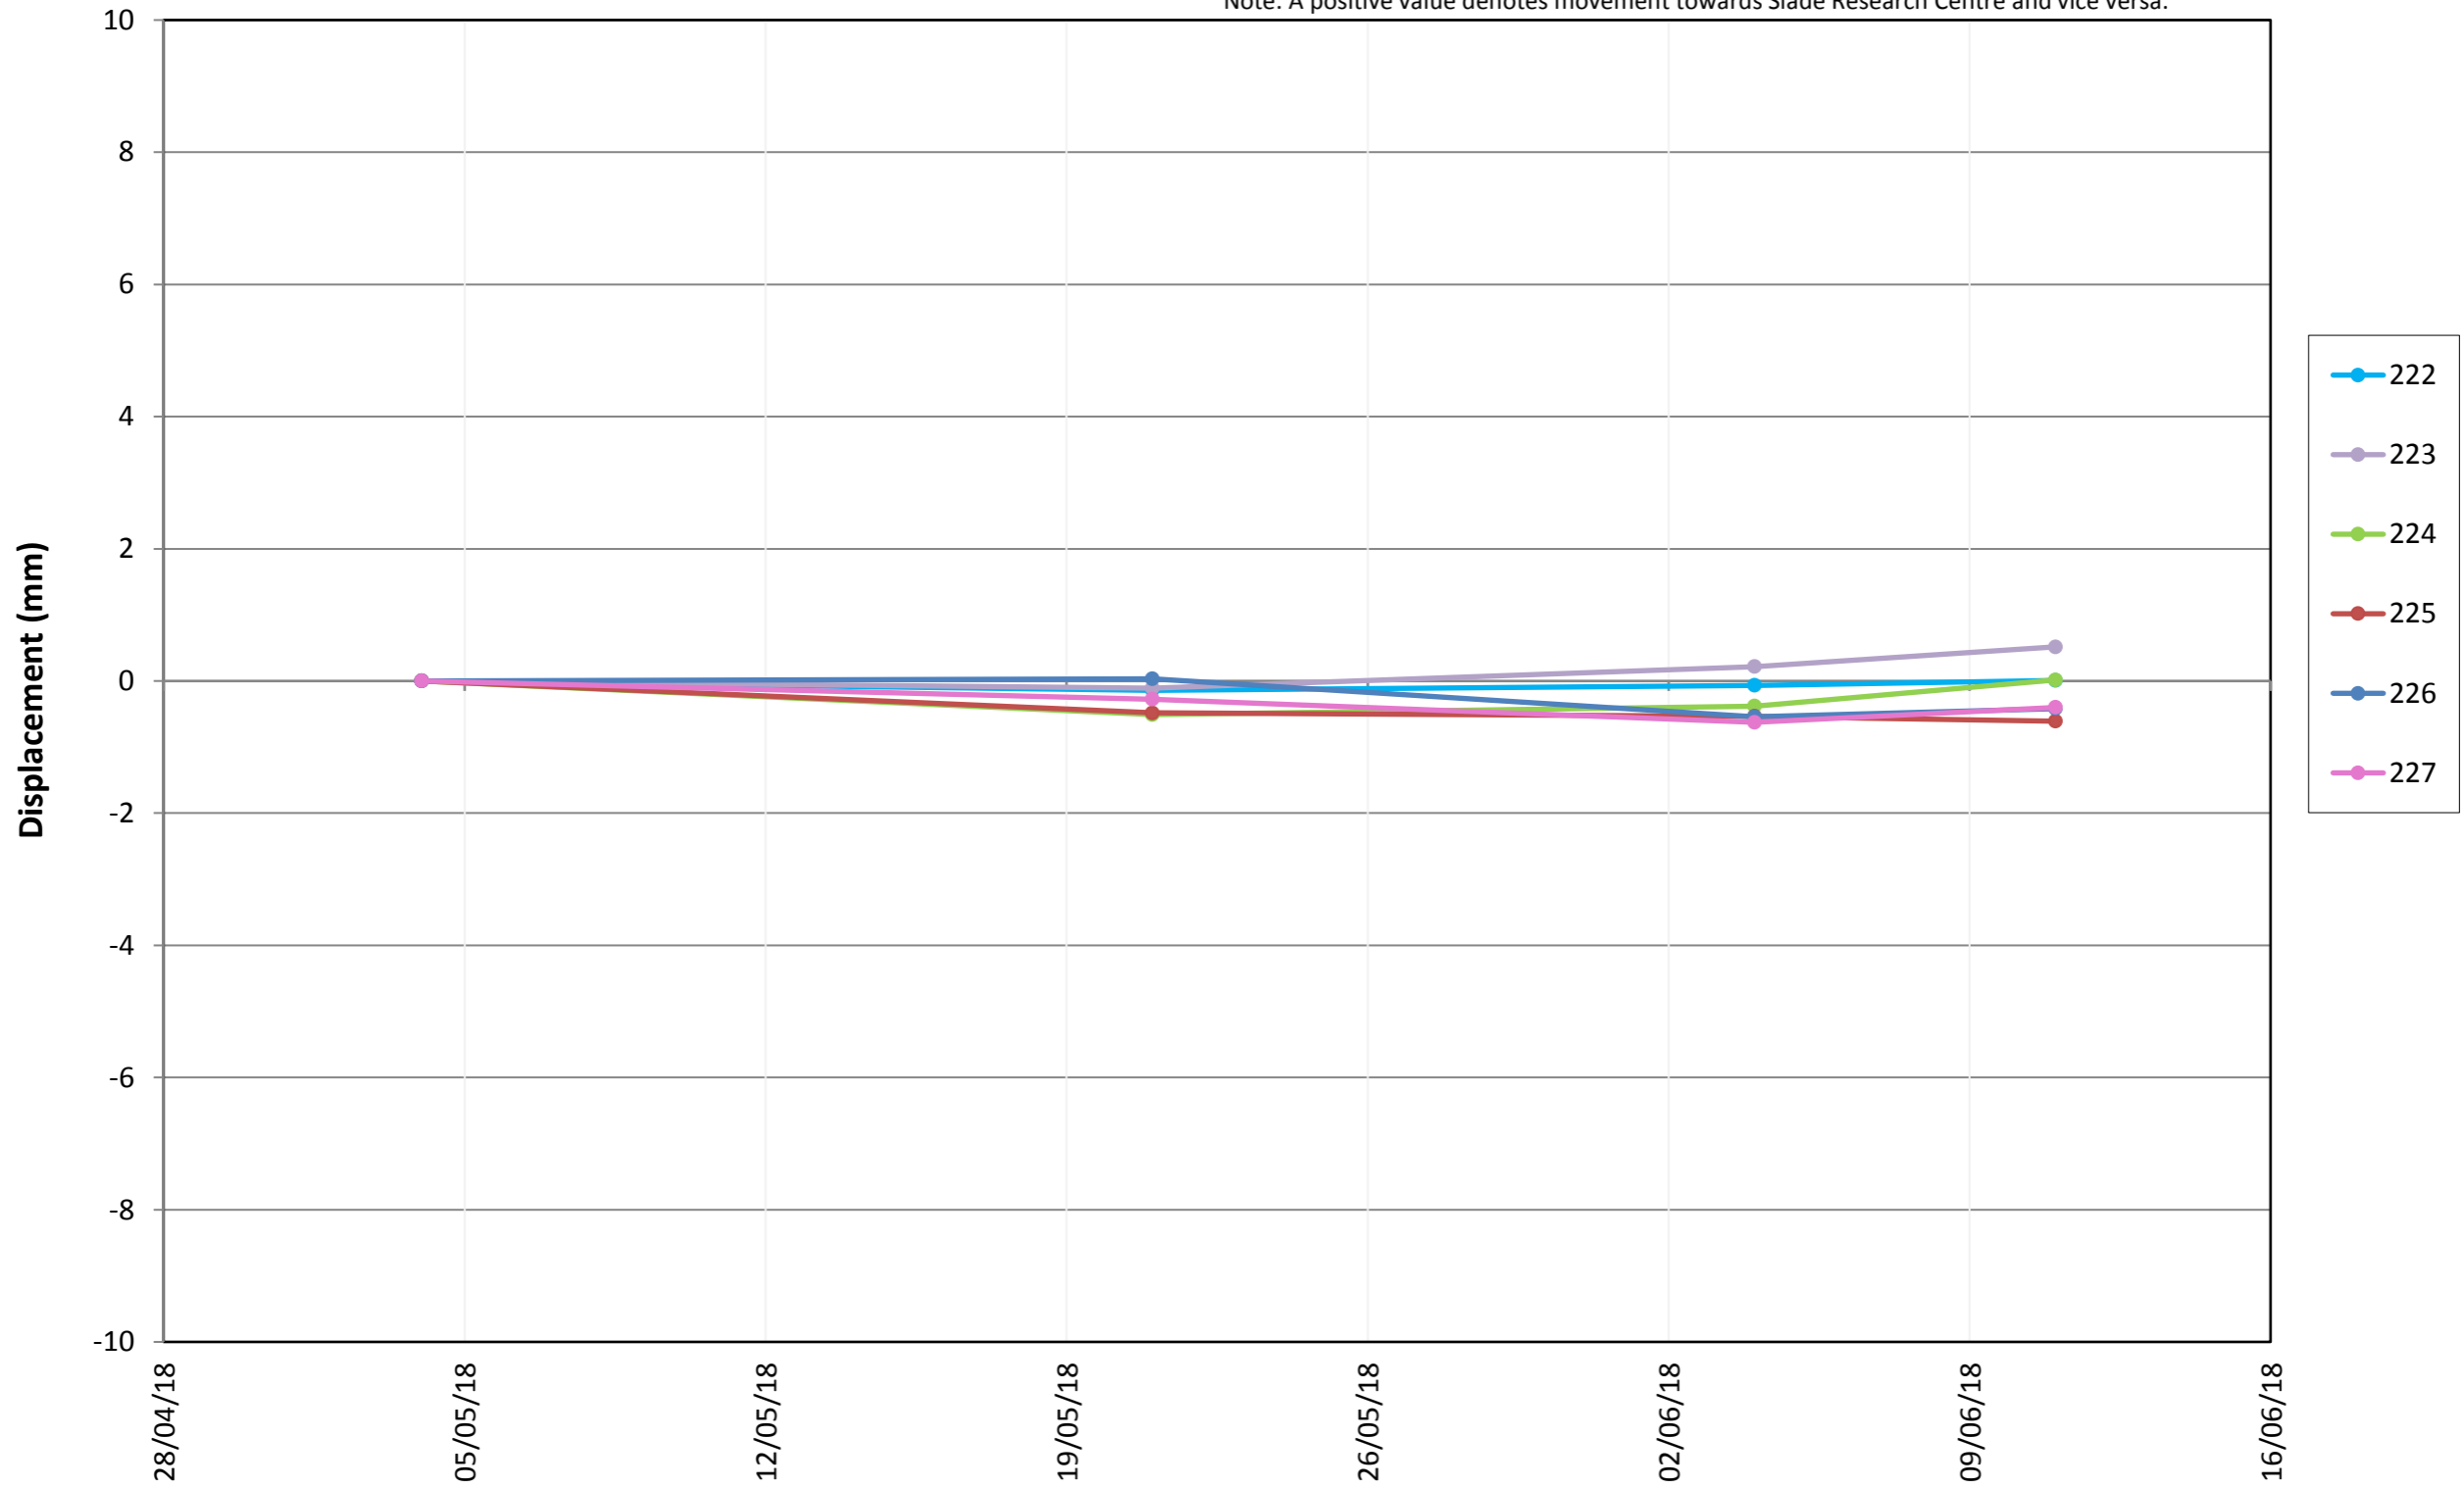
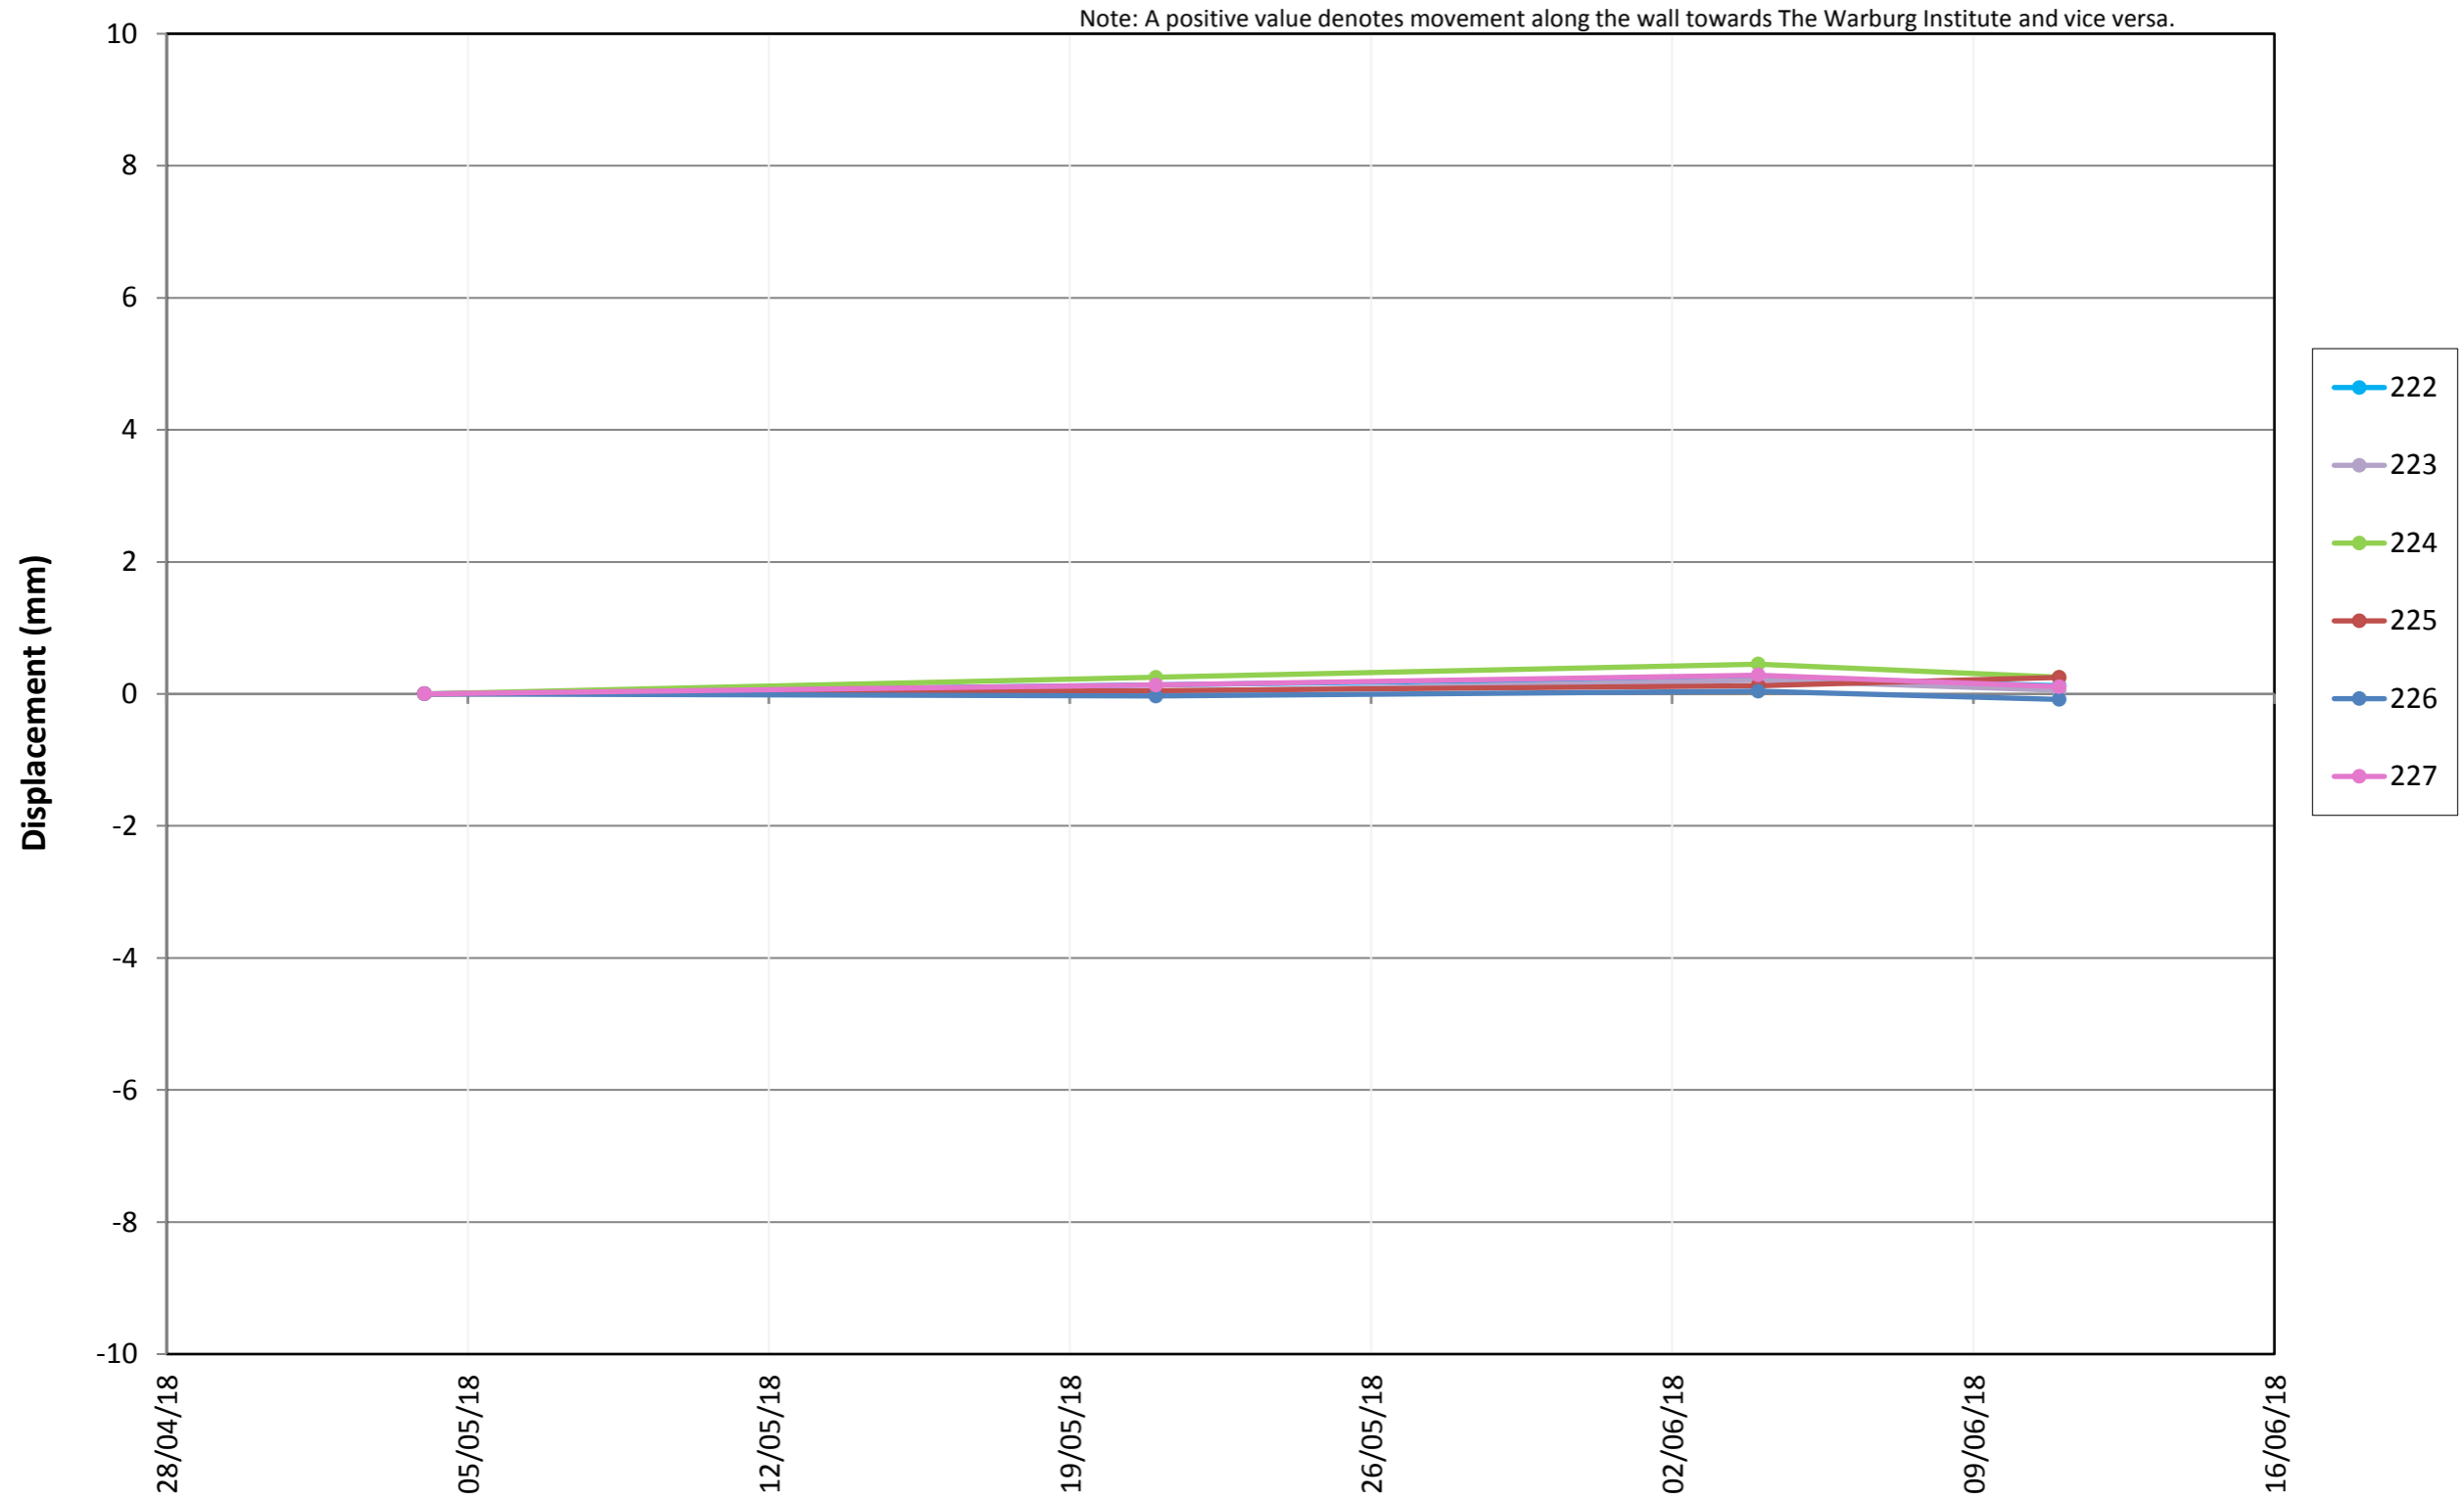
Graph 04T - Targets on Staircase

Targets on Staircase

Targets are showing negligible horizontal movement.
Targets are showing negligible vertical movement.
