32-33 TORRINGTON SQUARE
MONITORING

Monitoring Report
SES-10215-MR03

Date of survey completion: 11th June 2018

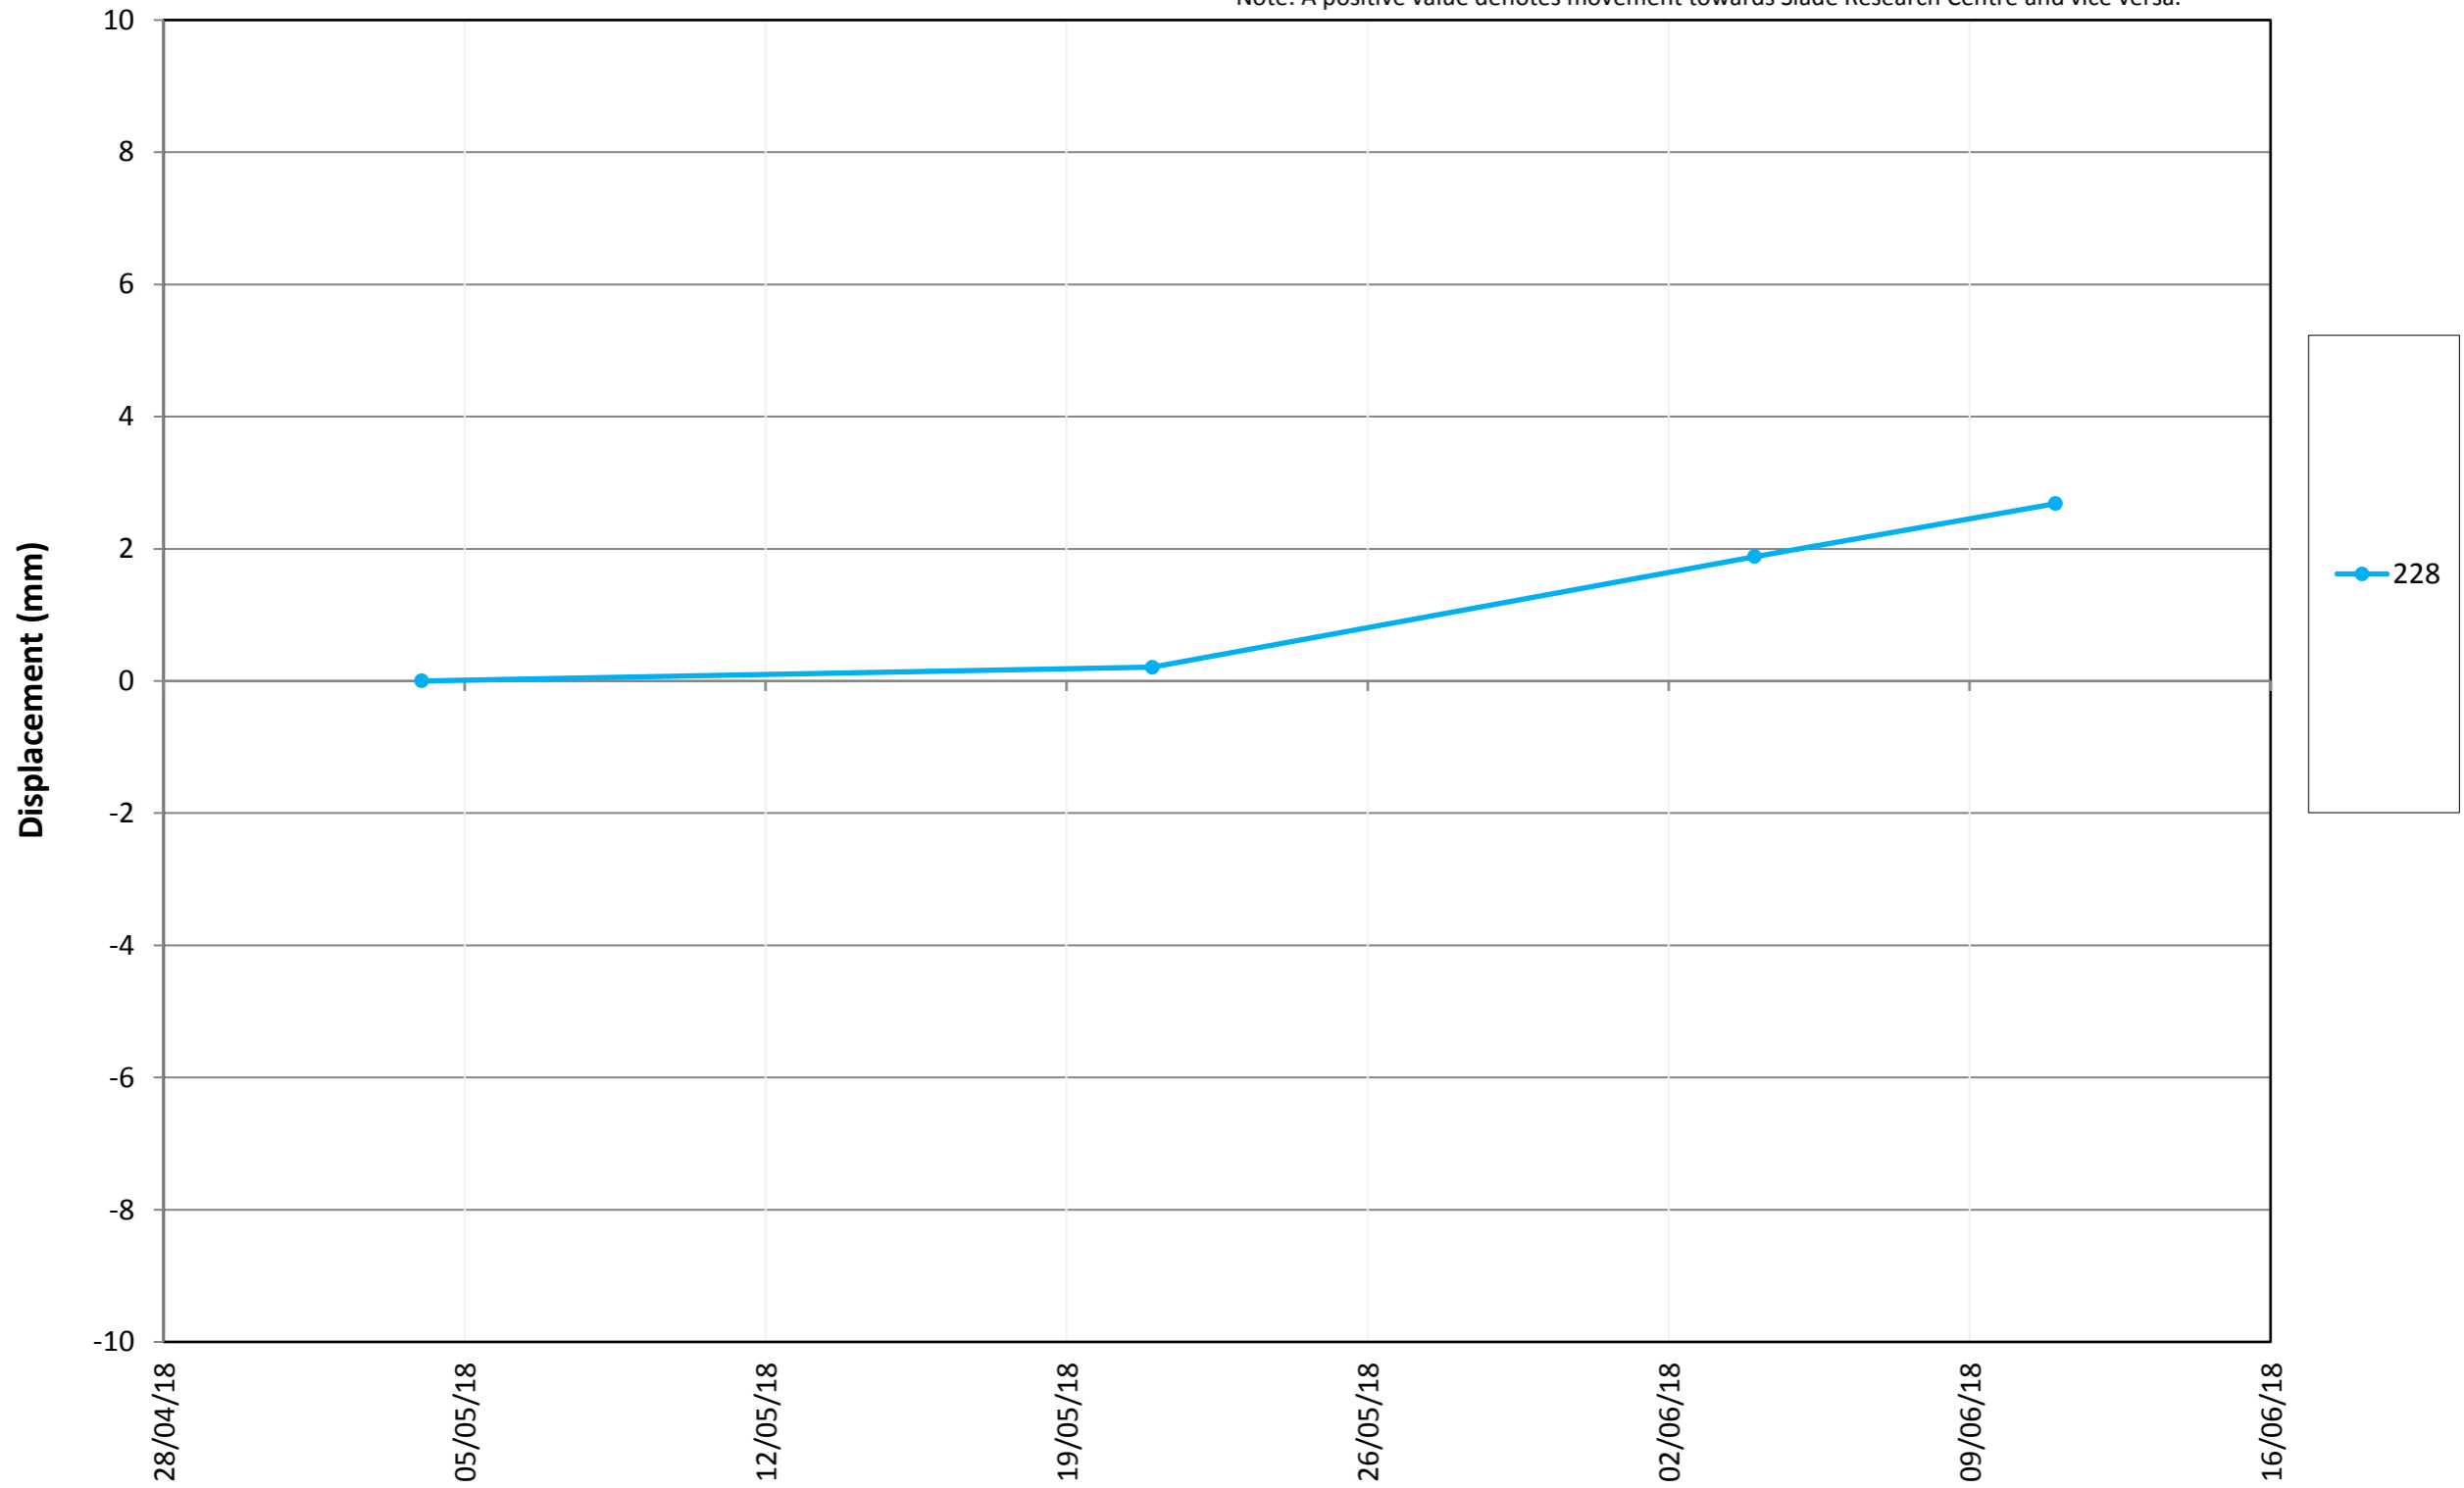
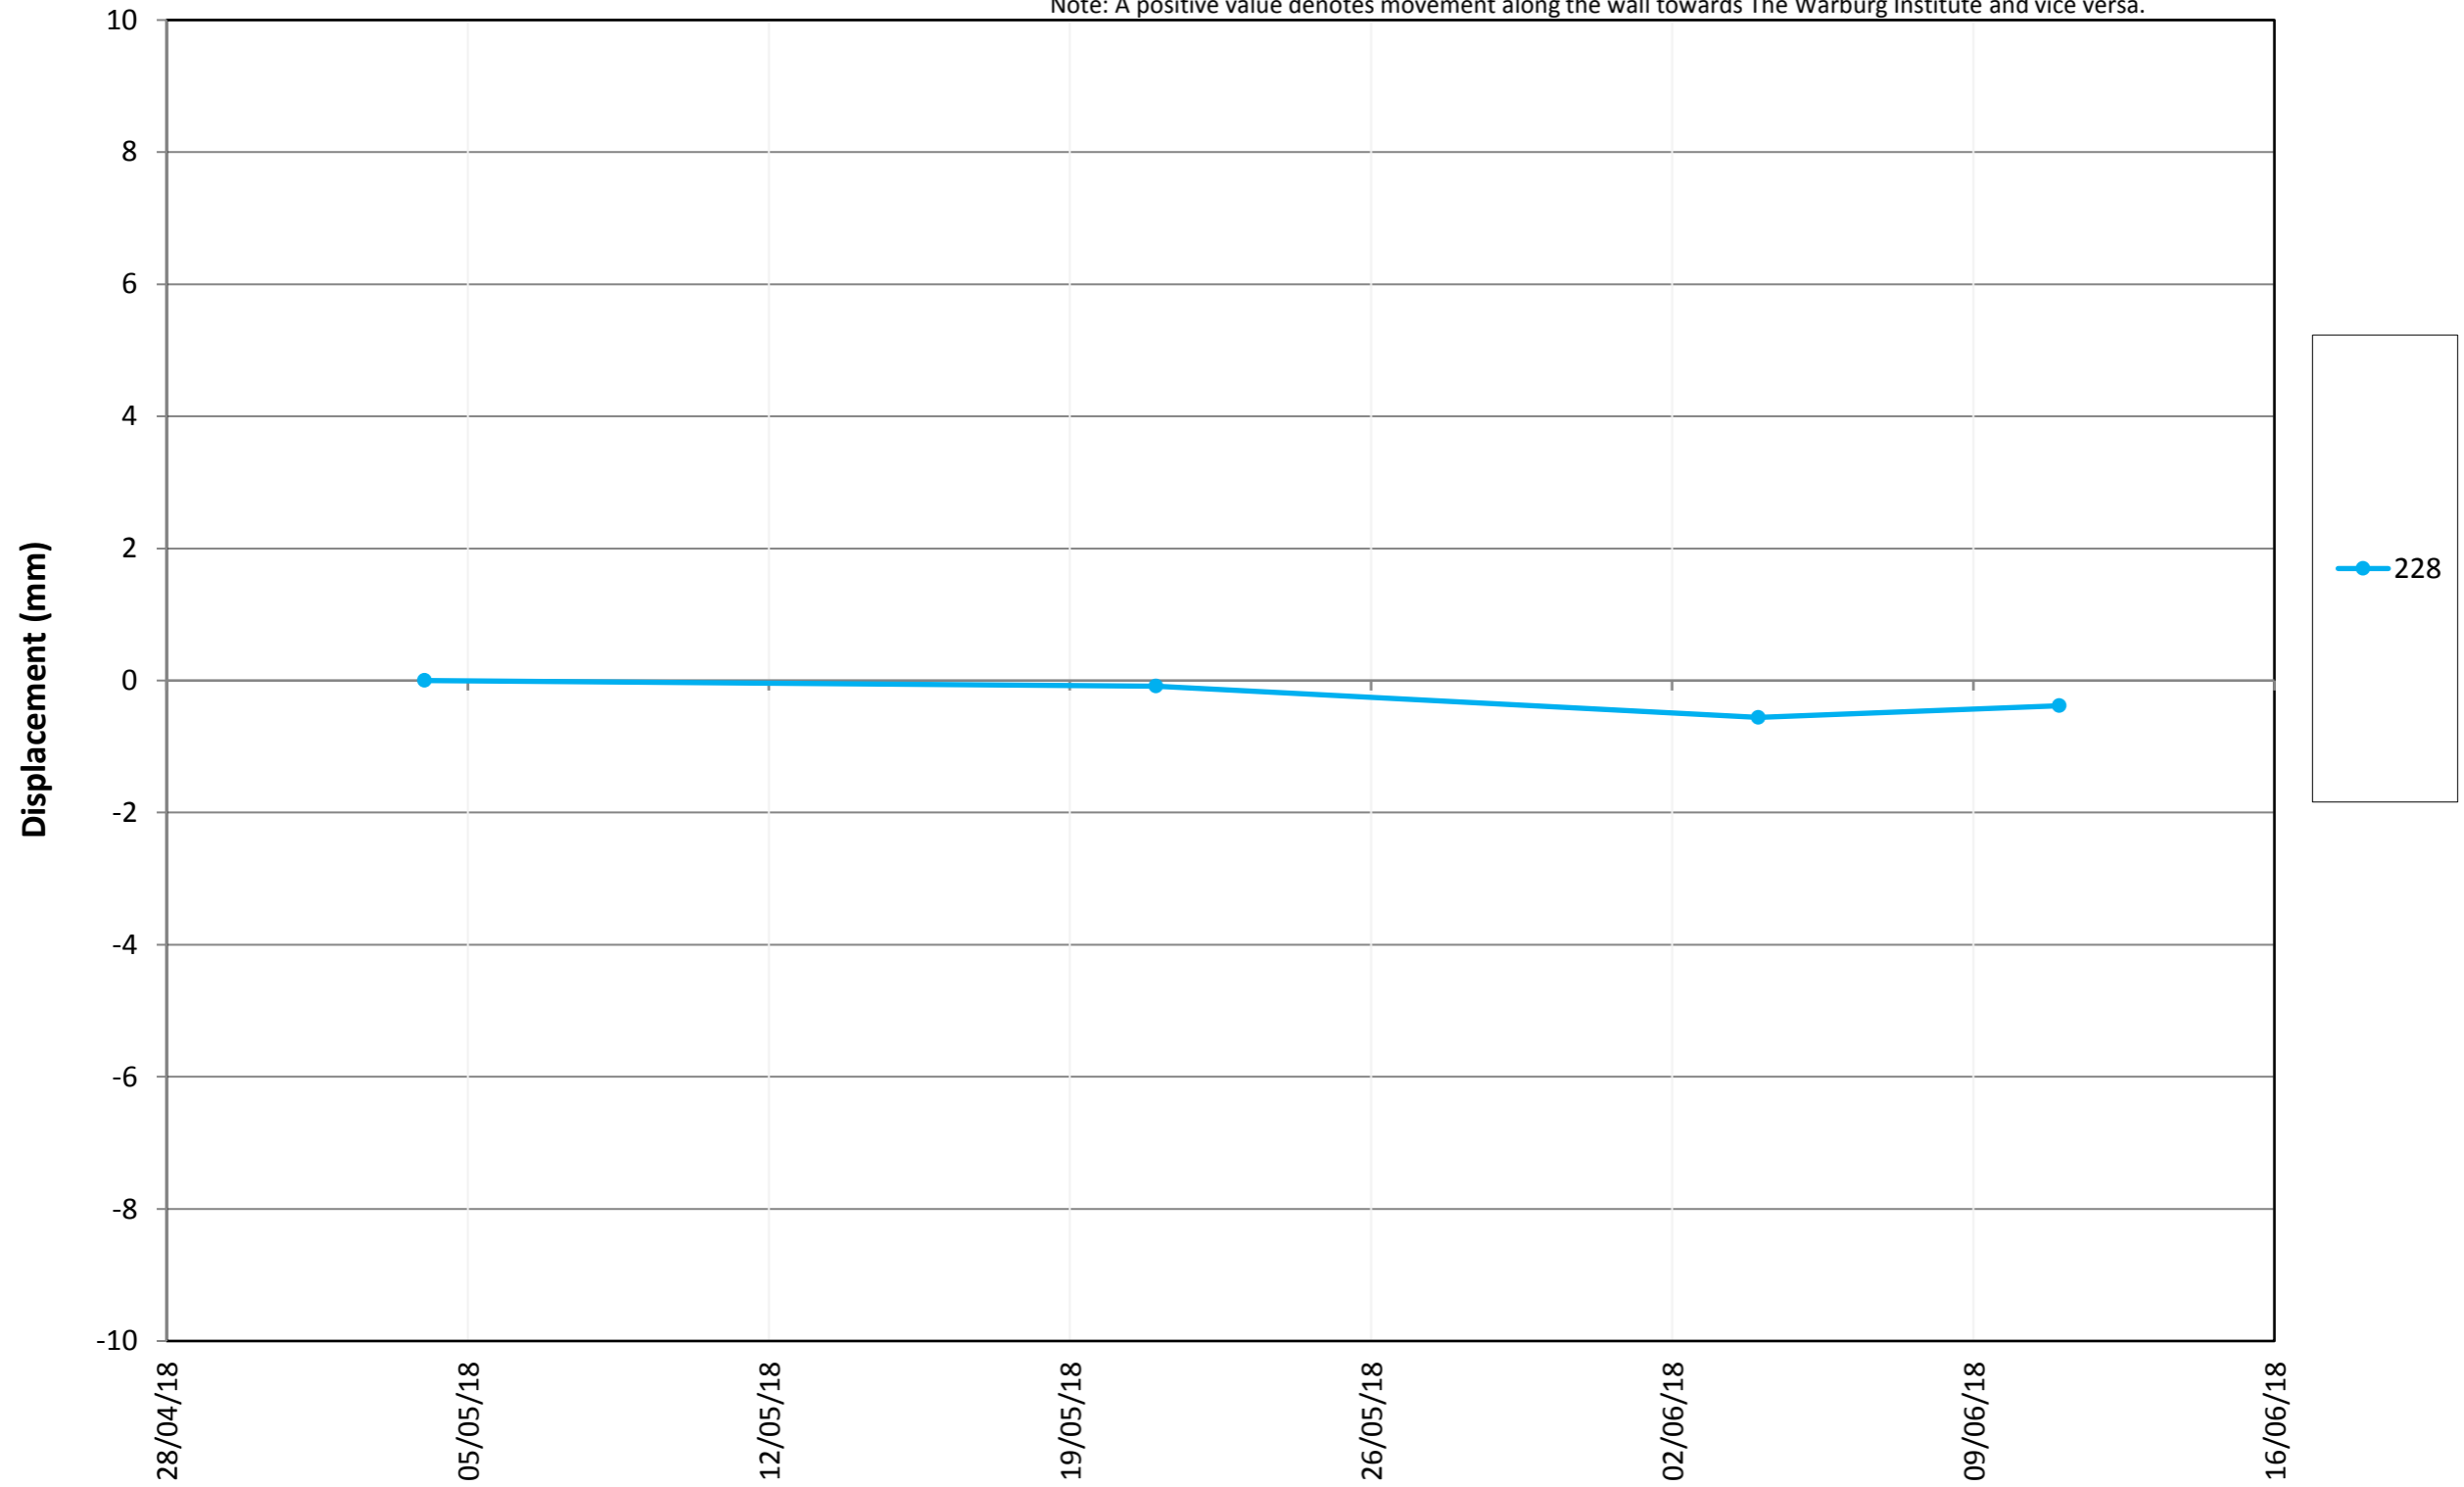
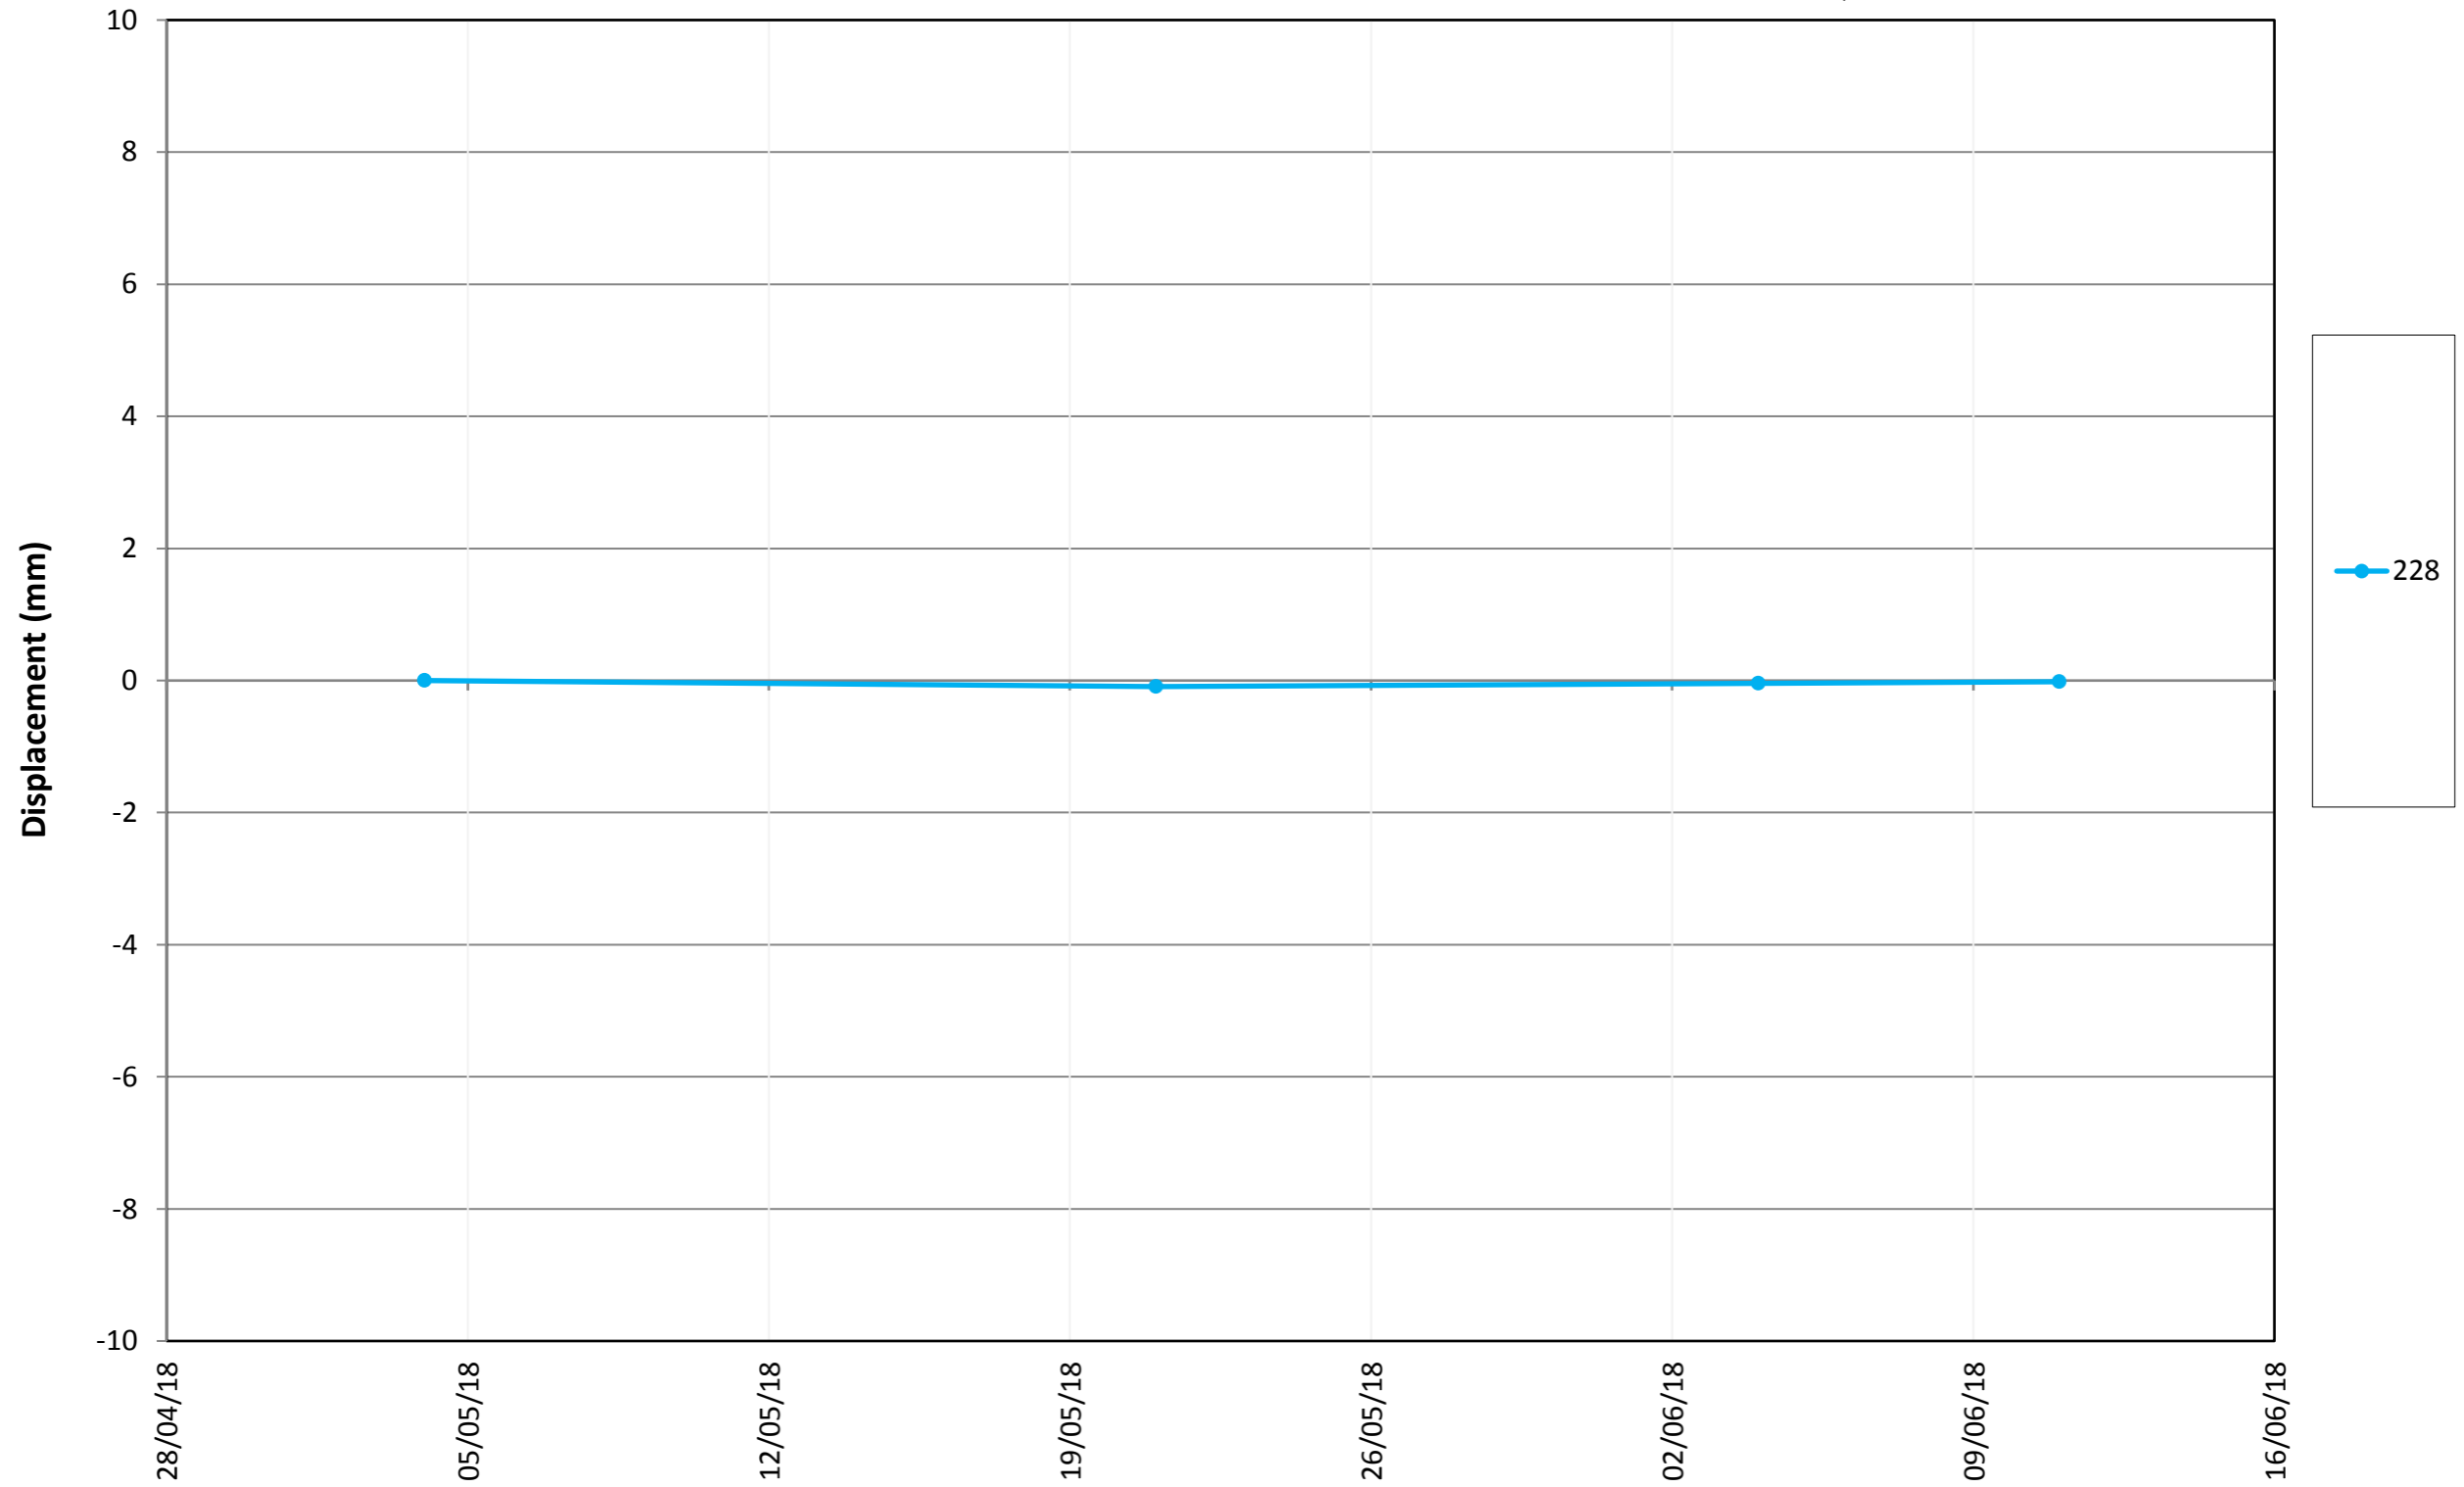
Graph 06T - Targets on back garden of No. 31 Torrington Square

Targets on back garden of No. 31 Torrington Square

Targets are showing horizontal movement of up to 3 mm in Eastings.
Targets are showing negligible vertical movement.

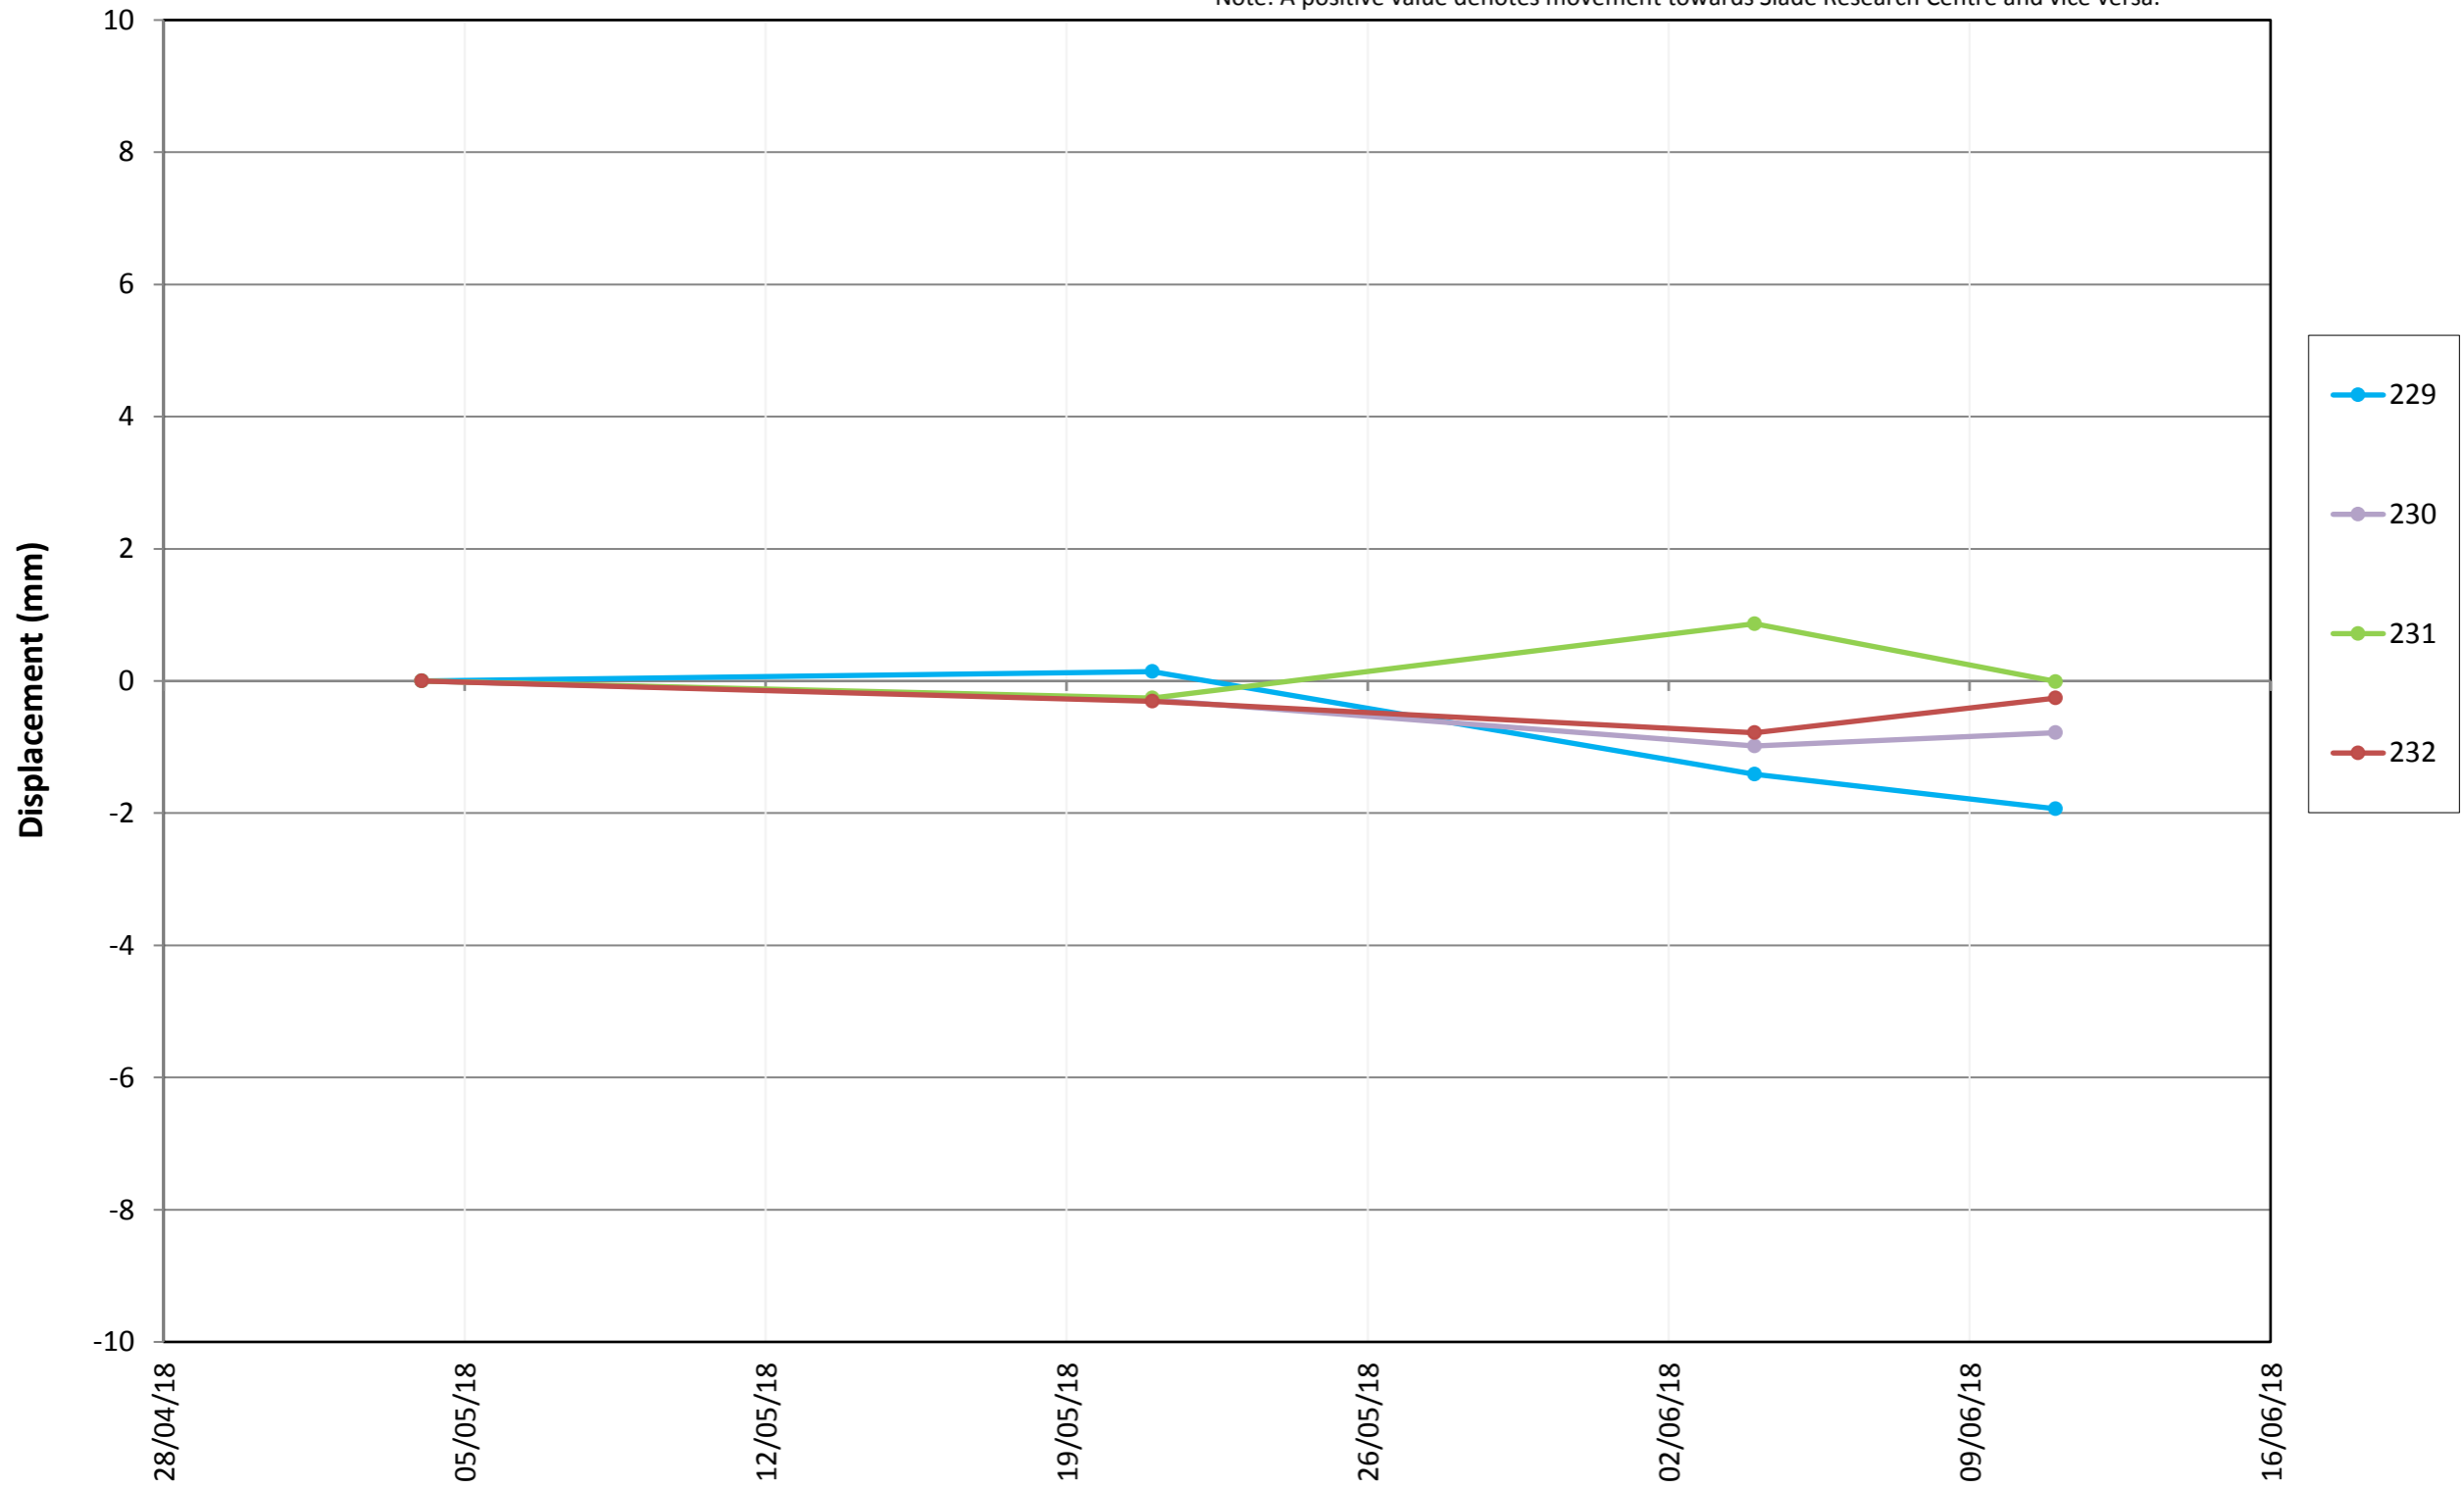
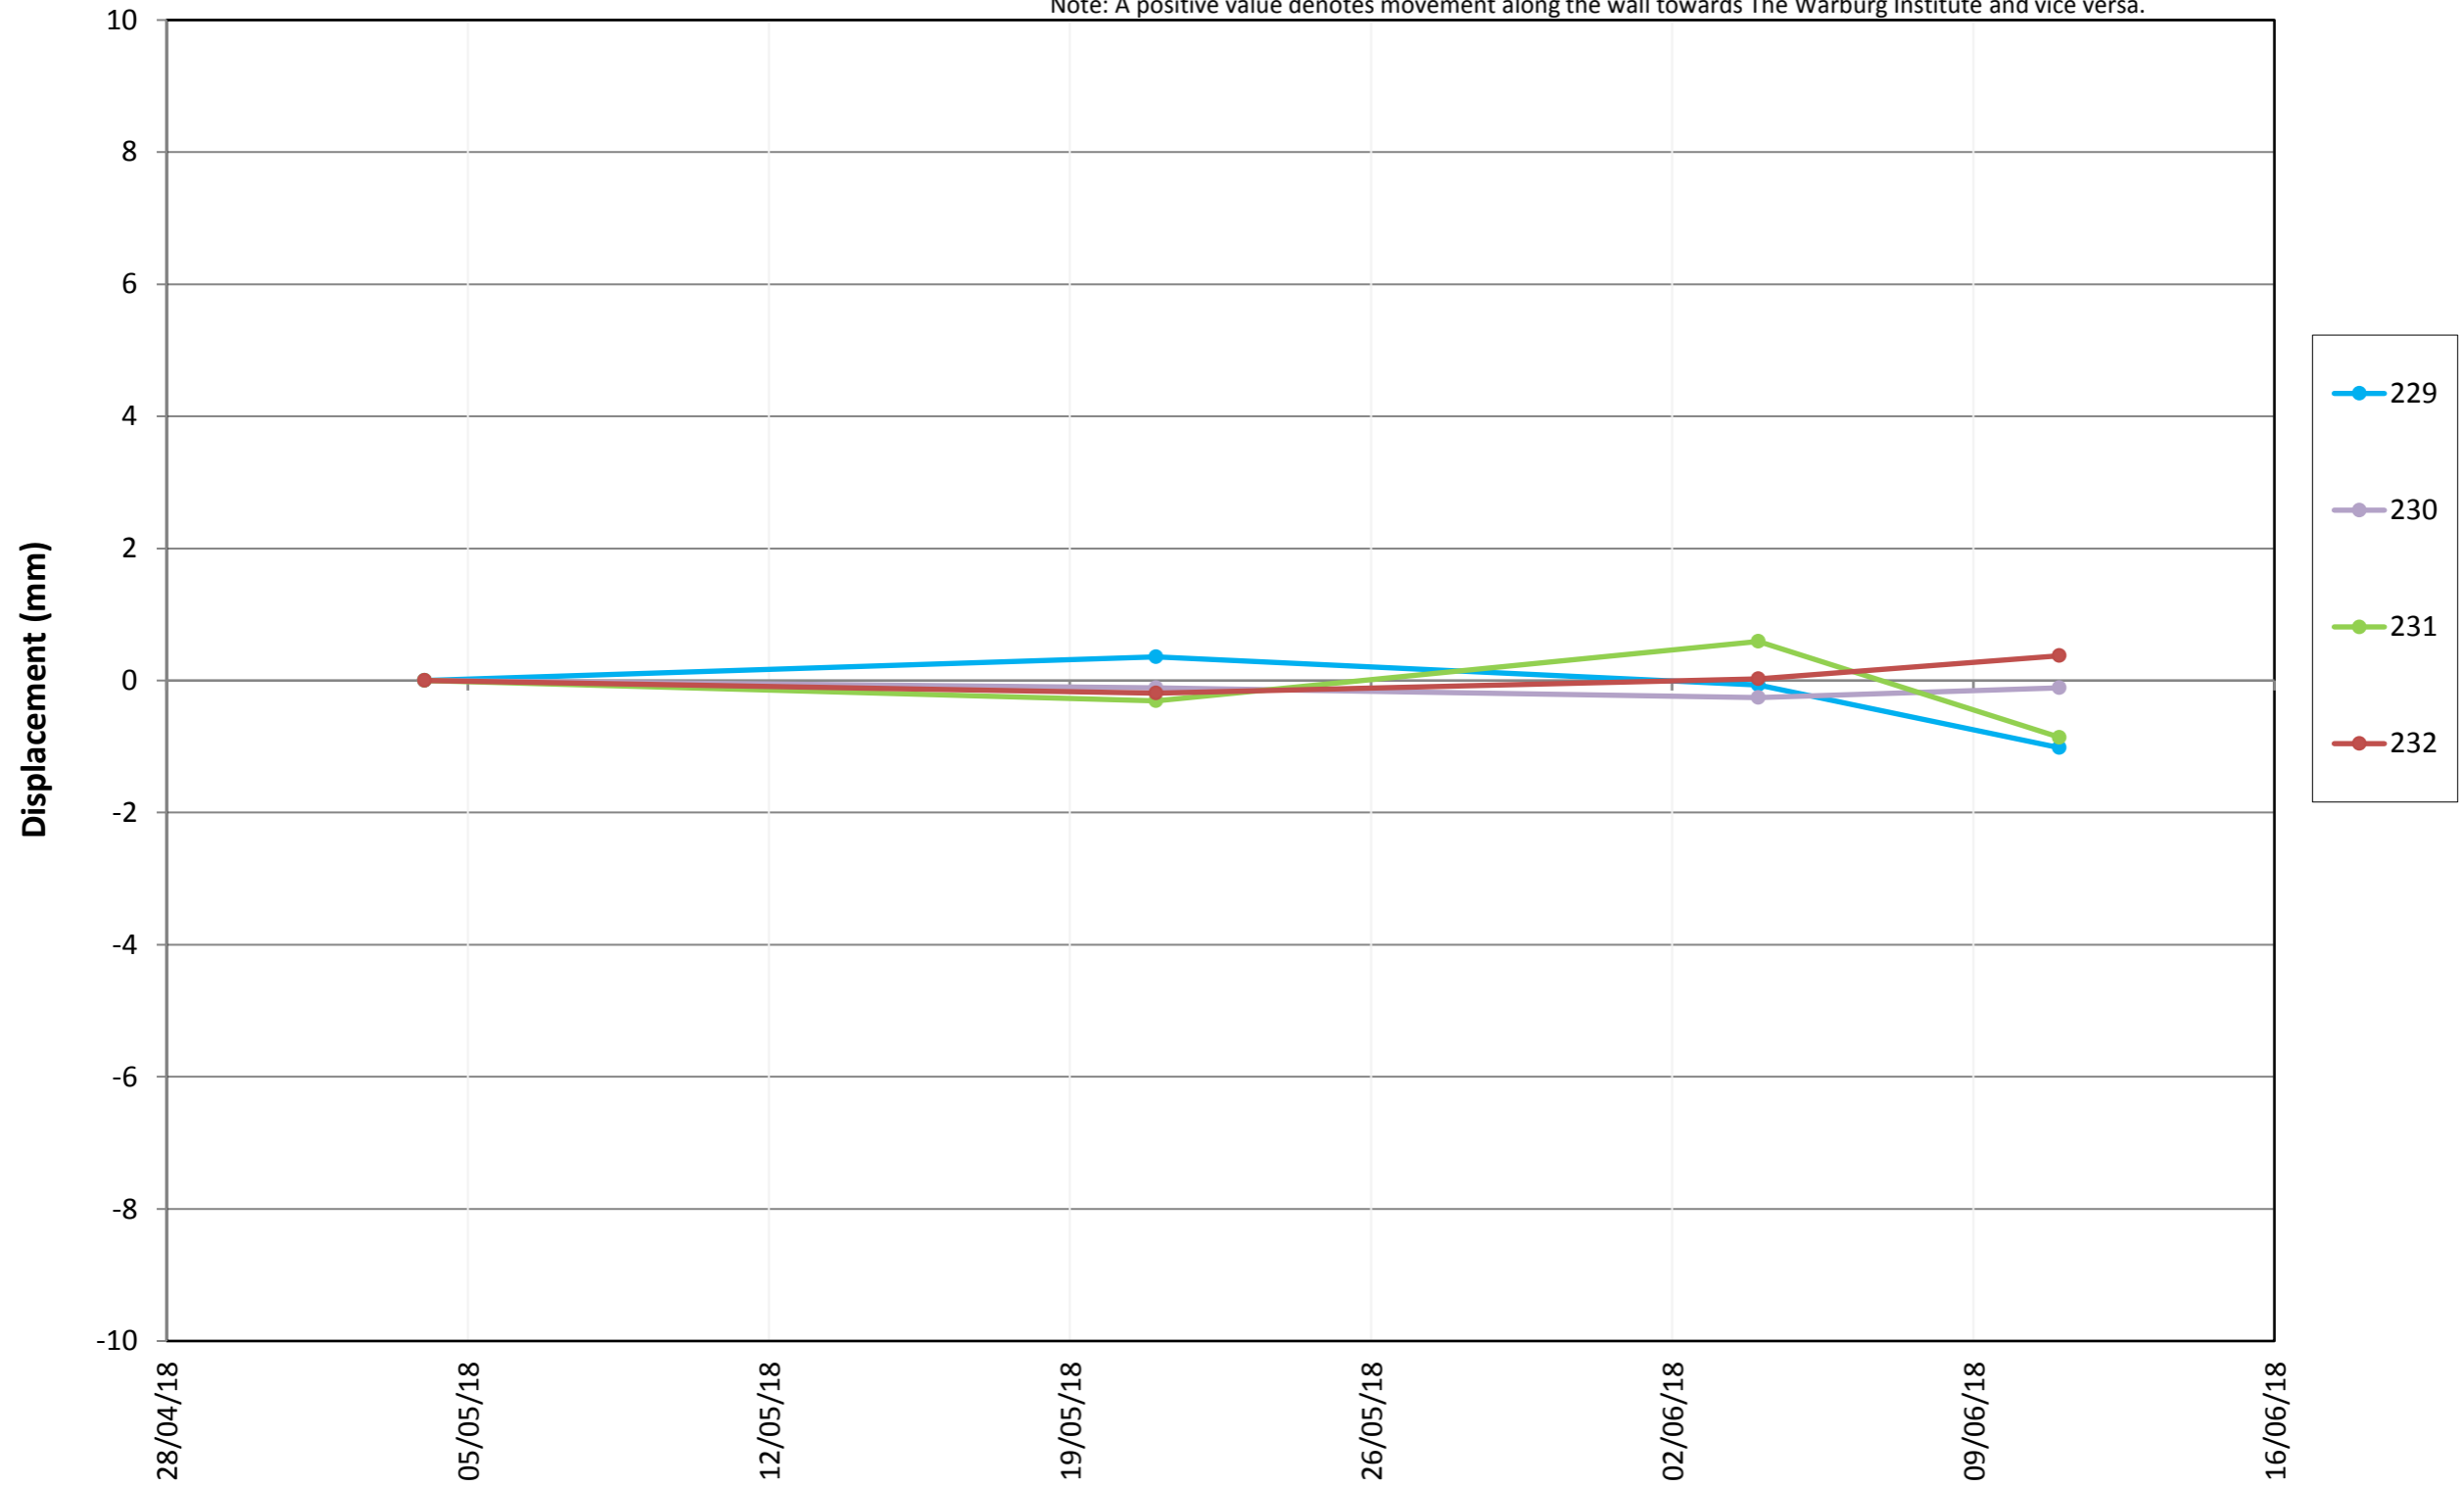
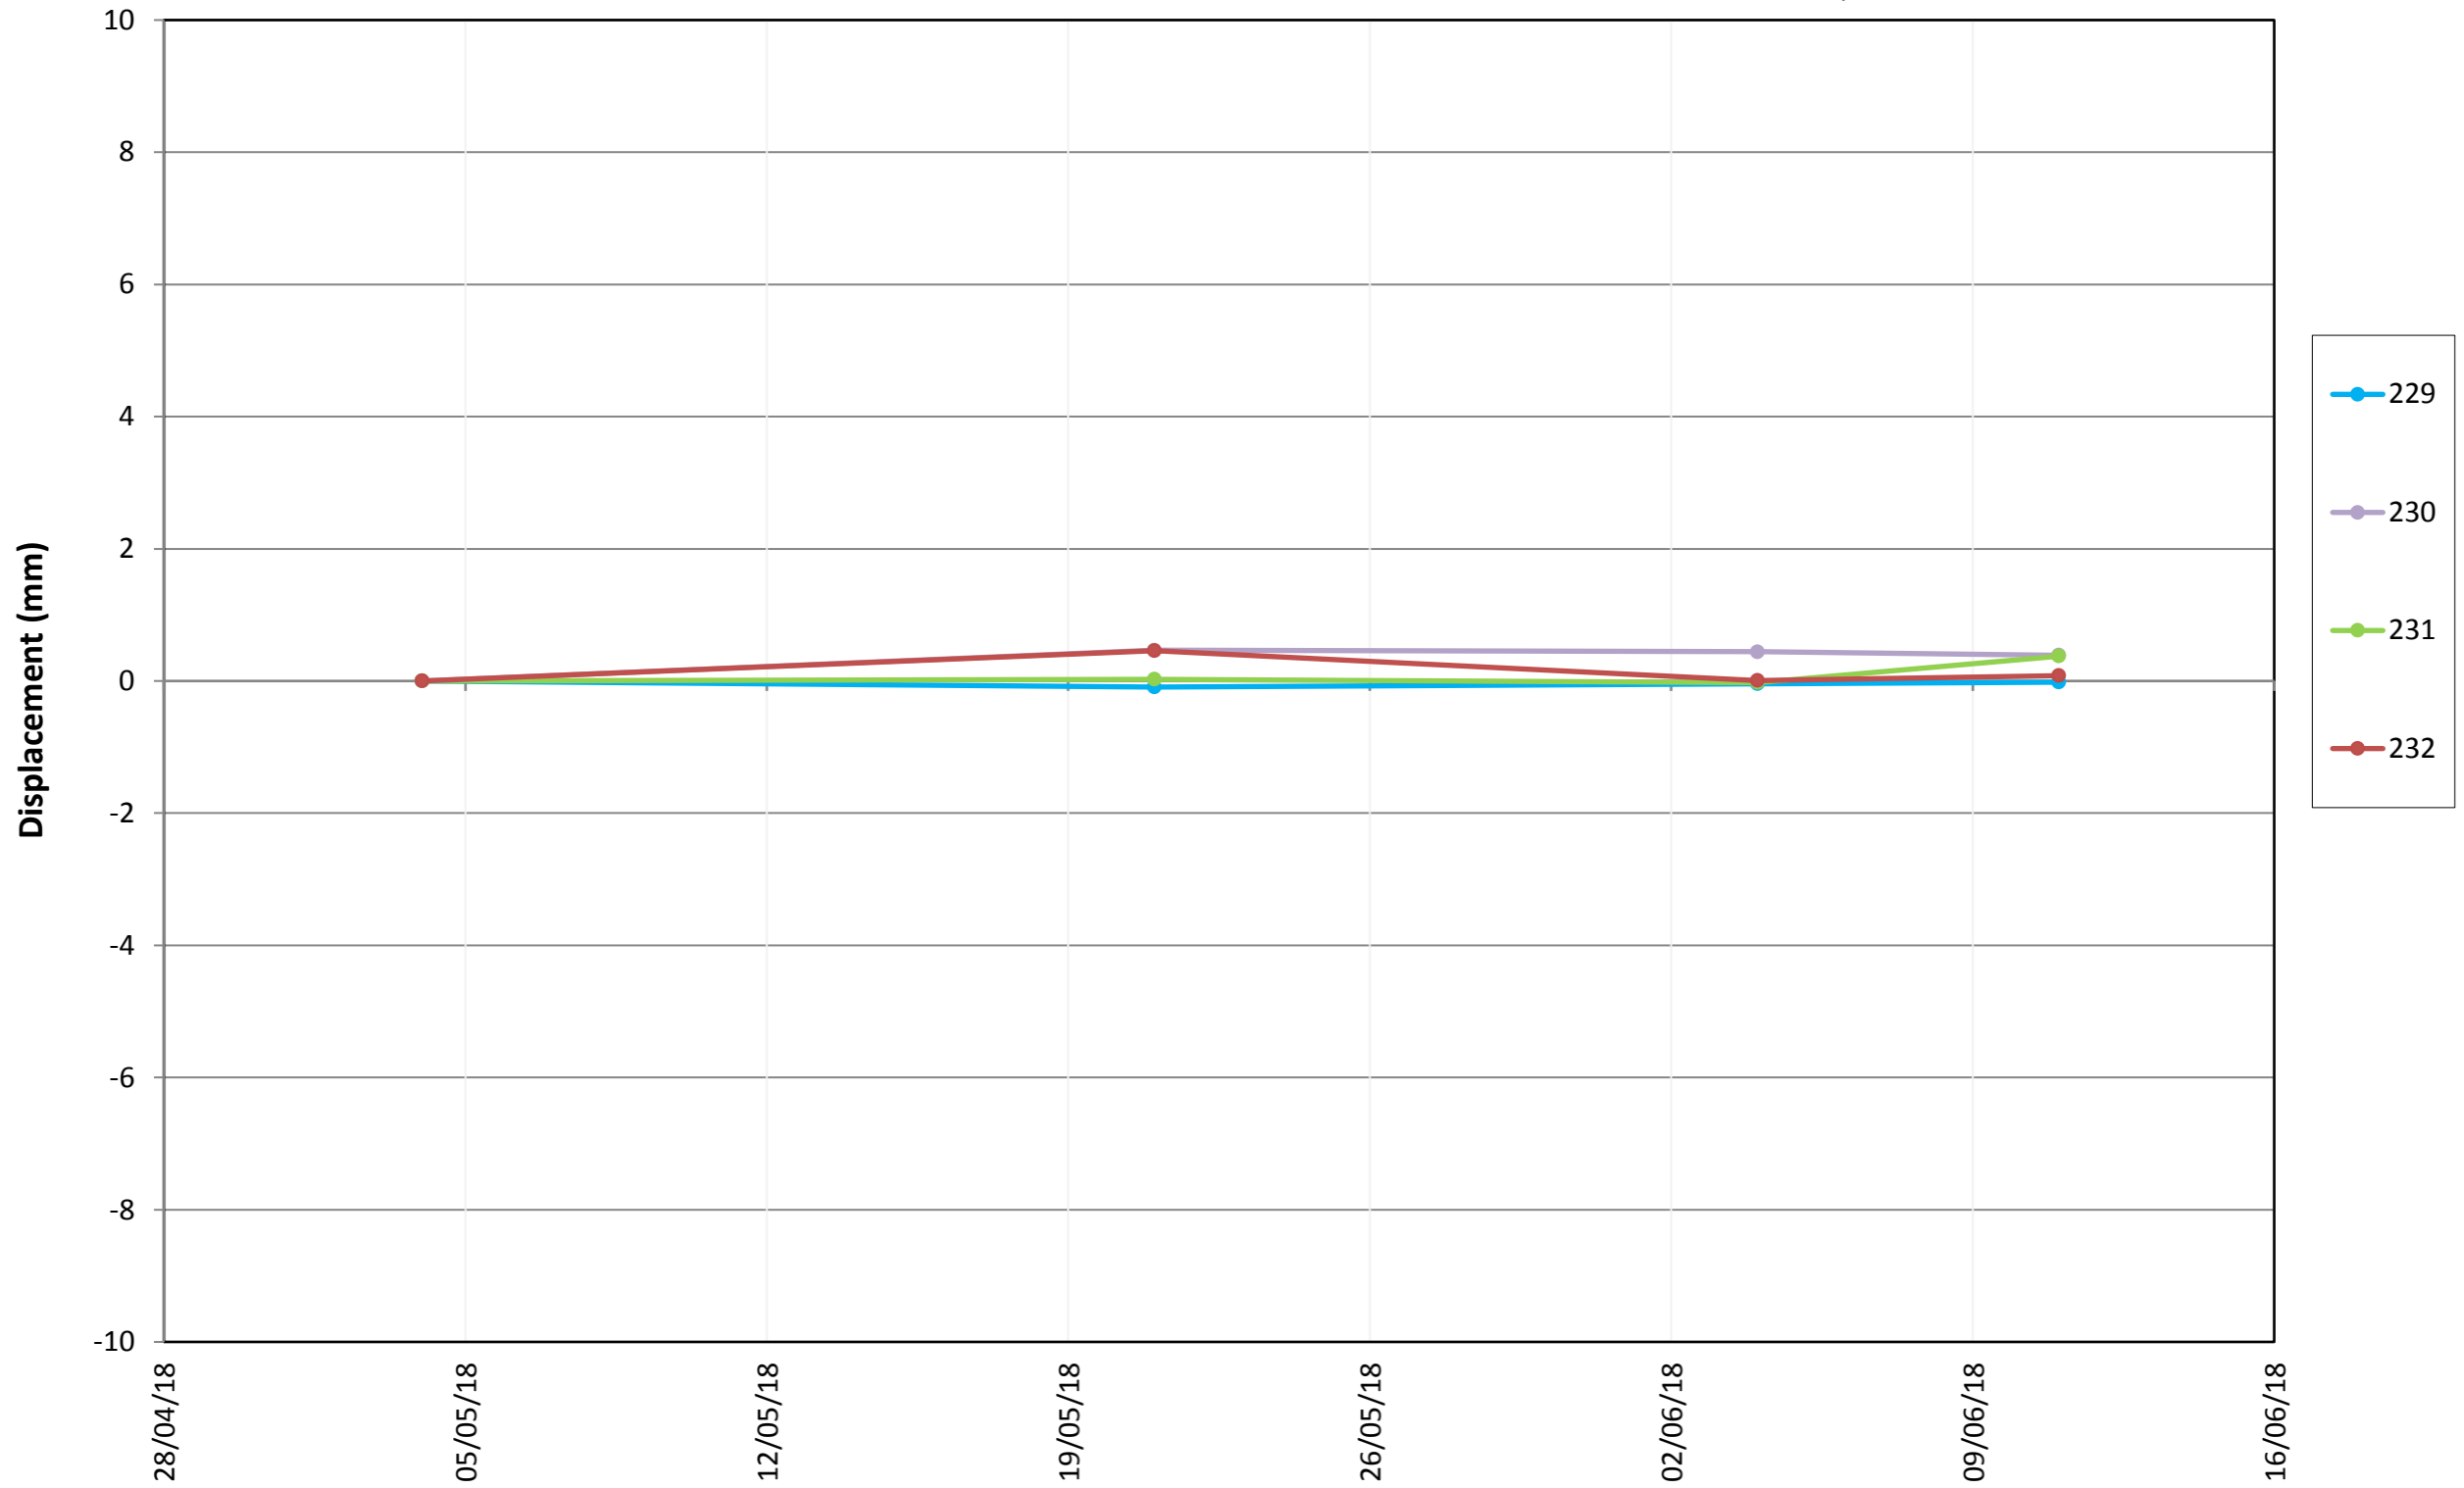
Graph 07T - Targets on back garden of No. 32 Torrington Square

Targets on back garden of No. 32 Torrington Square

Targets are showing negligible horizontal movement.
Targets are showing negligible vertical movement.
Target 233 was obstructed by leaves.
