32-33 TORRINGTON SQUARE
MONITORING

Monitoring Report
SES-10215-MR03

Date of survey completion: 11th June 2018

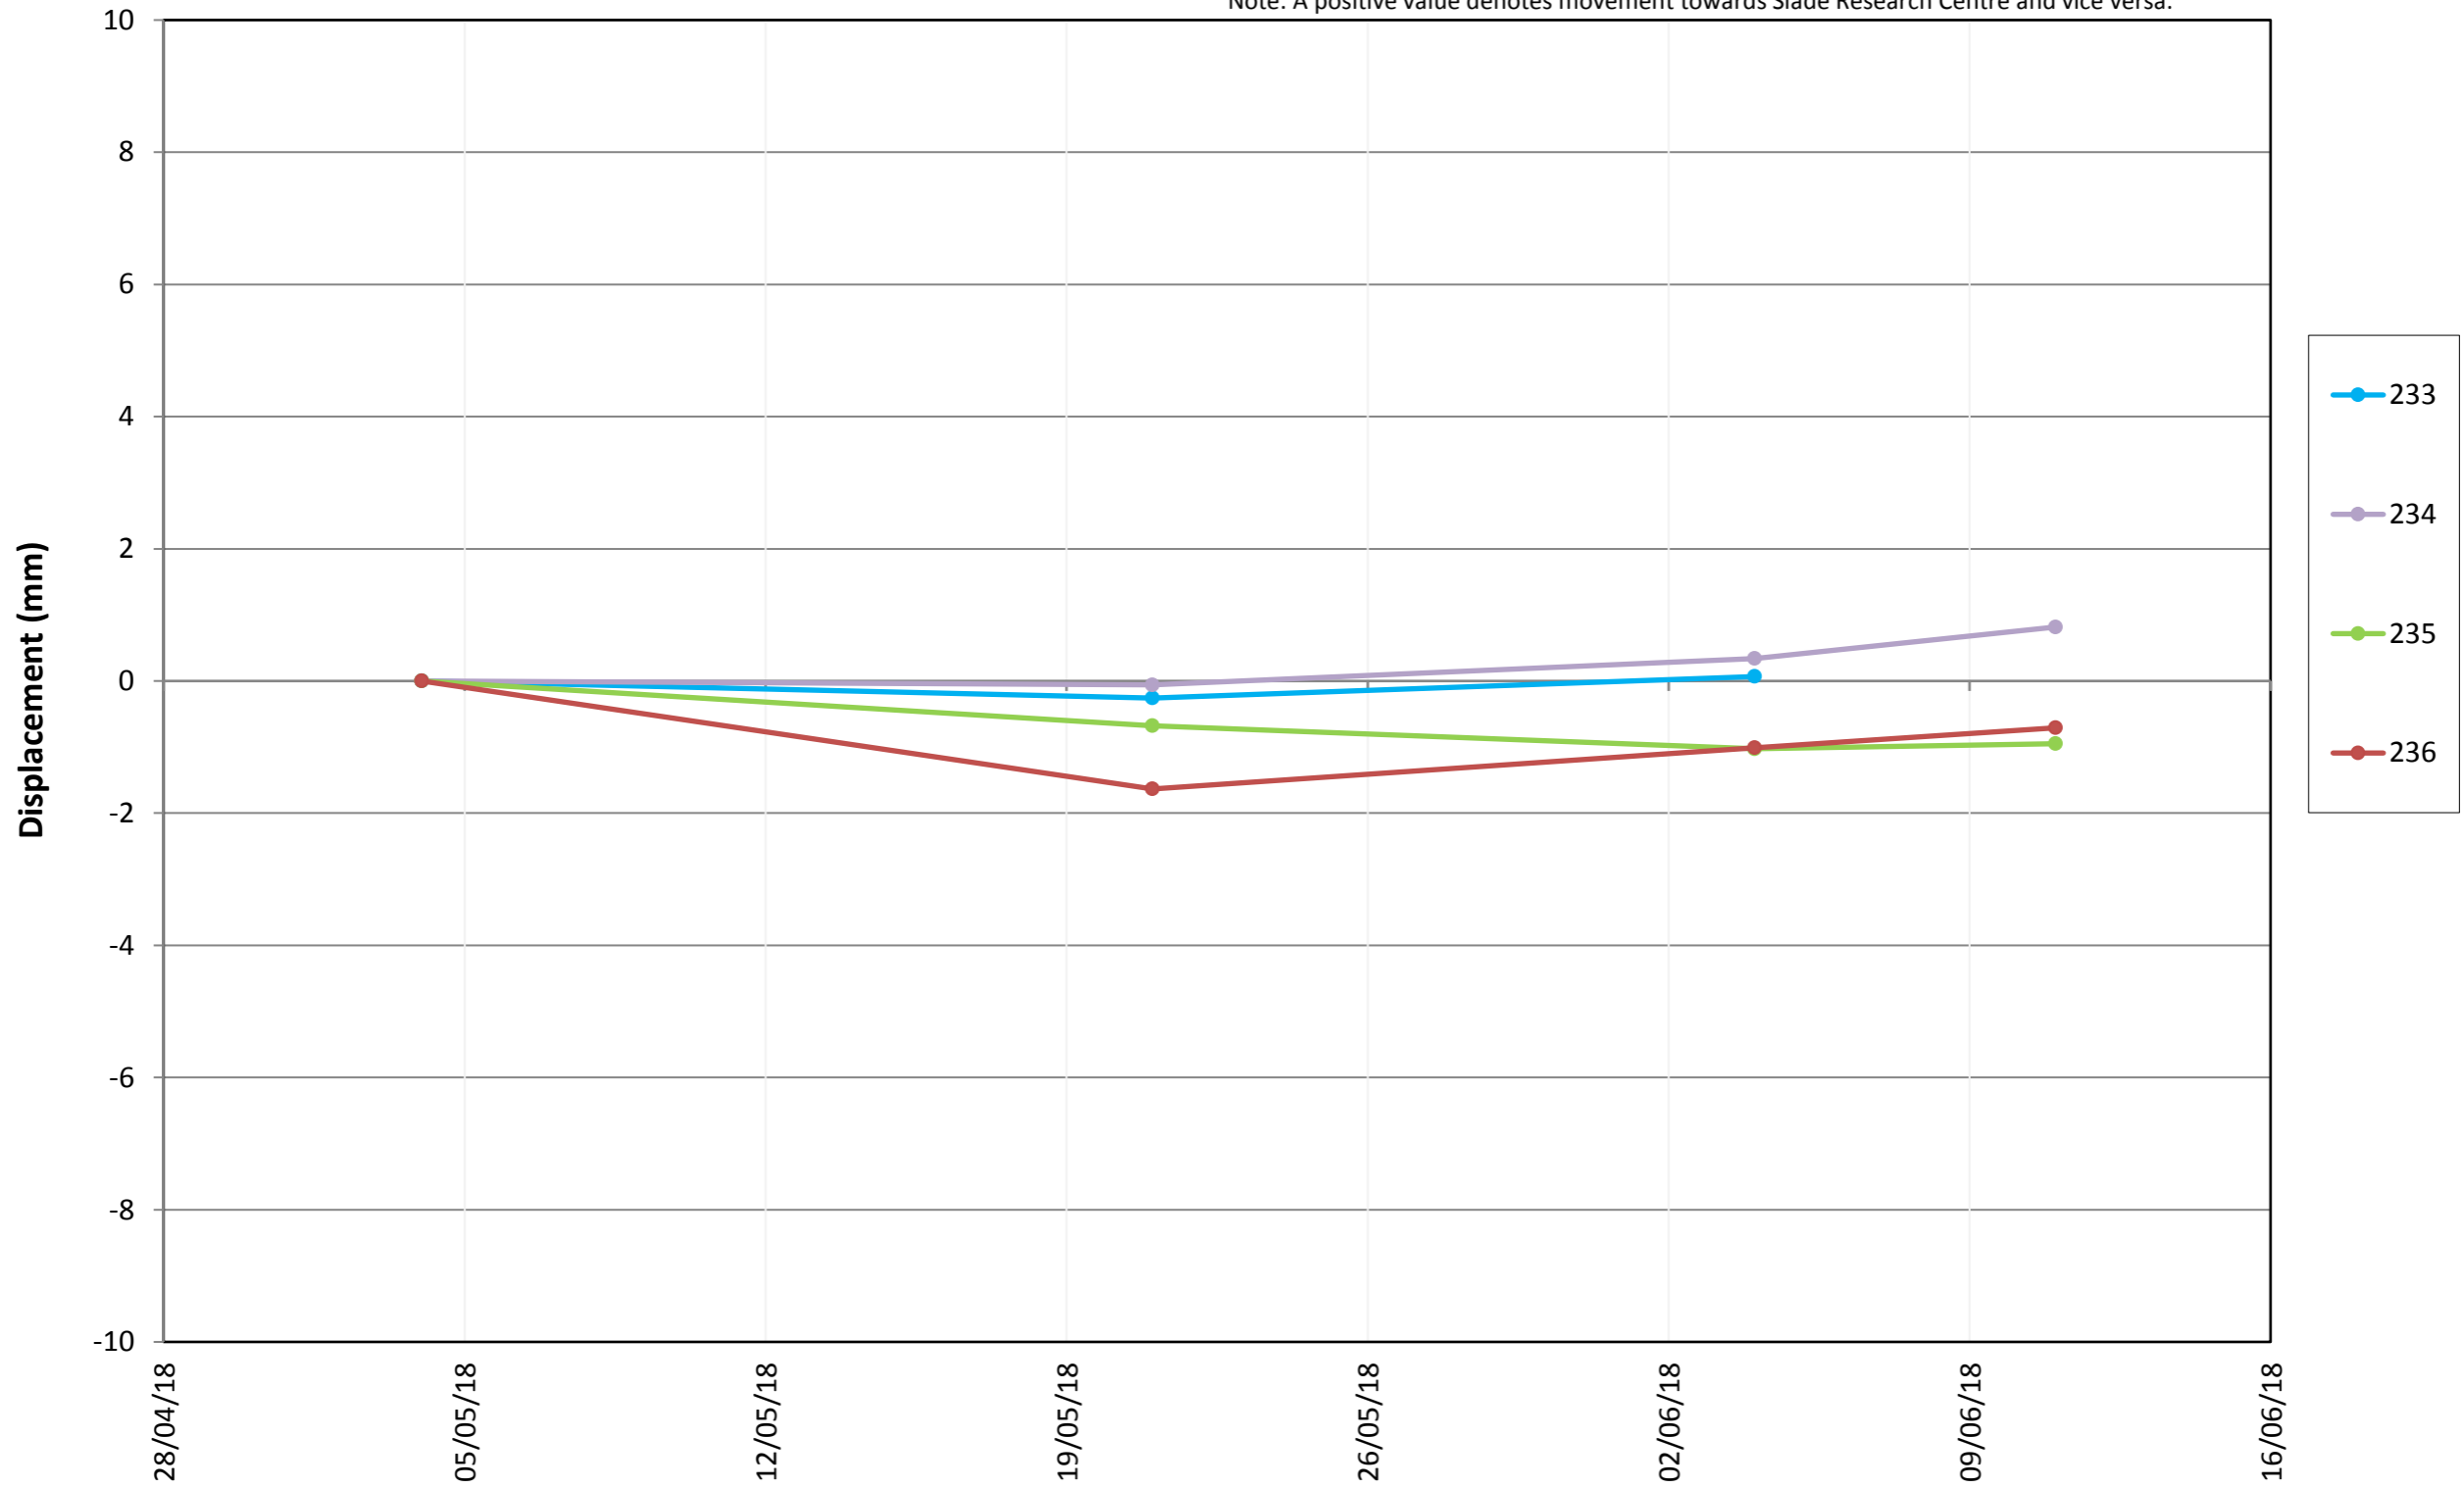
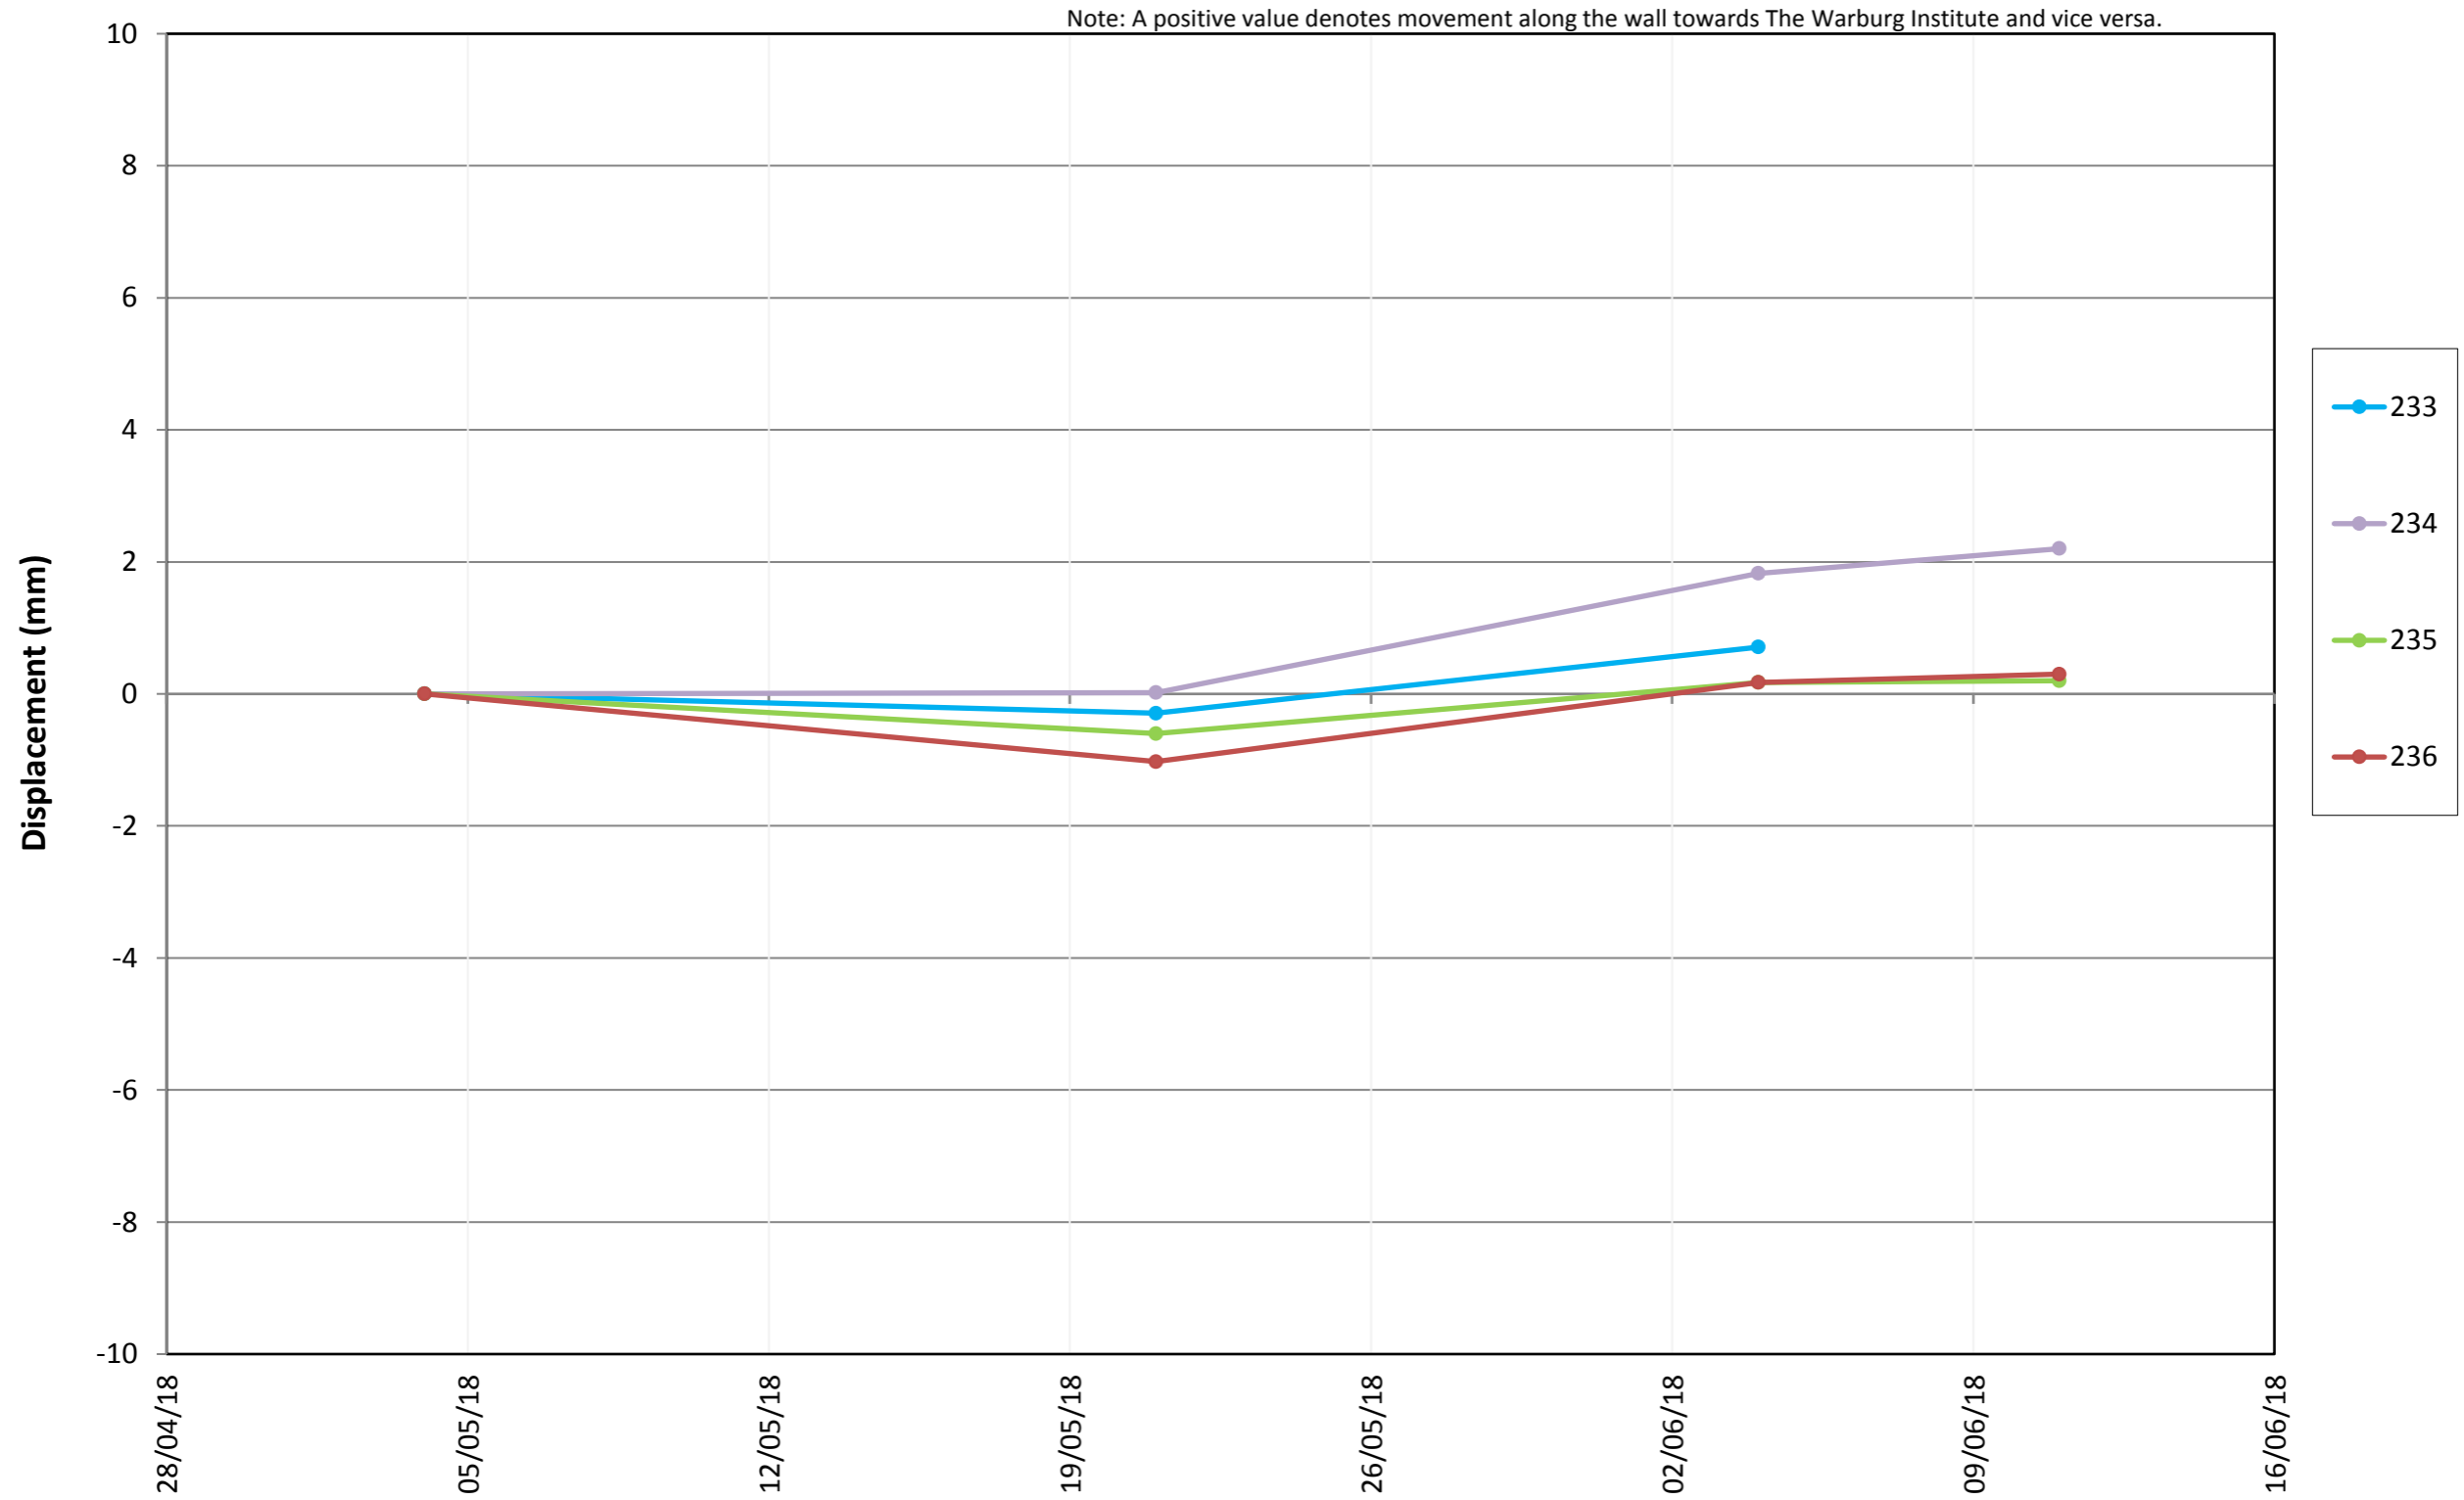
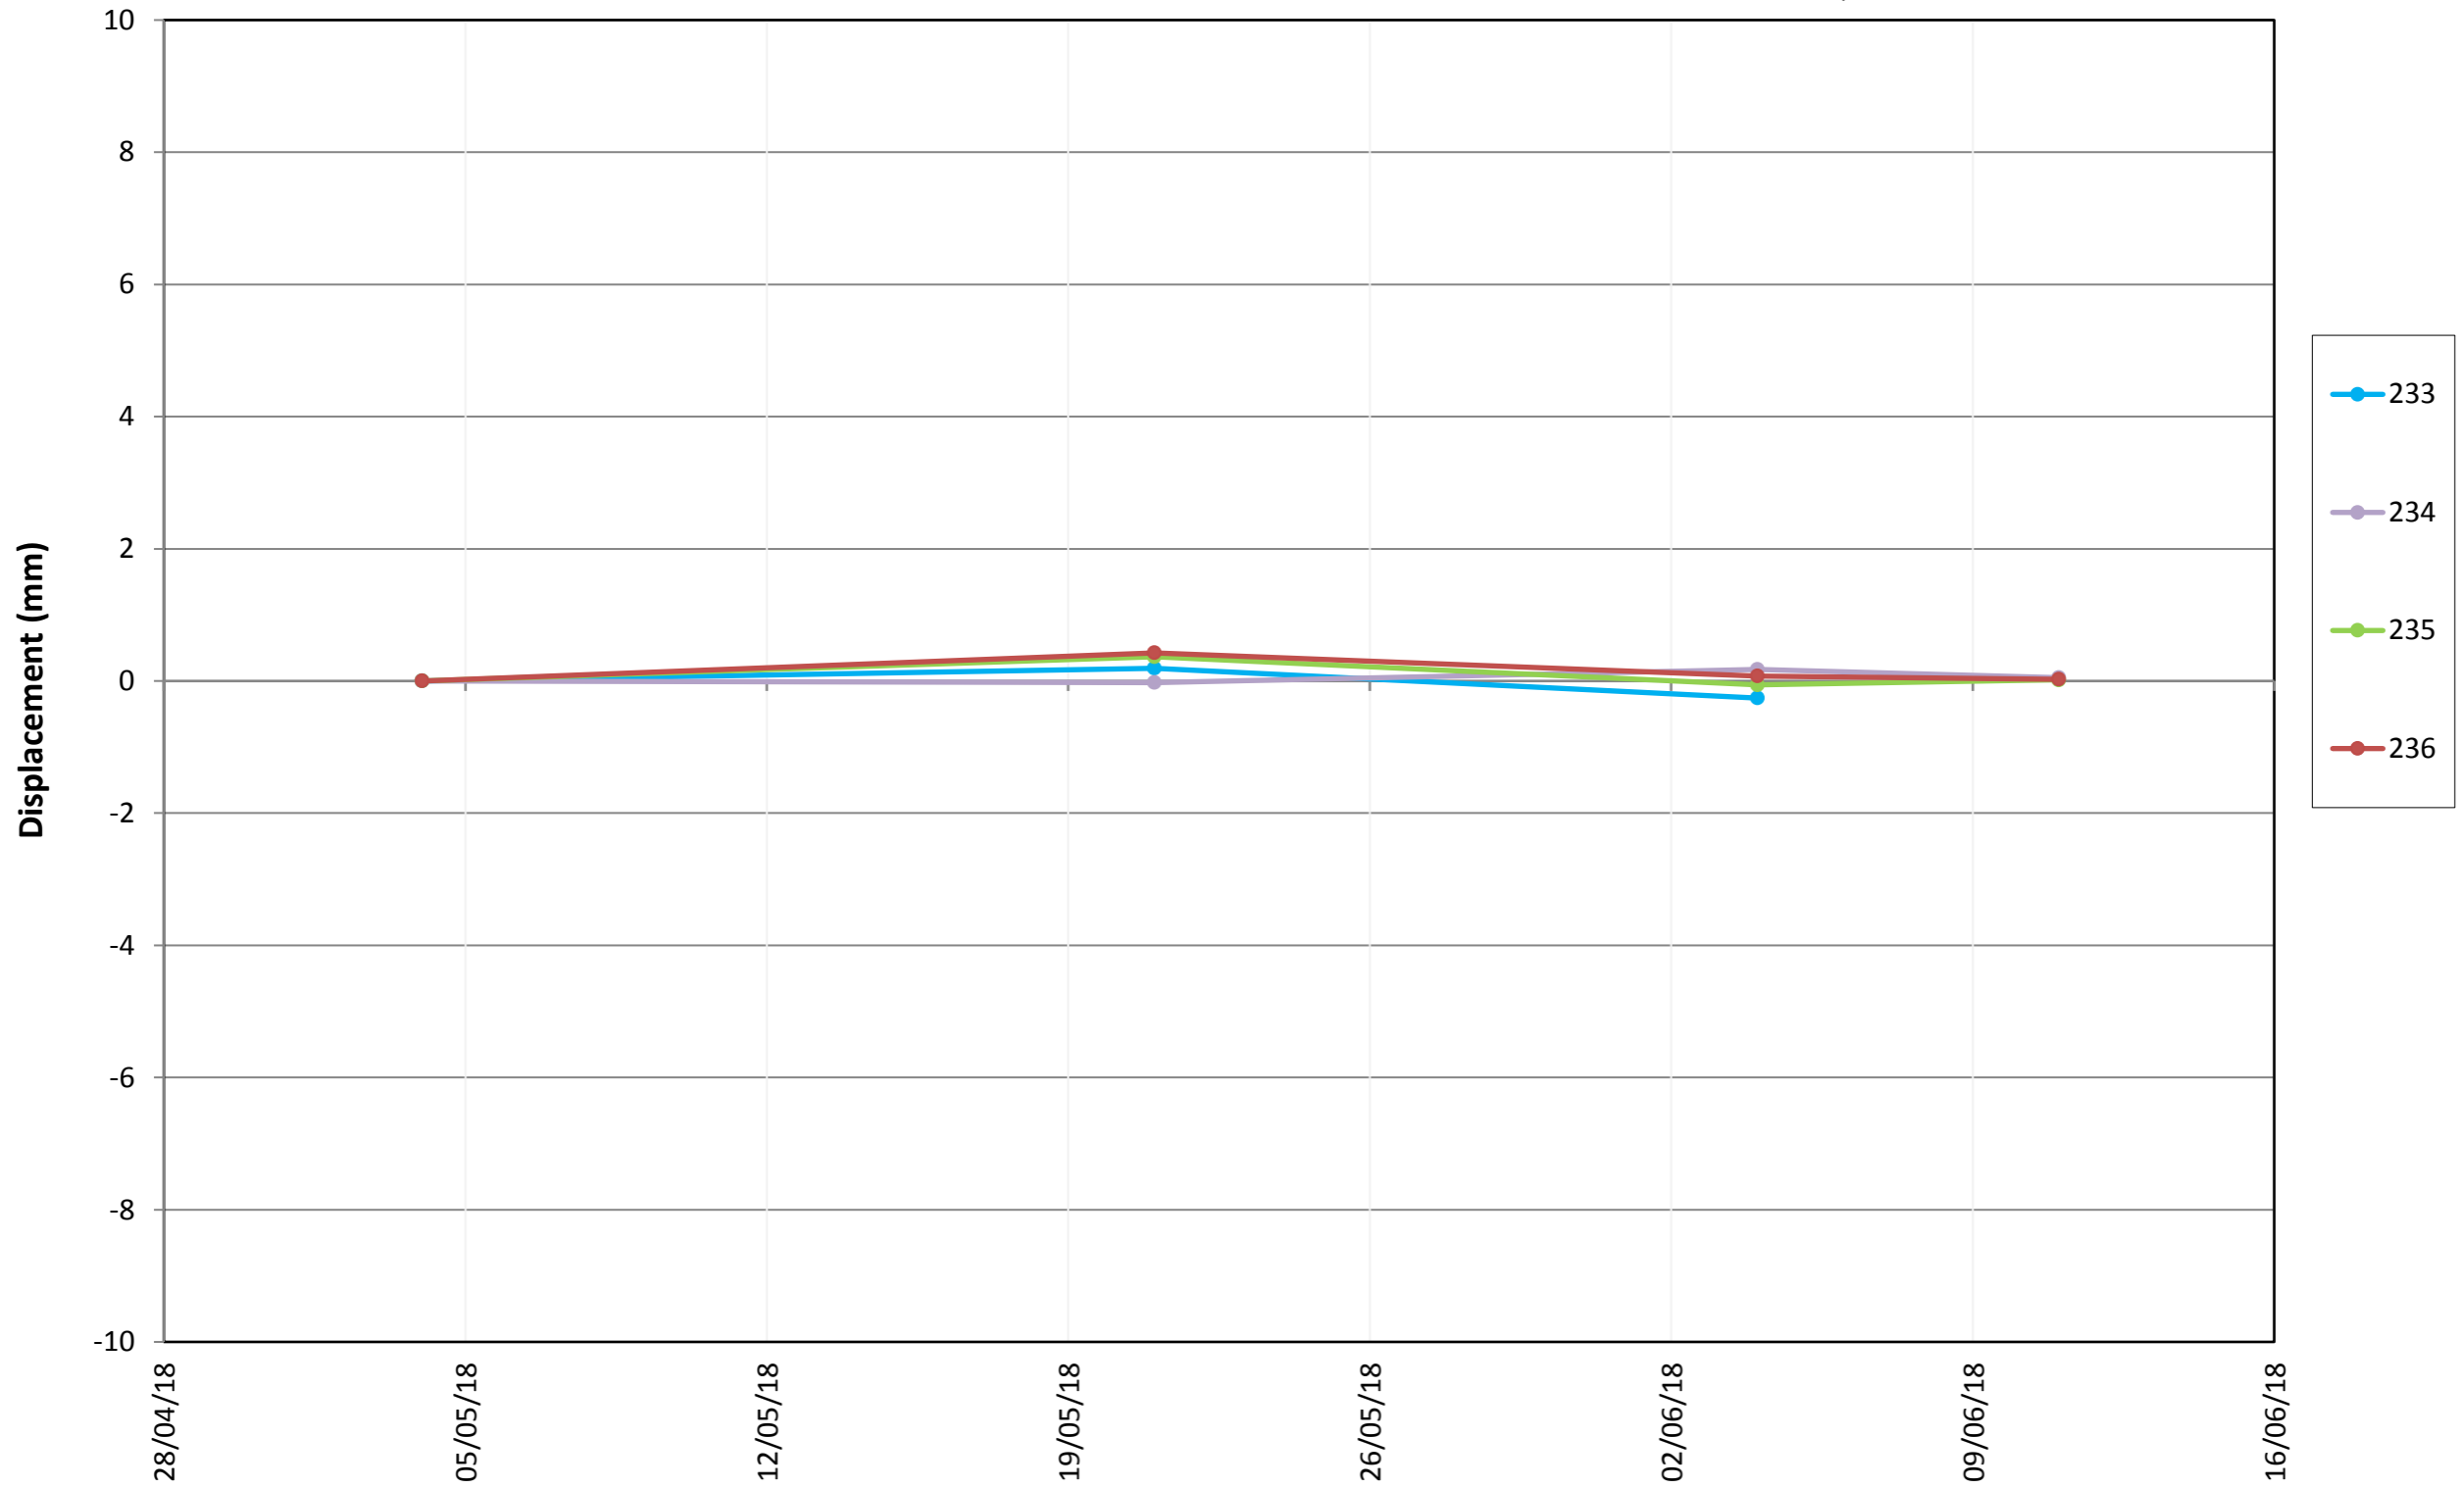
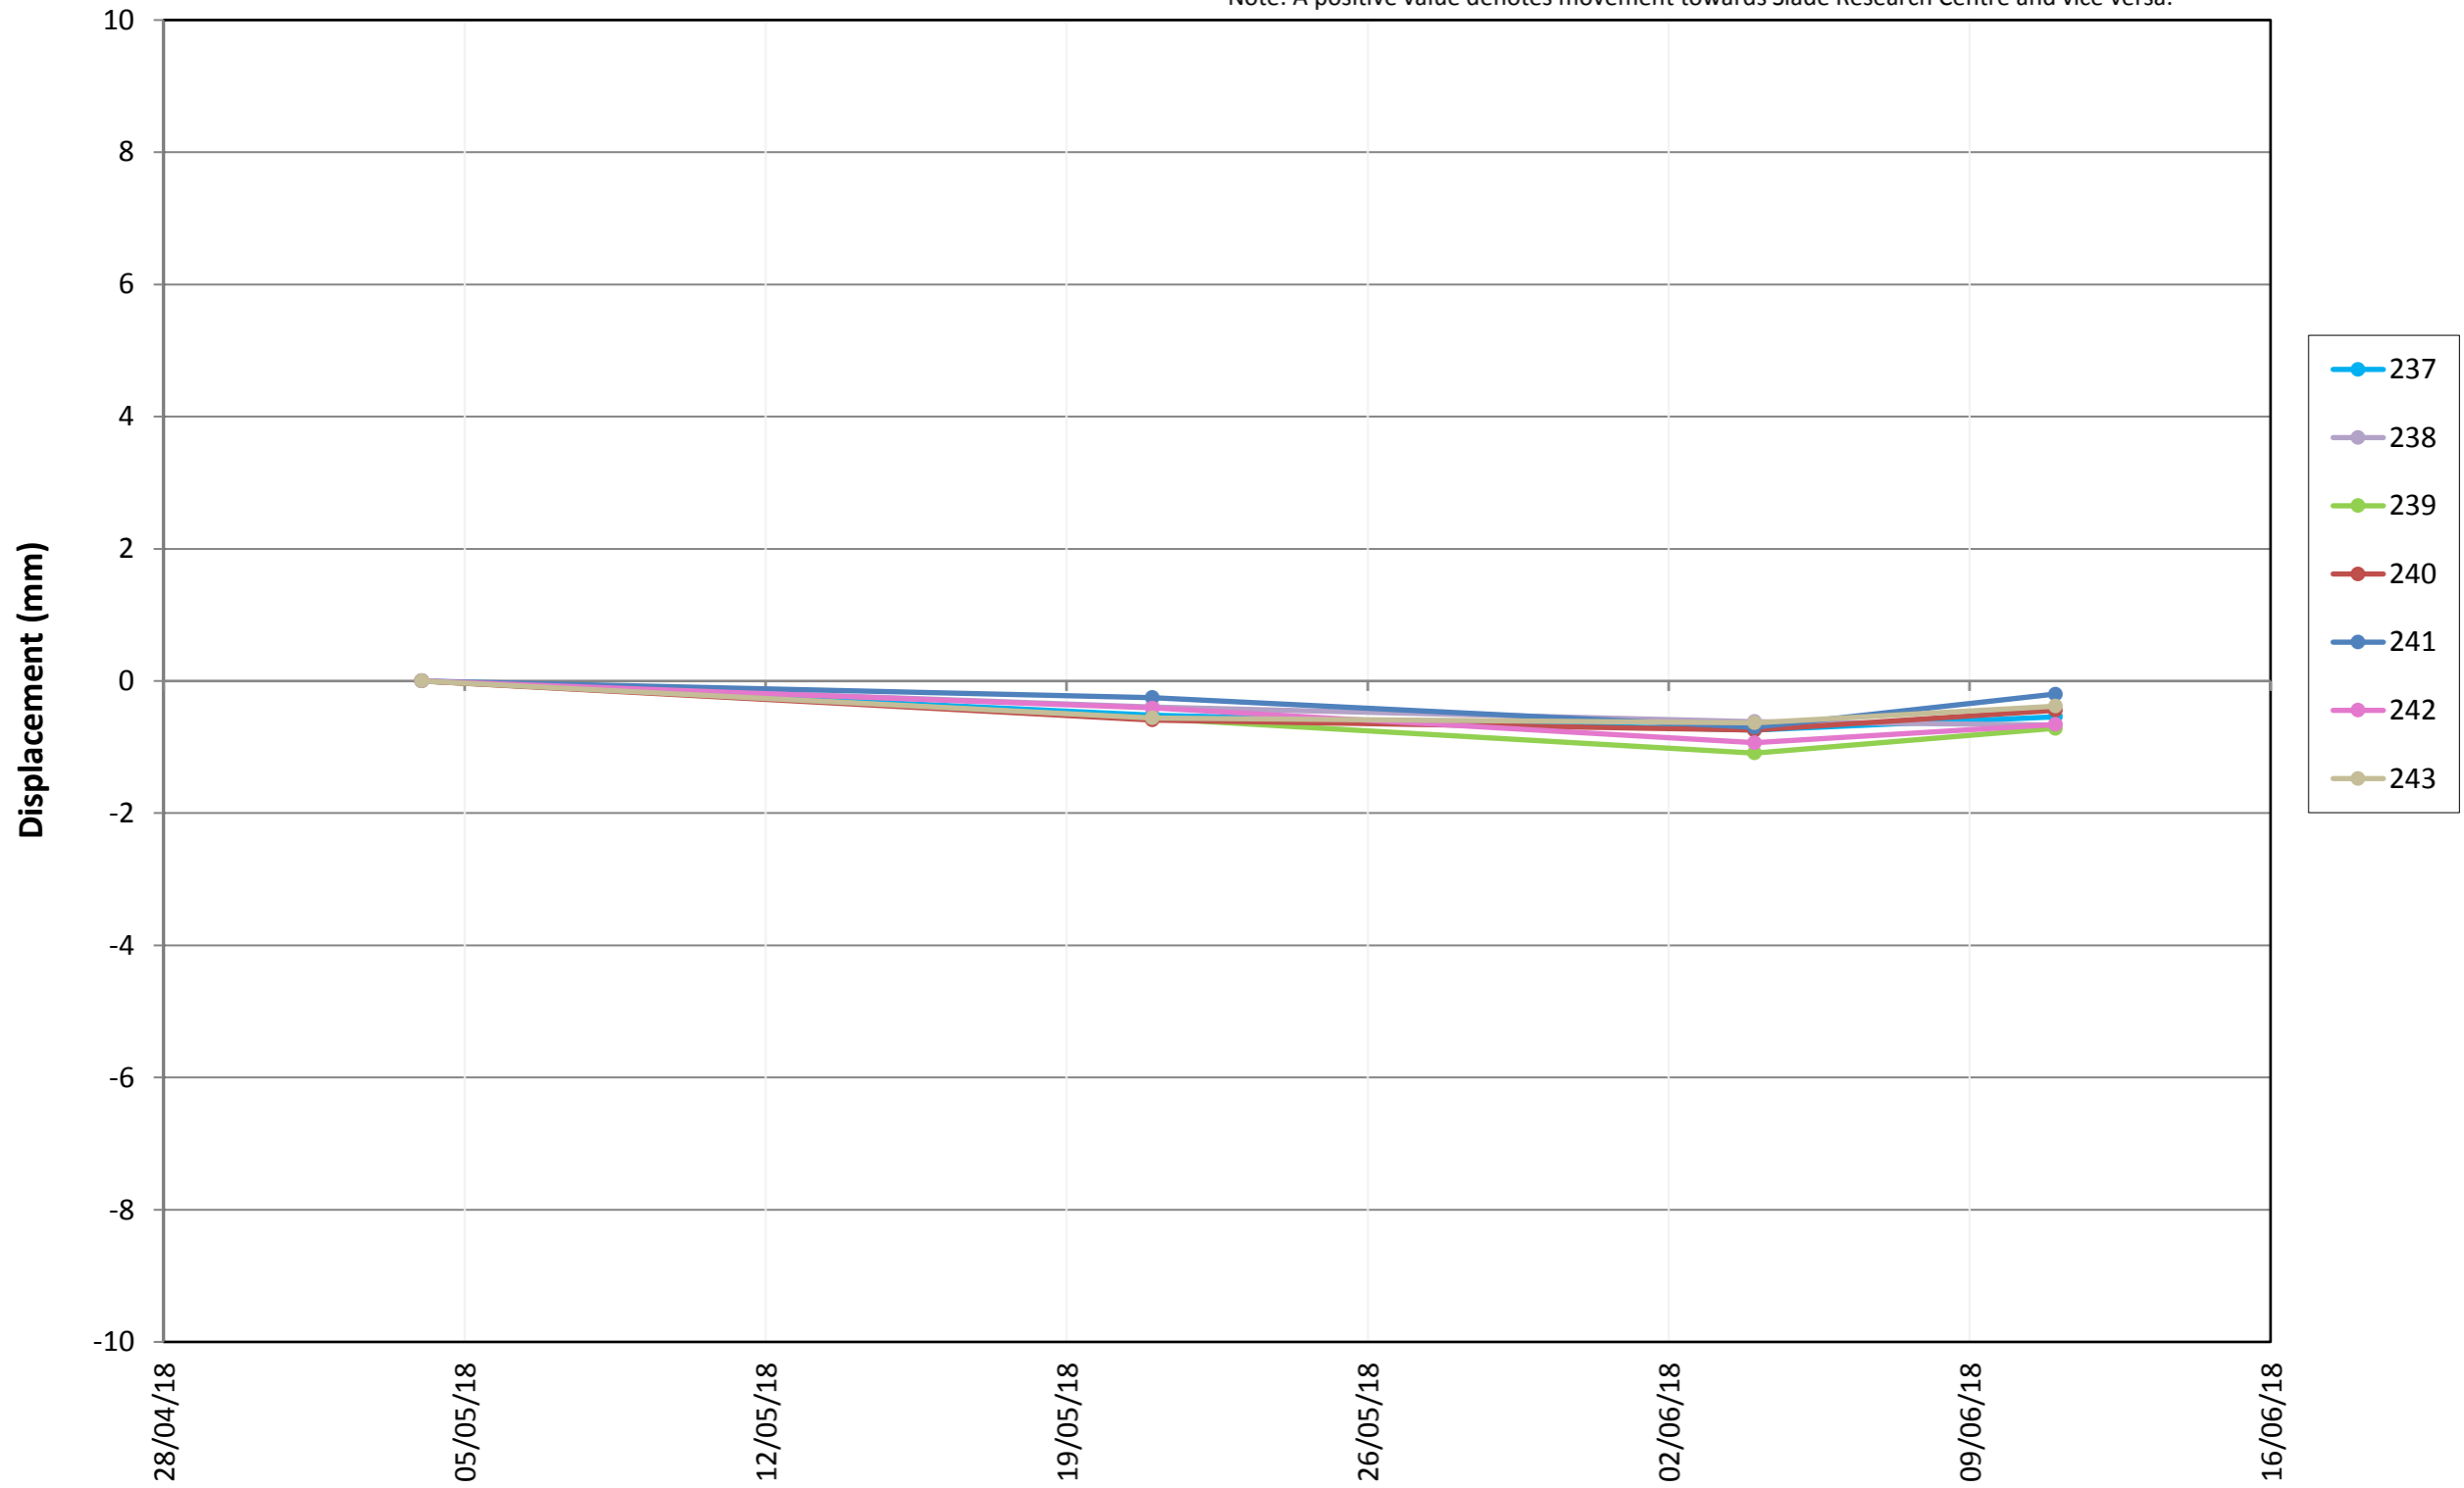
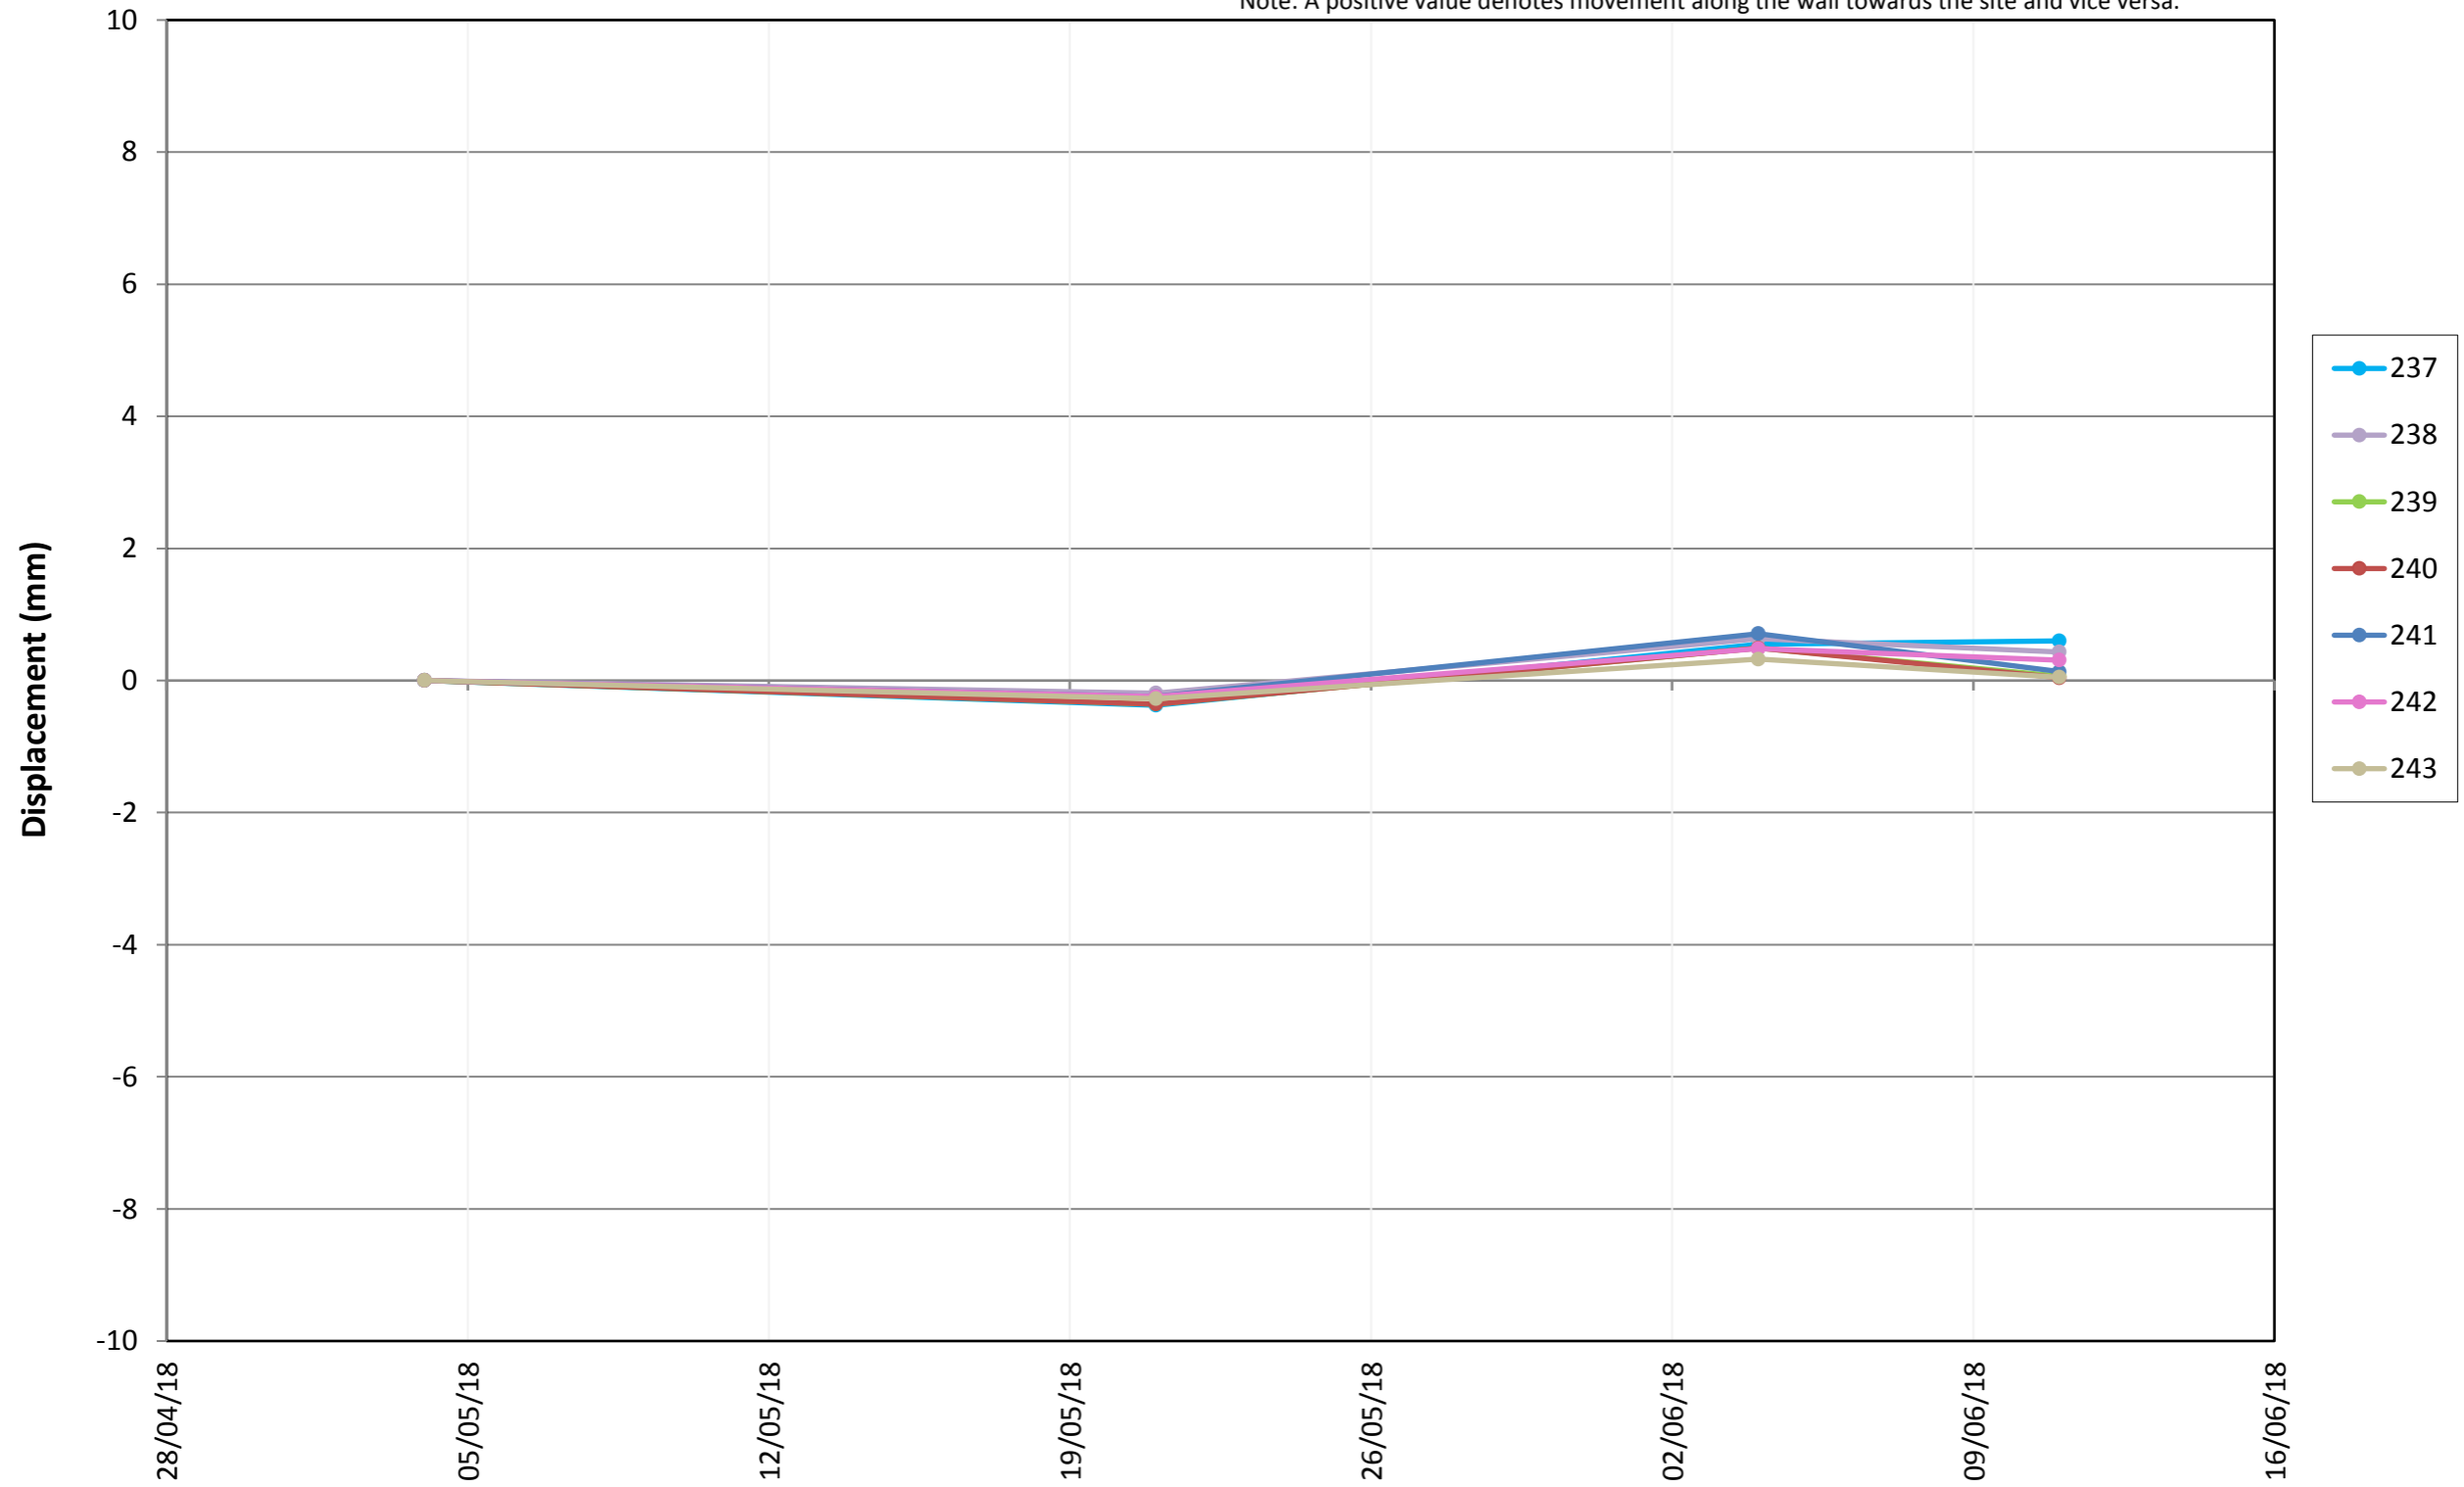
Graph 08T - Targets on Rear Elevation of No. 32 Torrington Square

Targets on Rear Elevation of No. 32 Torrington Square

Targets are showing negligible horizontal movement.
Targets are showing negligible vertical movement.
