32-33 TORRINGTON SQUARE
MONITORING

Monitoring Report
SES-10215-MR03

Date of survey completion: 11th June 2018

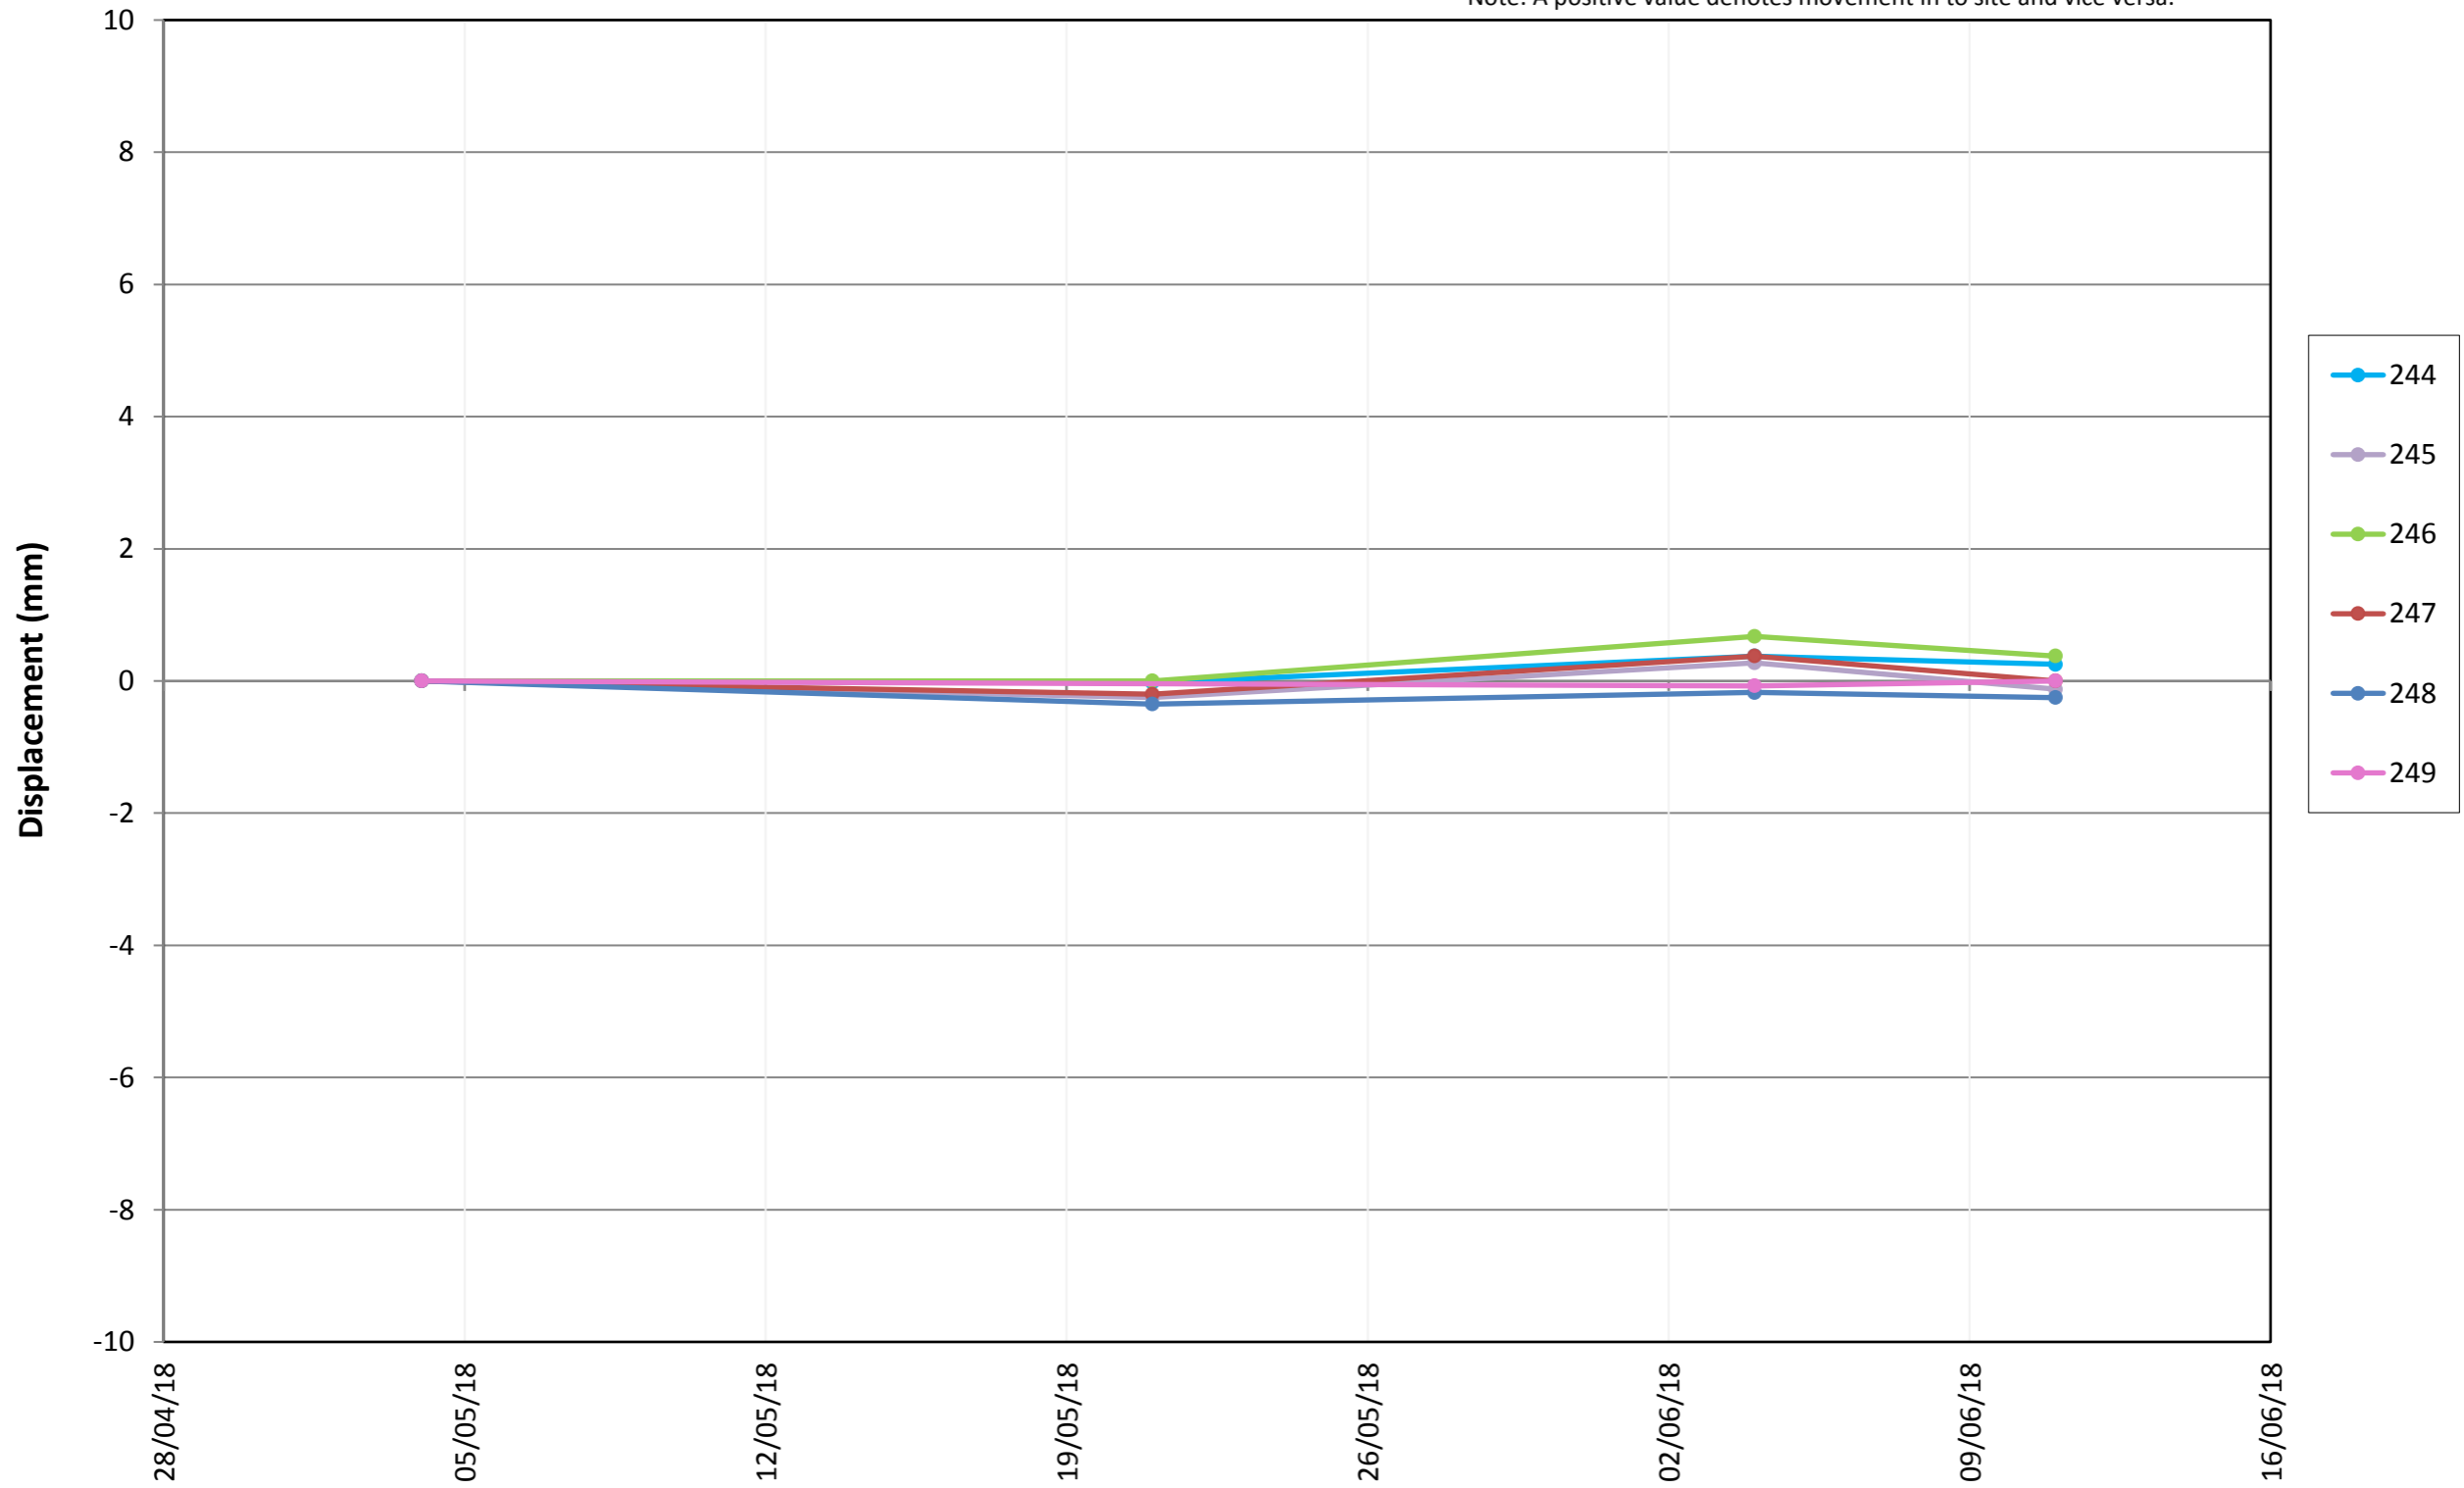
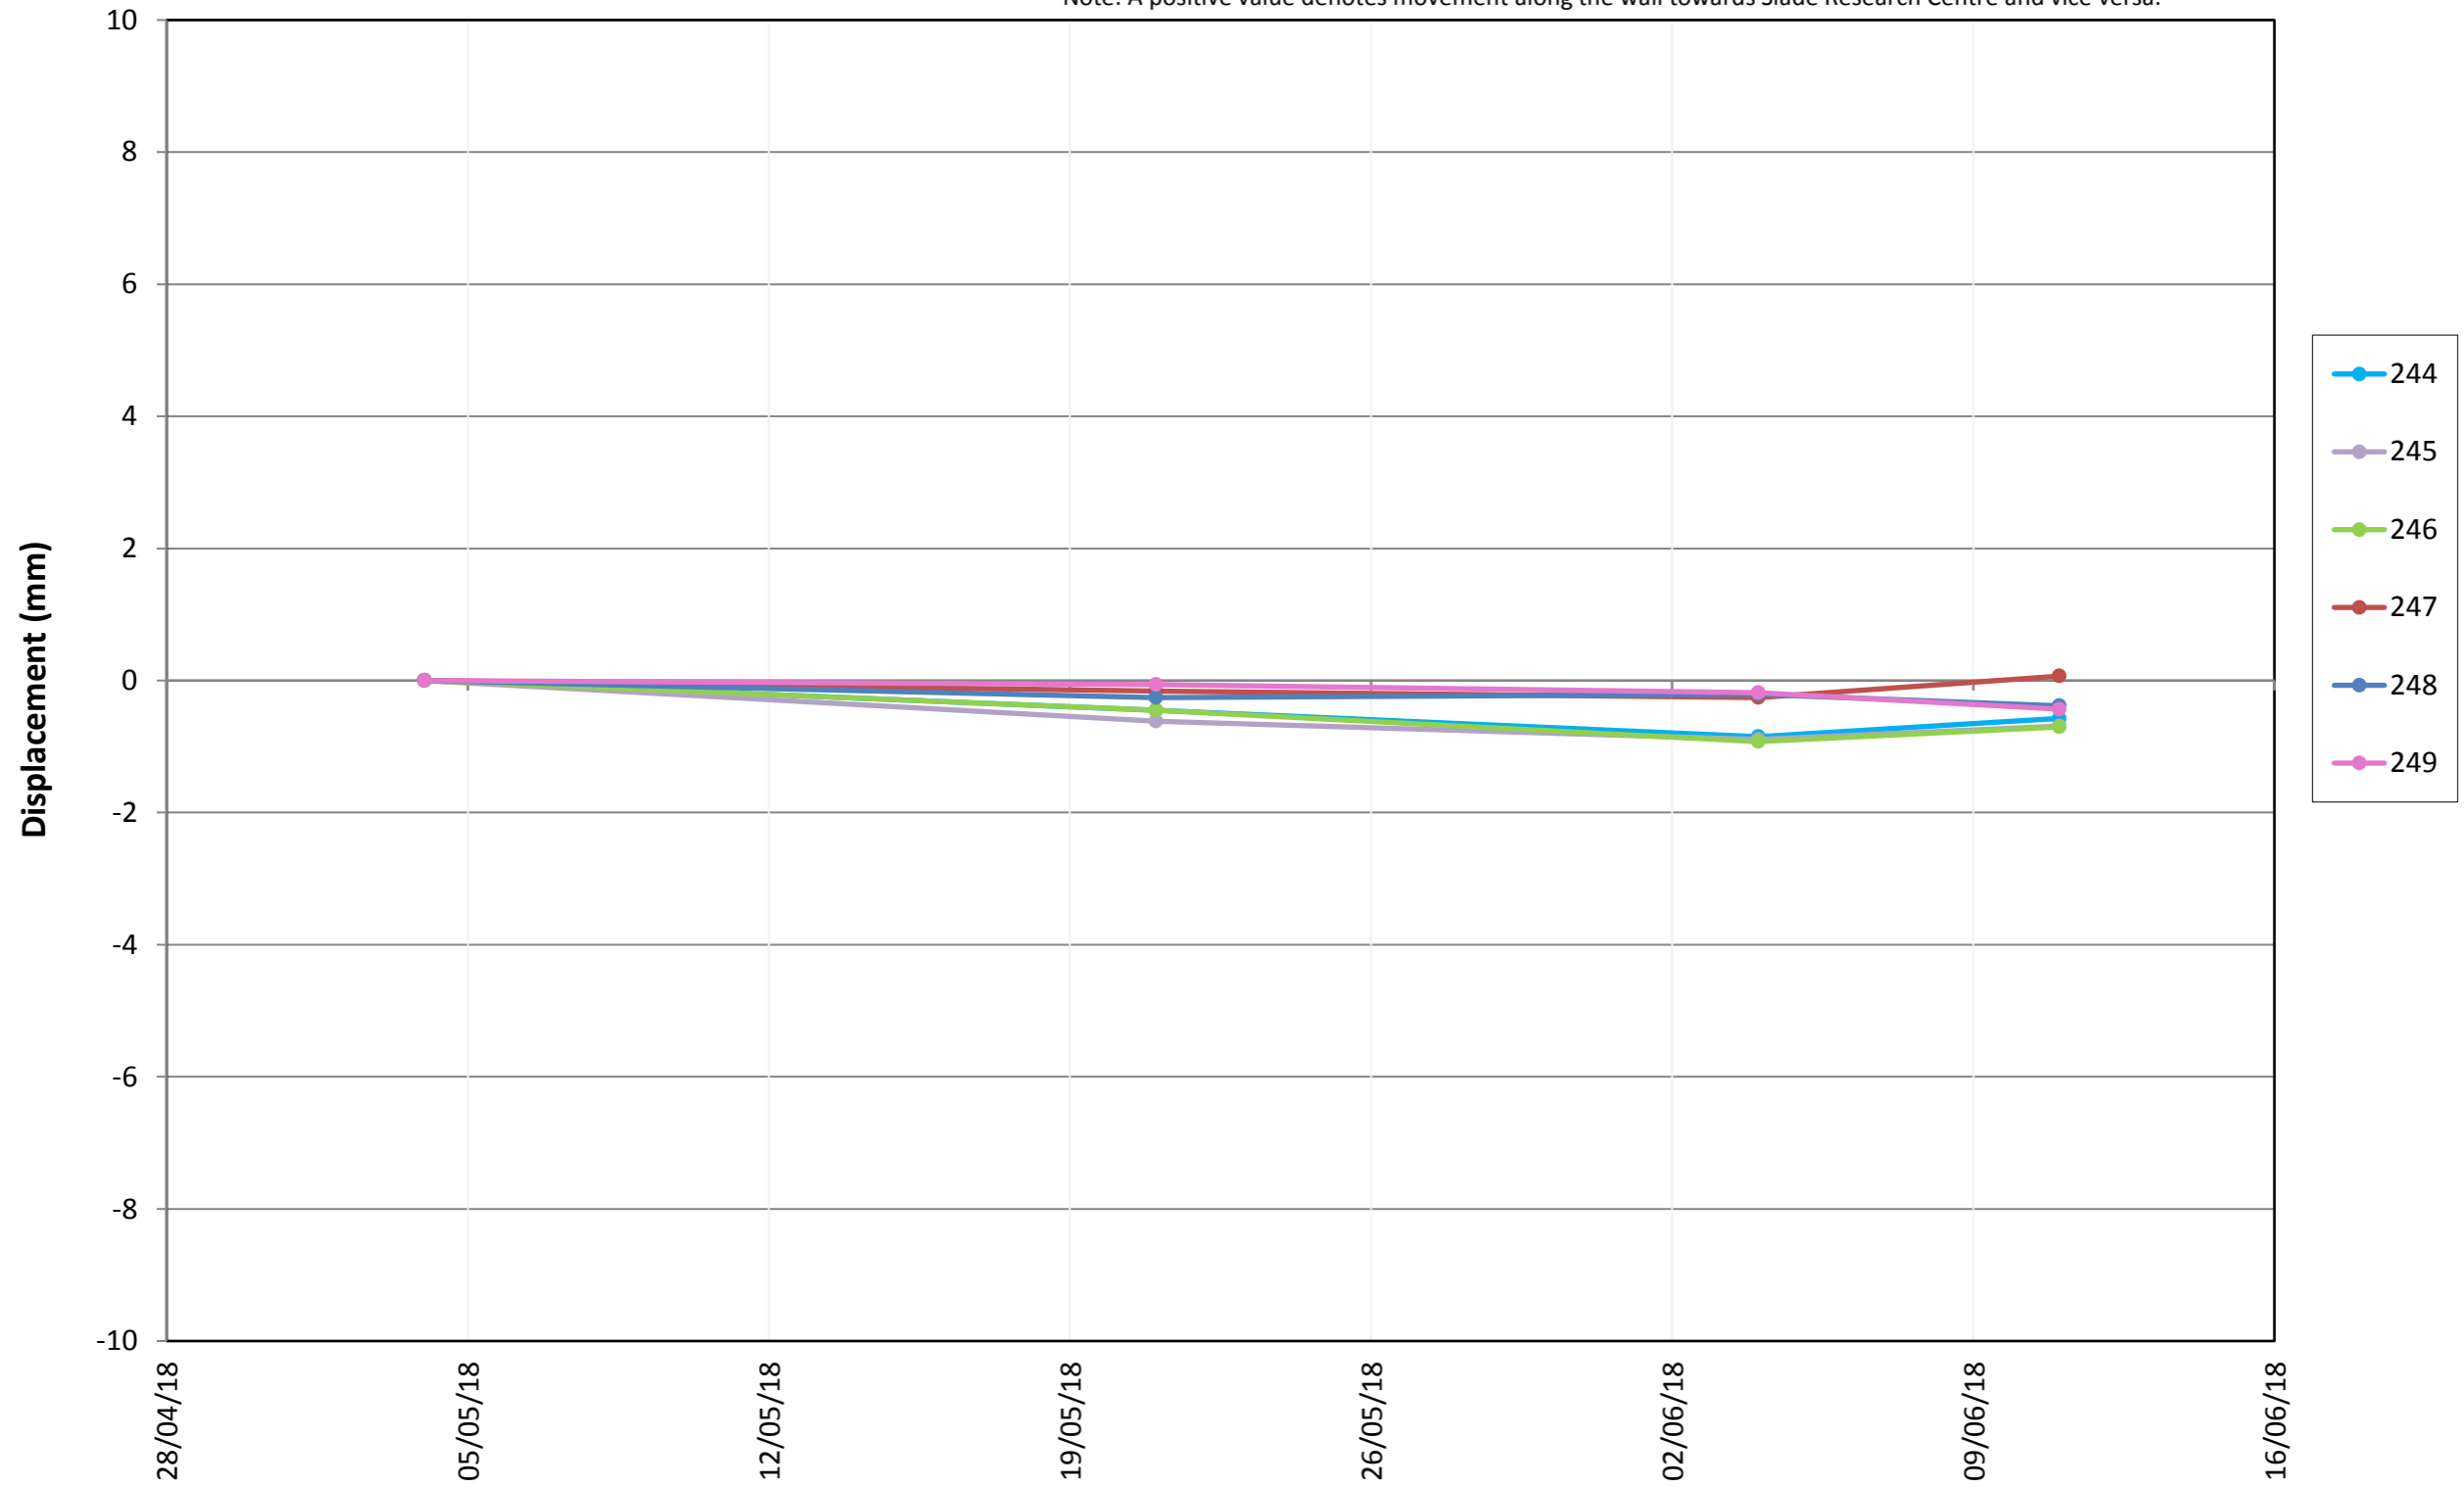
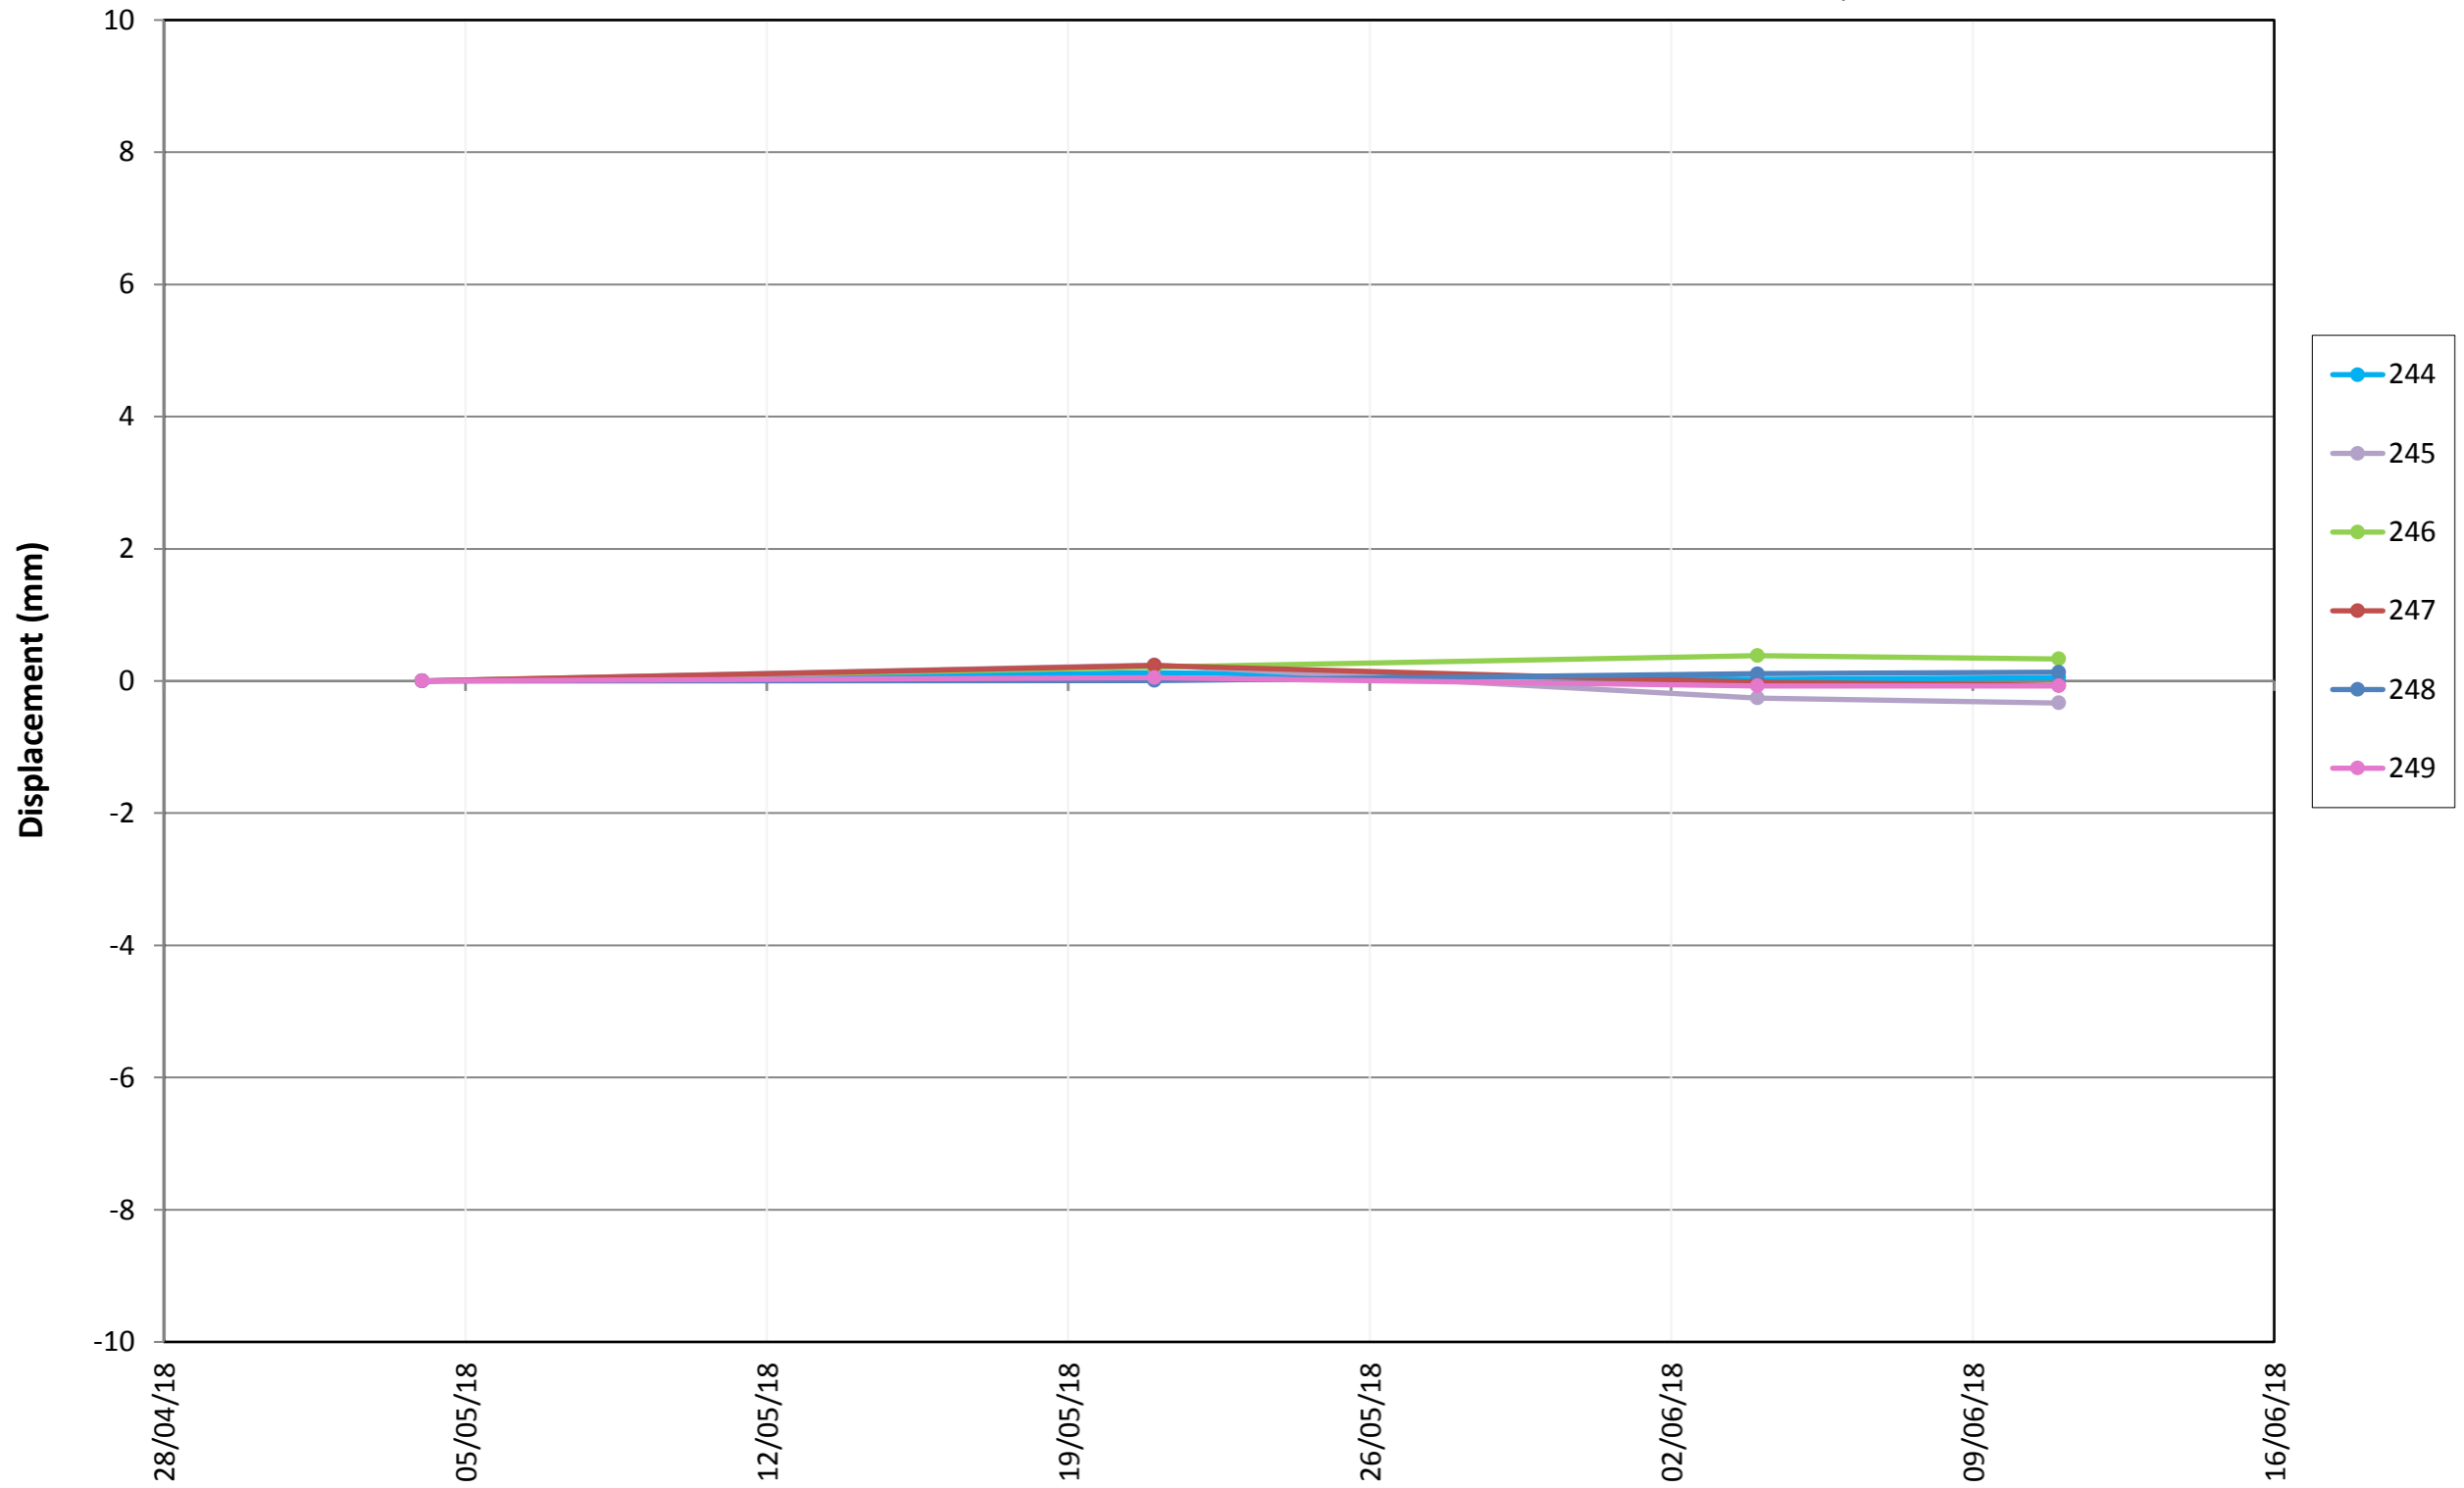
Graph 10T - Targets on Side Elevation of No. 32 Torrington Square

Targets on Side Elevation of No. 32 Torrington Square

Targets are showing negligible horizontal movement.

Targets are showing negligible vertical movement.
