32-33 TORRINGTON SQUARE
MONITORING

Monitoring Report
SES-10215-MR03

Date of survey completion: 11th June 2018

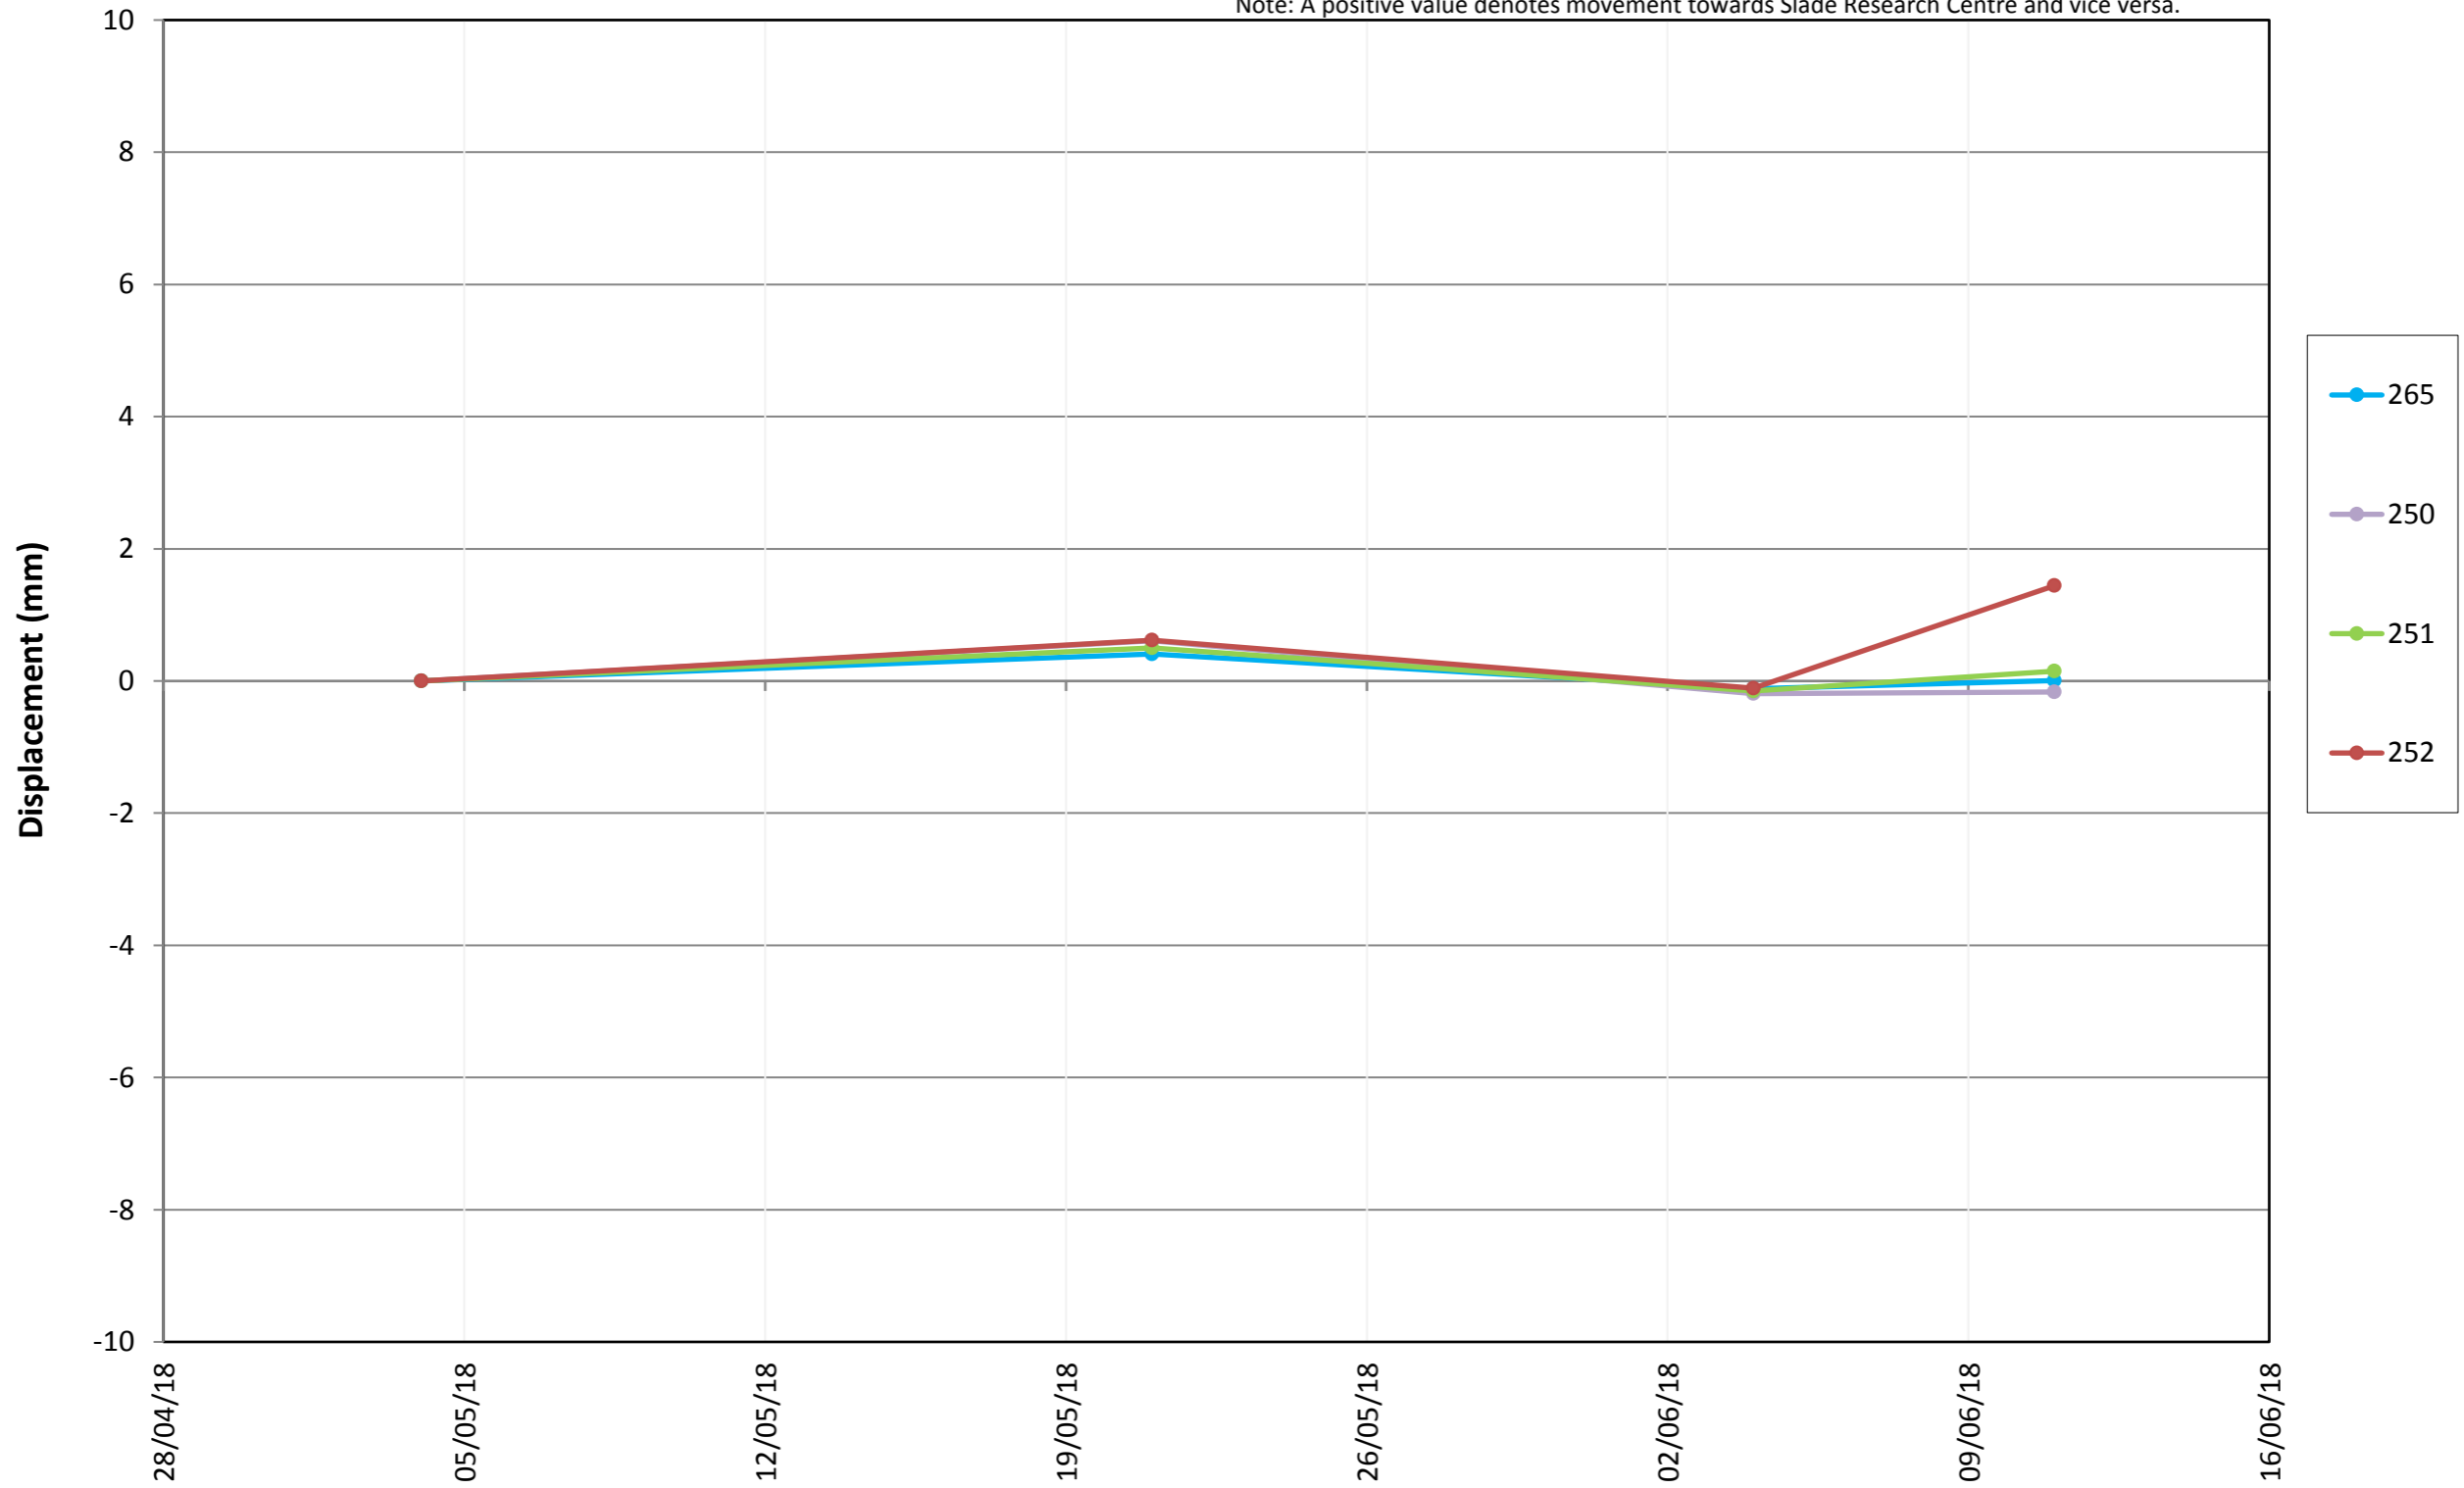
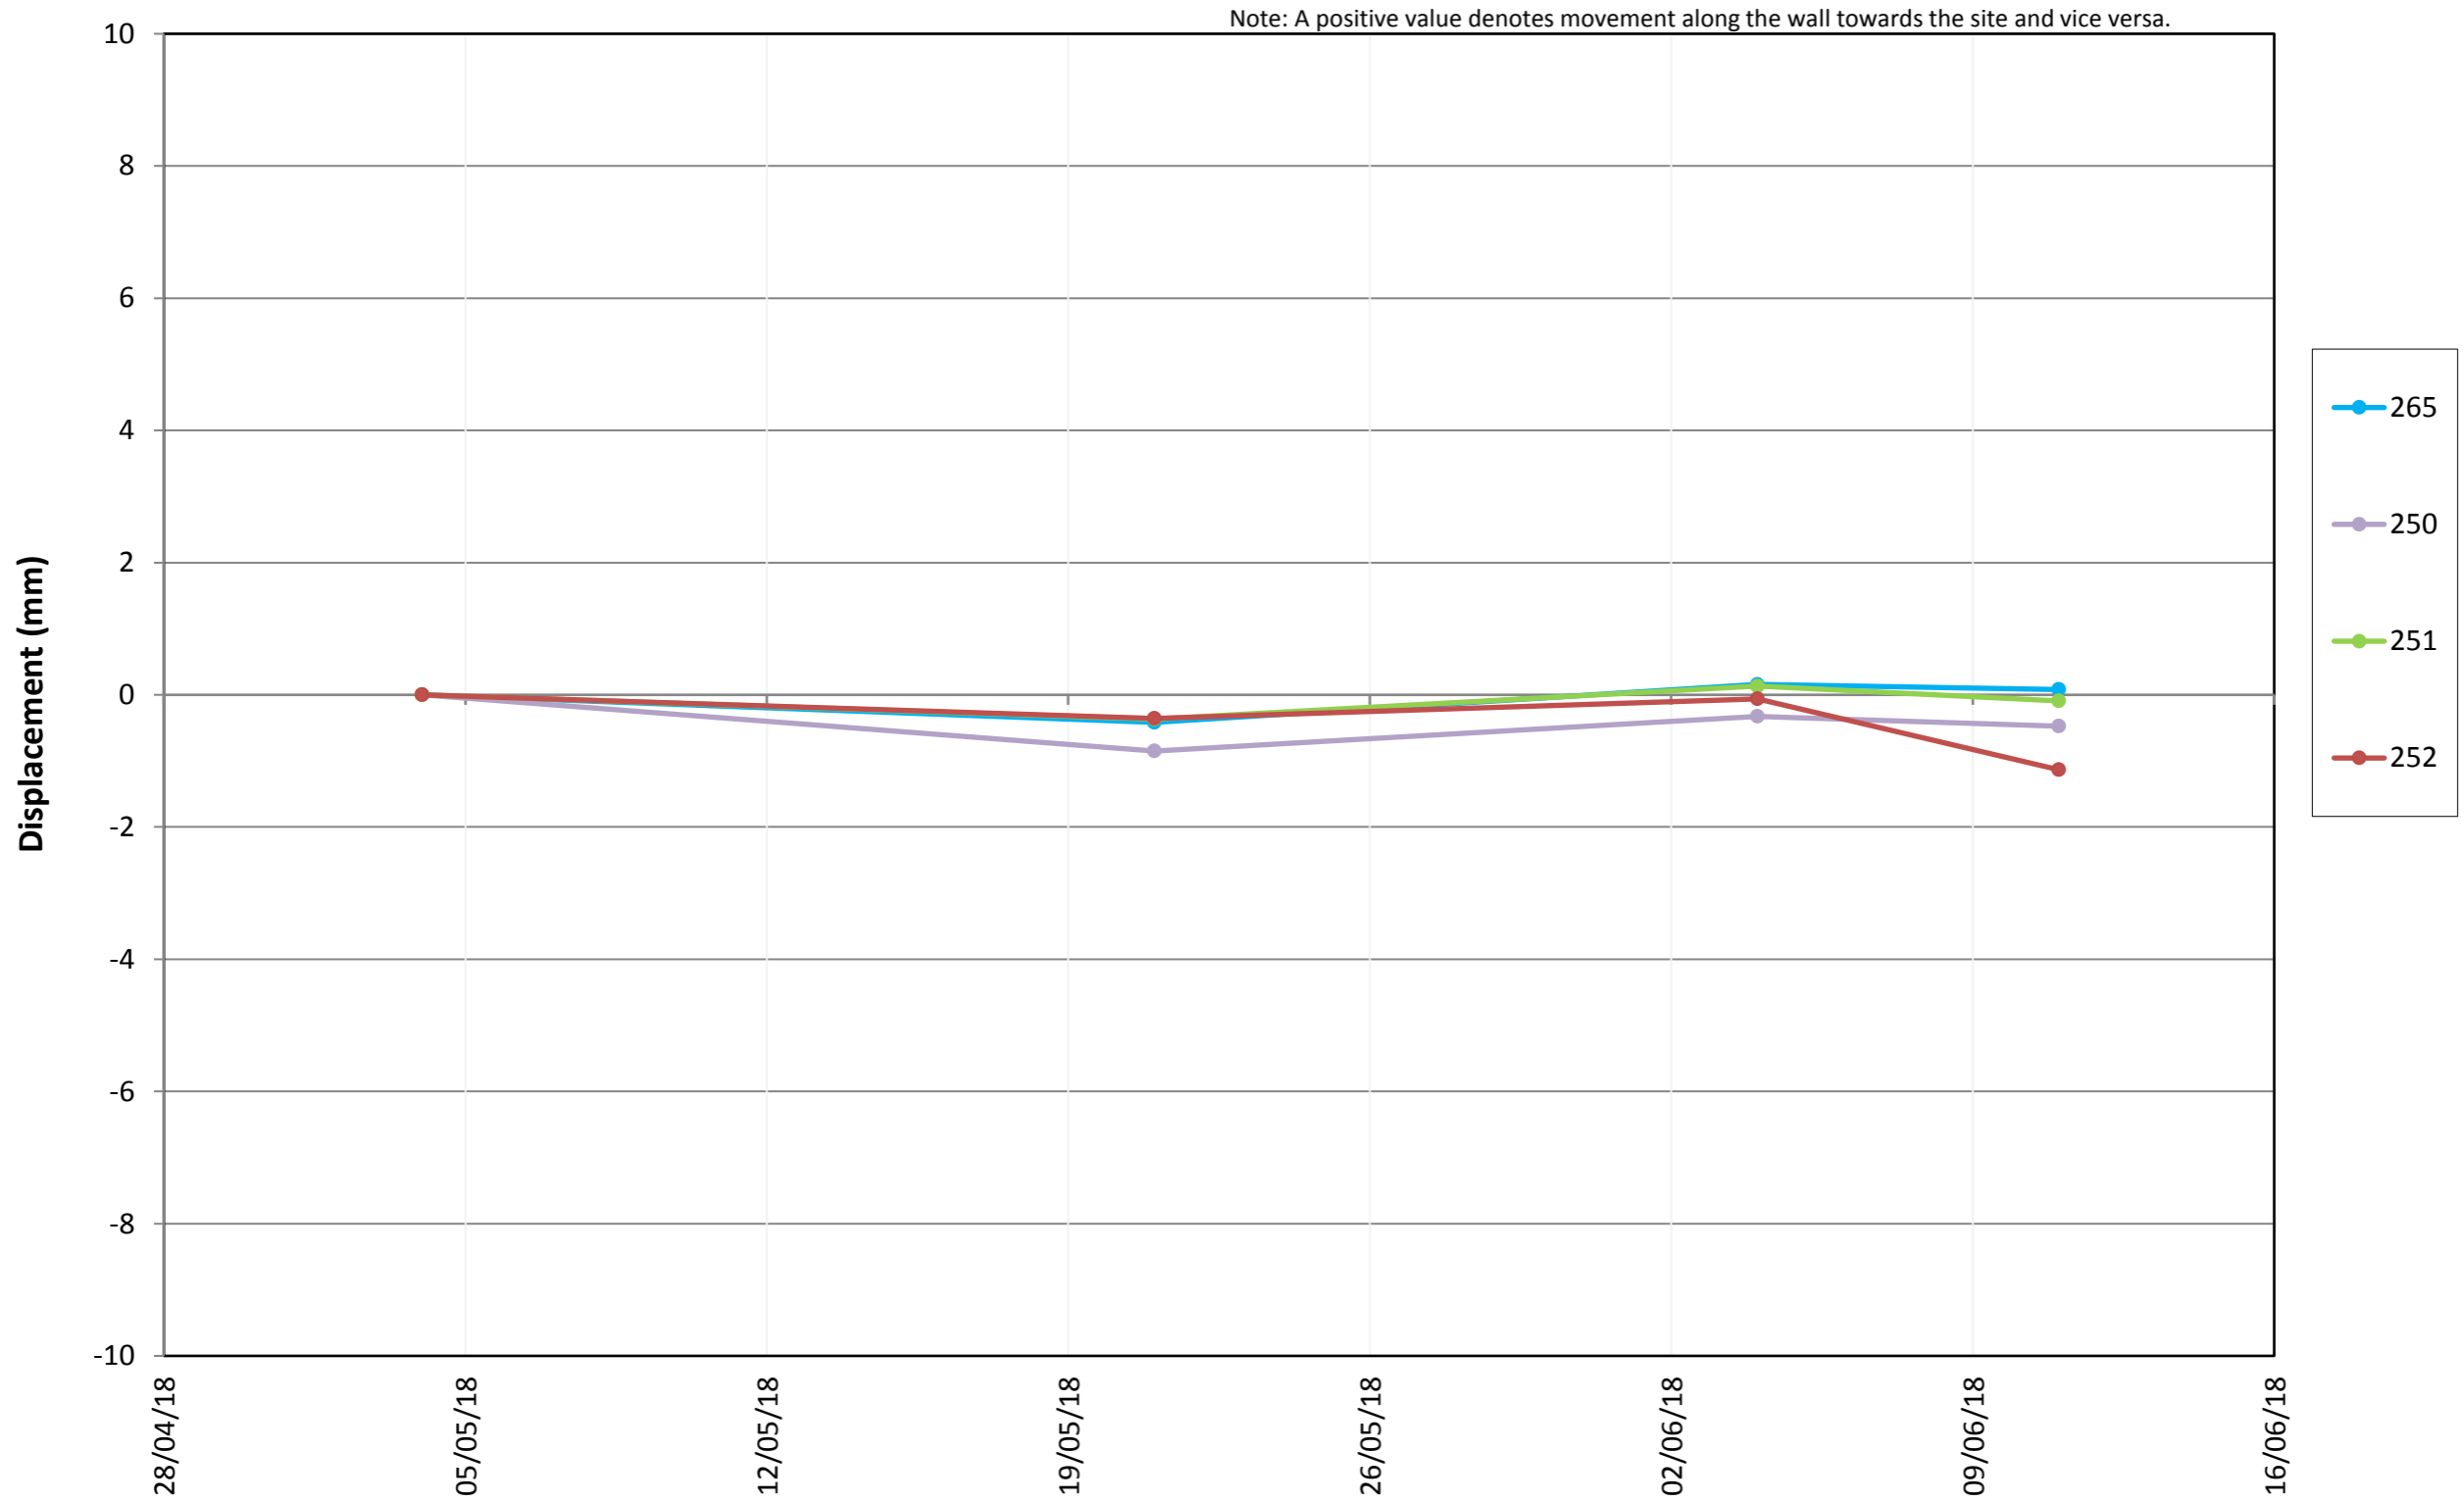
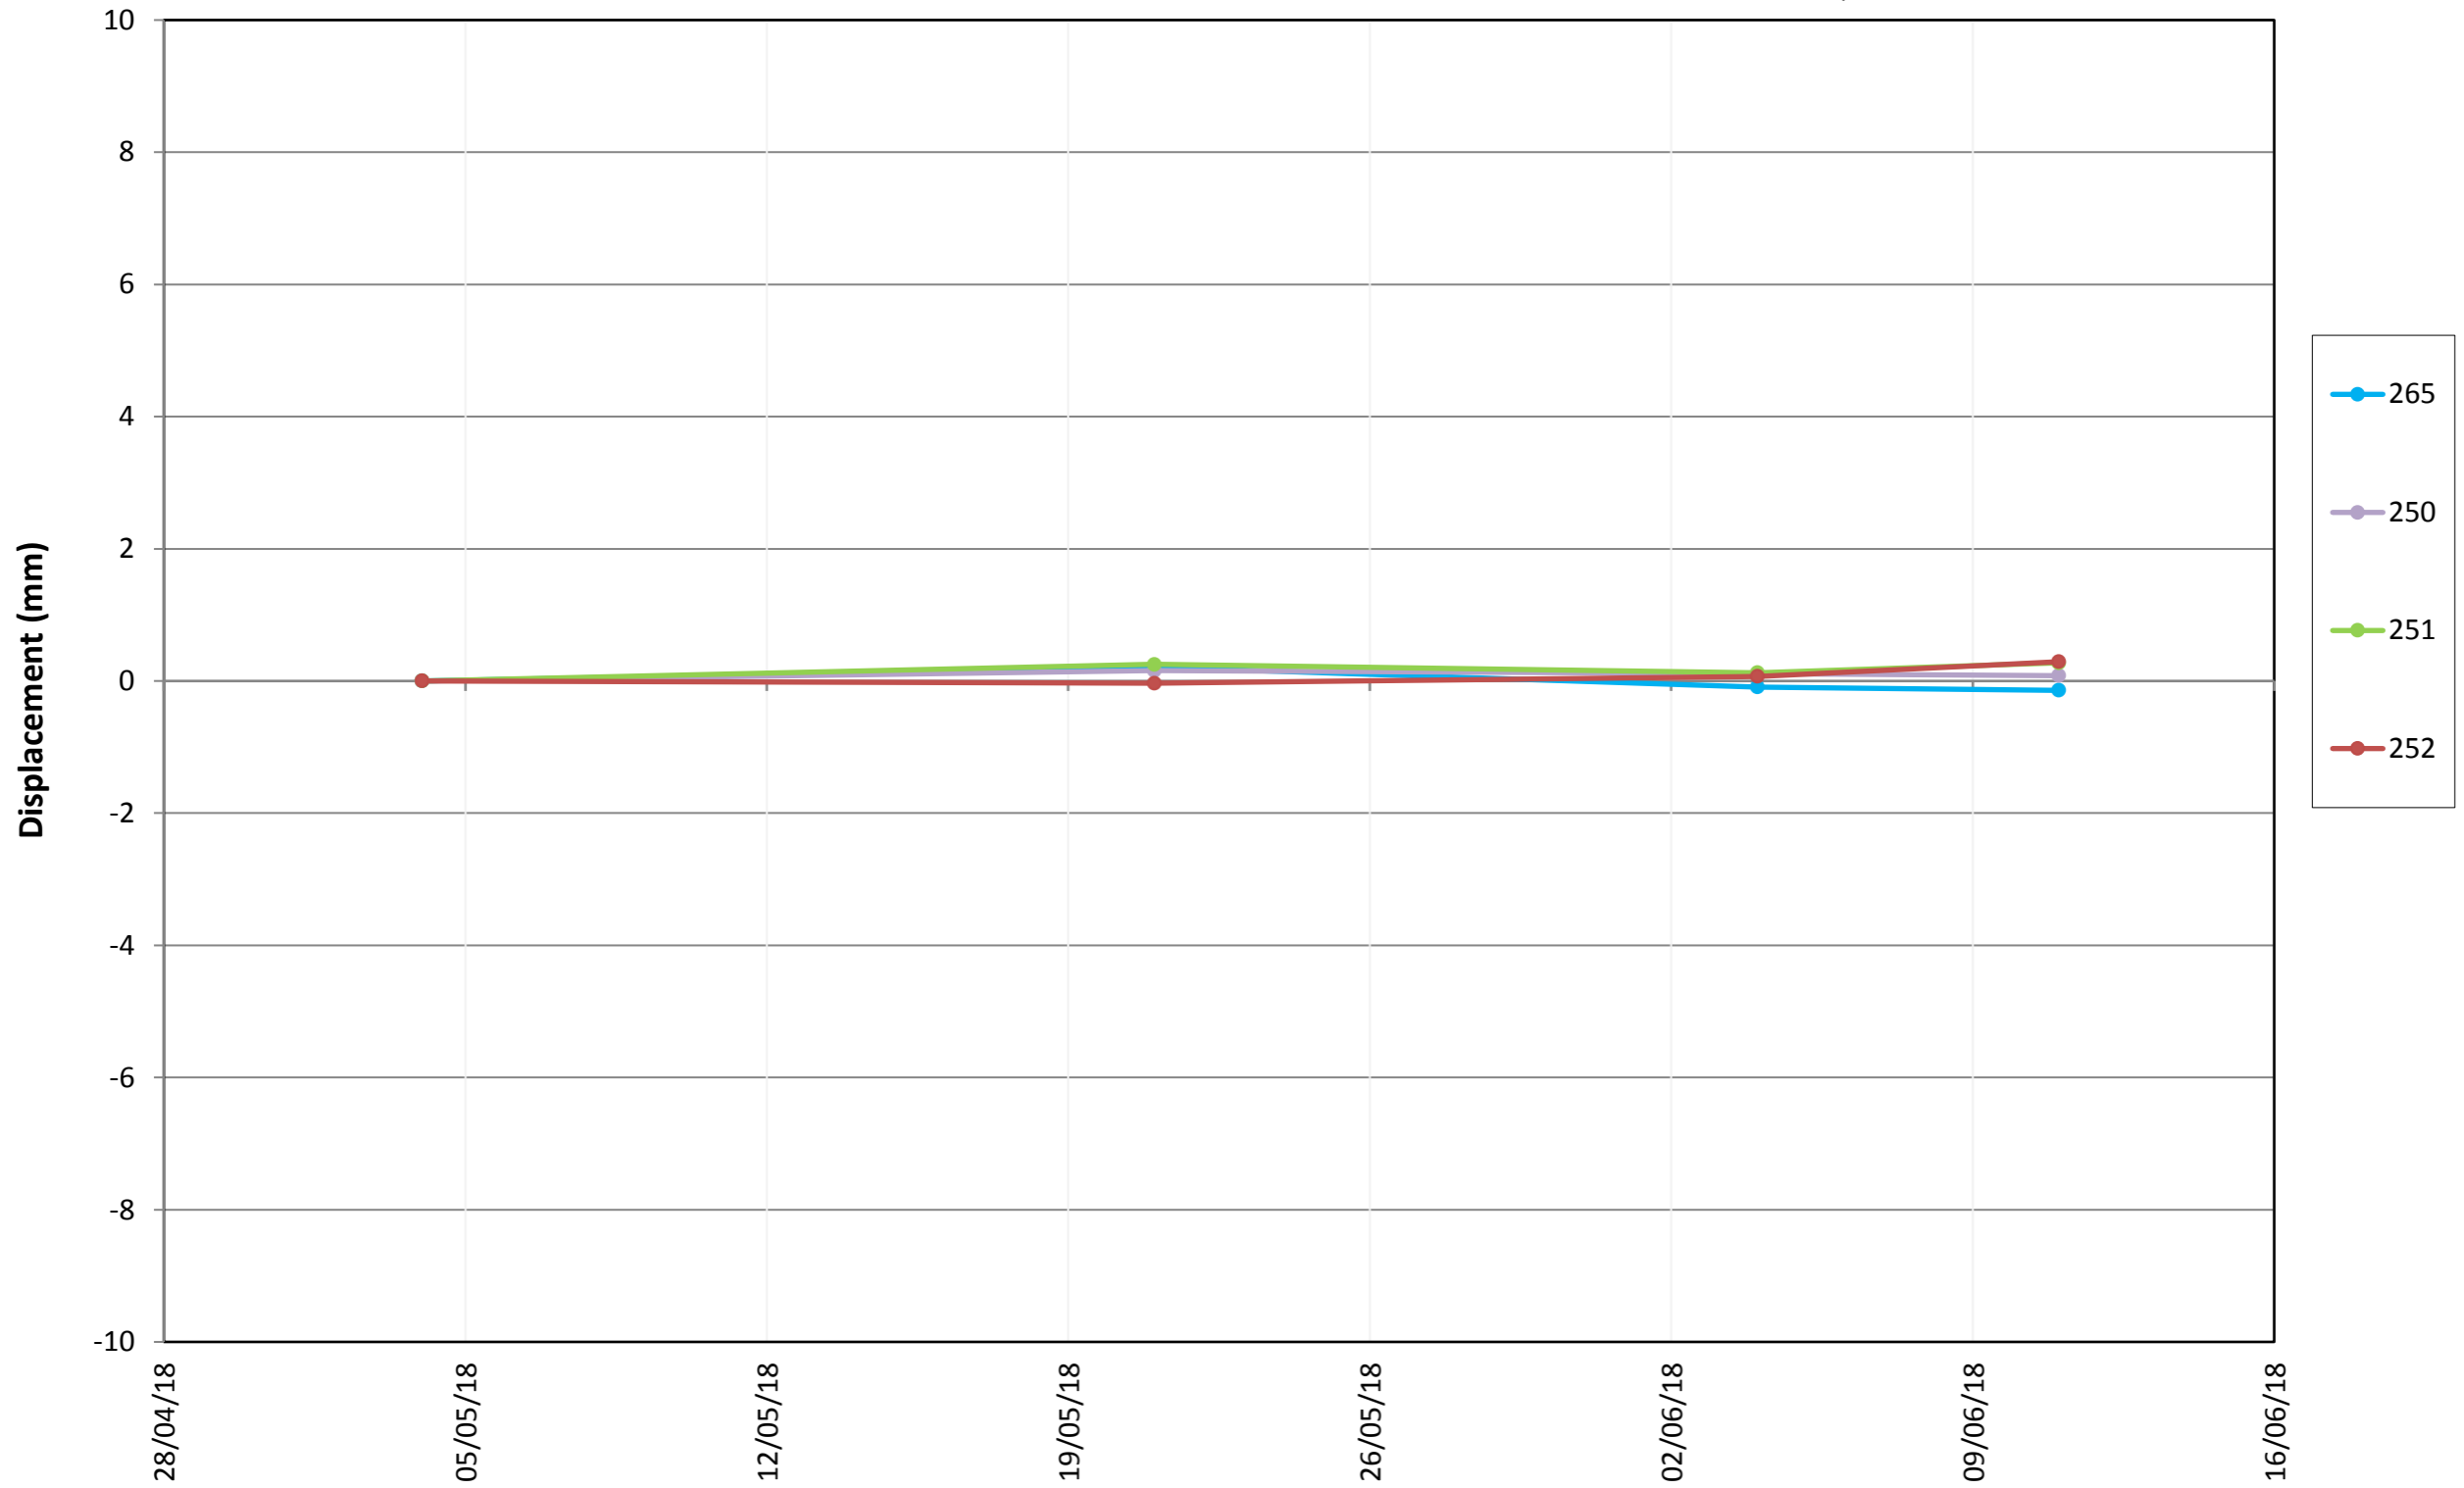
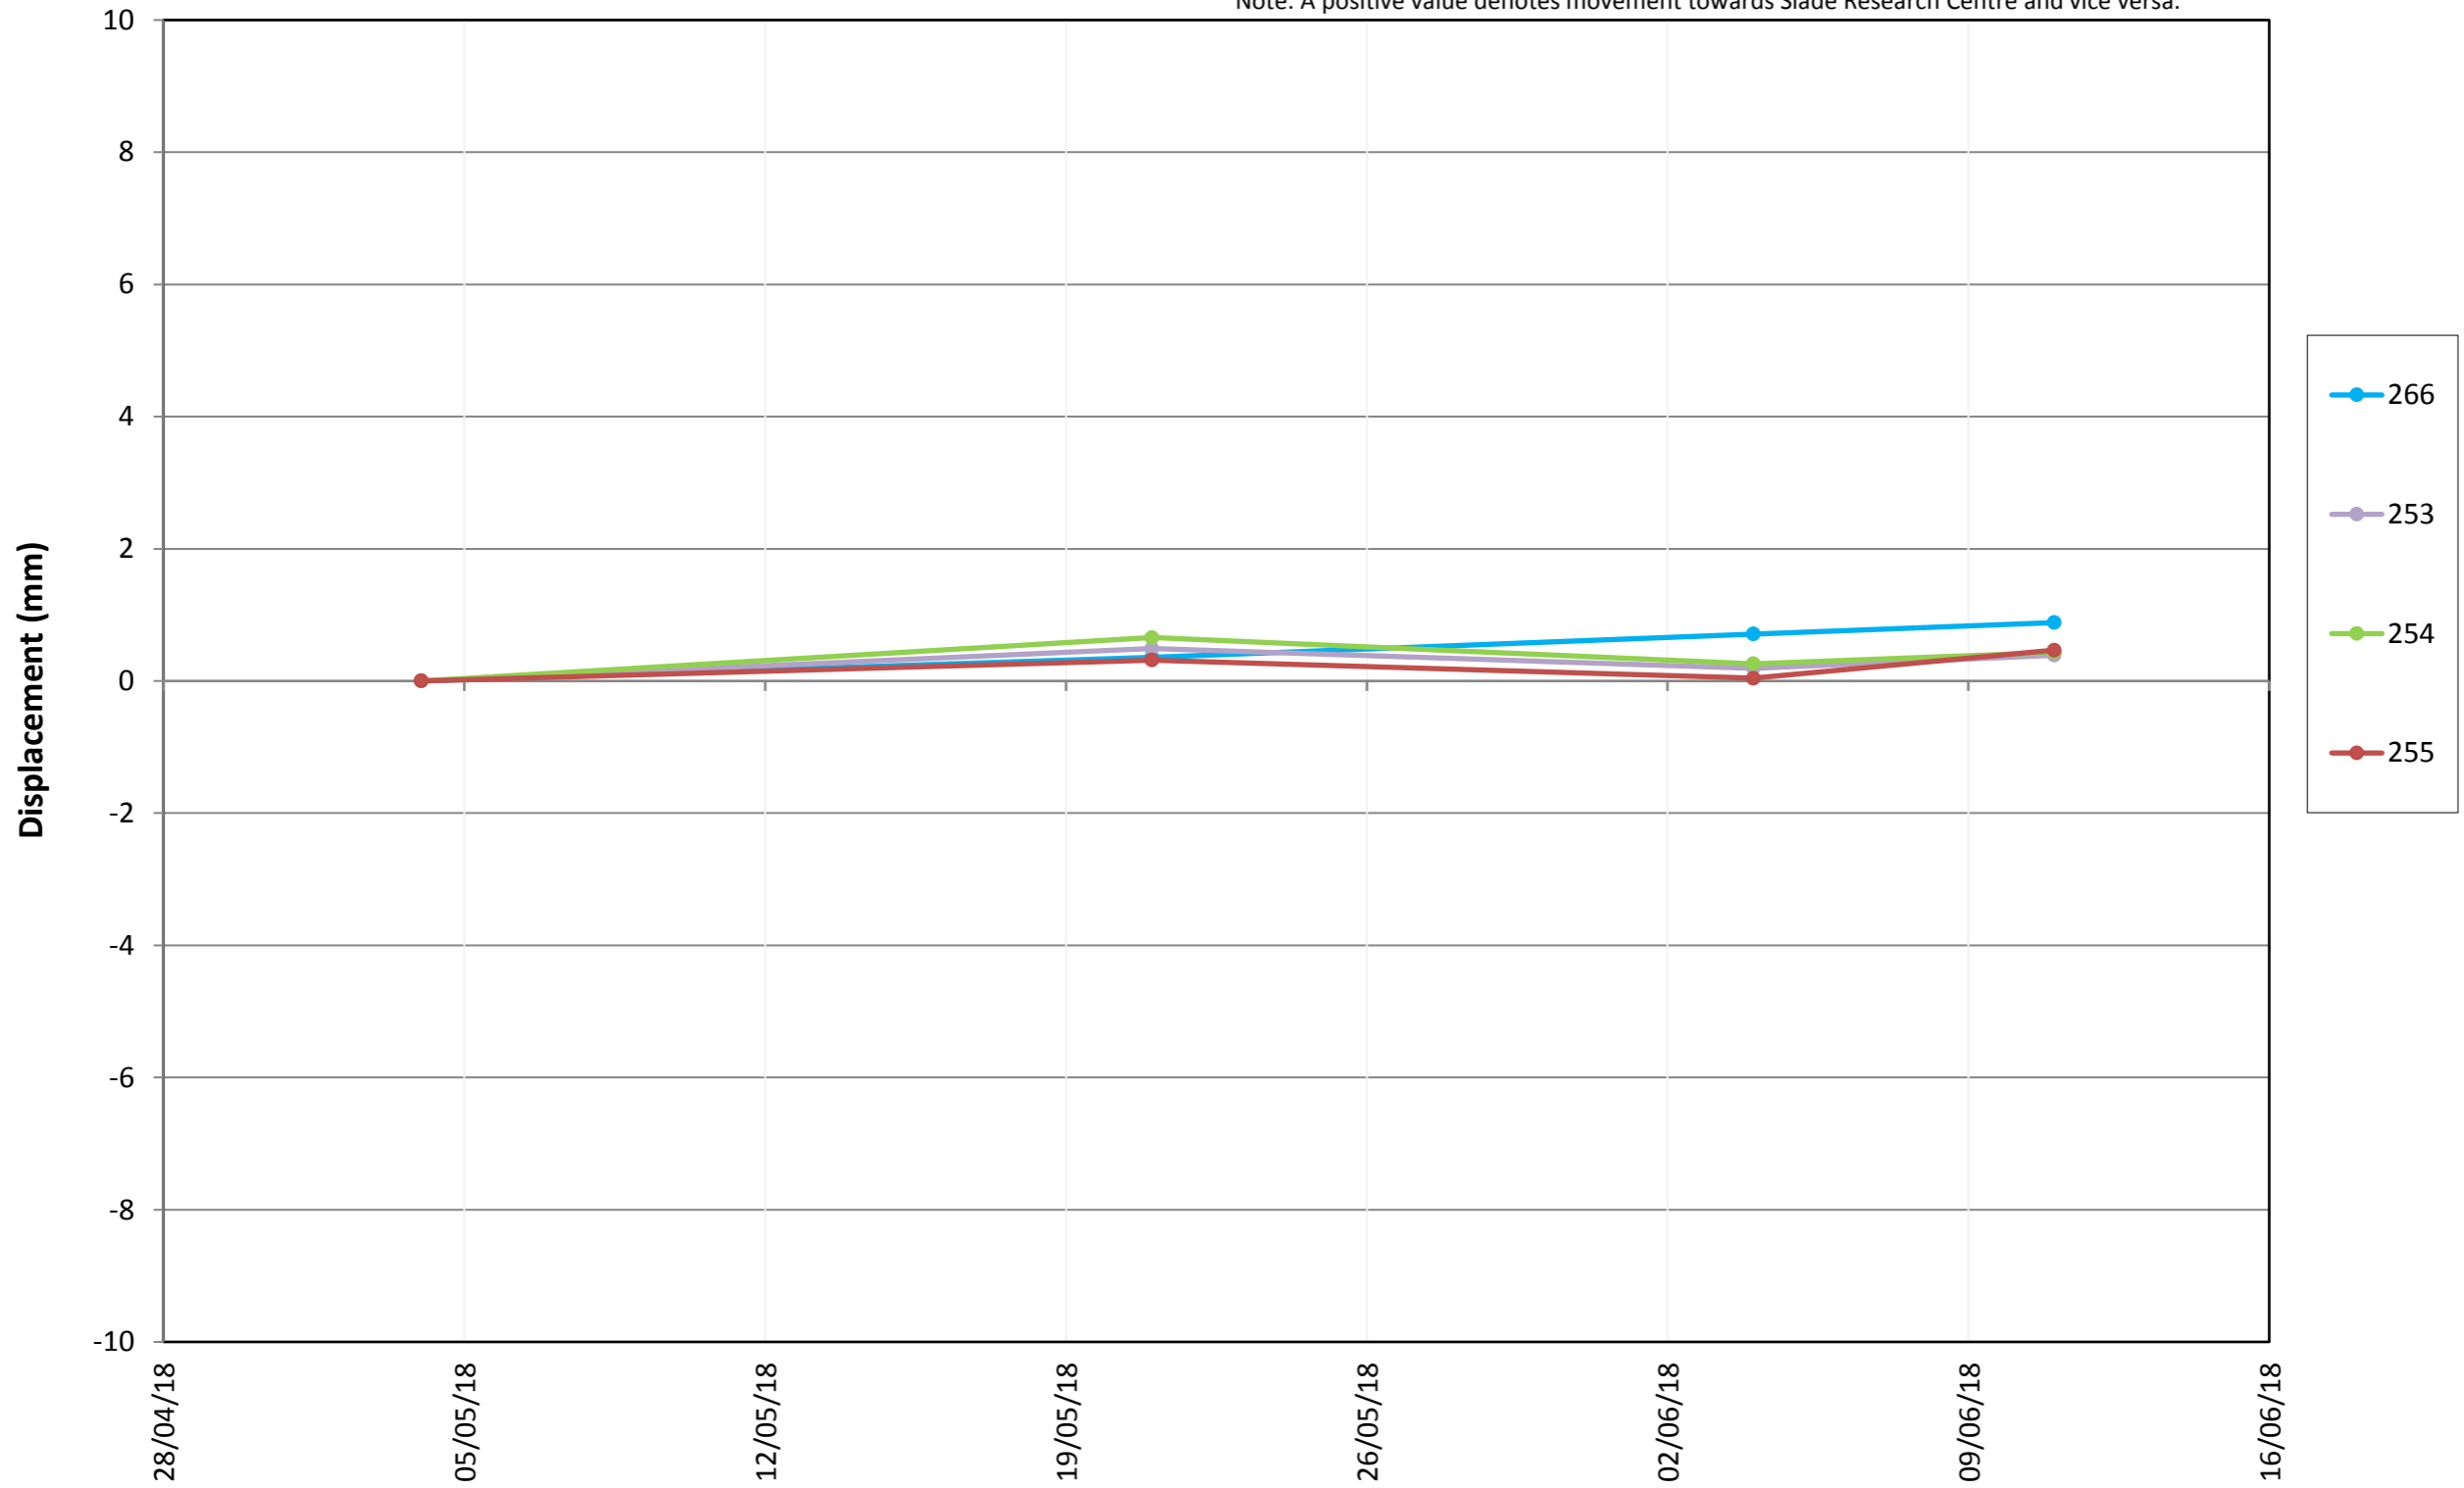
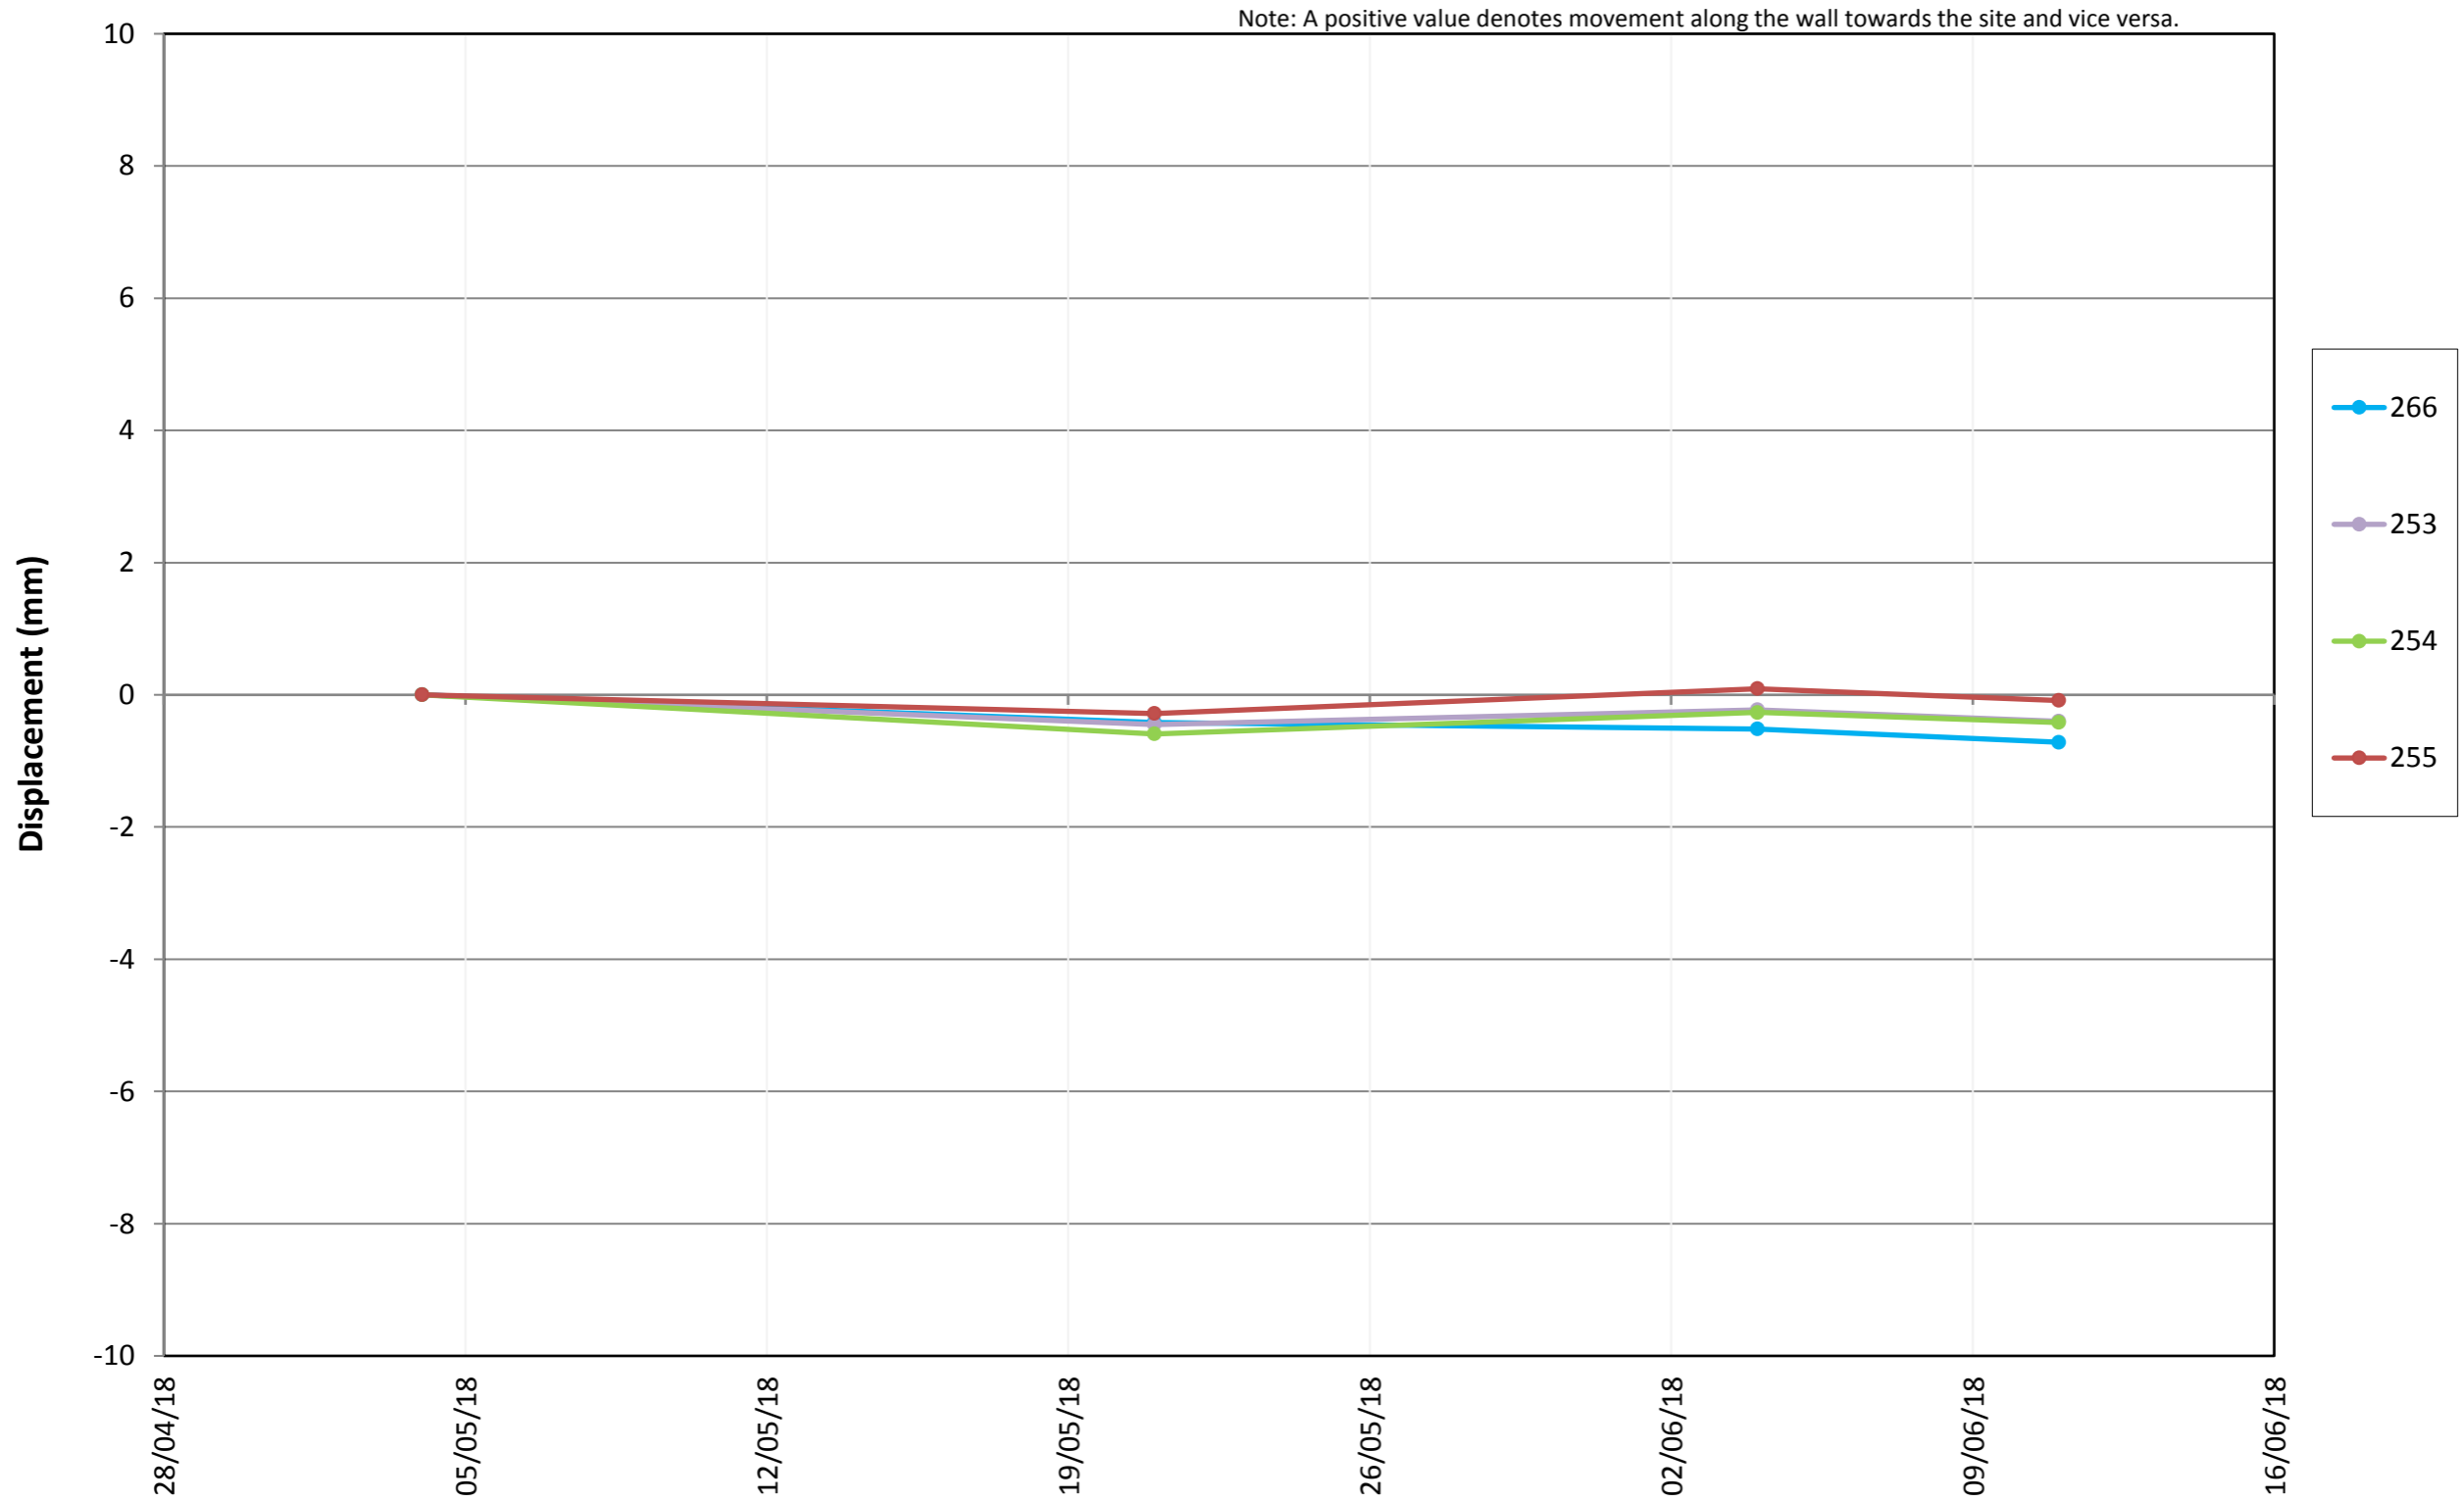
Graph 11T - Targets on Front Elevation of No. 32 Torrington Square

Targets on Front Elevation of No. 32 Torrington Square

Targets are showing negligible horizontal movement.

Targets are showing negligible vertical movement.
