32-33 TORRINGTON SQUARE
MONITORING

Monitoring Report
SES-10215-MR03

Date of survey completion: 11th June 2018

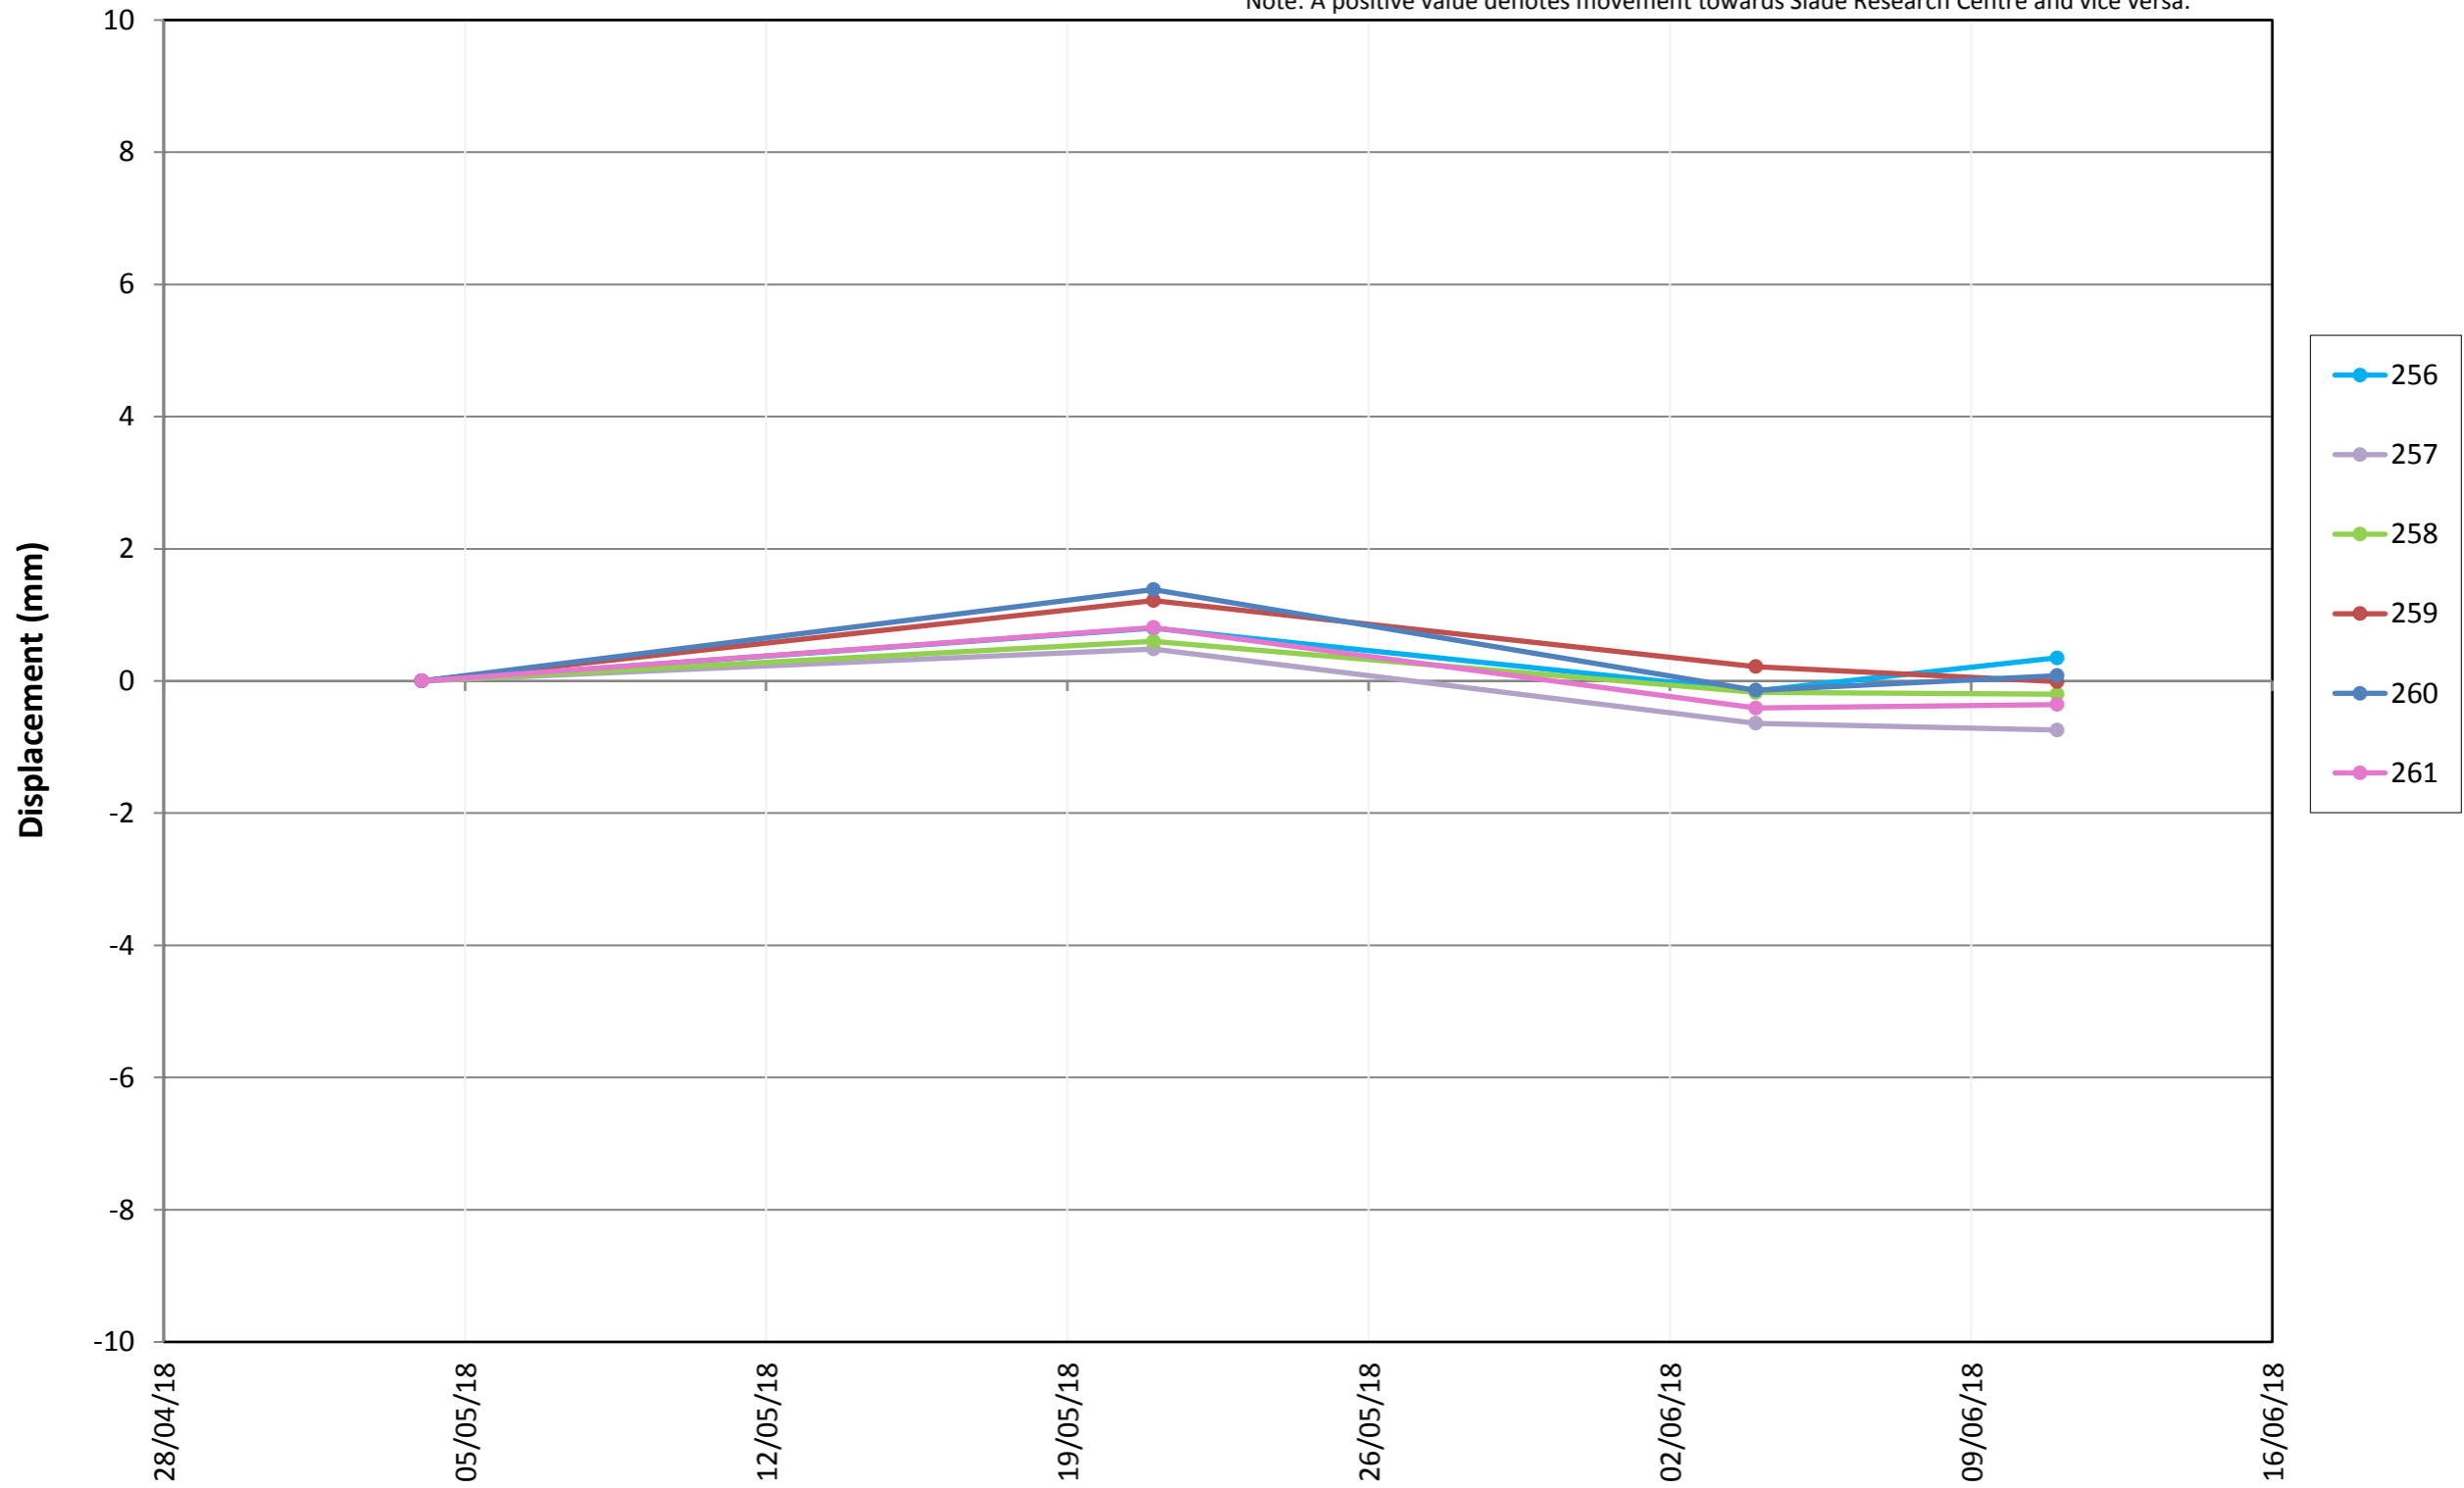
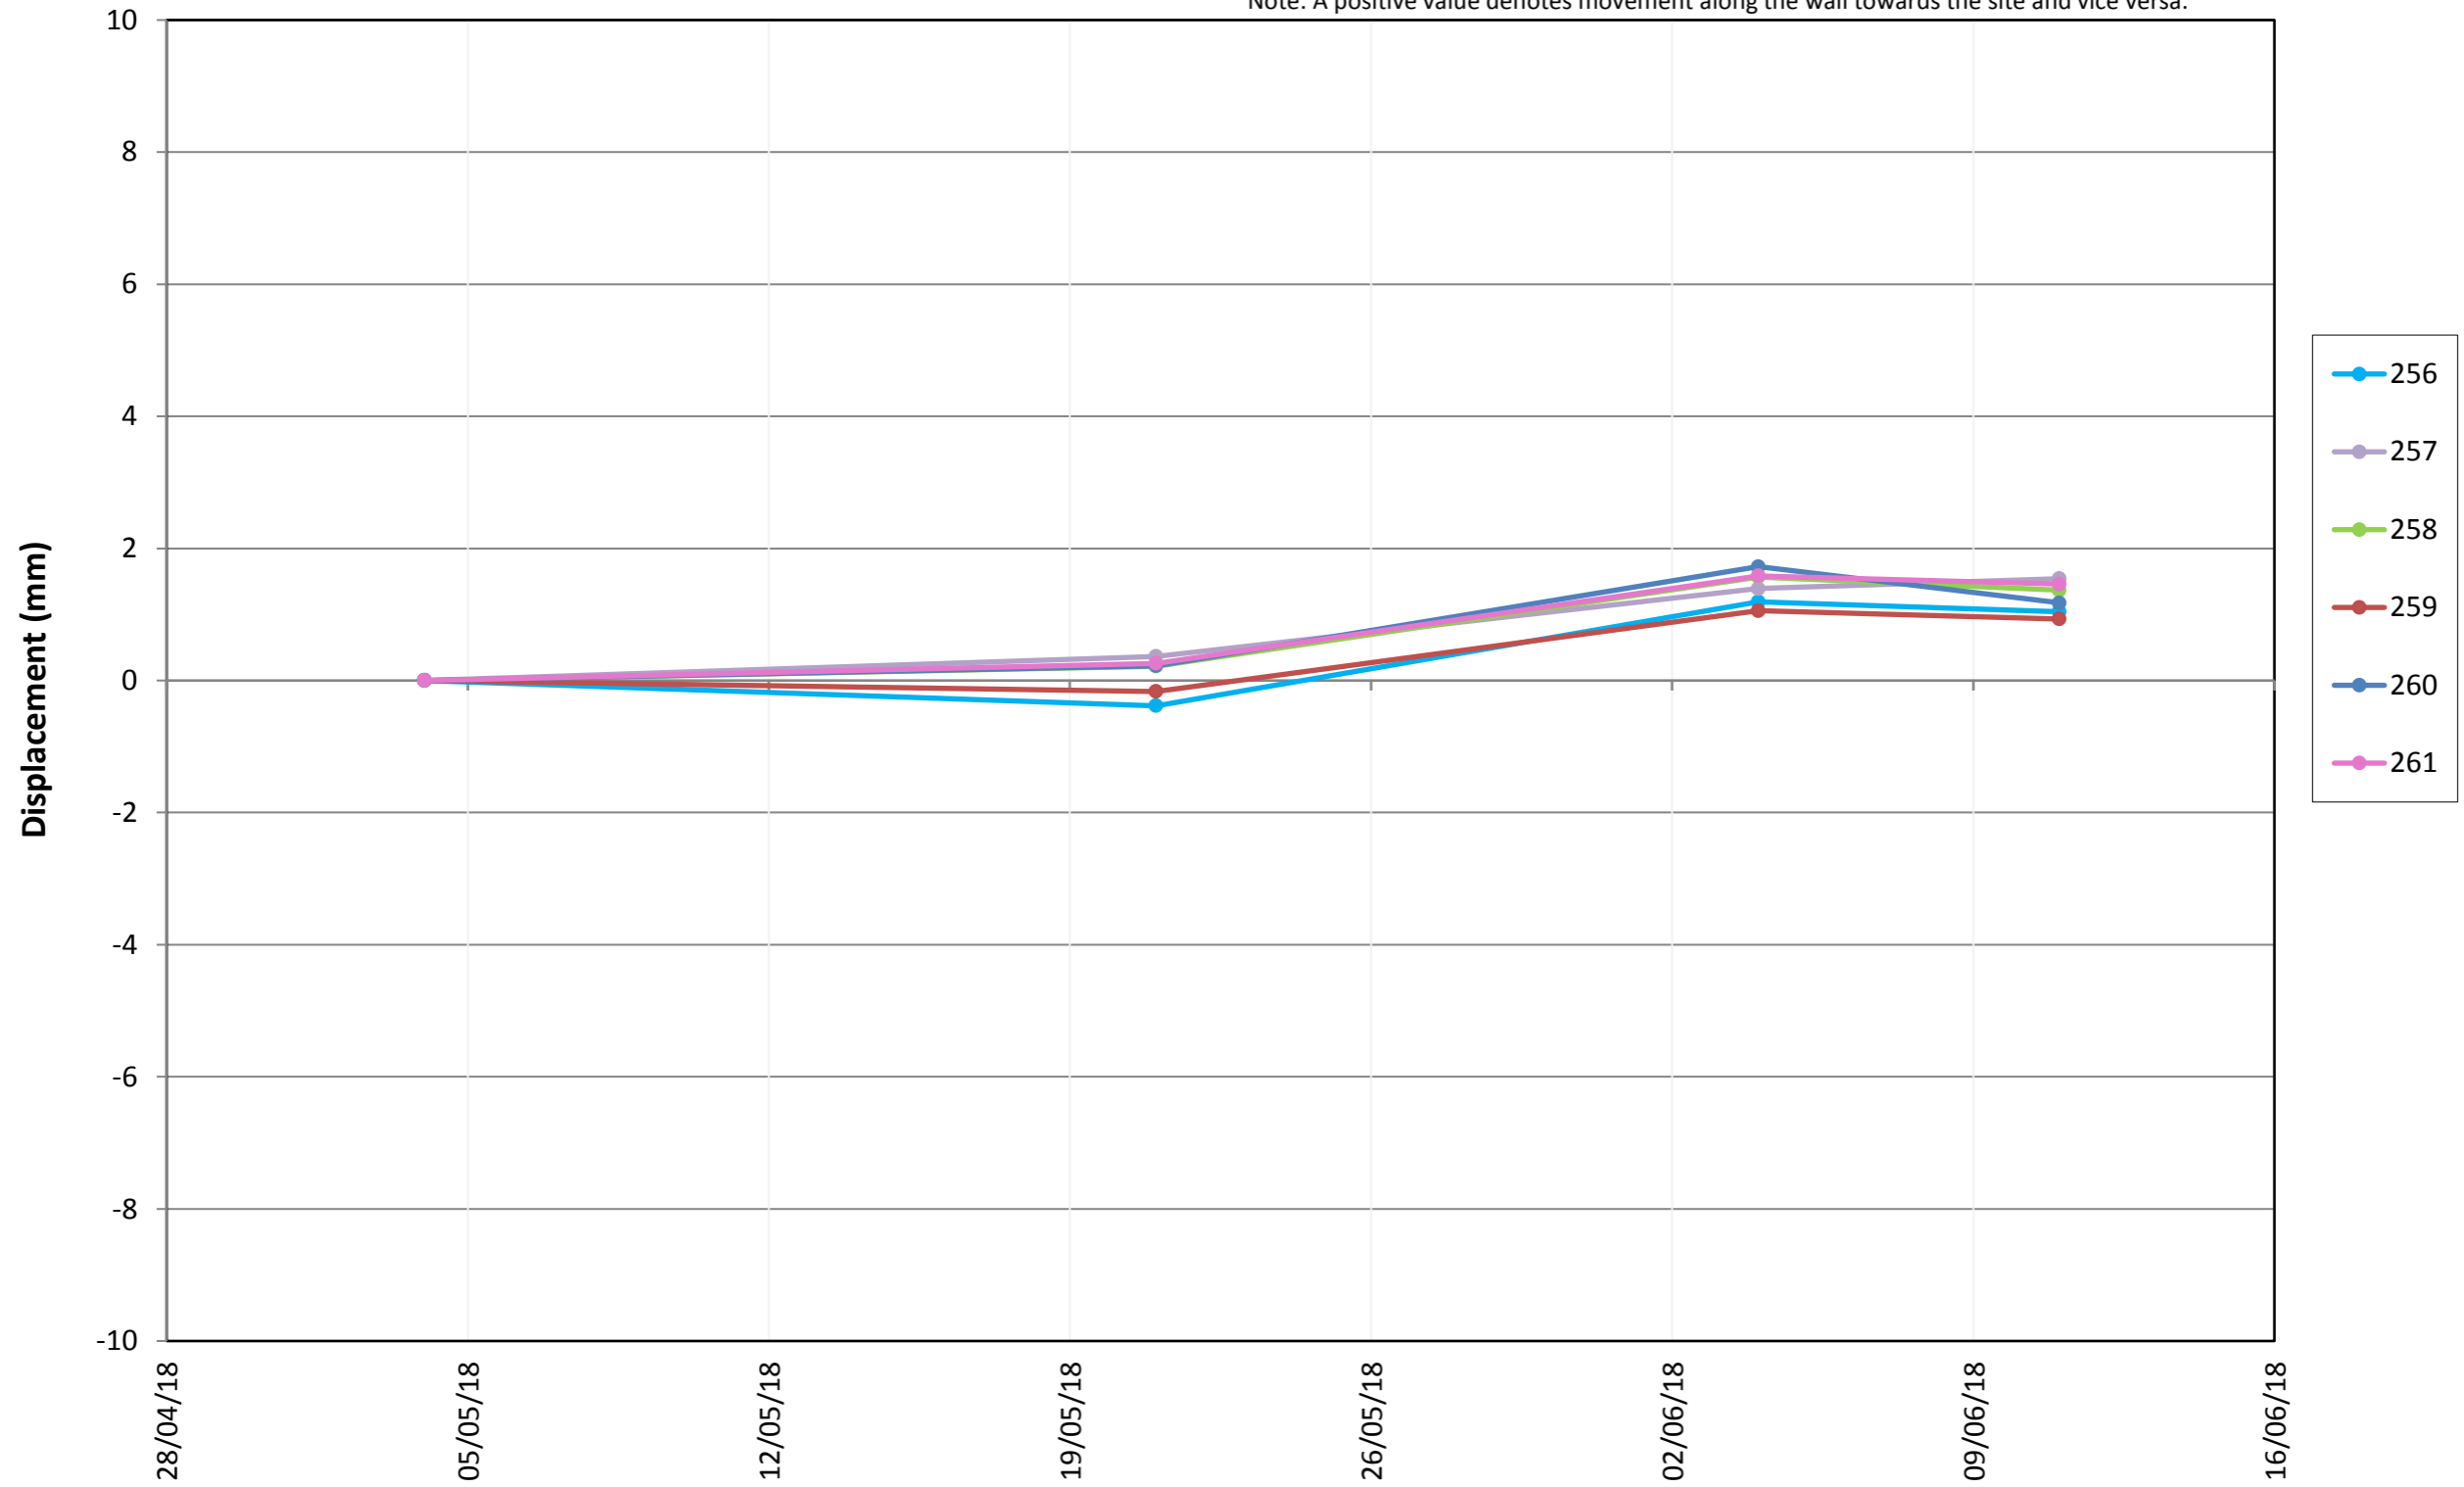
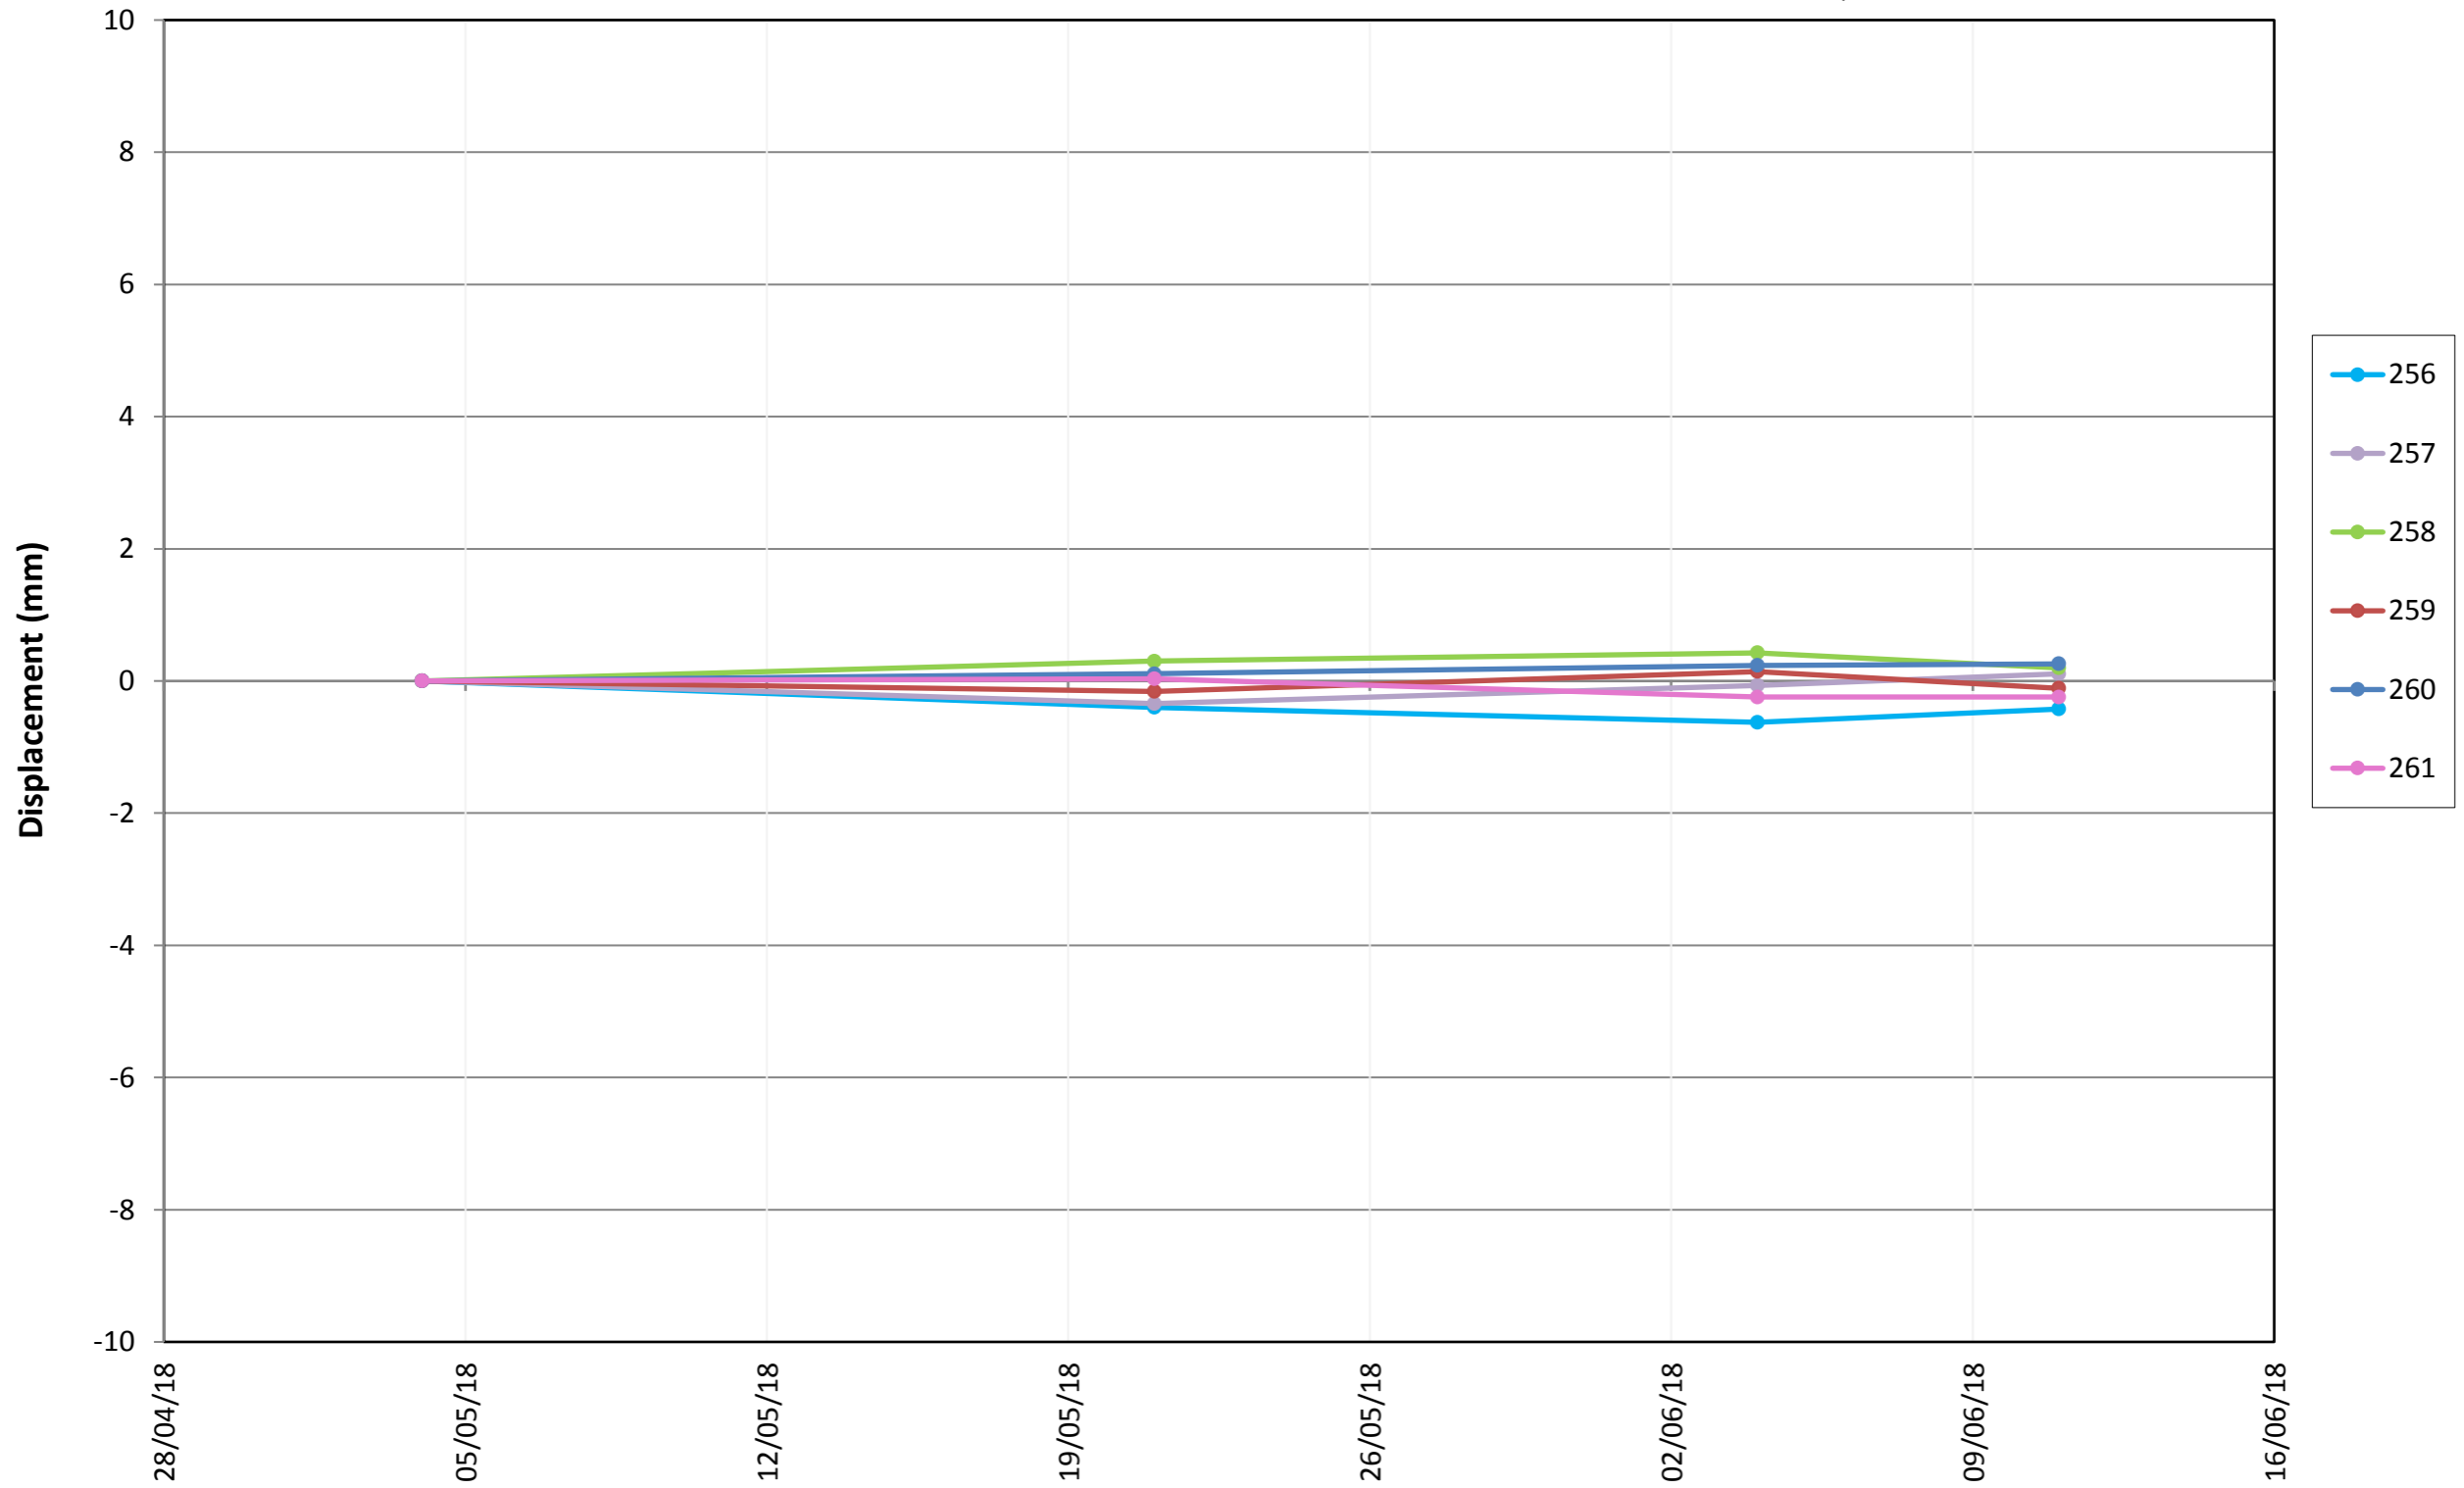
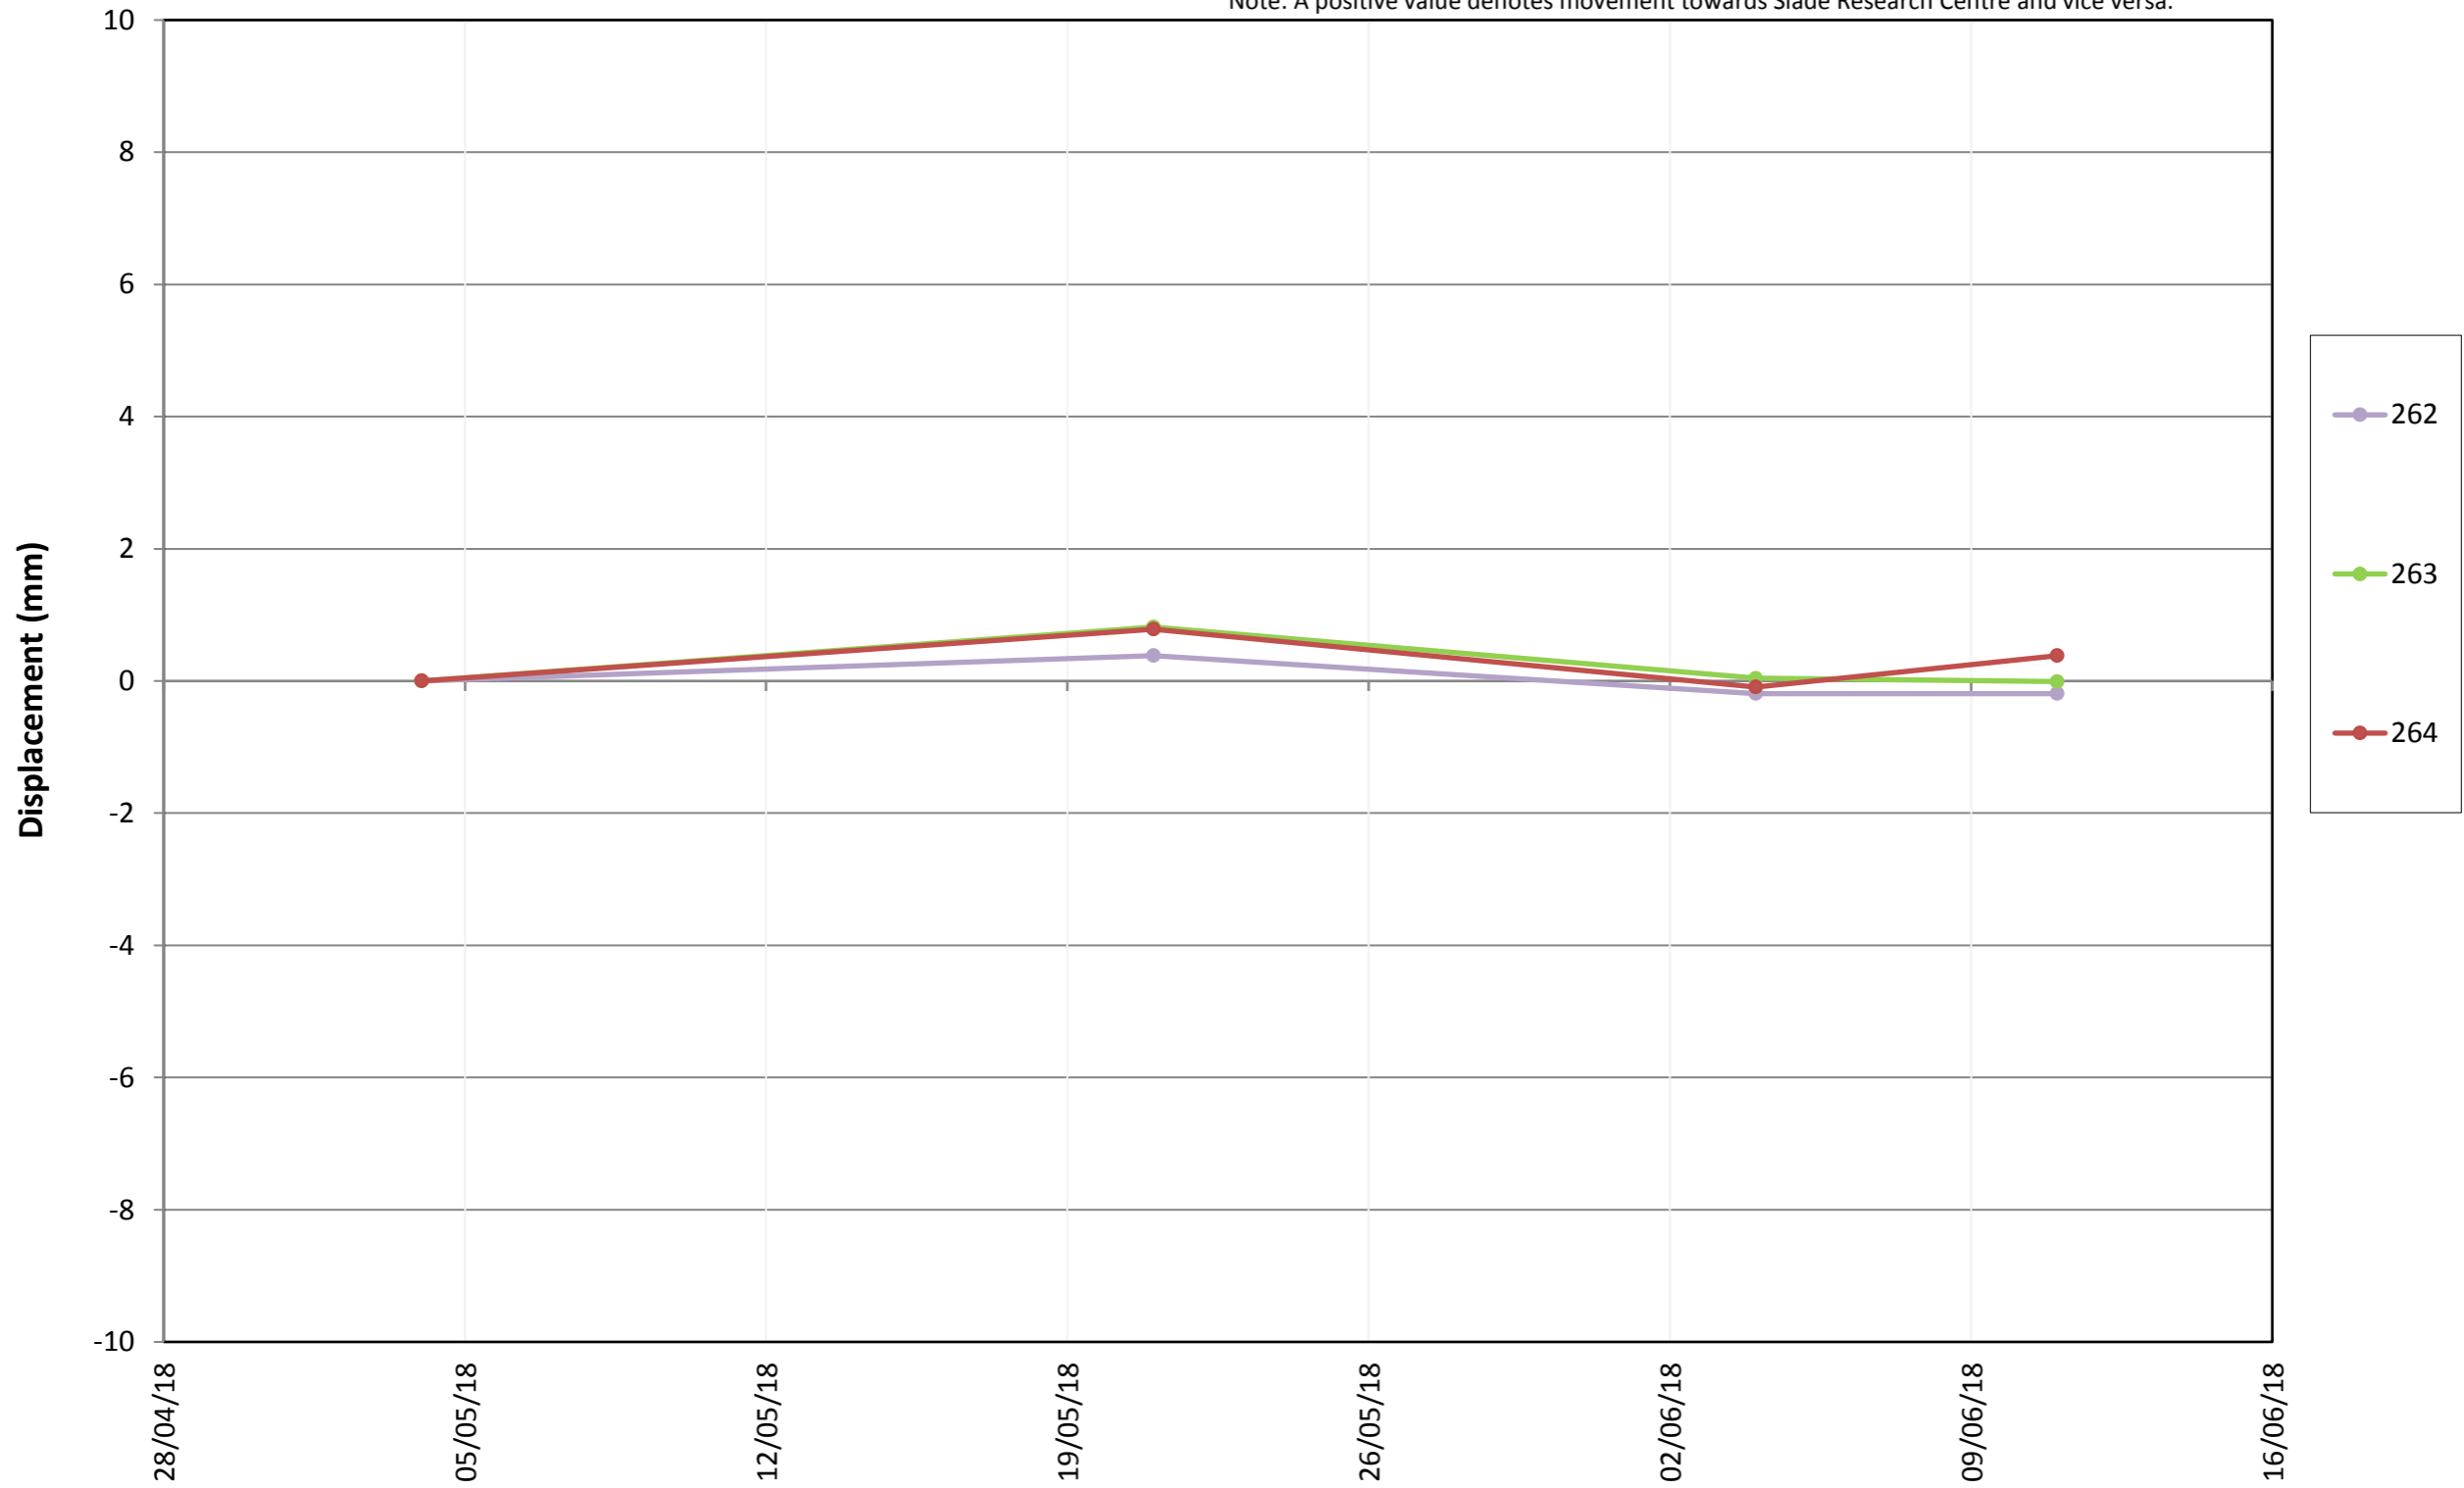
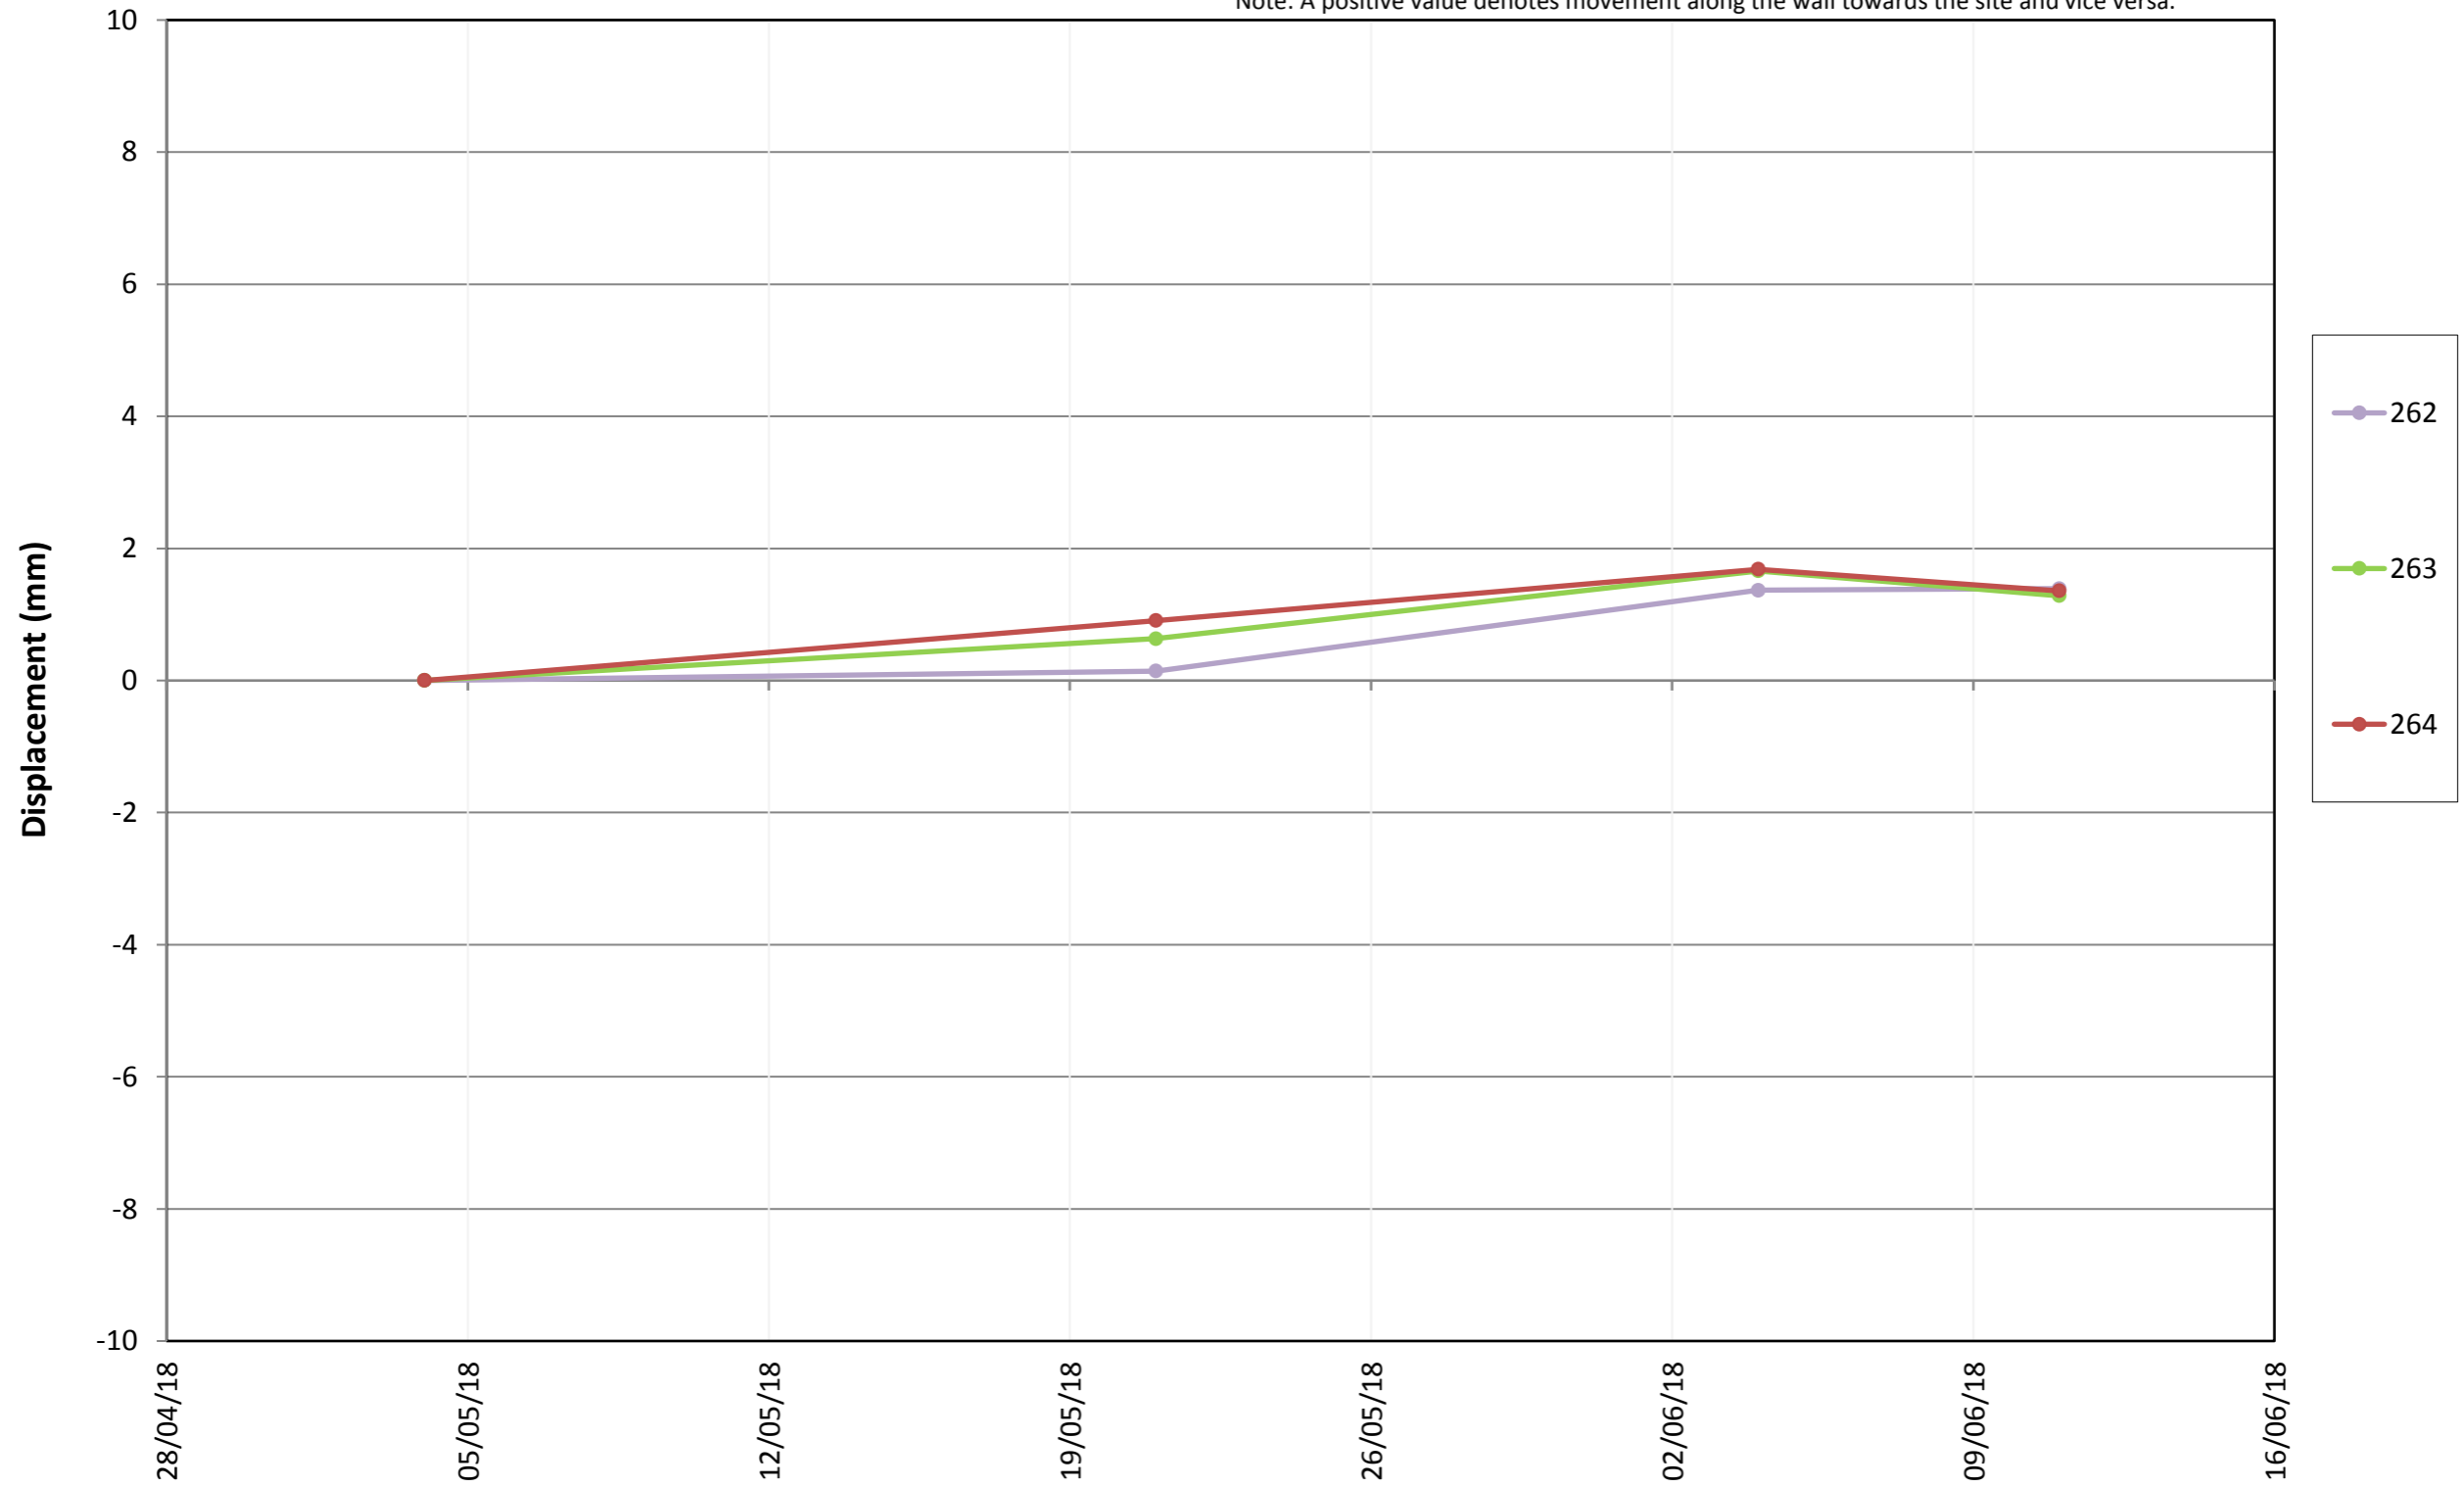
Graph 13T -Targets on Front Elevation of No. 31 Torrington Square

Targets on Front Elevation of No. 31 Torrington Square

Targets are showing negligible horizontal movement.

Targets are showing negligible vertical movement.
