32-33 TORRINGTON SQUARE
MONITORING

Monitoring Report
SES-10215-MR03

Date of survey completion: 11th June 2018

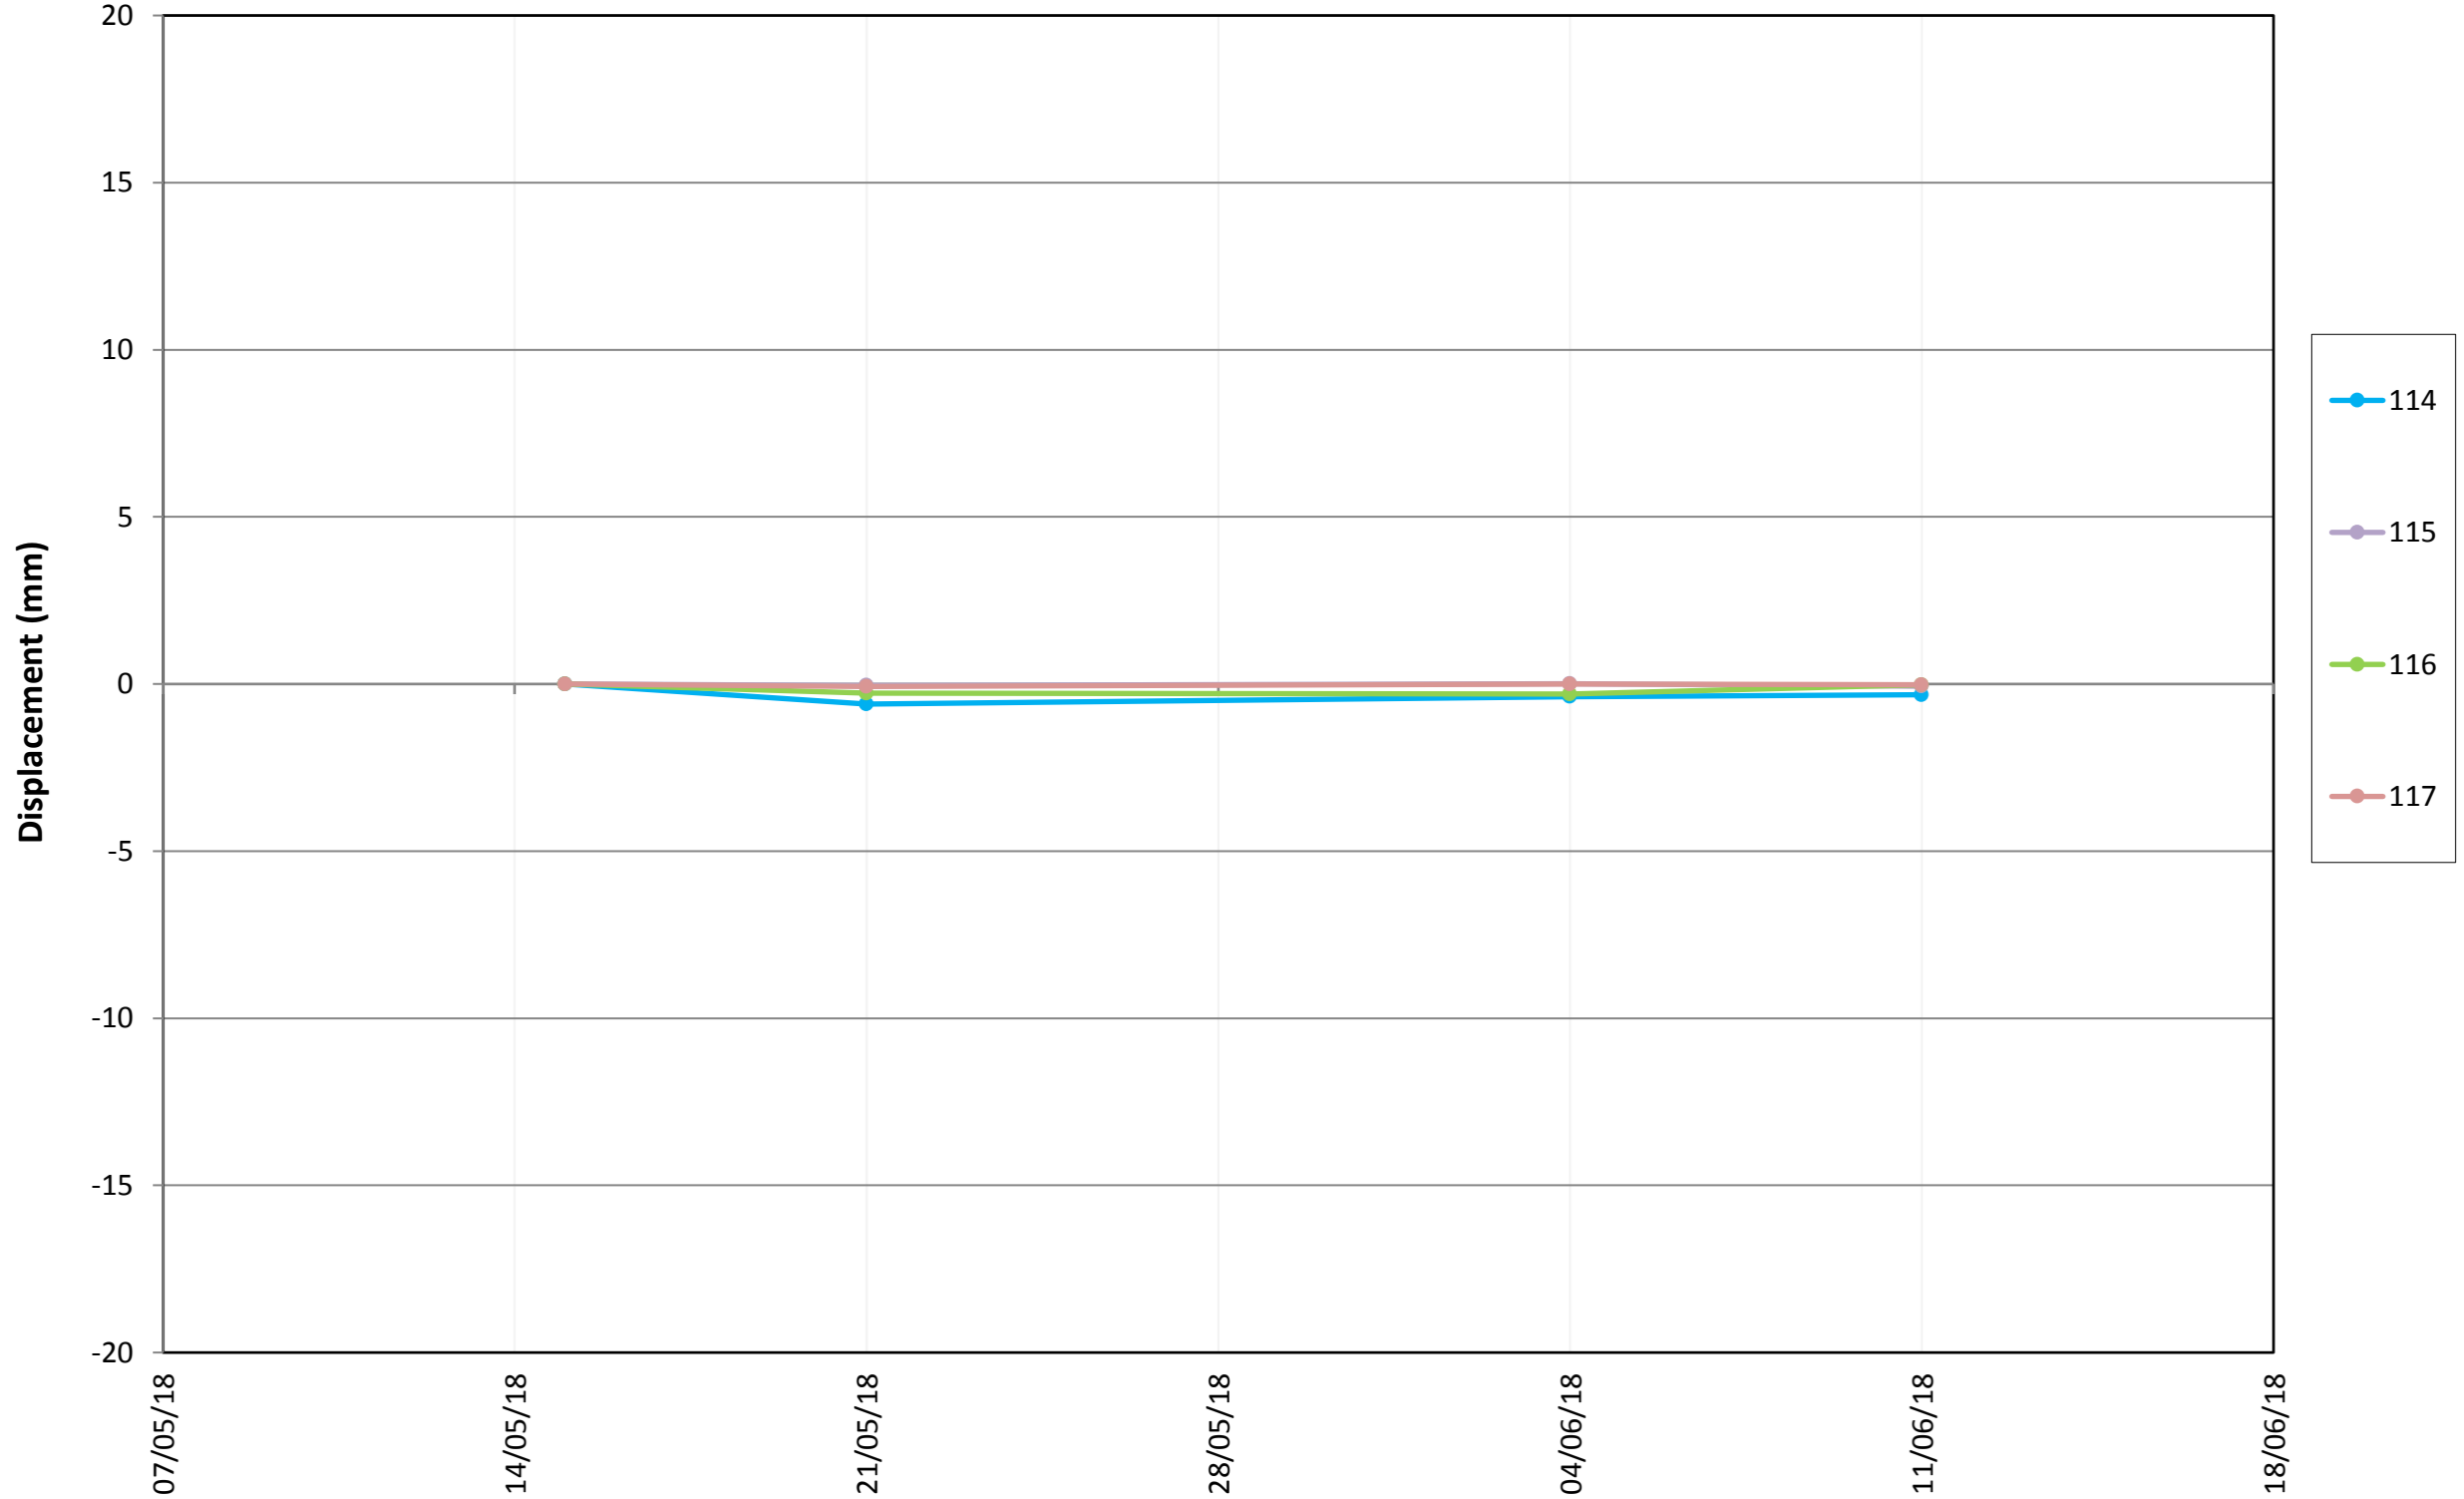
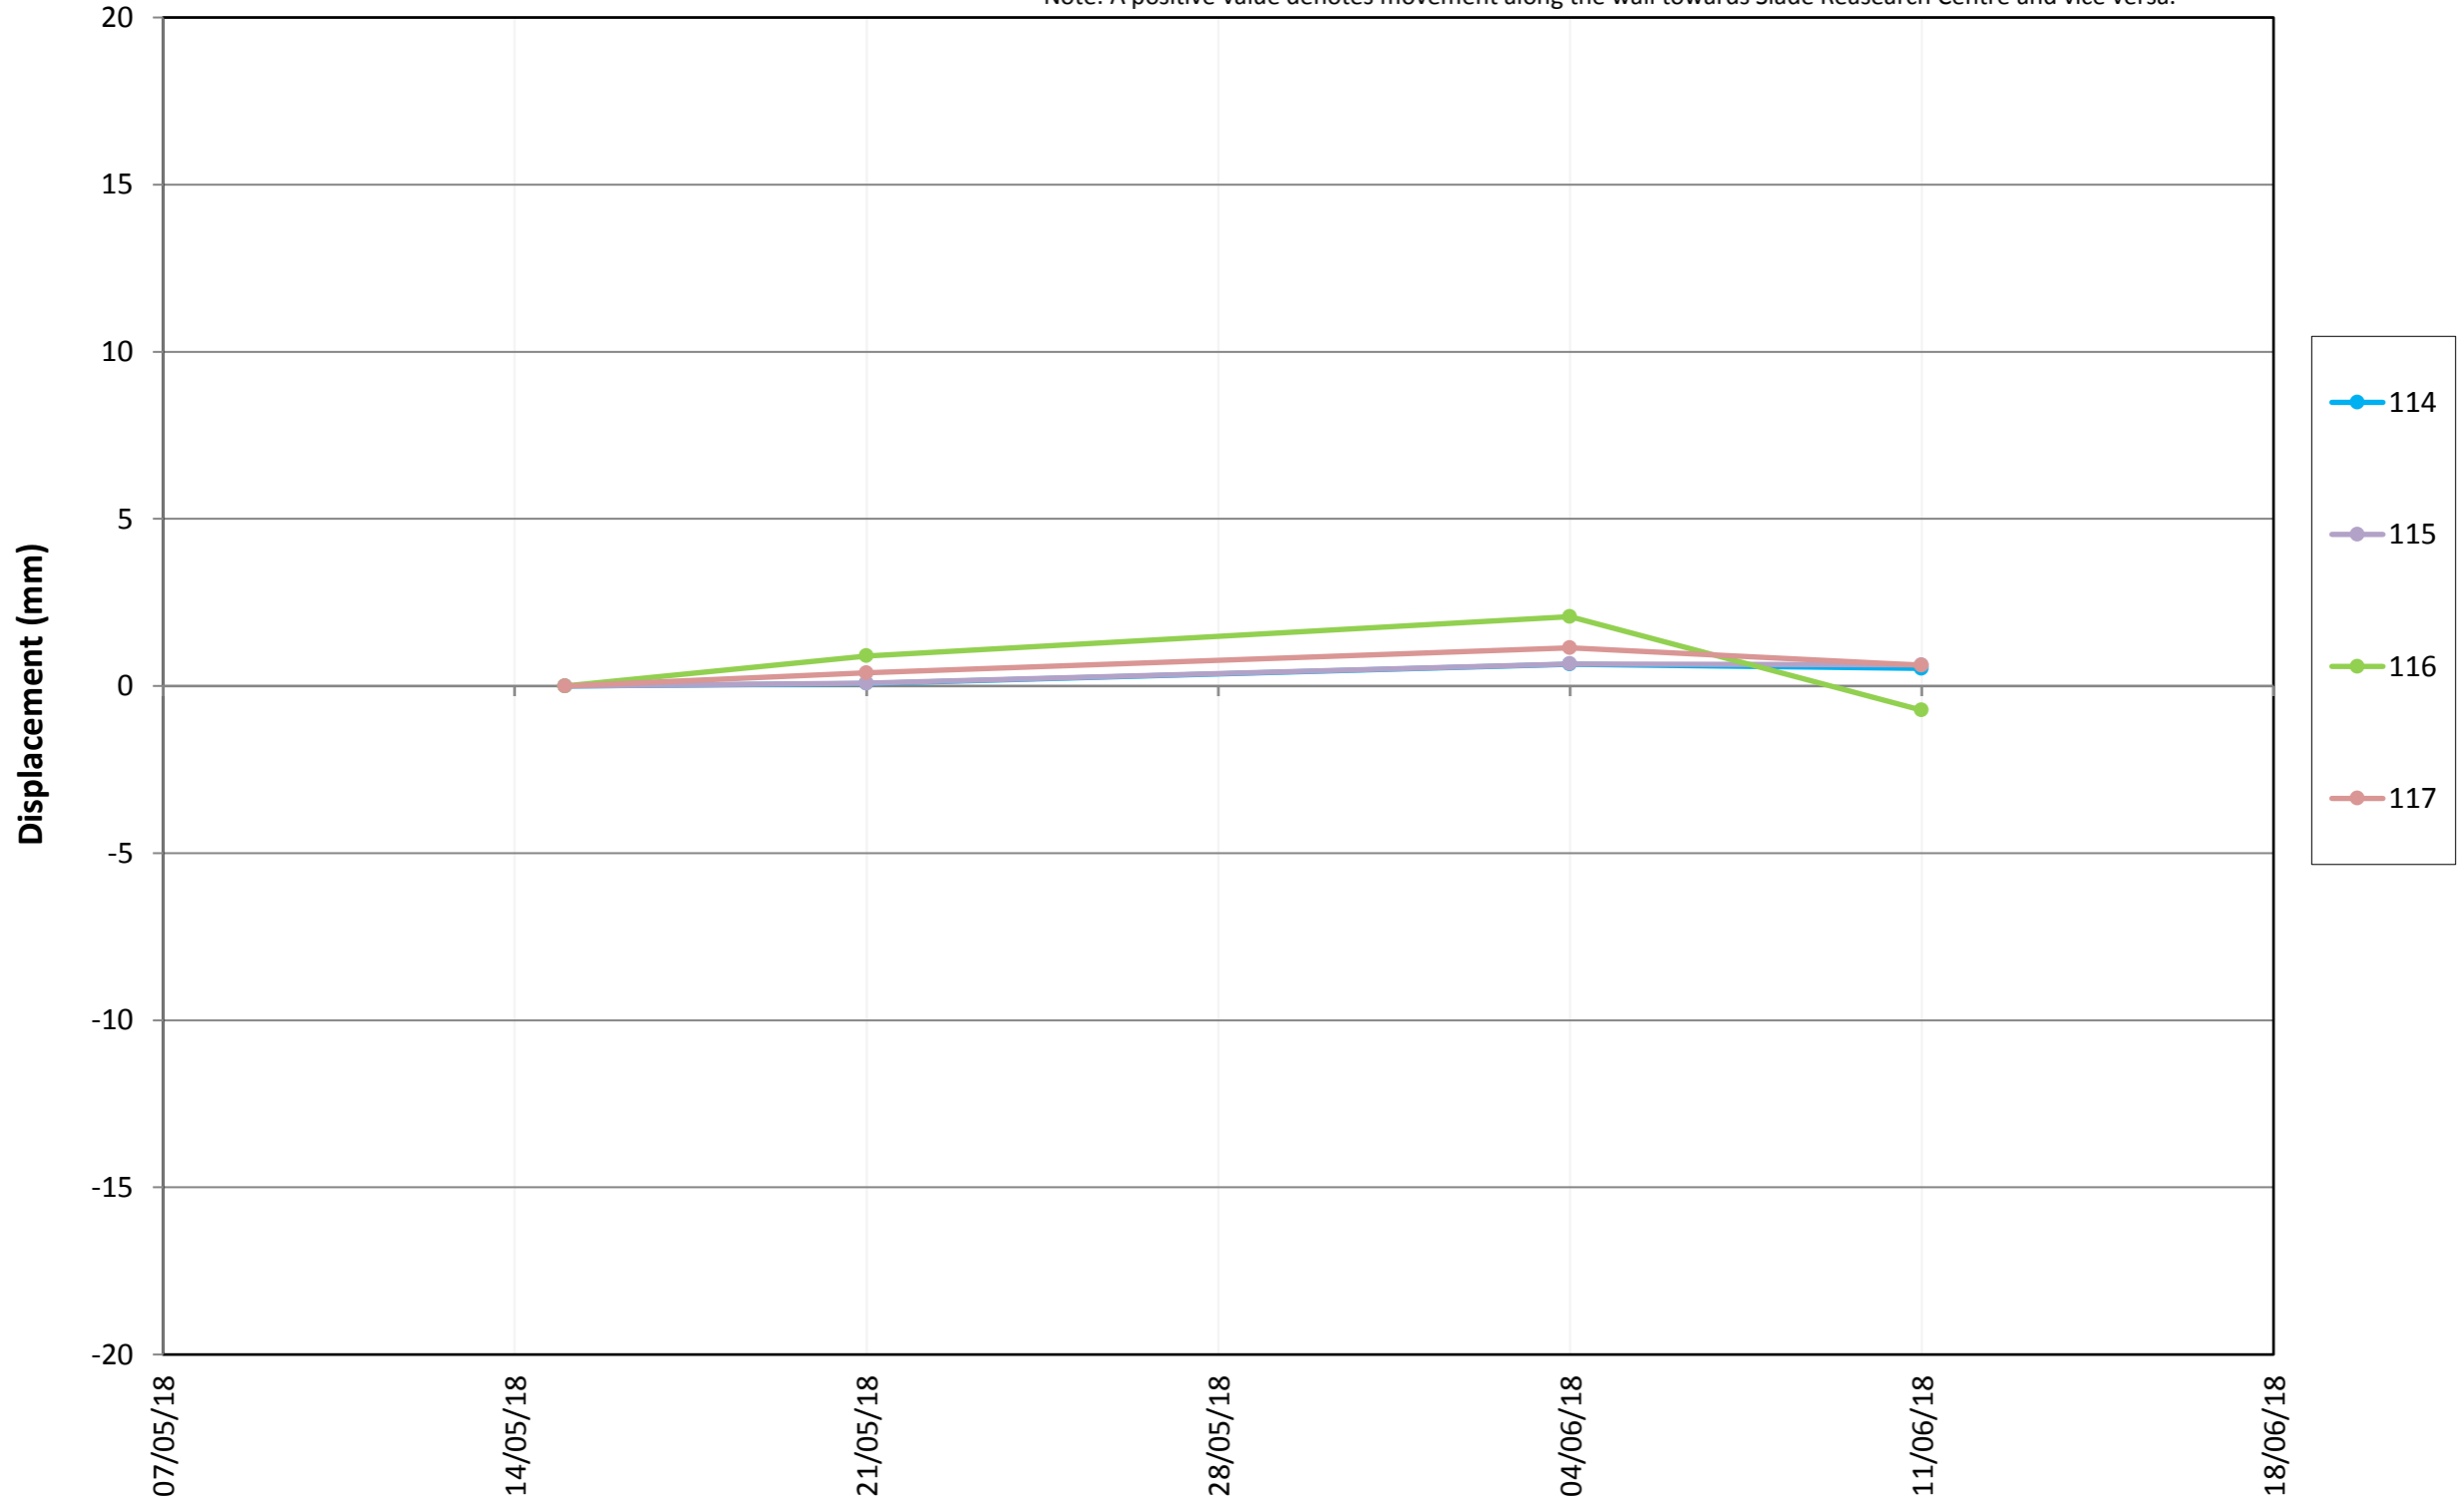
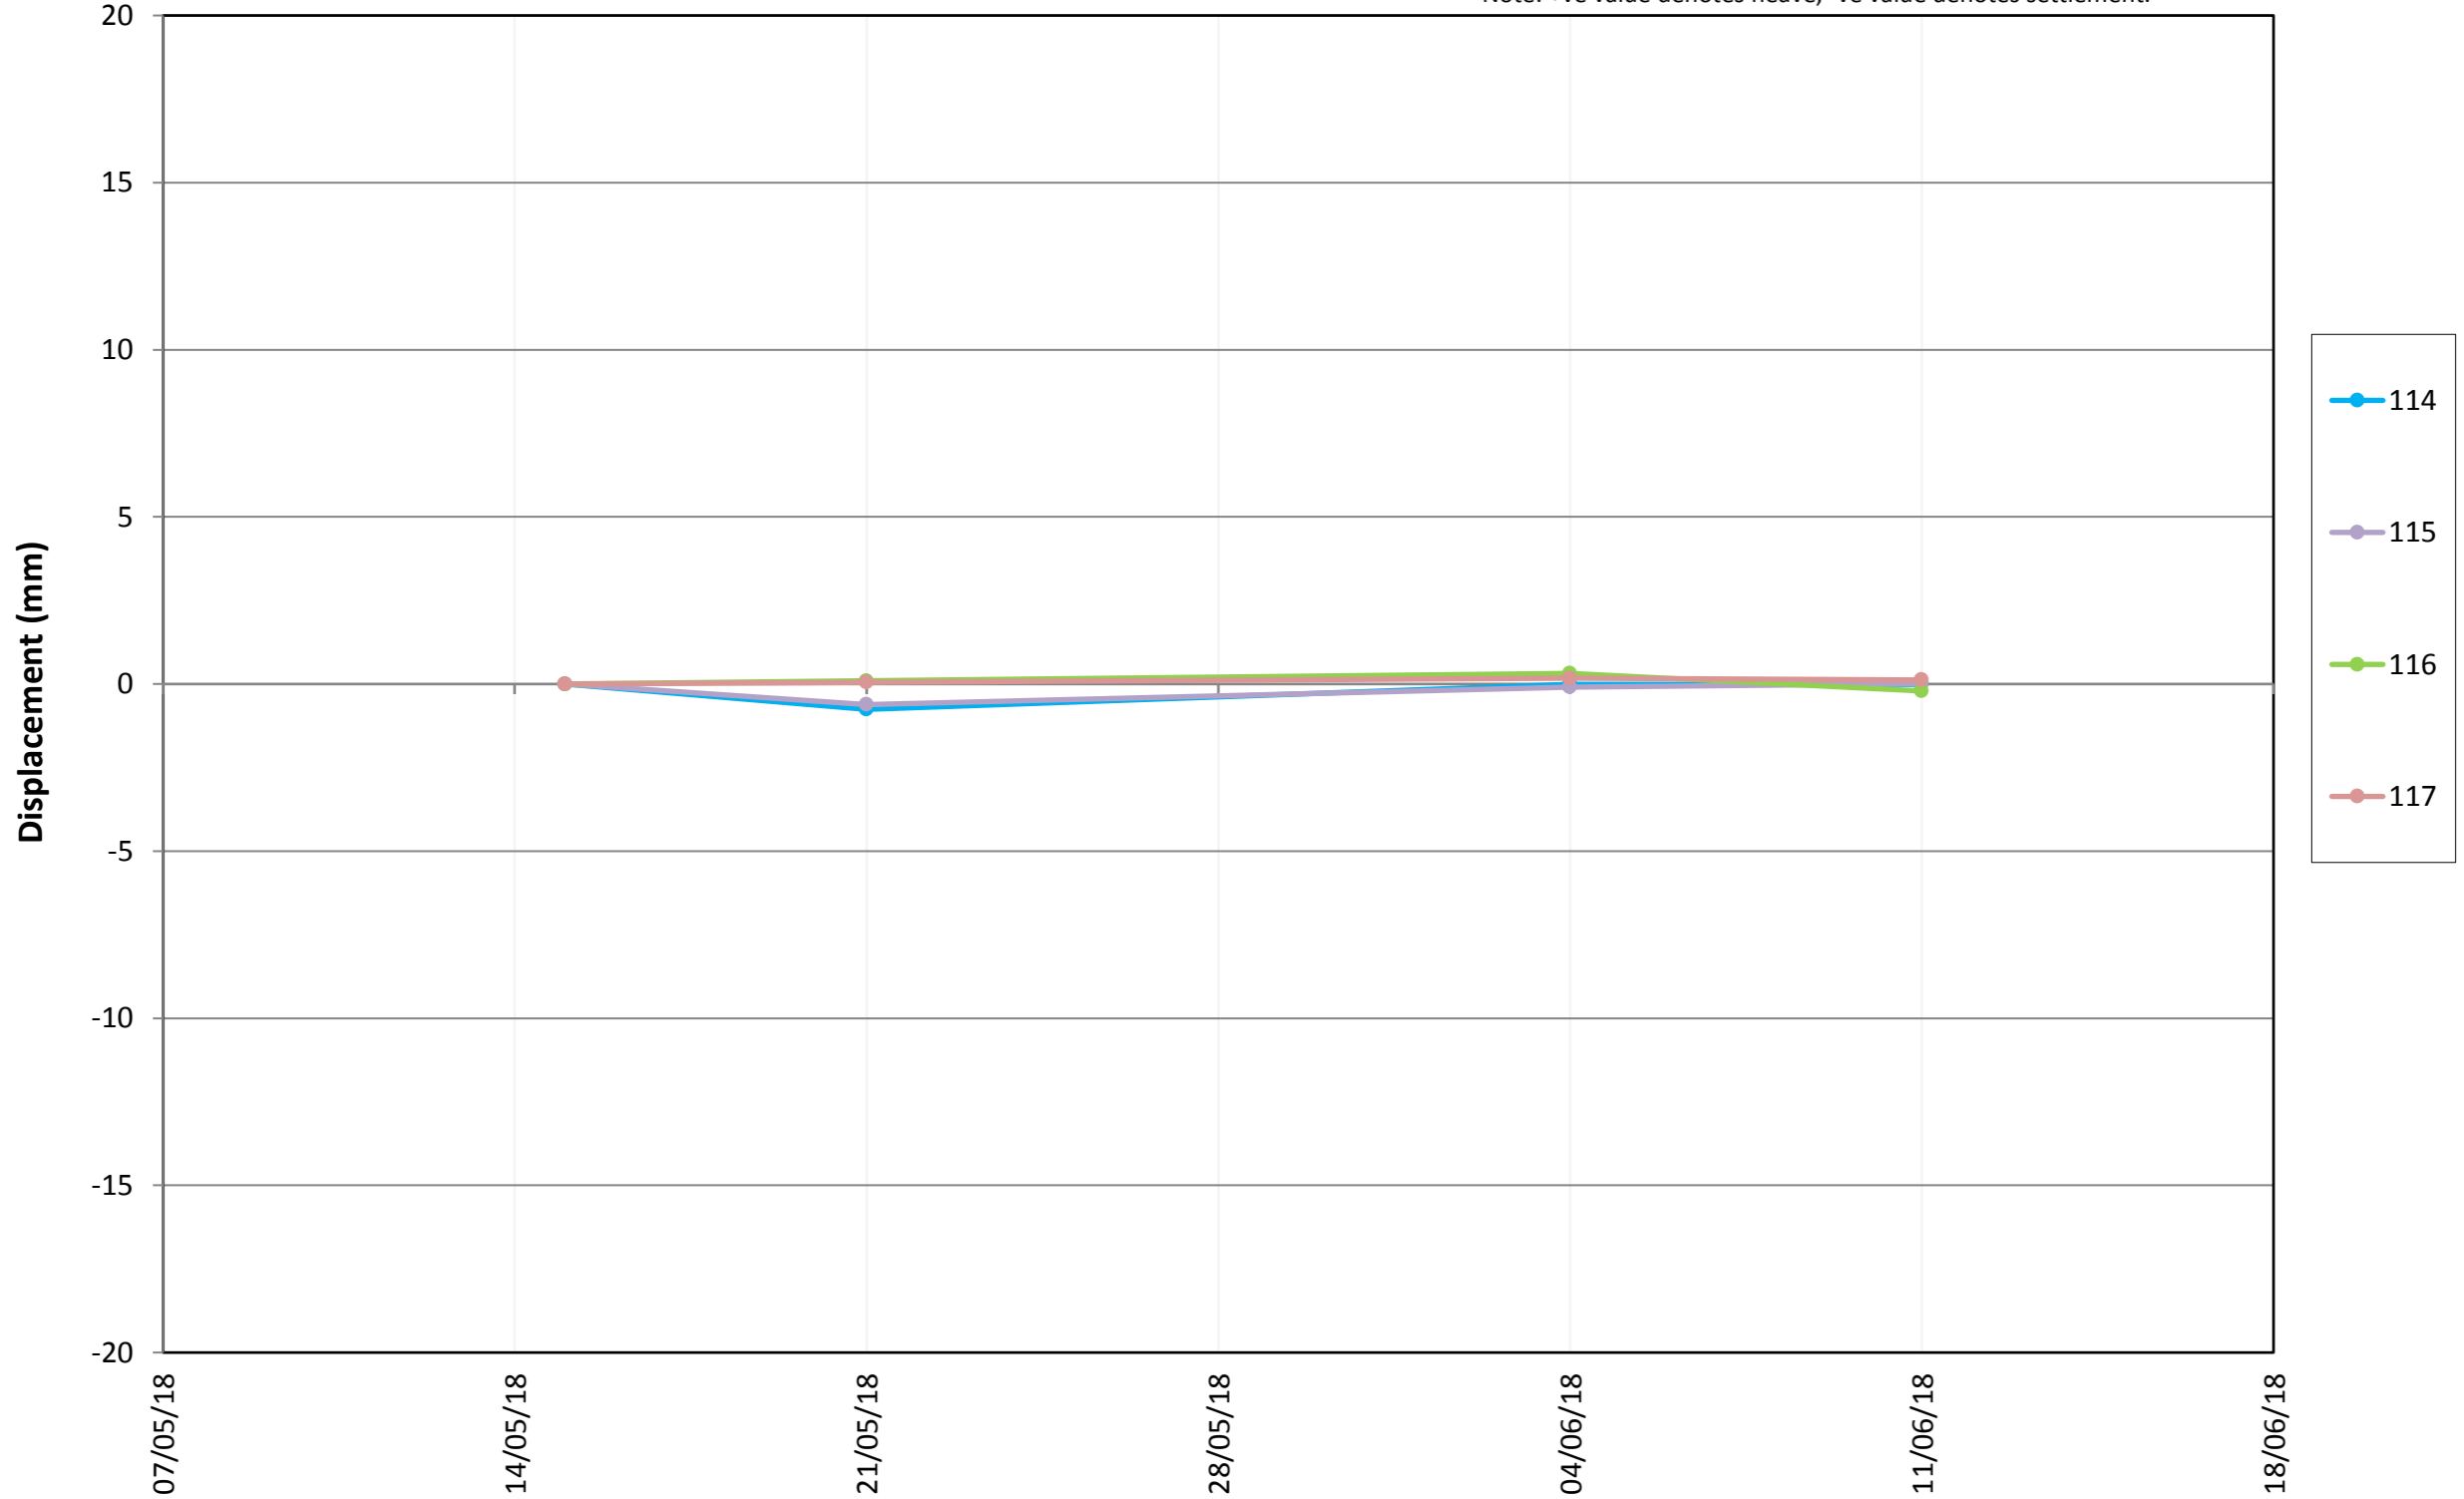
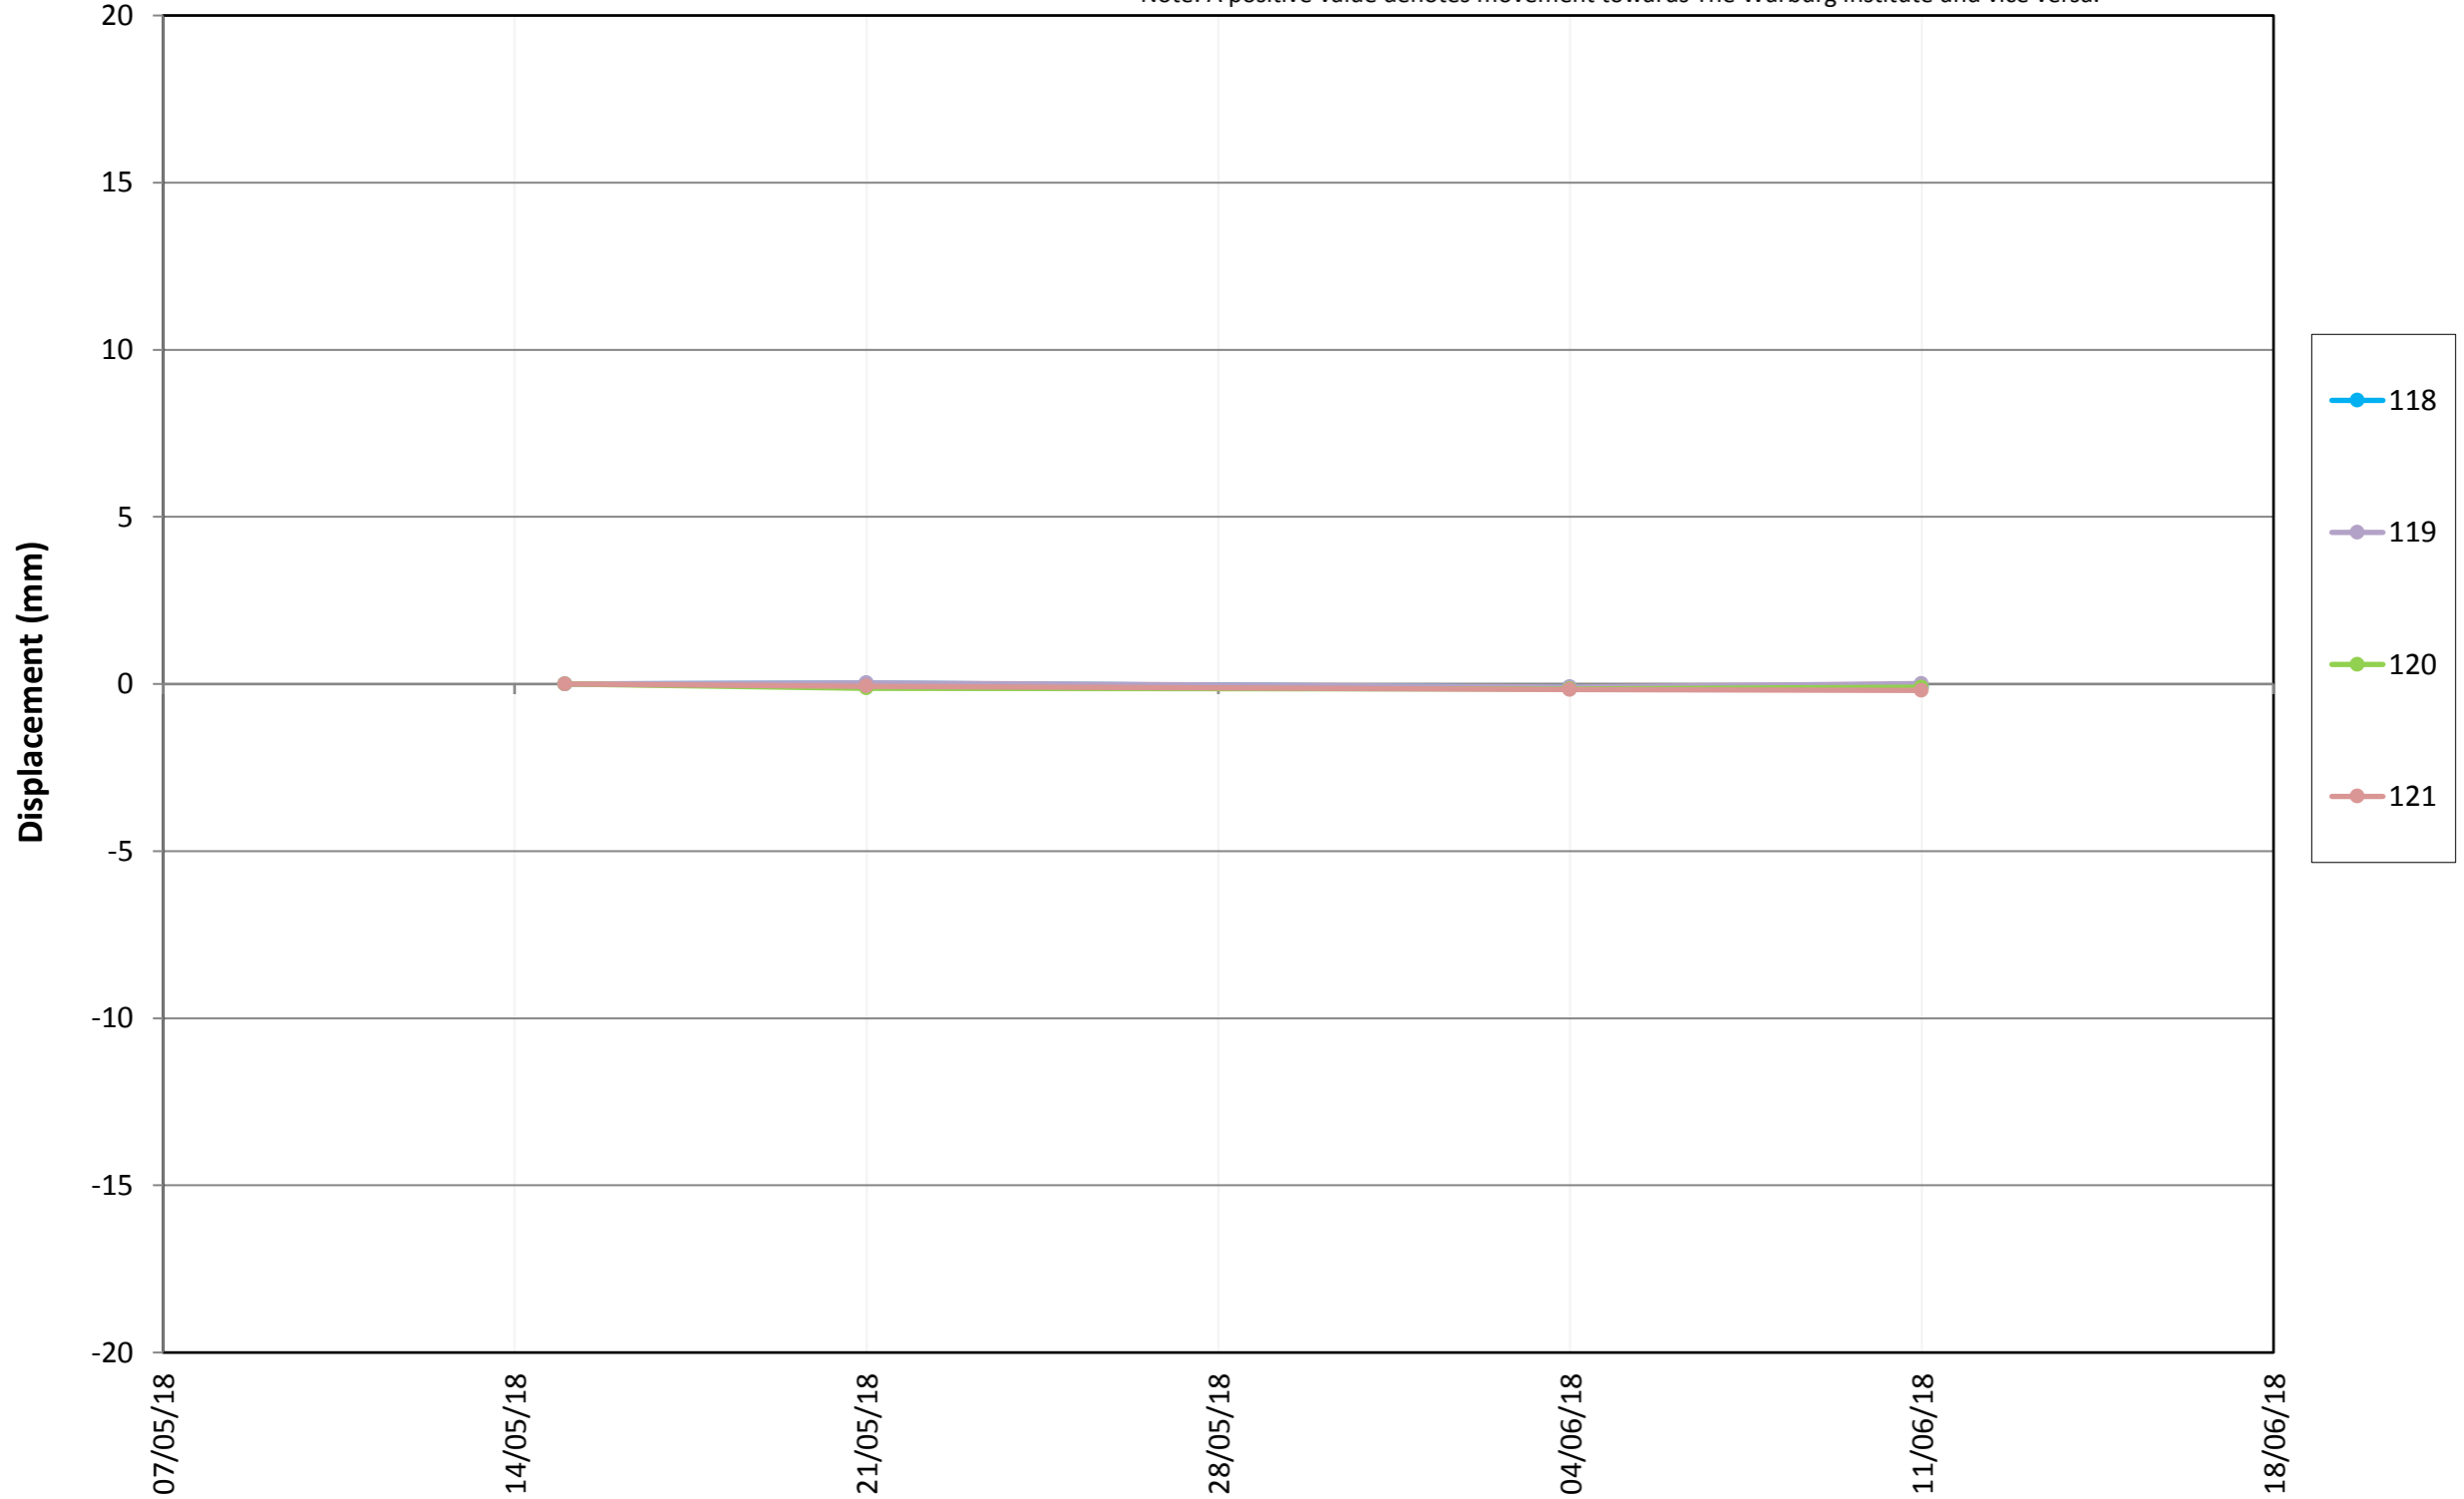
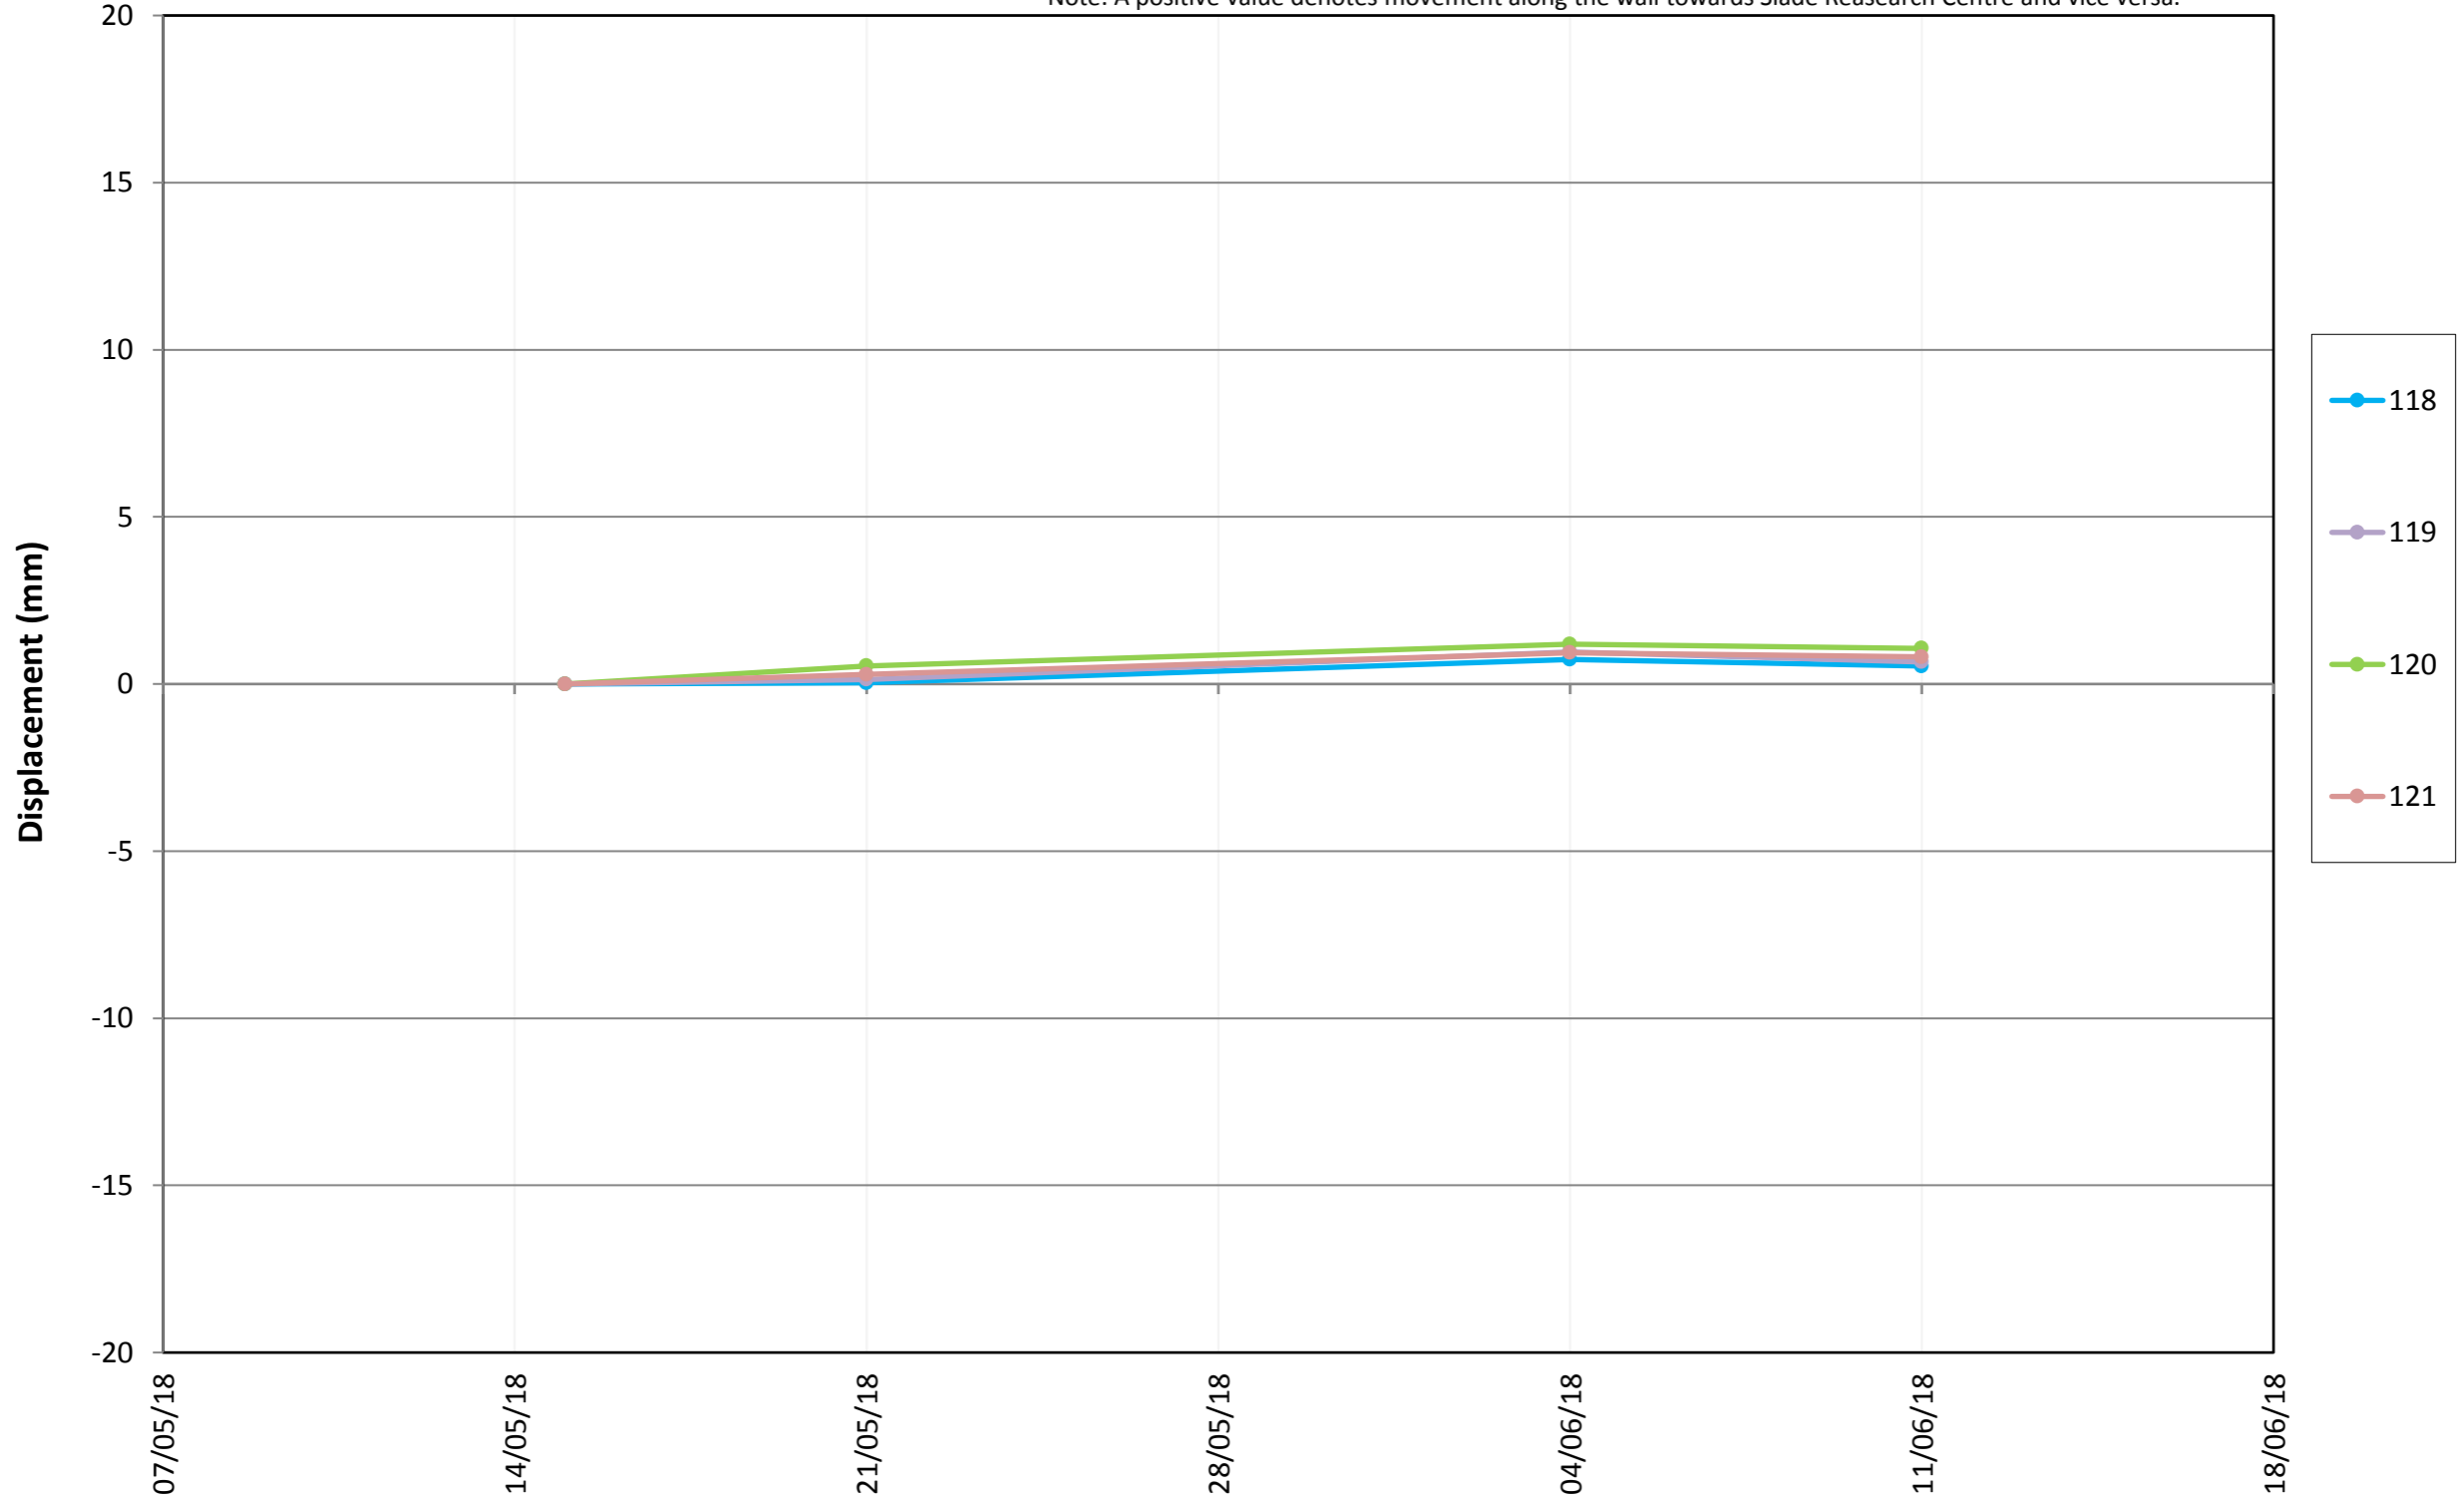
Graph 16T - Targets on Heating Tunnel

Targets on Heating Tunnel

Targets are showing negligible horizontal movement.

Targets are showing negligible vertical movement.

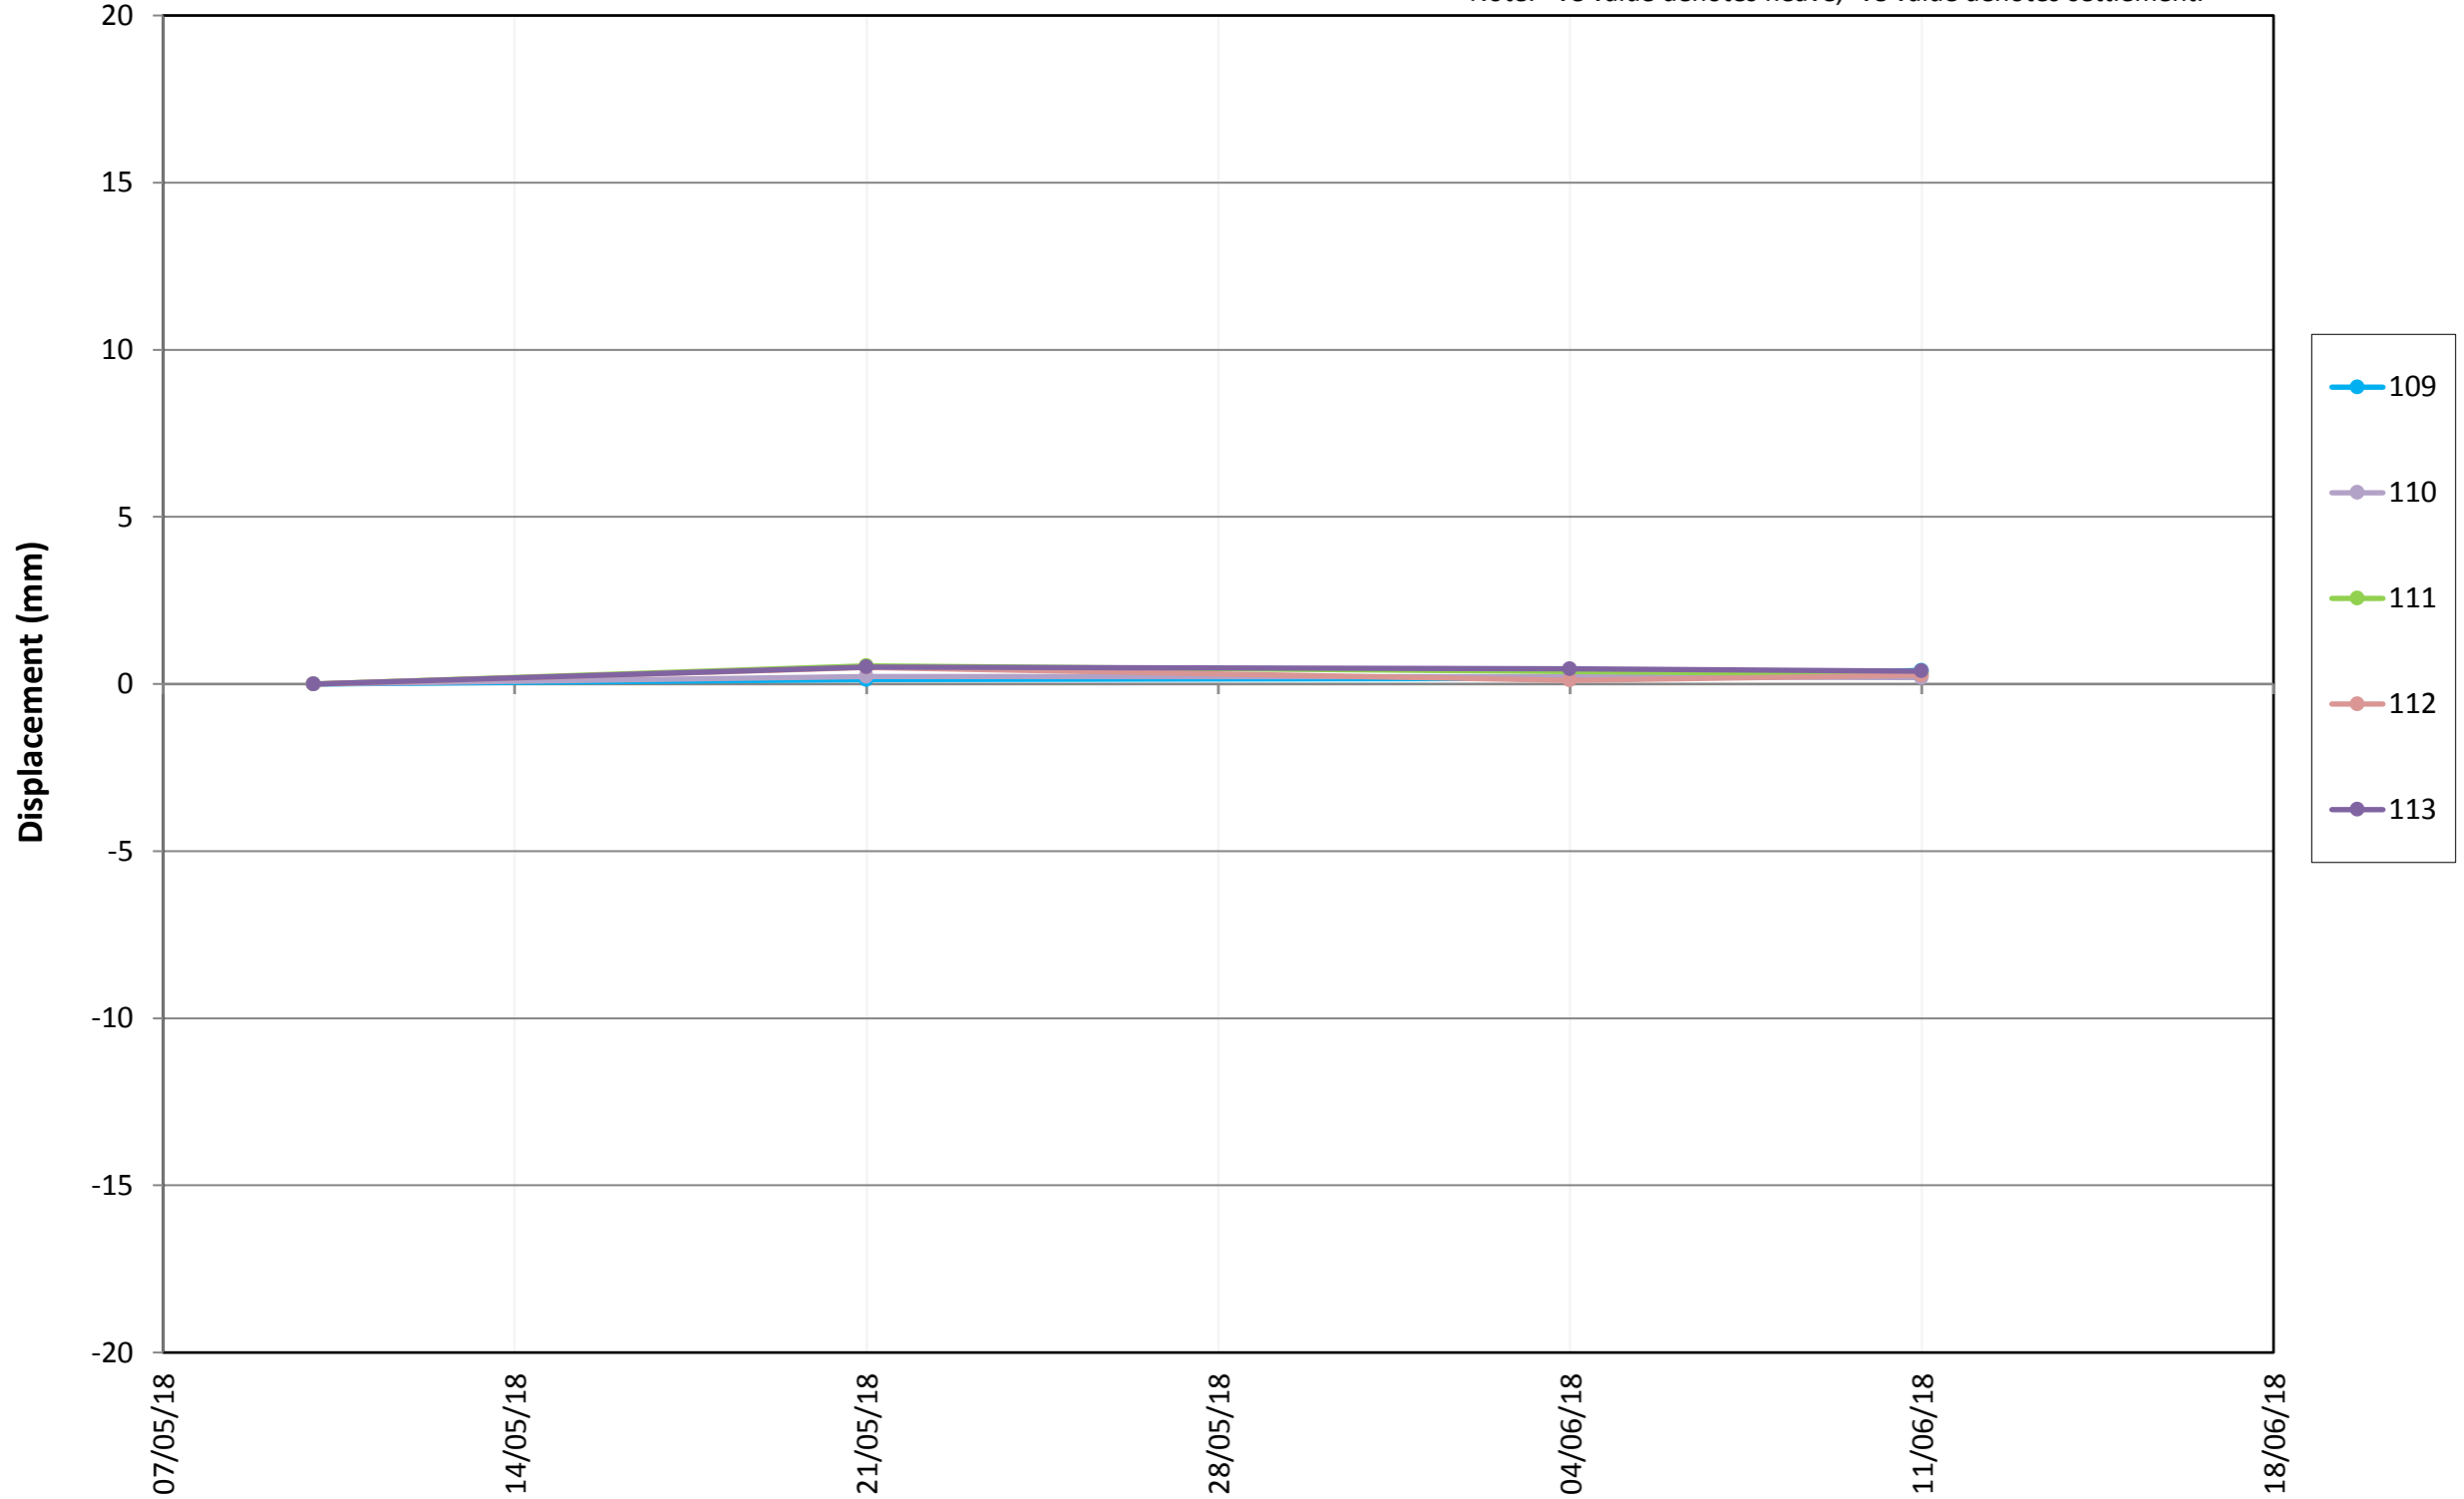
Graph 03 - Precise Level Points along courtyard

Precise Level Points along courtyard

Precise level points are showing negligible movement.

Precise level 111 point was found disturbed by digger.
