32-33 TORRINGTON SQUARE
MONITORING

Monitoring Report
SES-10215-MR03

Date of survey completion: 11th June 2018

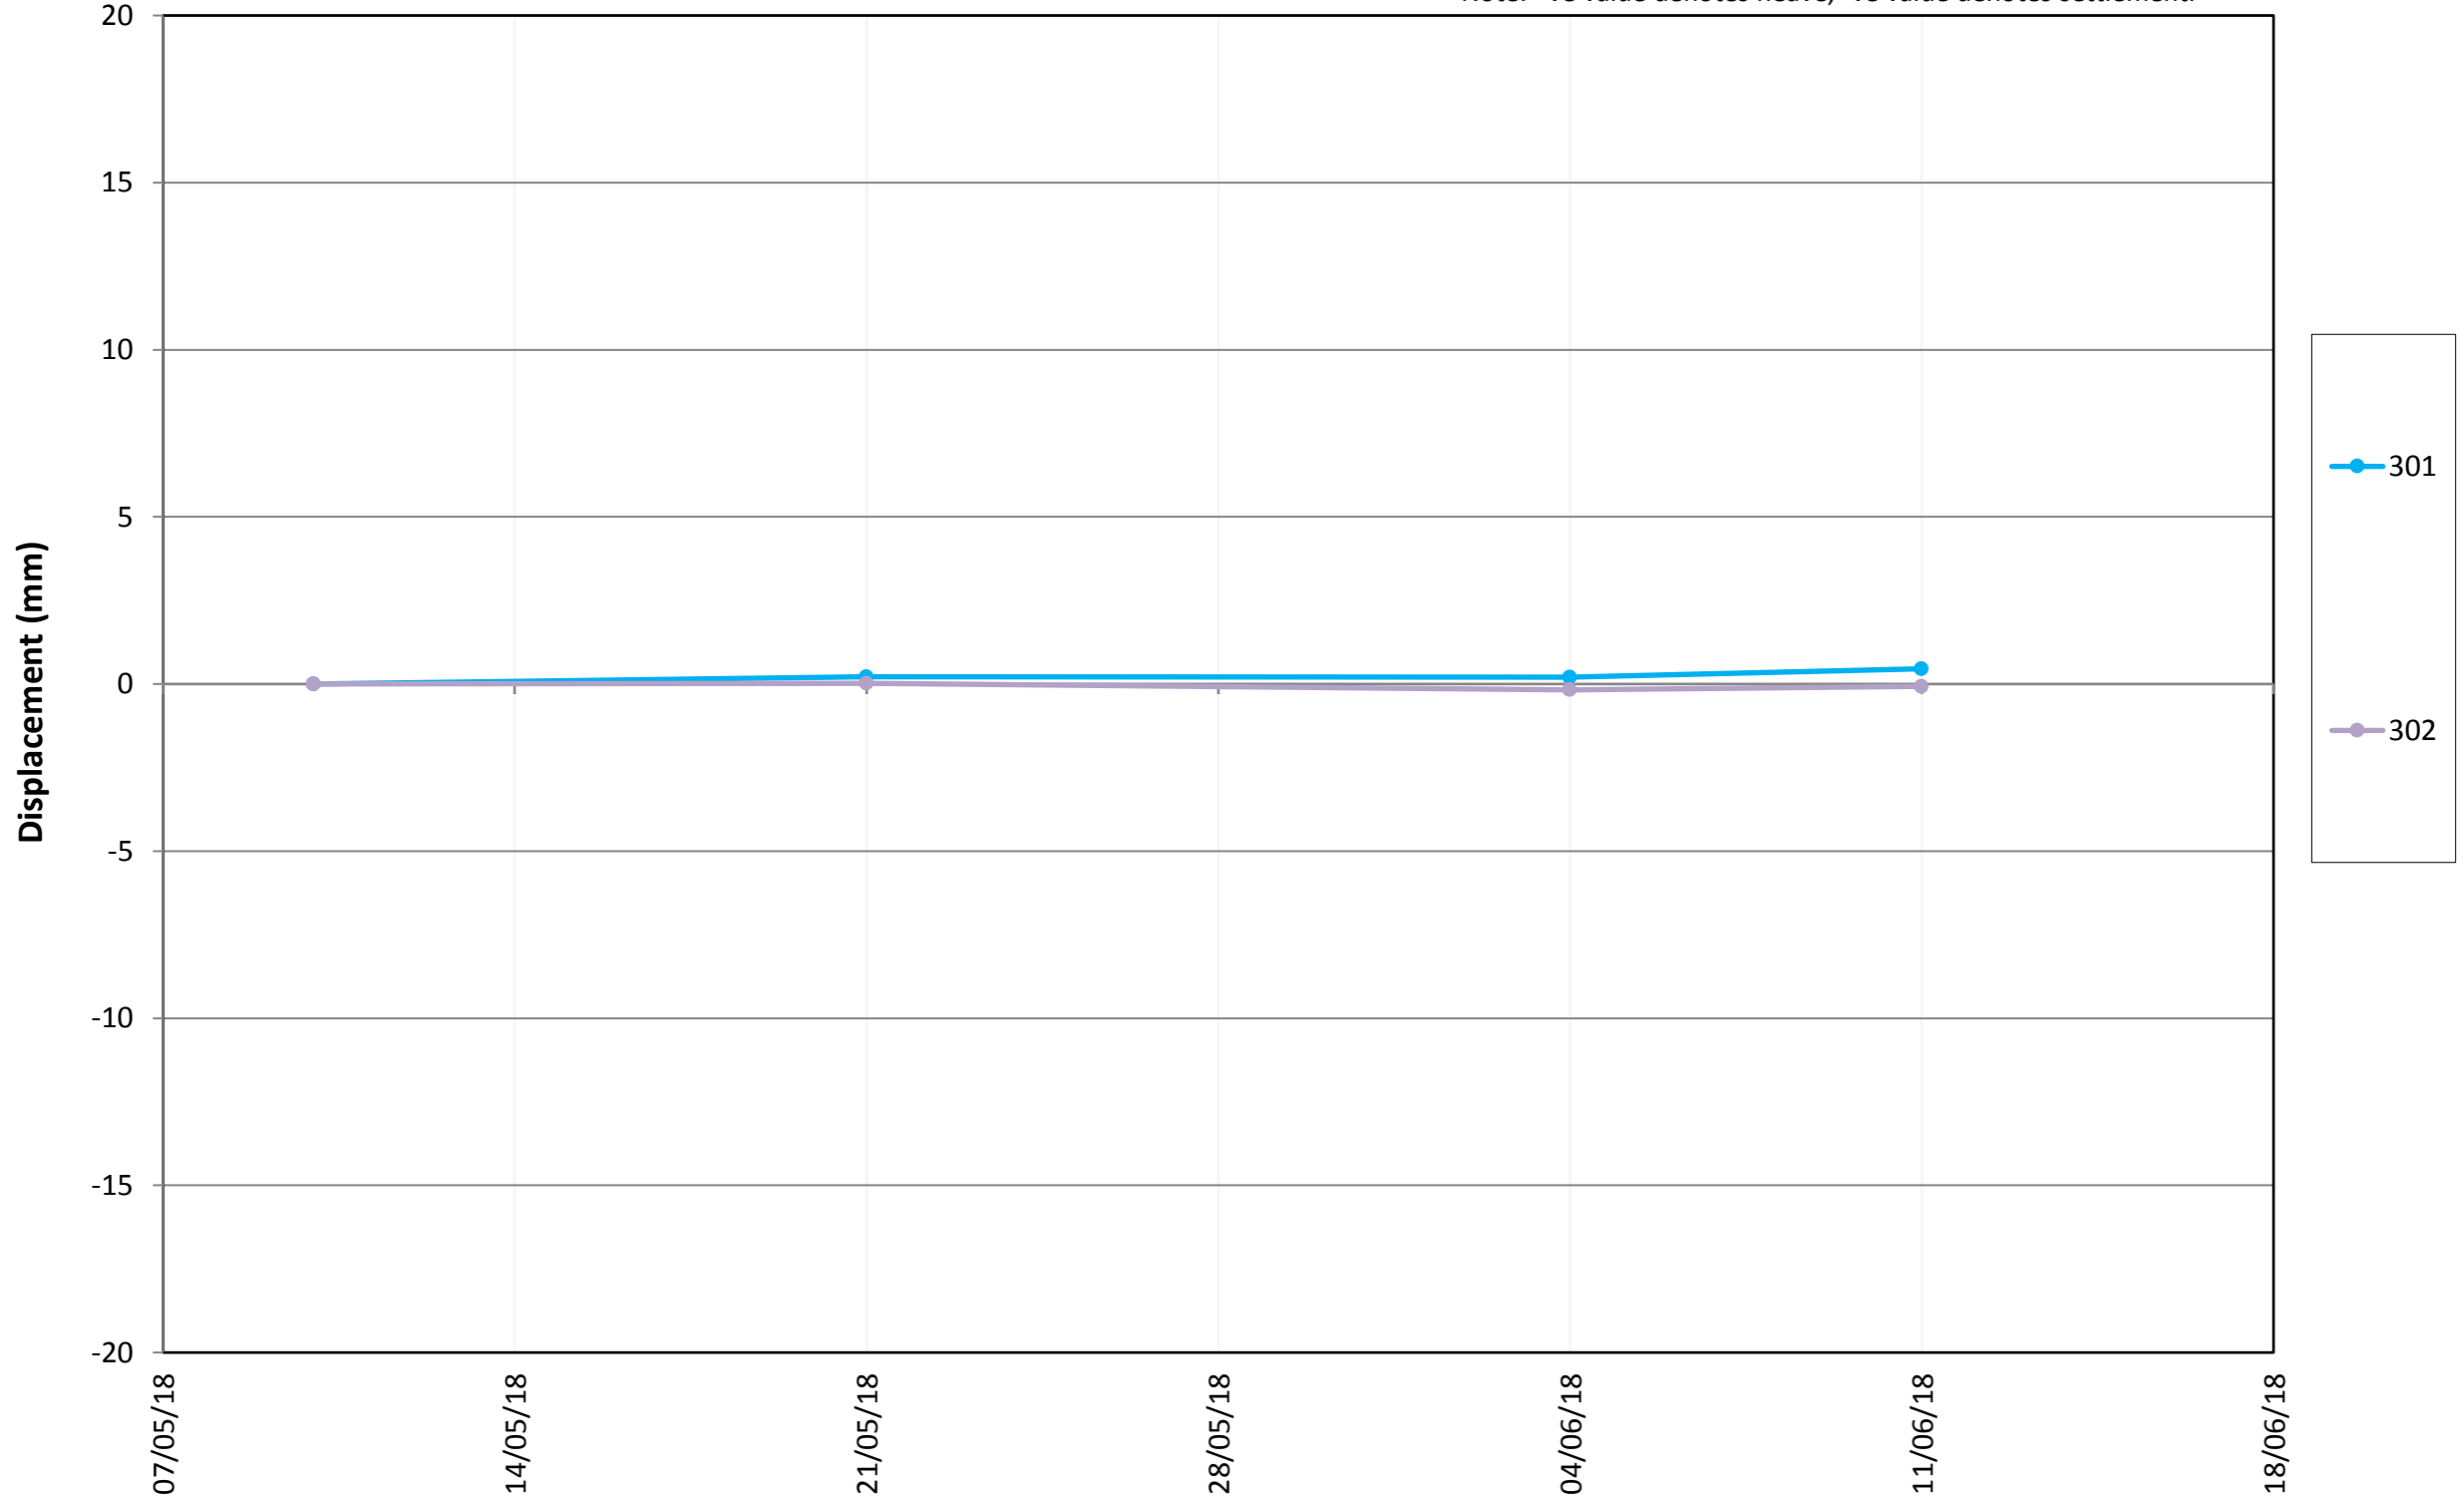
Graph 04 - Precise Level Points on Front Elevation of The Warburg Institute

Precise Level Points on Front Elevation of The Warburg Institute

Precise level points are showing negligible movement.

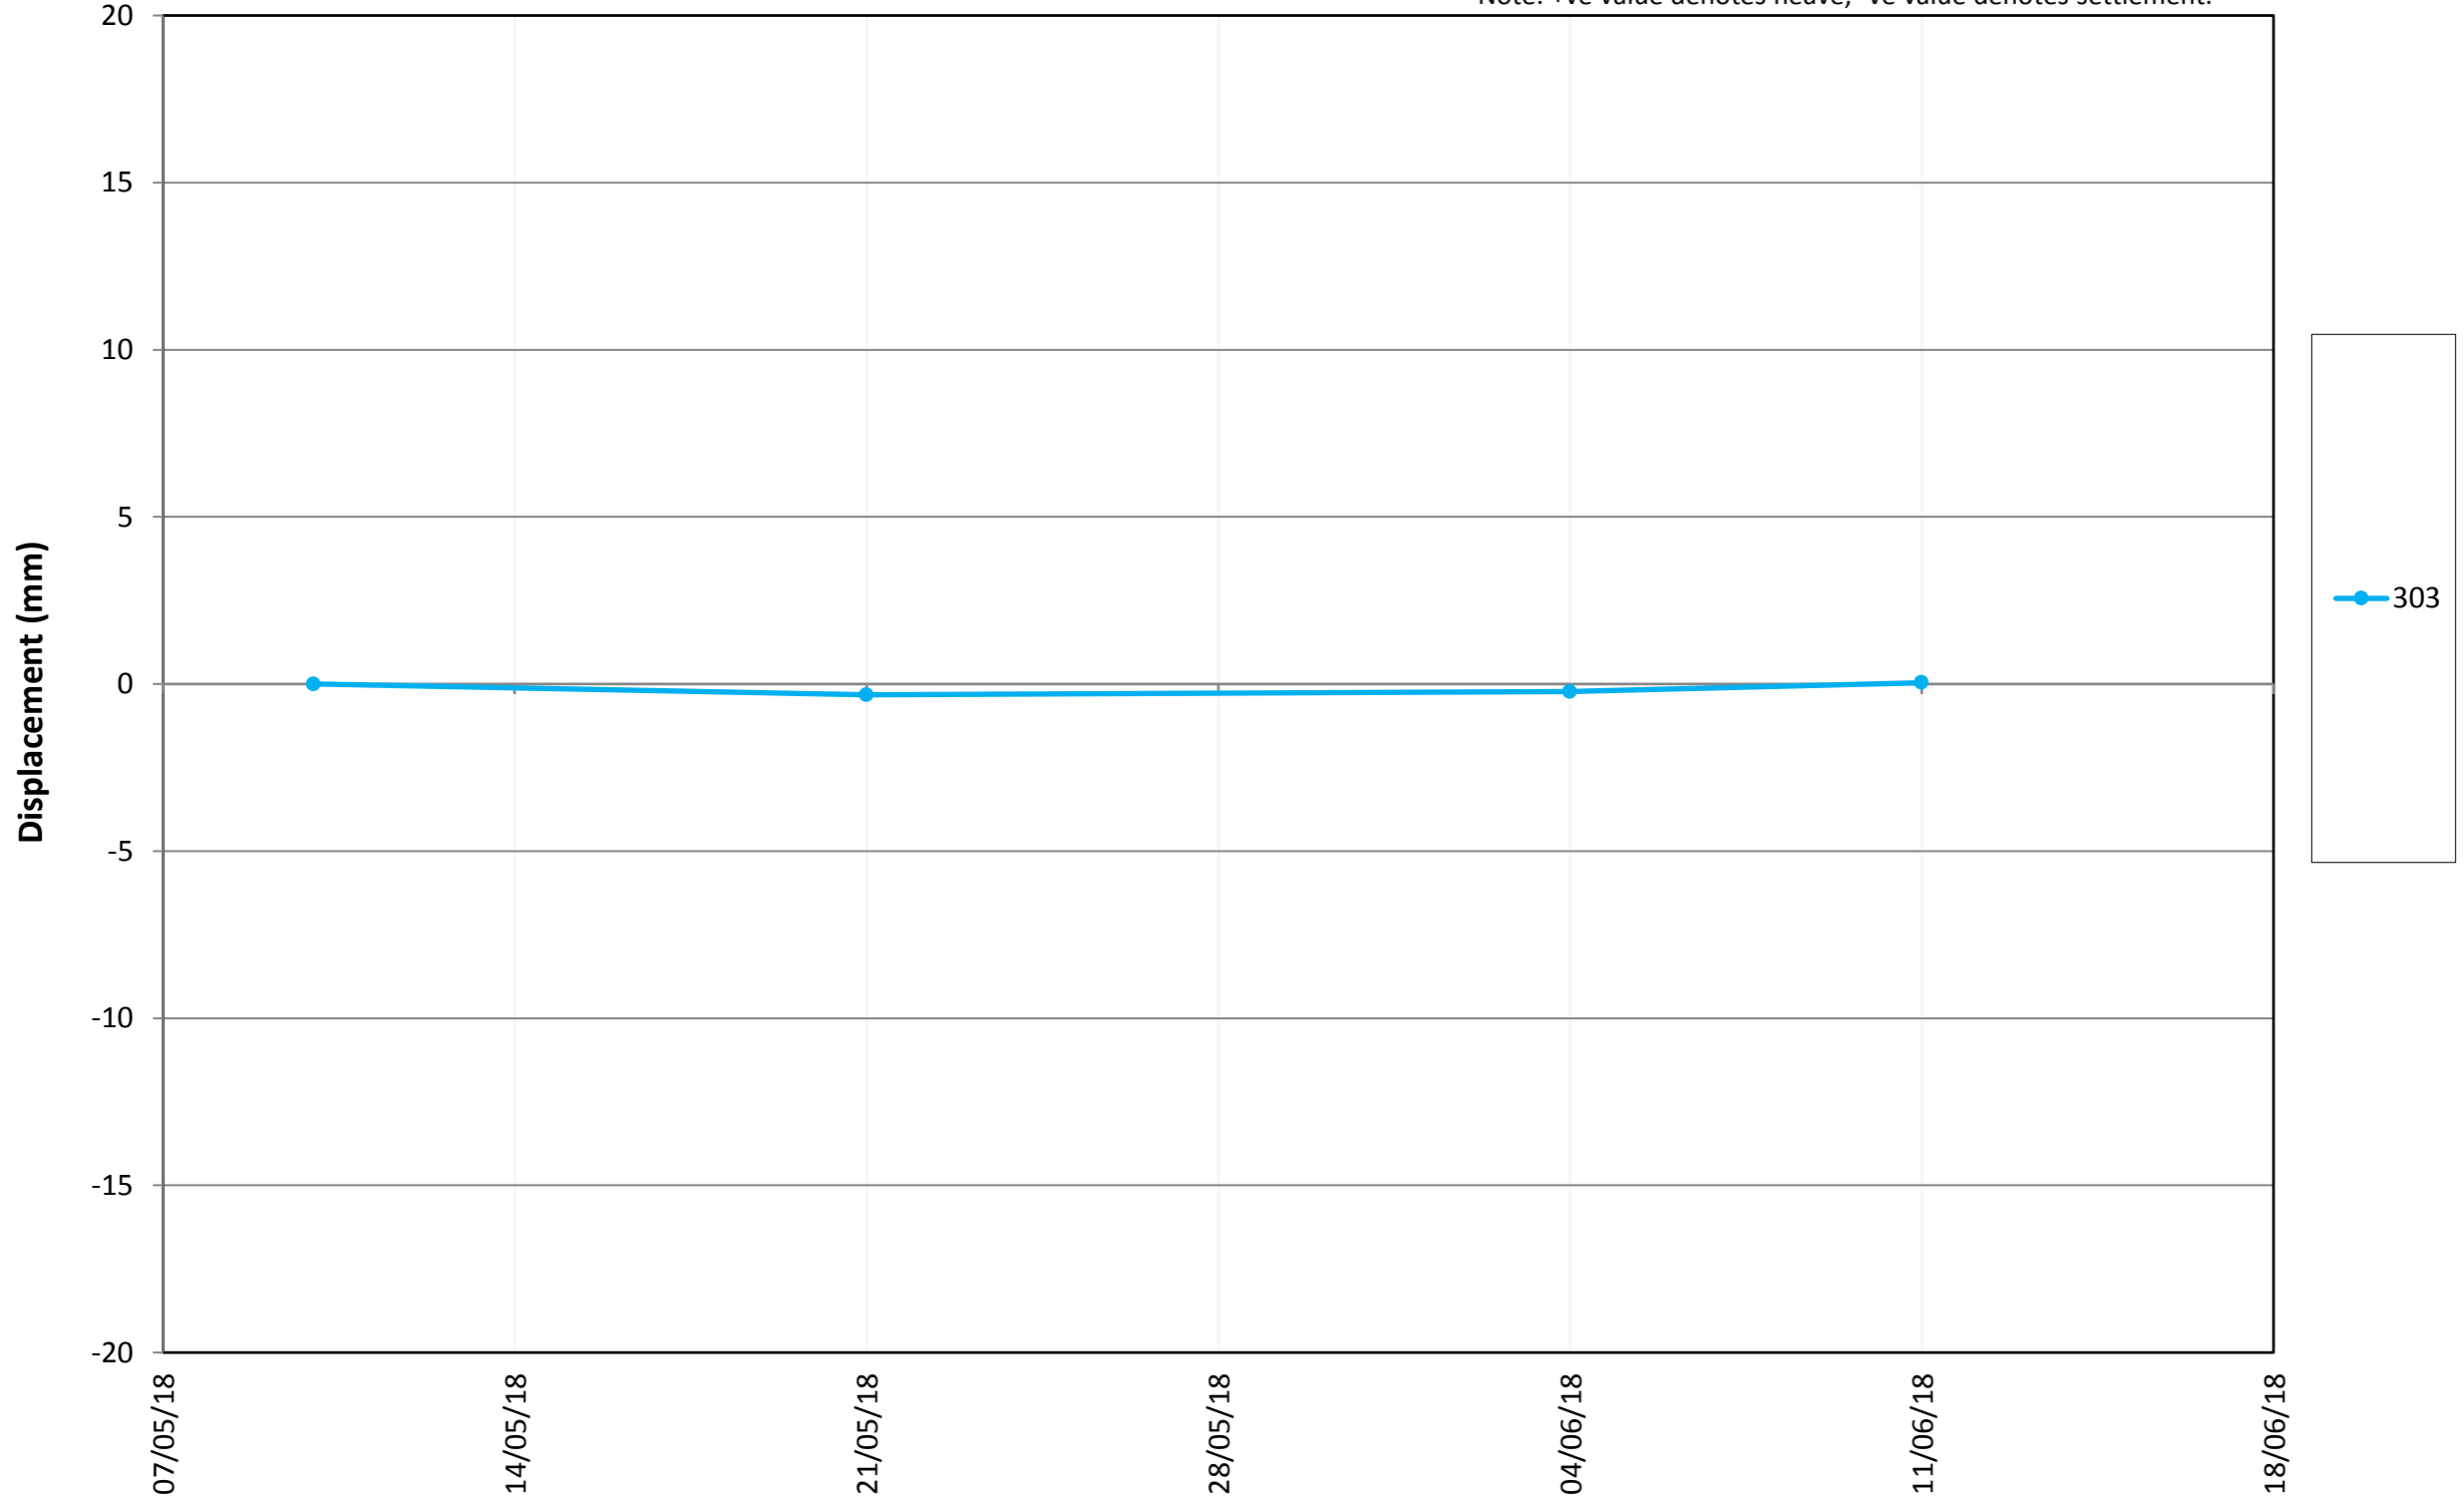
Graph 05 - Precise Level Points on Side Elevation of The Warburg Institute

Precise Level Points on Side Elevation of The Warburg Institute

Precise level points are showing negligible movement.

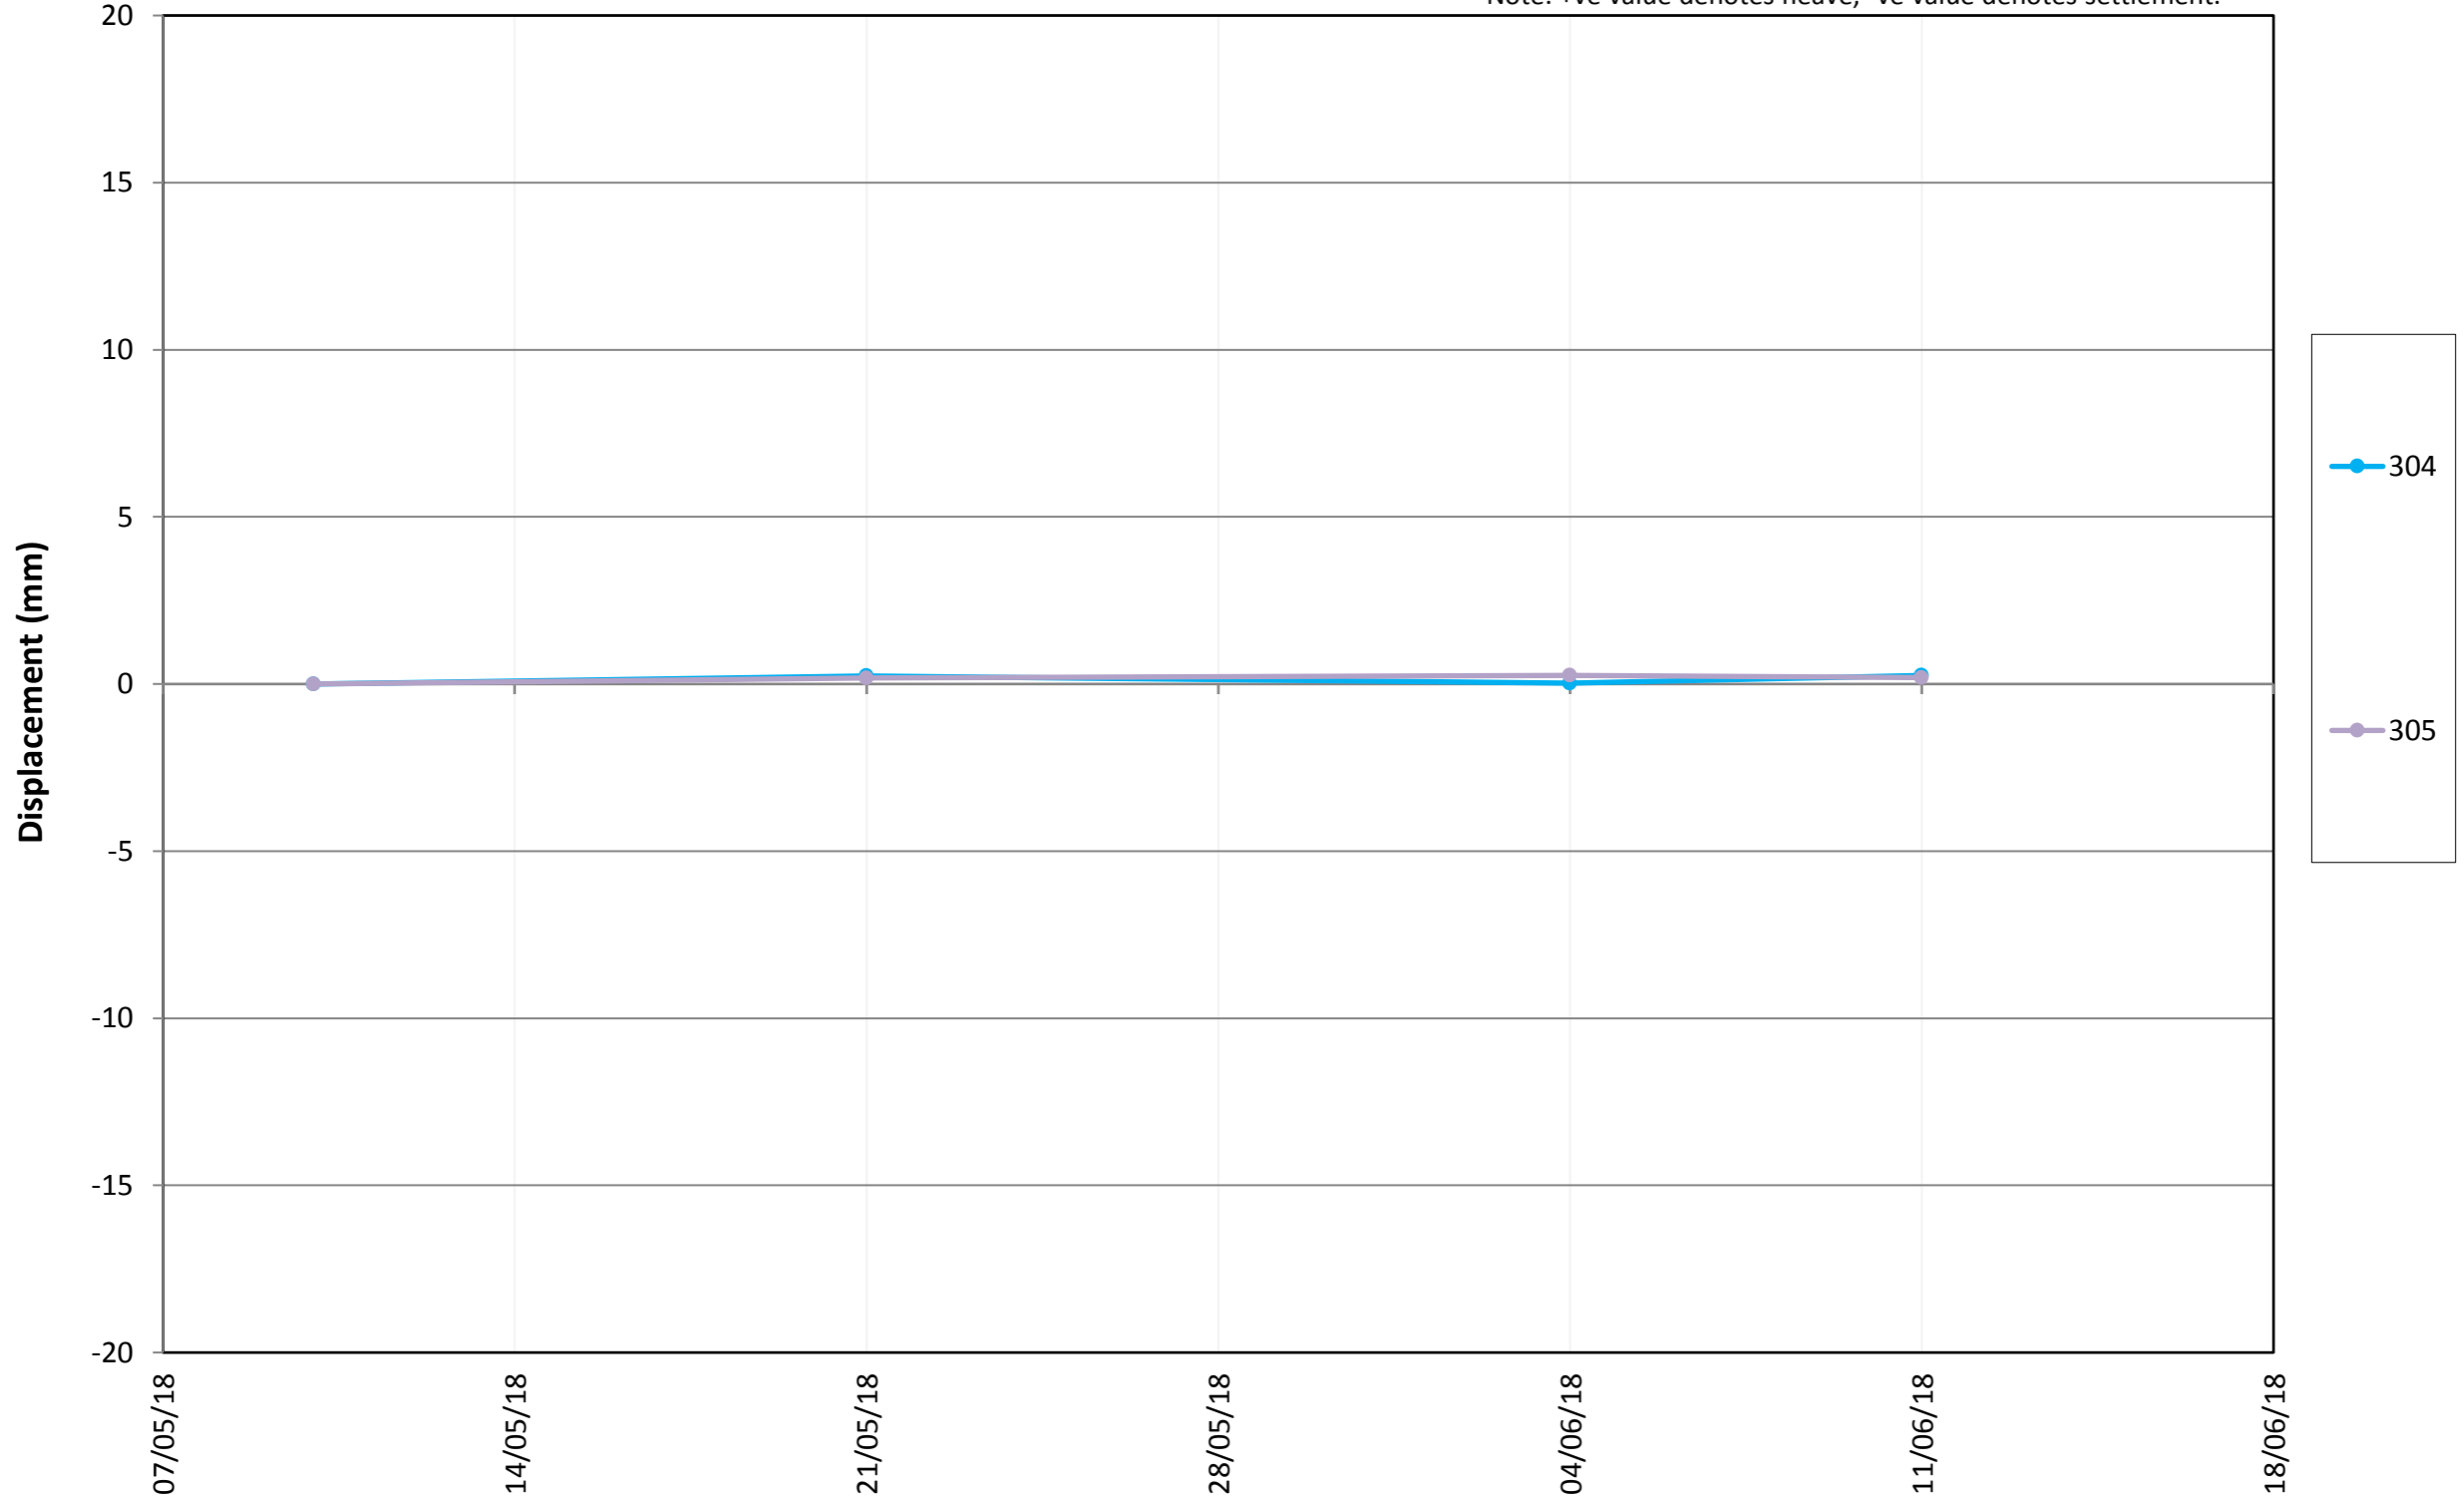
Graph 06 - Precise Level Points on Rear Elevation of The Warburg Institute

Precise Level Points on Rear Elevation of The Warburg Institute

Precise level points are showing negligible movement.

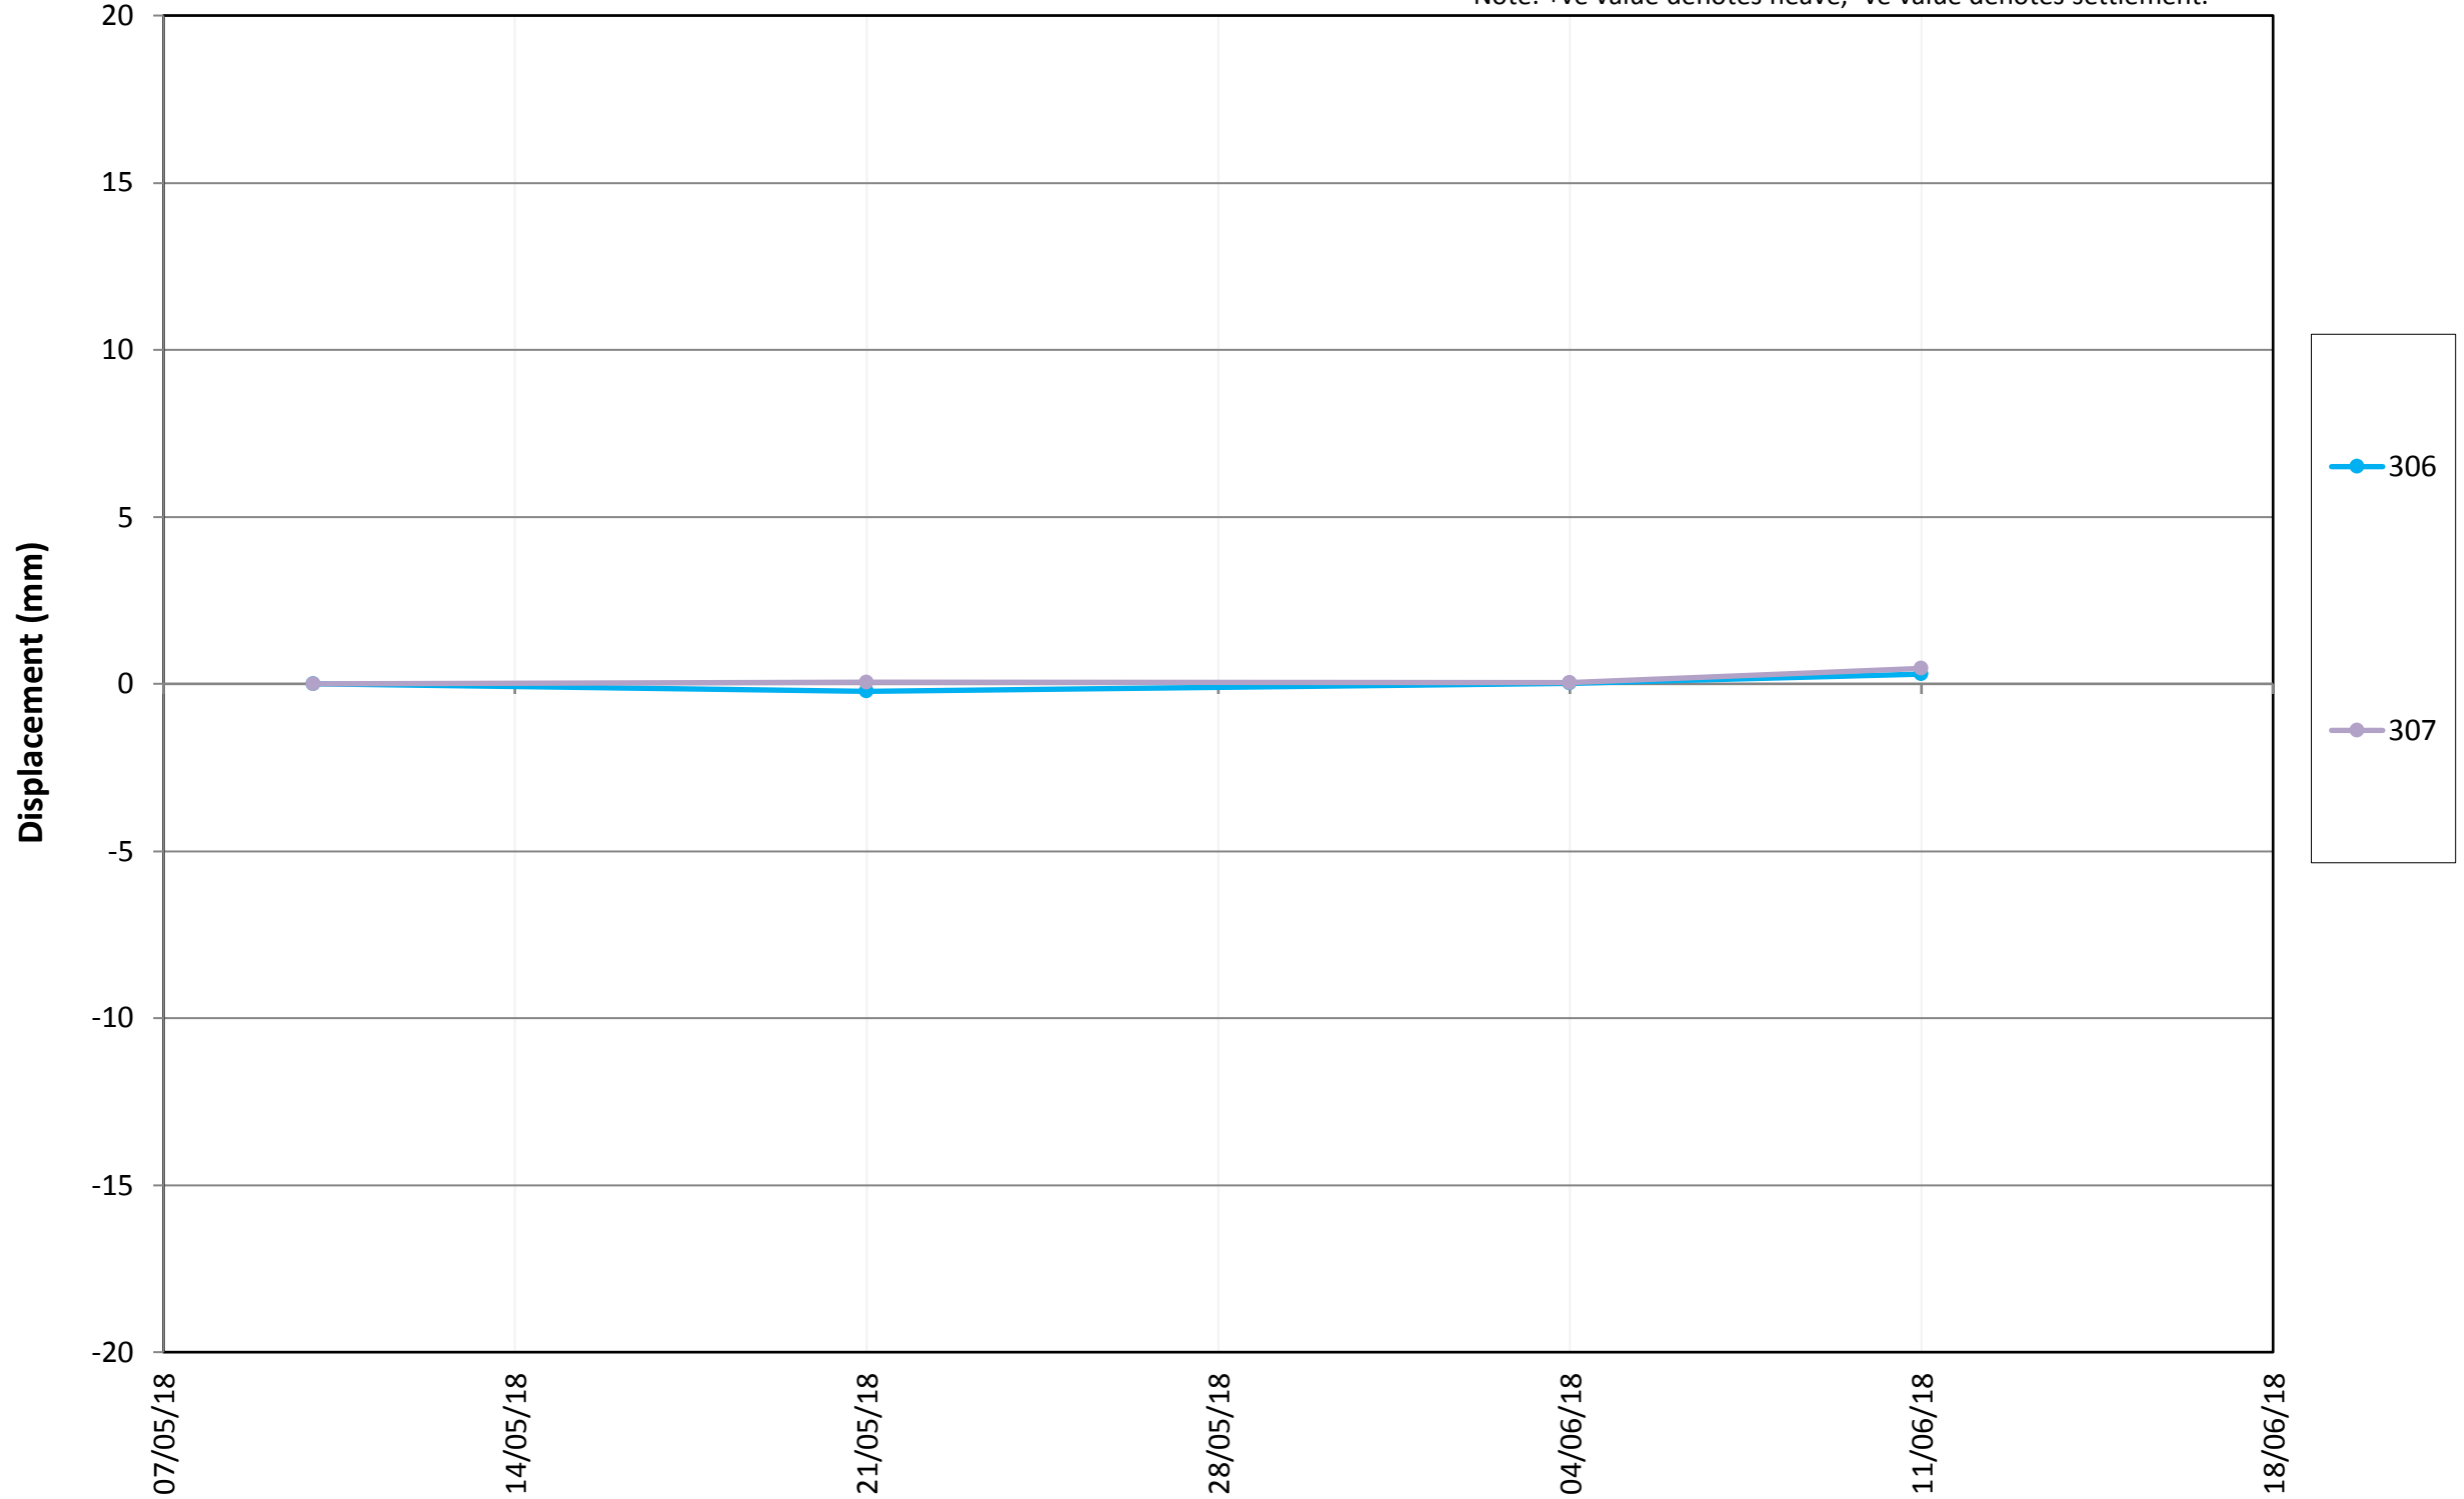
Graph 07 - Precise Level Points on Side Elevation of No. 32 Torrington Square

Precise Level Points on Side Elevation of No. 32 Torrington Square

Precise level points are showing negligible movement.

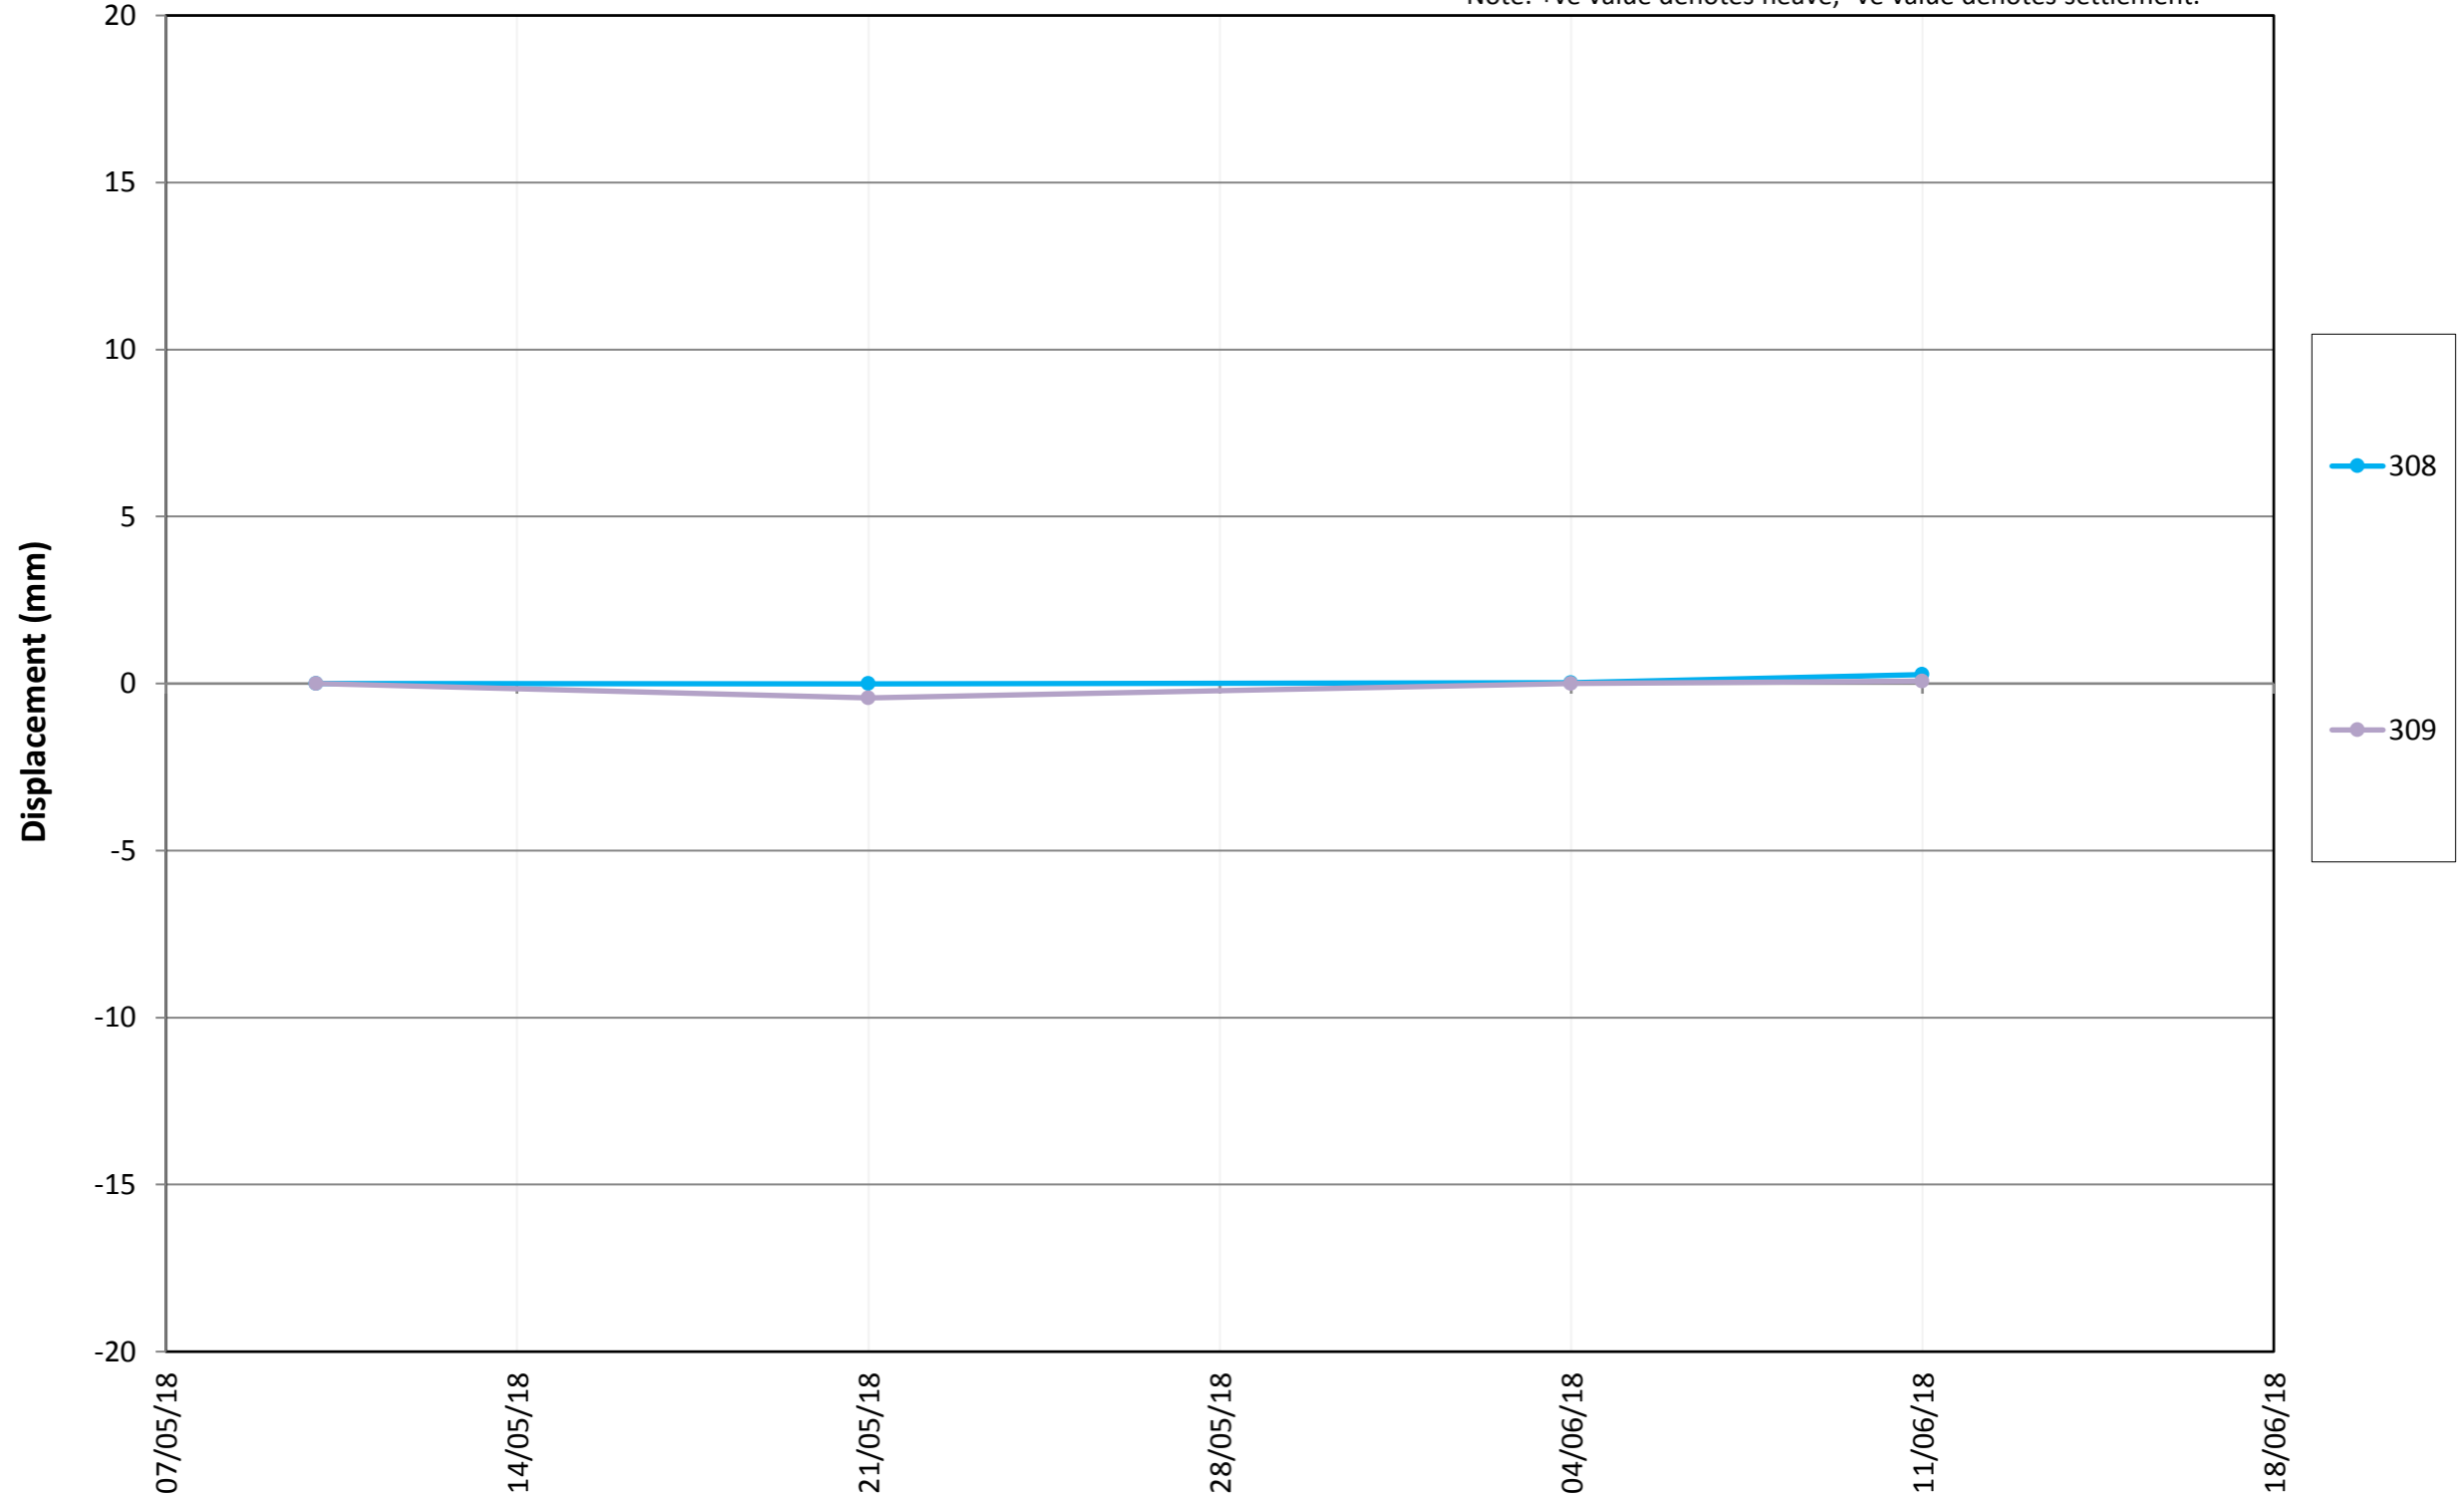
Graph 08 - Precise Level Points on Front Elevation of No. 32 Torrington Square

Precise Level Points on Front Elevation of No. 32 Torrington Square

Precise level points are showing negligible movement.

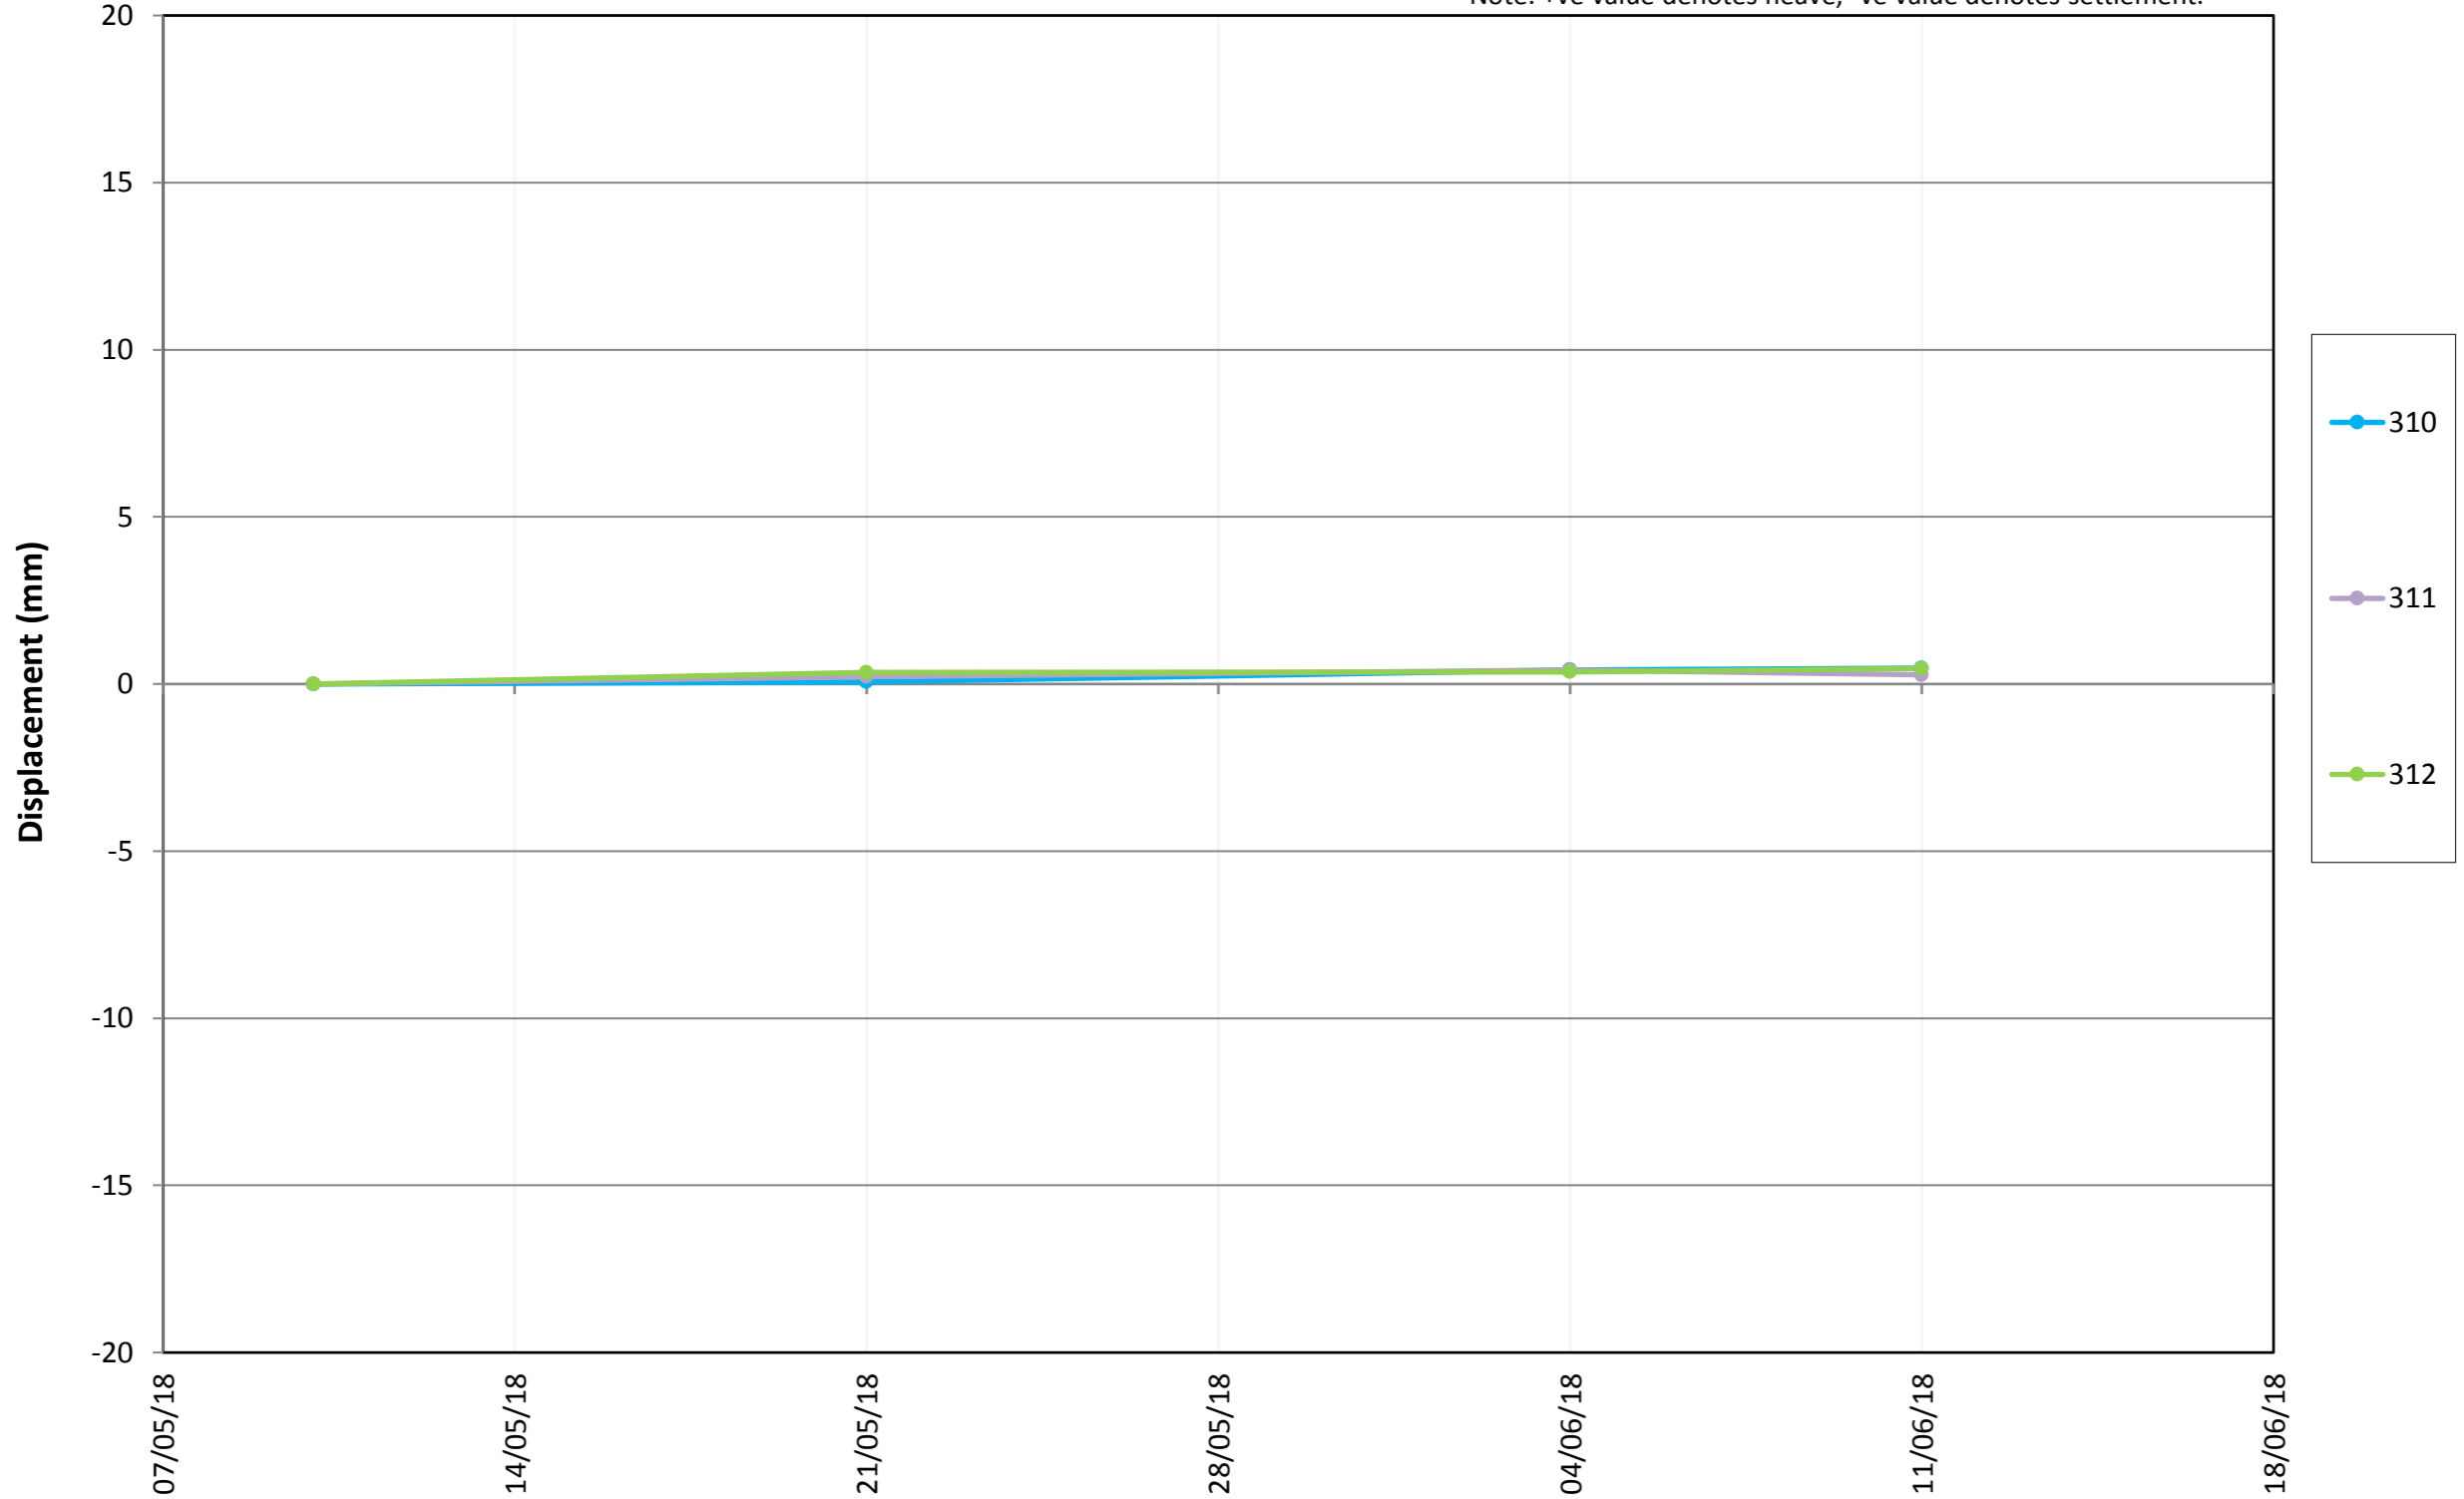
Graph 09 - Precise Level Points on Front Elevation of No. 31 Torrington Square

Precise Level Points on Front Elevation of No. 31 Torrington Square

Precise level points are showing negligible movement.
