32-33 TORRINGTON SQUARE
MONITORING

Monitoring Report
SES-10215-MR03

Date of survey completion: 11th June 2018

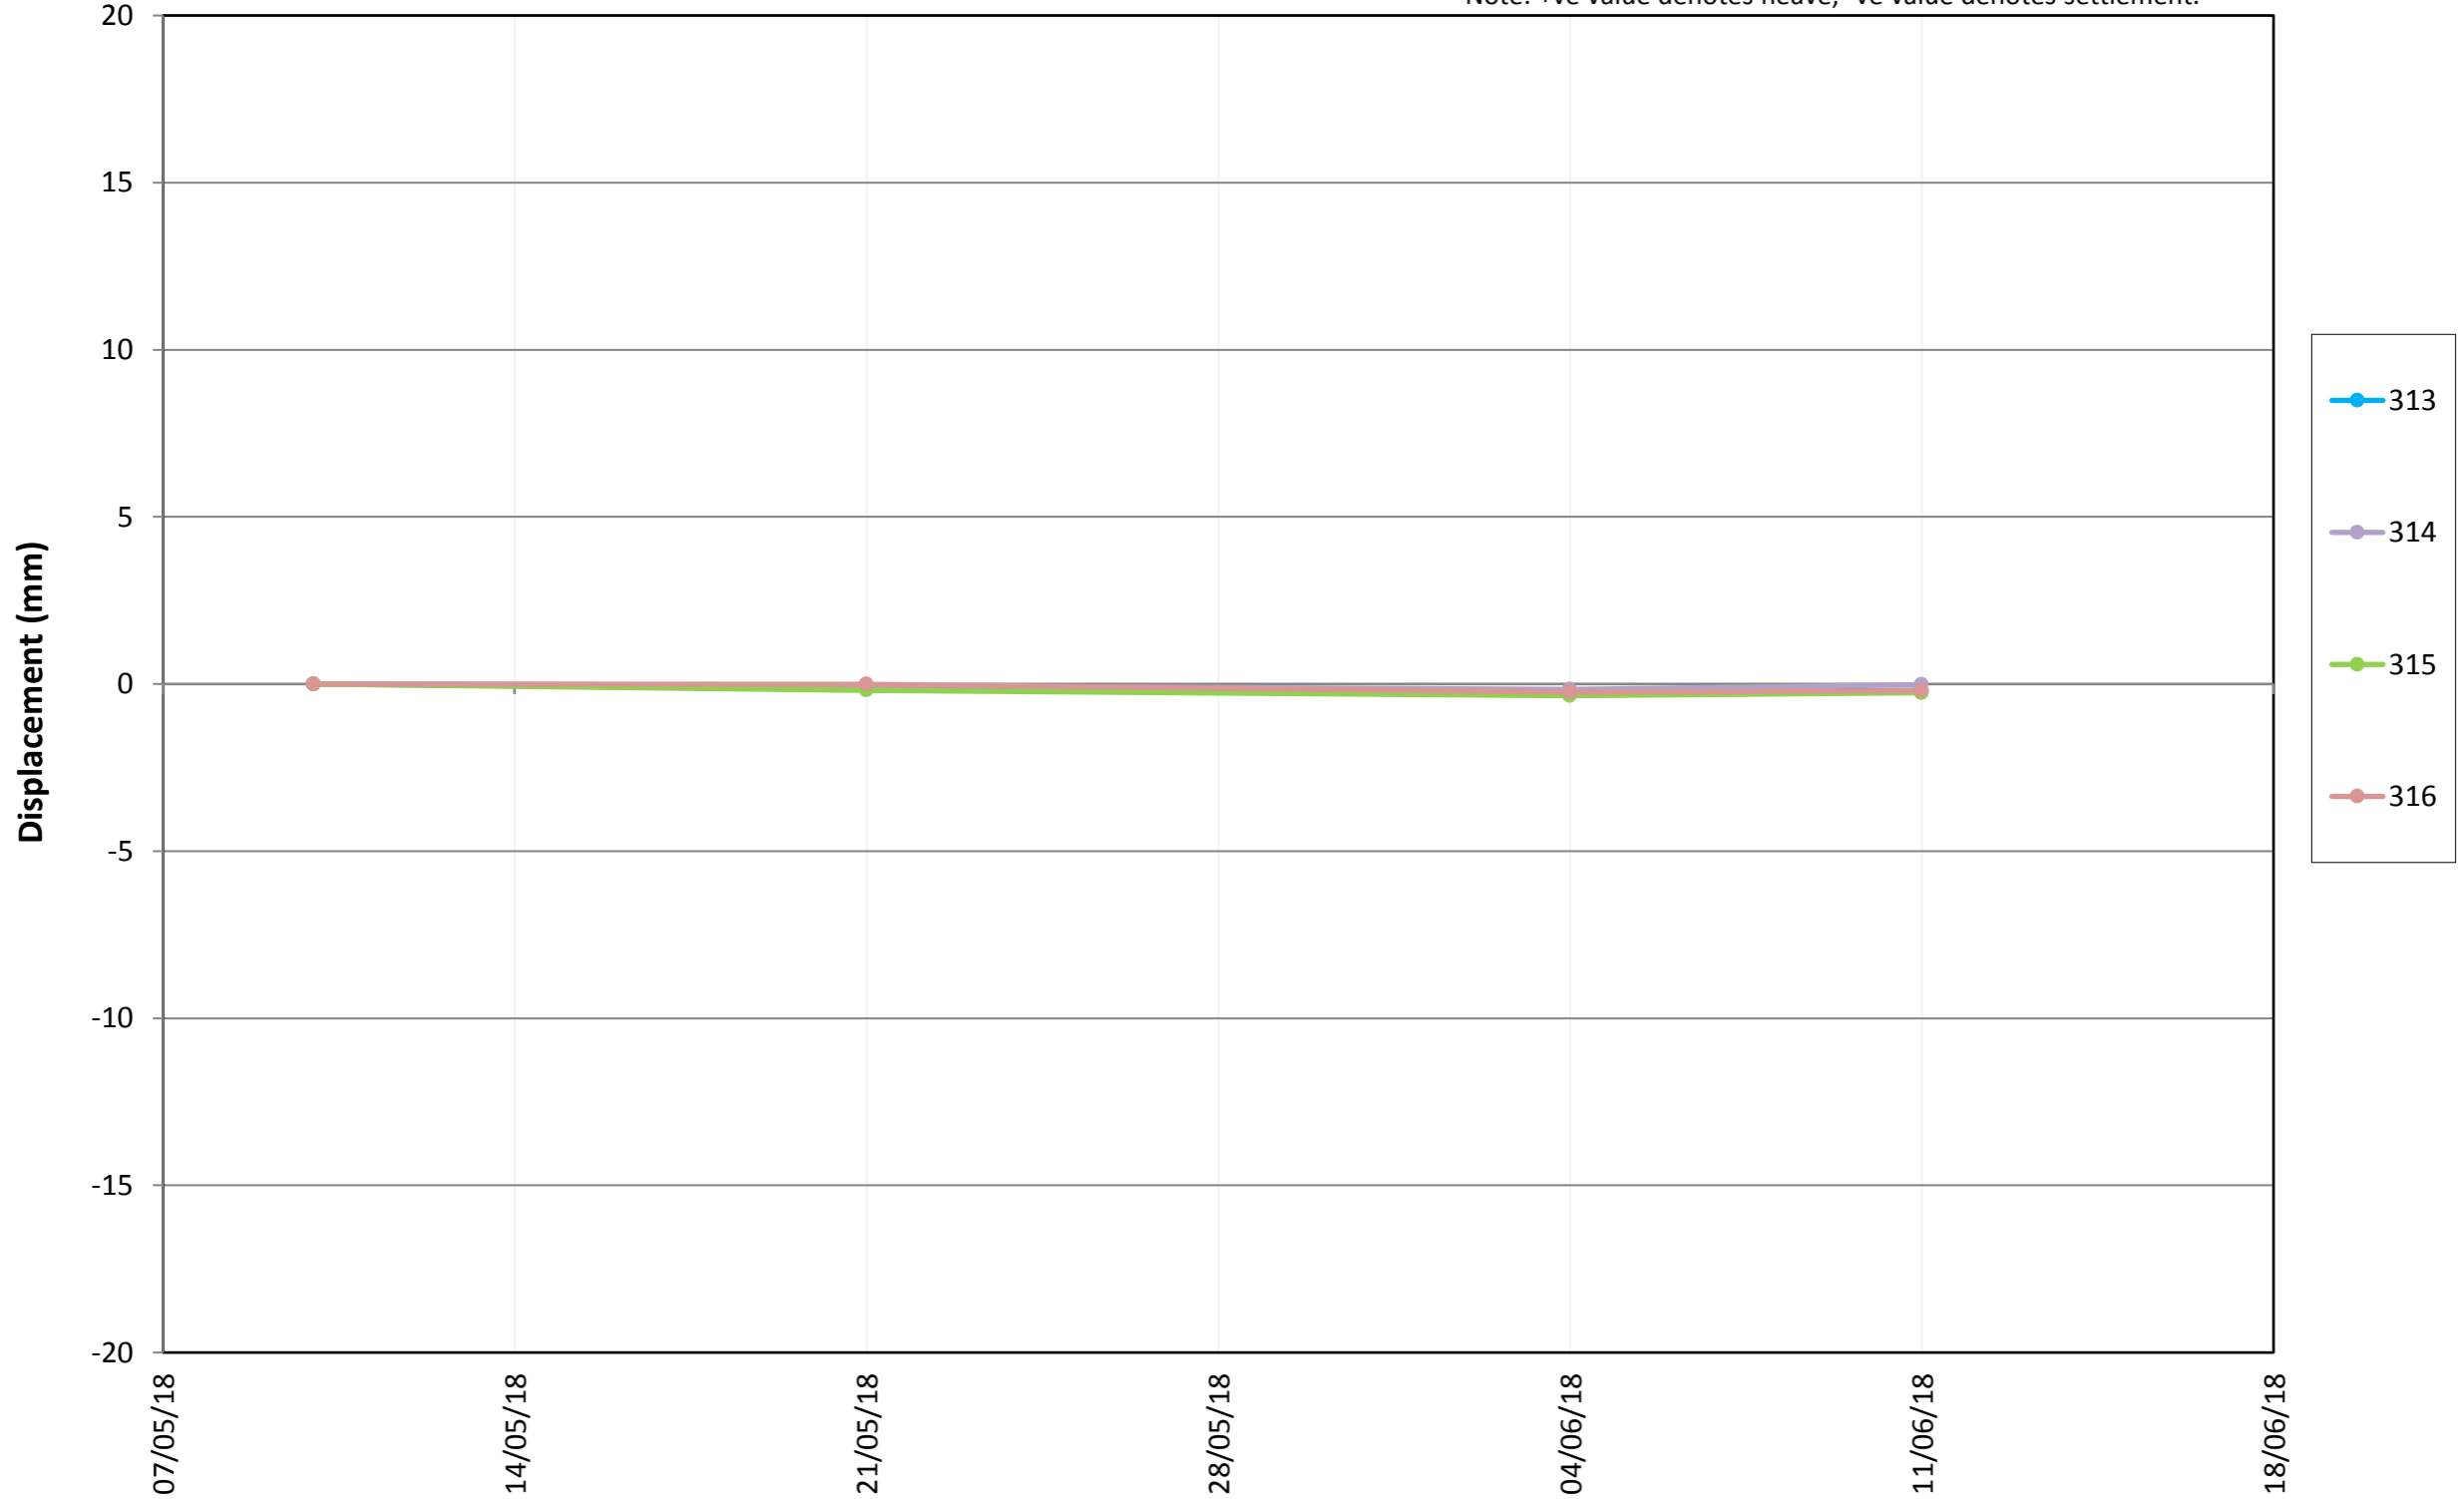
Graph 10 - Precise Level Points on Staircase

Precise Level Points on Staircase

Precise level points are showing negligible movement.
