32-33 TORRINGTON SQUARE
MONITORING

Monitoring Report
SES-10215-MR04

Date of survey completion: 18th June 2018

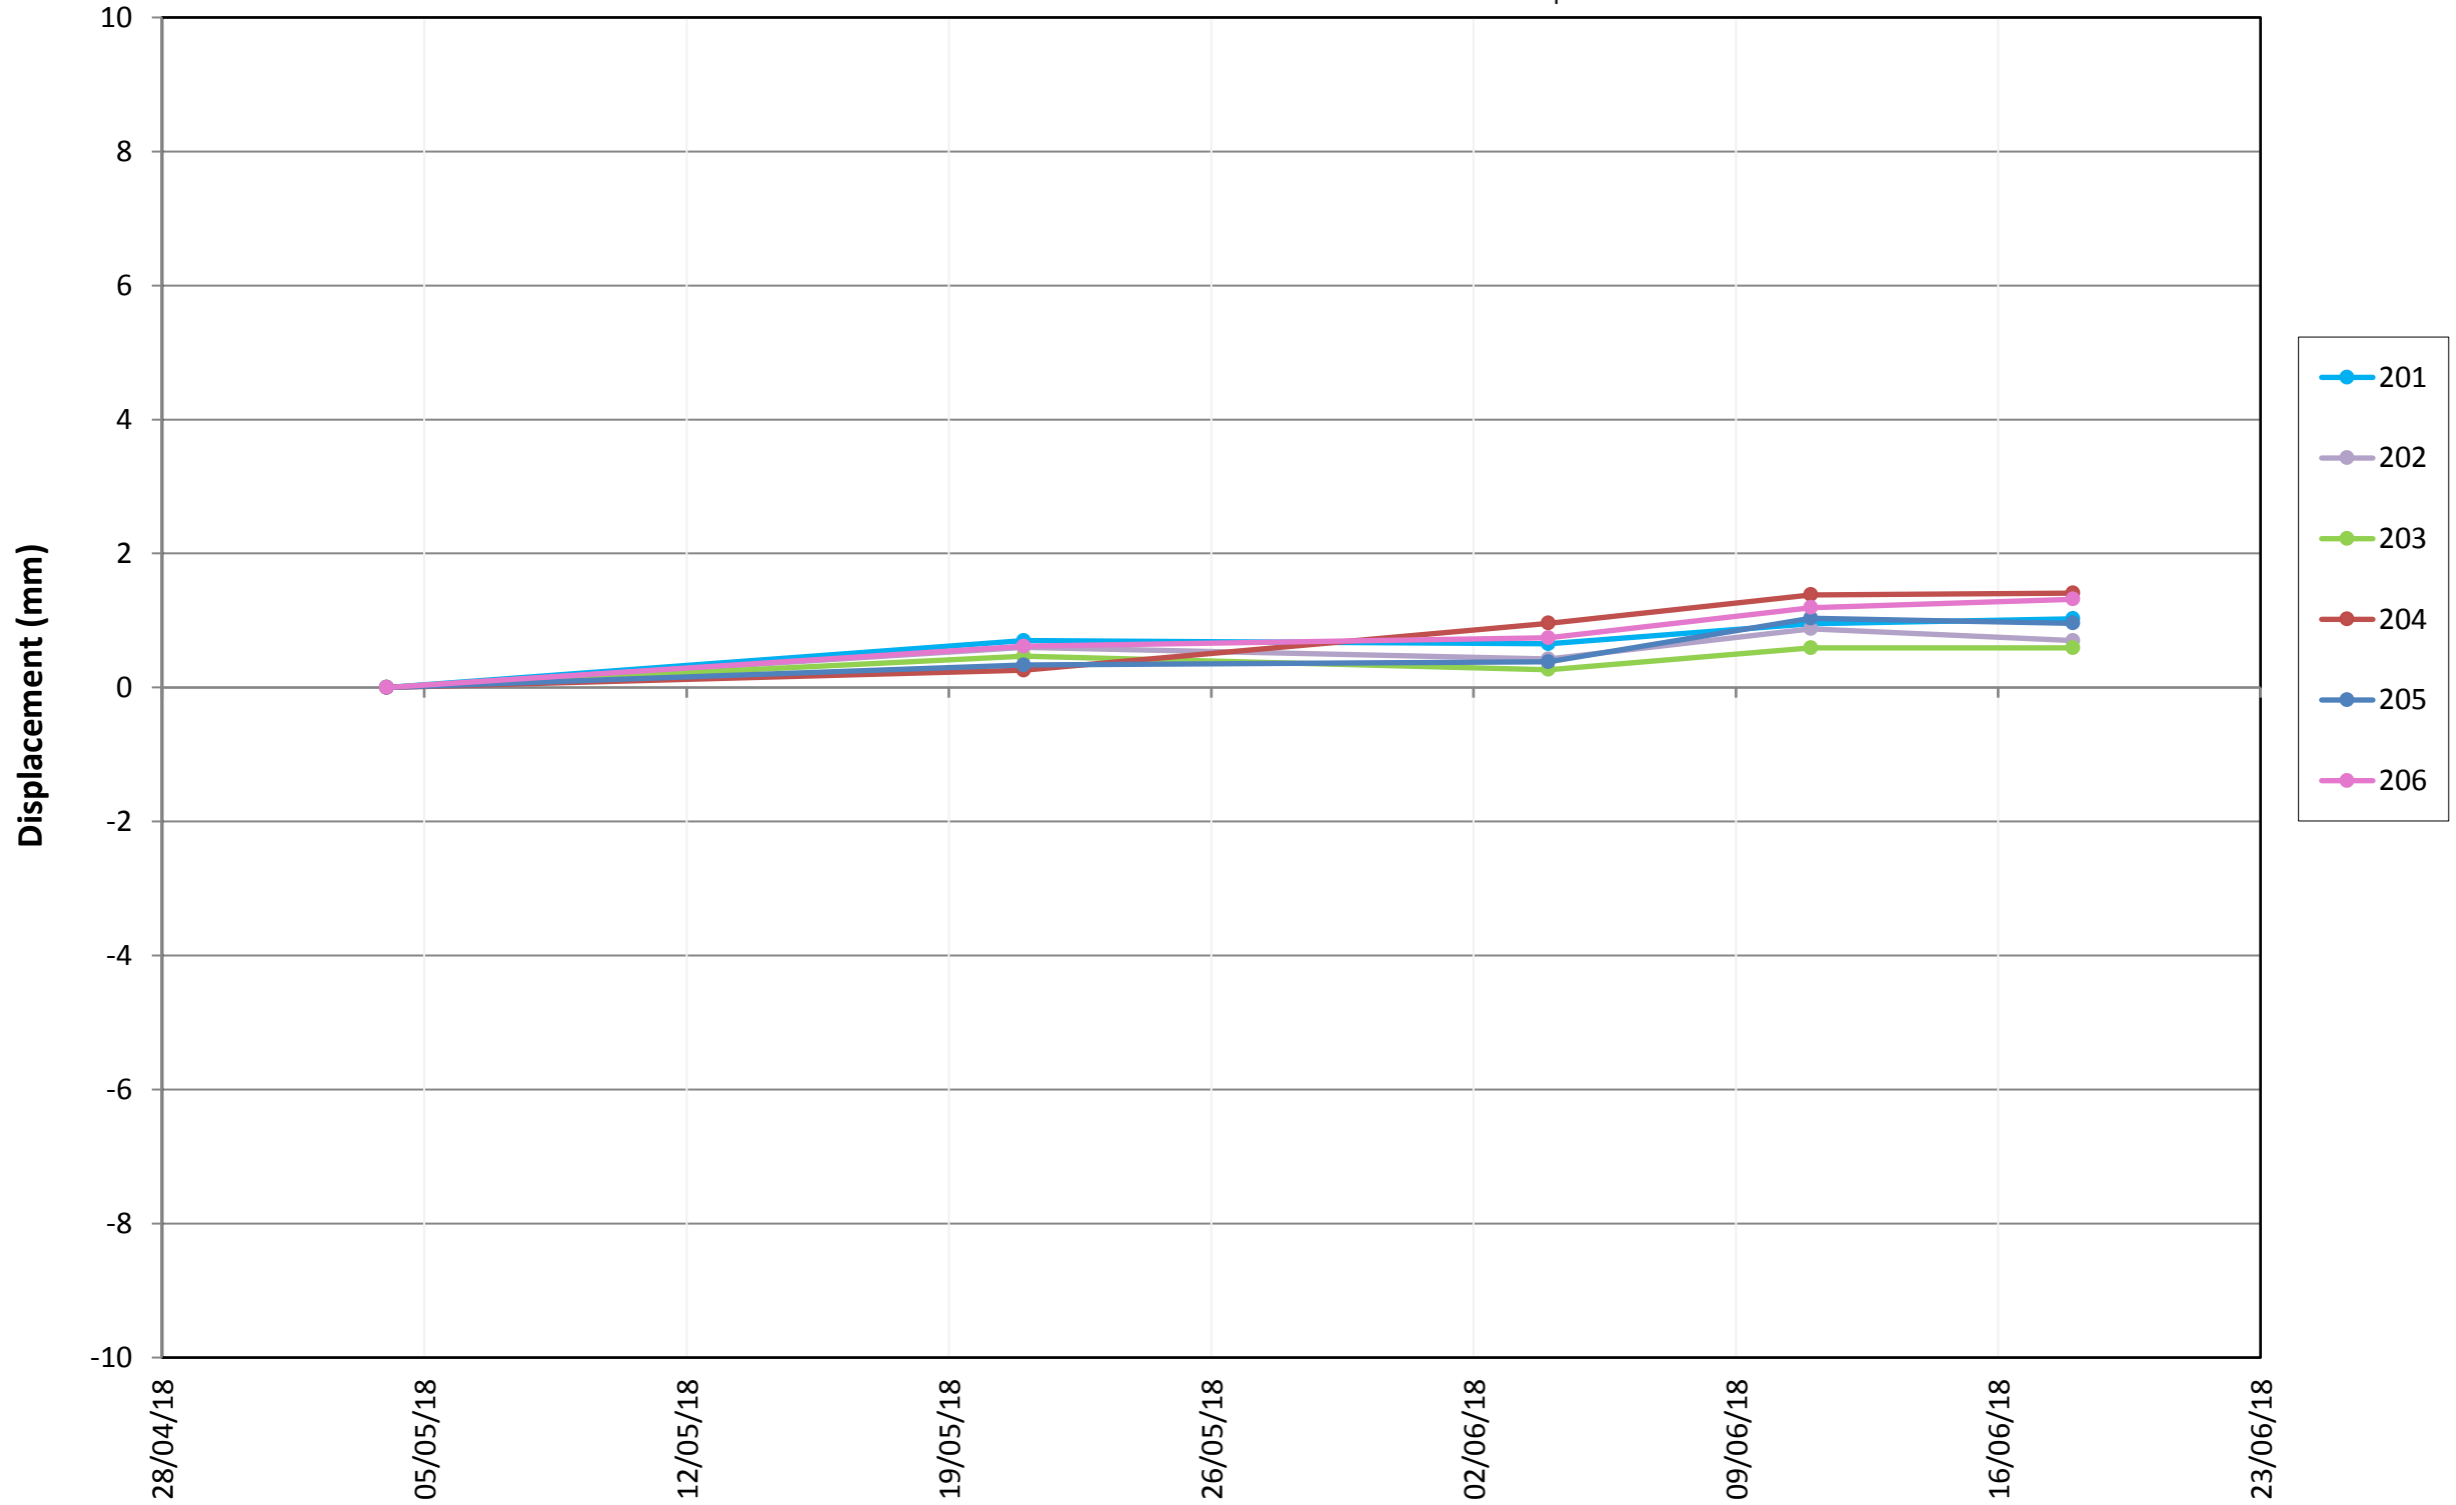
Graph 01T - Targets on Front Elevation of The Warburg Institute

Targets are showing negligible horizontal movement.
Targets are showing negligible vertical movement.

Note: A positive value denotes movement in to site and vice versa.

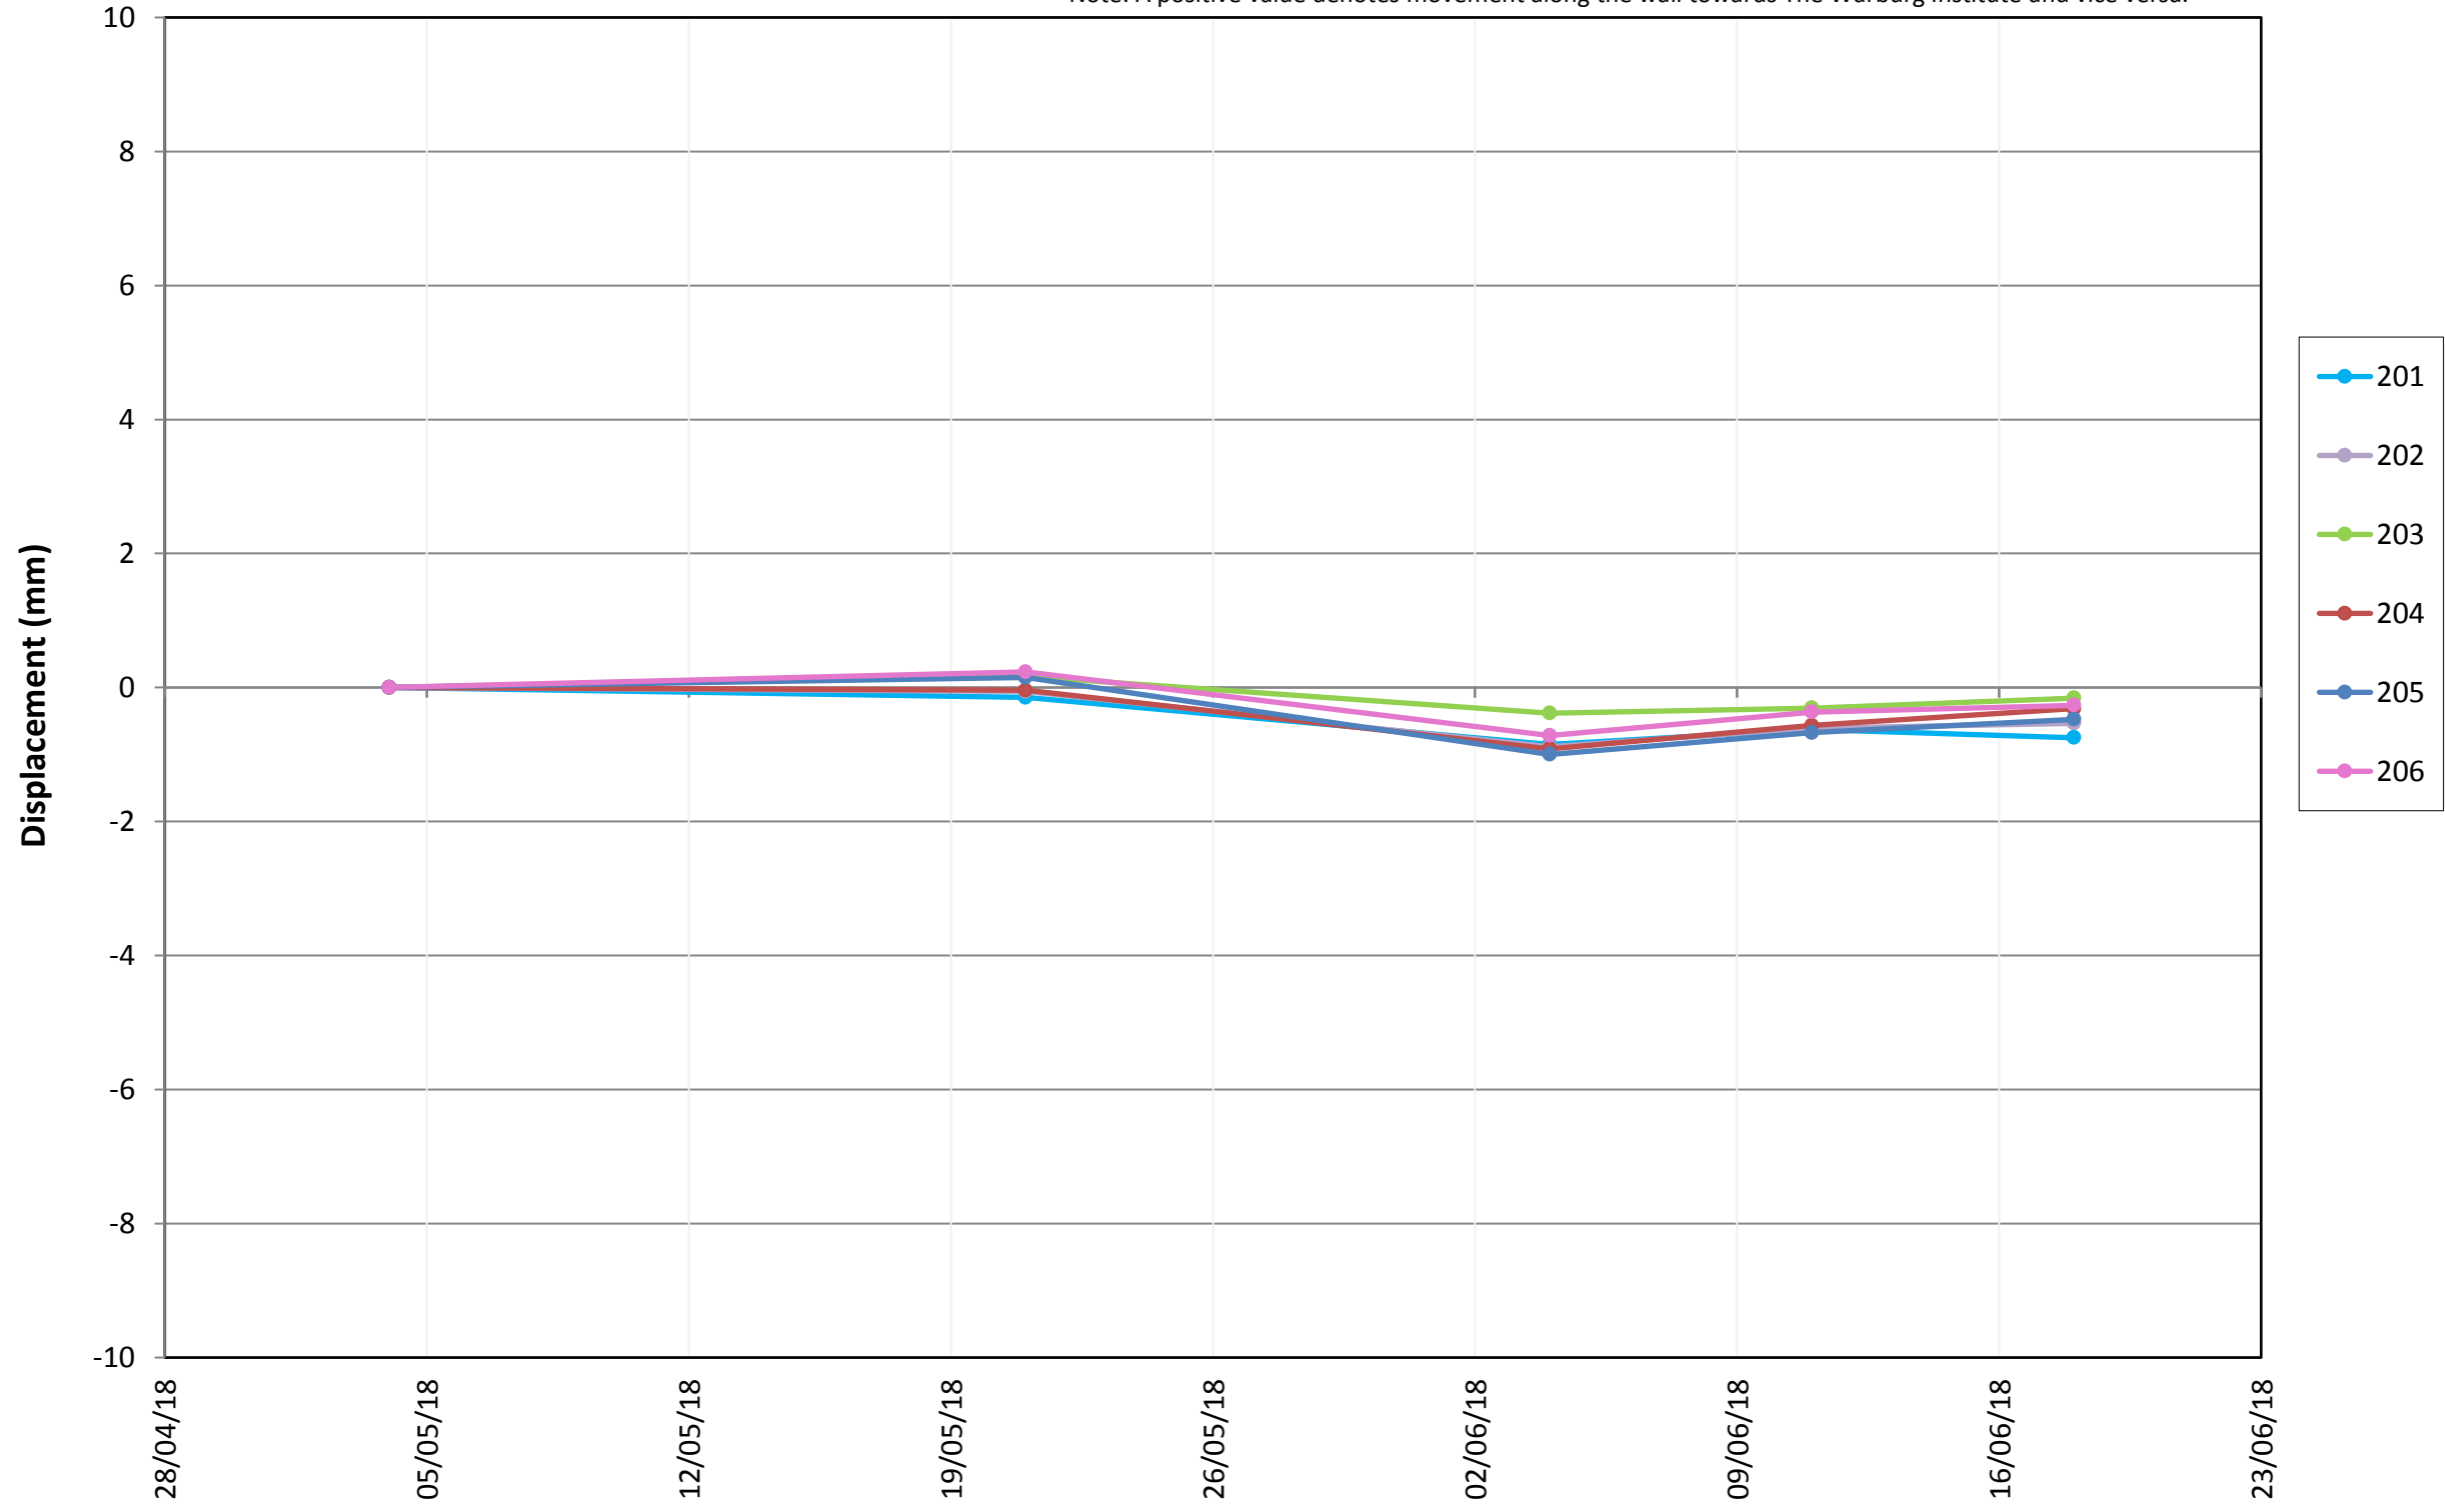
Graph 01L - Targets on Front Elevation of The Warburg Institute

Note: A positive value denotes movement along the wall towards The Warburg Institute and vice versa.

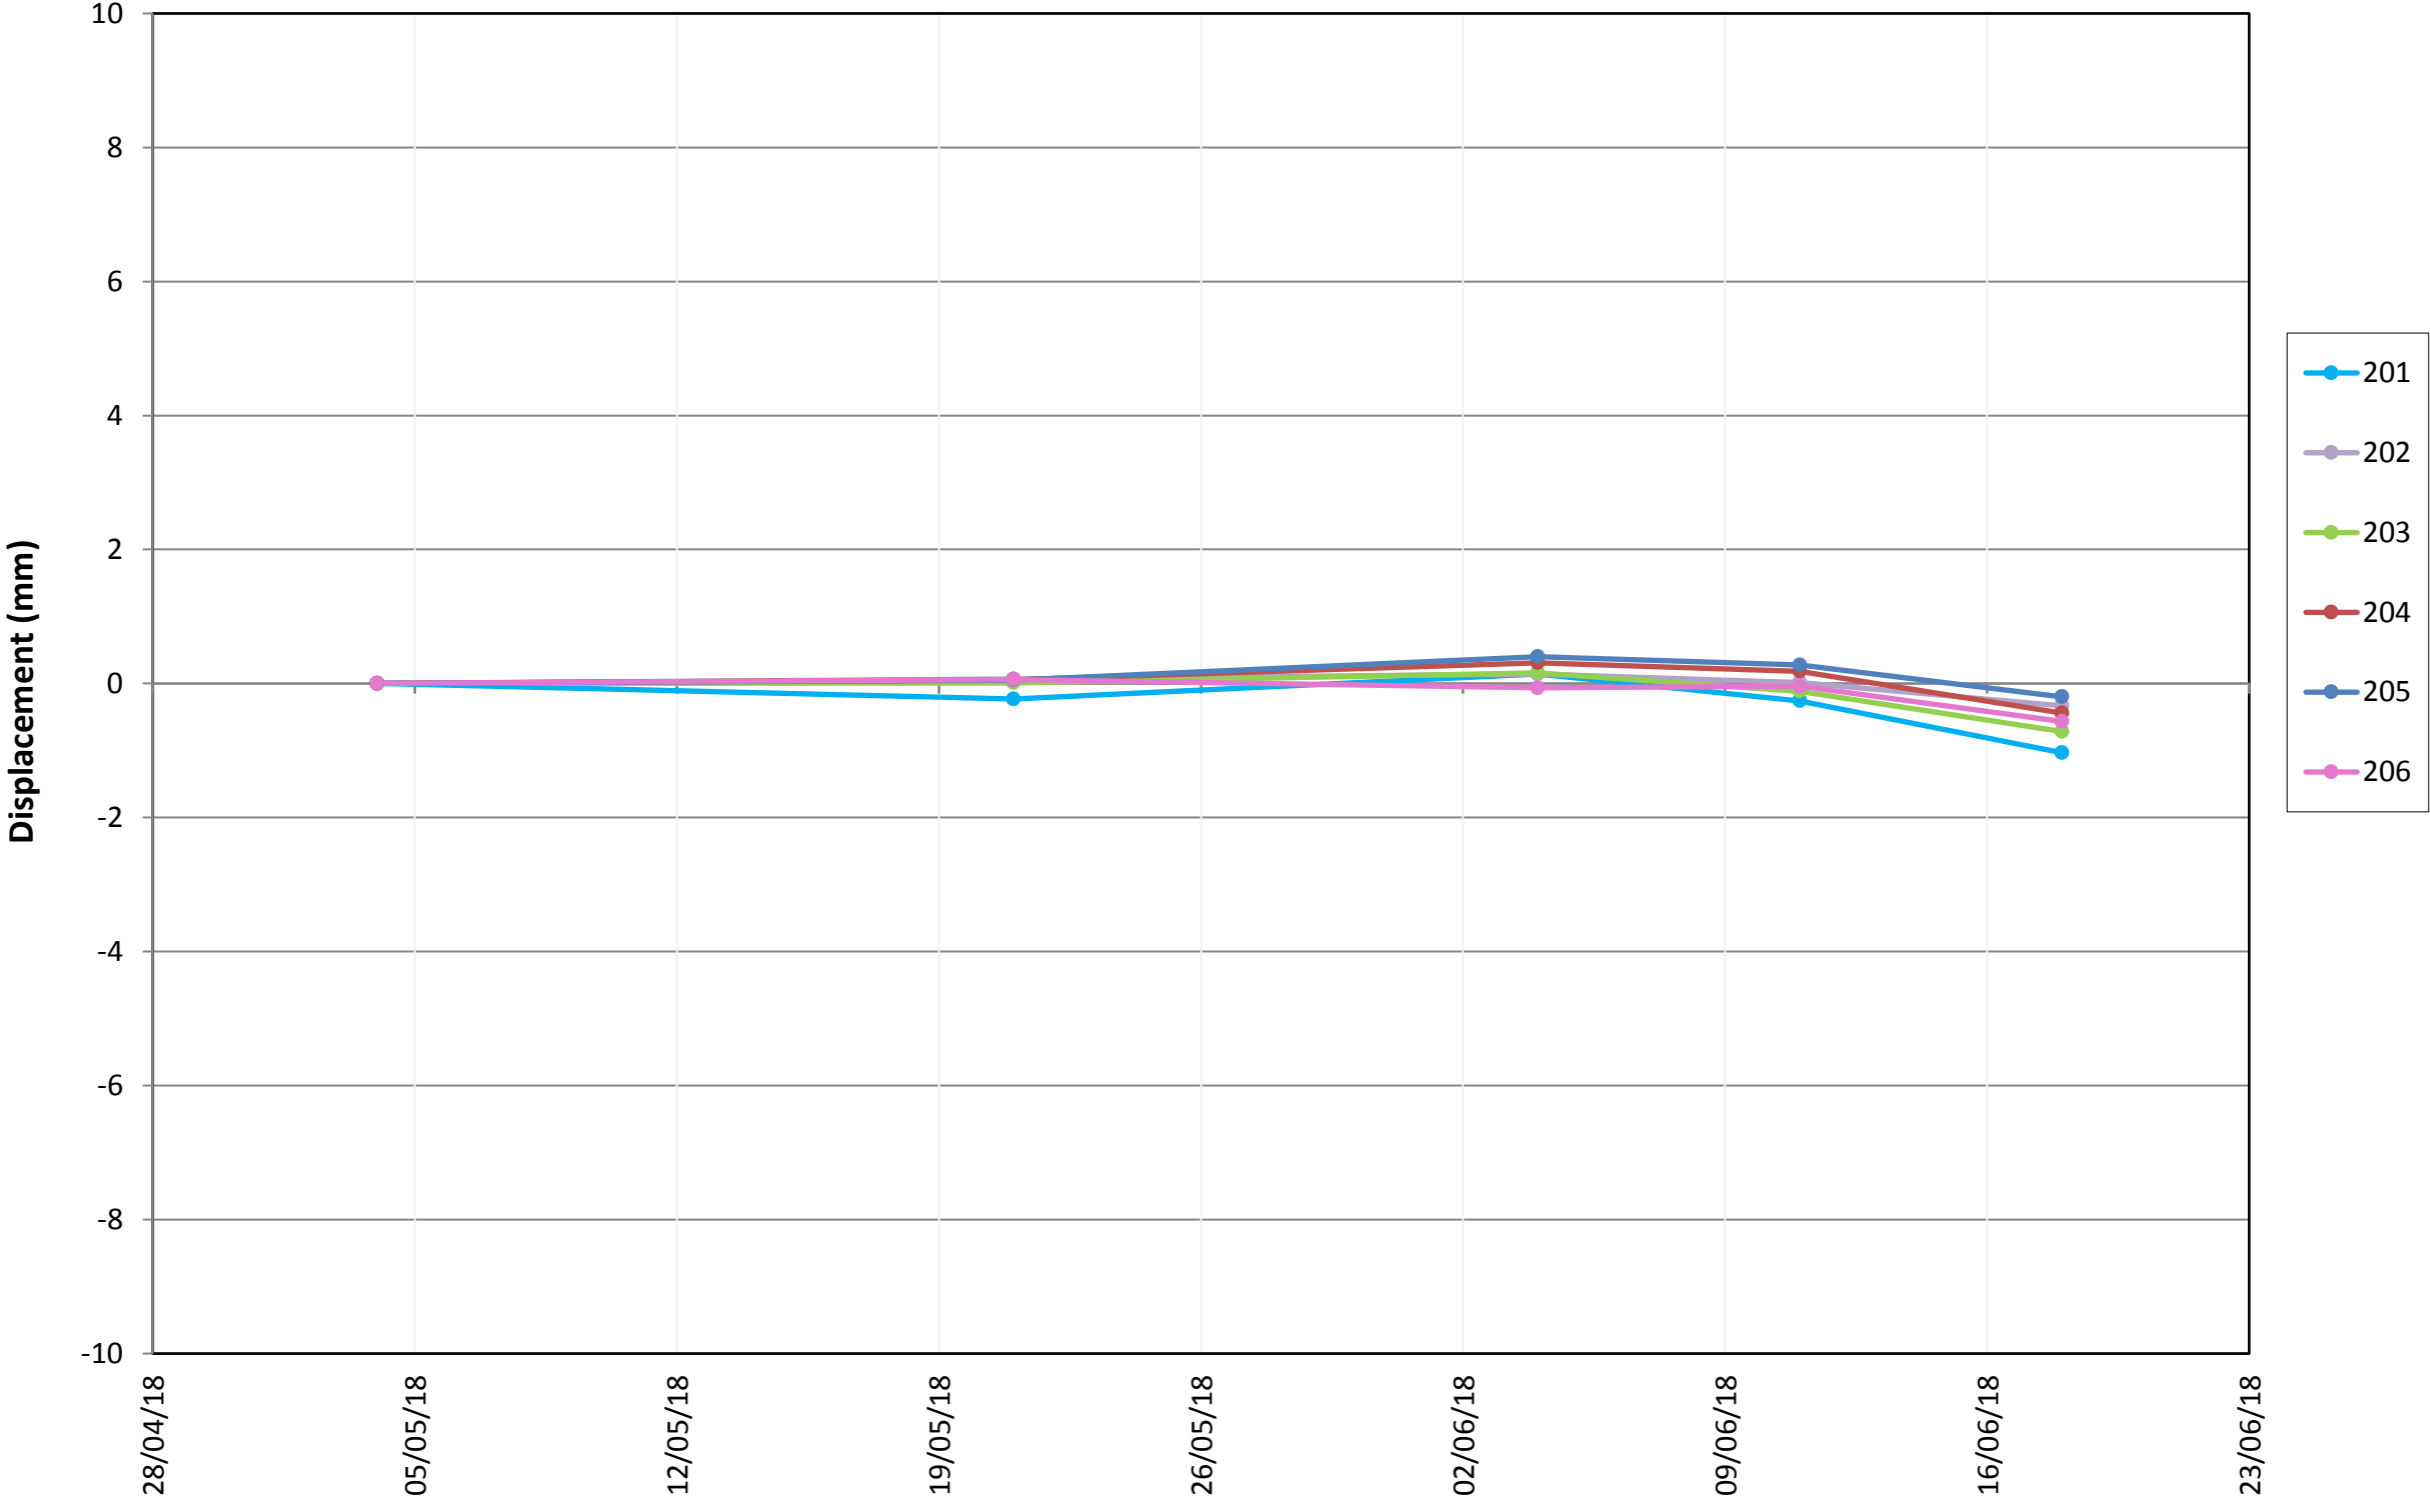
Graph 01V - Targets on Front Elevation of The Warburg Institute

Note: +ve value denotes heave, -ve value denotes settlement.

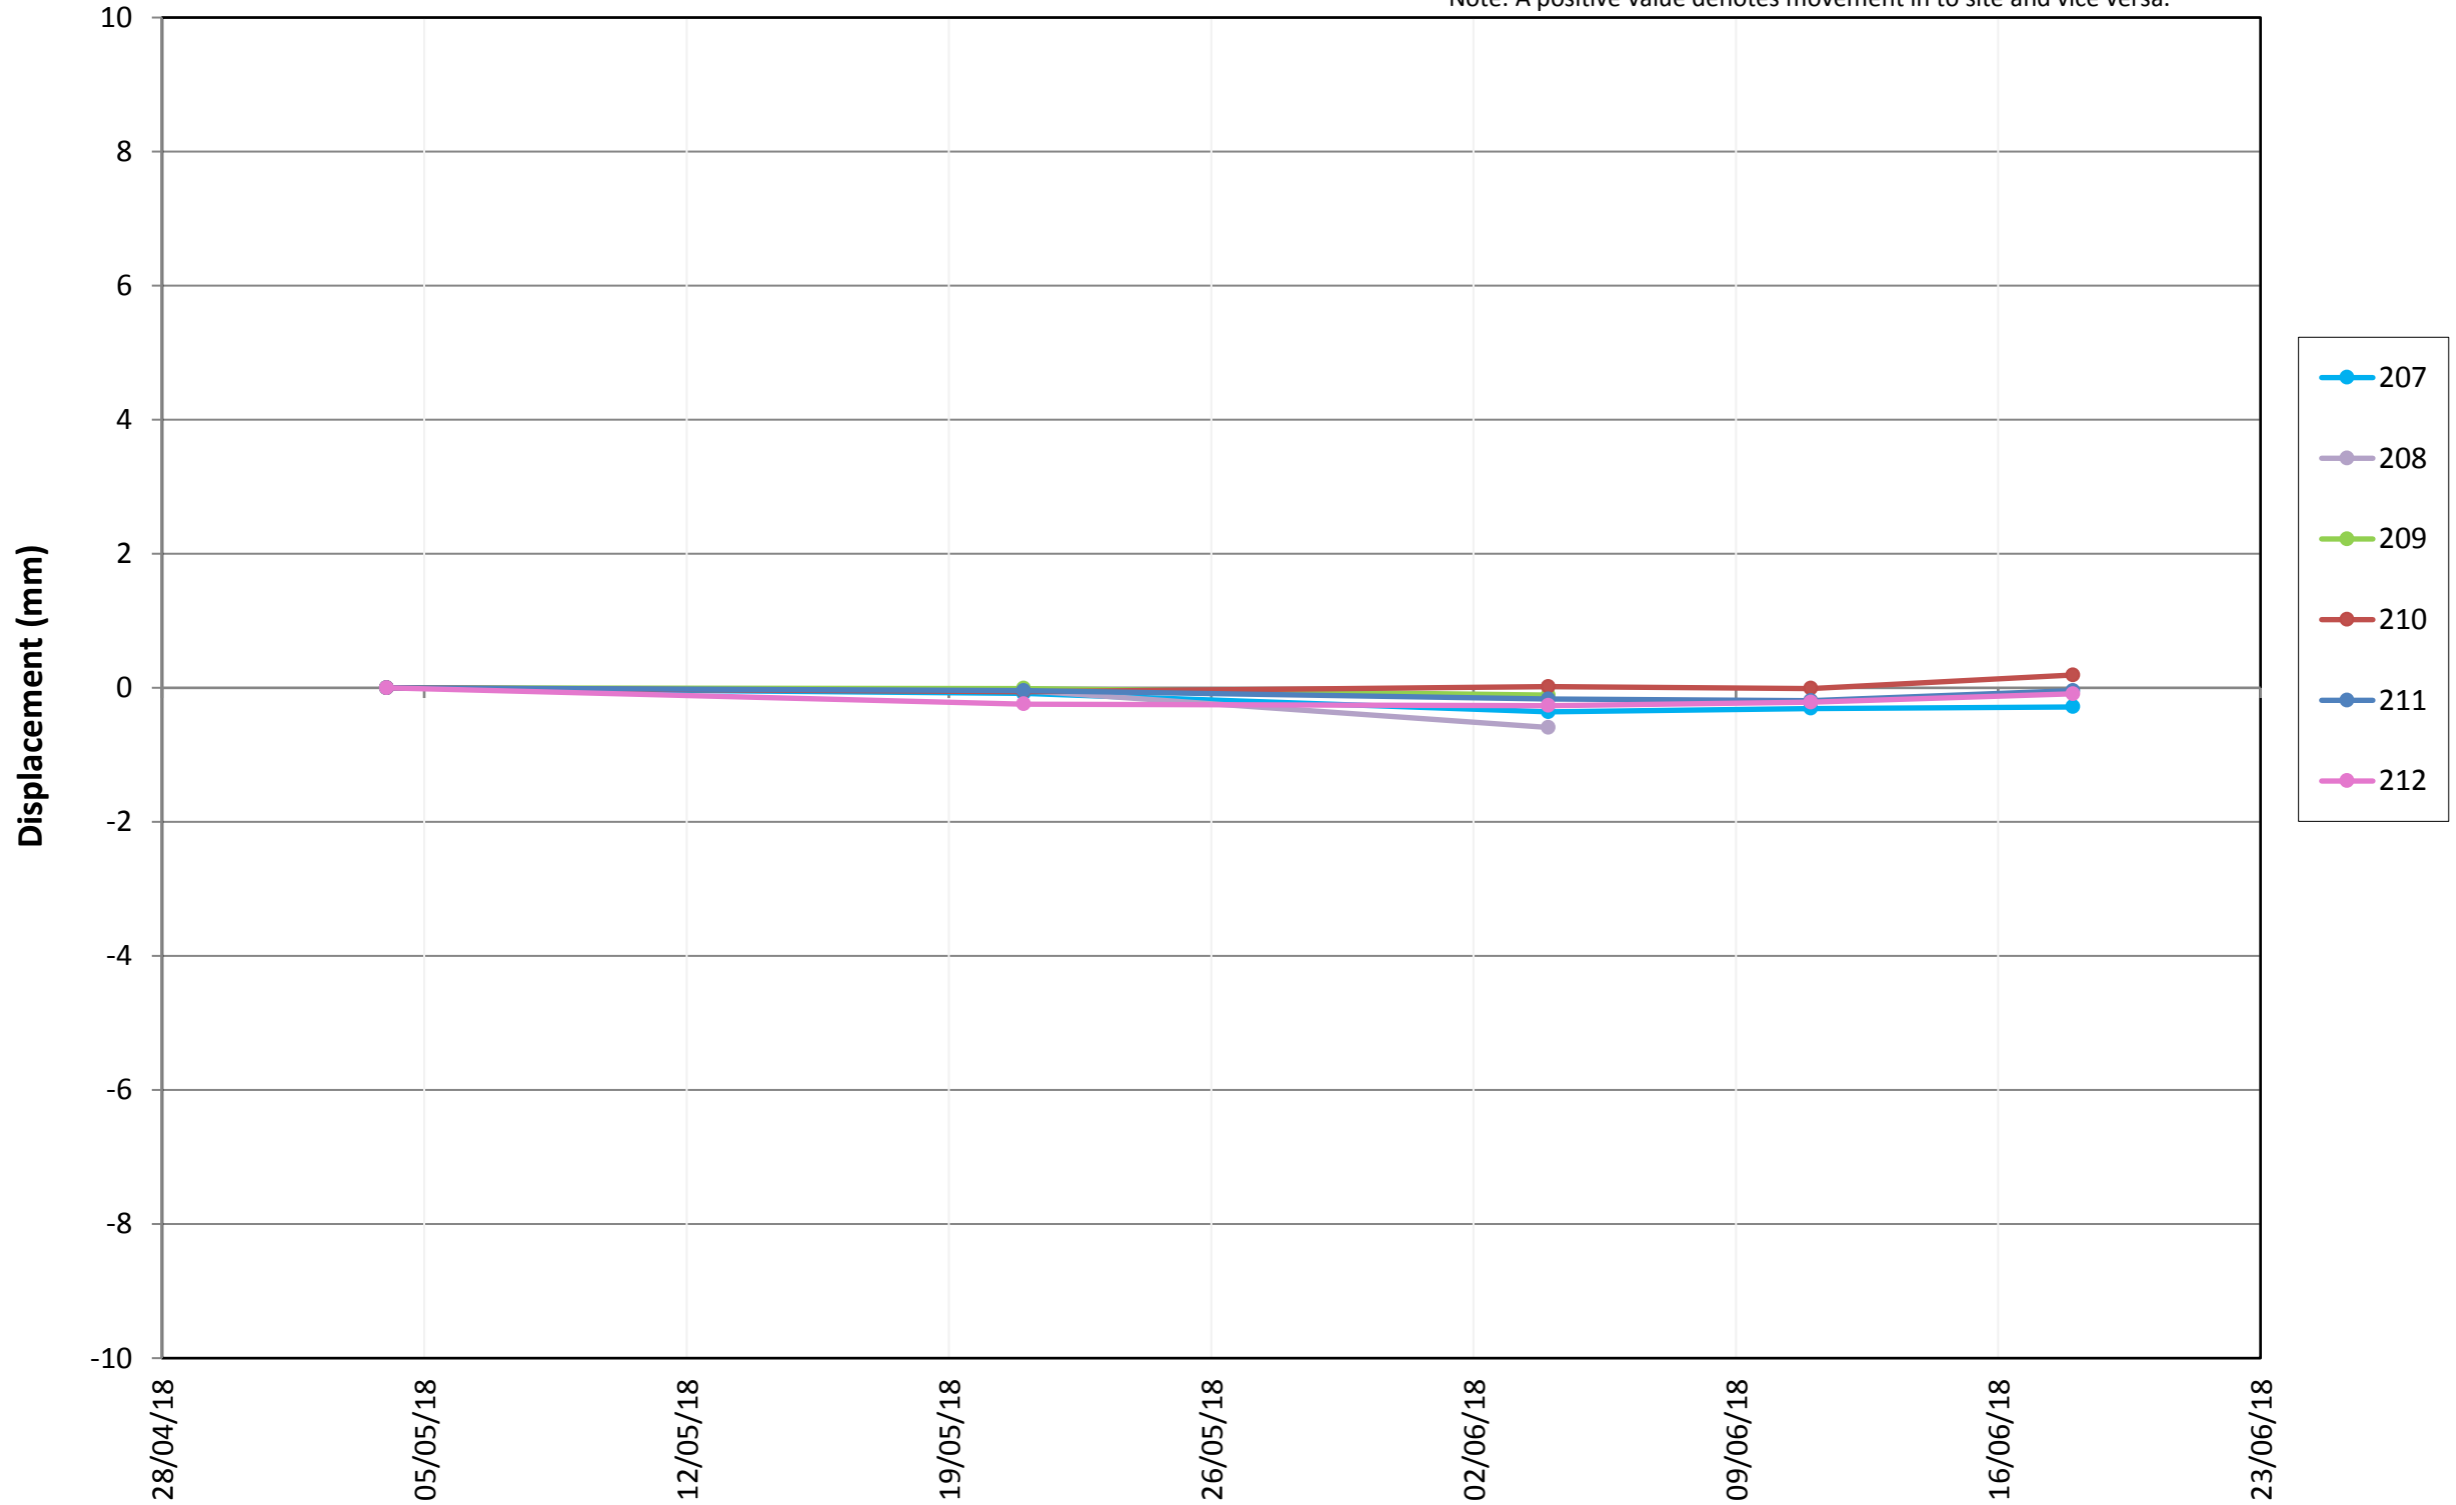
Graph 02T - Targets on Side Elevation of The Warburg Institute

Targets are showing negligible horizontal movement.
Targets are showing negligible vertical movement.
Target 208 is obstructed by scaffold.
Target 209 is destroyed

Note: A positive value denotes movement in to site and vice versa.

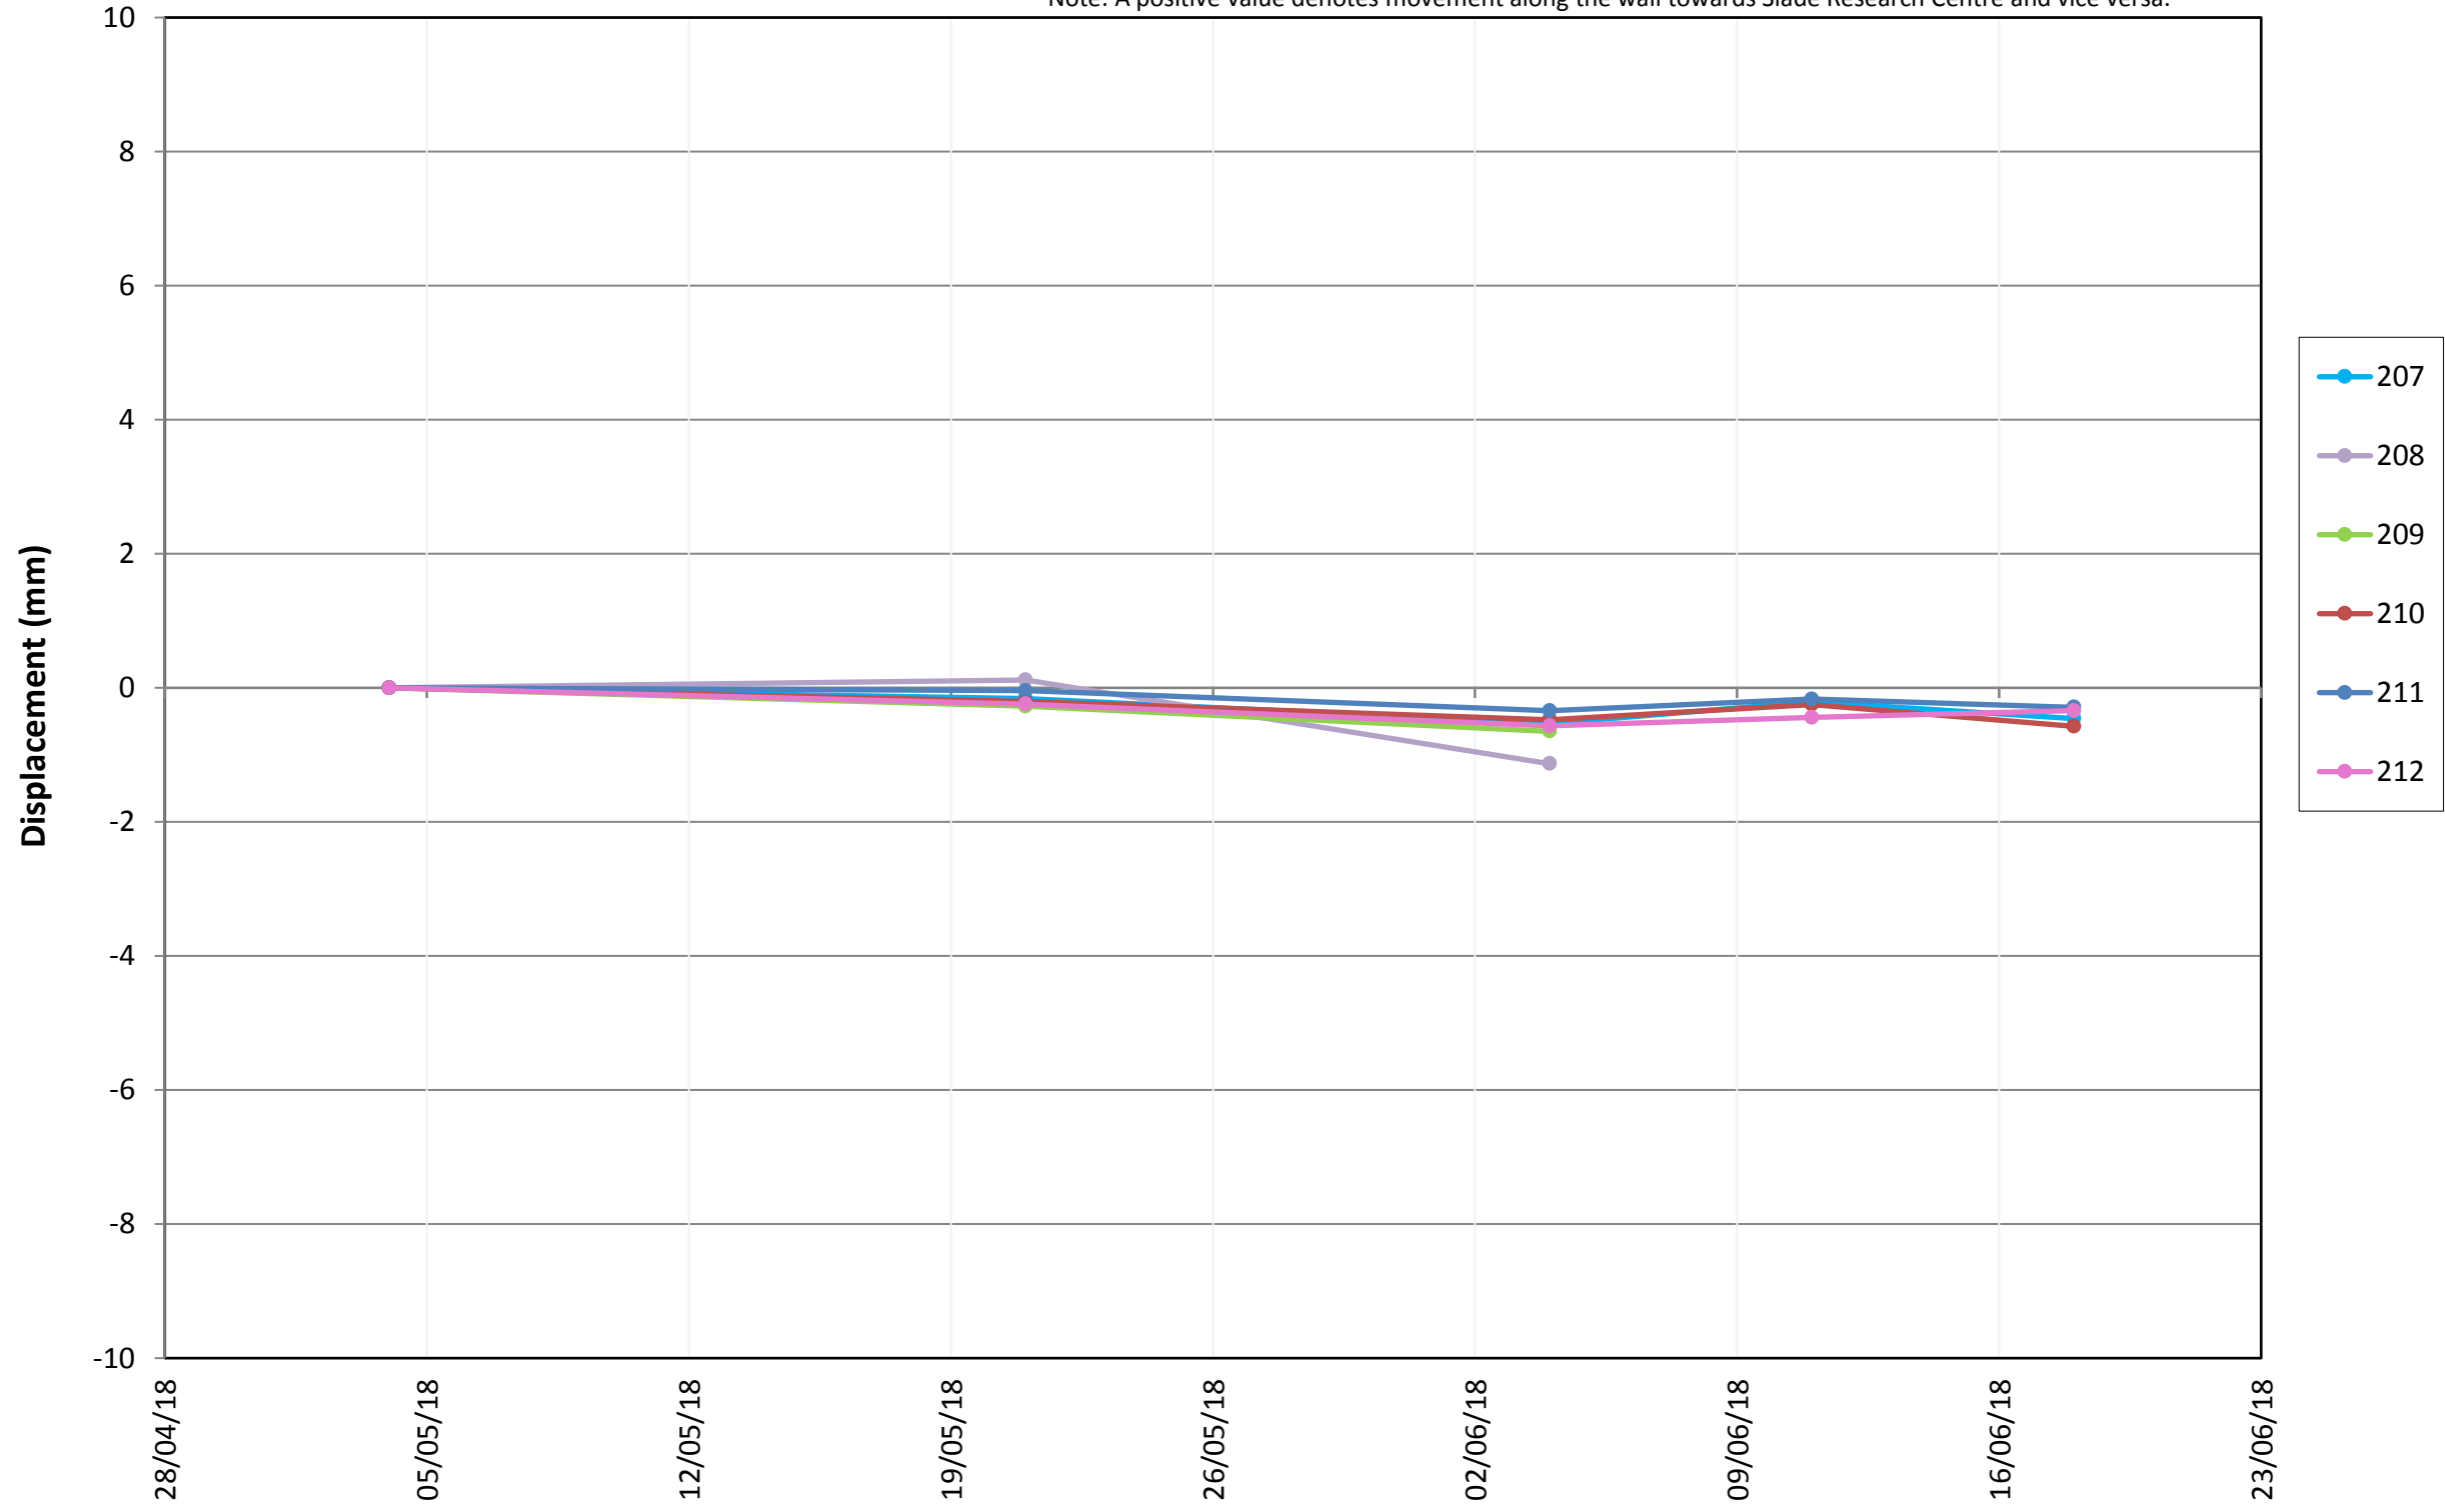
Graph 02L - Targets on Side Elevation of The Warburg Institute

Note: A positive value denotes movement along the wall towards Slade Research Centre and vice versa.

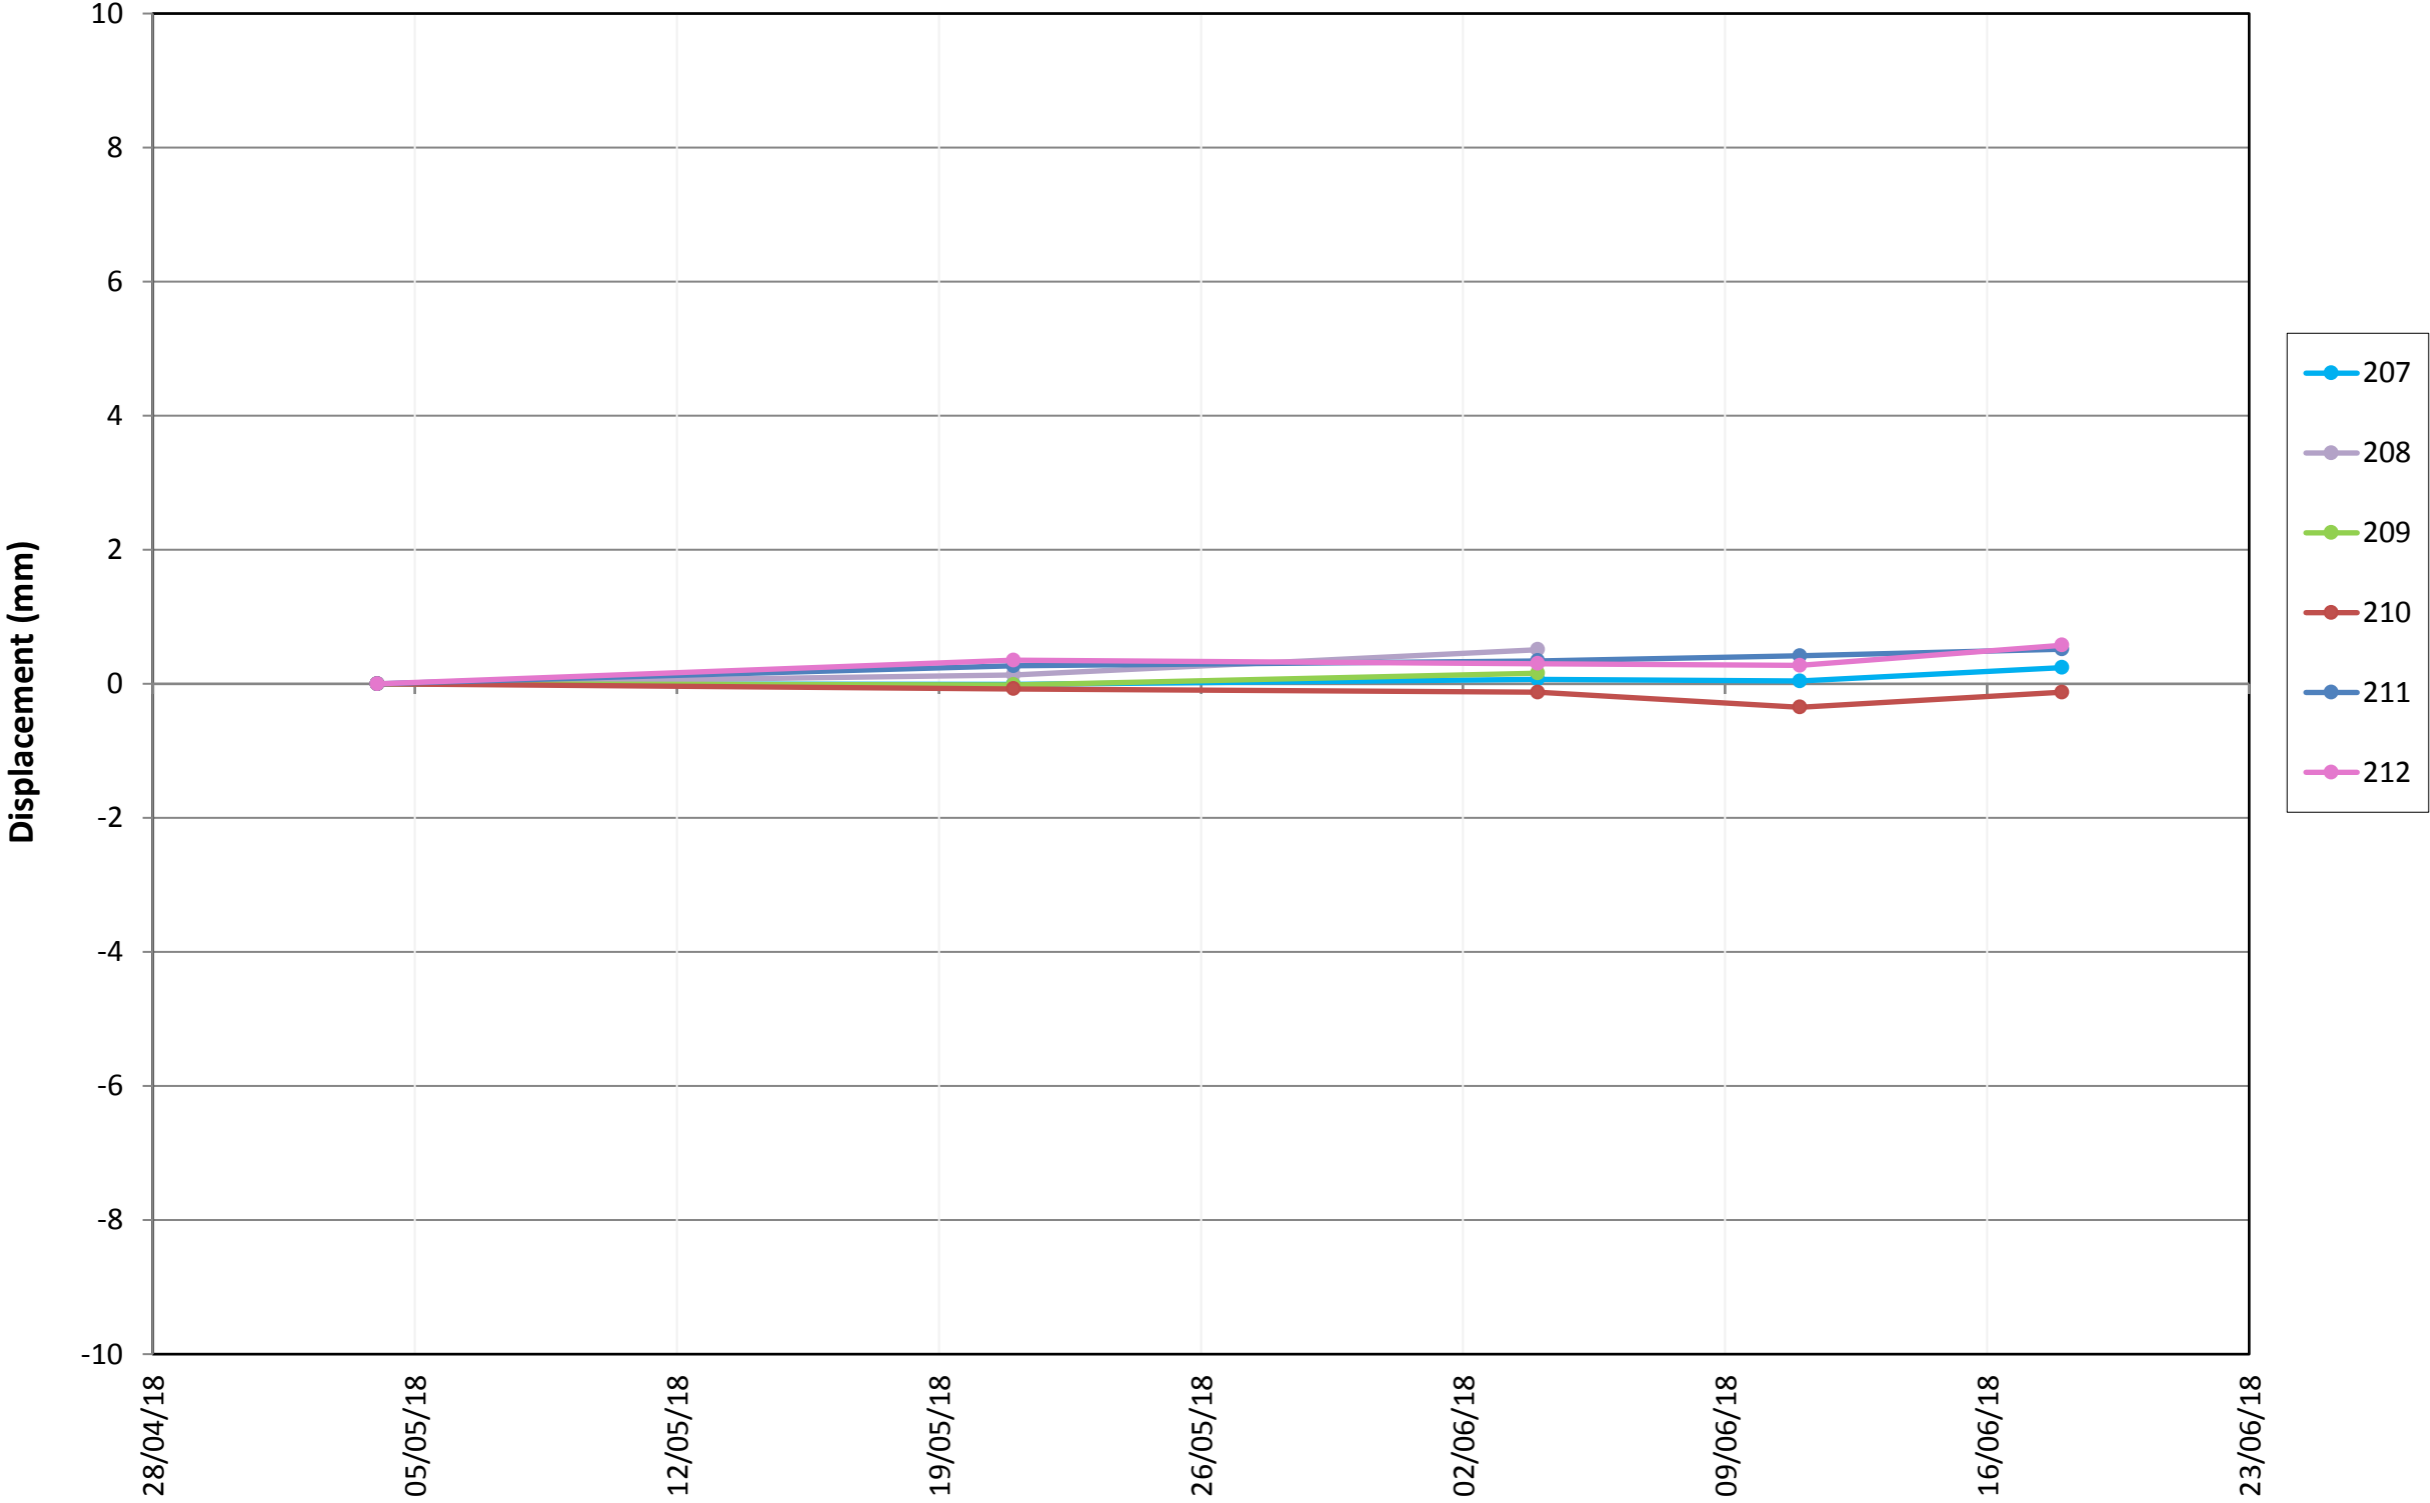
Graph 02V - Targets on Side Elevation of The Warburg Institute

Note: +ve value denotes heave, -ve value denotes settlement.
