32-33 TORRINGTON SQUARE
MONITORING

Monitoring Report
SES-10215-MR04

Date of survey completion: 18th June 2018

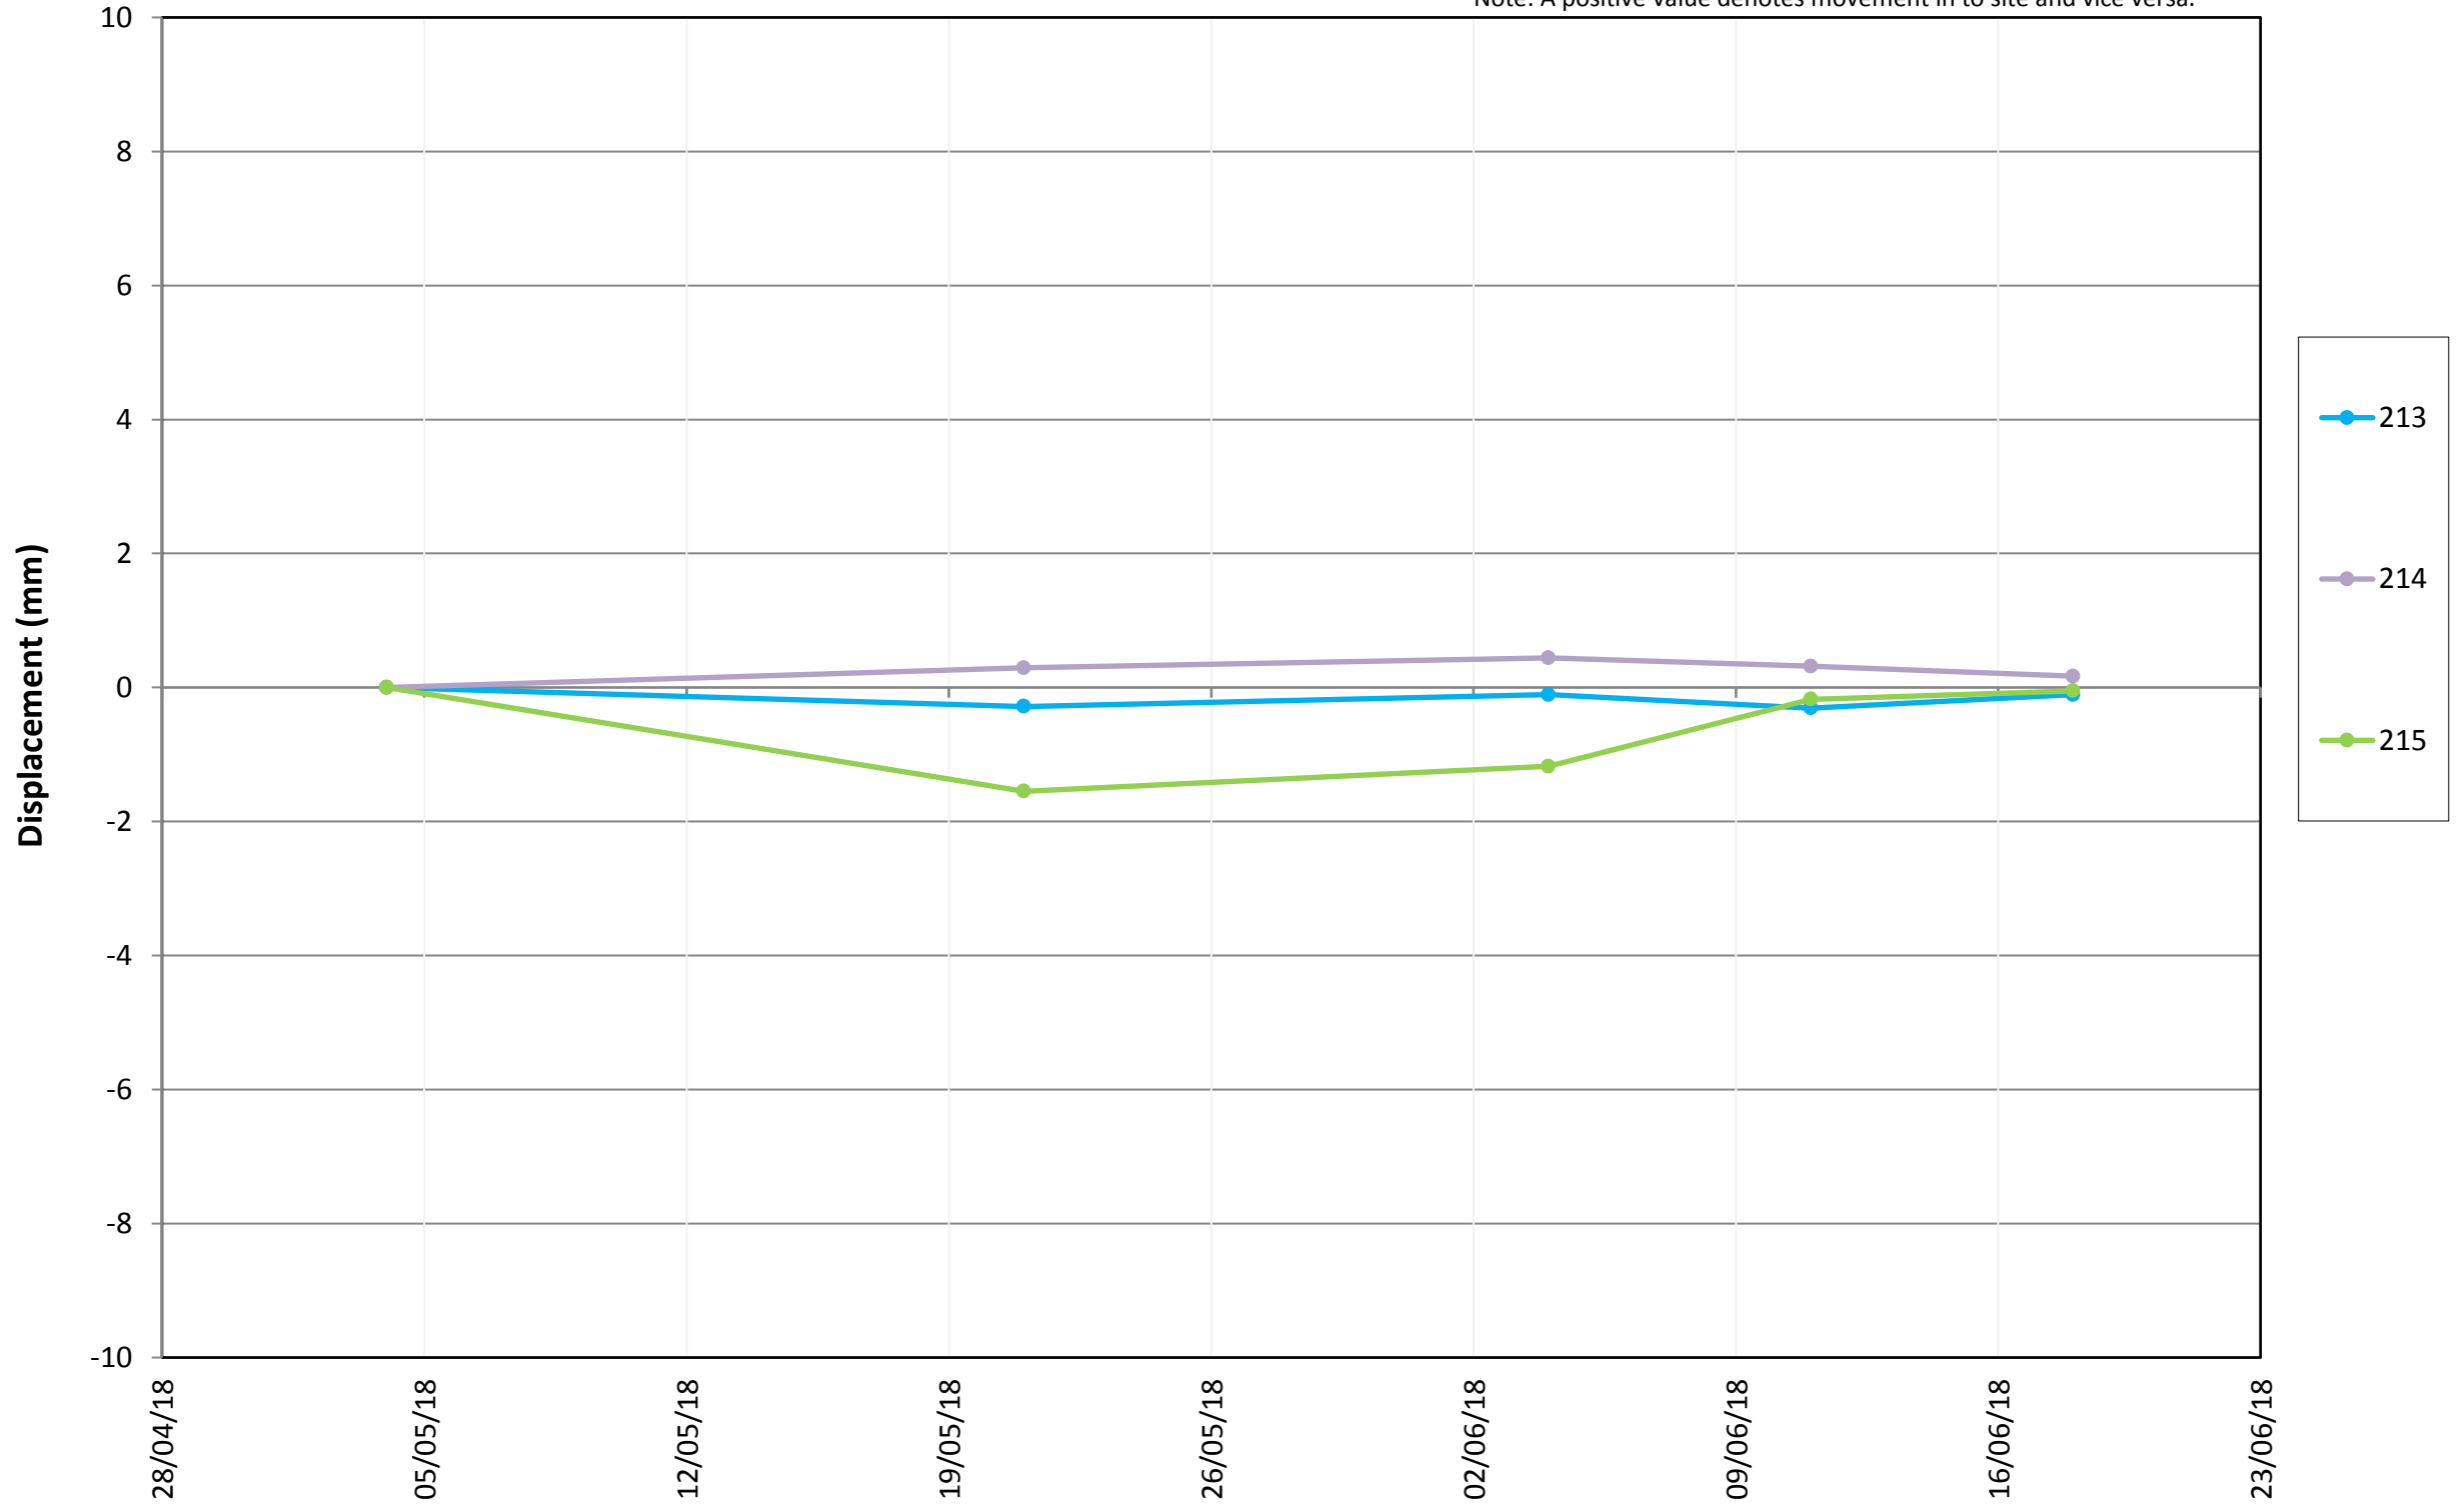
Graph 03T - Targets on Rear Elevation of The Warburg Institute

Targets are showing negligible horizontal movement.
Targets are showing negligible vertical movement.

Note: A positive value denotes movement in to site and vice versa.

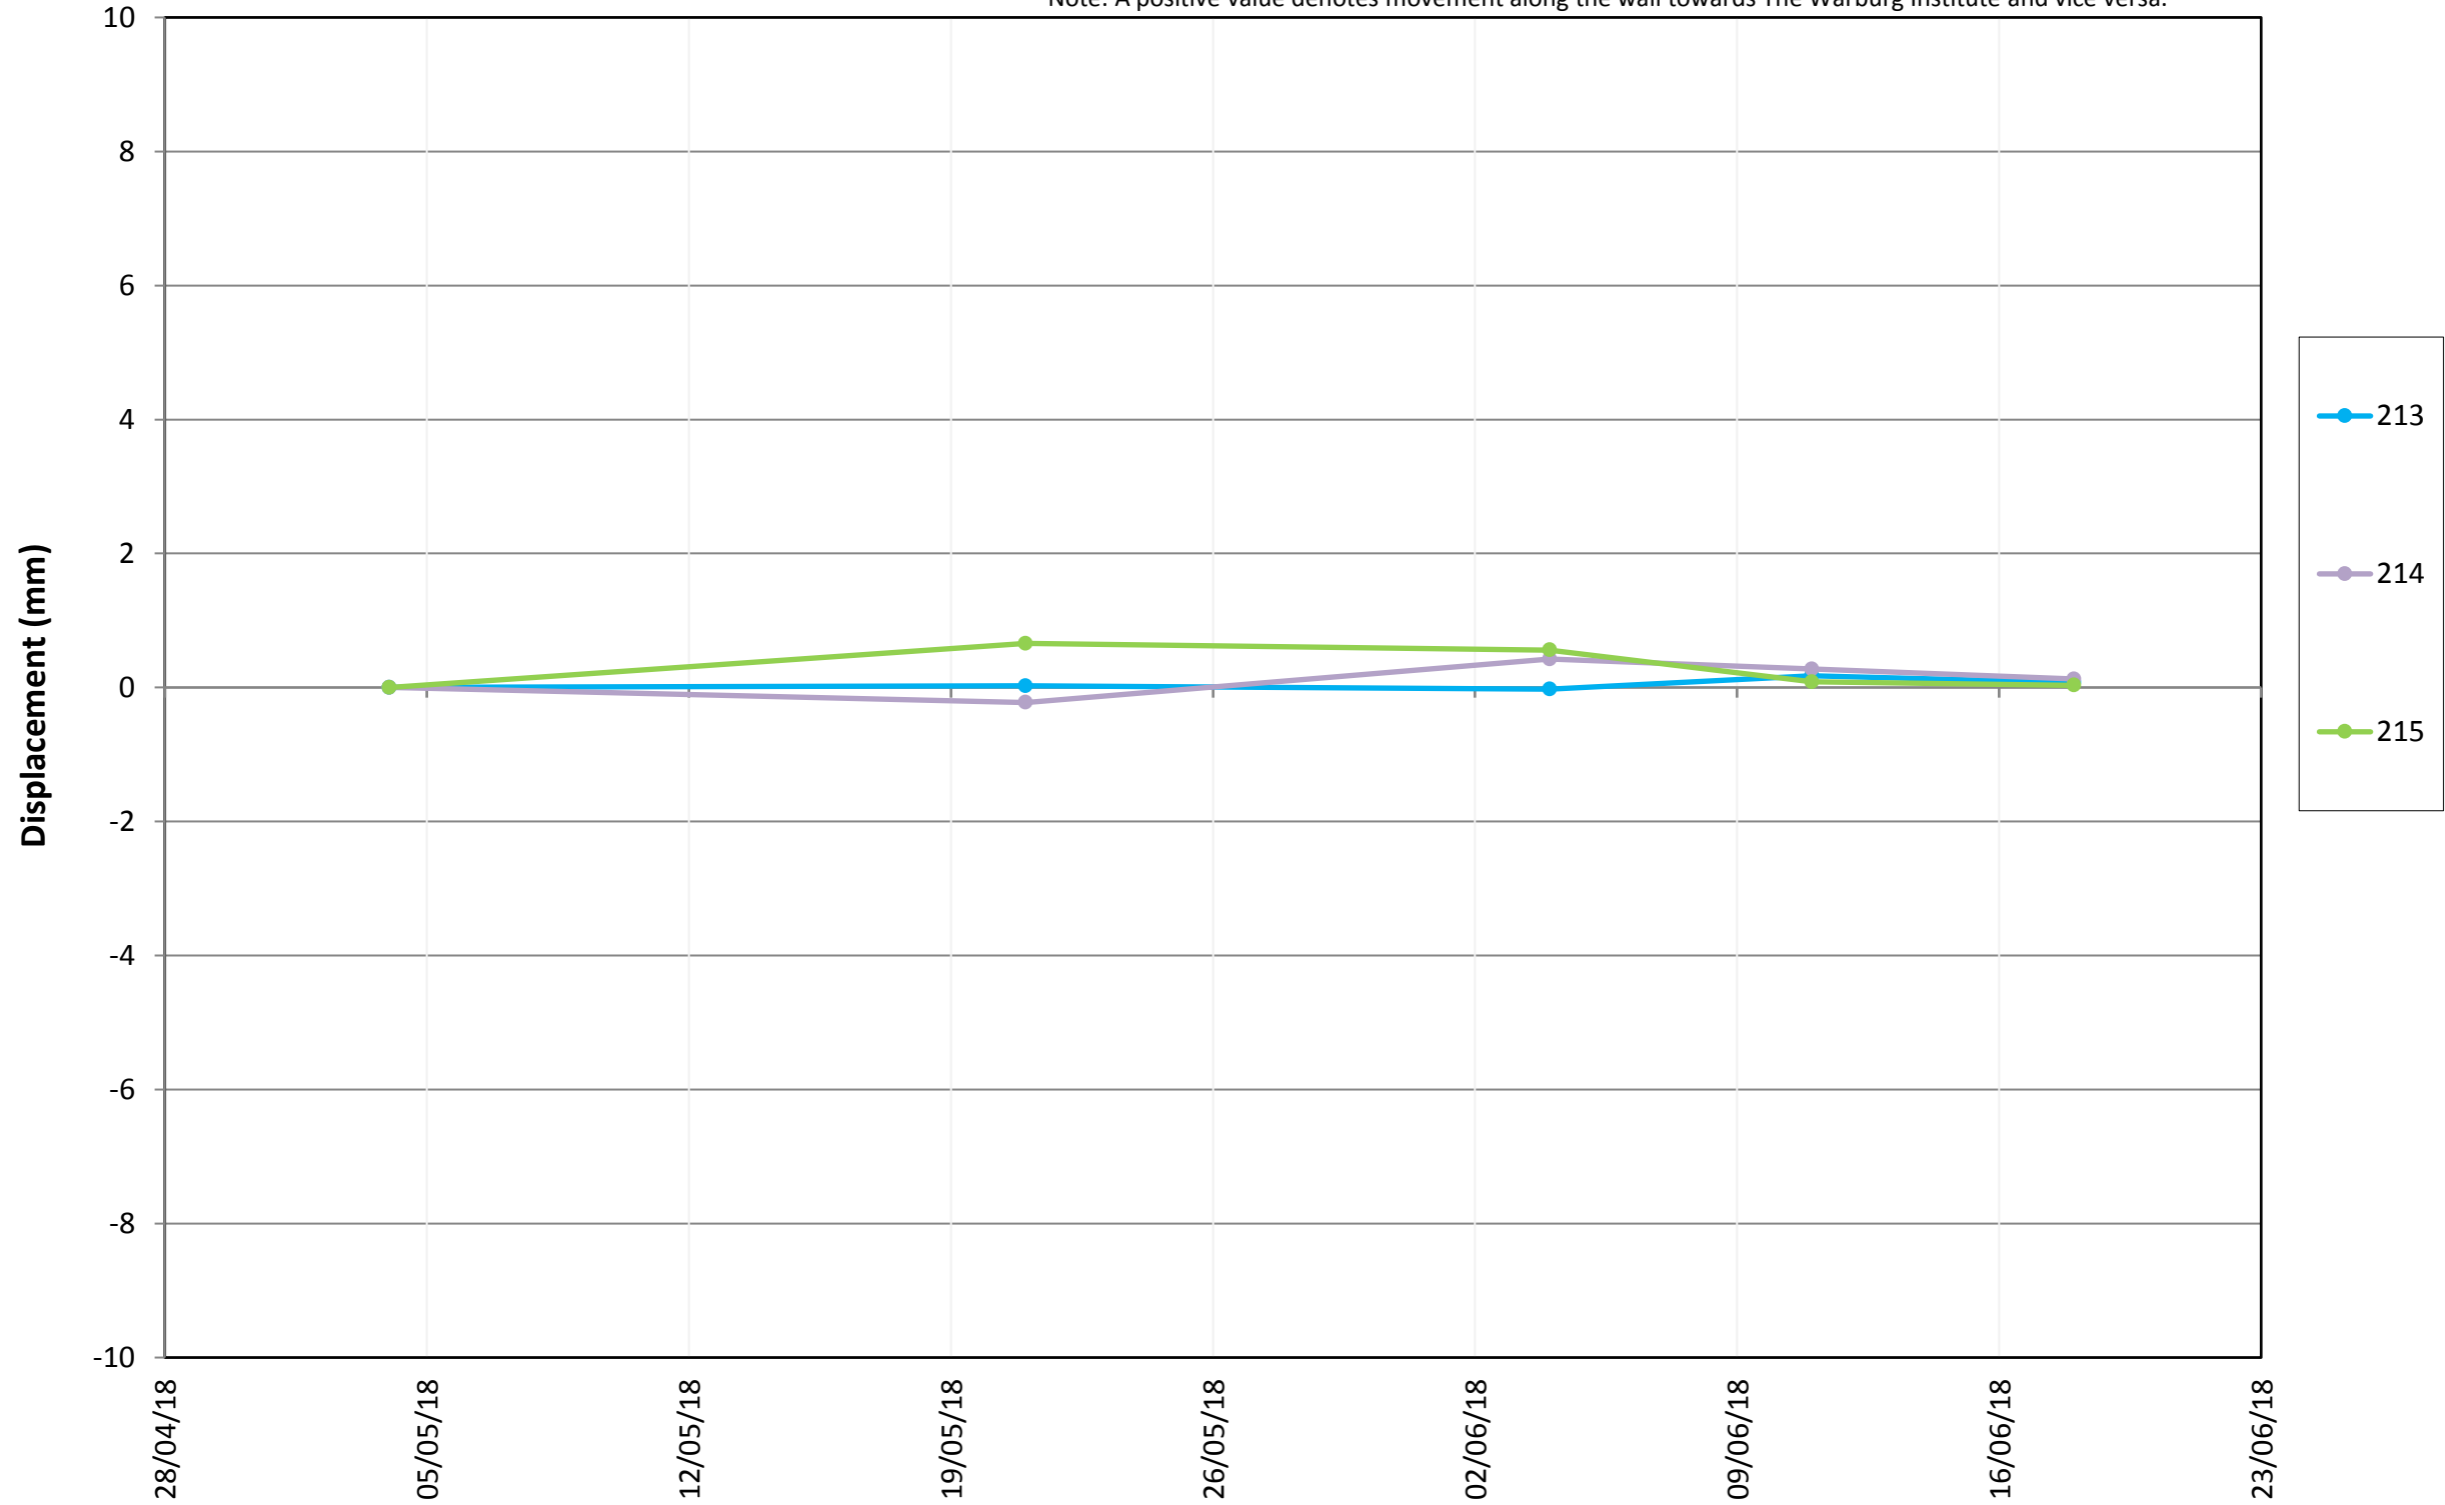
Graph 03L - Targets on Rear Elevation of The Warburg Institute

Note: A positive value denotes movement along the wall towards The Warburg Institute and vice versa.

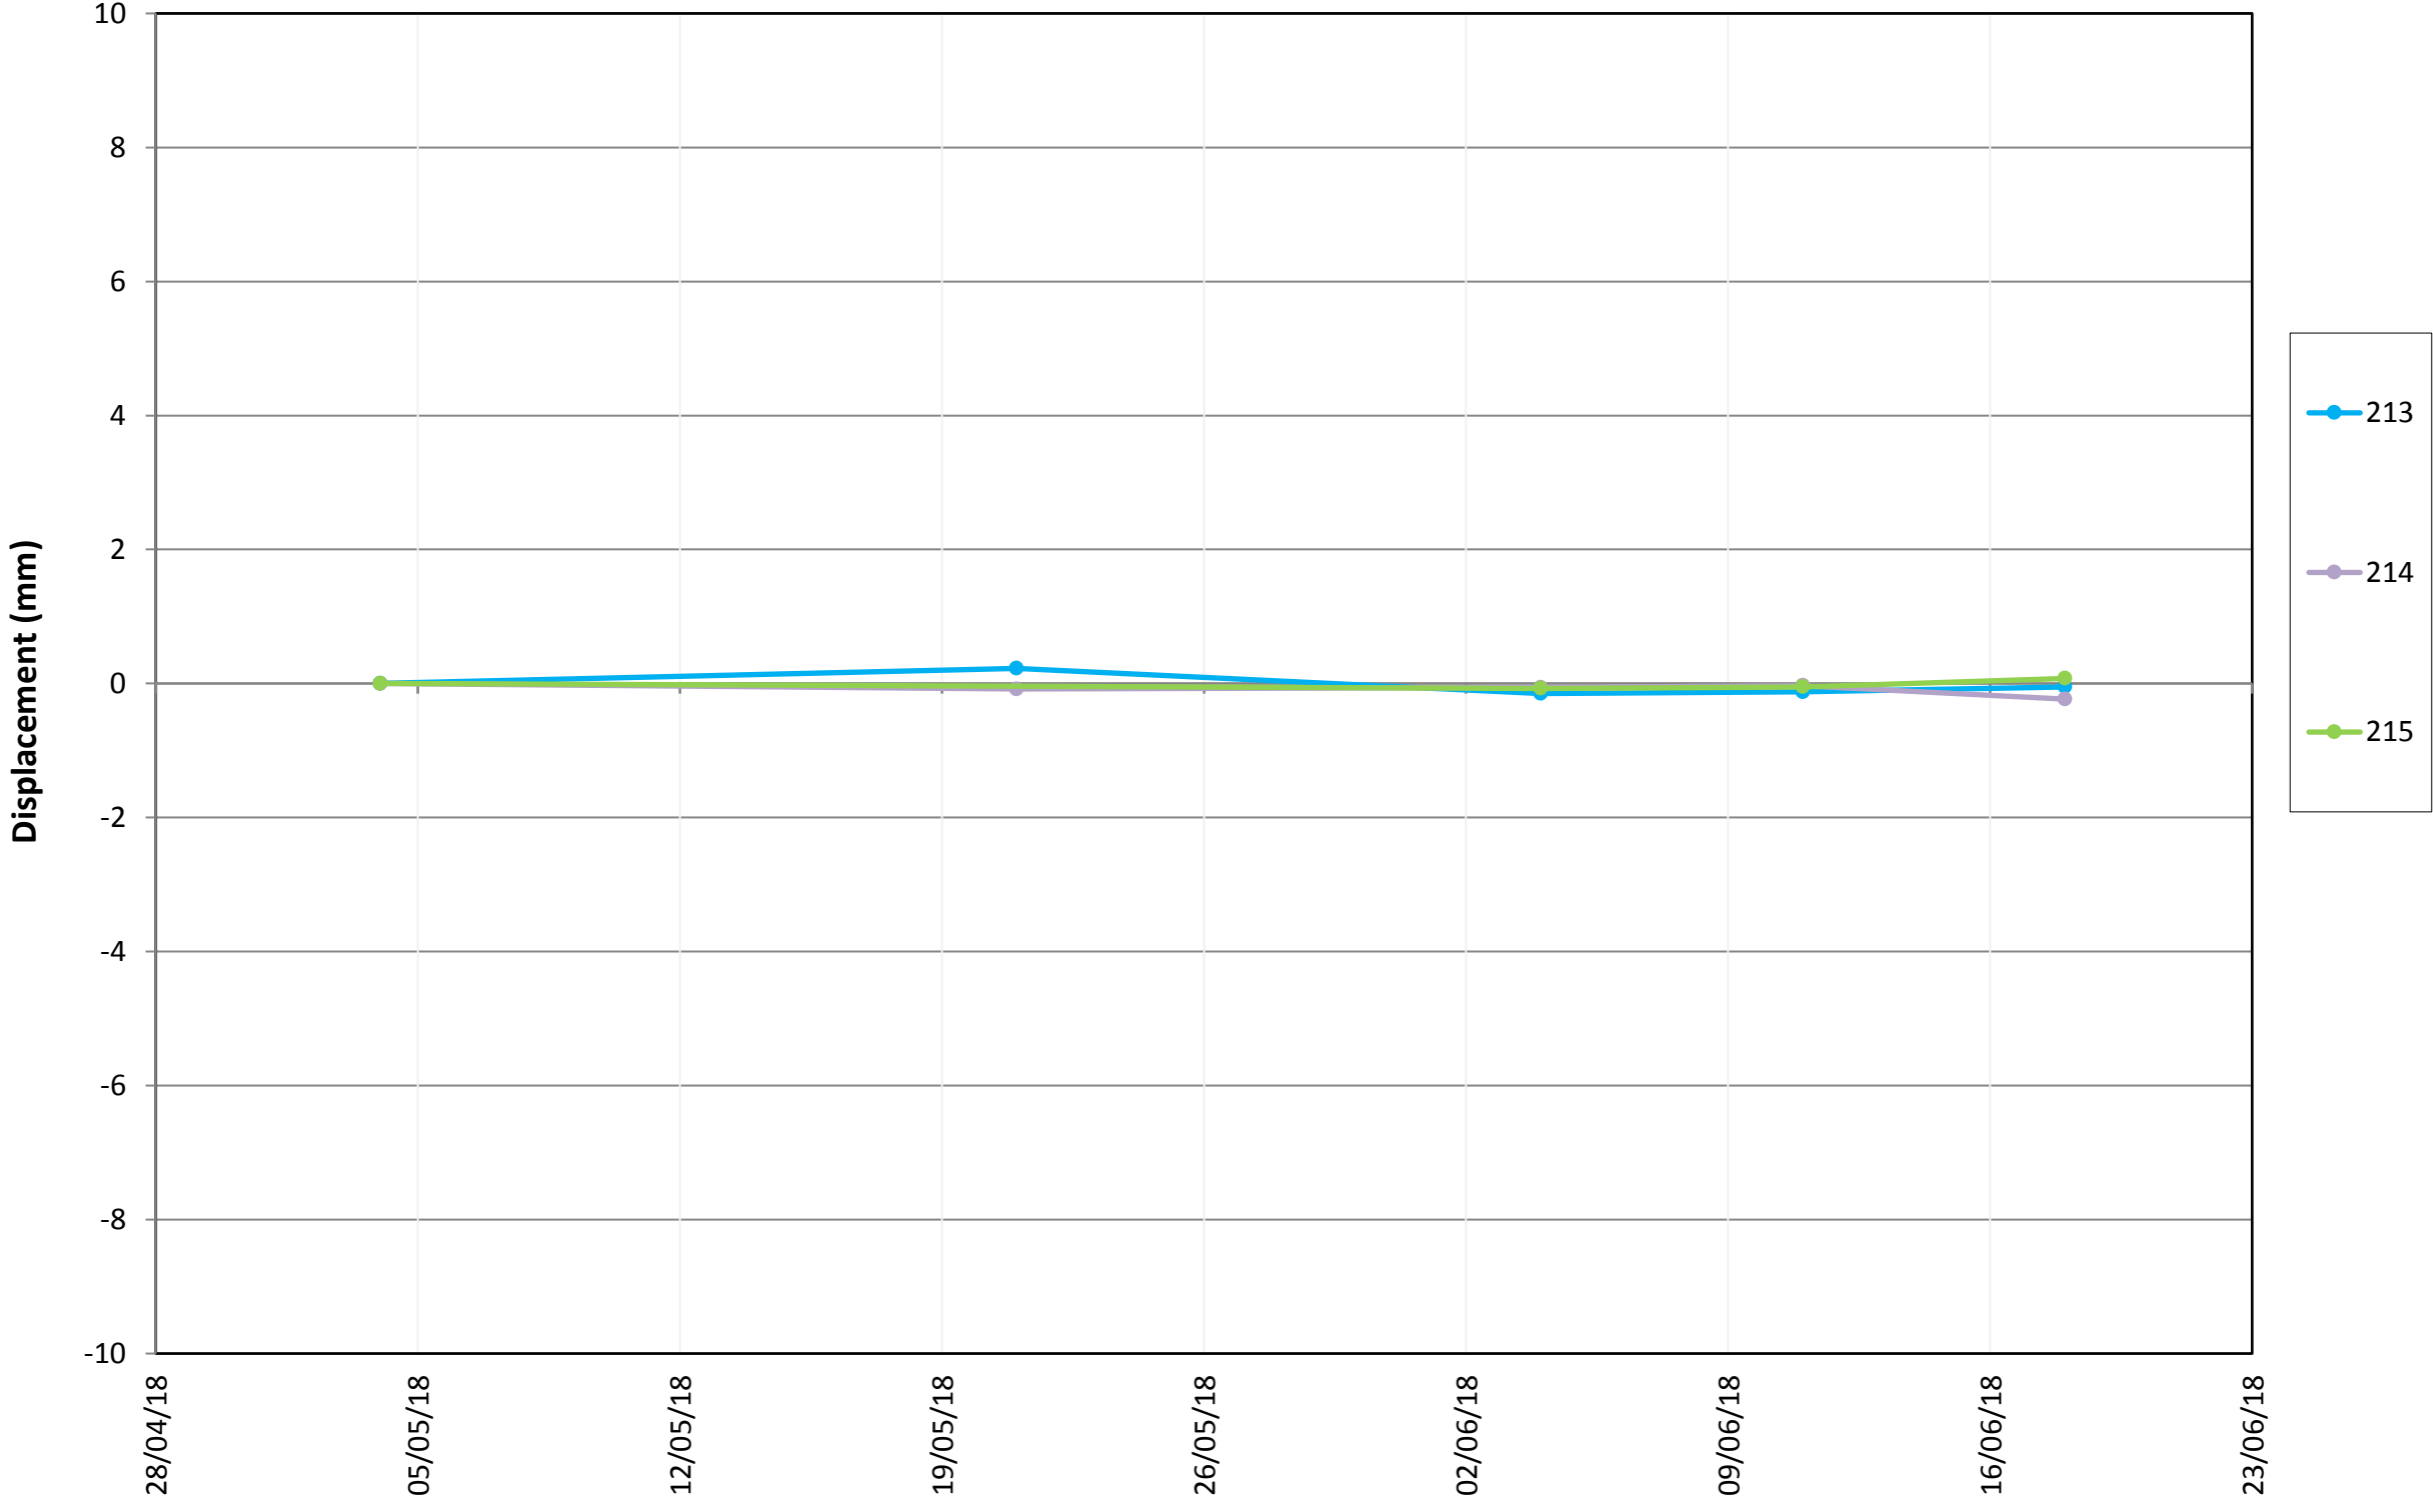
Graph 03V - Targets on Rear Elevation of The Warburg Institute

Note: +ve value denotes heave, -ve value denotes settlement.

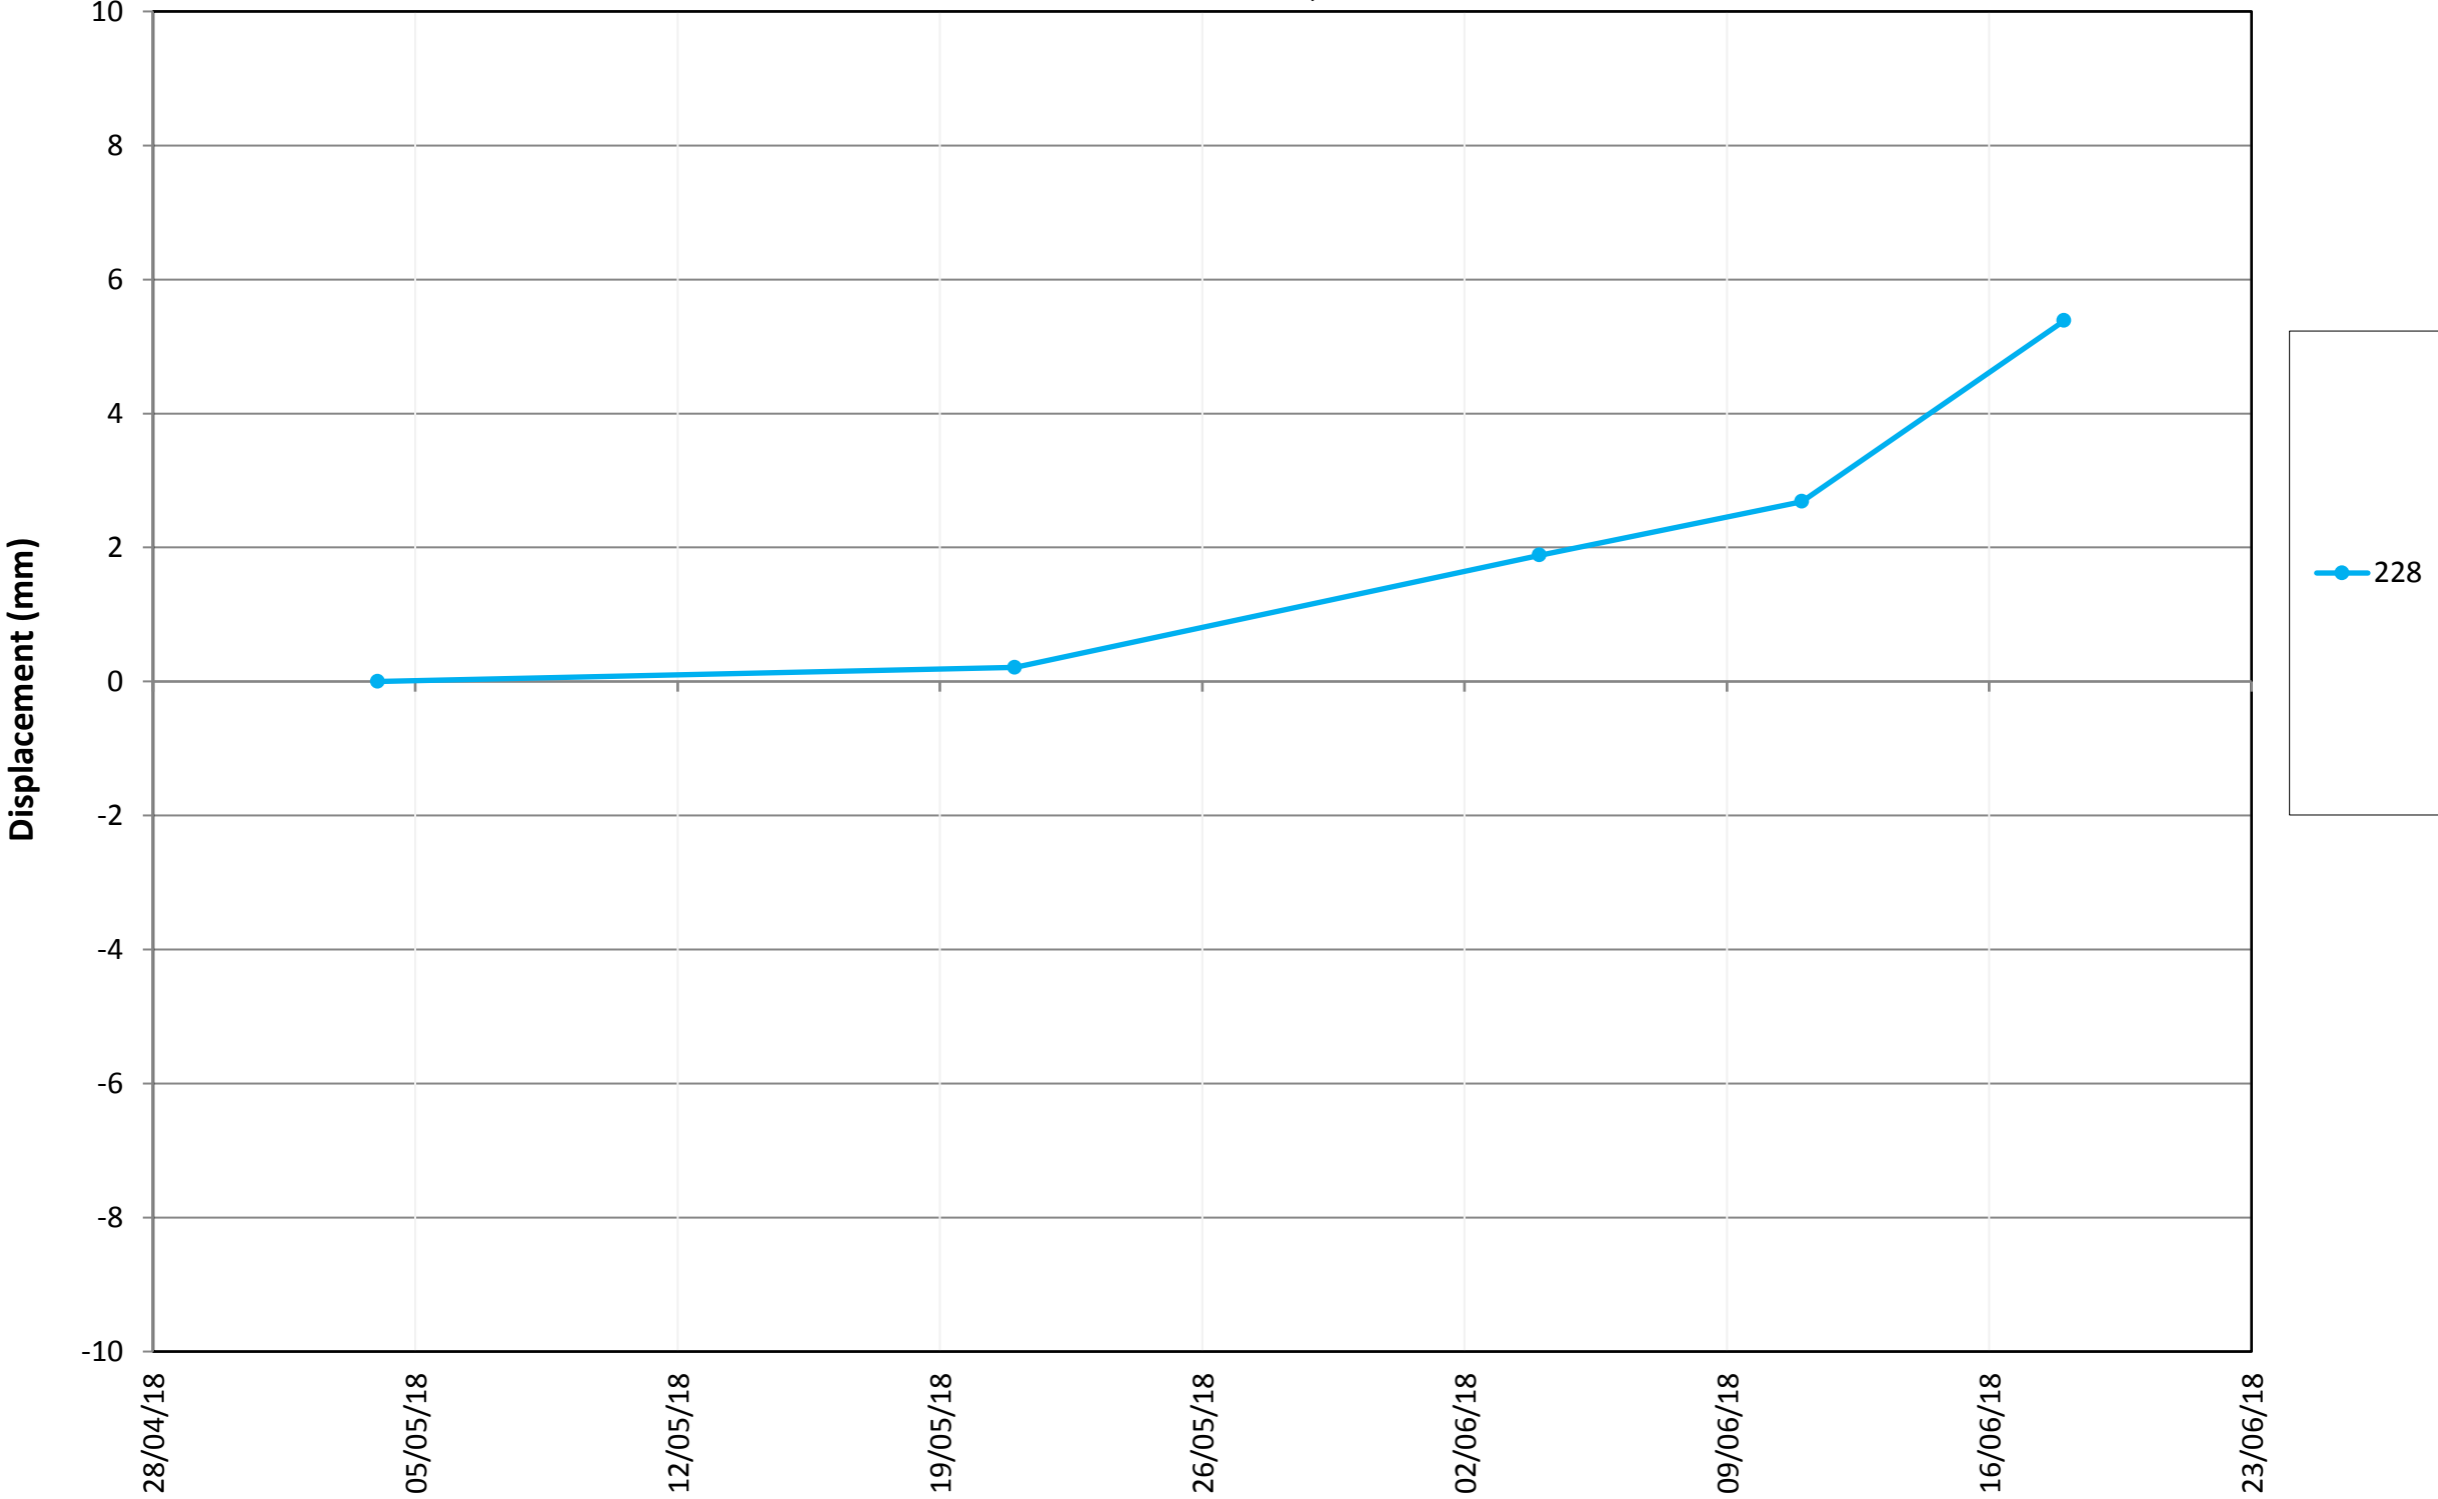
Graph 06T - Targets on back garden of No. 31 Torrington Square

Targets are showing horizontal movement of up to 5 mm in Eastings.
Targets are showing negligible vertical movement.

Note: A positive value denotes movement towards Slade Research Centre and vice versa.

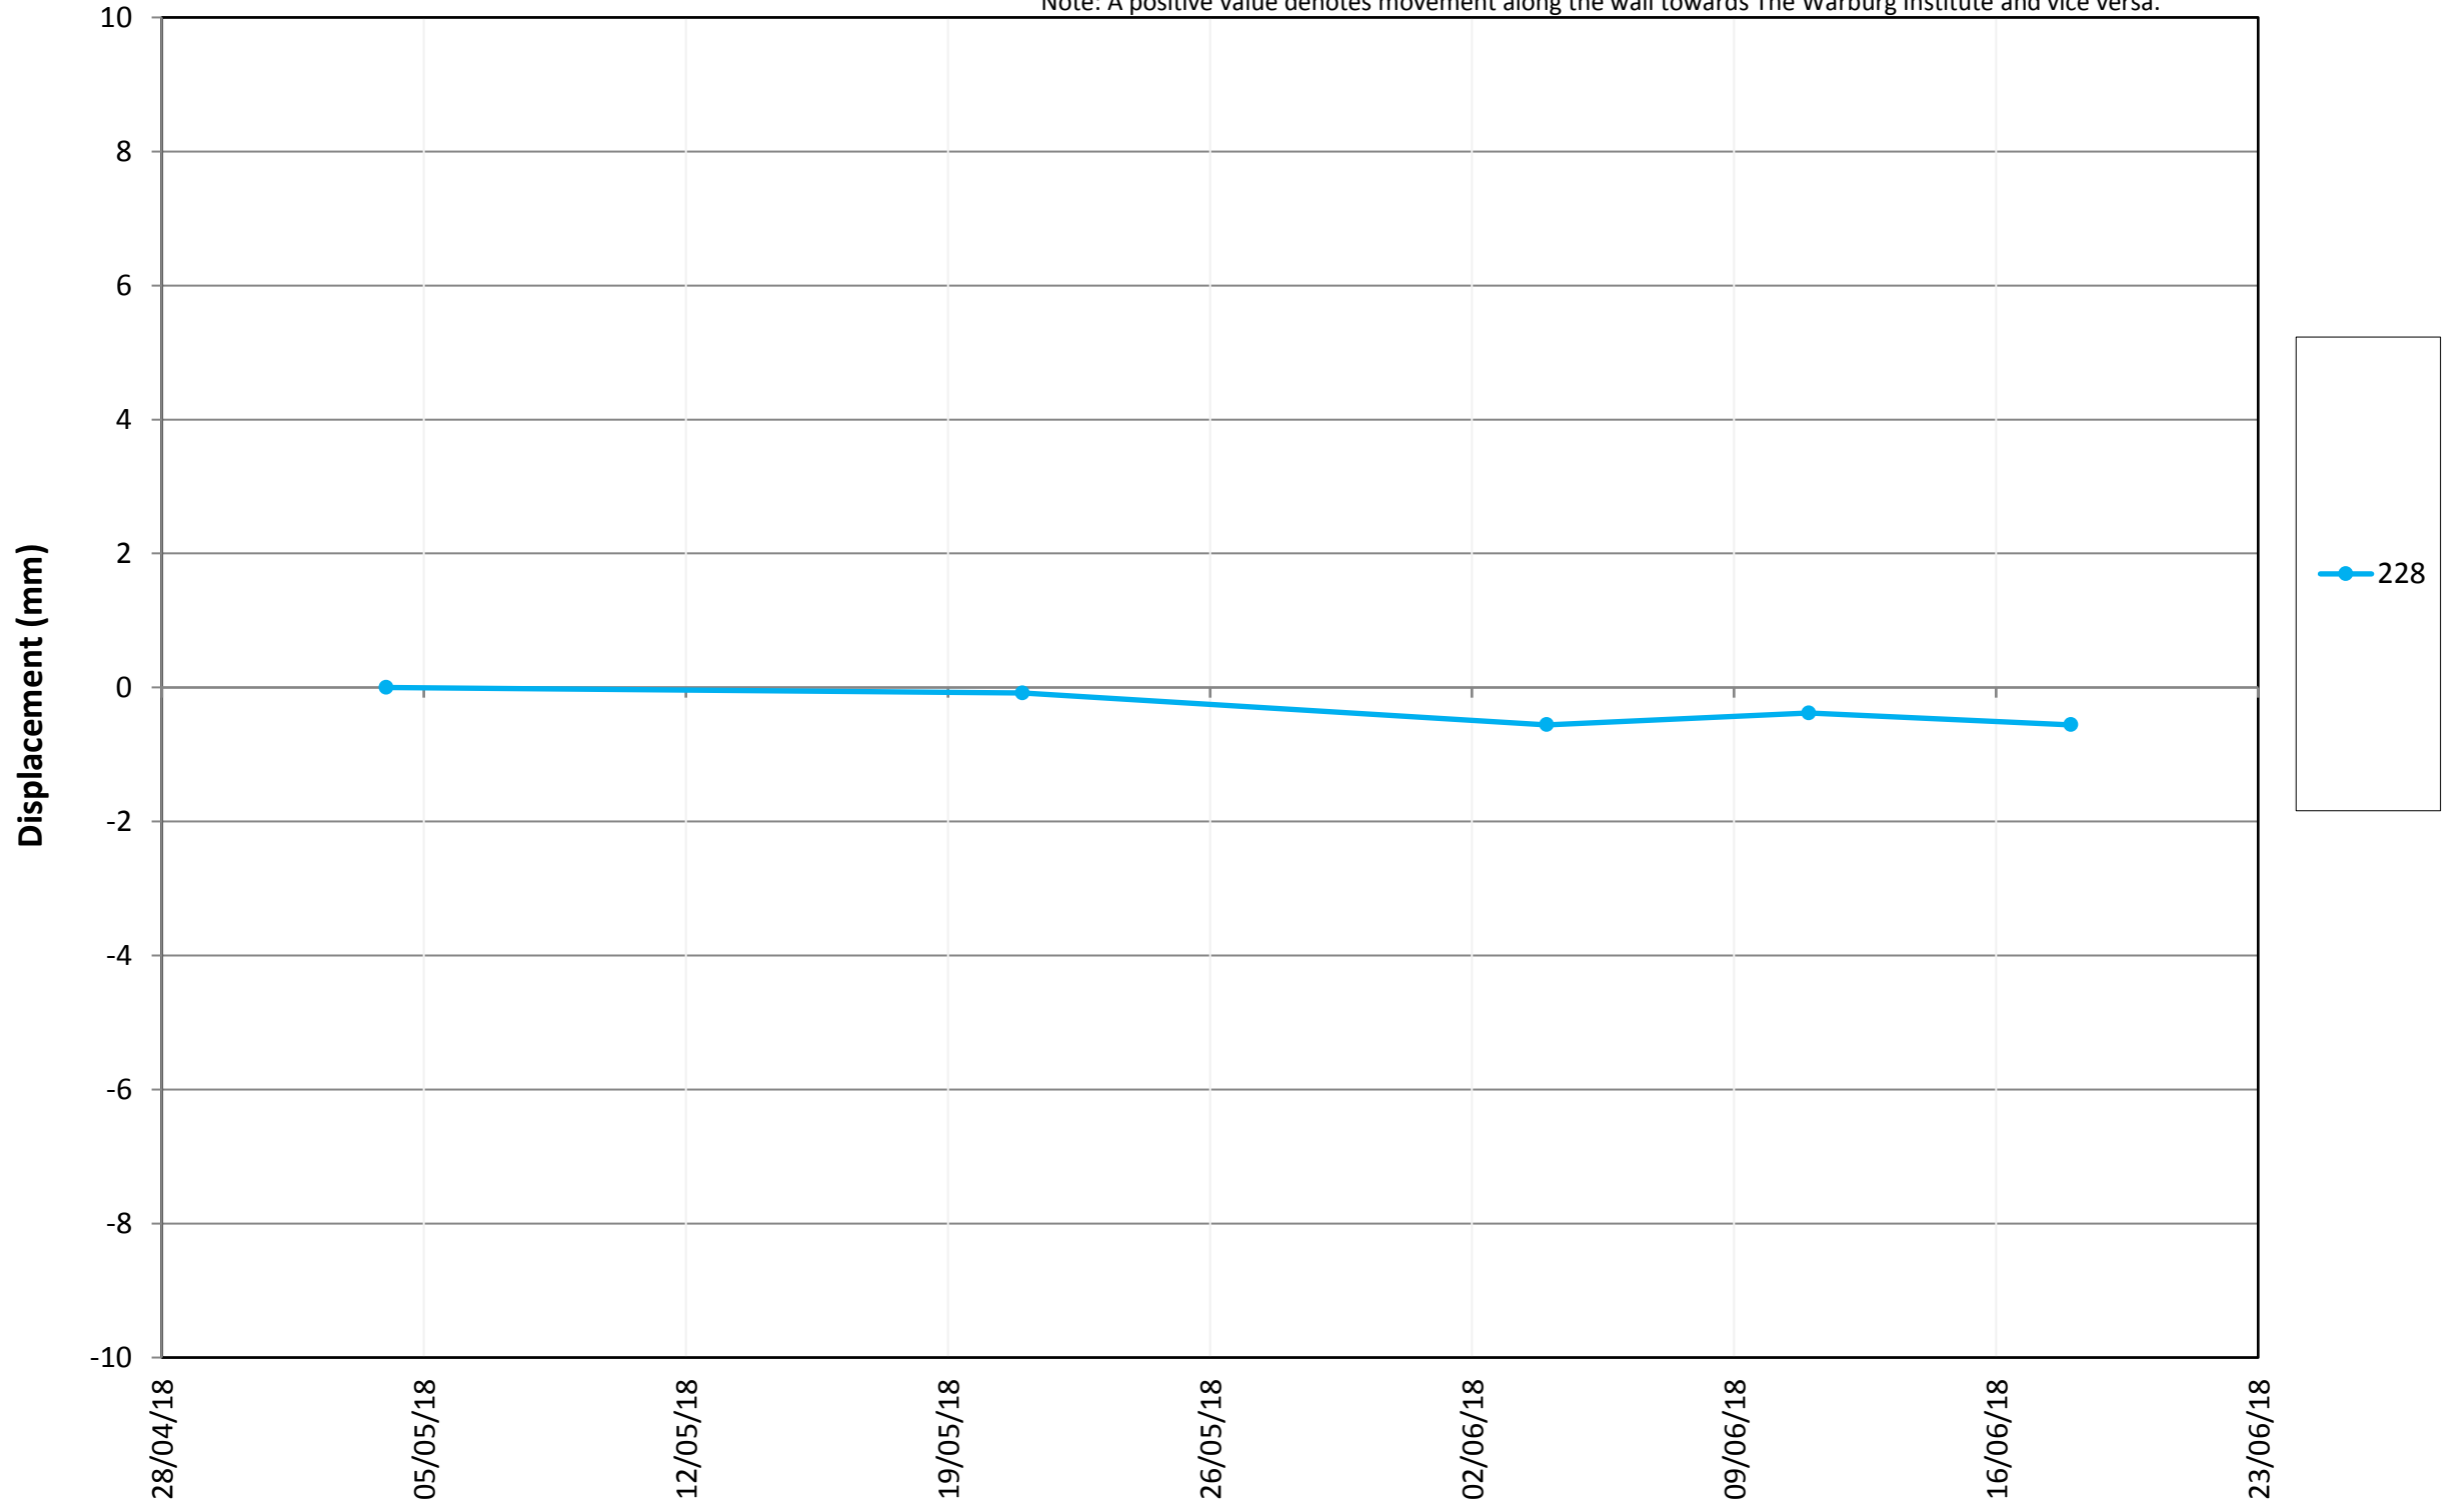
Graph 06L - Targets on back garden of No. 31 Torrington Square

Note: A positive value denotes movement along the wall towards The Warburg Institute and vice versa.

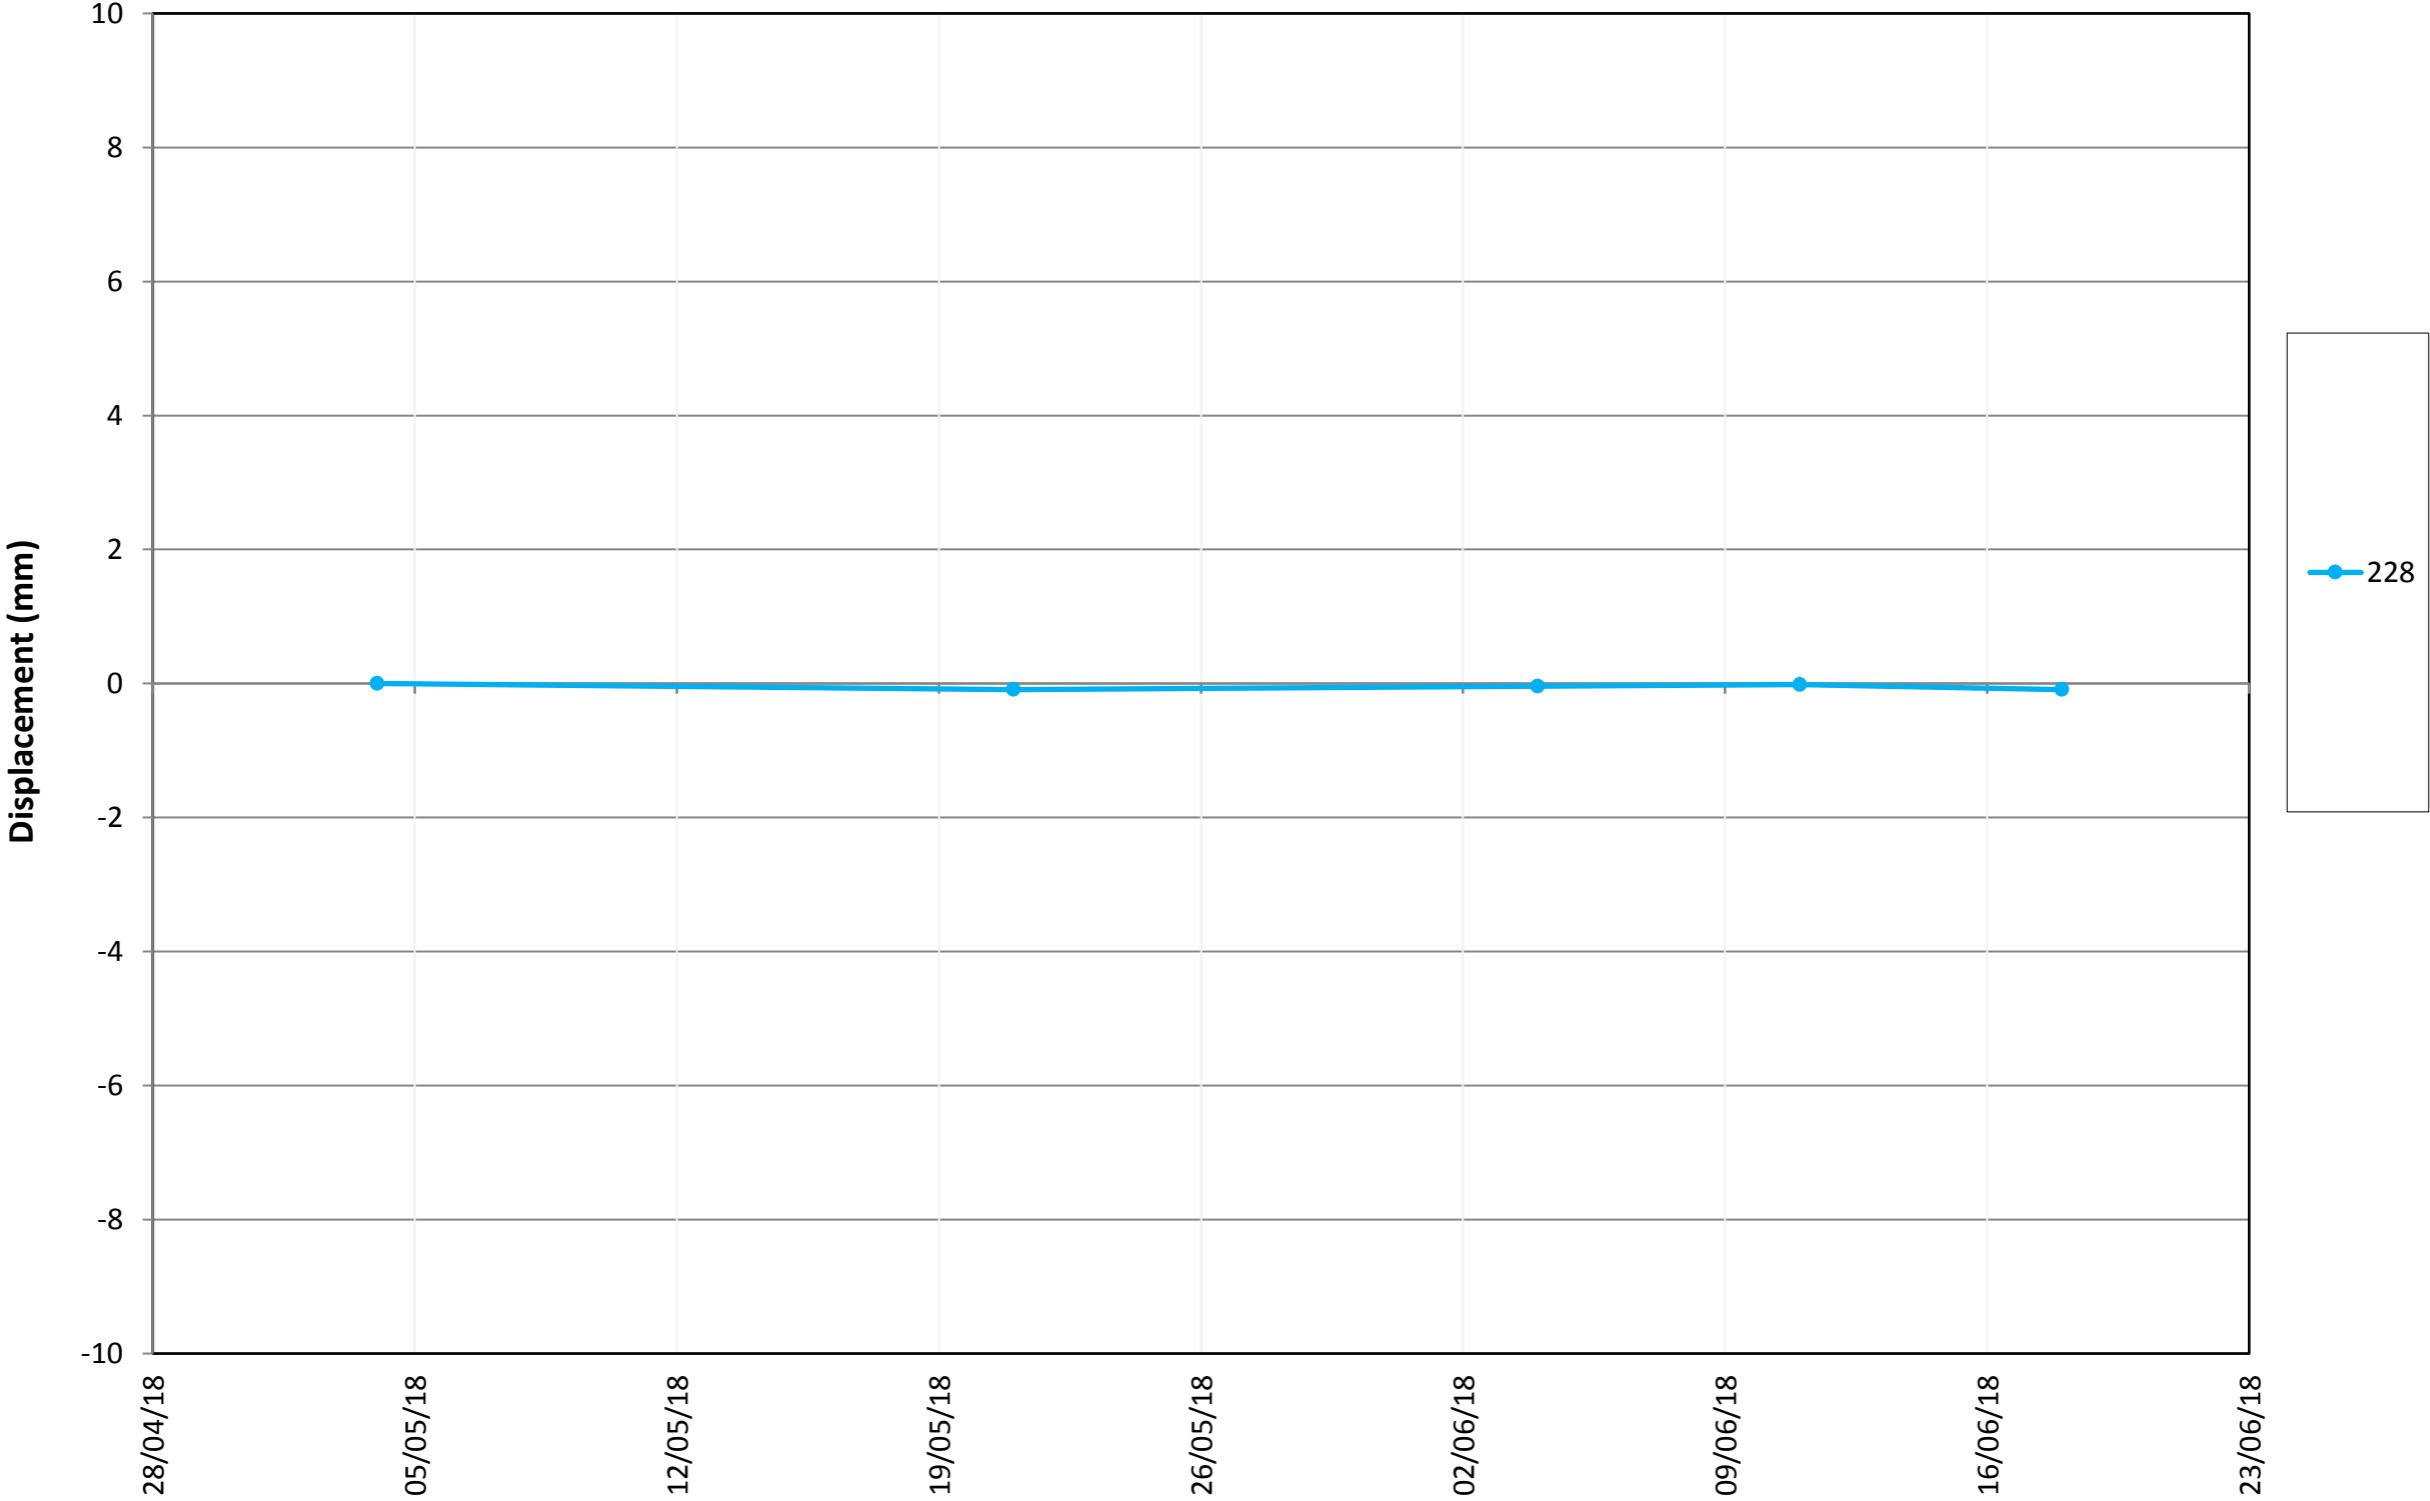
Graph 06V - Targets on back garden of No. 31 Torrington Square

Note: +ve value denotes heave, -ve value denotes settlement.
