32-33 TORRINGTON SQUARE
MONITORING

Monitoring Report
SES-10215-MR04

Date of survey completion: 18th June 2018

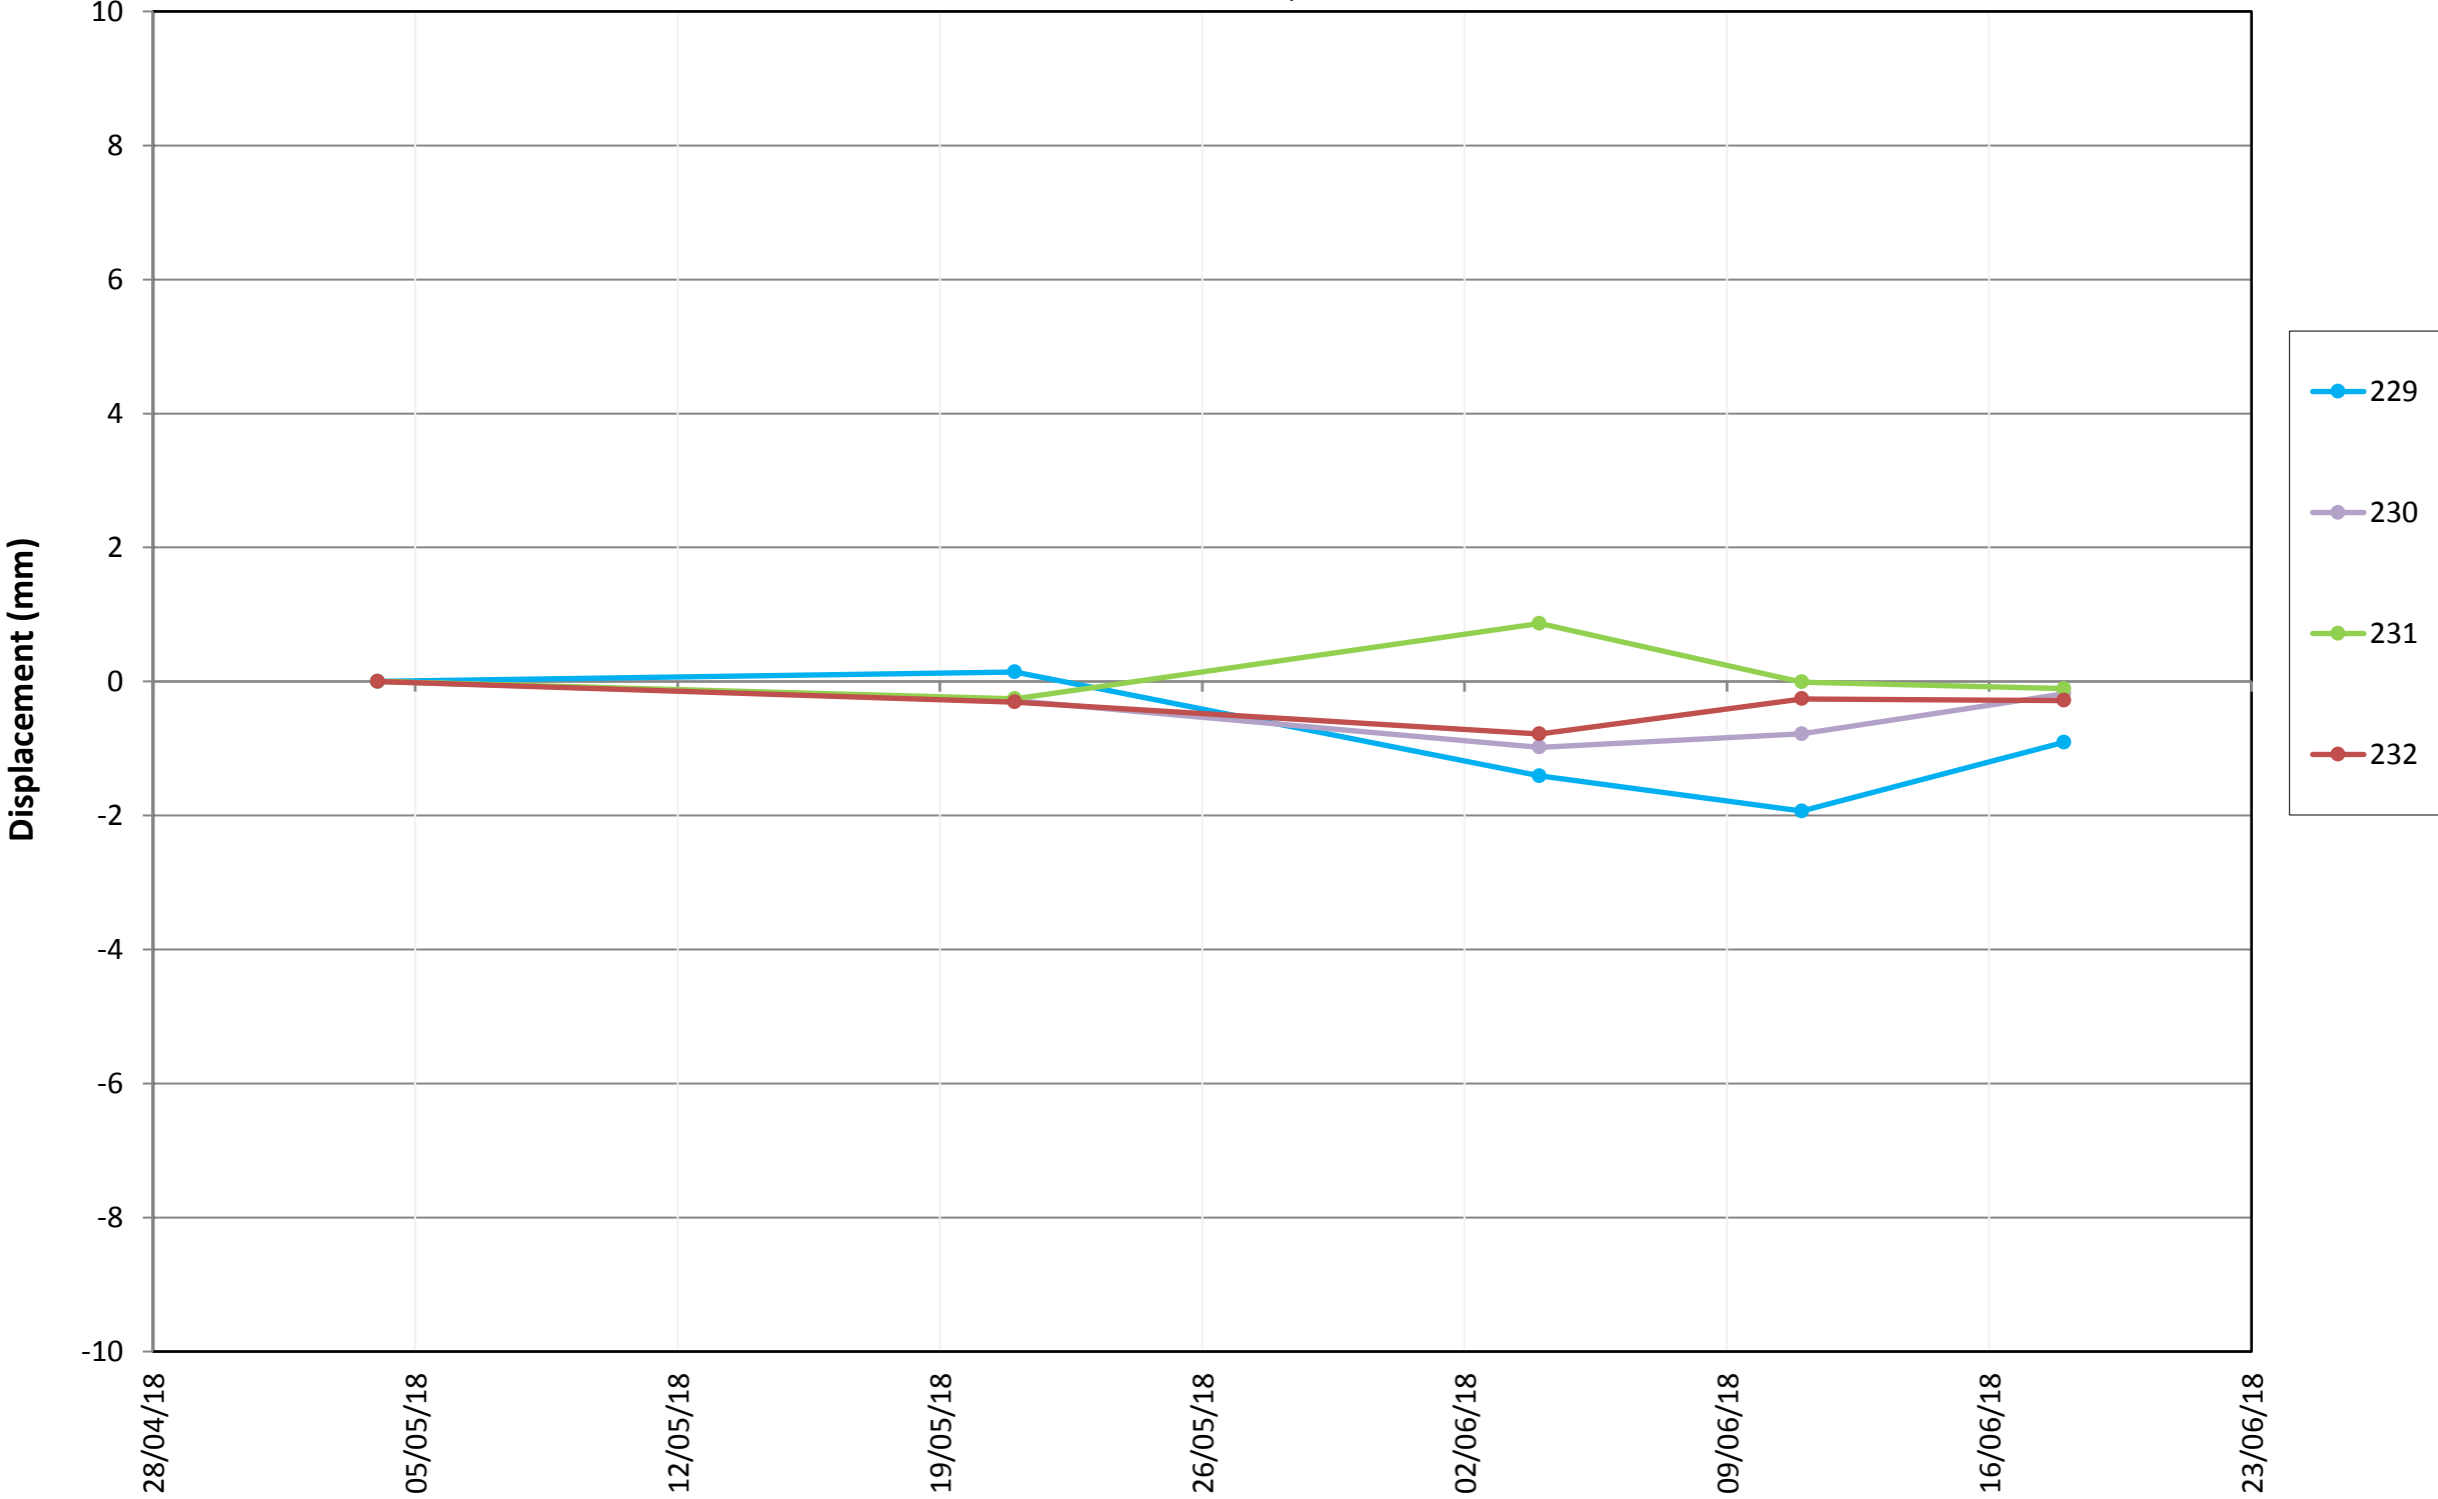
Graph 07T - Targets on back garden of No. 32 Torrington Square

Targets are showing negligible horizontal movement.
Targets are showing negligible vertical movement.
Target 233 was obstructed by leaves.

Note: A positive value denotes movement towards Slade Research Centre and vice versa.

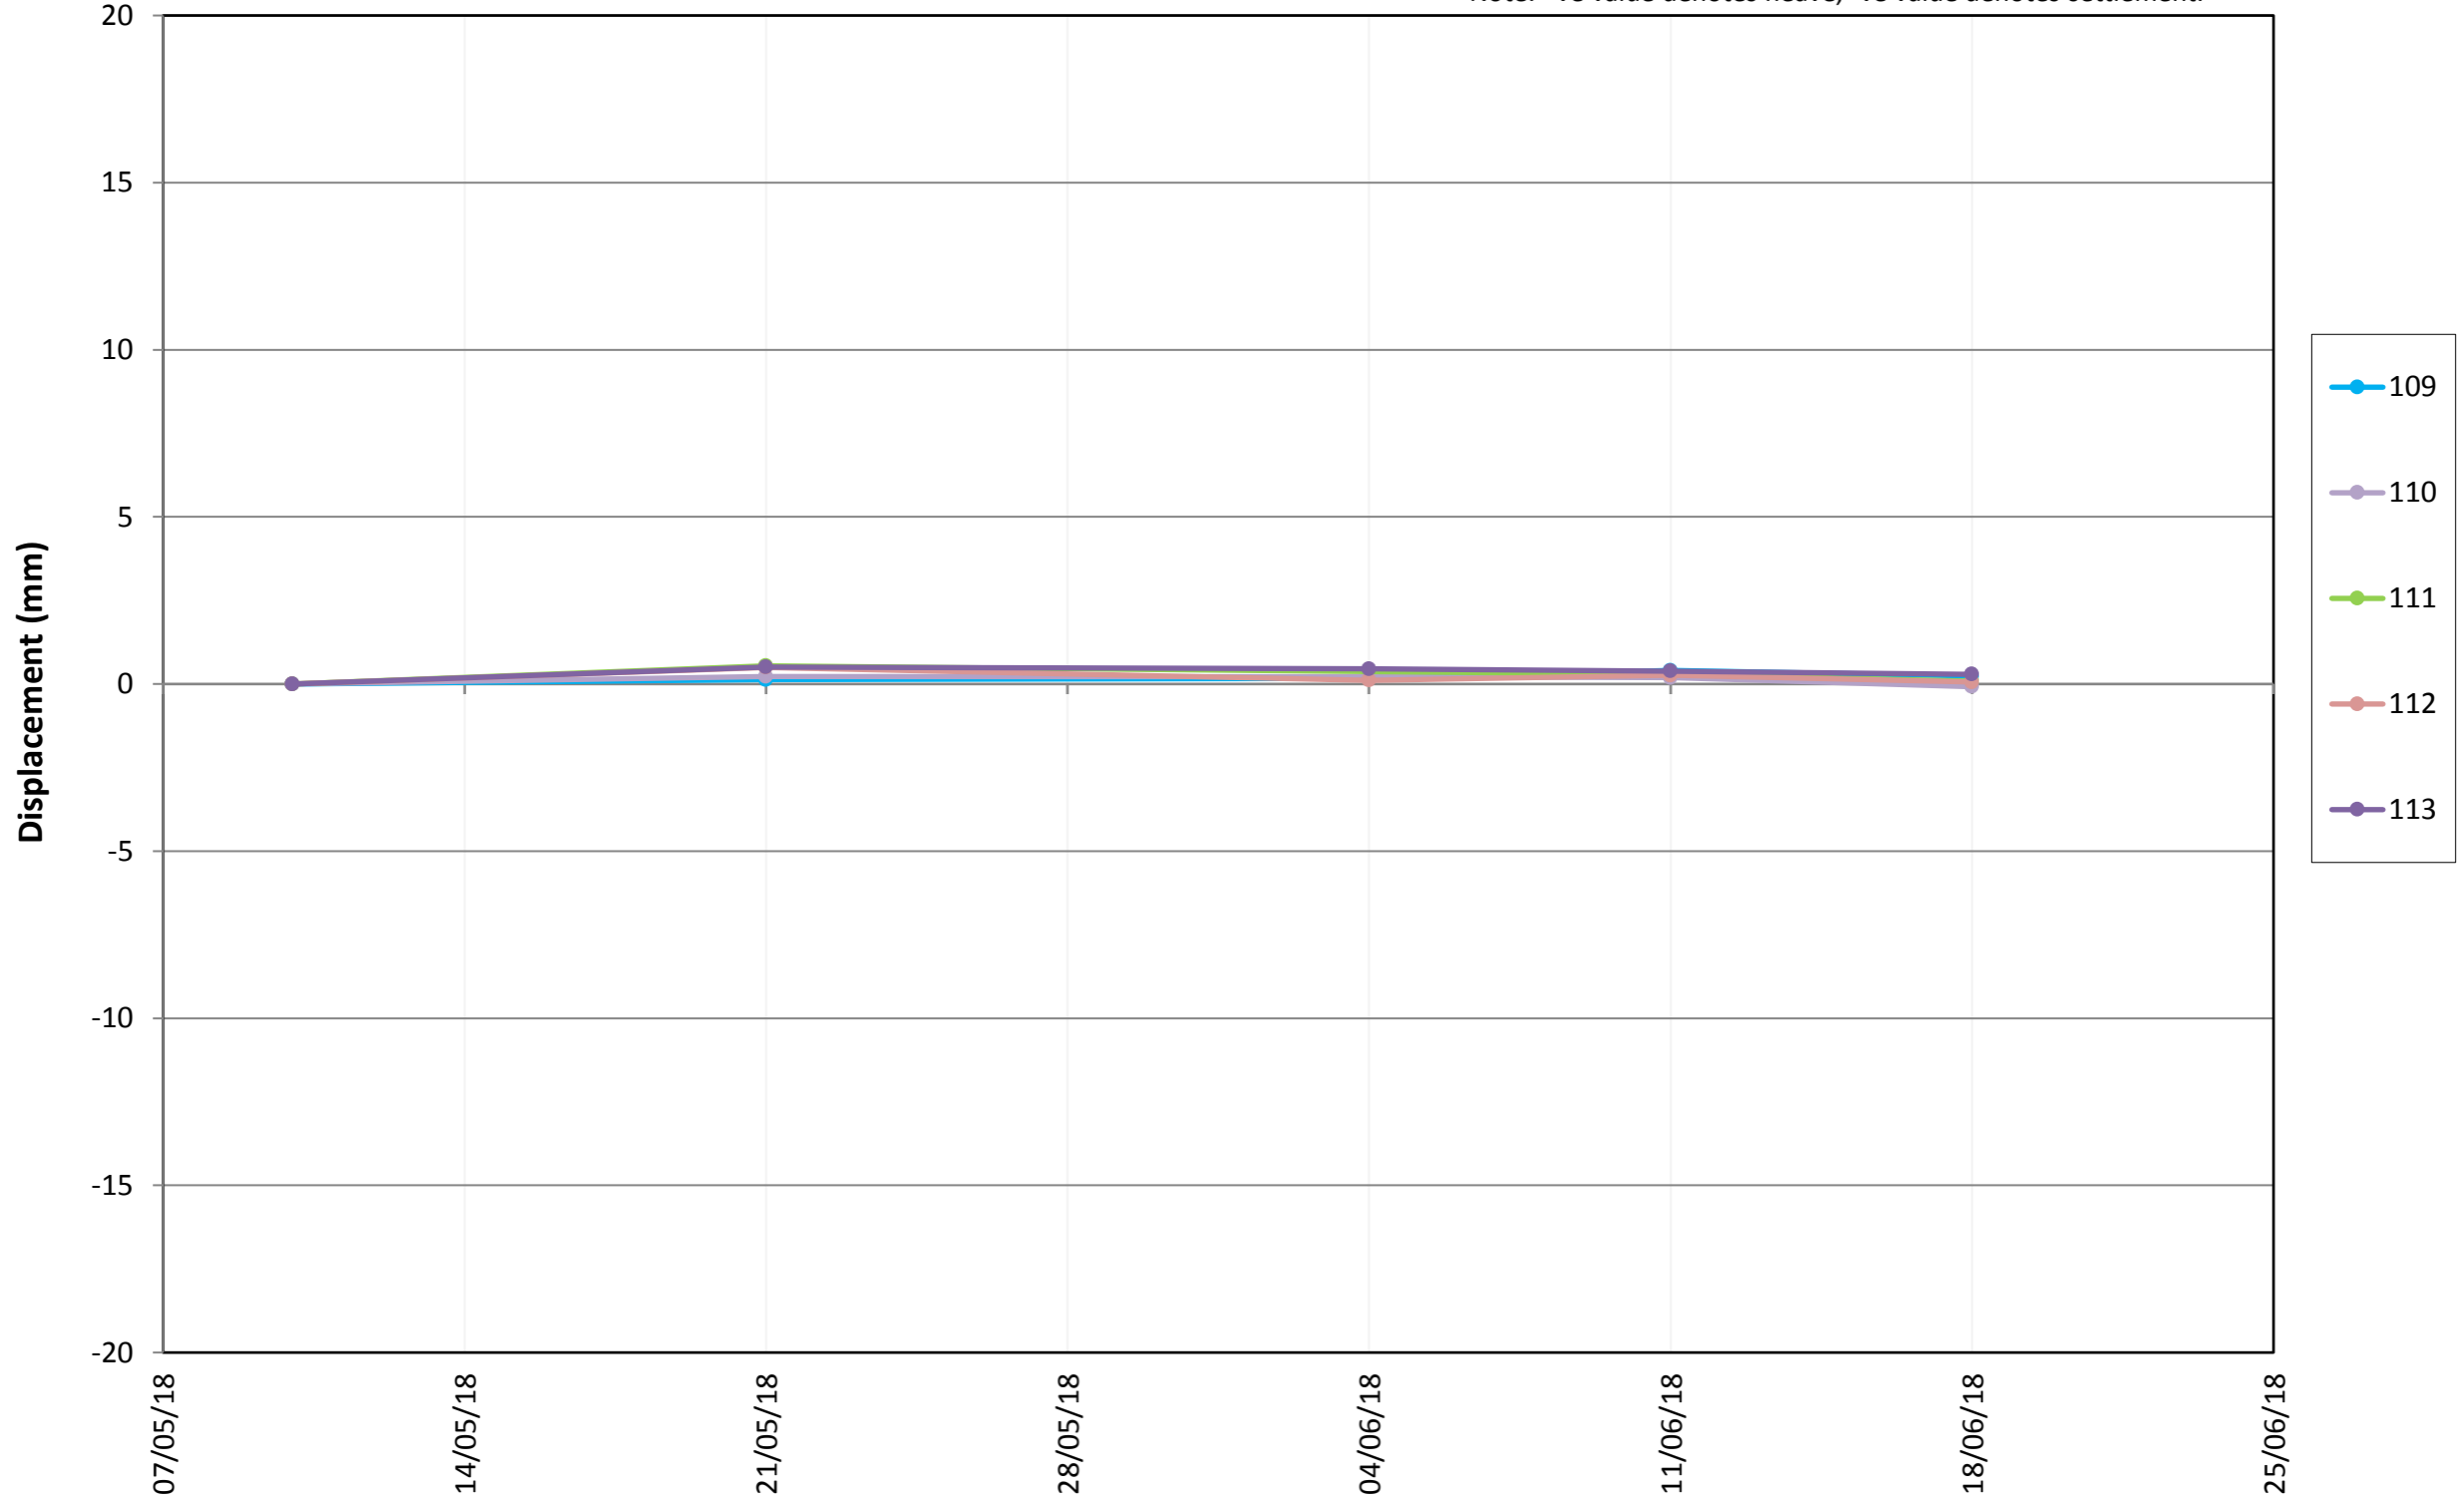
Graph 03 - Precise Level Points along courtyard

Precise level points are showing negligible movement.

Precise level 111 point was found disturbed by digger.

Note: +ve value denotes heave, -ve value denotes settlement.

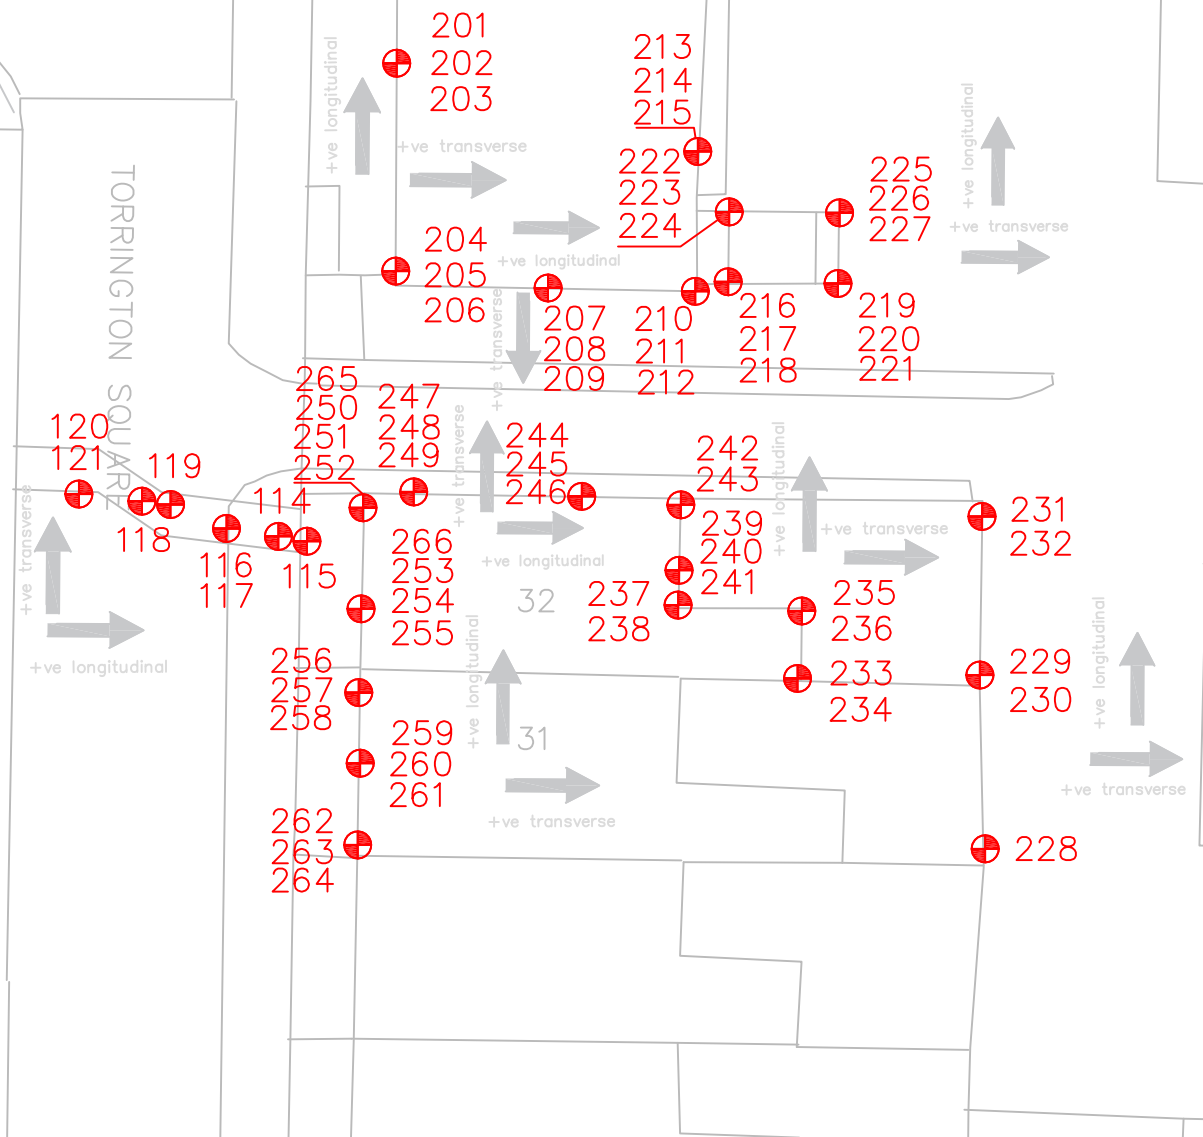
Monitoring 3D Targets Location Plan

Coordinate system orientated to be square with elevation of Nos. 32-33 Torrington Square
