32-33 TORRINGTON SQUARE  
MONITORING

Monitoring Report  
SES-10215-MR05

Date of survey completion: 25<sup>th</sup> June 2018

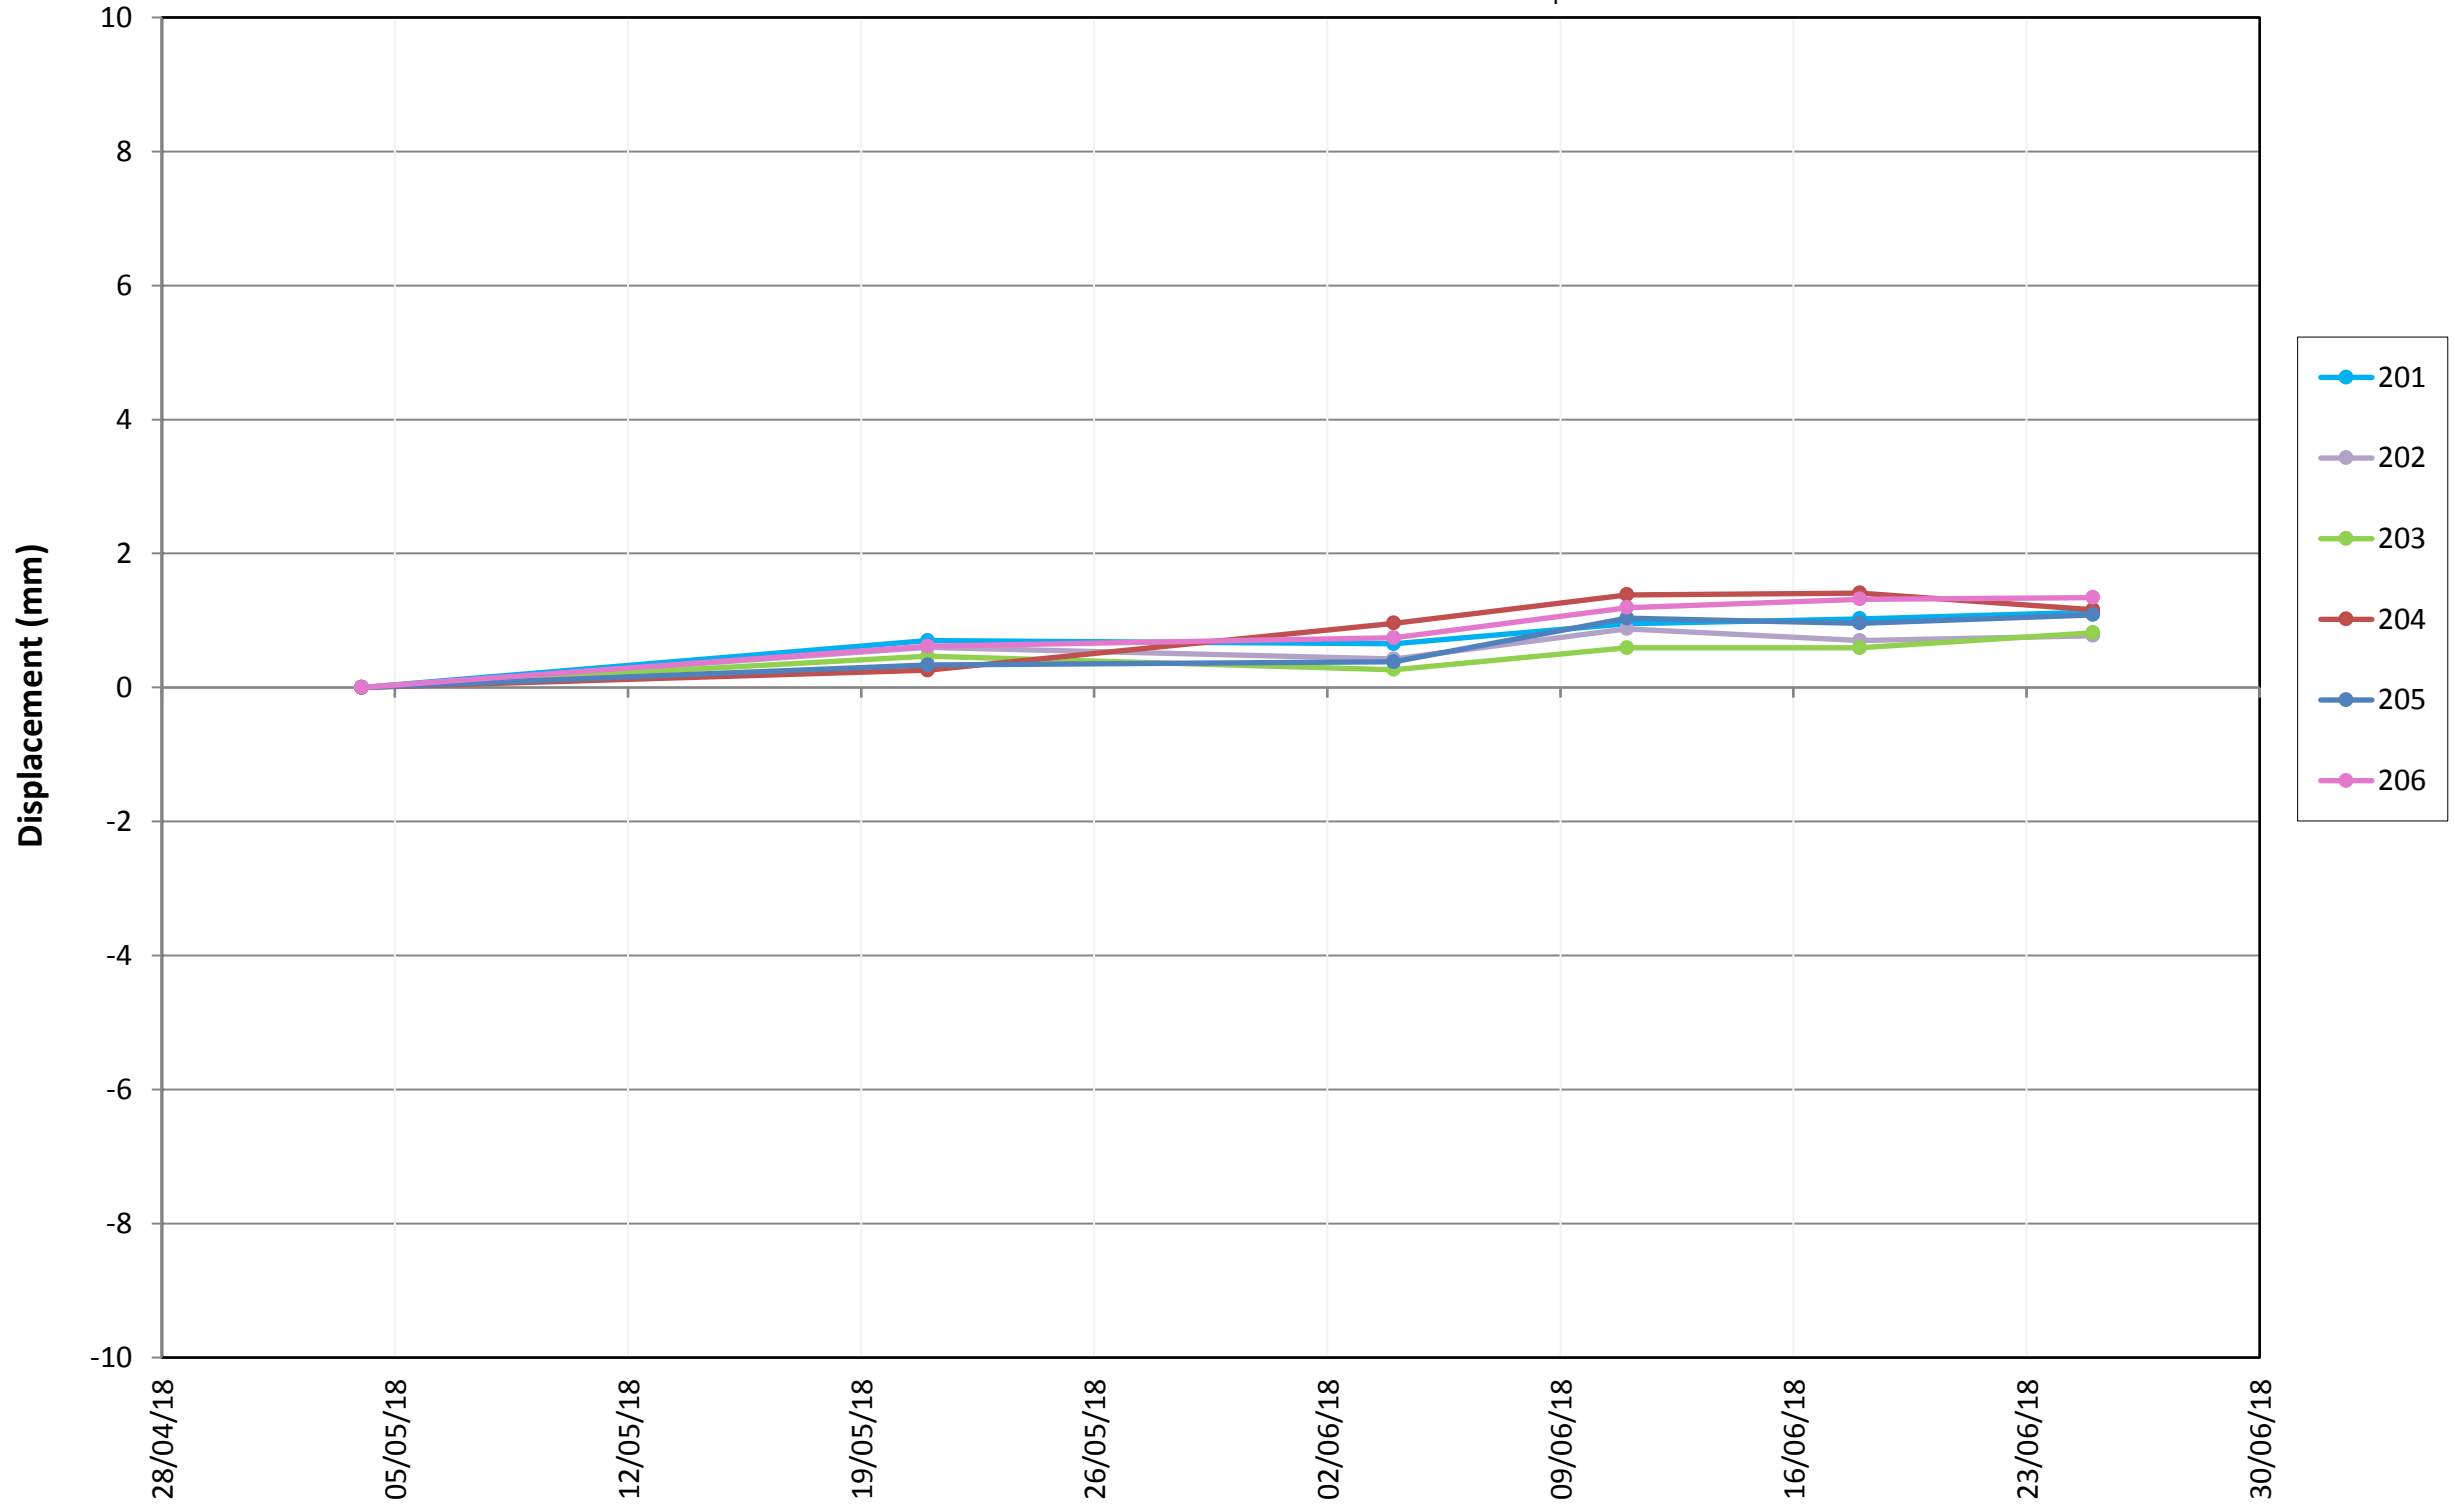
Graph 01T - Targets on Front Elevation of The Warburg Institute

Targets are showing negligible horizontal movement.  
Targets are showing negligible vertical movement.

Note: A positive value denotes movement in to site and vice versa.

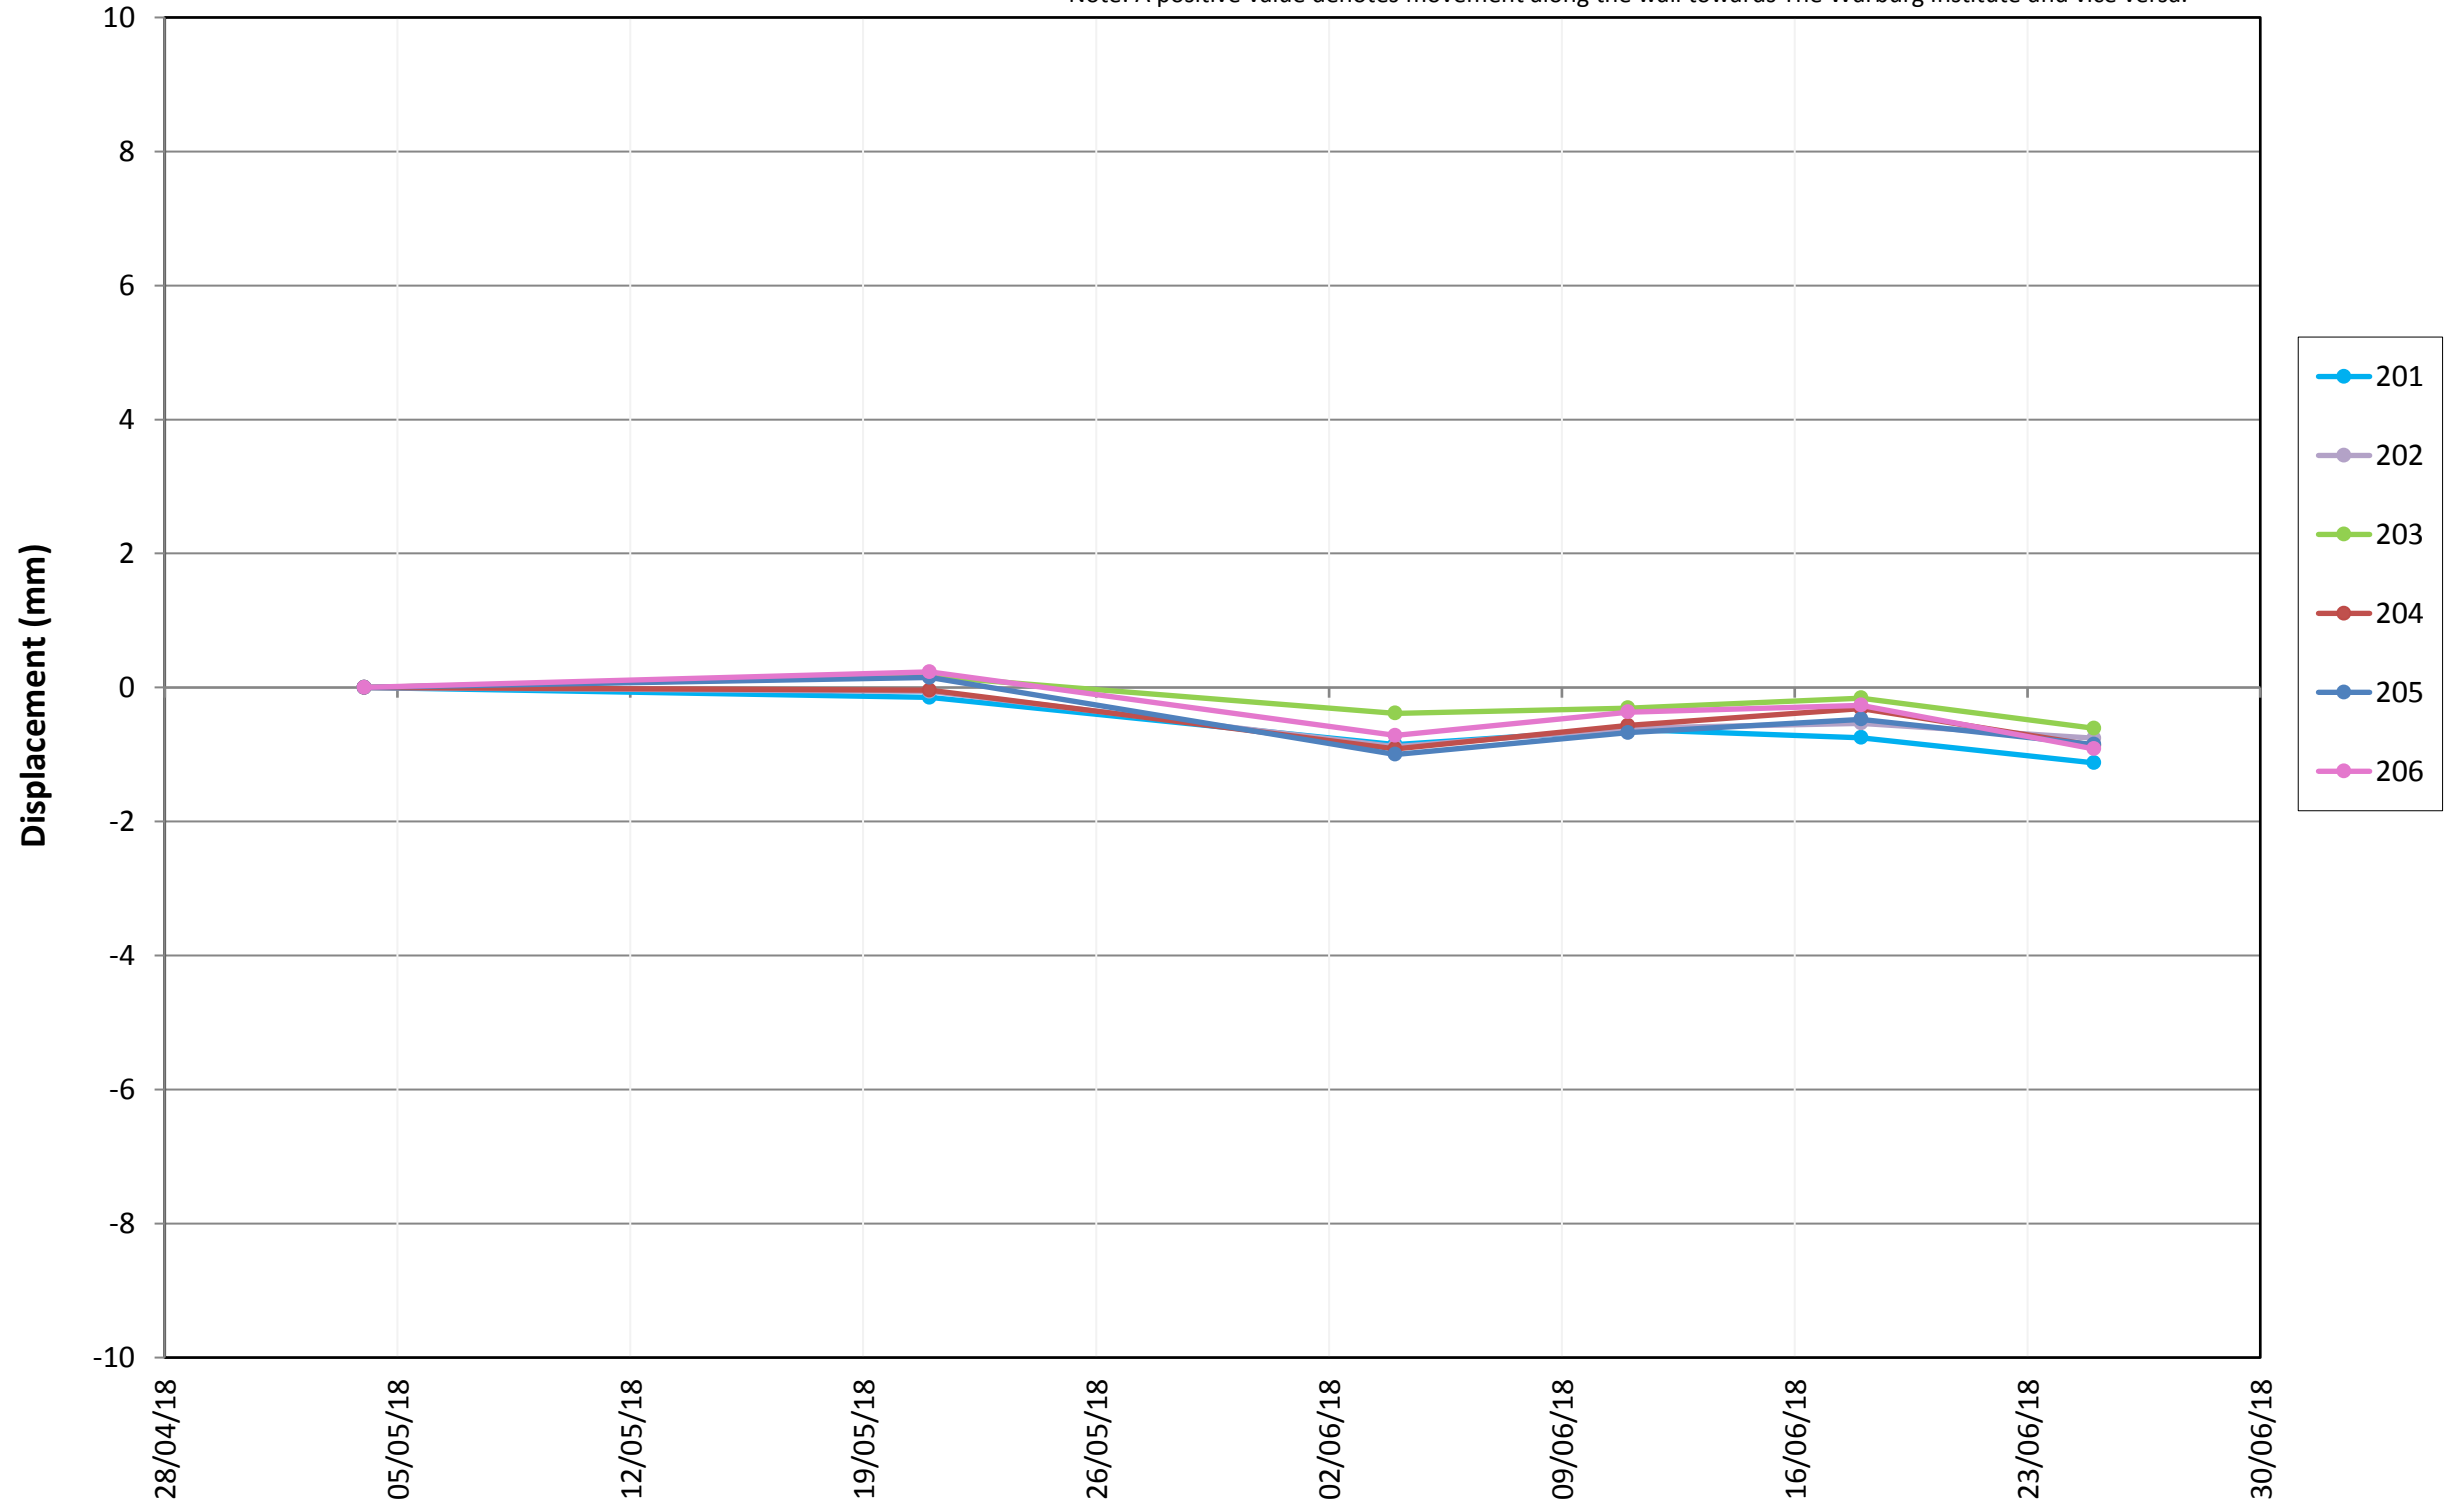
Graph 01L - Targets on Front Elevation of The Warburg Institute

Note: A positive value denotes movement along the wall towards The Warburg Institute and vice versa.

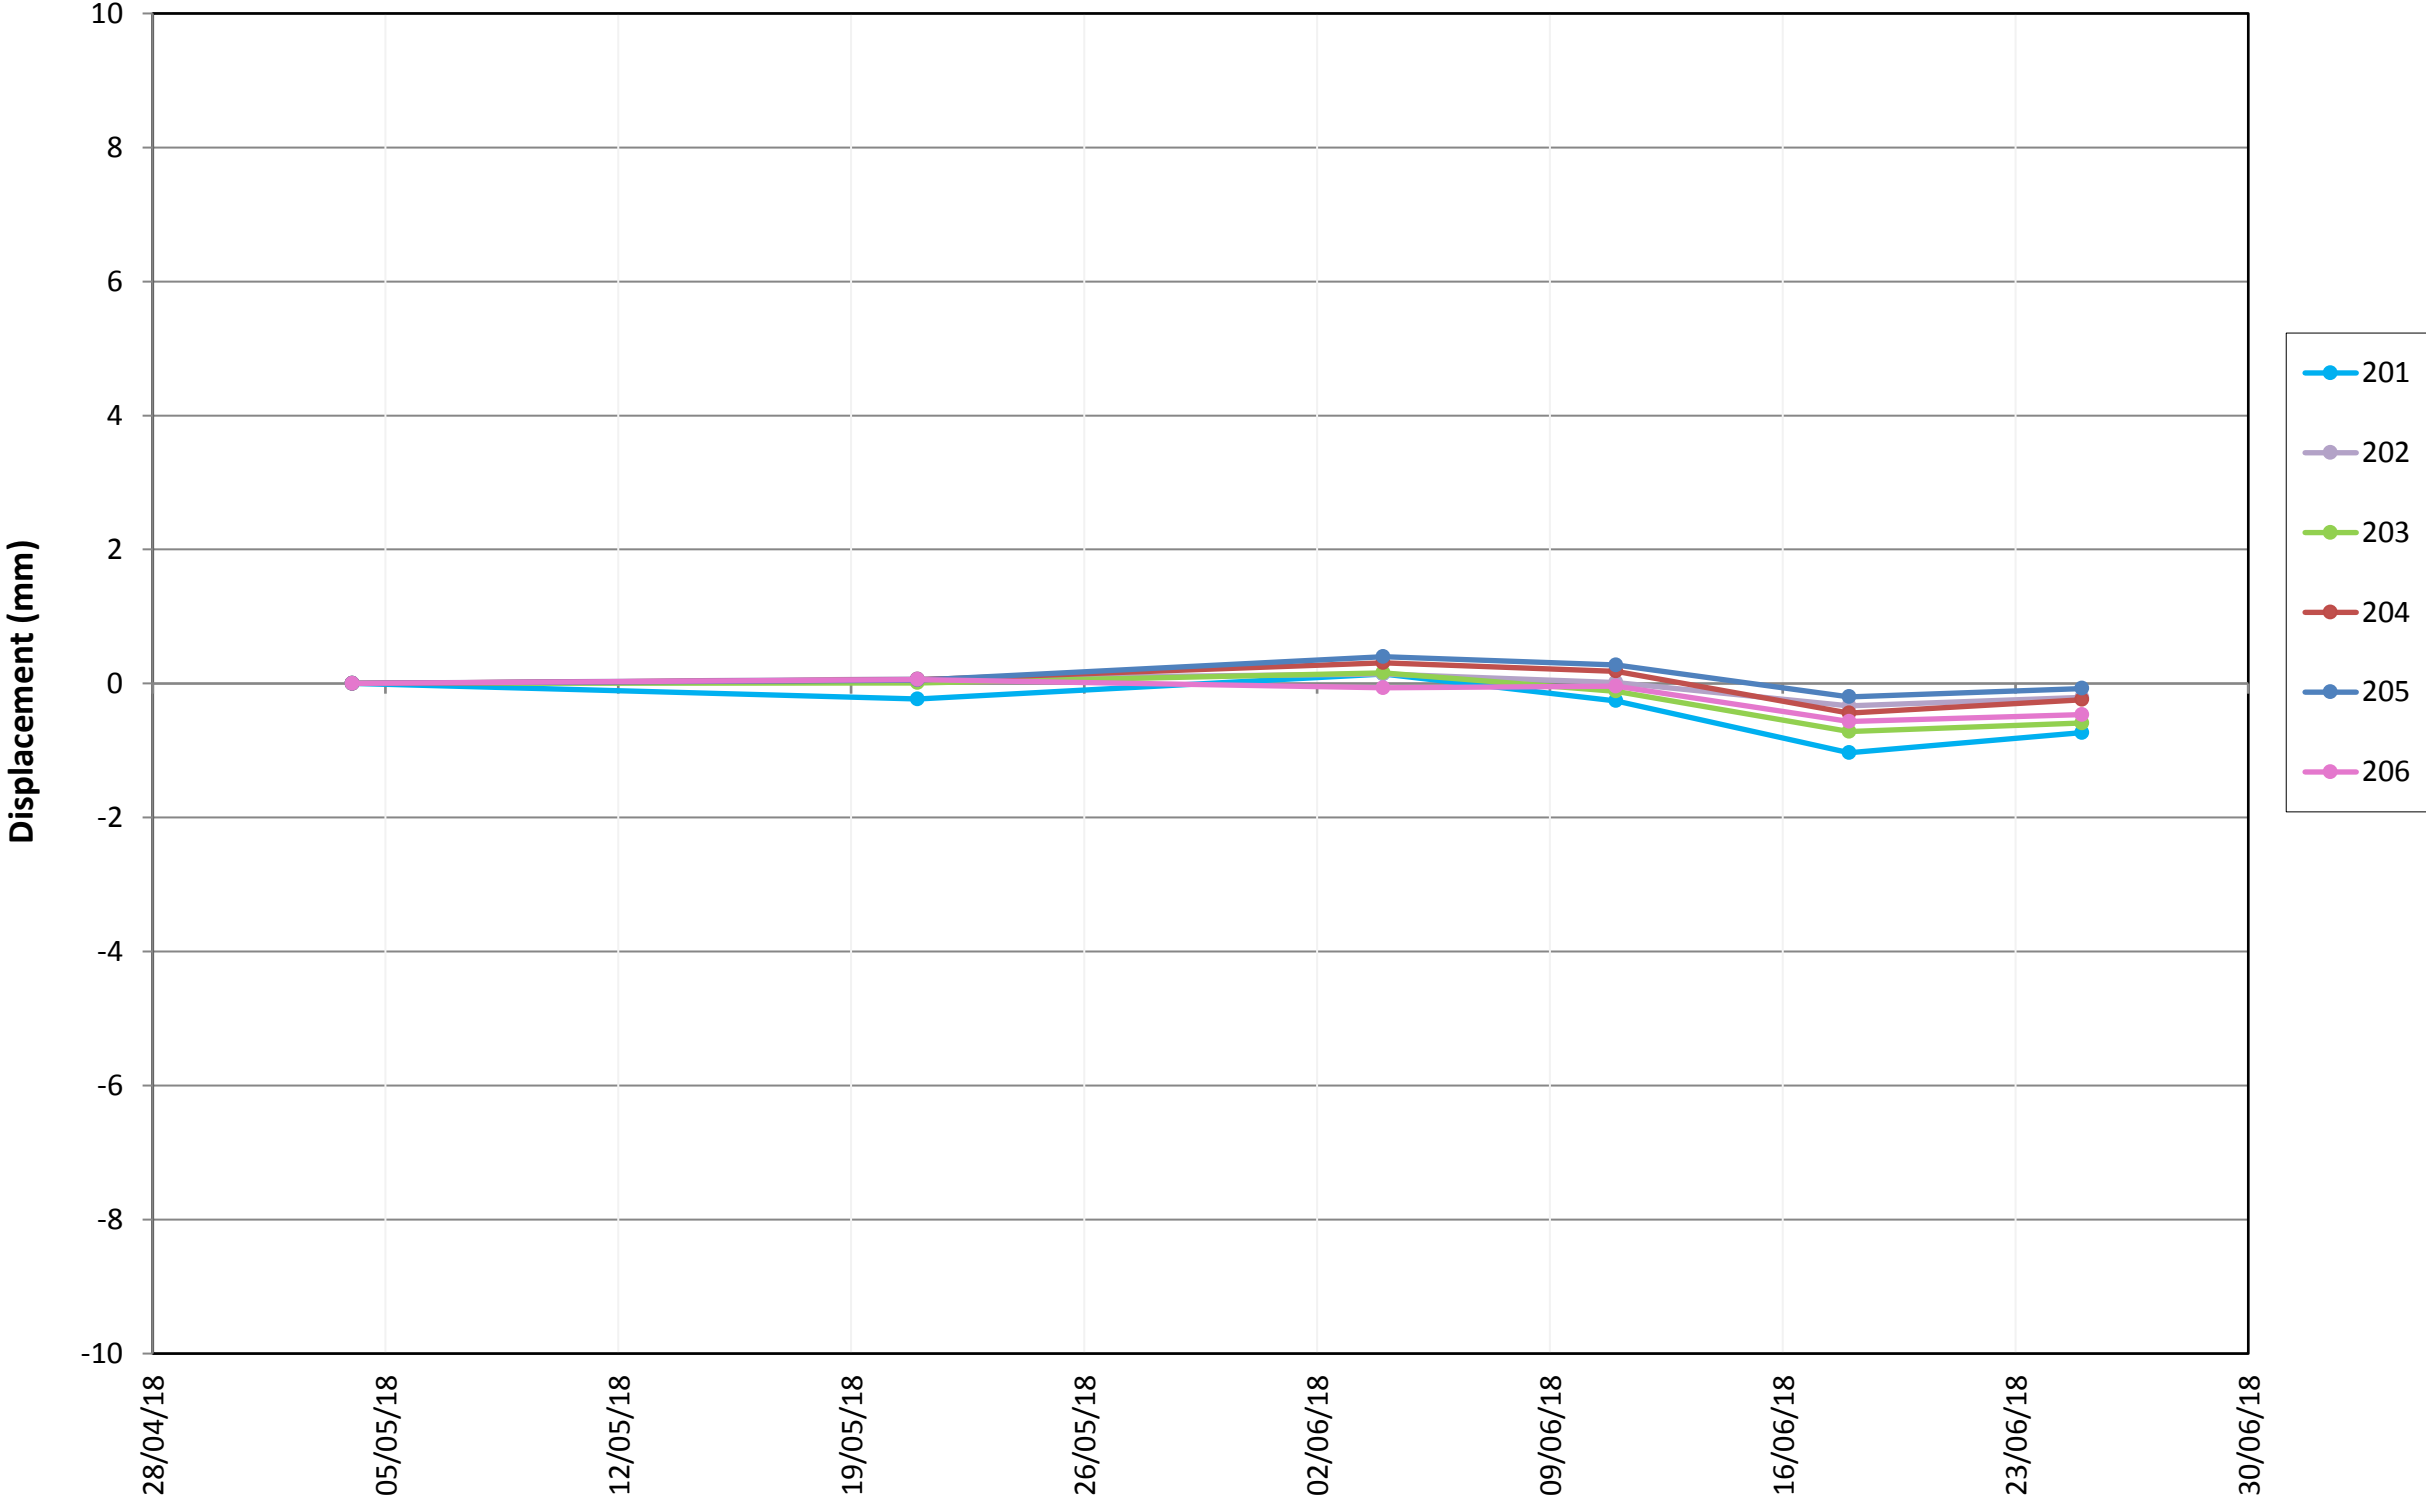
Graph 01V - Targets on Front Elevation of The Warburg Institute

Note: +ve value denotes heave, -ve value denotes settlement.

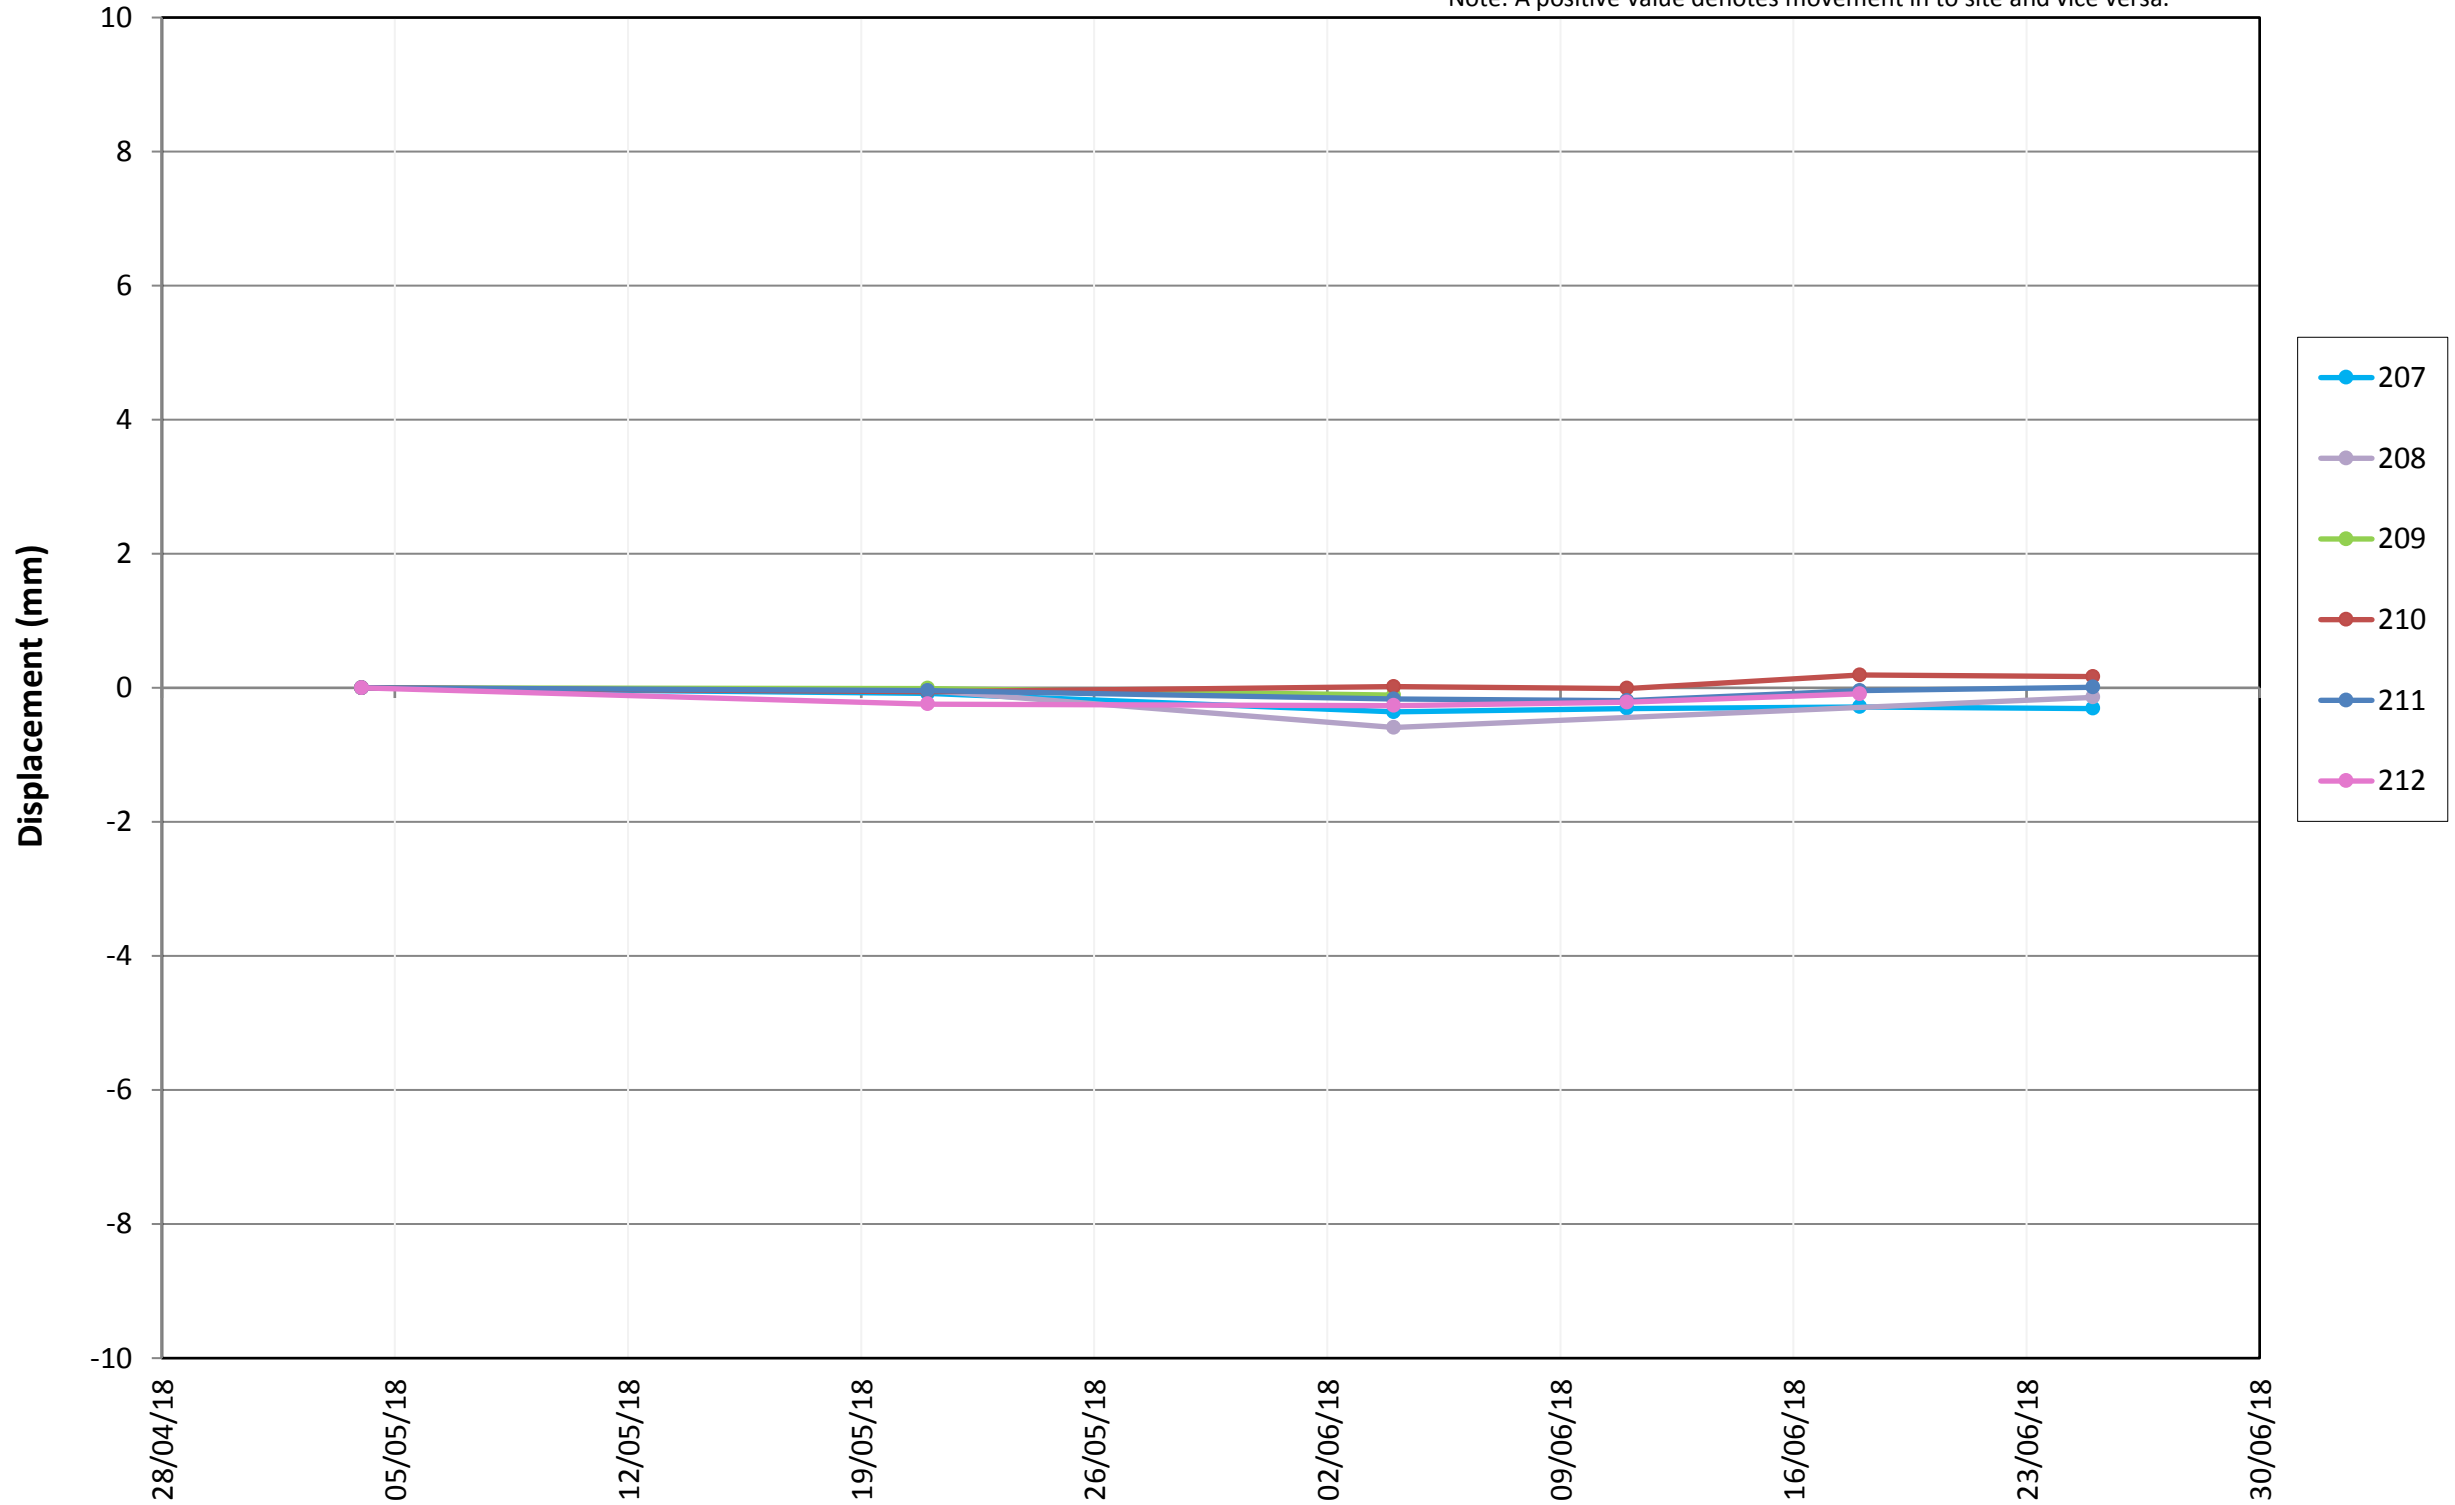
Graph 02T - Targets on Side Elevation of The Warburg Institute

Targets are showing negligible horizontal movement.  
Targets are showing negligible vertical movement.  
Targets 209,212 are destroyed

Note: A positive value denotes movement in to site and vice versa.

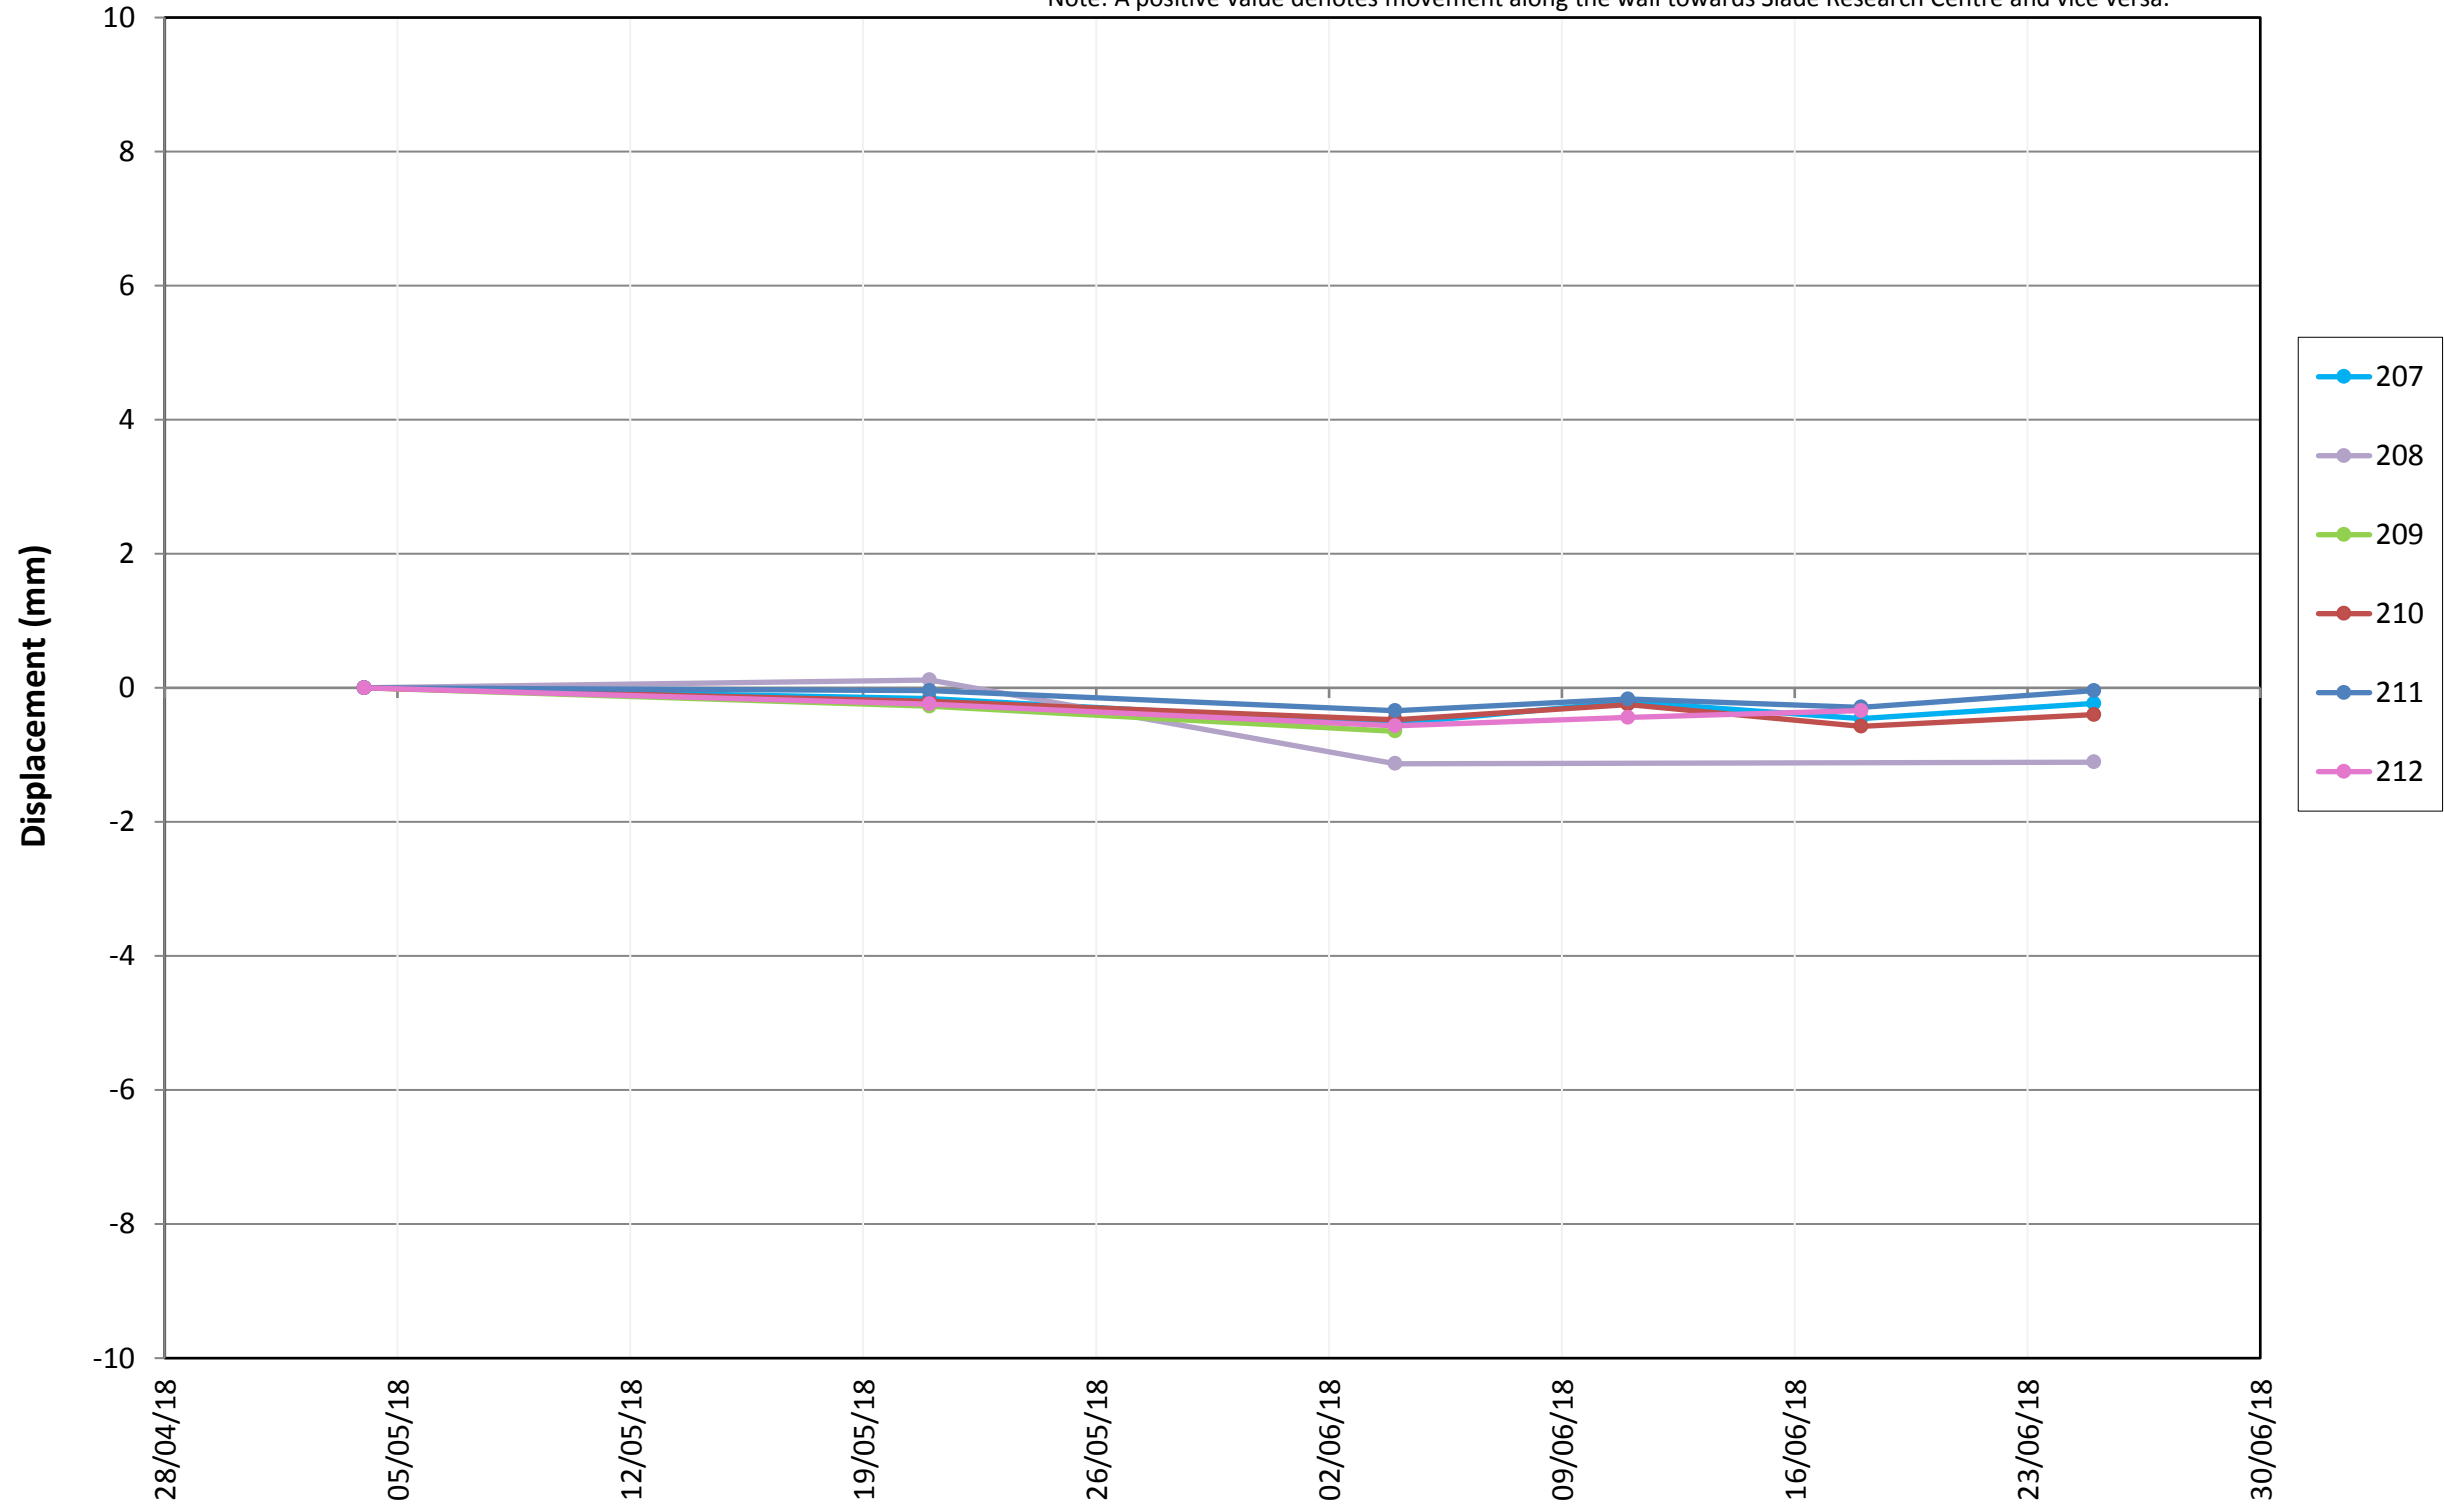
Graph 02L - Targets on Side Elevation of The Warburg Institute

Note: A positive value denotes movement along the wall towards Slade Research Centre and vice versa.

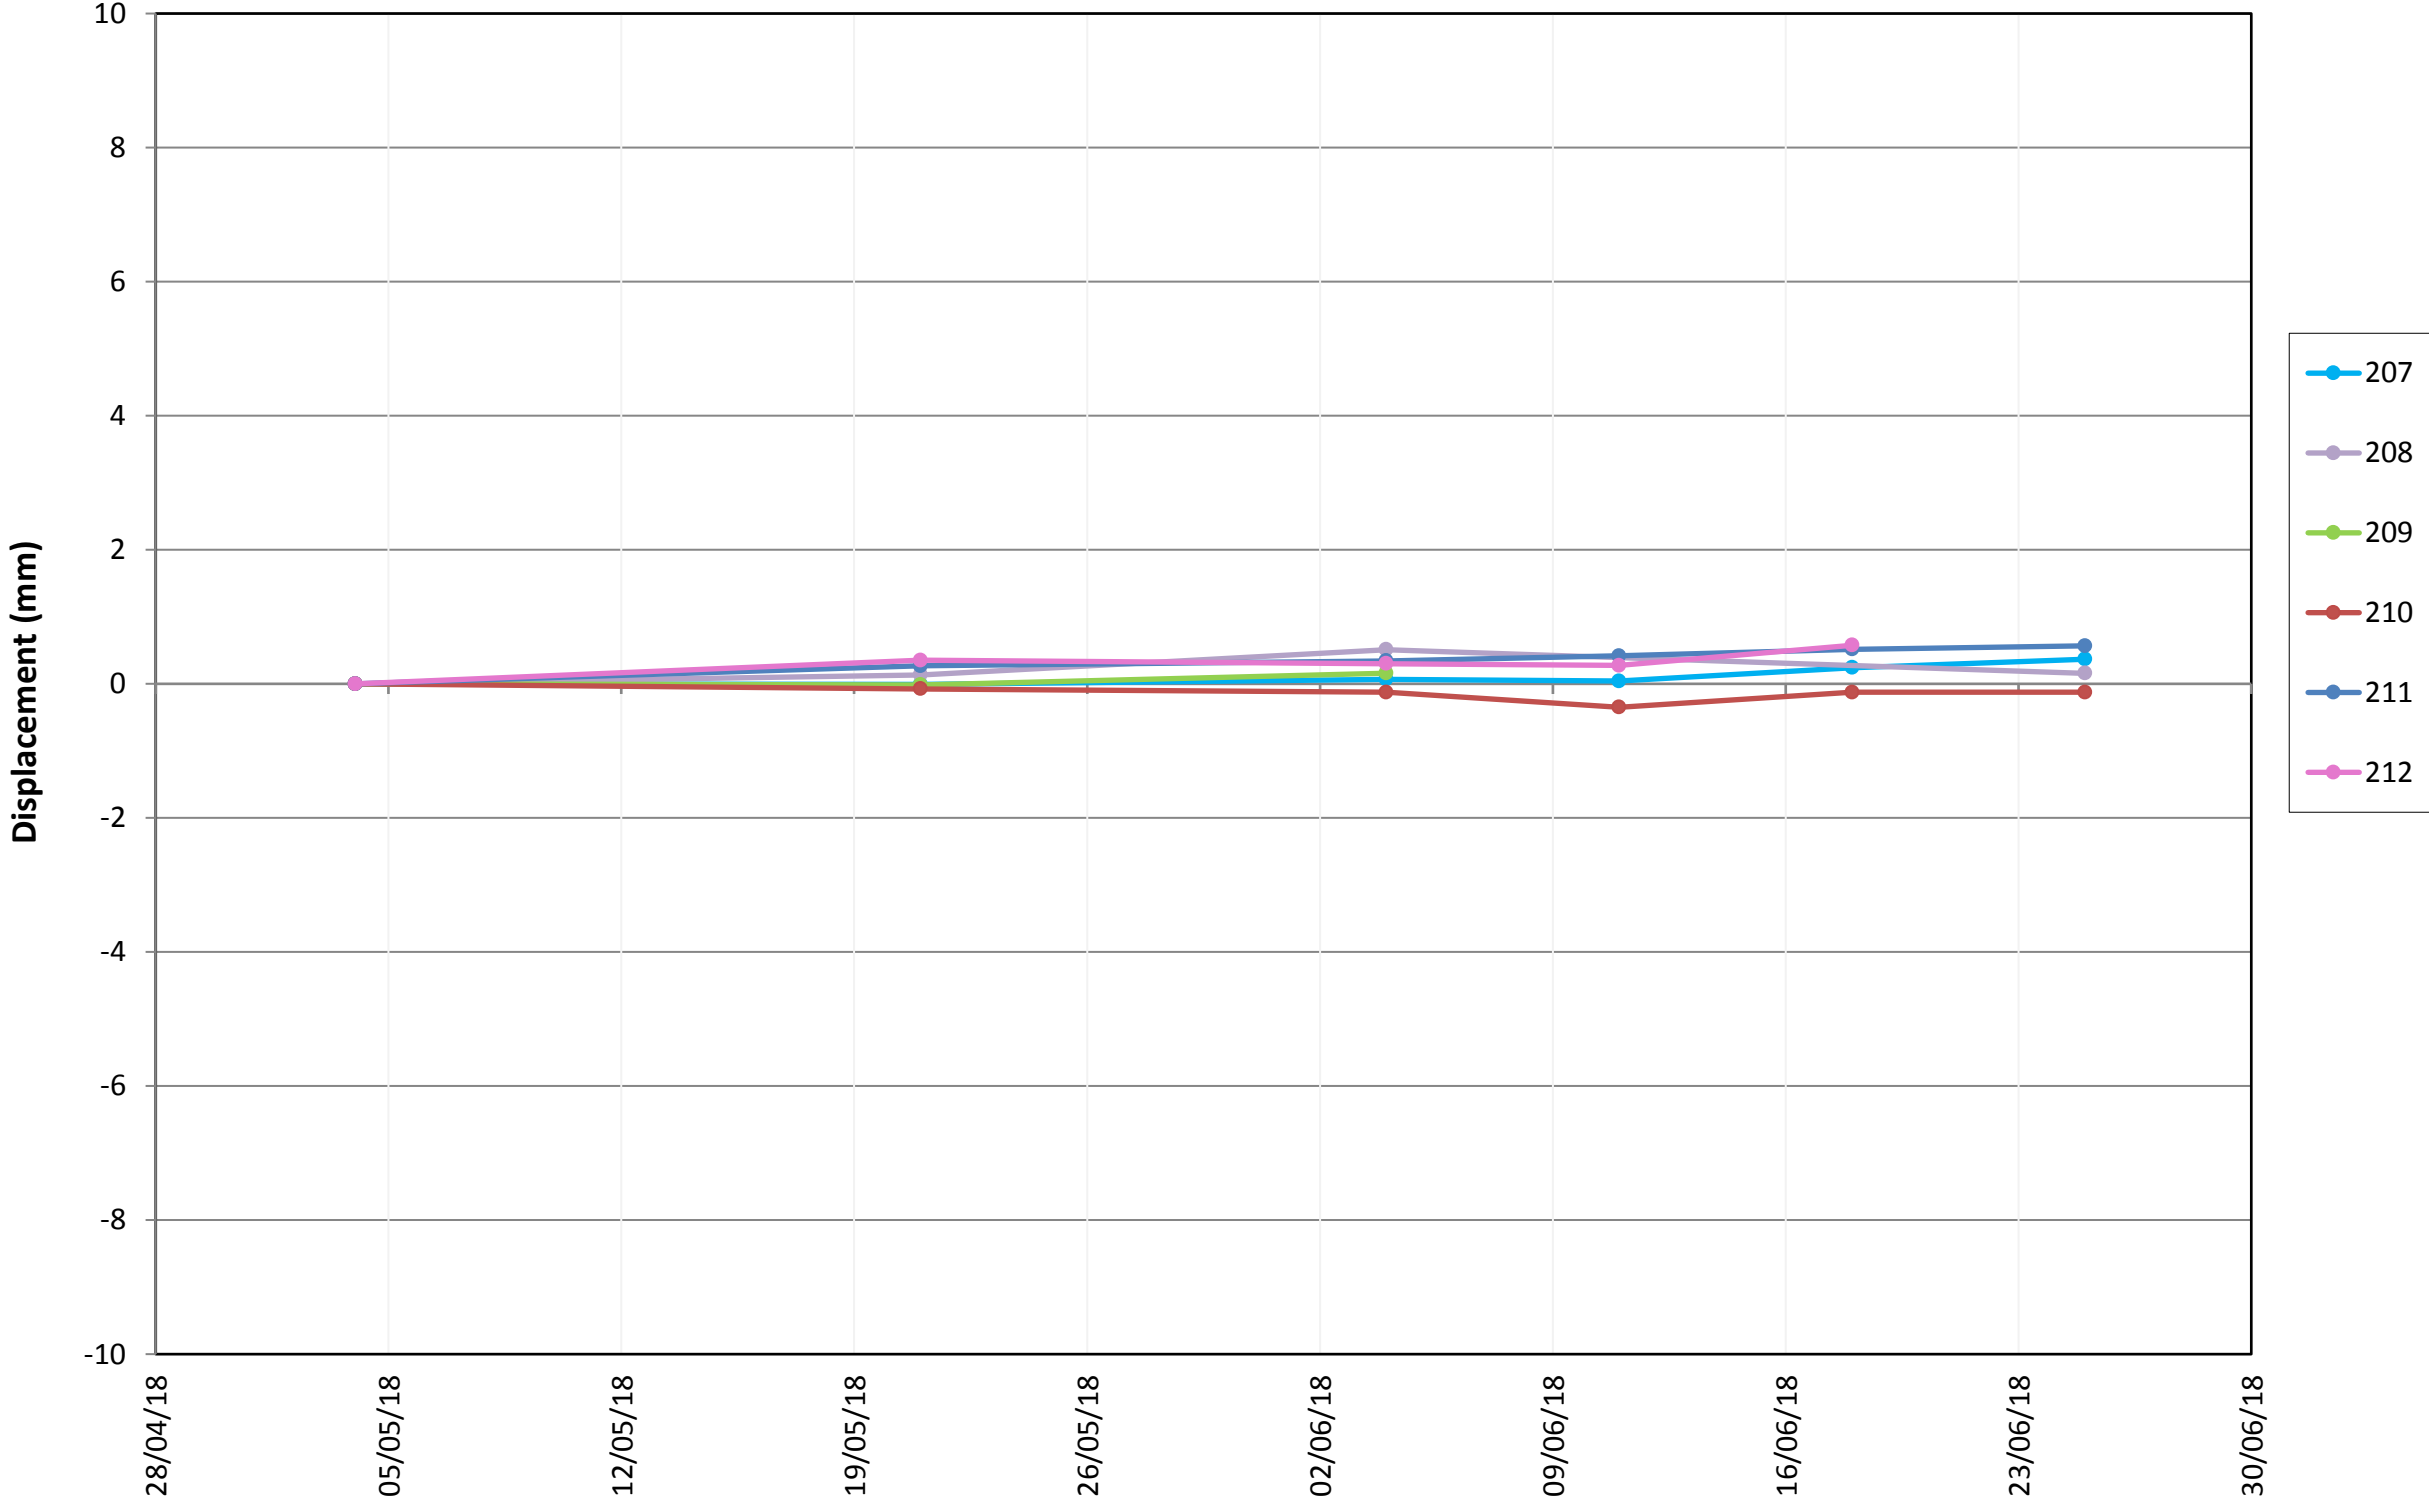
Graph 02V - Targets on Side Elevation of The Warburg Institute

Note: +ve value denotes heave, -ve value denotes settlement.
