32-33 TORRINGTON SQUARE  
MONITORING

Monitoring Report  
SES-10215-MR05

Date of survey completion: 25<sup>th</sup> June 2018

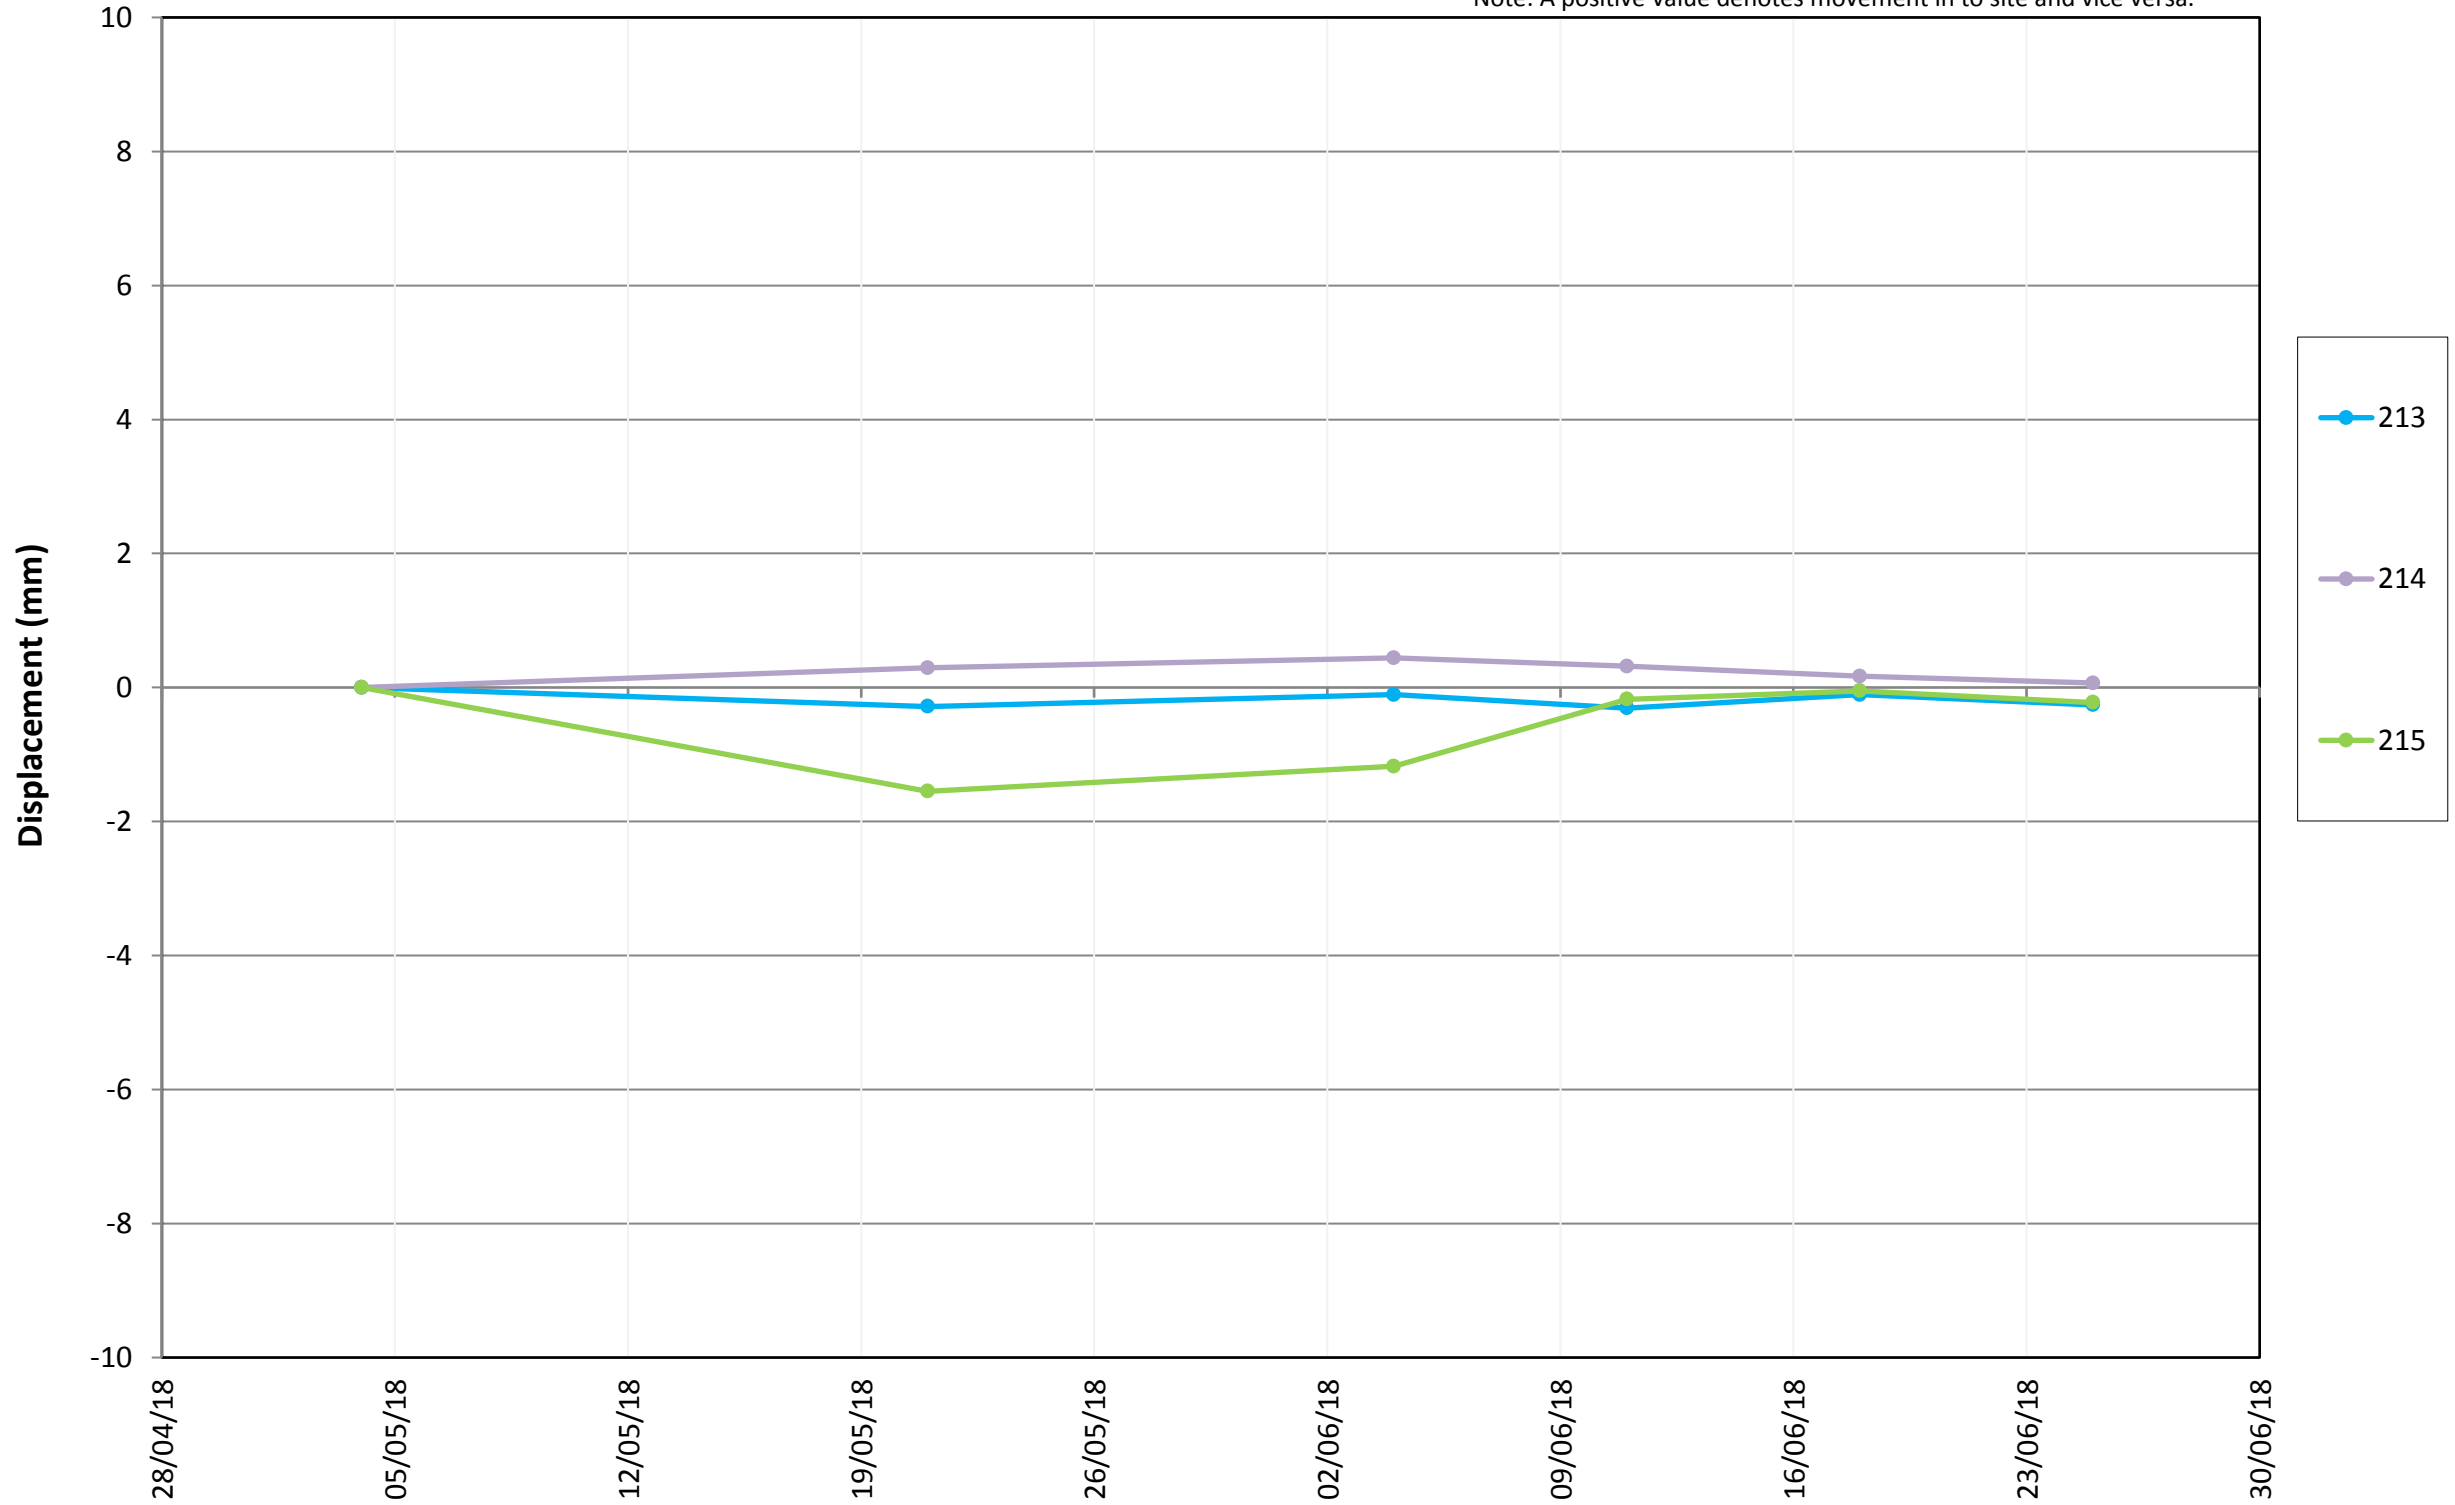
Graph 03T - Targets on Rear Elevation of The Warburg Institute

Targets are showing negligible horizontal movement.  
Targets are showing negligible vertical movement.

Note: A positive value denotes movement in to site and vice versa.

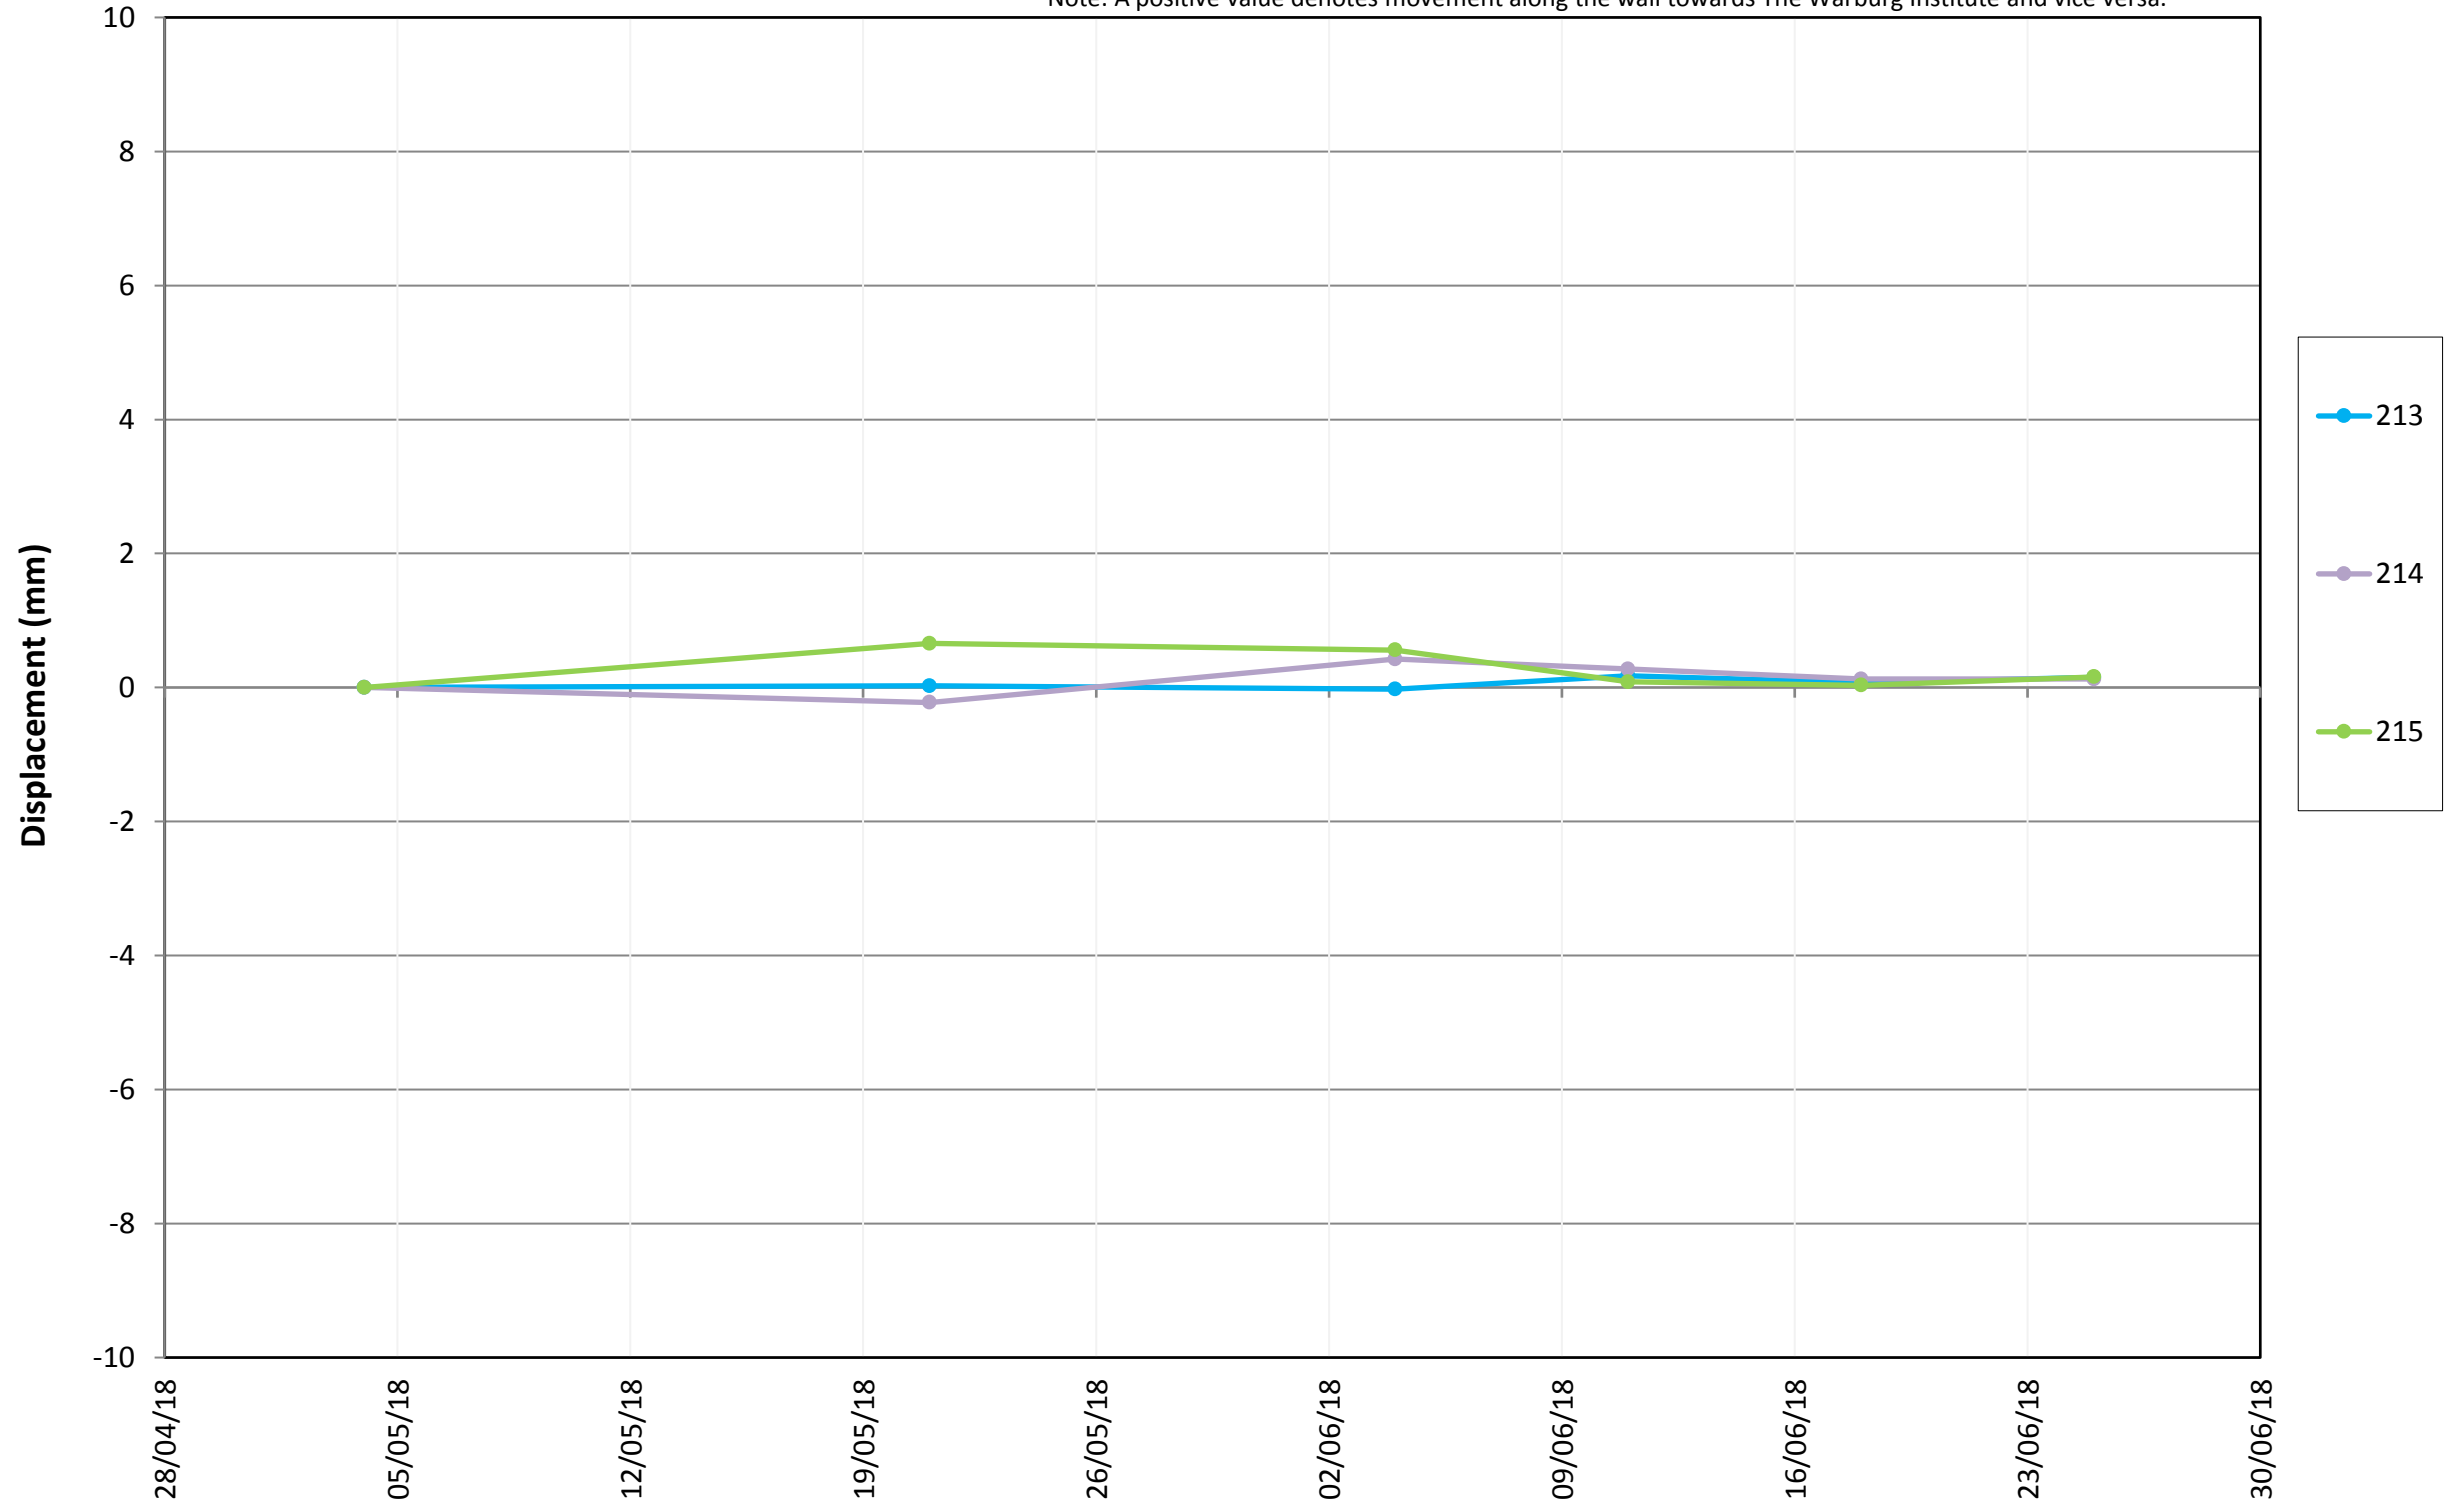
Graph 03L - Targets on Rear Elevation of The Warburg Institute

Note: A positive value denotes movement along the wall towards The Warburg Institute and vice versa.

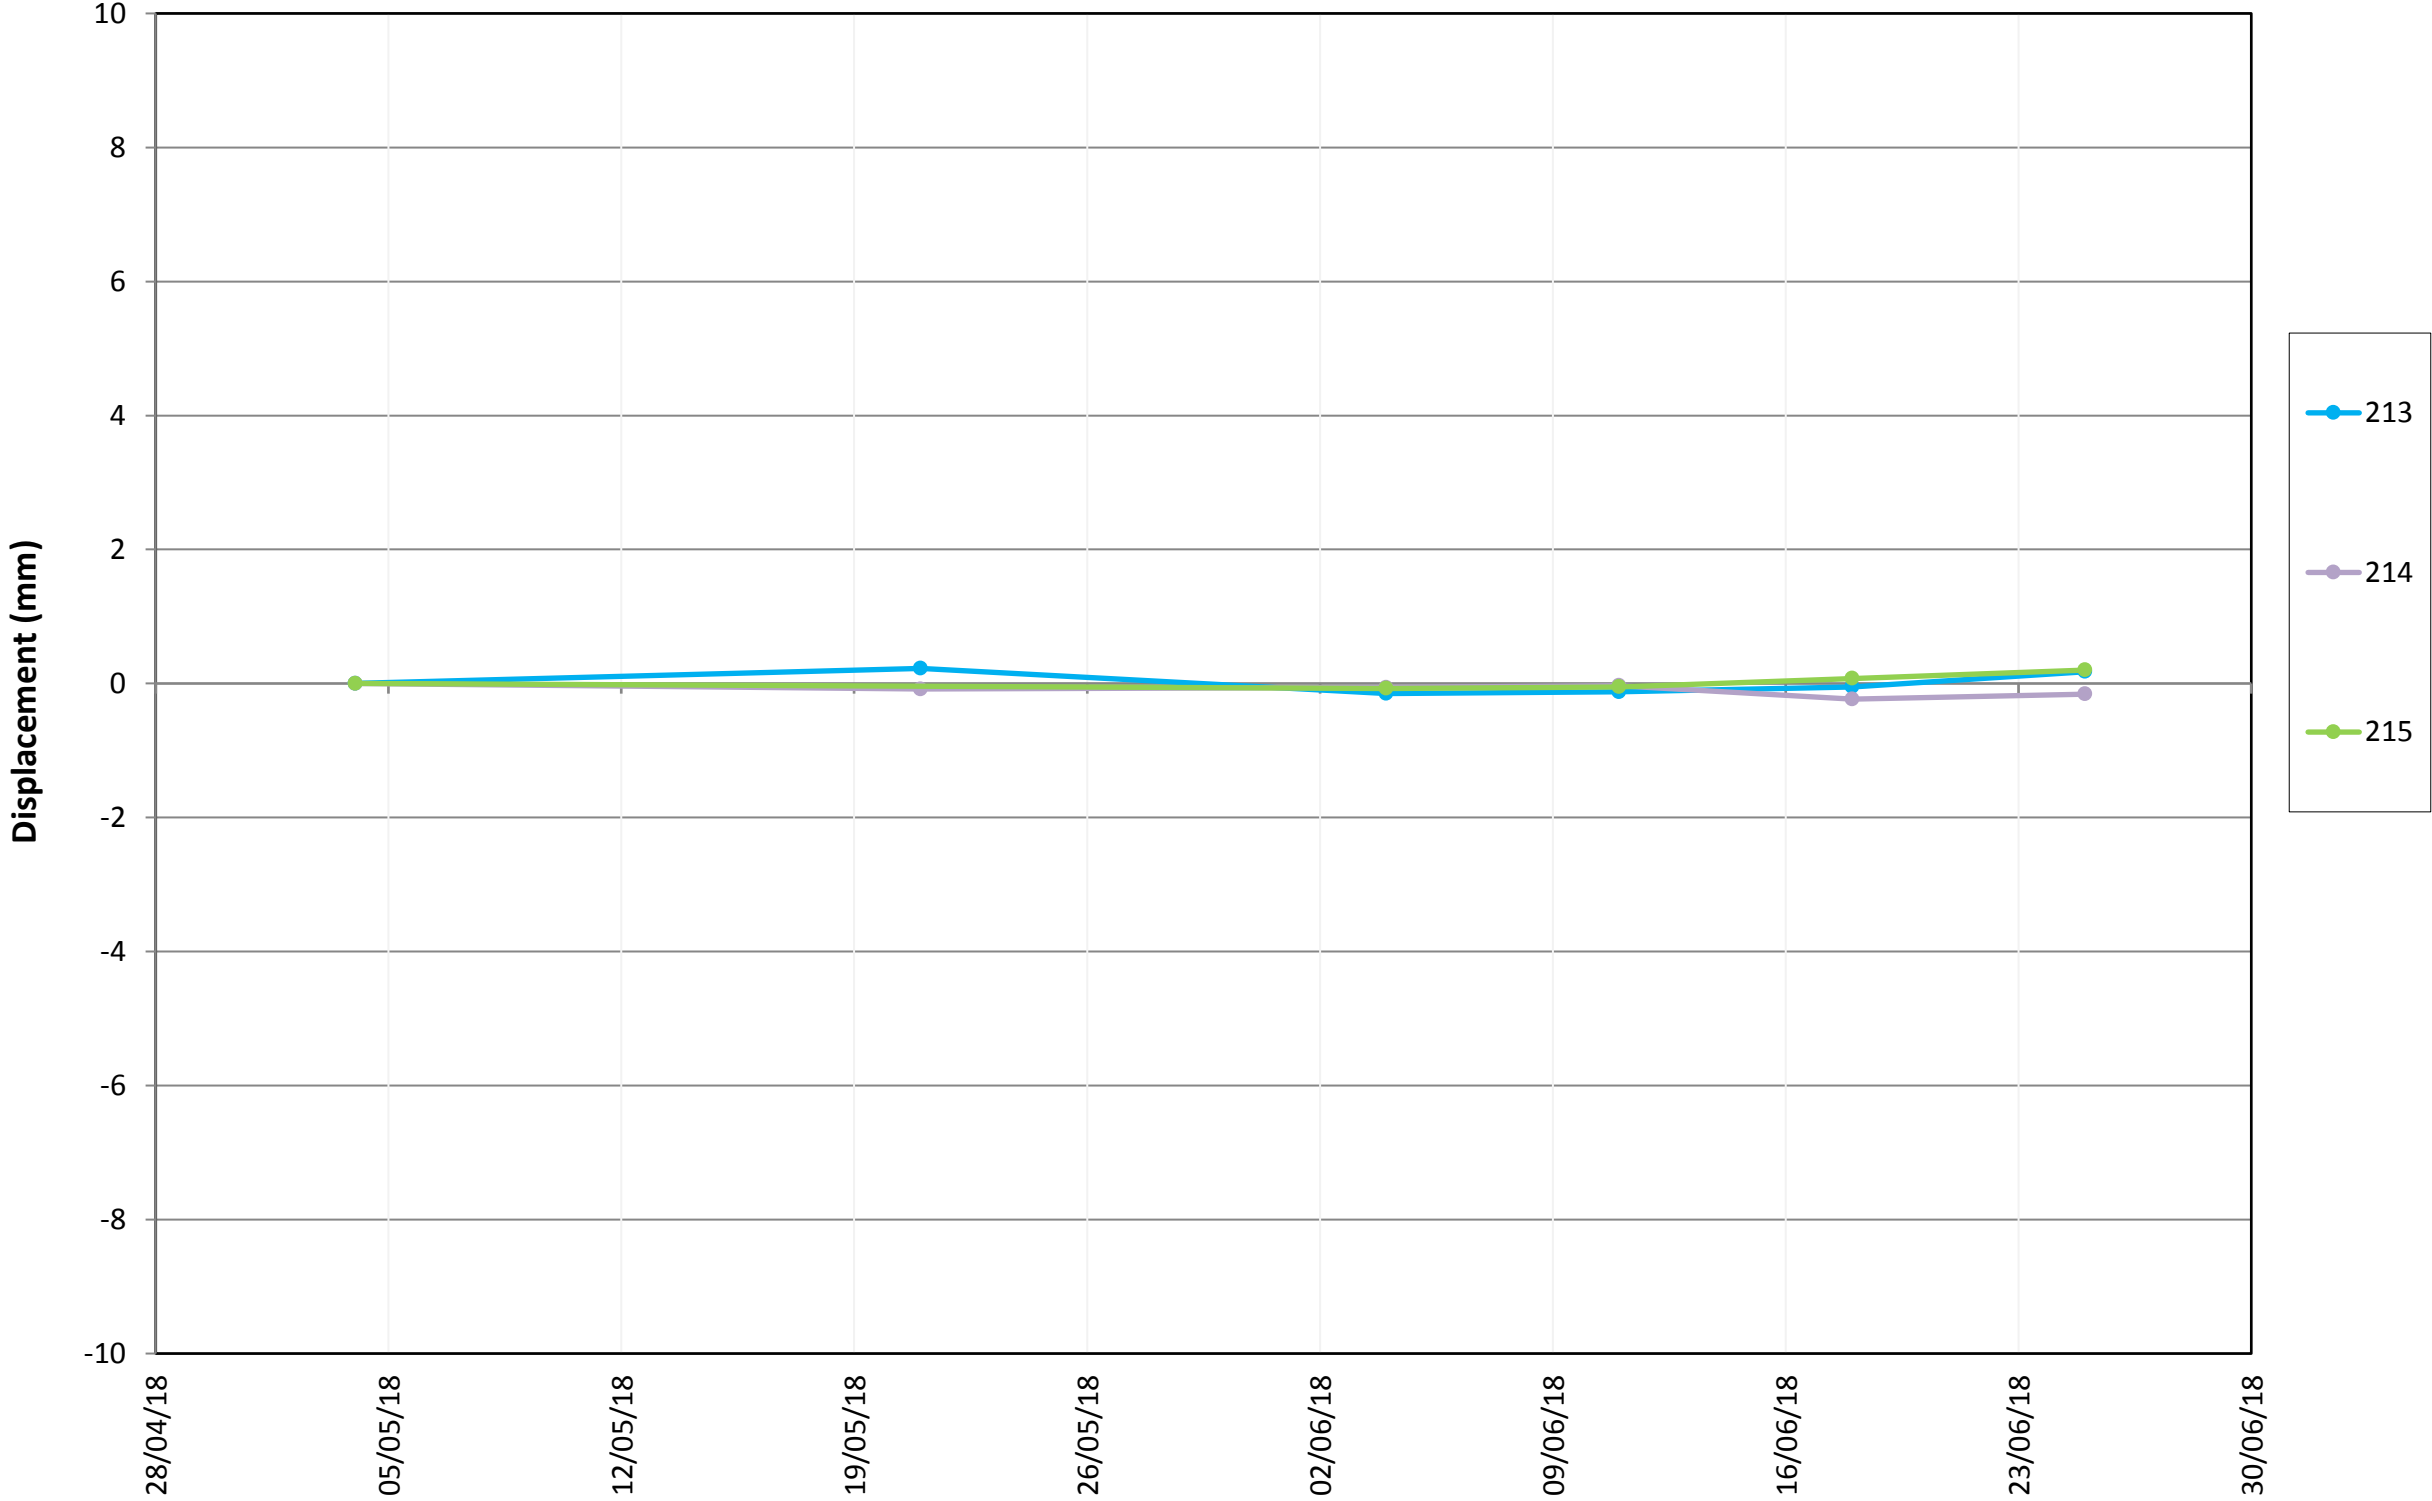
Graph 03V - Targets on Rear Elevation of The Warburg Institute

Note: +ve value denotes heave, -ve value denotes settlement.

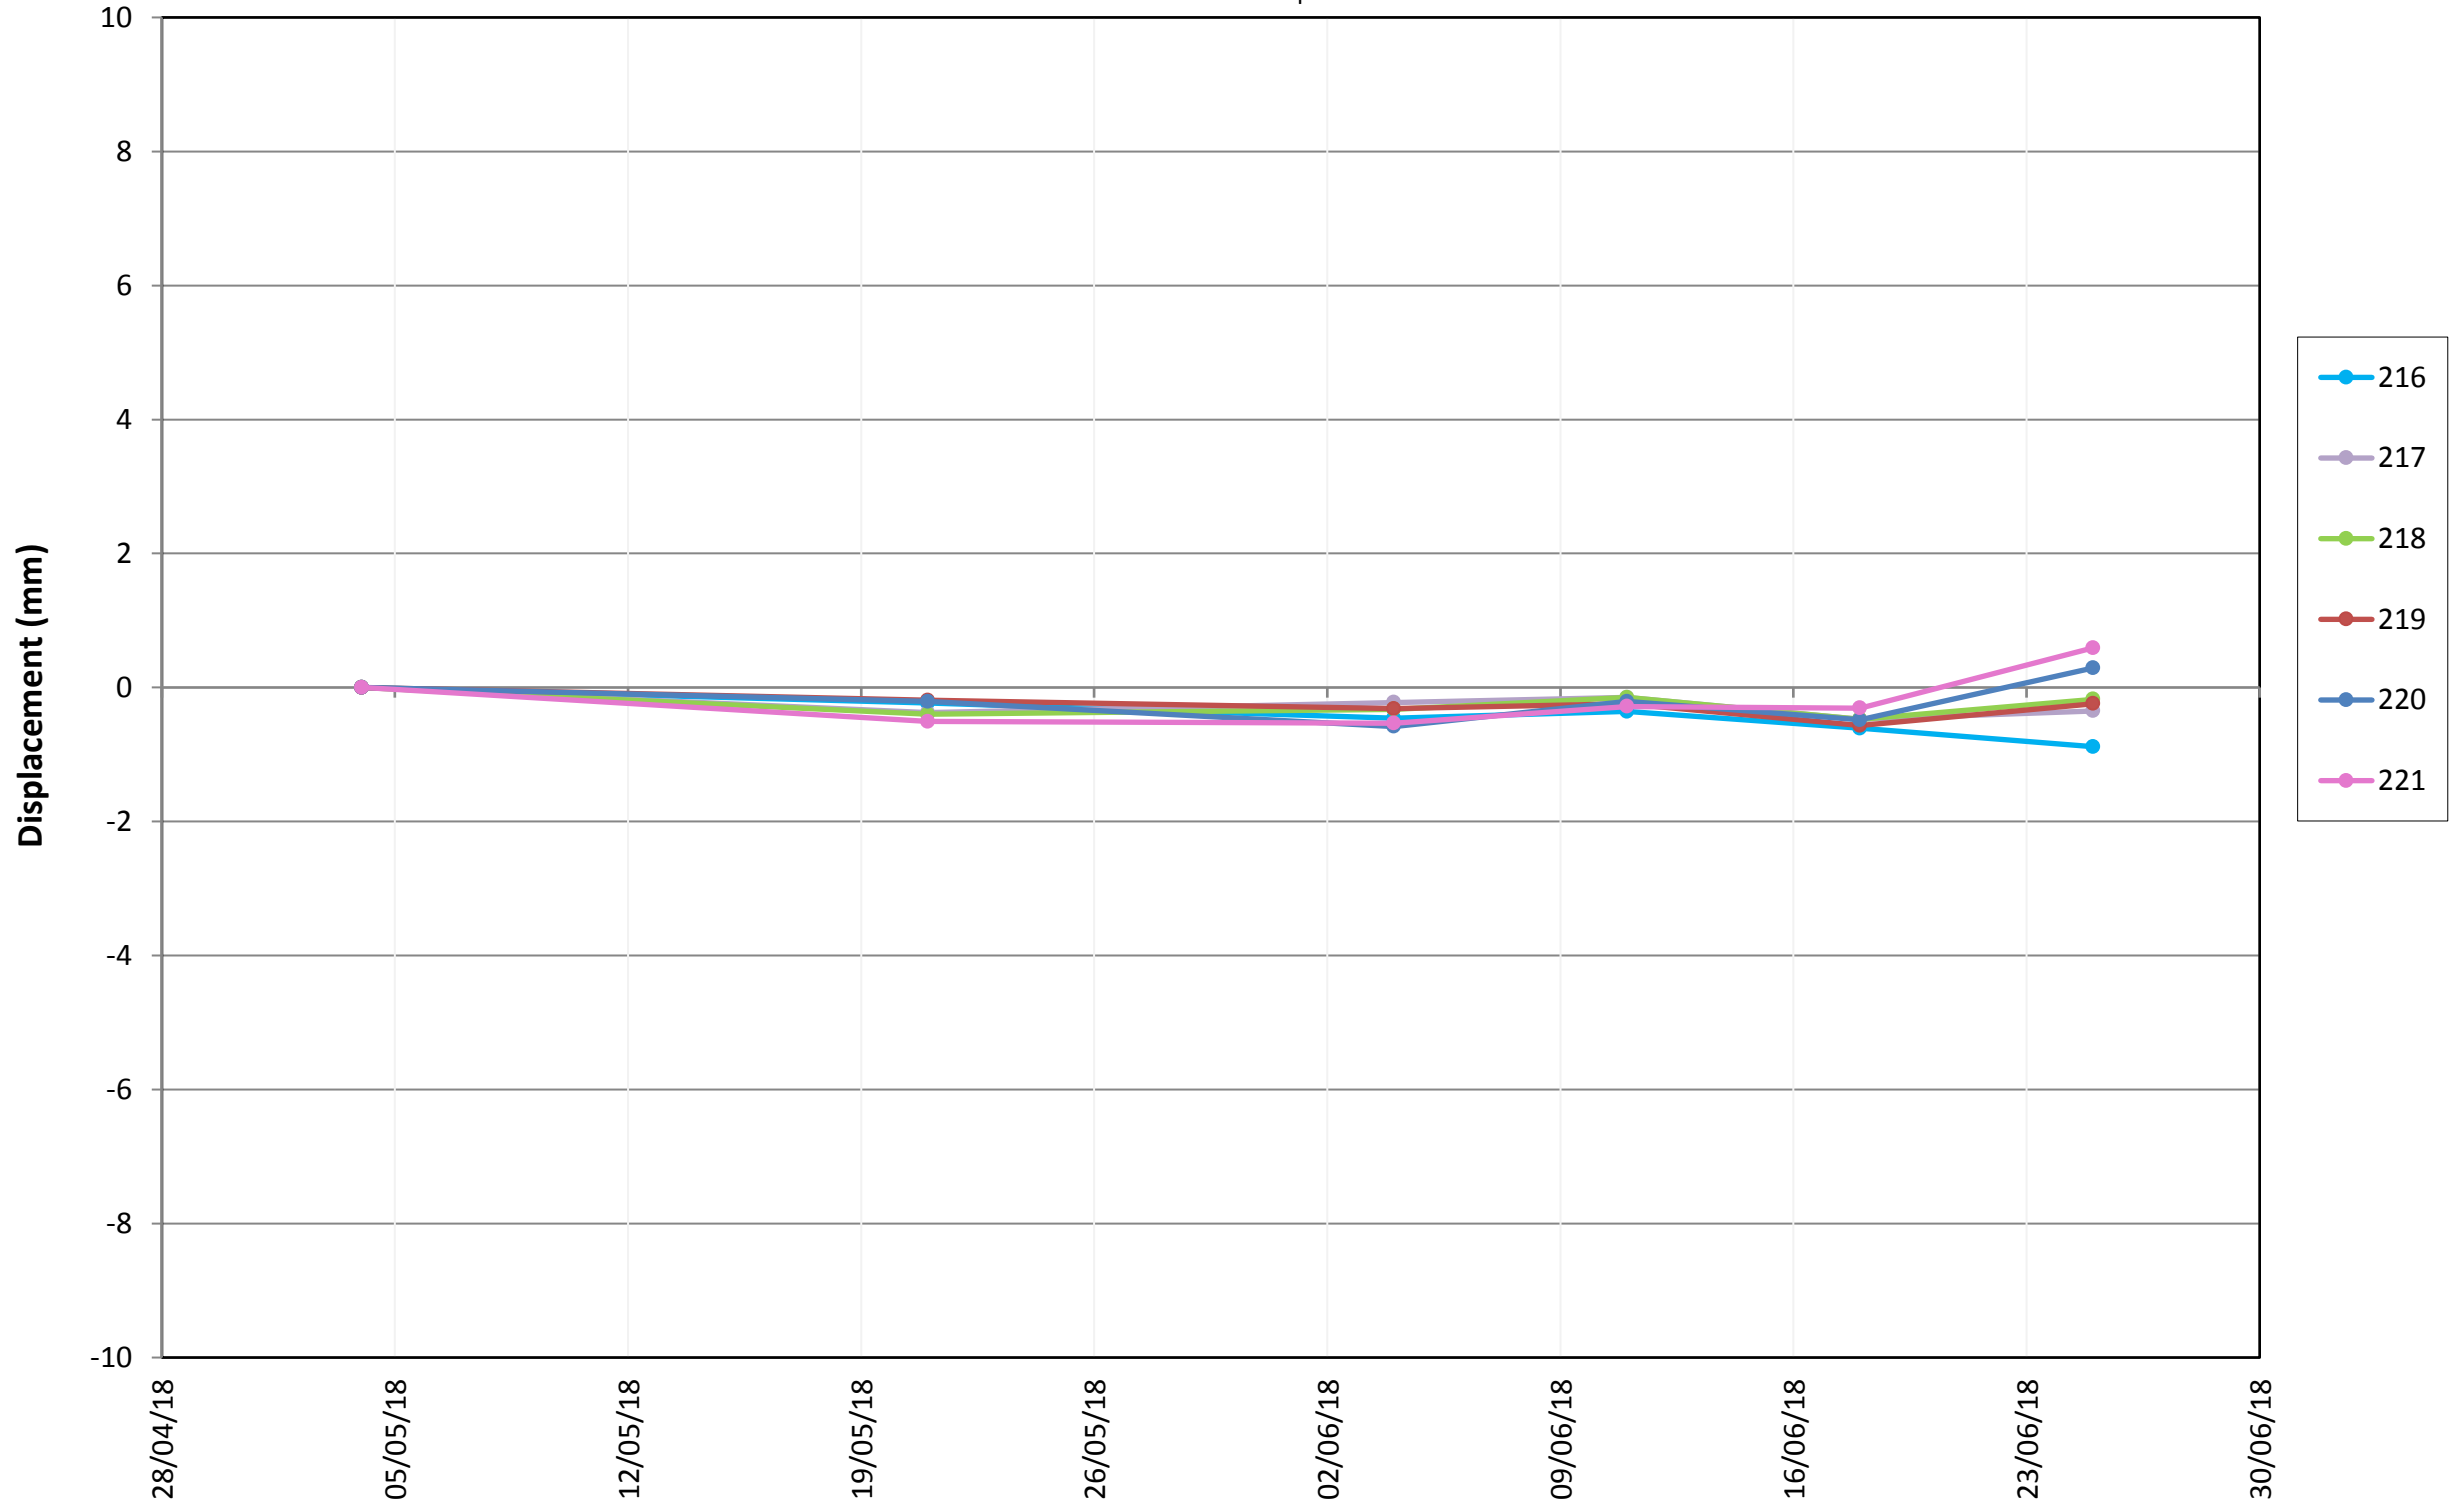
Graph 04T - Targets on Staircase

Targets are showing negligible horizontal movement.  
Targets are showing negligible vertical movement.

Note: A positive value denotes movement towards Slade Research Centre and vice versa.

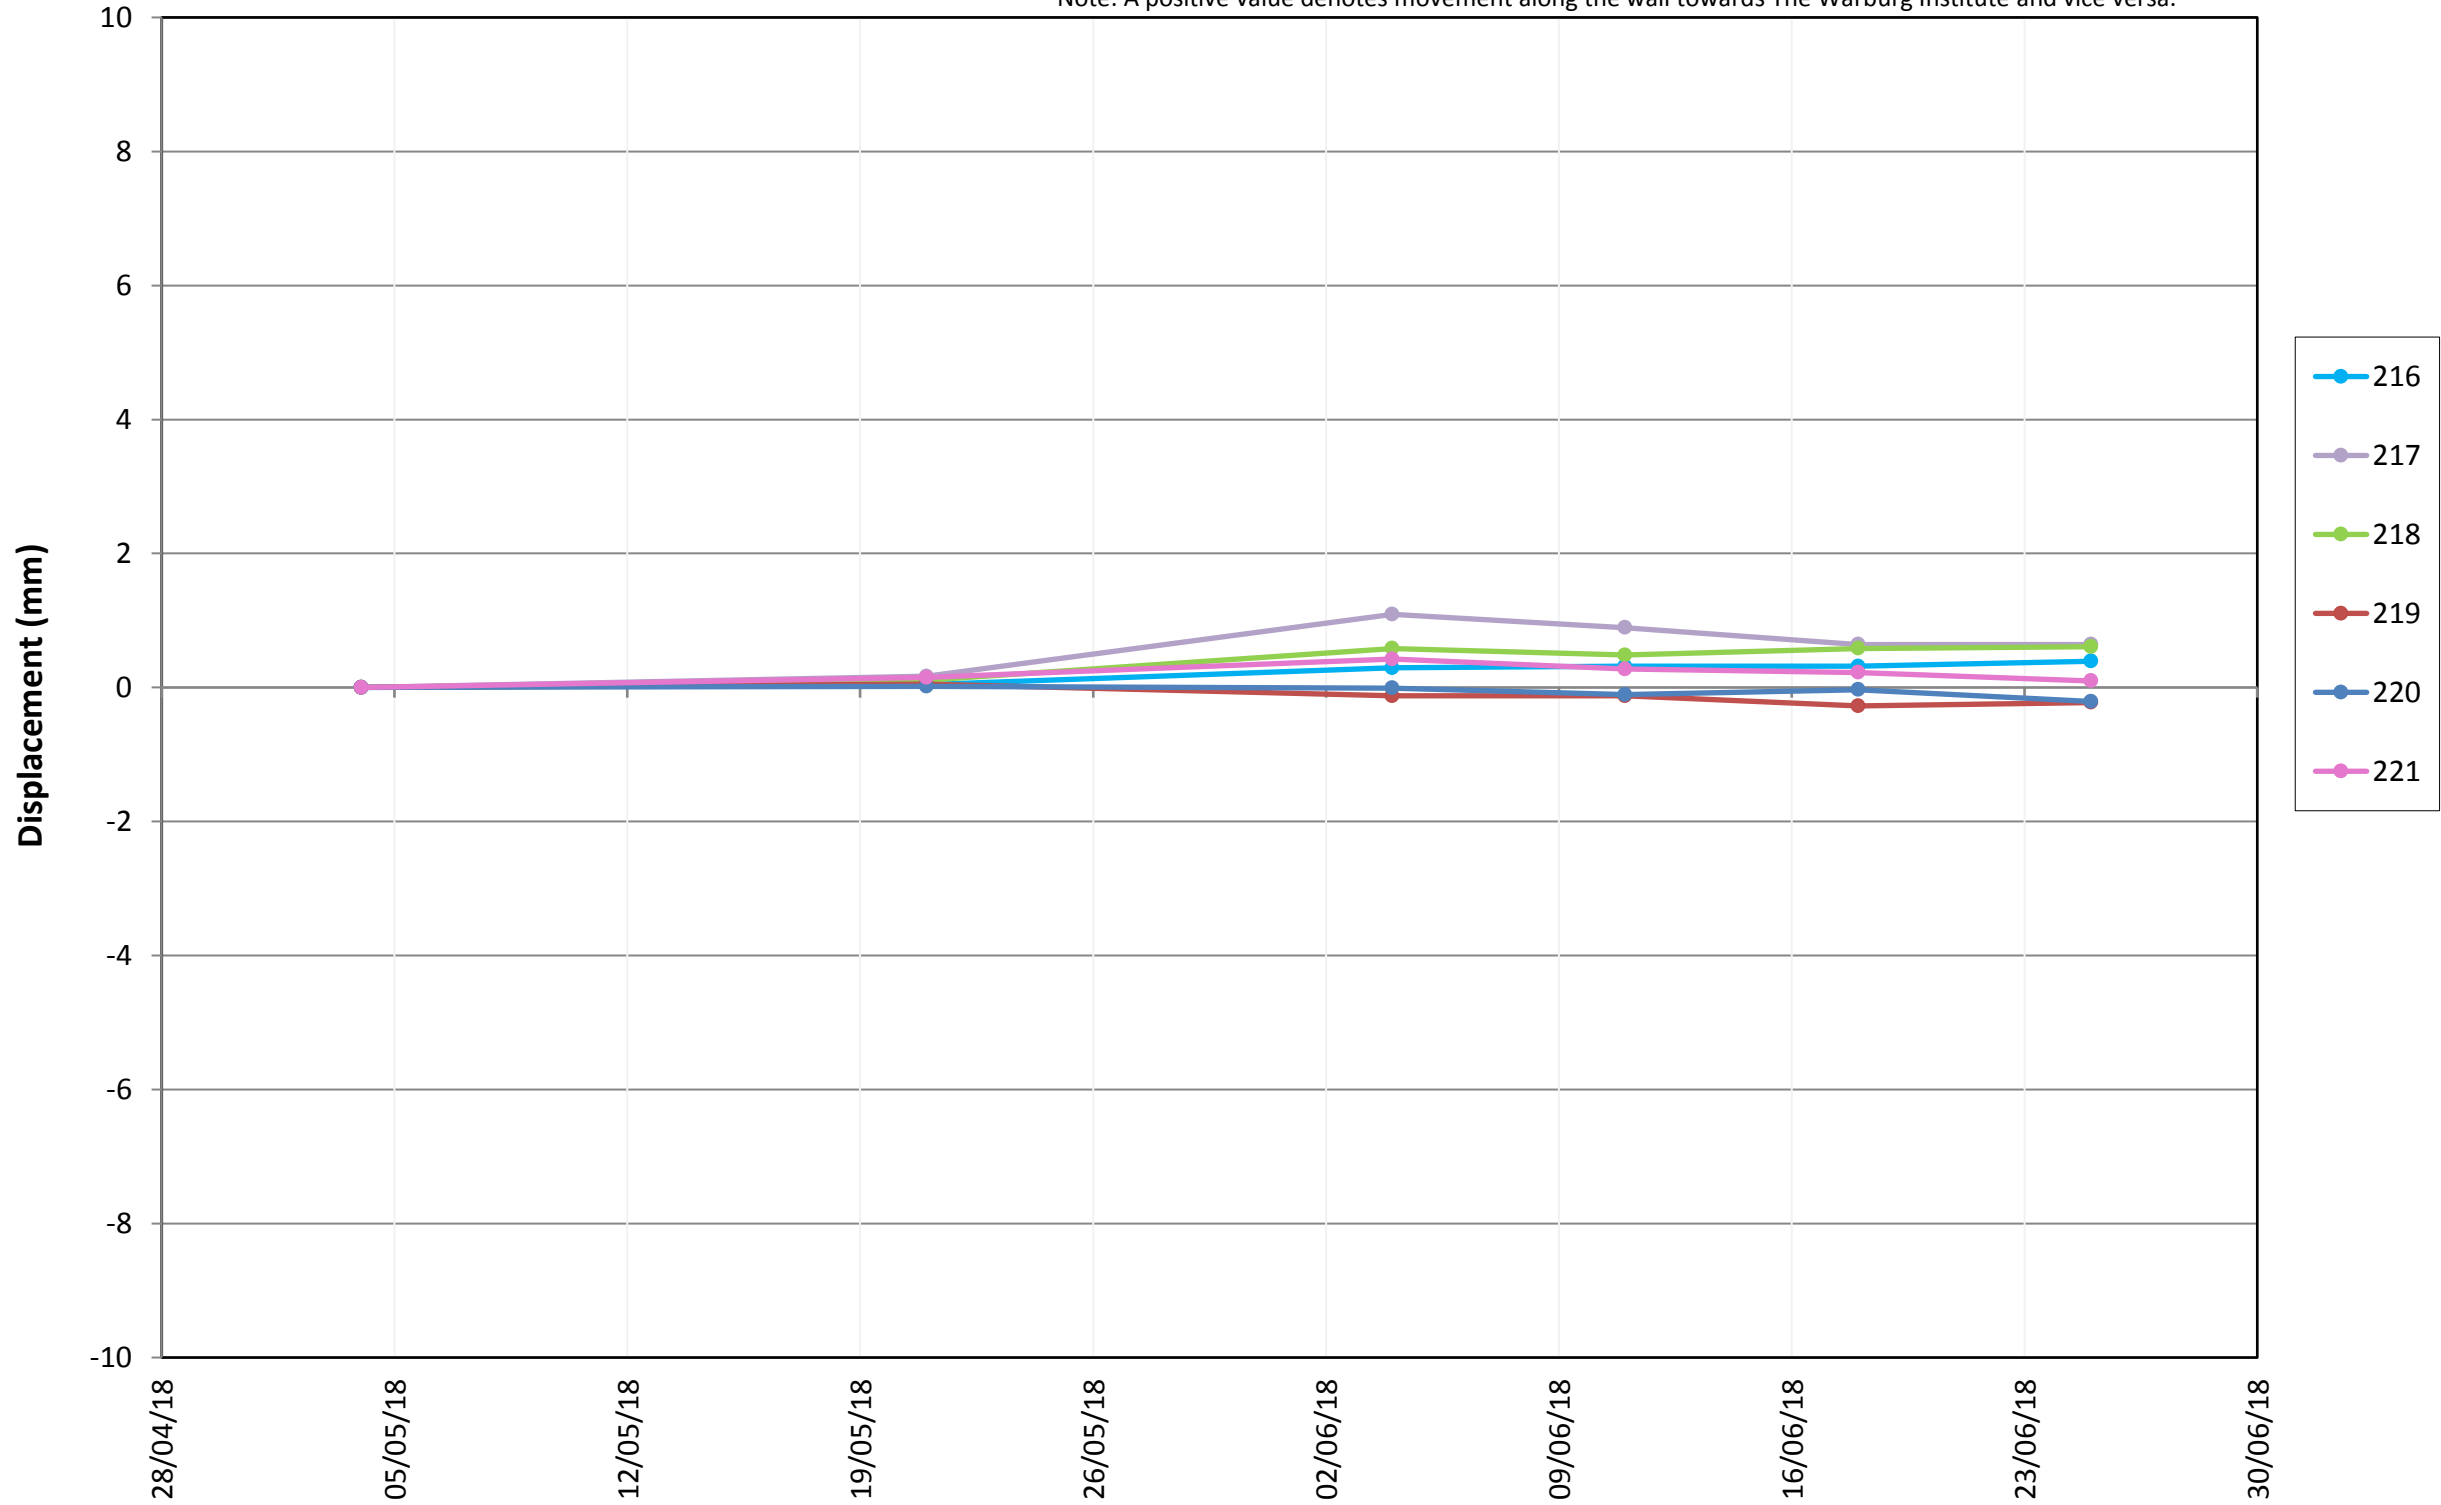
Graph 04L - Targets on Staircase

Note: A positive value denotes movement along the wall towards The Warburg Institute and vice versa.

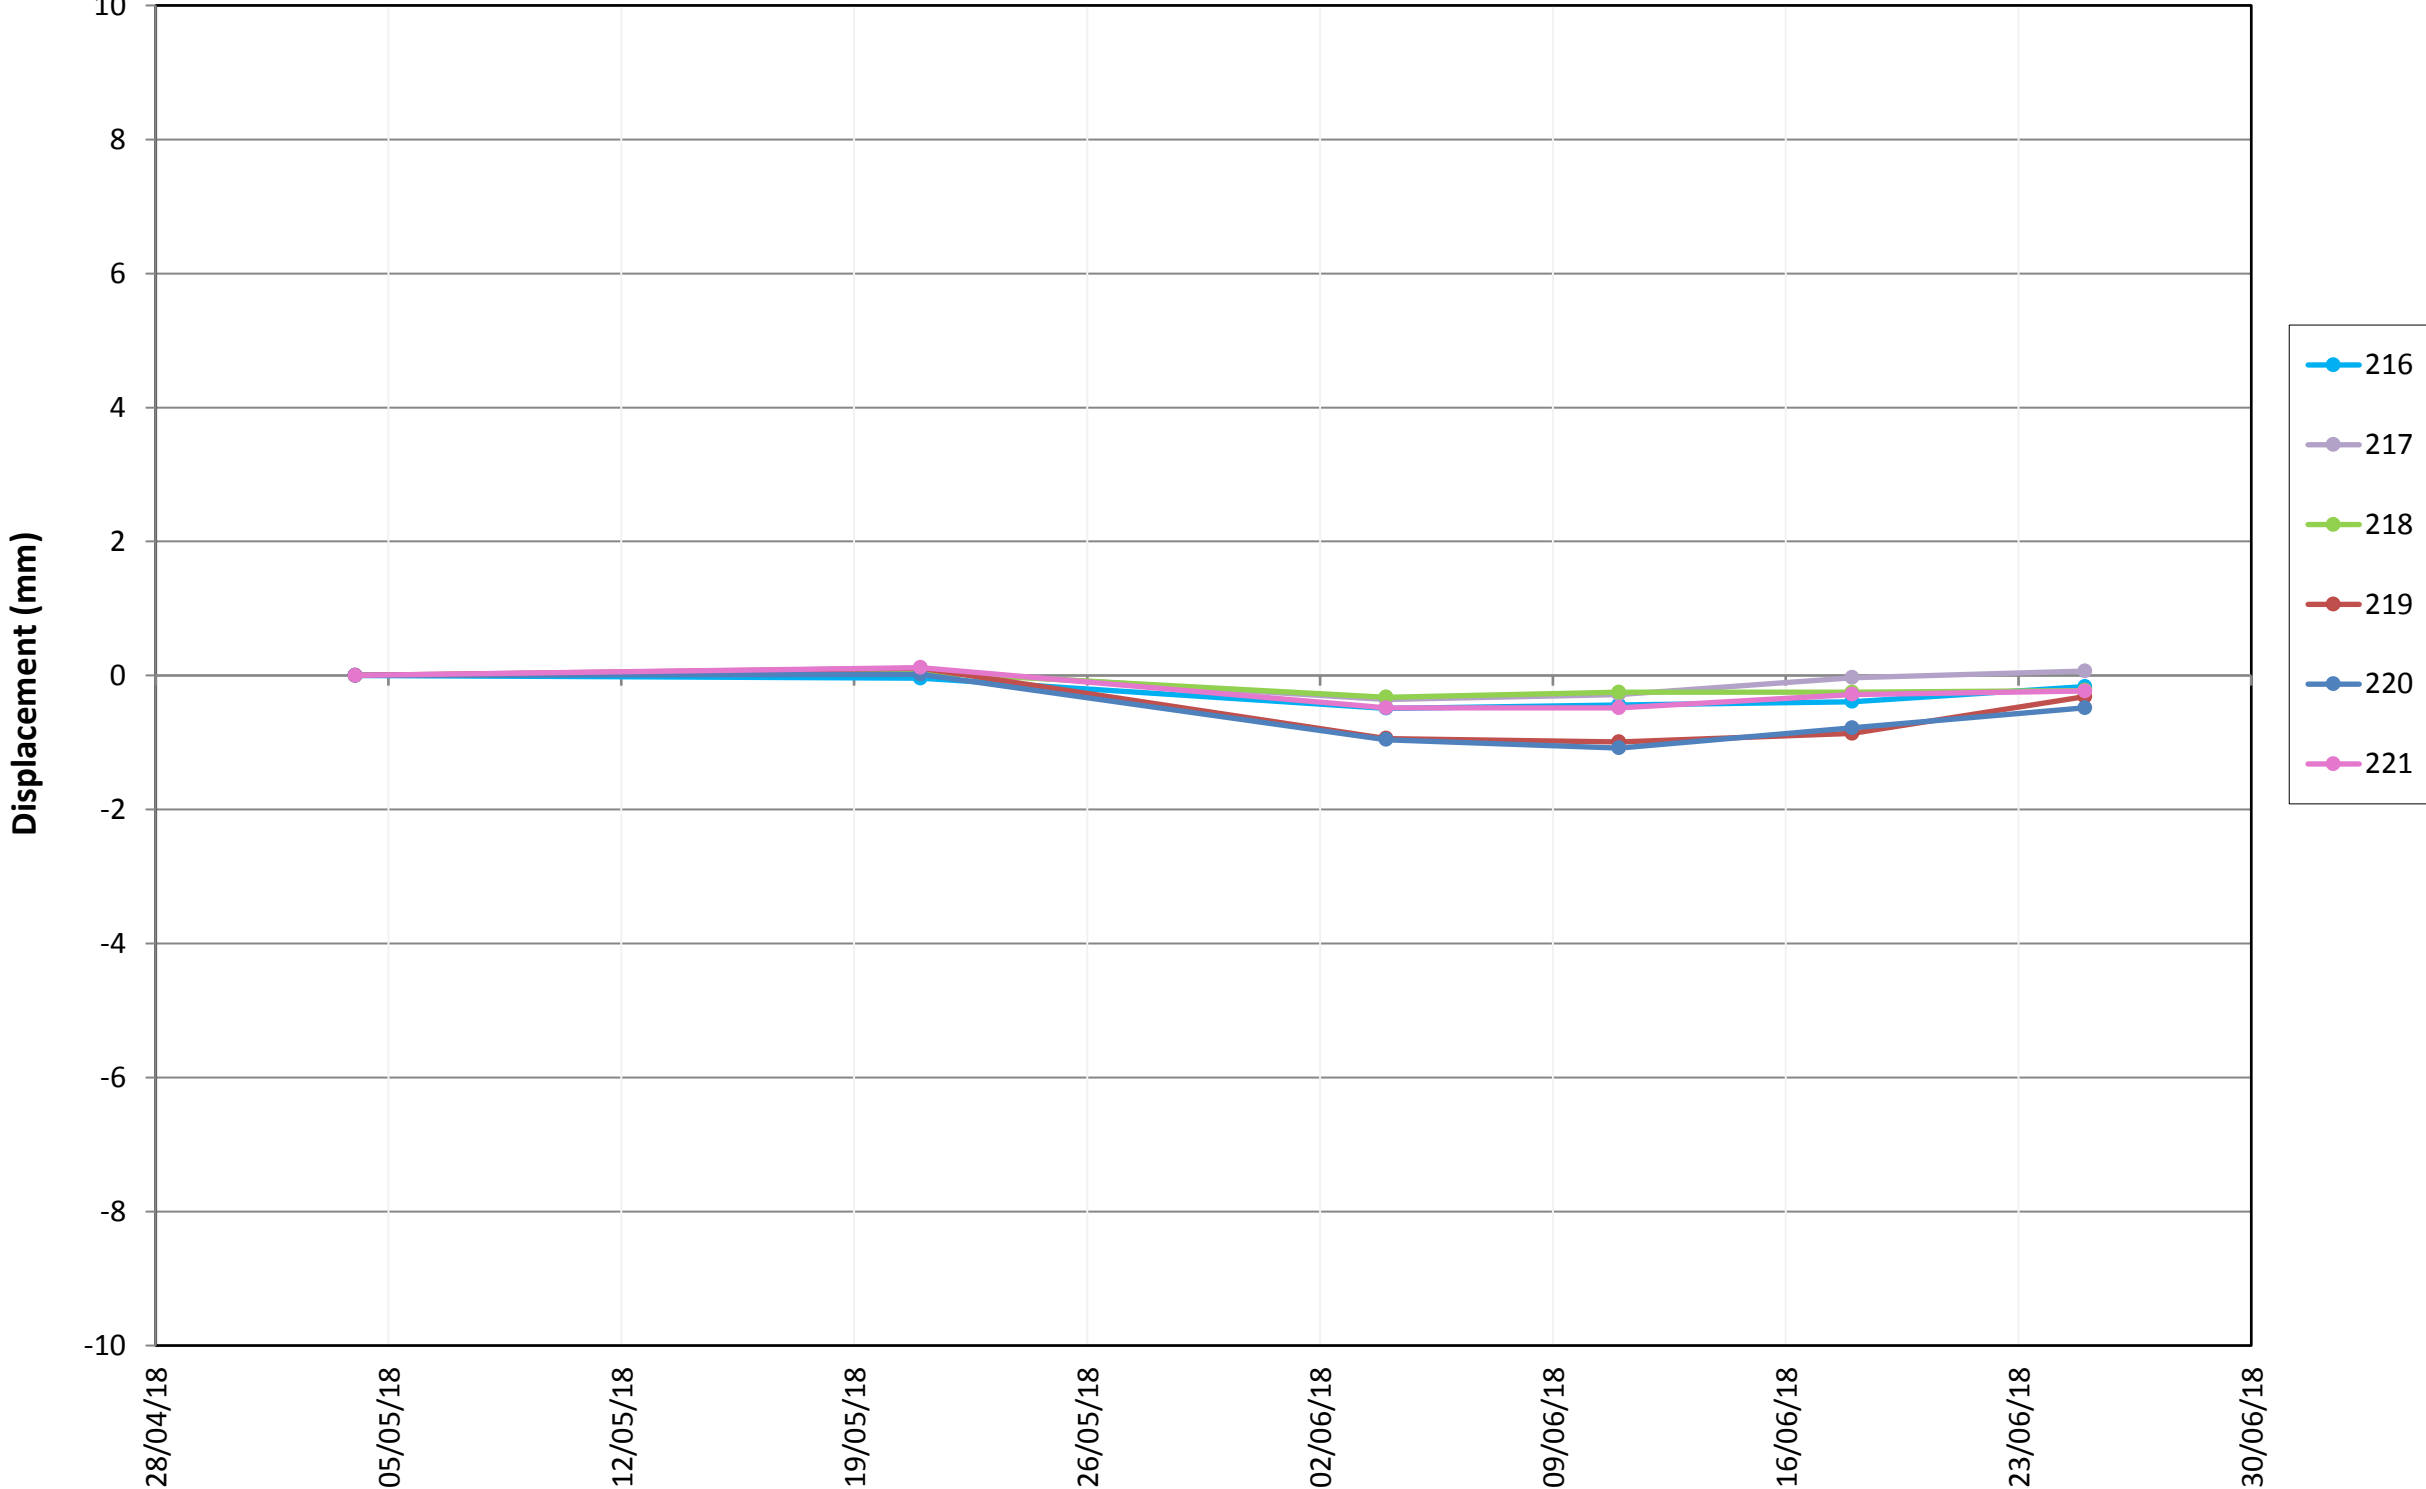
Graph 04V - Targets on Staircase

Note: +ve value denotes heave, -ve value denotes settlement.
