32-33 TORRINGTON SQUARE  
MONITORING

Monitoring Report  
SES-10215-MR05

Date of survey completion: 25<sup>th</sup> June 2018

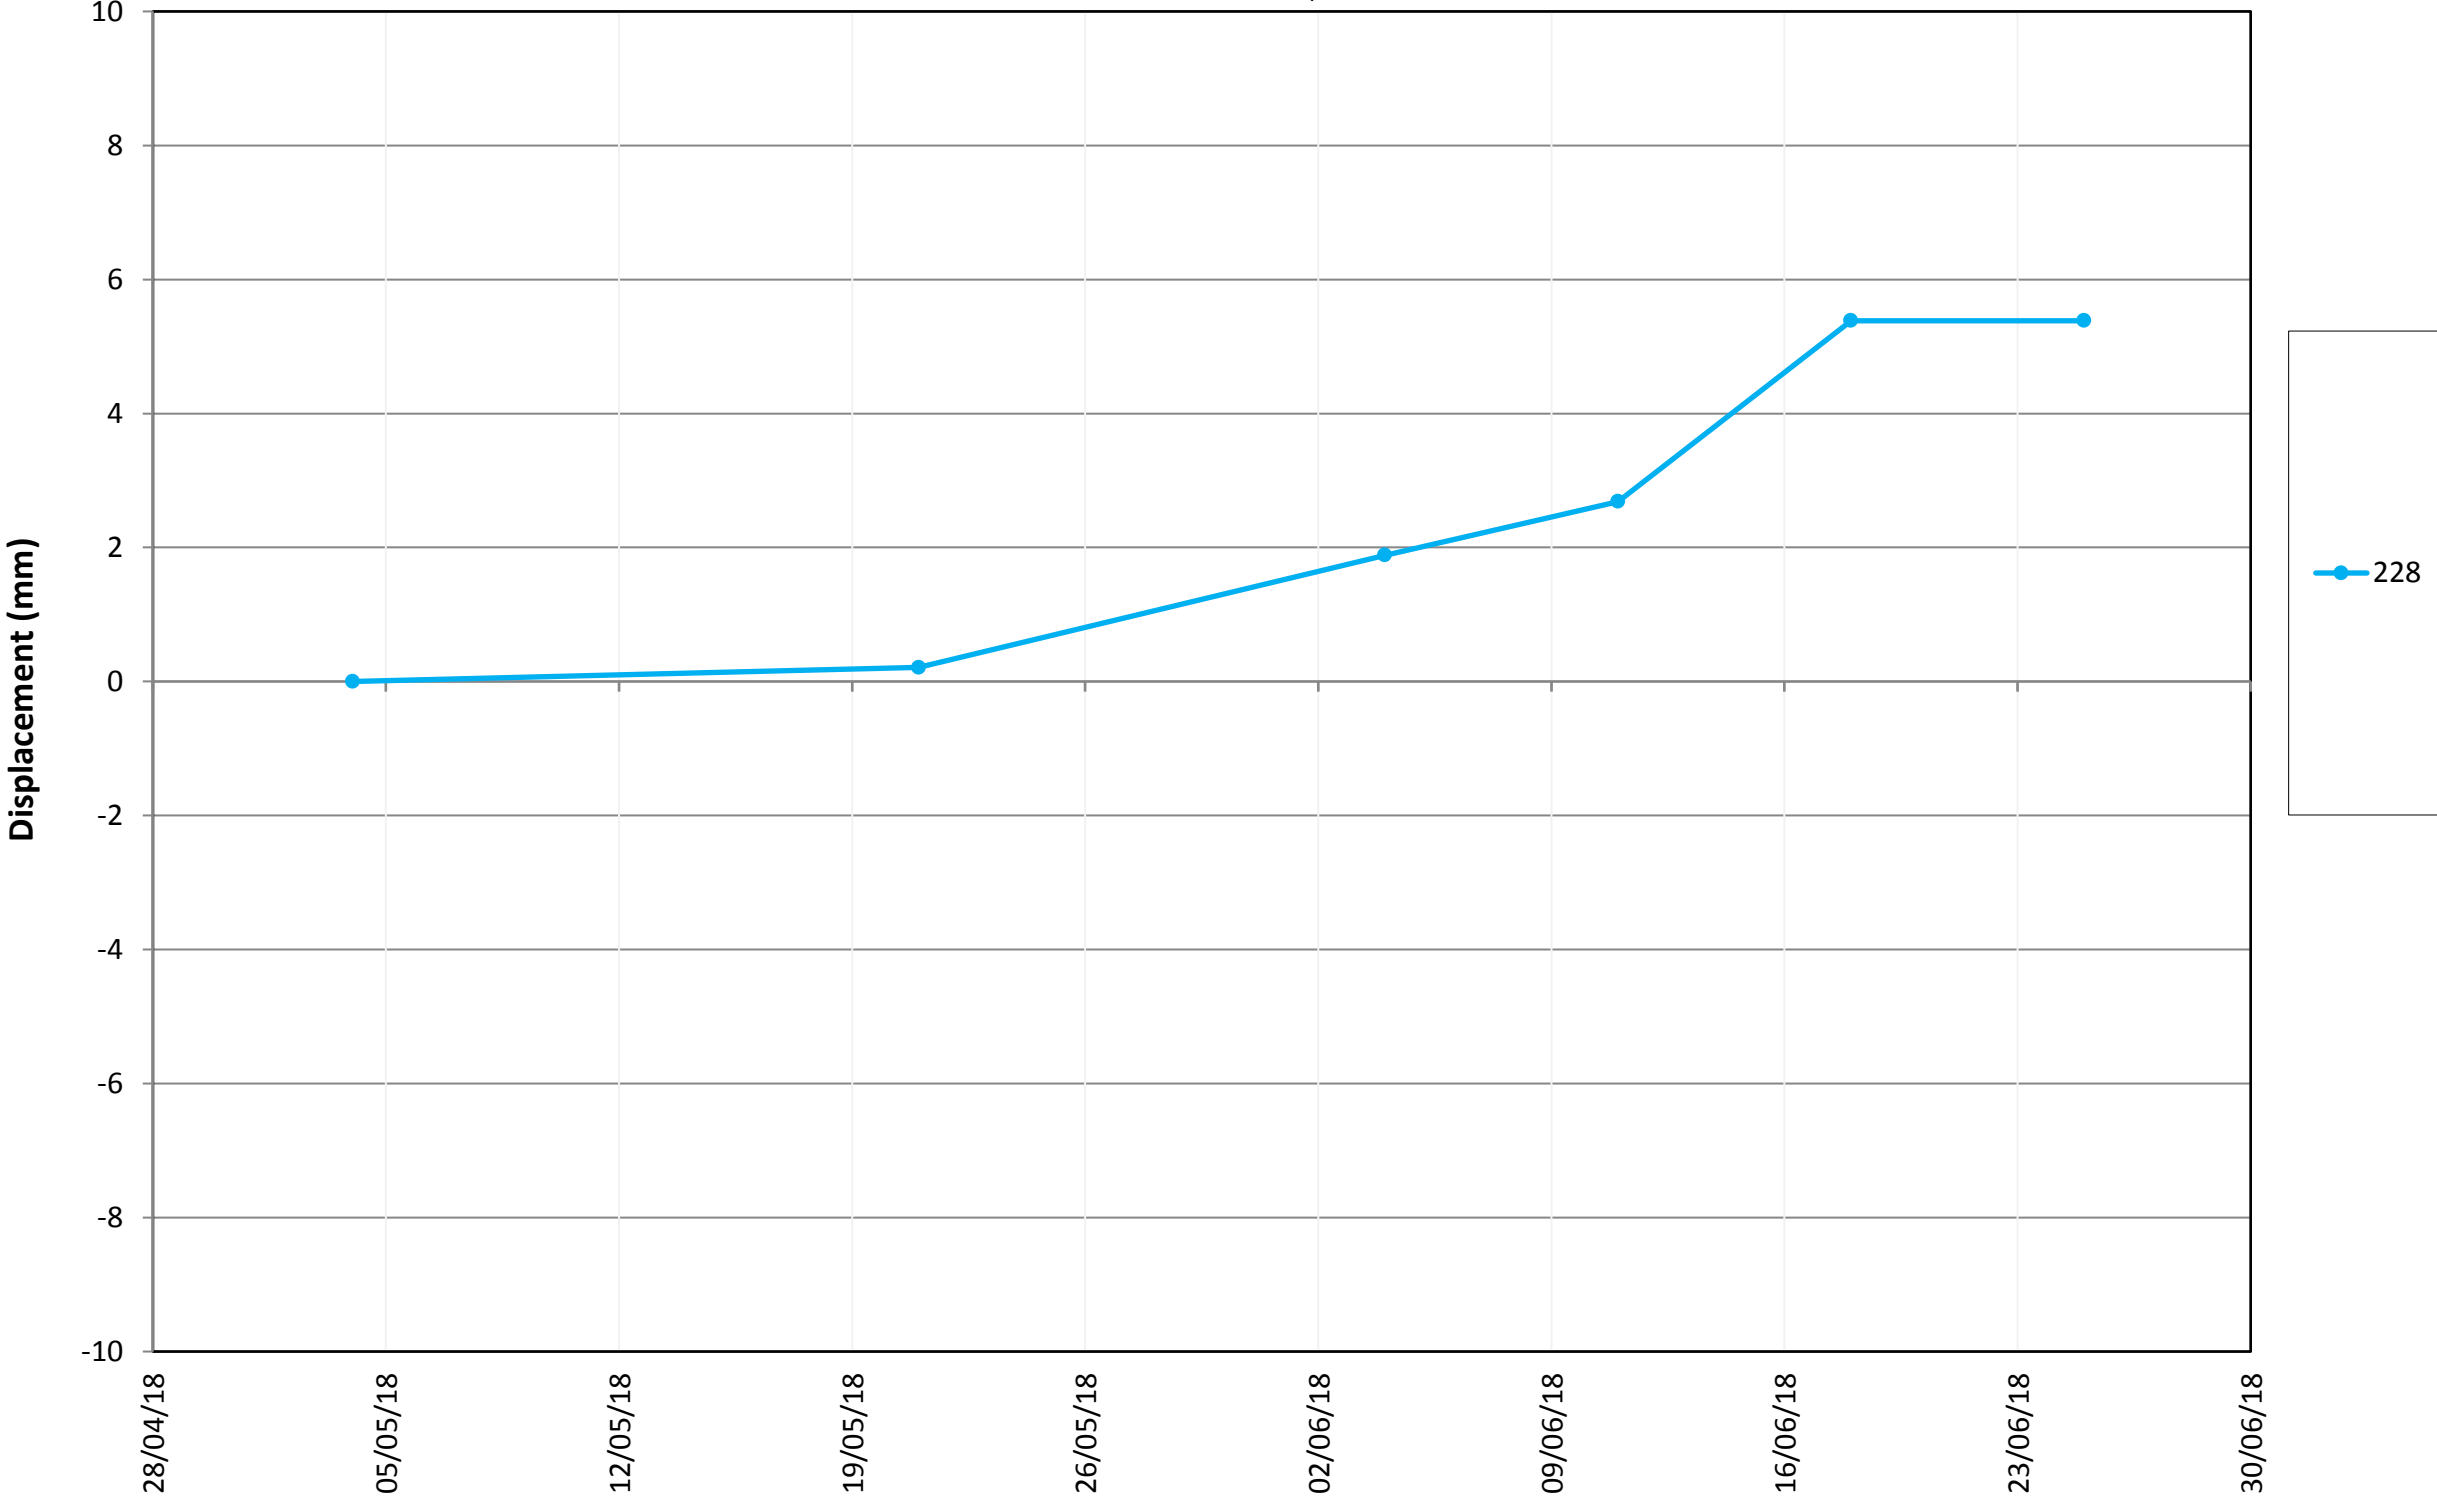
Graph 06T - Targets on back garden of No. 31 Torrington Square

Targets are showing horizontal movement of up to 5 mm in Eastings.  
Targets are showing negligible vertical movement.

Note: A positive value denotes movement towards Slade Research Centre and vice versa.

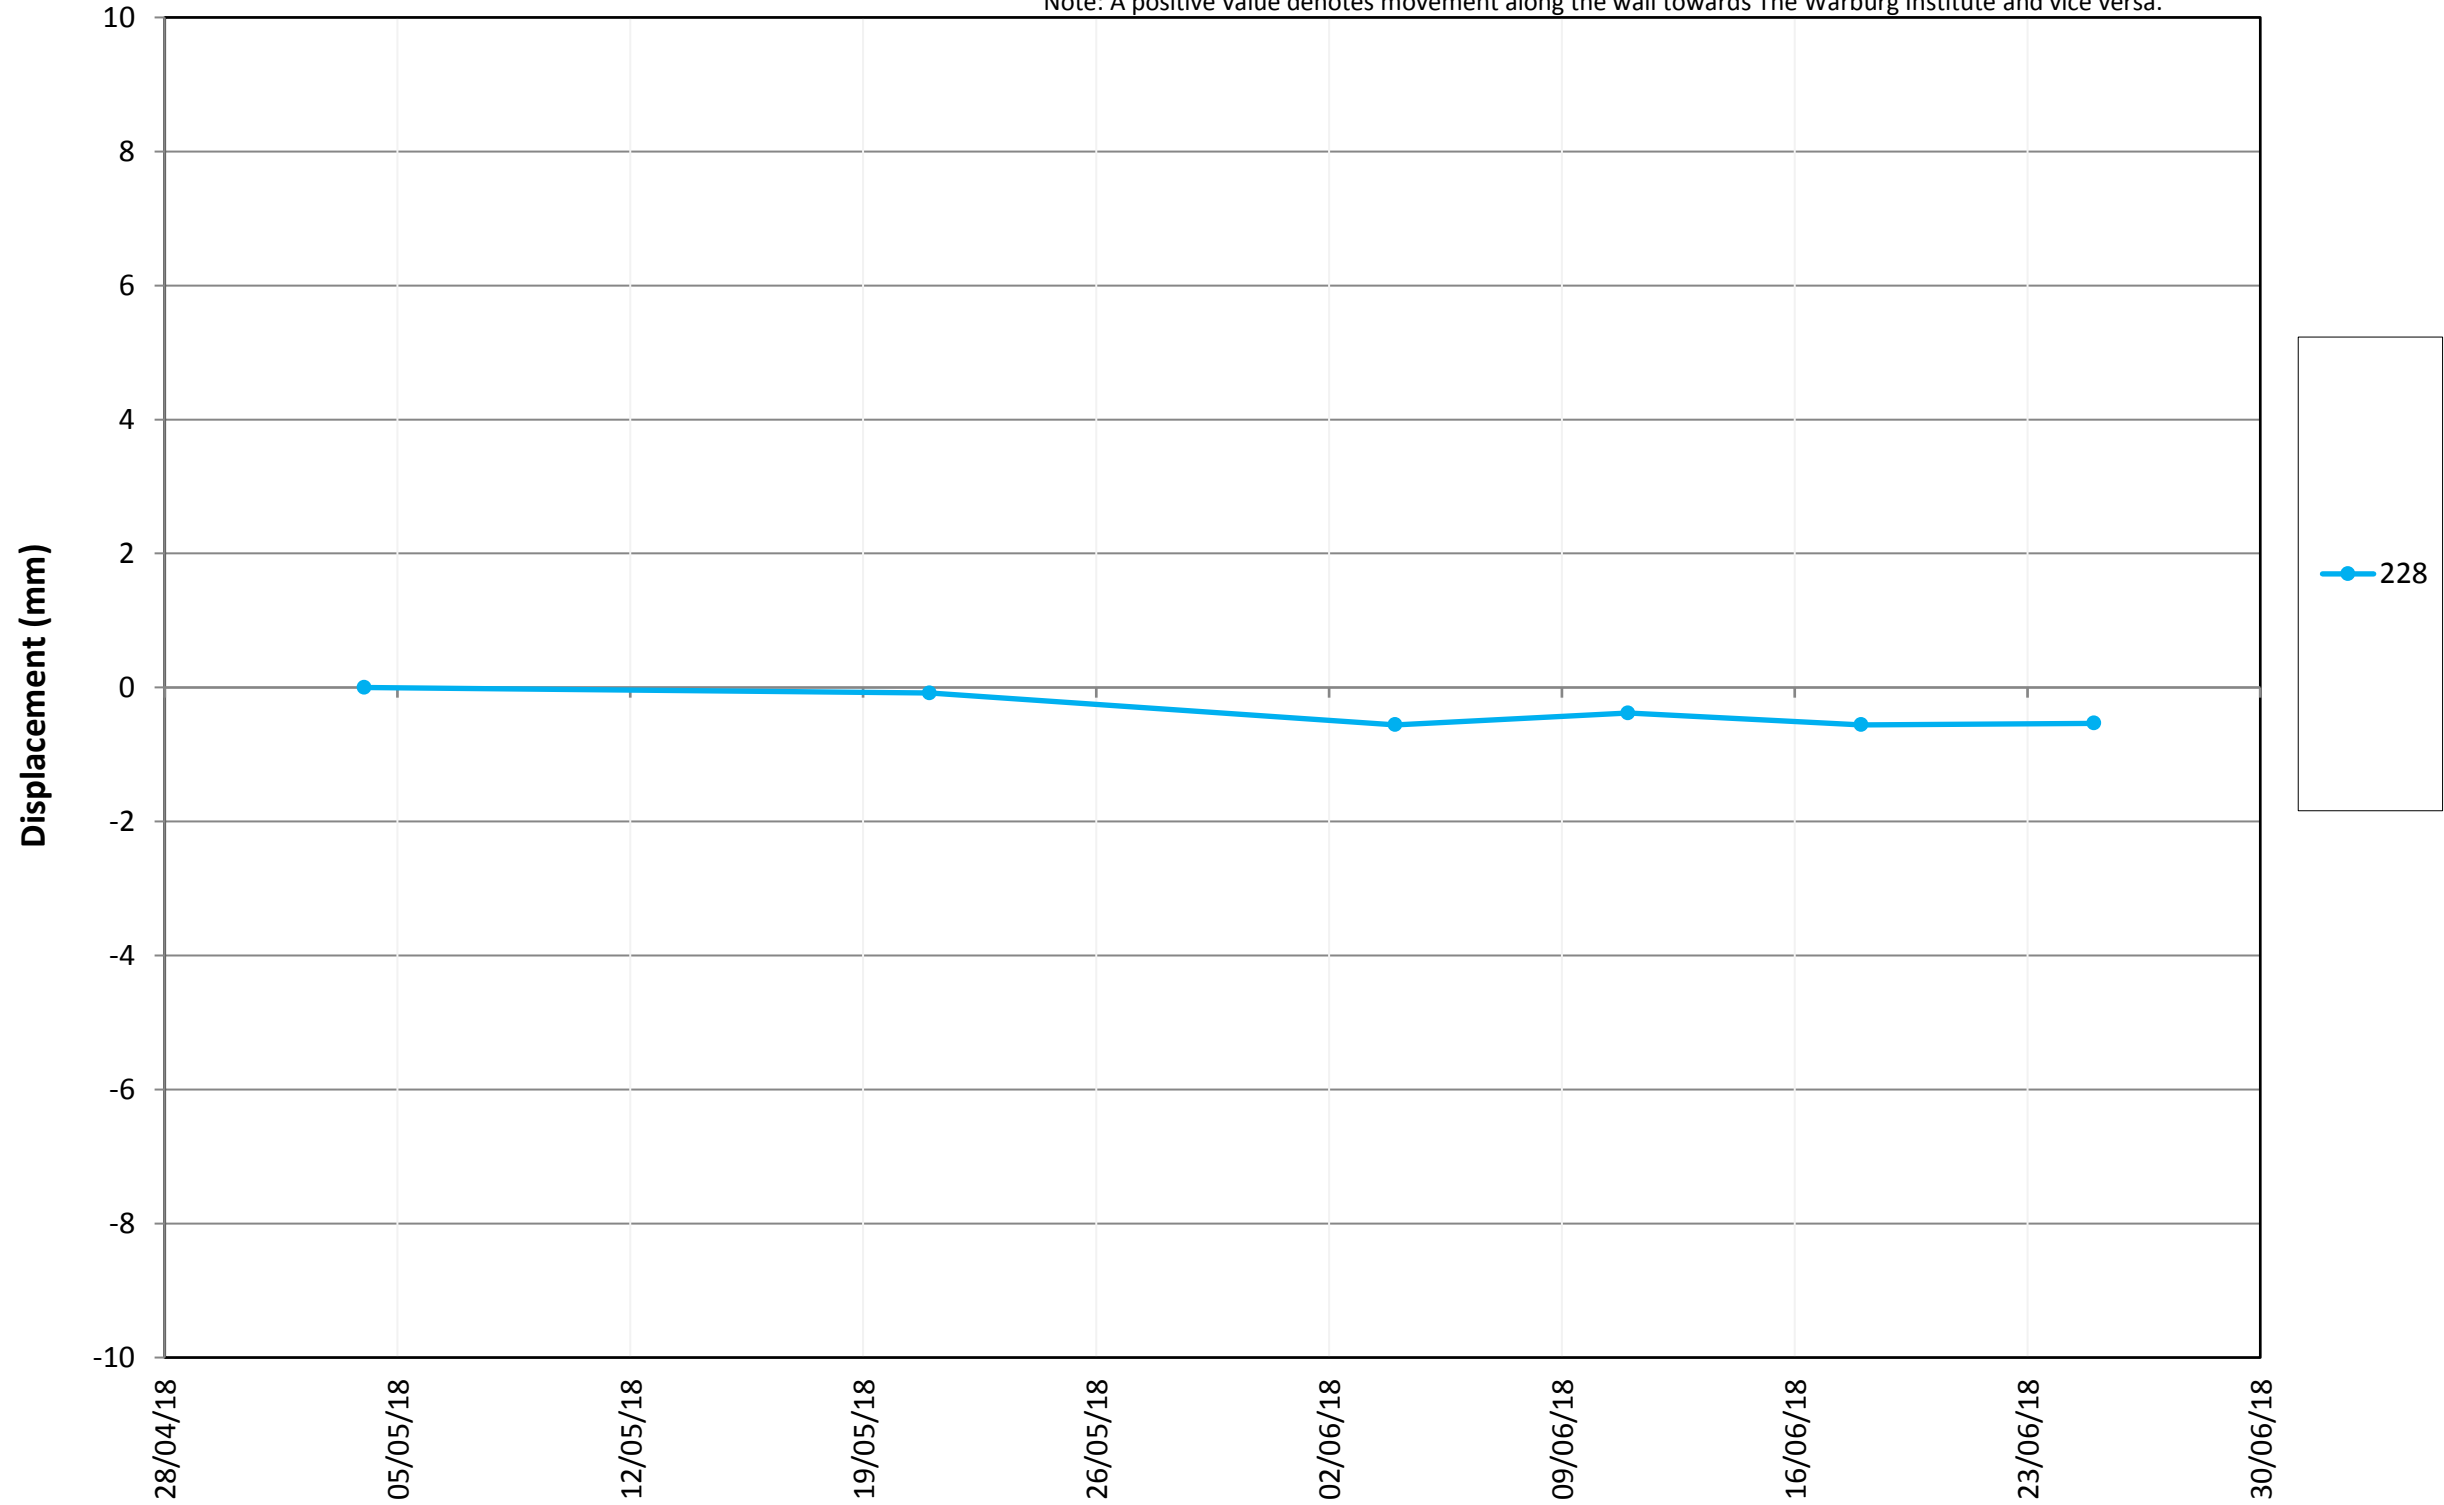
Graph 06L - Targets on back garden of No. 31 Torrington Square

Note: A positive value denotes movement along the wall towards The Warburg Institute and vice versa.

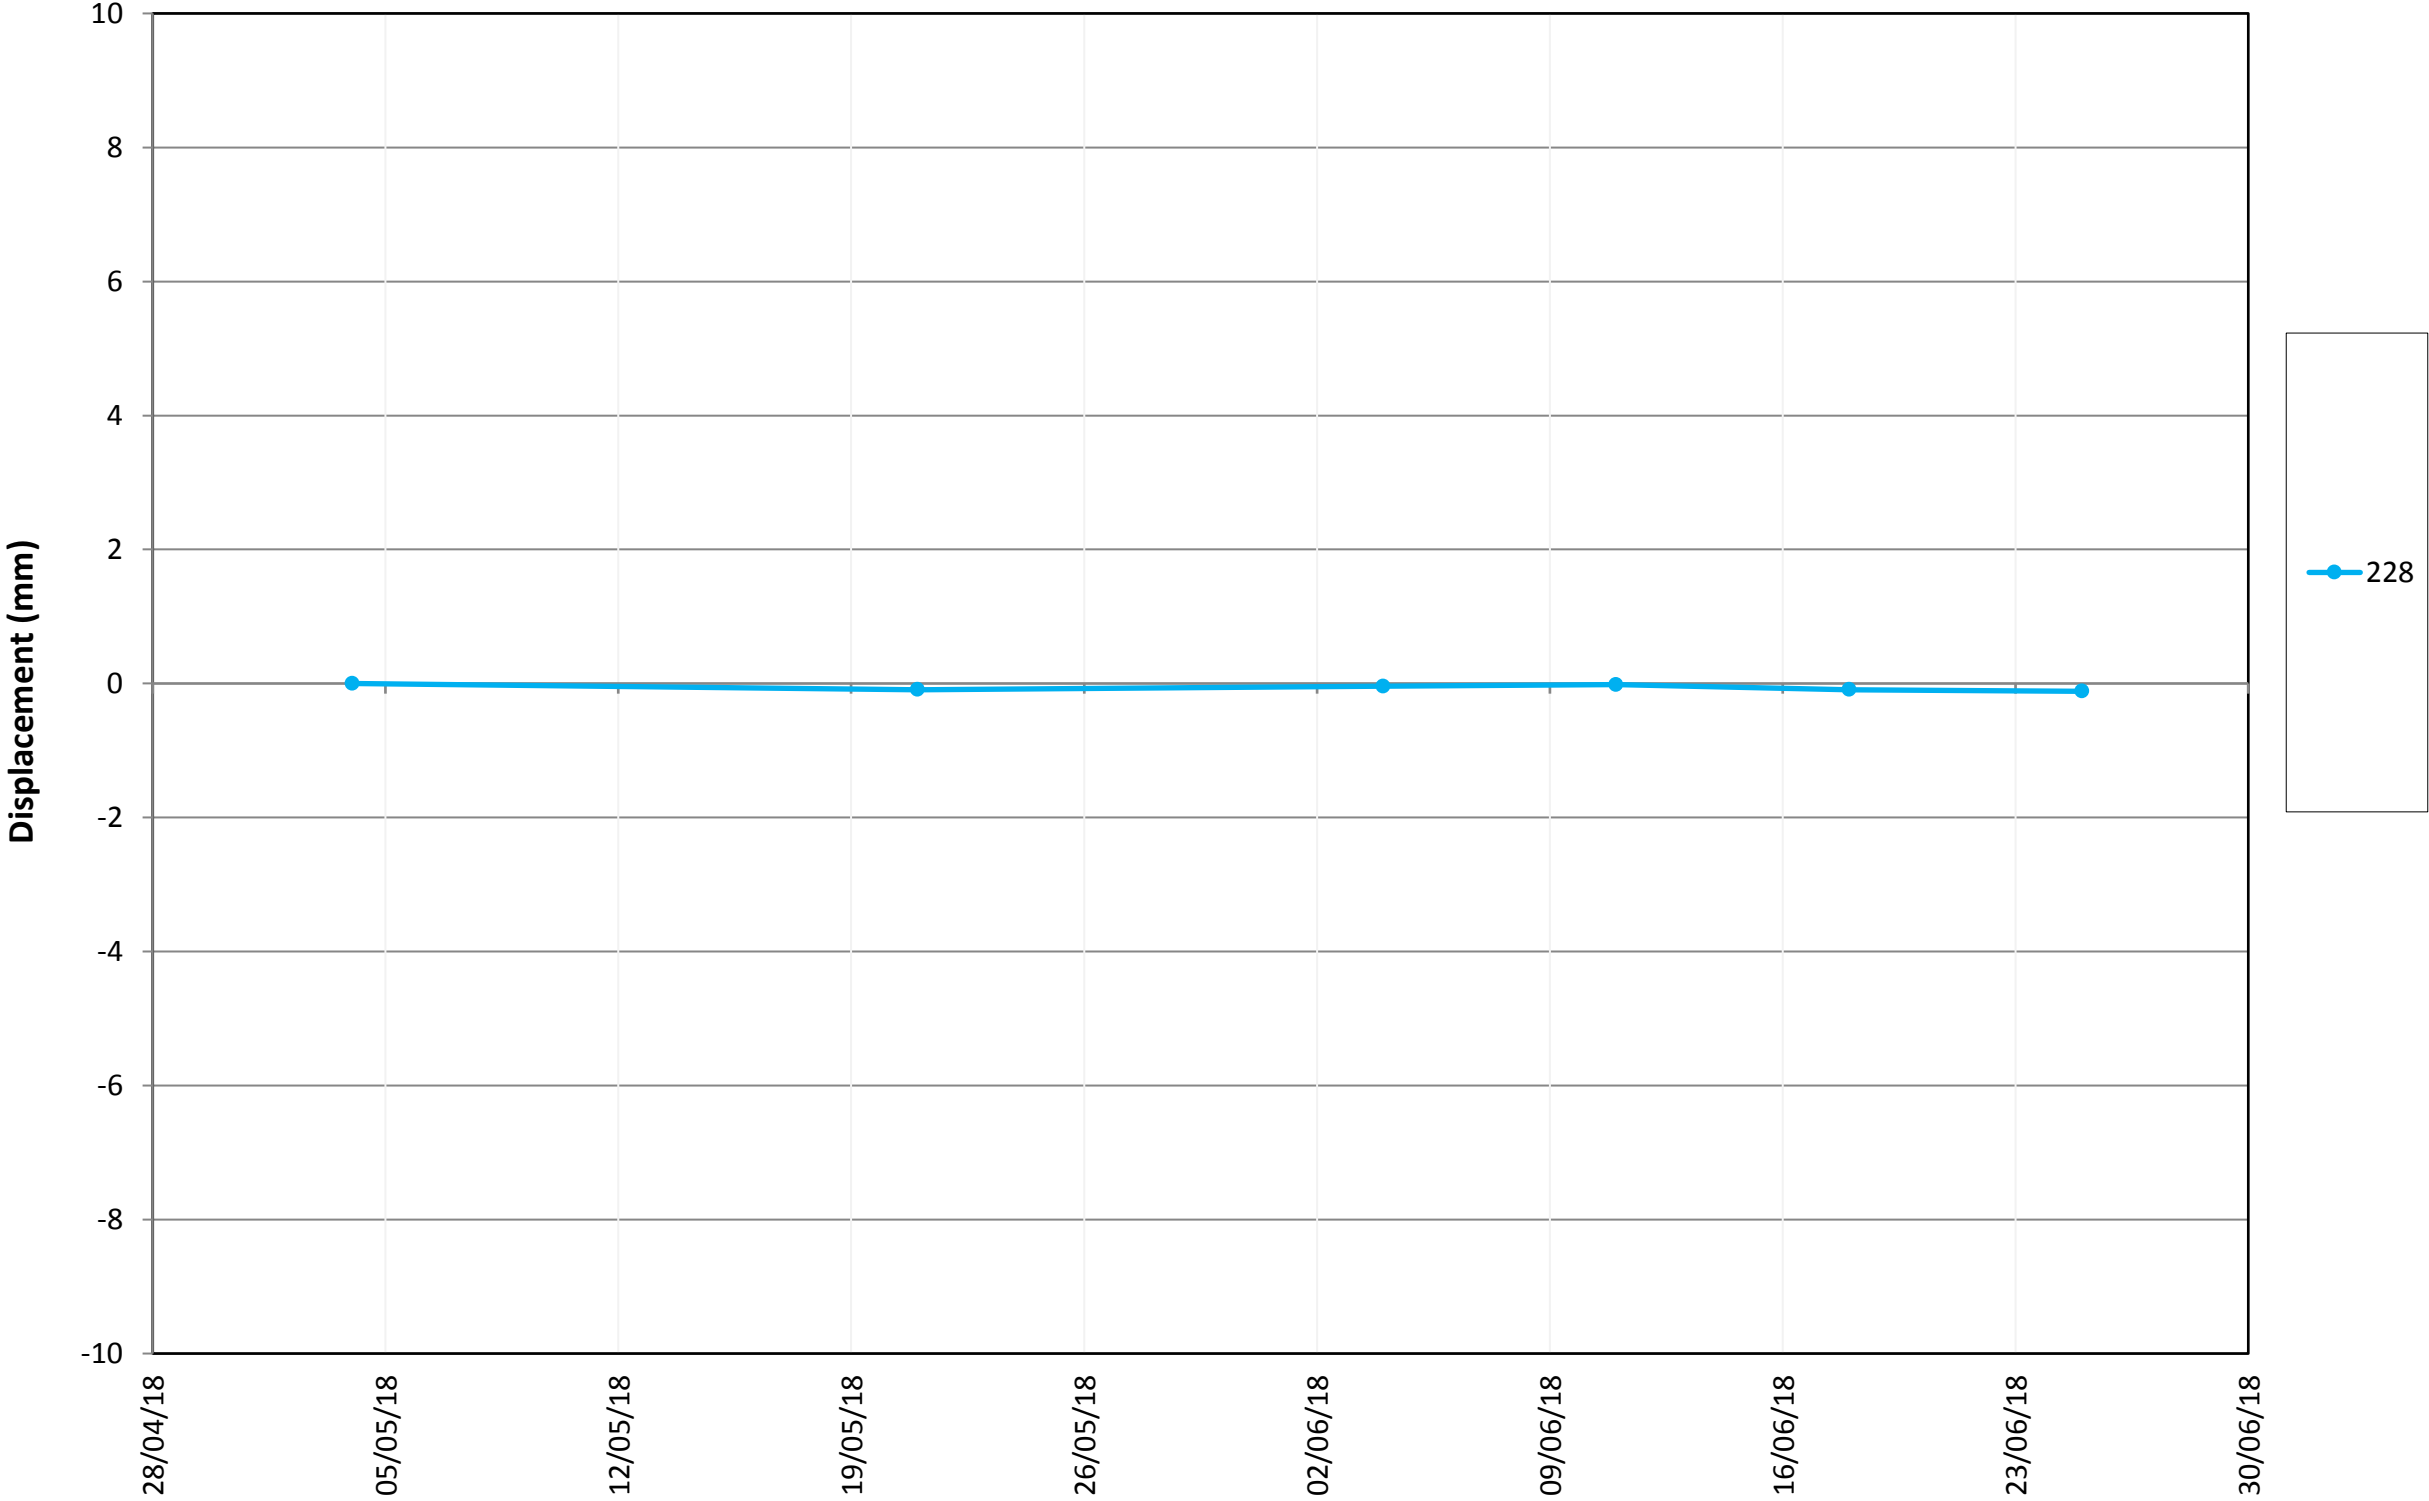
Graph 06V - Targets on back garden of No. 31 Torrington Square

Note: +ve value denotes heave, -ve value denotes settlement.

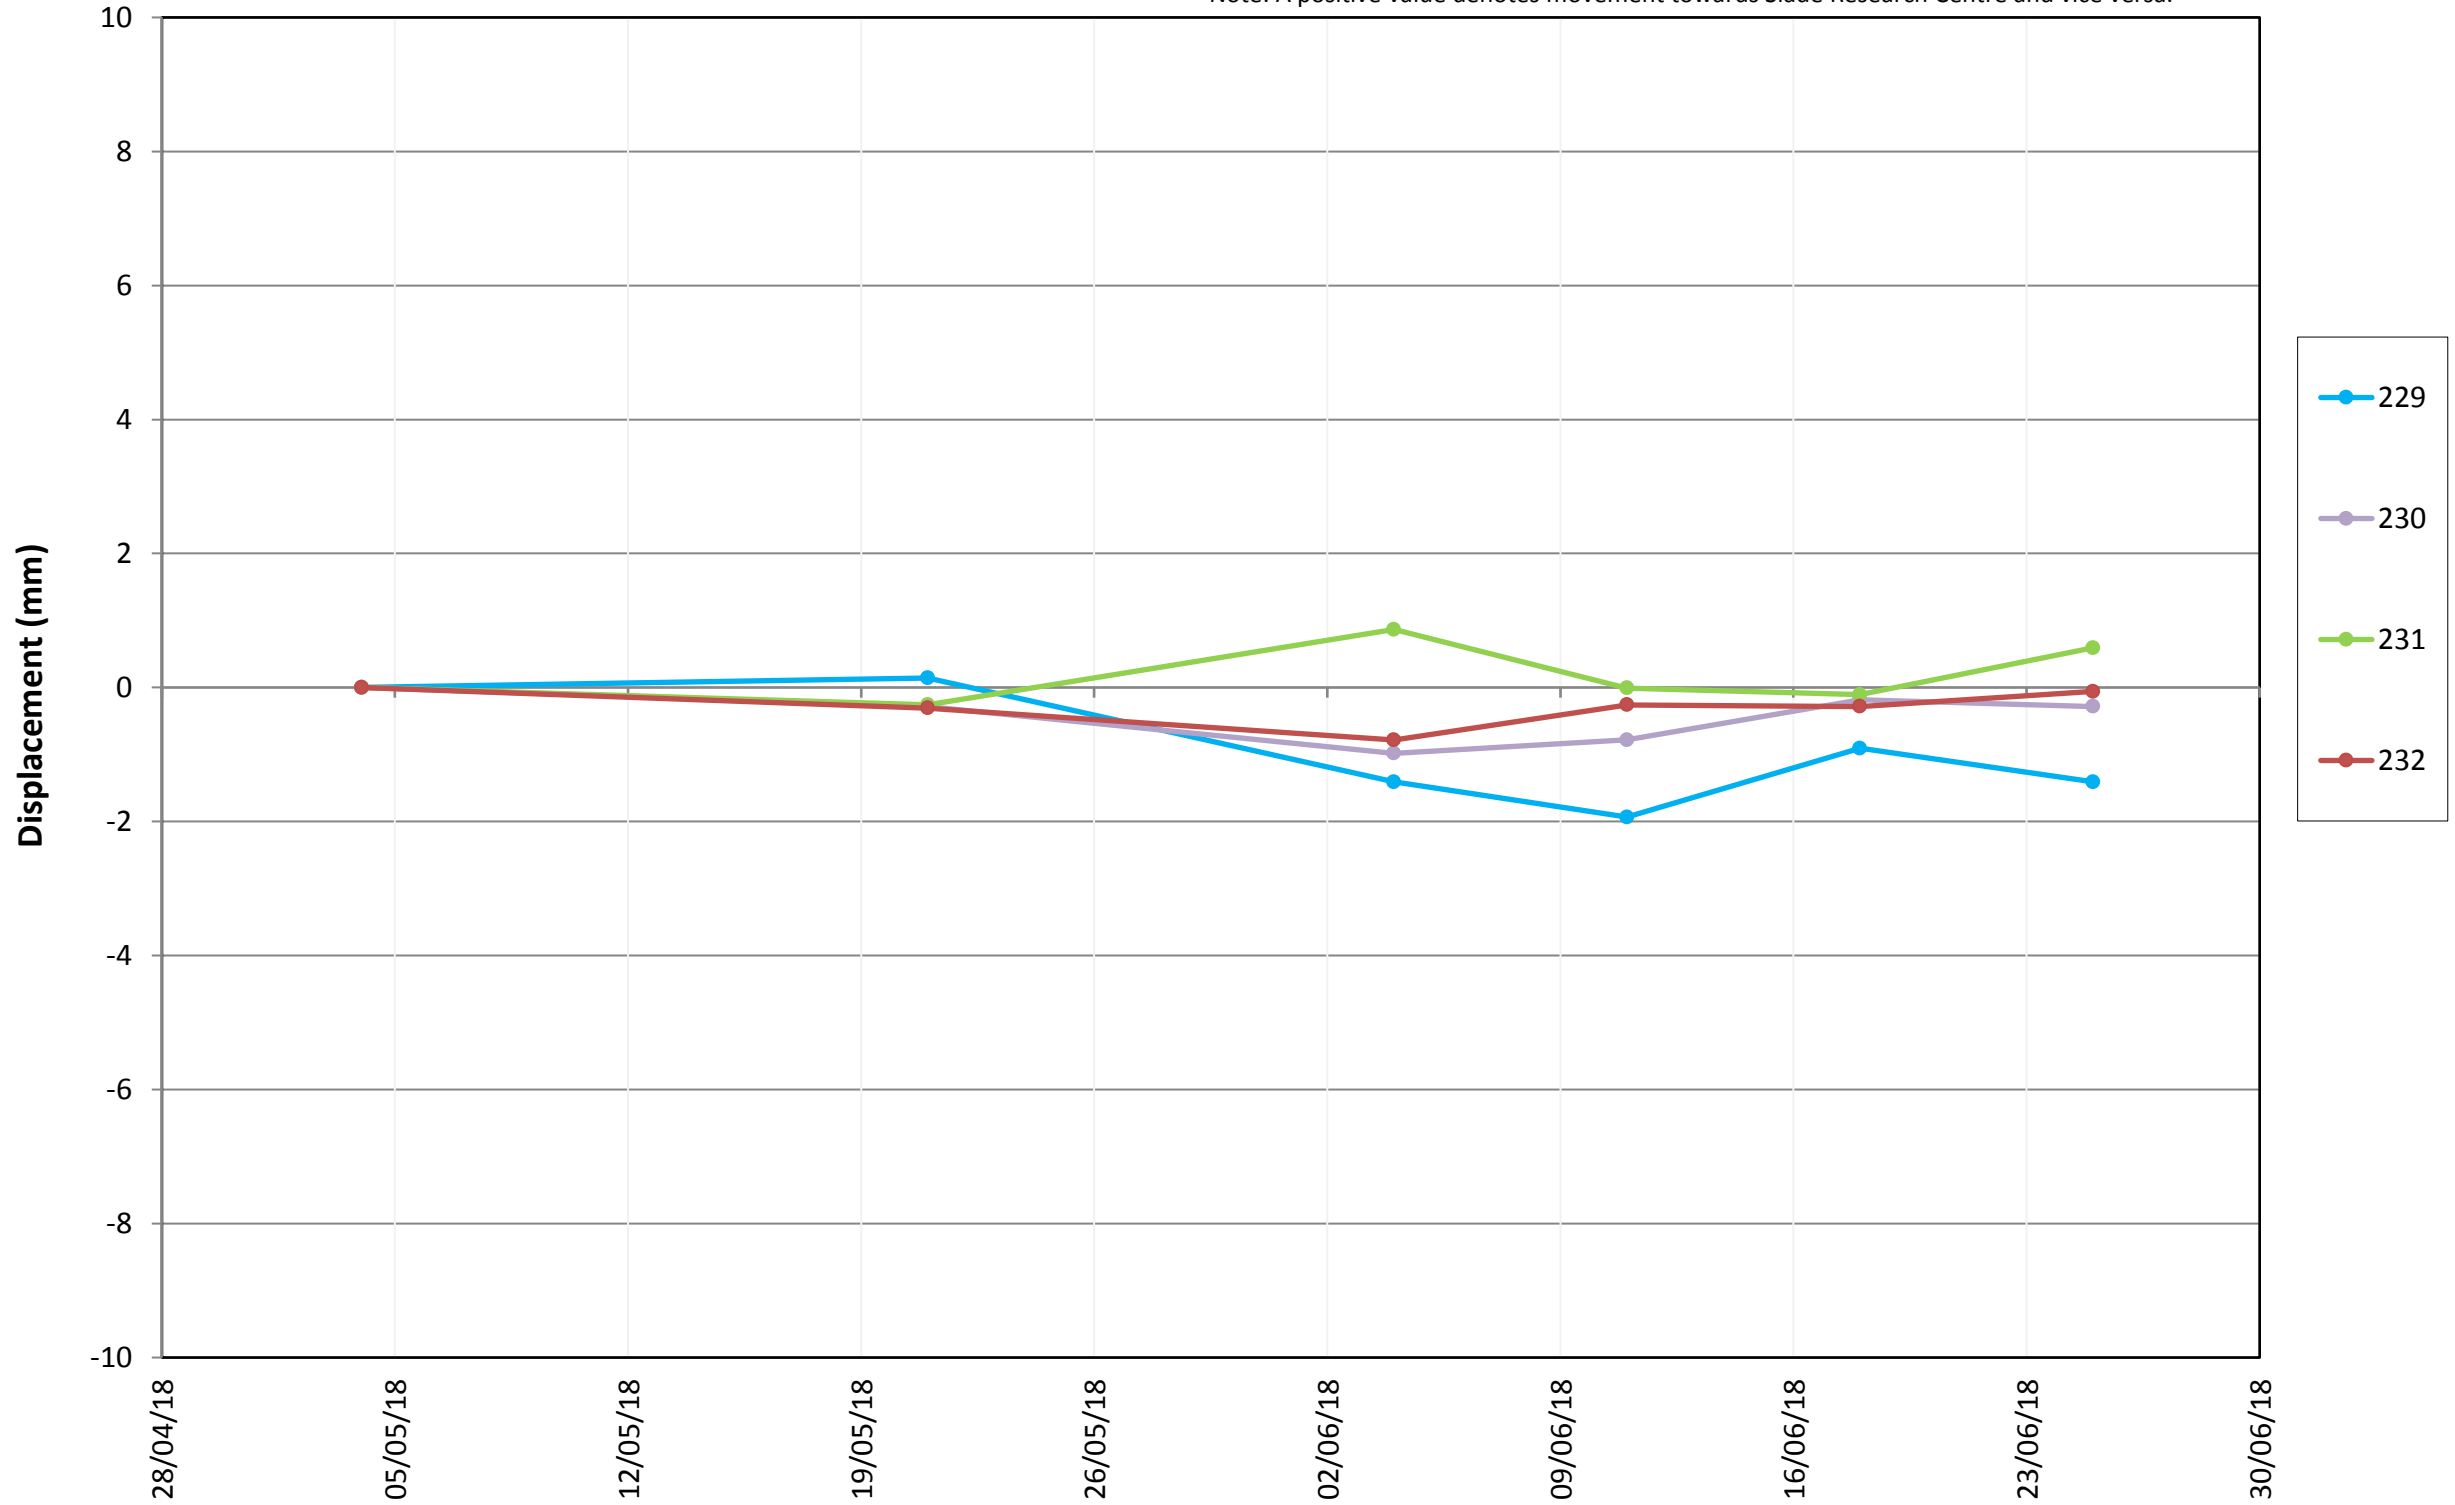
Graph 07T - Targets on back garden of No. 32 Torrington Square

Targets are showing negligible horizontal movement.  
Targets are showing negligible vertical movement.  
Targets 233,234 are obstructed by leaves.

Note: A positive value denotes movement towards Slade Research Centre and vice versa.

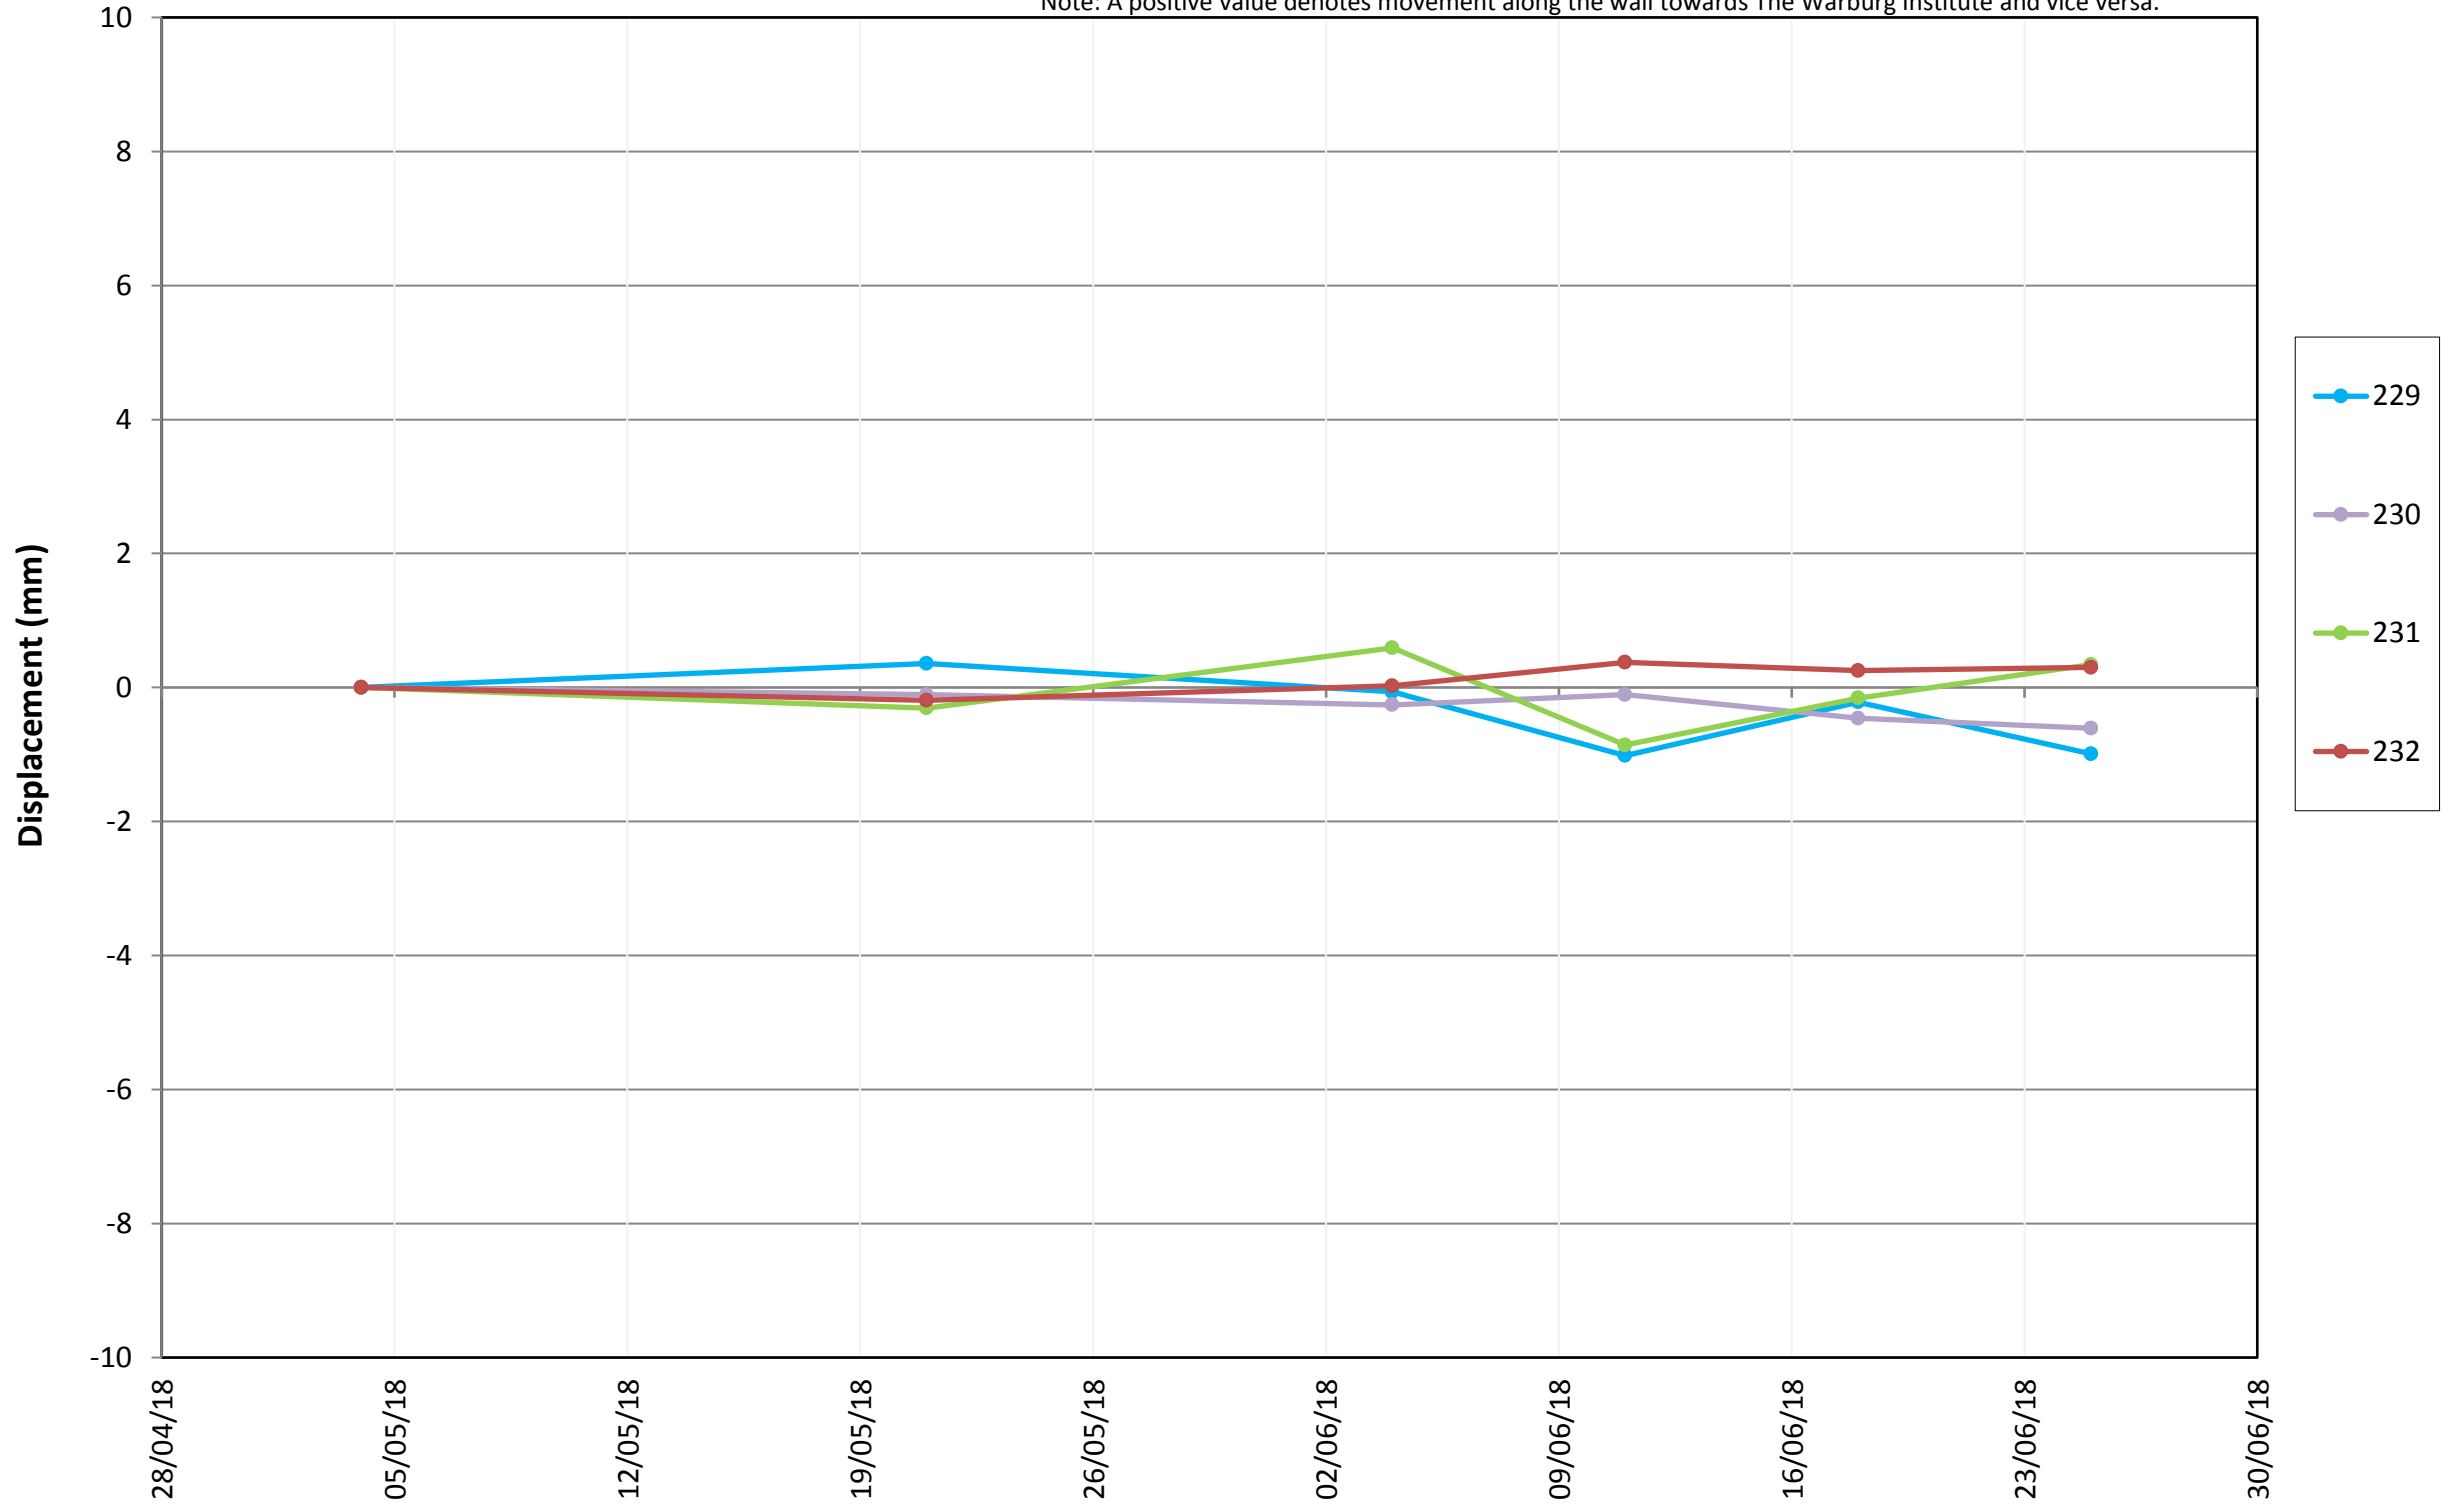
Graph 07L - Targets on back garden of No. 32 Torrington Square

Note: A positive value denotes movement along the wall towards The Warburg Institute and vice versa.

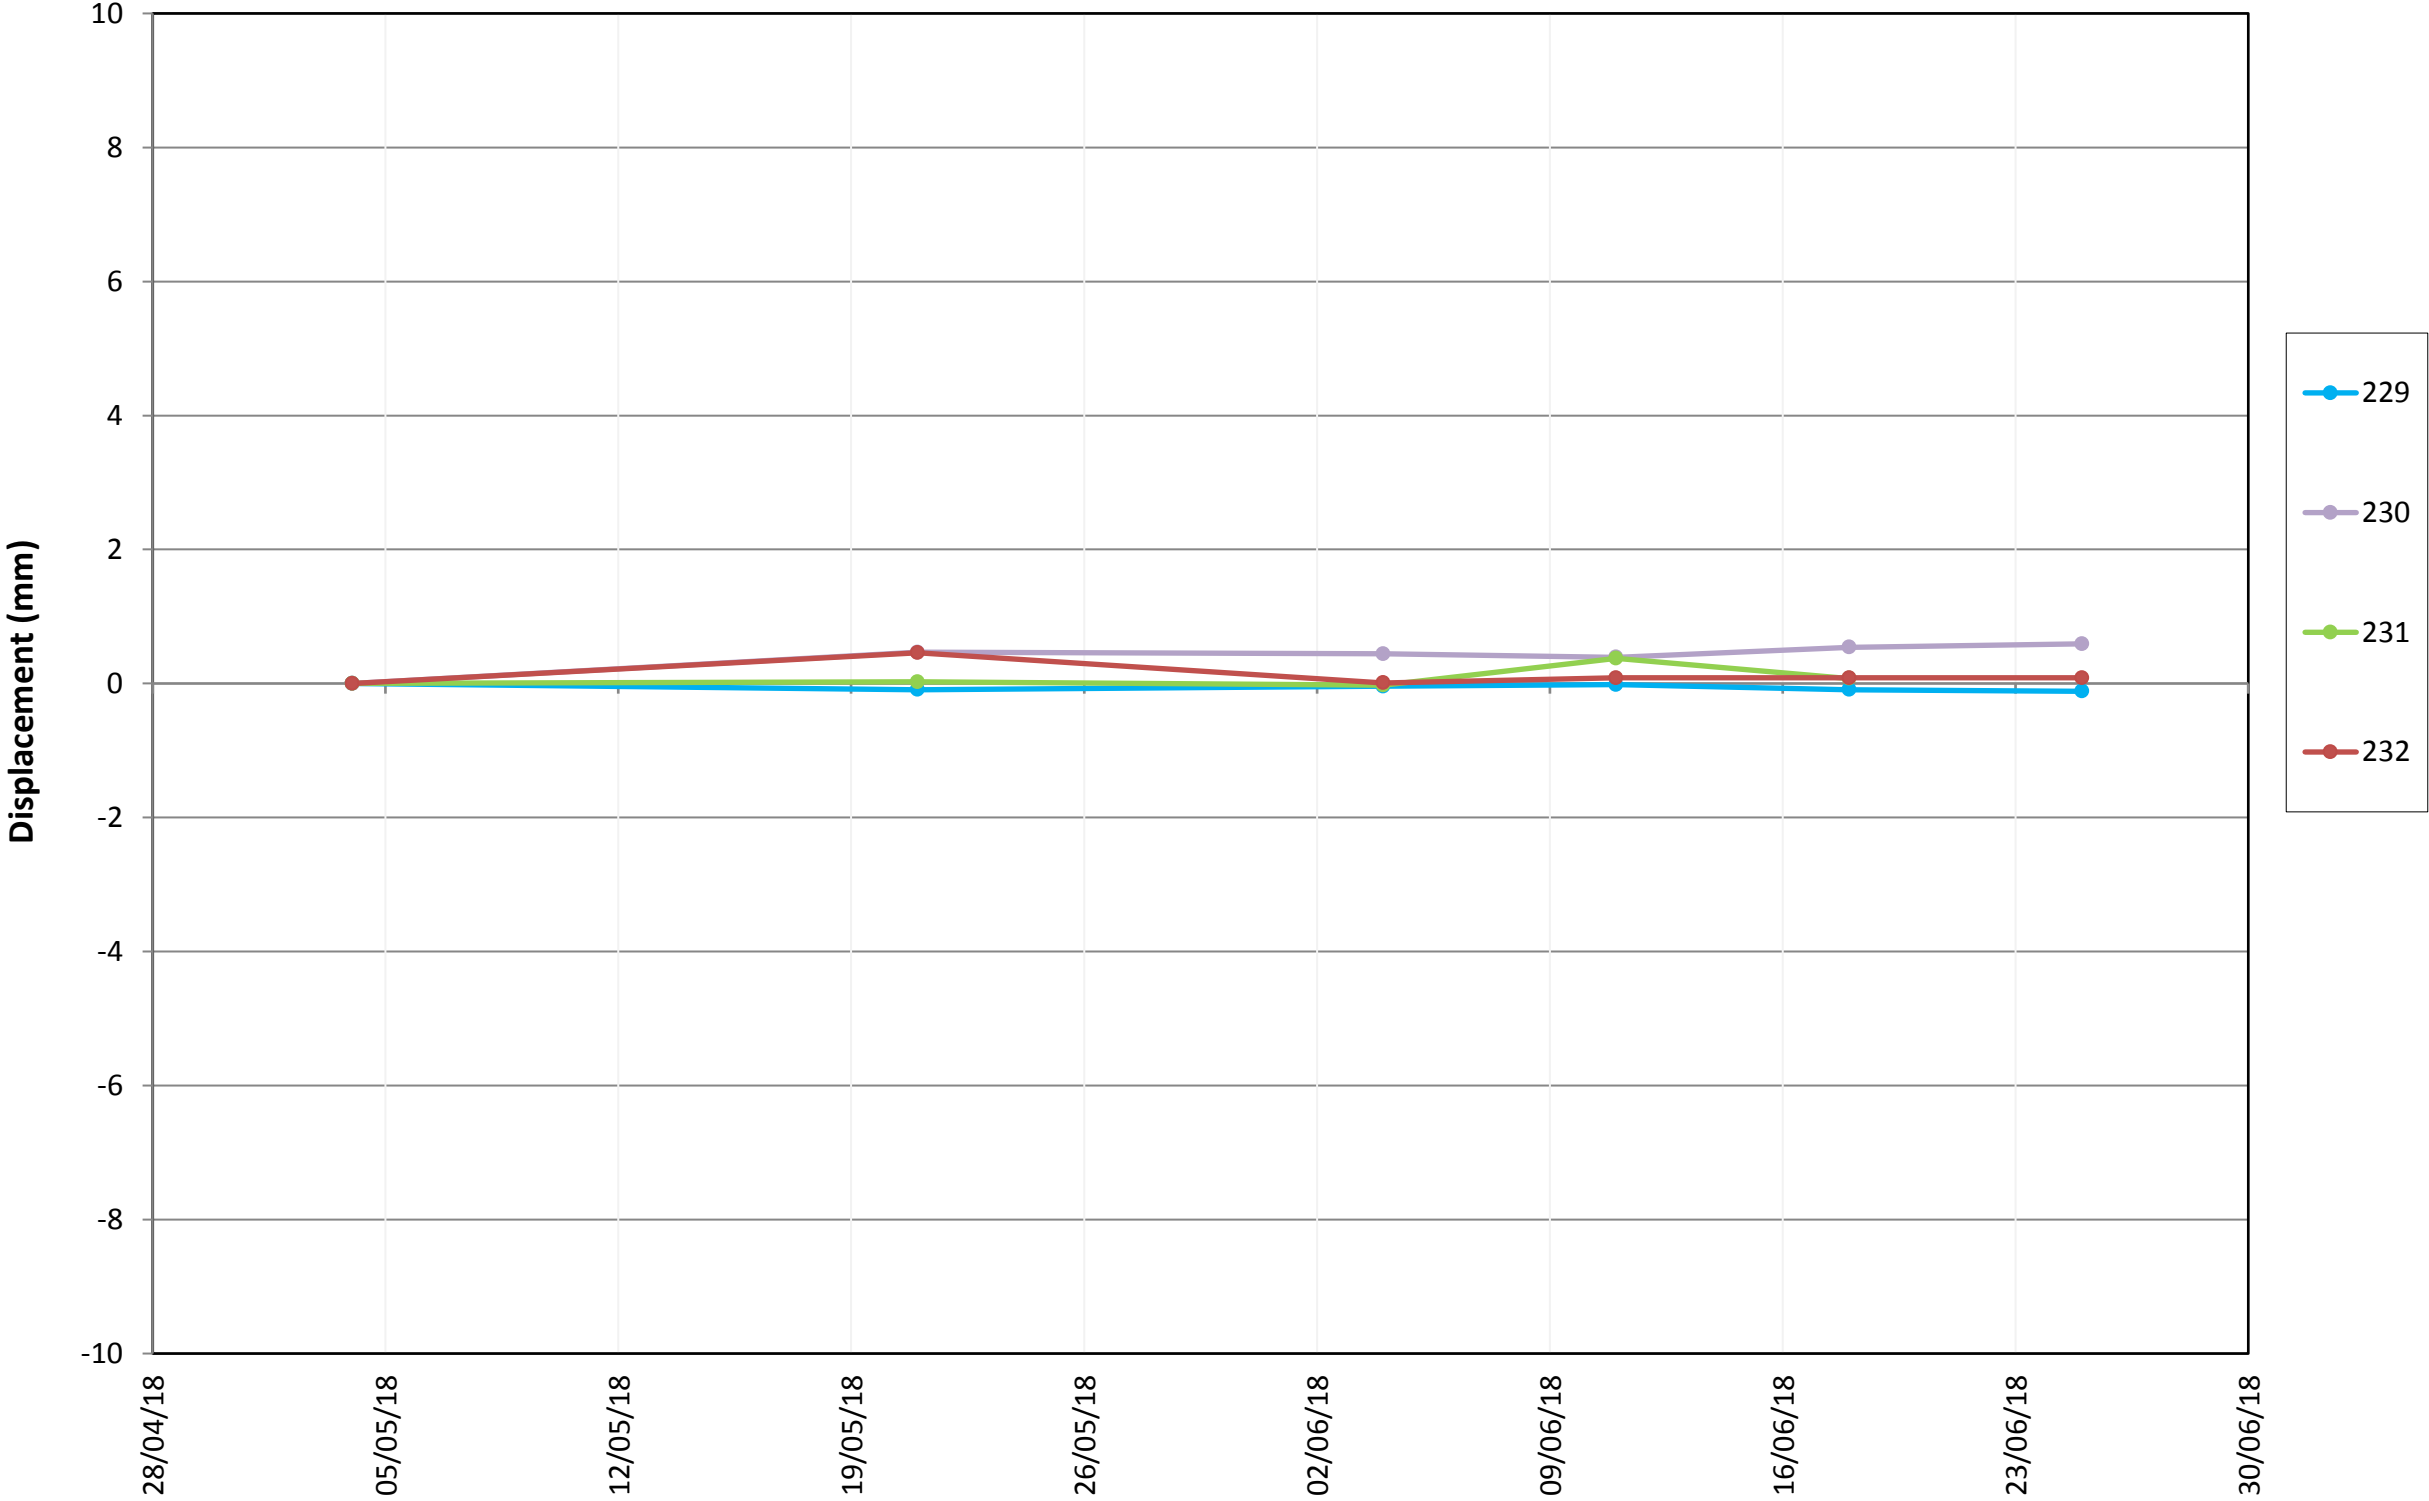
Graph 07V - Targets on back garden of No. 32 Torrington Square

Note: +ve value denotes heave, -ve value denotes settlement.
