32-33 TORRINGTON SQUARE  
MONITORING

Monitoring Report  
SES-10215-MR05

Date of survey completion: 25<sup>th</sup> June 2018

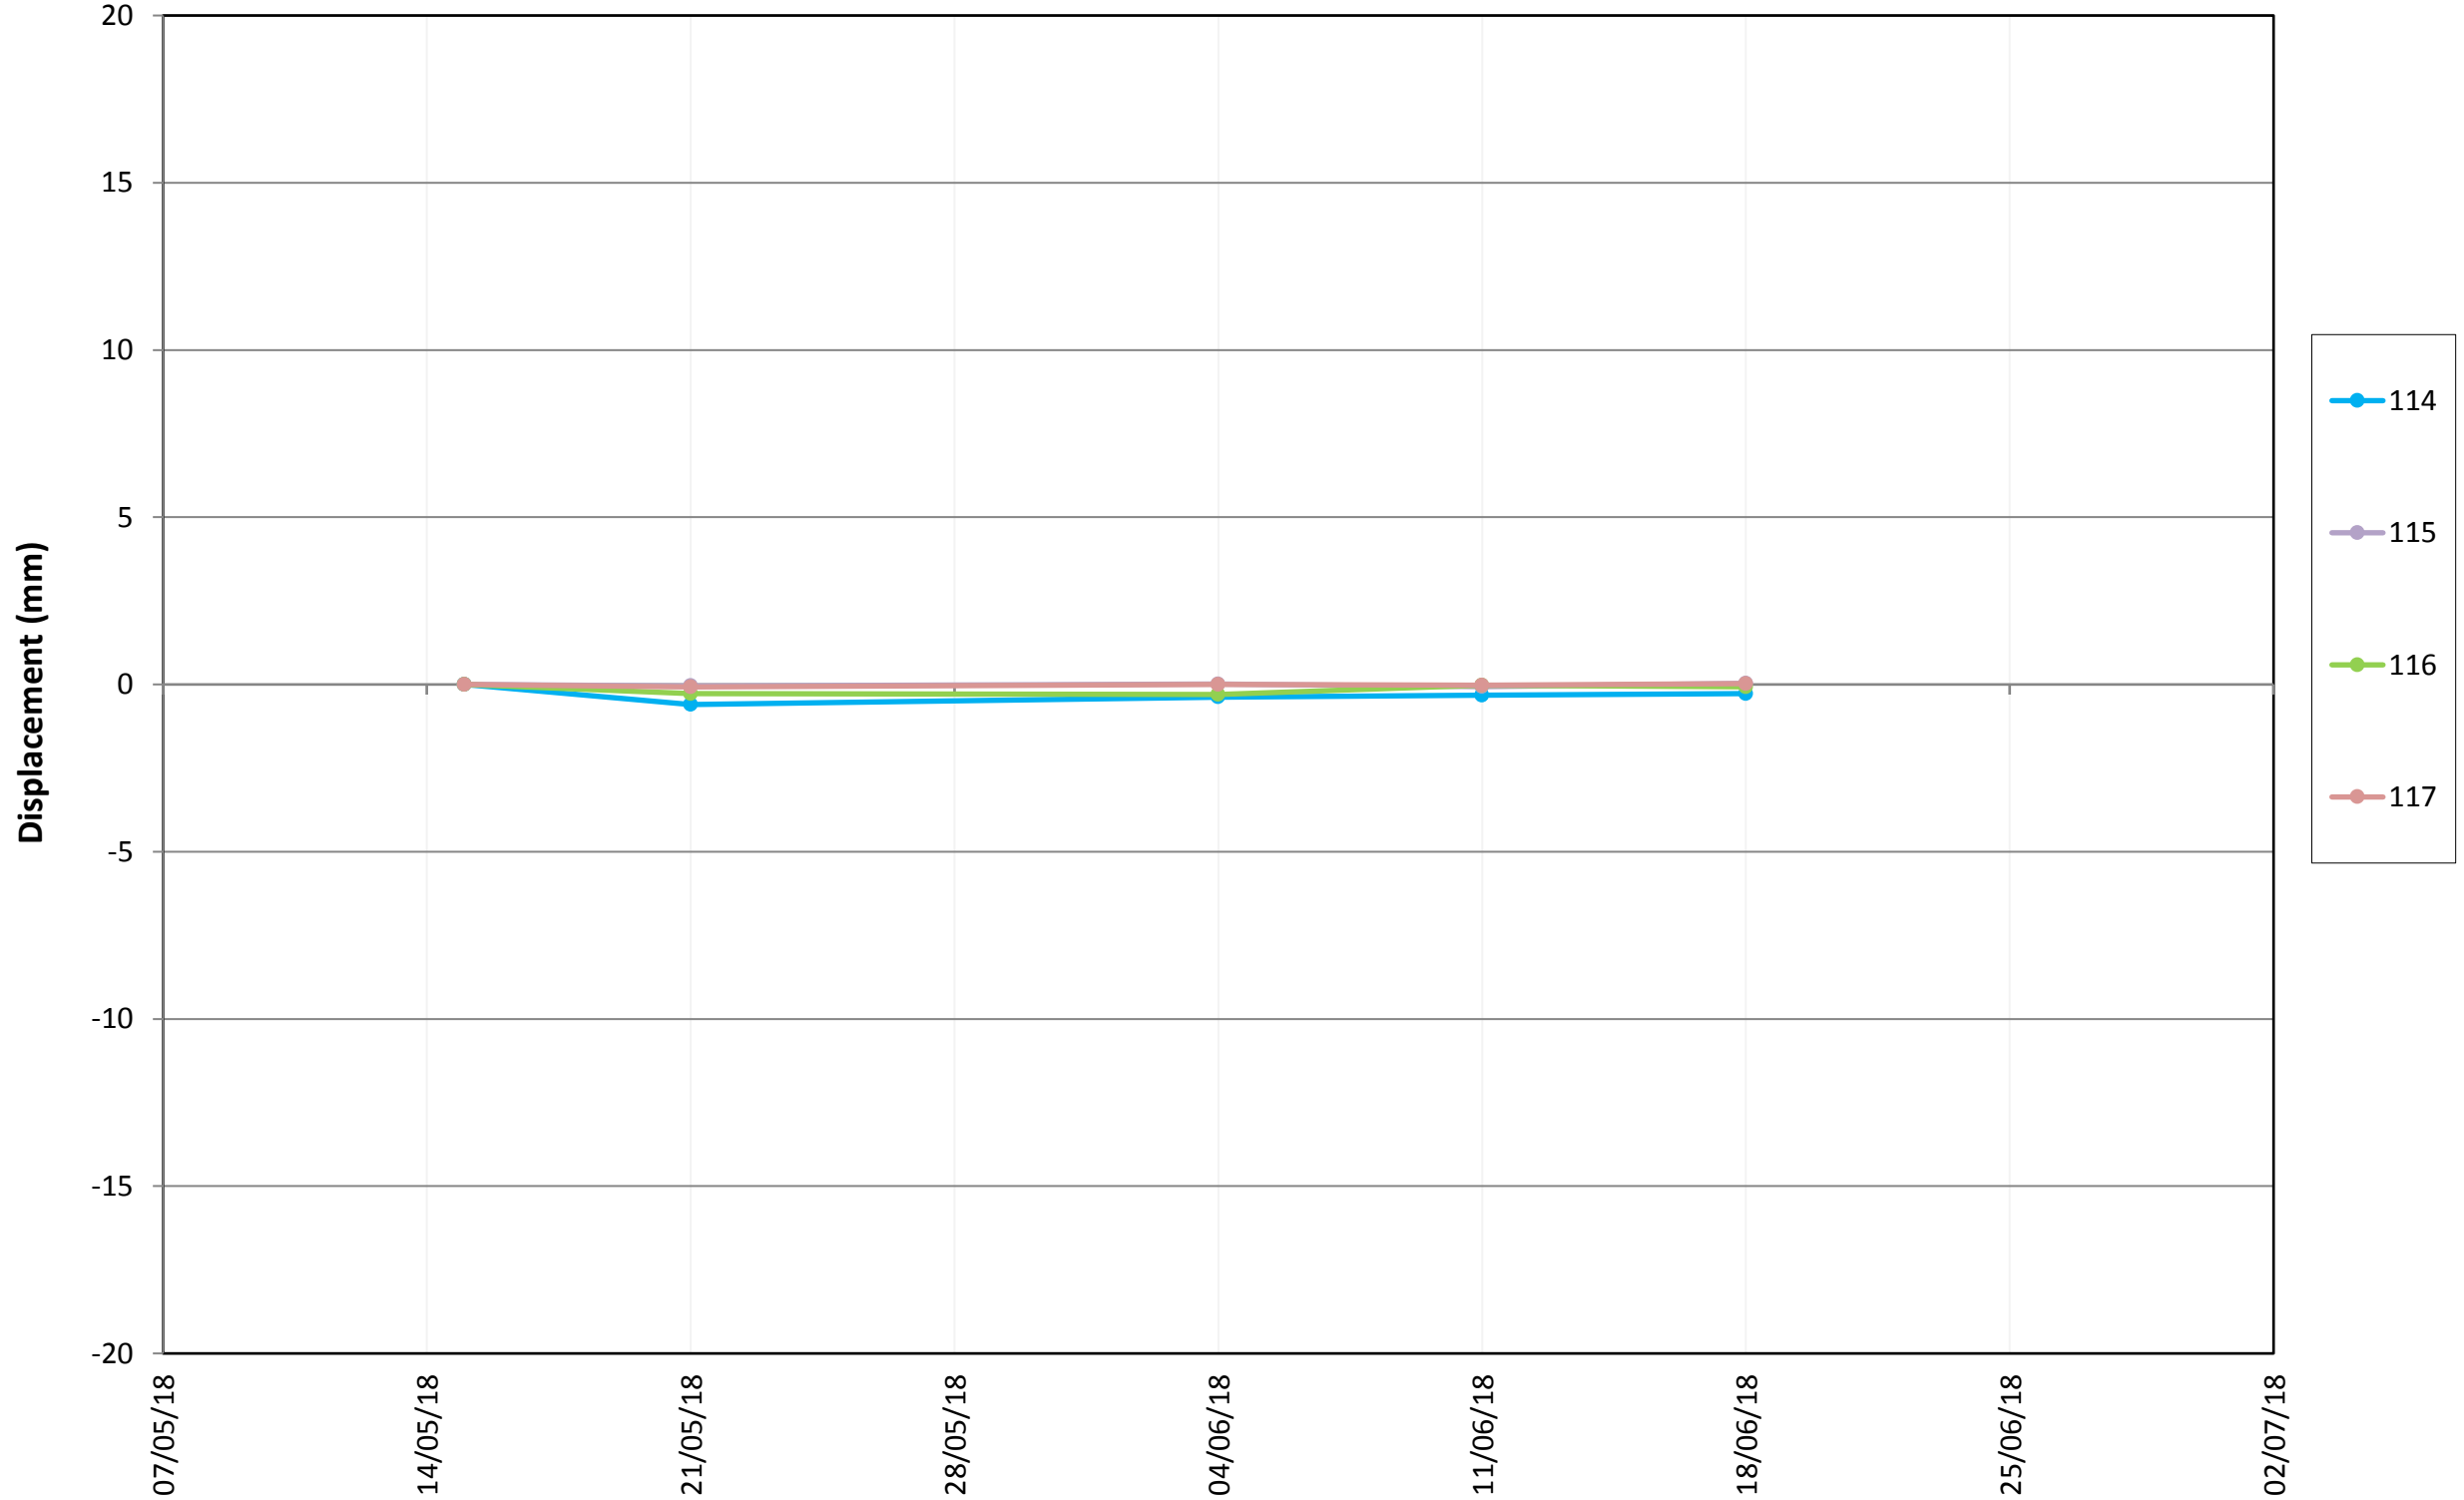
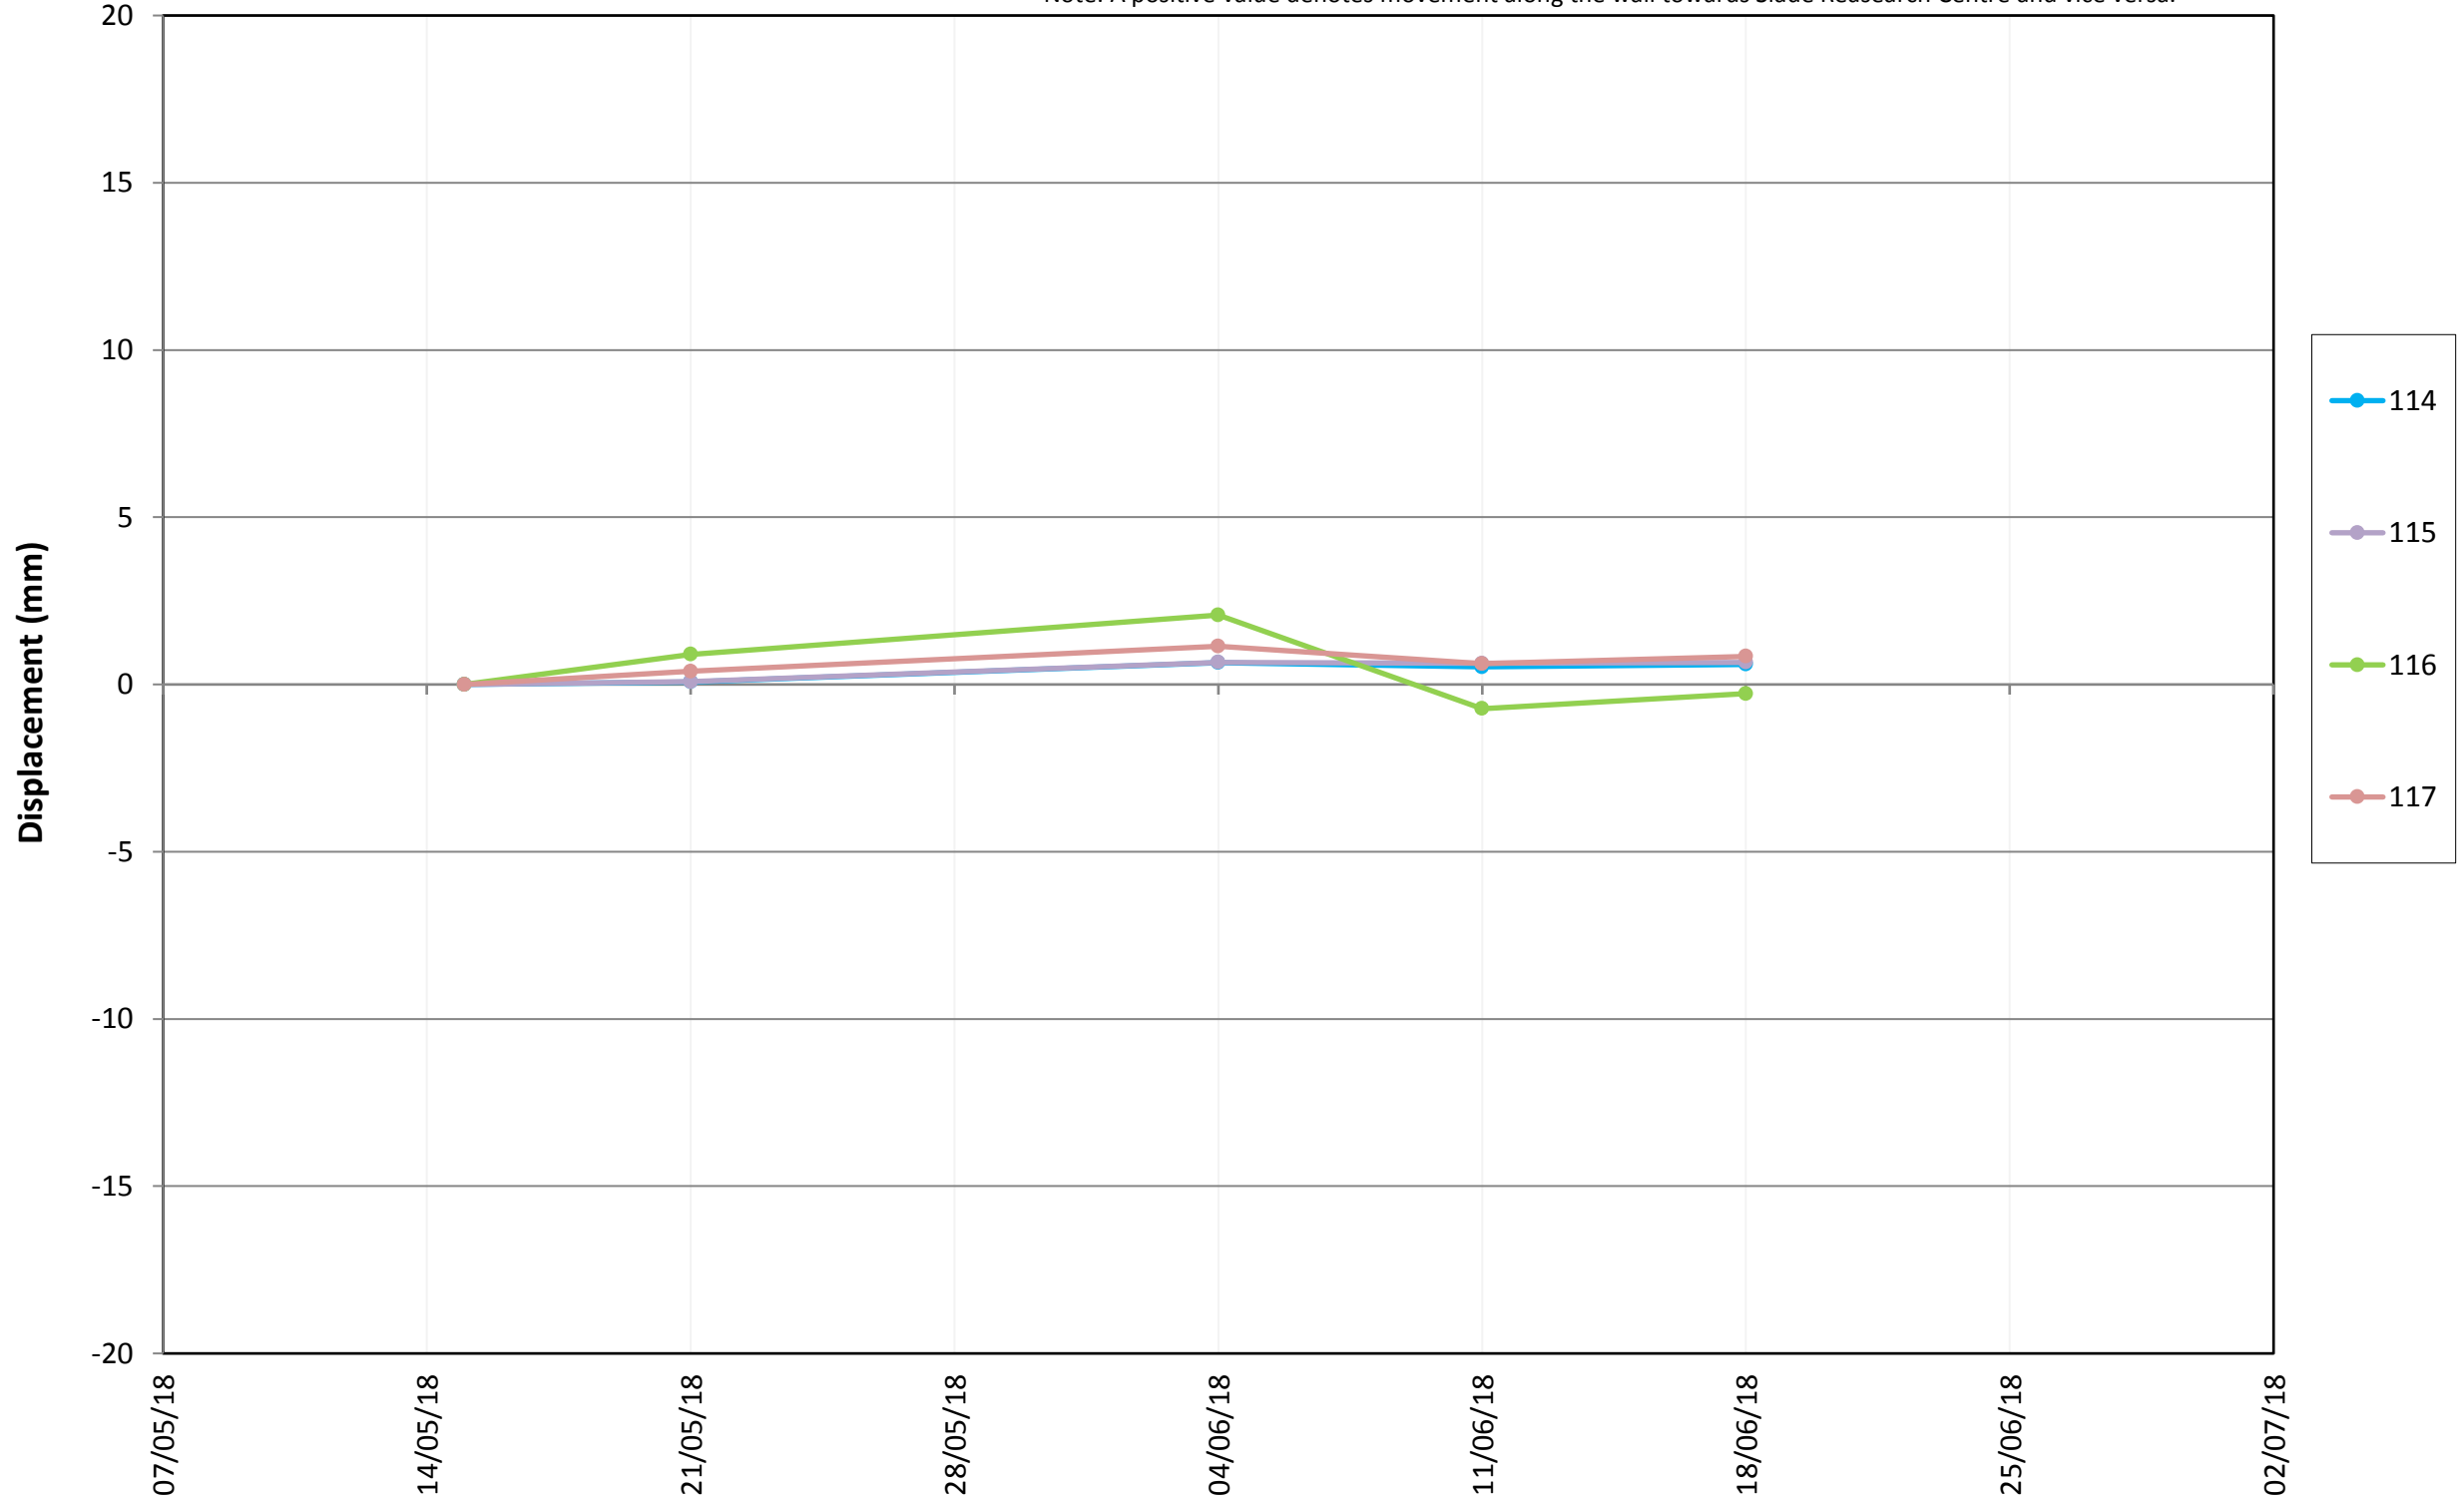
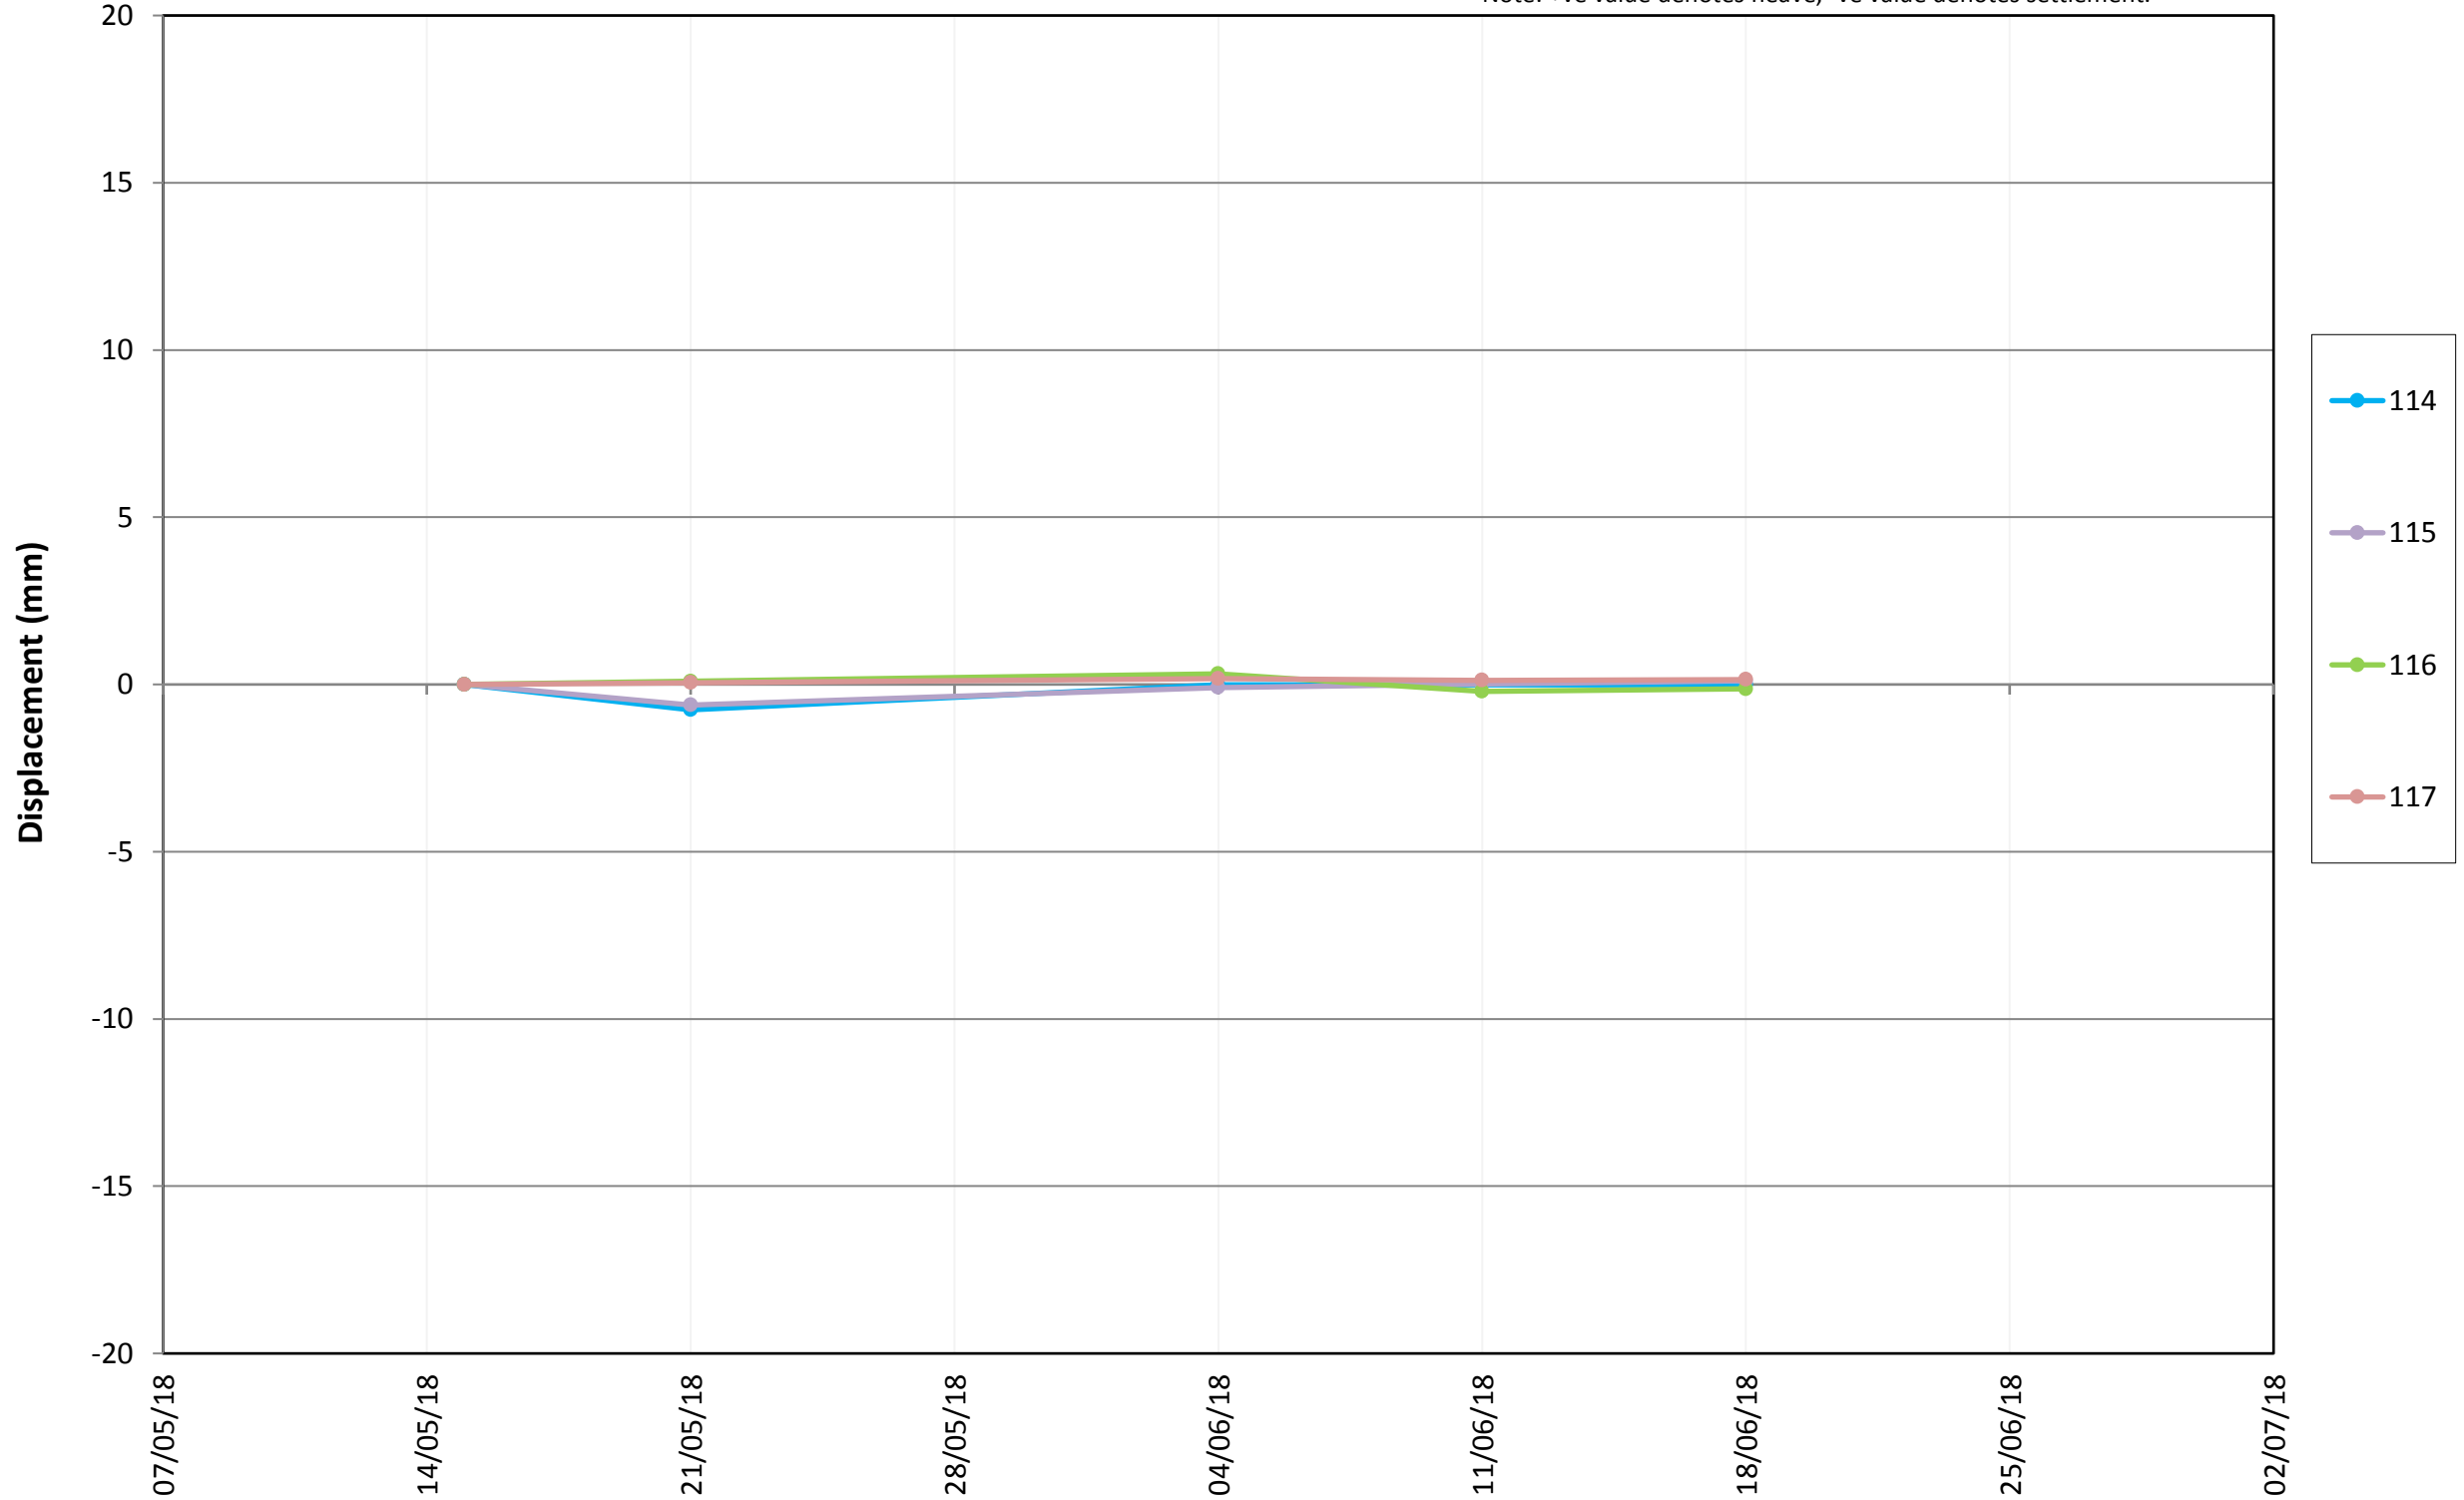
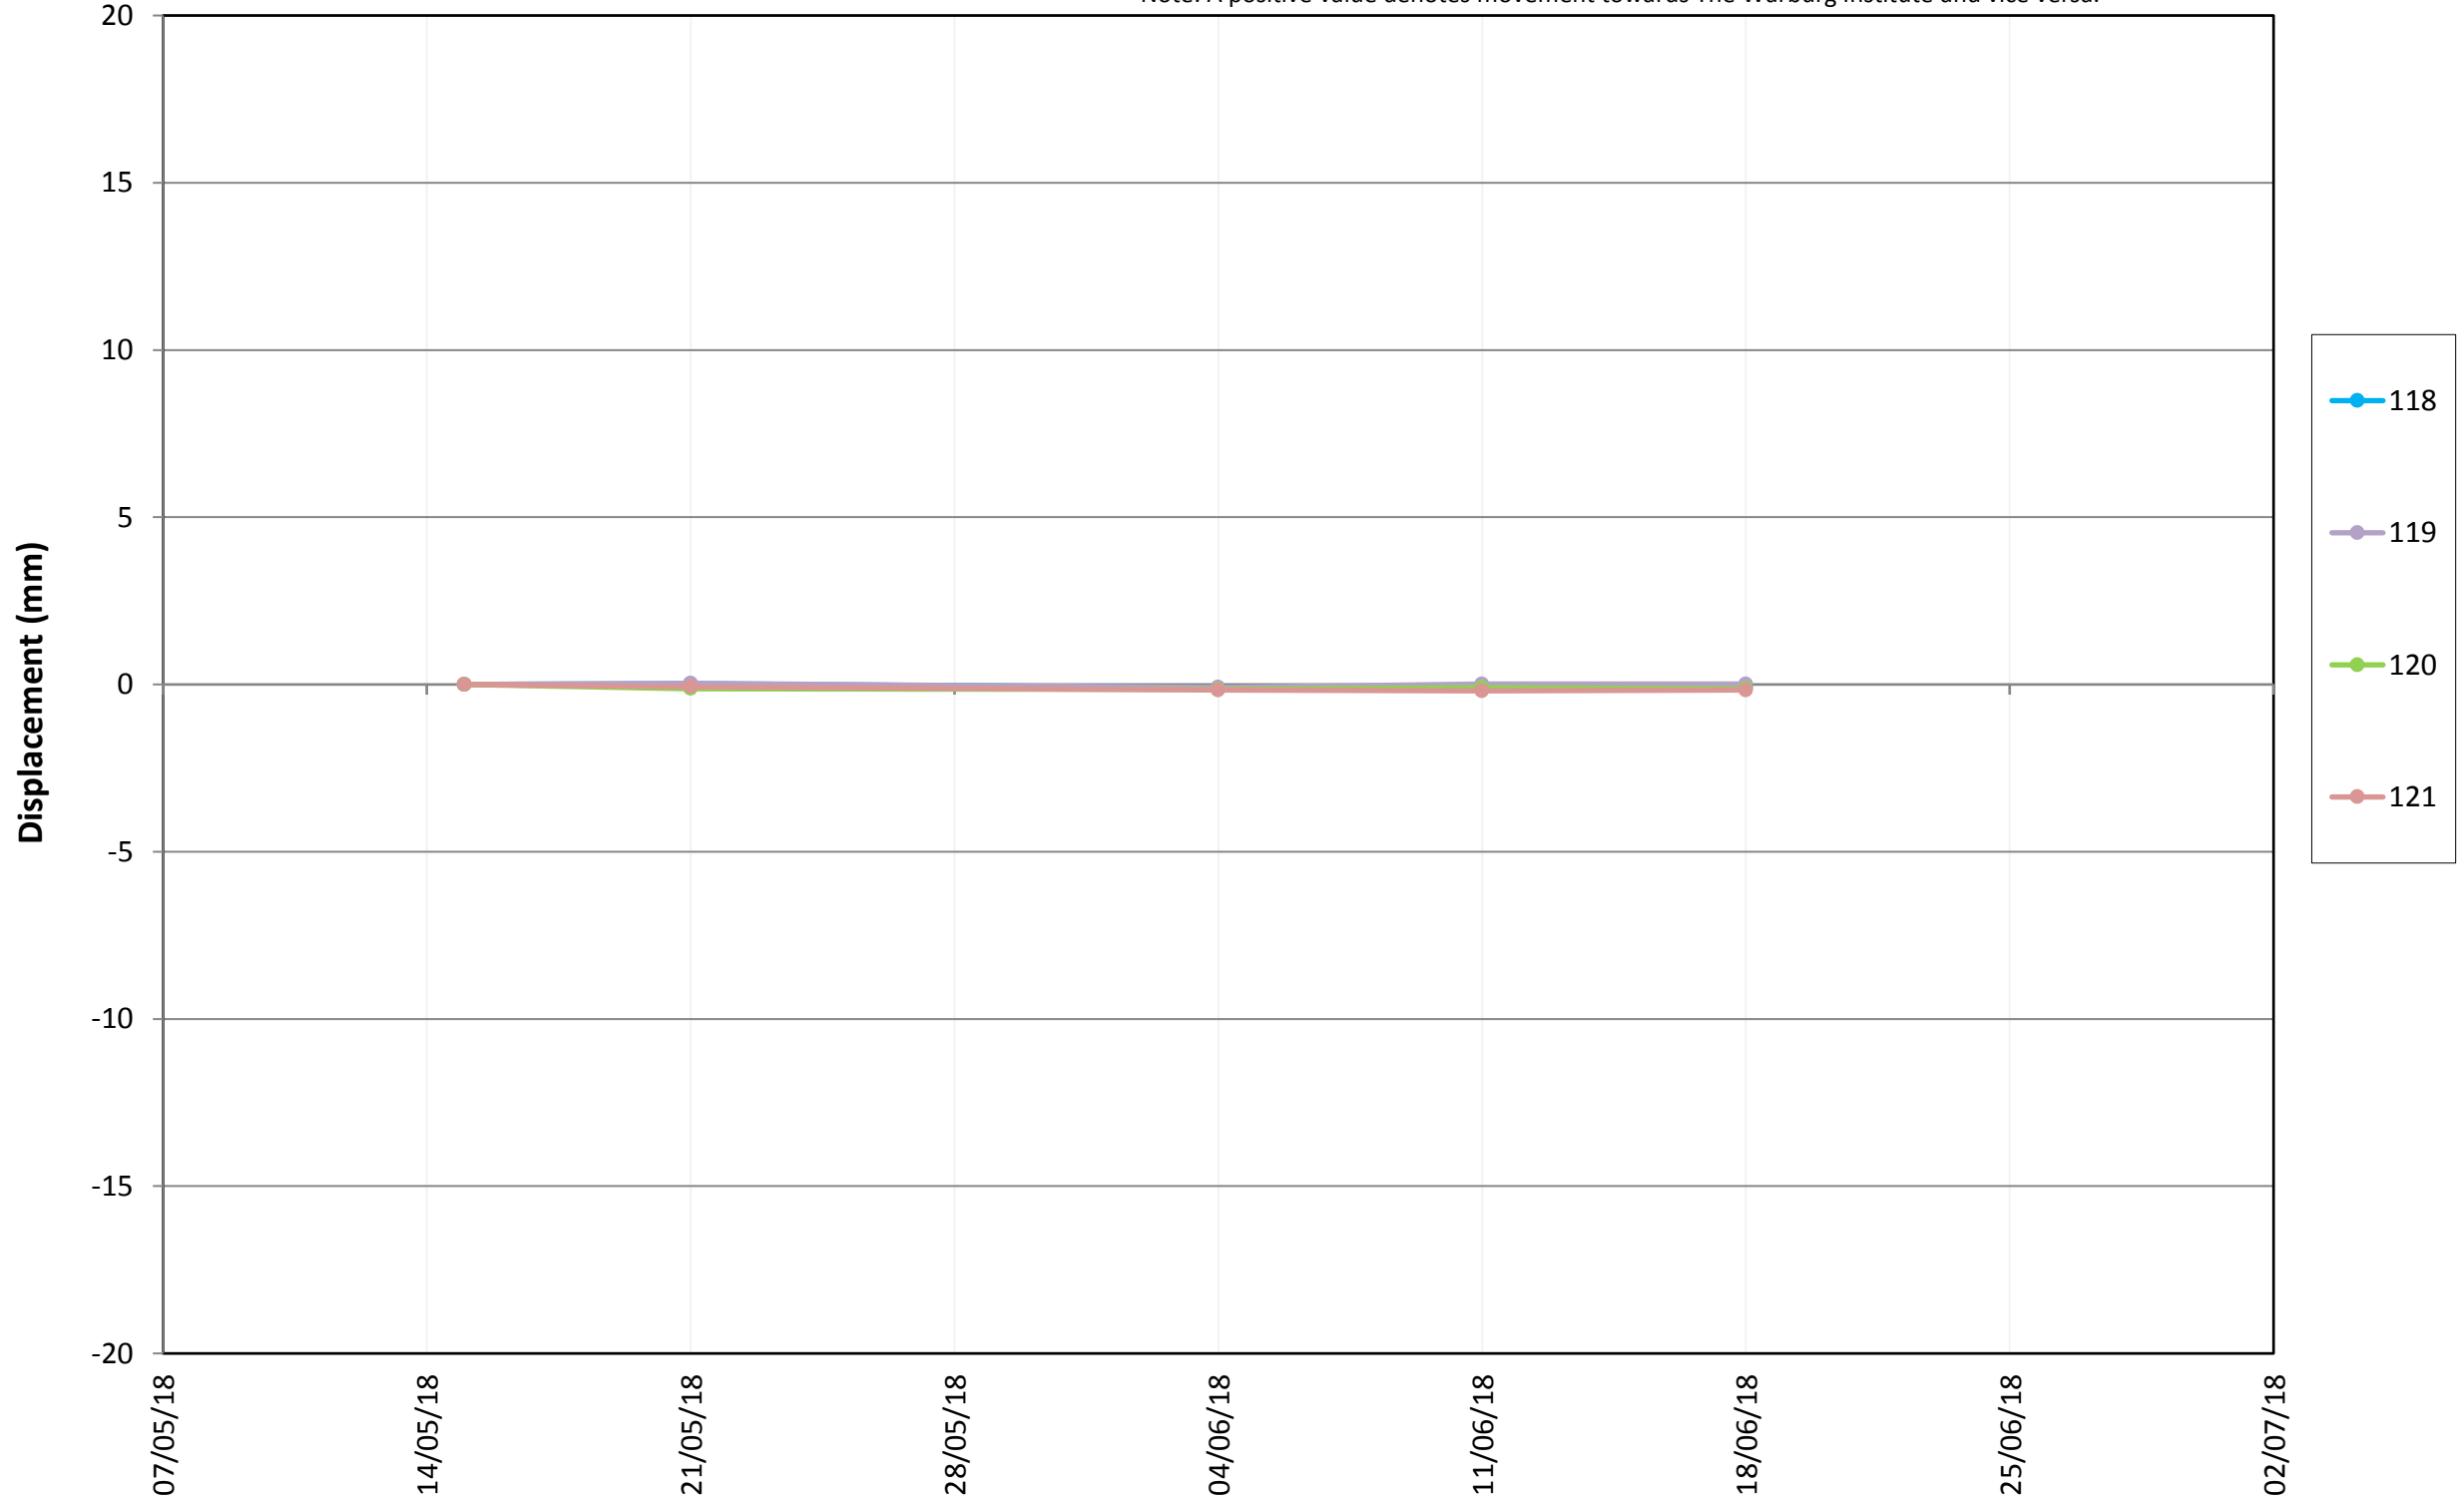
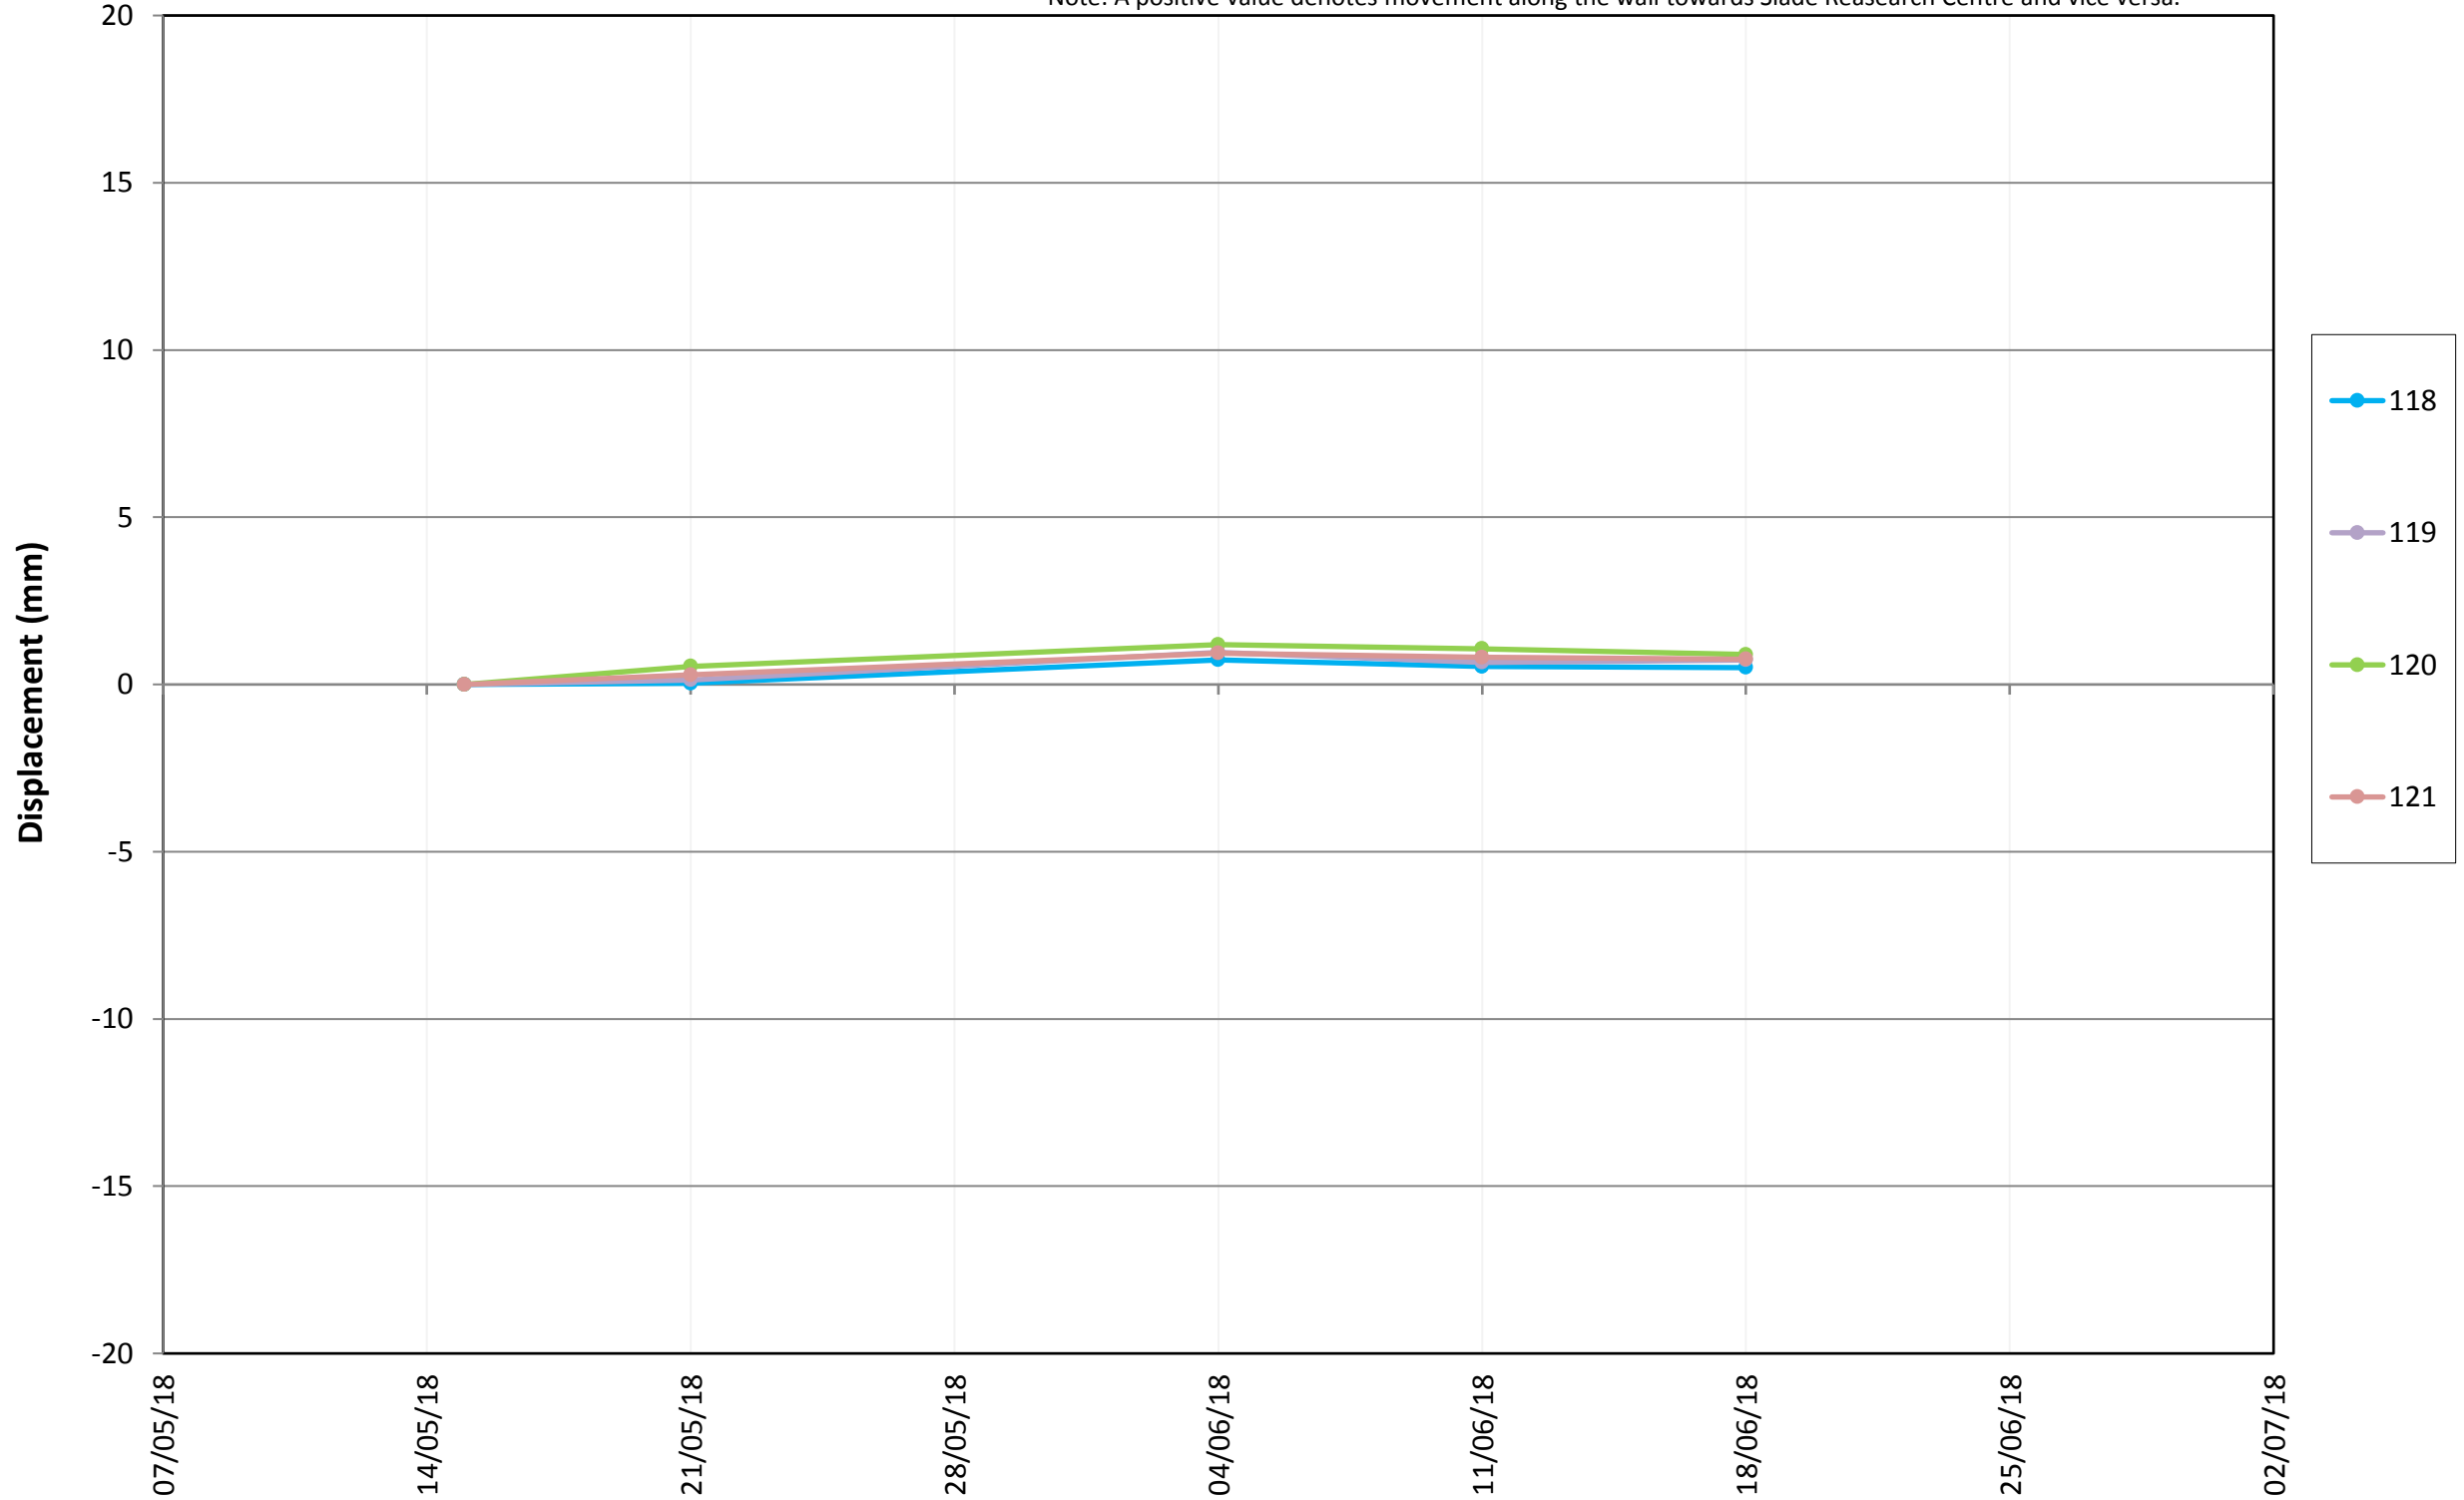
There was no access to survey the targets due to asbestos removal.

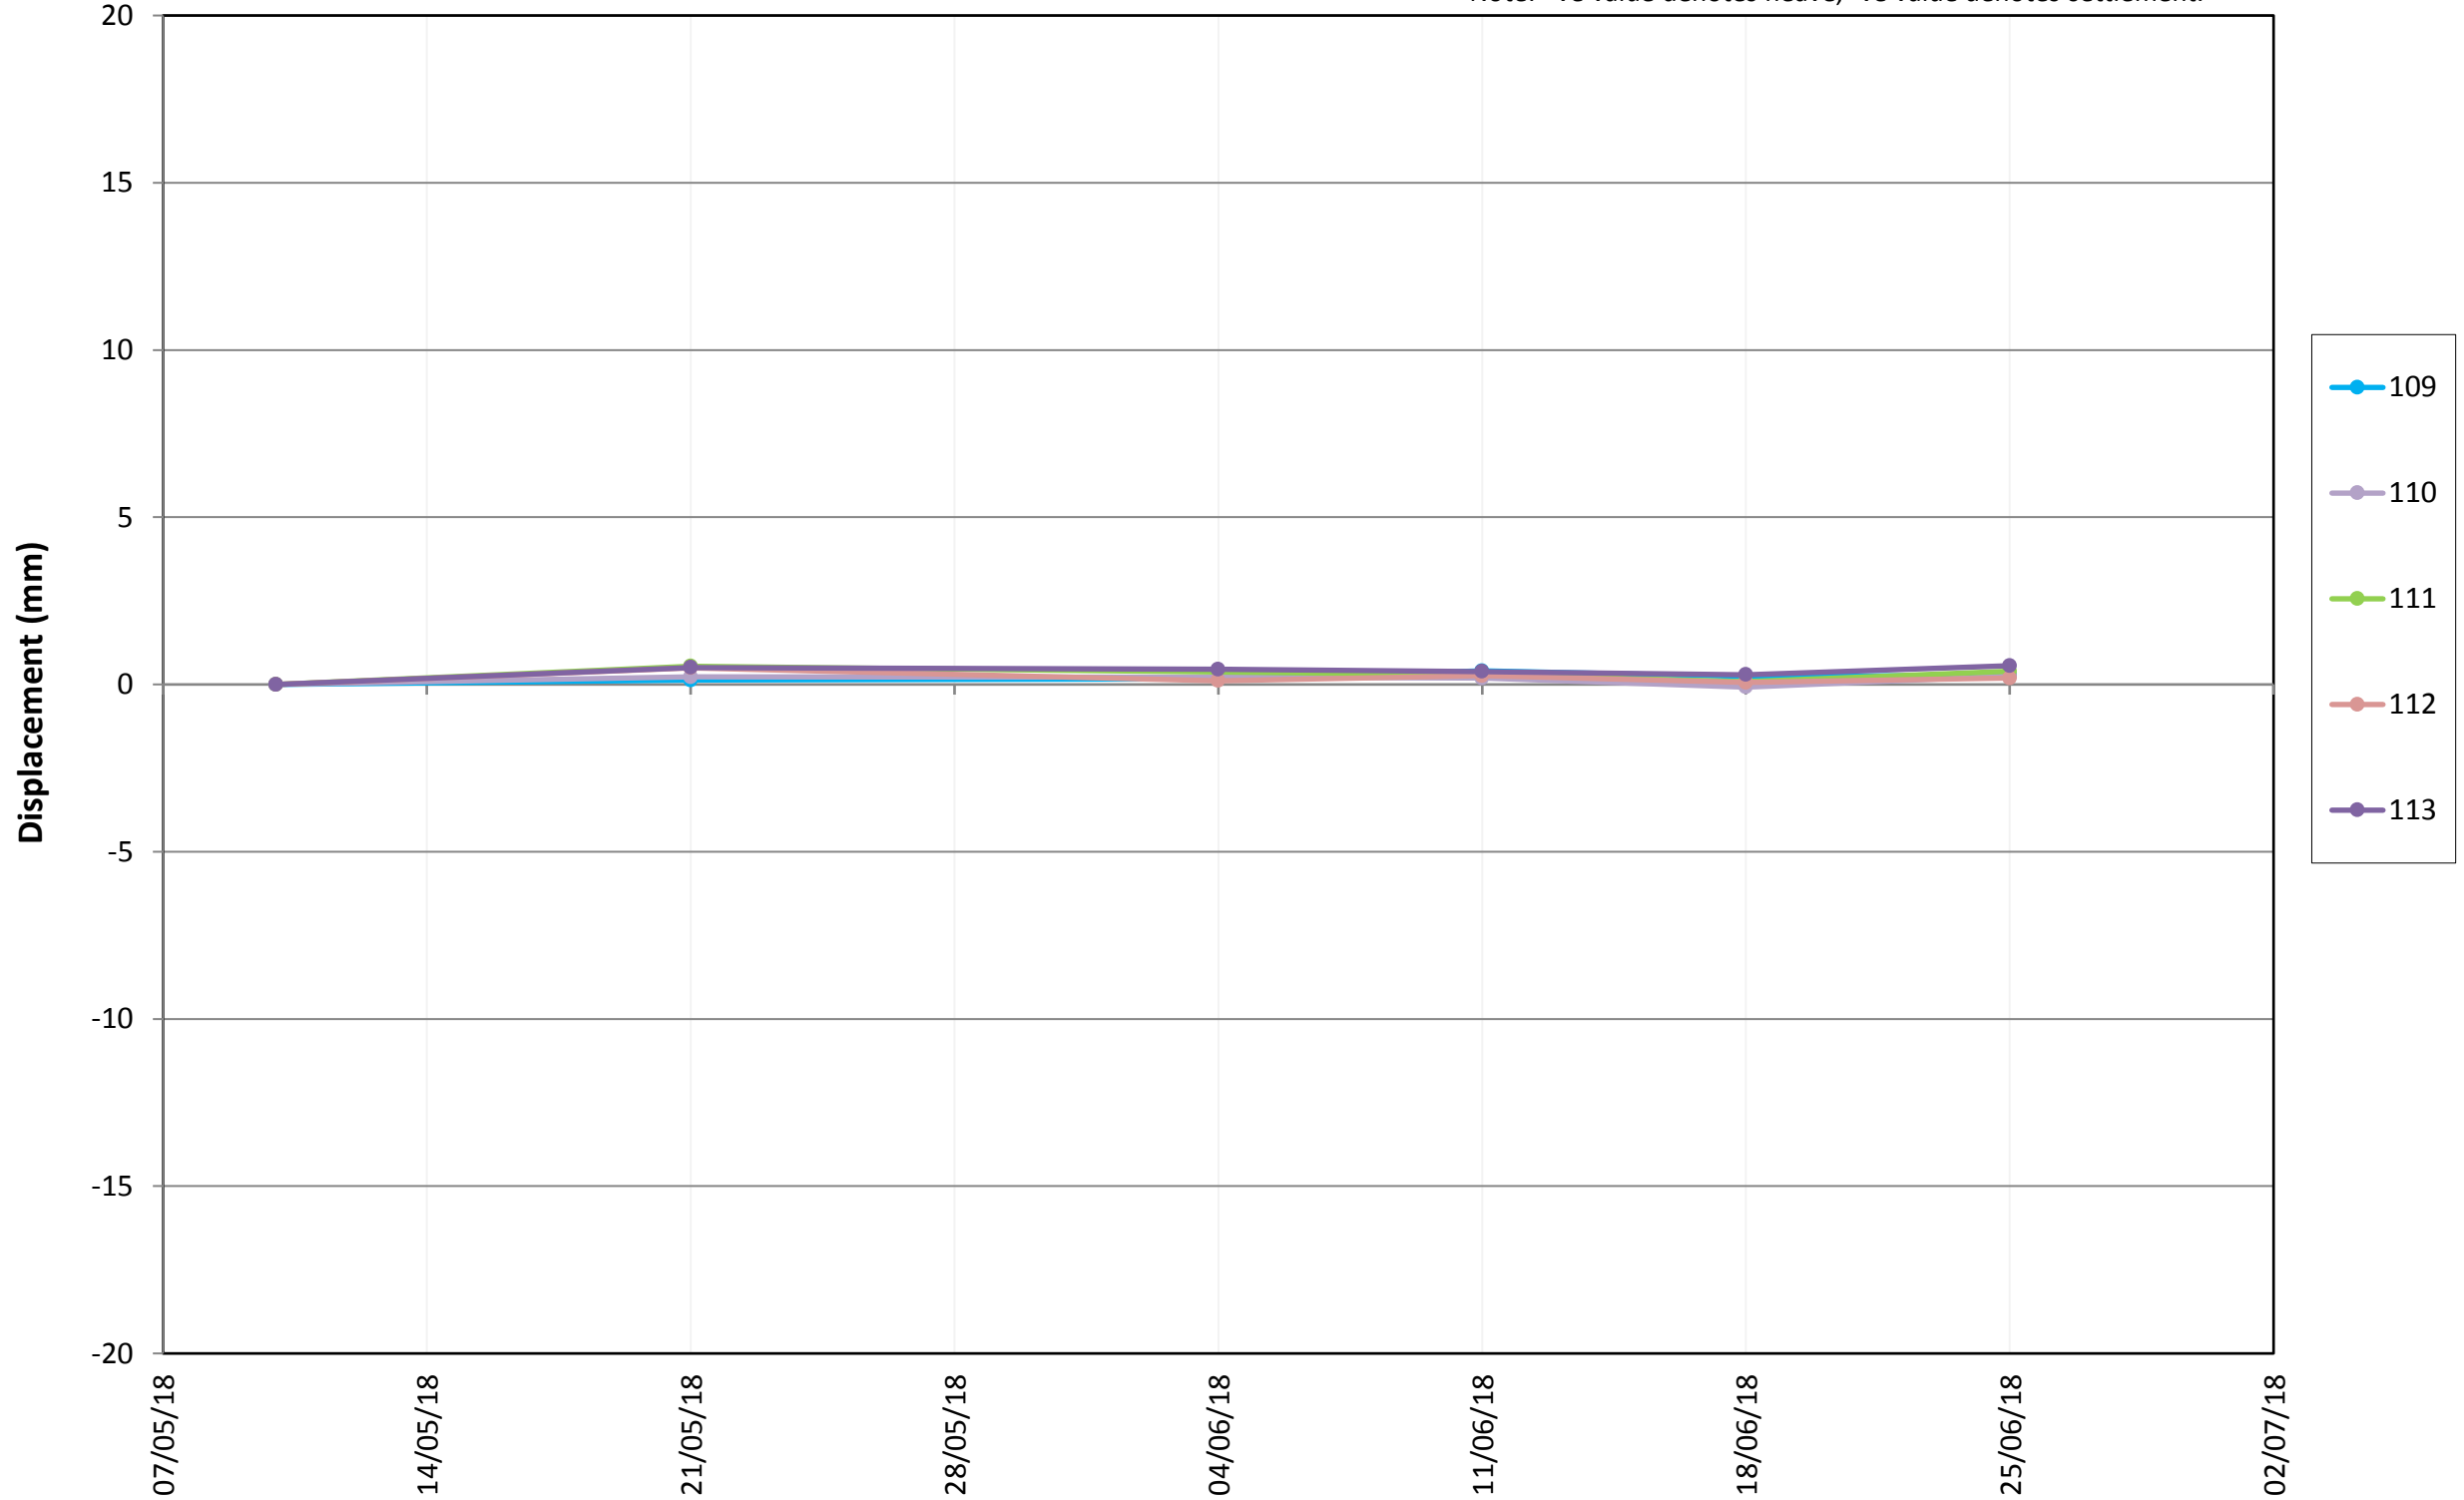
Graph 03 - Precise Level Points along courtyard

Precise level points are showing negligible movement.

Note: +ve value denotes heave, -ve value denotes settlement.
